Severn Estuary Rapid Coastal Zone
Assessment Survey:
Purton Hulks Aerial Photographic
Progression Study

(English Heritage Project No. 3885 2a PILOT)

Version 2.3 – Final

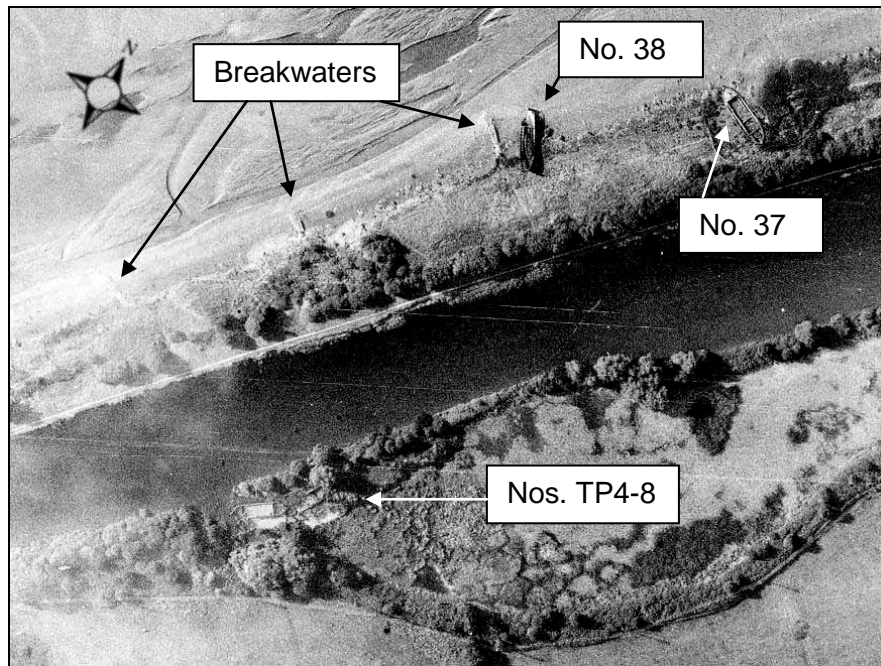
Figure 5. Photograph of vessels to the south in 1945.

This aerial photograph shows hulks Nos. 37 (*Barge Abbey*) and 38 (*Salina Jane*) to the south of Purton, as well as wrecks Nos. TP4 - 8, visible within the canal basin. (NMR RAF/106G/UK/733 3048 26-AUG-1945 © English Heritage (NMR) RAF Photography).

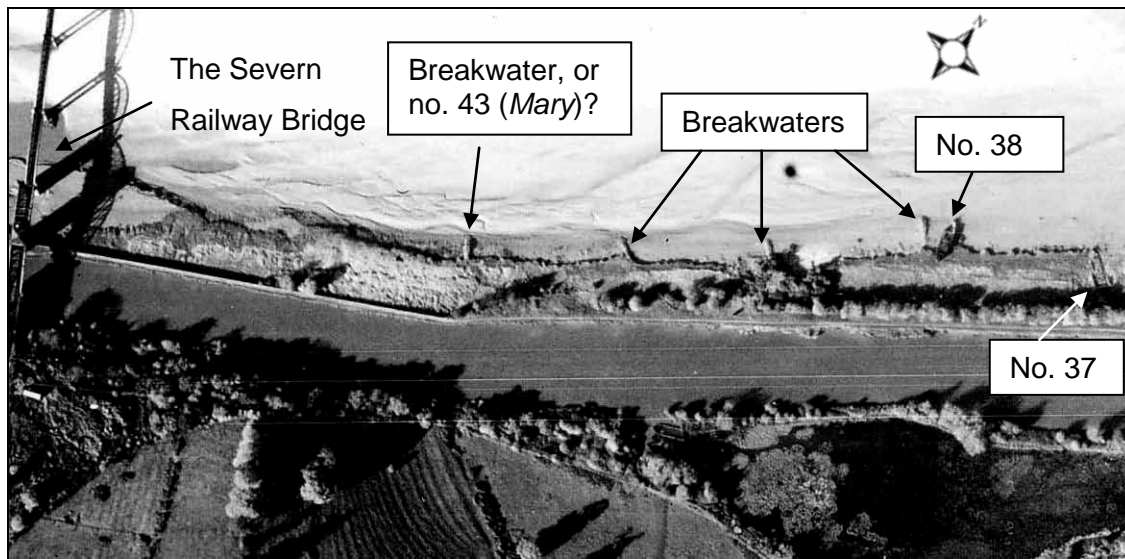
Figure 6. Purton hulks visible in 1946.

Vessels visible on an aerial photograph taken in 1946. This vertical photograph also shows at least three breakwaters down river to the south of vessel Nos. 37-38. (NMR RAF/CPE/UK/1825 4066 04-NOV-1946 © English Heritage (NMR) RAF Photography).

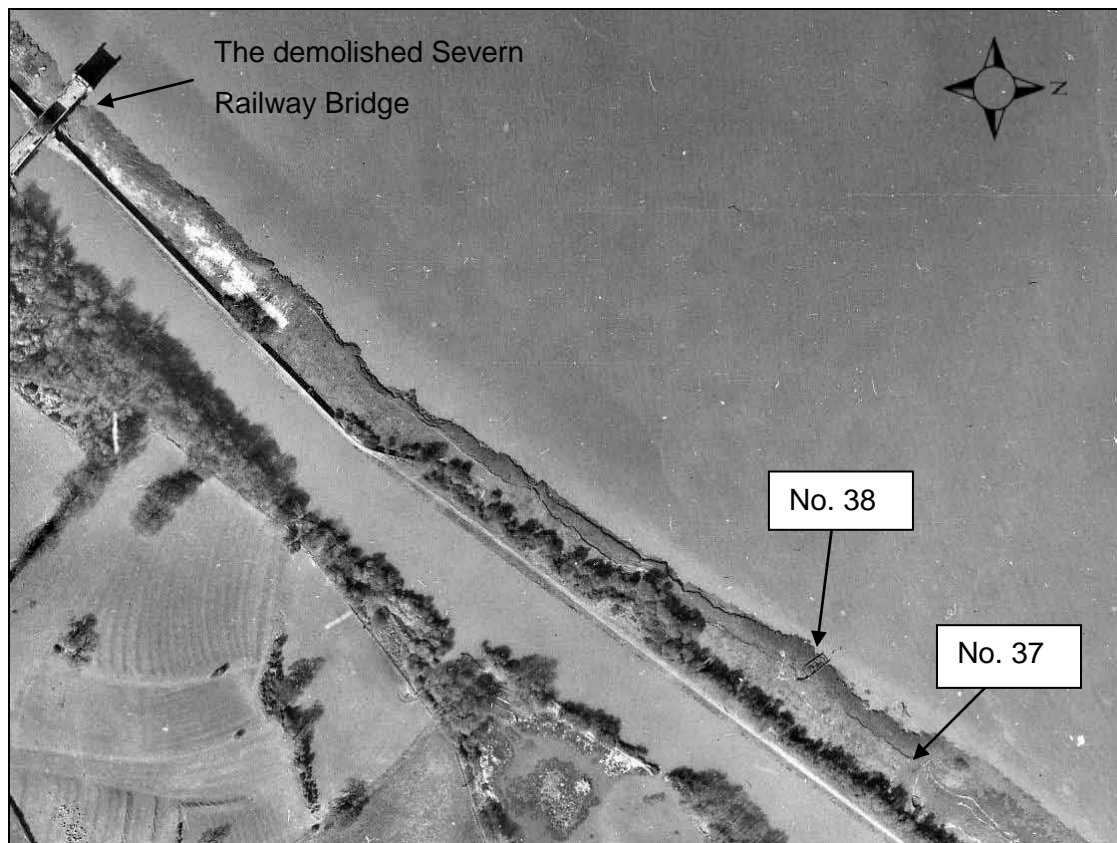
Figure 7. The breakwaters in 1969.

The breakwaters are not visible in 1969. Vessel Nos. 37-38 can still be seen. (OS/69117 155 18-APR-1969 © Crown copyright. Ordnance Survey).

Aerial photographs from 1969 (Figure 7), just four years after Wheeler's plan, show neither breakwaters nor new beached vessels, so it is possible that the hulks were buried between 1965-1969. This suggestion is supported by Barnett who states that the 1940s-60s saw this part of the site being inundated with several thousand tonnes of canal dredging and cuttings which in turn may have aided rapid vessel interment (Woodward pers. comm. to Barnett., see also Figure 14). The 1969 photographs were taken at high tide and it is therefore possible that remains of the breakwaters survived to that date but were underwater and therefore not visible.

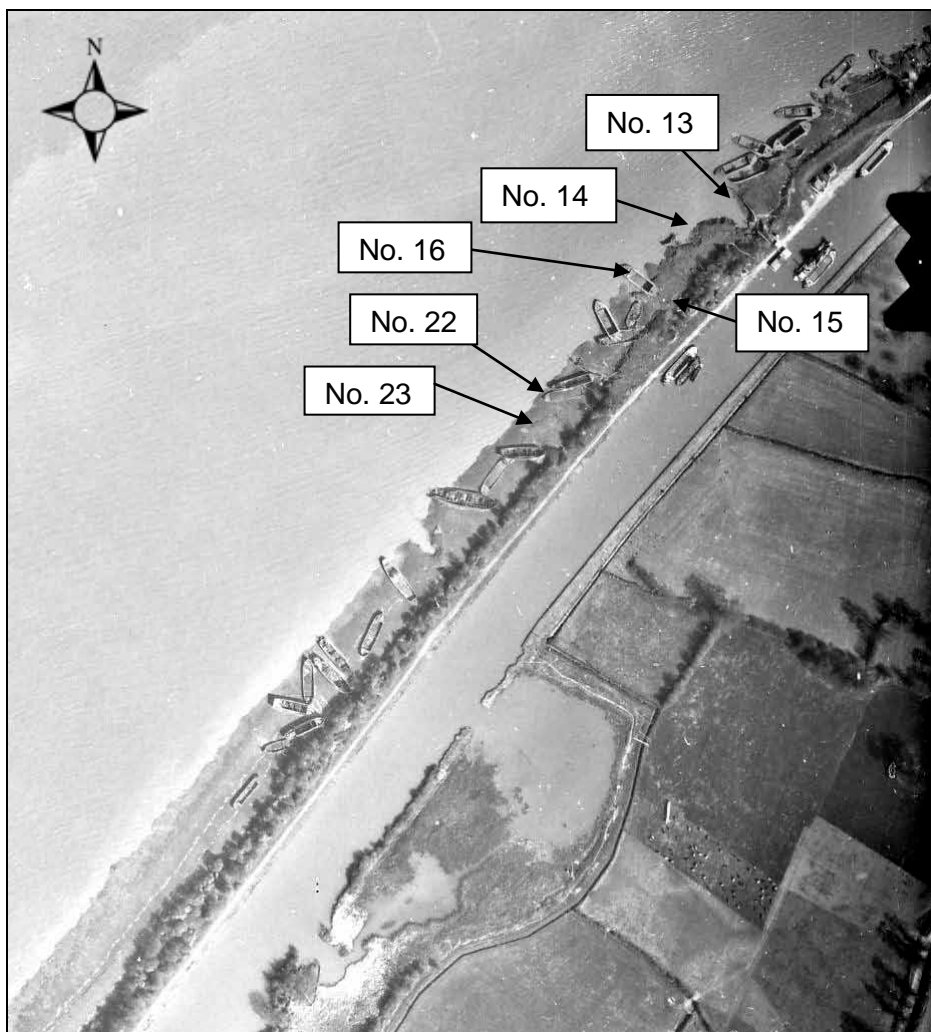
Figure 8. Purton hulks visible in 1969.

The vessels visible in 1969. Vessel Nos. 13 (*Barry*), 14 (*Petrus*), 22 (*Rockby*) and 23 (*Britannia*) are just visible, and No. 15 (*Mary Ann*) has been completely buried. (OS/69117 156 18-APR-1969 © Crown Copyright. Ordnance Survey).

The majority of vessels beached by 1946 were still visible, though some were partially buried, and Nos. 13 (*Barry*), 14 (*Petrus*), 22 (*Rockby*) and 23 (*Britannia*) were just discernible. Vessel No. 15 (*Mary Ann*) was completely buried, and hulk No. 16 (*FCB 52*) had been placed on top of it (Figure 8).

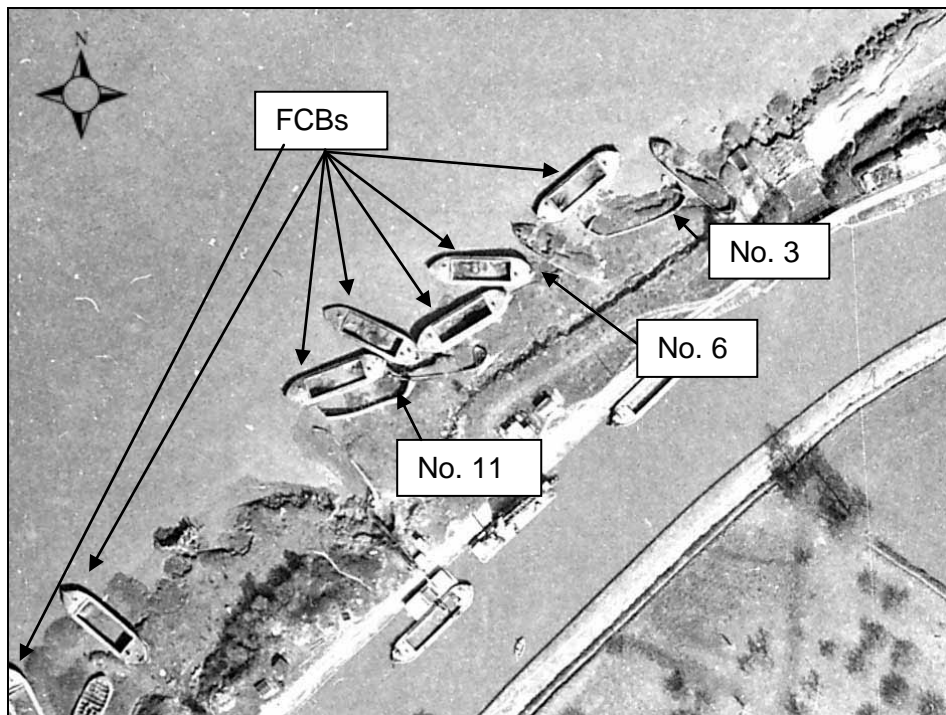
Figure 9. FCBs and partially buried vessels.

This 1969 aerial photograph shows the Ferrous Concrete Lighters beached in 1963-1965. Timber vessel Nos. 3 (*Newark*), 6 (*40 ton Flat*) and 11 (*J & A. R*) were first visible in 1969, but were already largely buried. (OS/69117 234 18-APR-1969 © Crown Copyright. Ordnance Survey).

Many of the vessels beached after 1947 were Ferrous Concrete Barges (FCBs), seven of which were visible in 1969 (Figure 9). Built in 1941 in order to replace steel harbour lighters lost in the Second World War, they were finally run aground in 1963-1965 (Barnett 2008: 7-8). Vessel No. 16 (*FCB 52*) was re-floated and moved to the National Waterways Museum on 29th March 1990 (Hugh Conway Jones pers. comm. to Barnett

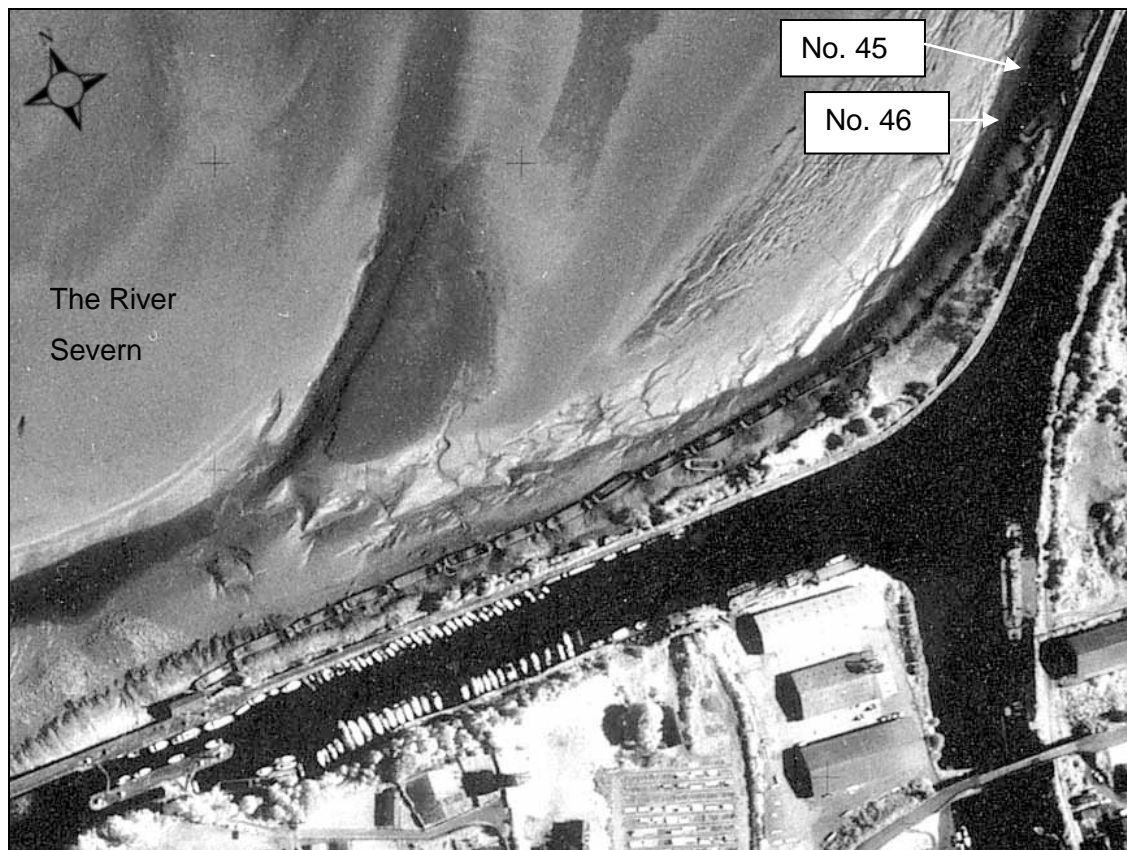
Figure 10. The Sharpness hulks in 1979.

The hulks visible on the Sharpness foreshore on a 1979 aerial photograph. Vessels No. 45 (*Severn Conveyor*) and No. 46 (*Lighter No. 9*) are just discernable in the upper right corner of the image. (OS/79034 026 19-MAY-1979© Crown Copyright. Ordnance Survey).

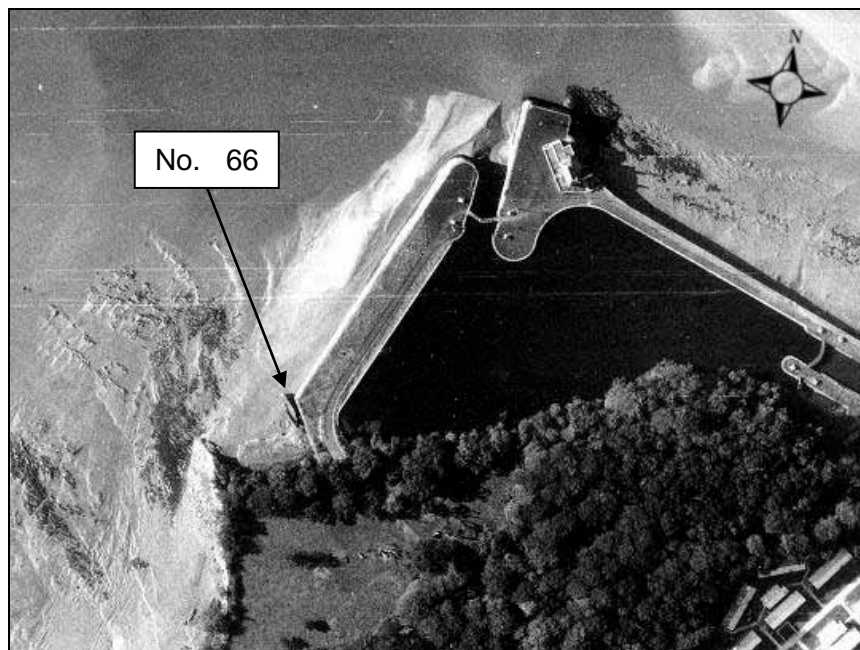
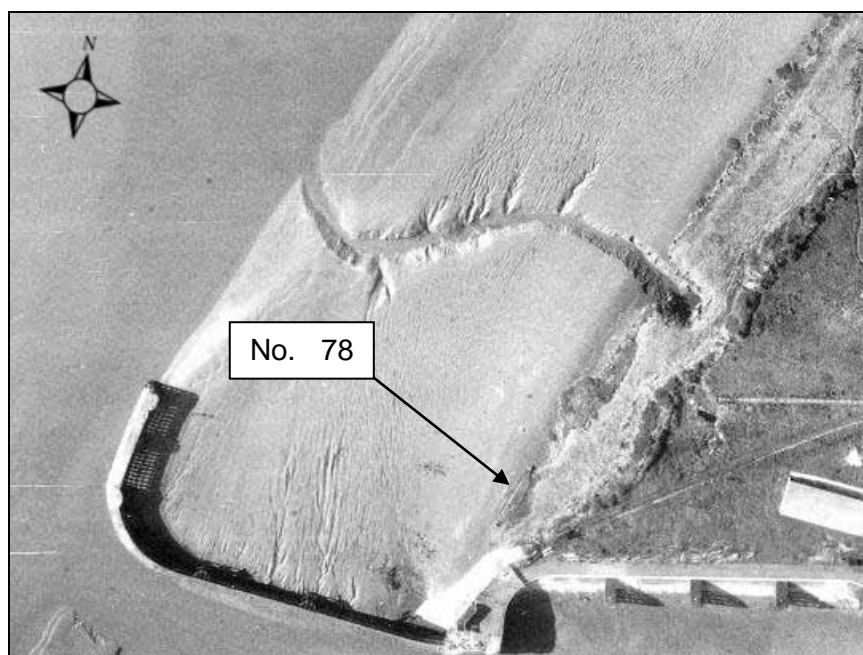
Figure 11. The two wrecks at Sharpness Docks.

The top photograph (Figure 11a) shows vessel No. 66 (*Alaska*), and the bottom photograph (Figure 11b) shows vessel No. 78 (*Tribune*), both visible in 1945. (NMR RAF/106G/UK/733 3052 26-AUG-1945 © English Heritage (NMR) RAF Photography).

Further south on the east bank were two wrecks (Figure 11) which were also mapped as part of this study (vessel Nos. 66 *Alaska* and 78 *Tribune* (after Barnett 2008). Both were visible on 1945 aerial photographs, but not those taken subsequently. Paul Barnett has provided further details regarding the history of these vessels. They were abandoned and then broken up. The *Alaska* keel eventually drifted off the bank c. 1977 and the remains of the WWI Cruiser *H.M.S. Tribune* were eventually buried after the majority of her steel was recovered by local scrap merchants c.1922 (L. P. Barnett pers. comm. 2009).

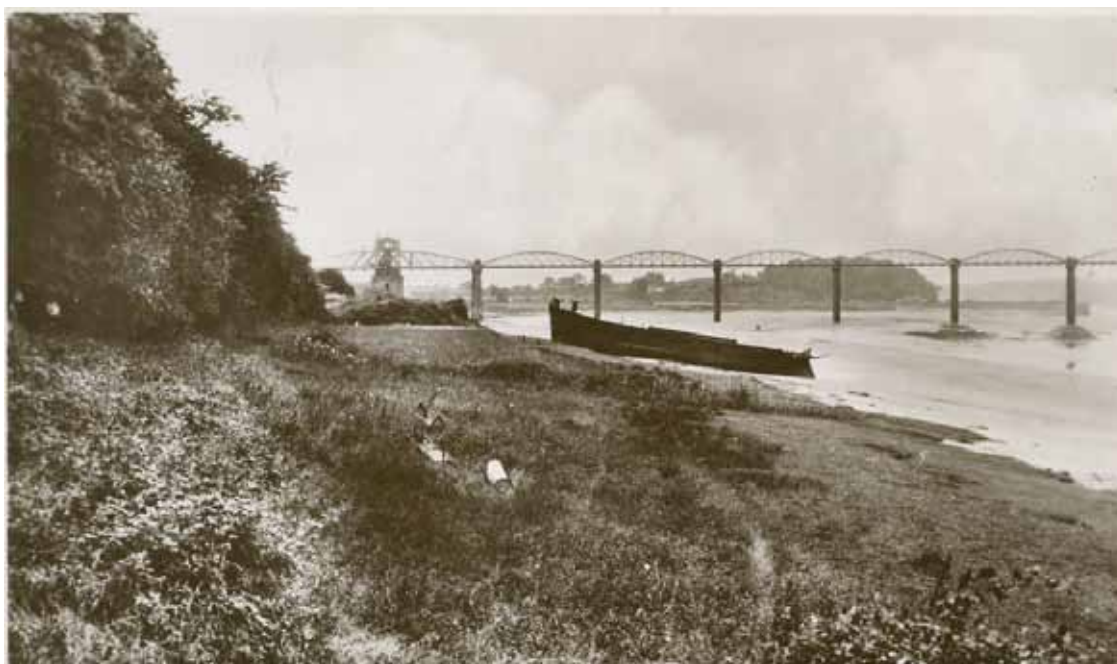
Figure 14. Late 1940s? photograph looking south towards the railway bridge

Photograph reproduced courtesy of Pat Greatorex. Note the build up of dredging material to the north of the railway bridge. Vessel 38 (*Selina Jane*) is visible in the middle ground.

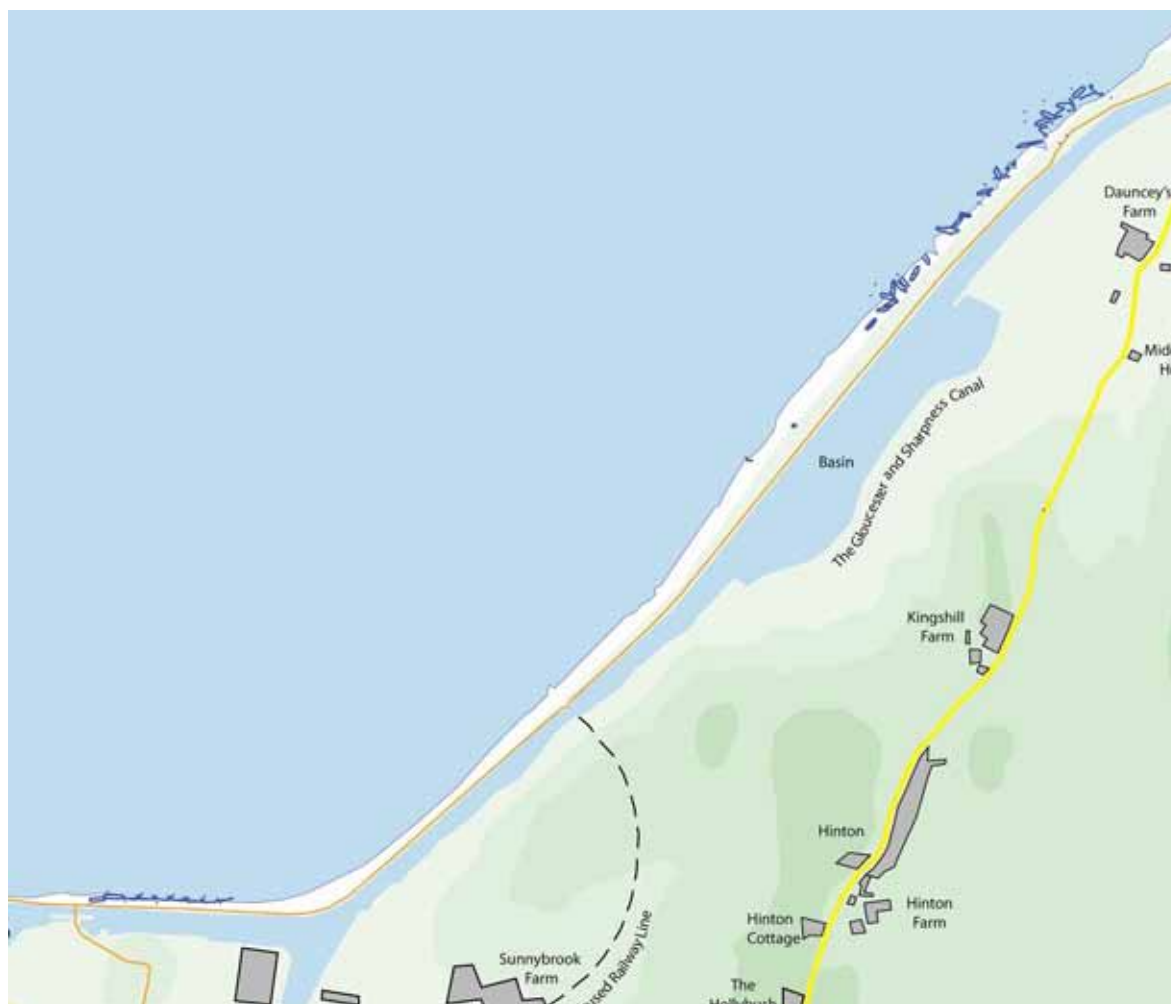
Figure 22 The GPS survey of 2009

The GPS survey indicates all vessels visible on the ground in 2009. Results kindly supplied by Laurie Coleman. (Base Map © Crown copyright, All rights reserved. Gloucestershire County Council 100019134 2010).
