# Worlebury hillfort and the linear earthworks to its east, Weston-super-Mare, North Somerset

Archaeological Survey Report

NGR: ST 312 624

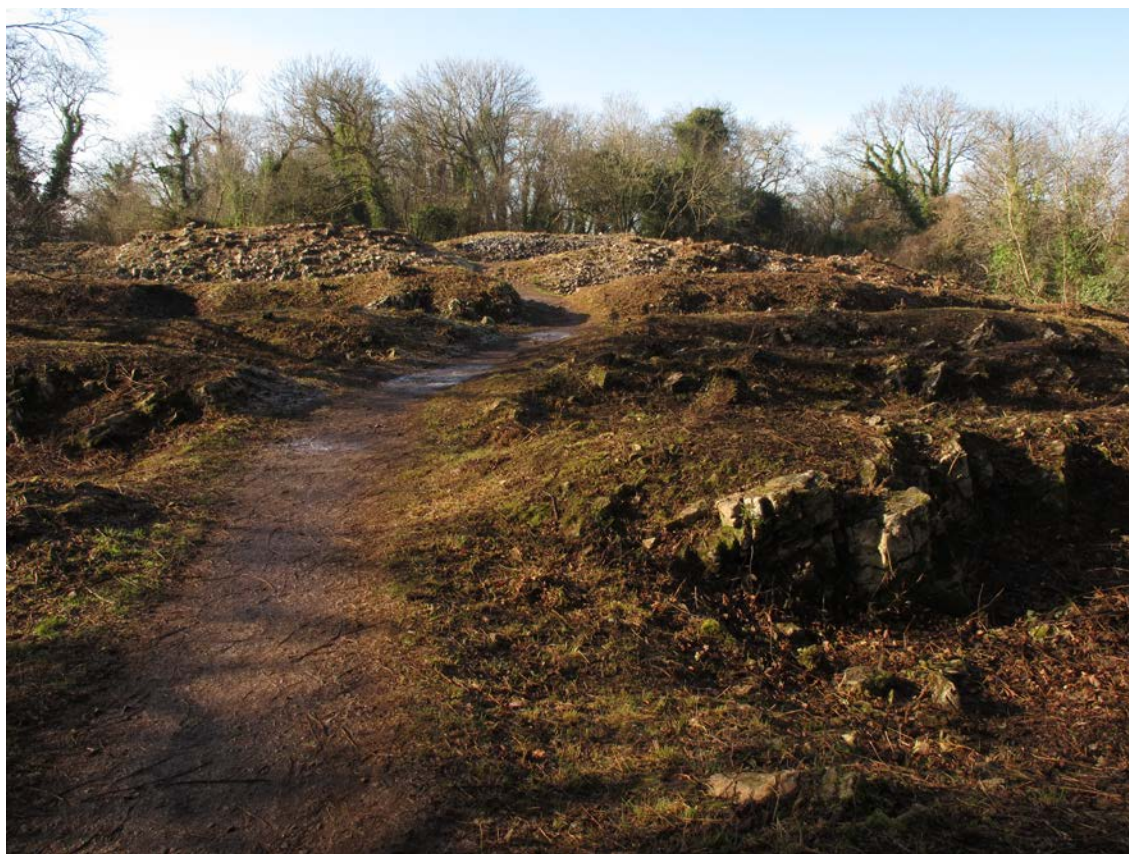
*Fig 7: The array of rock-cut ditches fronting the main ramparts at the east end of the hillfort, with the modern path cutting across the middle of them; January 2019*

these elements are overlain near their central axis by a modern path, now the main entrance to the fort, which has smoothed their profiles (Fig 7). The outermost ditch (a) consists just of three short isolated lengths. The second (b) is more continuous but has a single causeway towards its northern end. The third (c) is continuous but ends in a curious terminal at its north end. The fourth, (d) is longer than the others, wrapping around the northern and southern flanks; to the north it is just a ledge but to the south it runs for a considerable distance as a well-defined ditch. The fifth (e) is longer still to the north, though again it only survives here as a ledge at its extreme end; to the south it loses its form on the natural slope but also survives as a ledge and a break of slope for a considerable distance. These ditches are no more than 4m to 6m wide and up to 1.6m deep; though they are not large they represent an impressive investment of labour and resource. There is not much evidence of material on the relatively narrow ledges between these multiple outer ditches and it is probable that much of the rock derived from them has been used to enhance the two main ramparts, both of which are very substantial and possibly contain more material than can have been derived from their own ditch, wide though it is. This main ditch (f) is broad but does not appear now to be very deep and may never have been so. Dymond's excavations do not throw very much light on this, though he excavated the ditches at 'every critical point – clearing out the material with which they were choked' (1902, 37-8). He seems to have paid more attention to the outer ditch (e) and the ditch along the southern side of the fort (g). His section drawings of these (1902, pl V fig 5, pl VI figs 3, 4, 5, 6 and 7) suggest that these ditches are slight and irregular, as they appear now; ditch (g) appears as no more than a ledge for most of its length. The outer of the two main ramparts (h) is perhaps best described as a counterscarp, though it is very large; behind it is the main ditch and then the main or inner rampart (j), another very large mass of stone (see cover image).

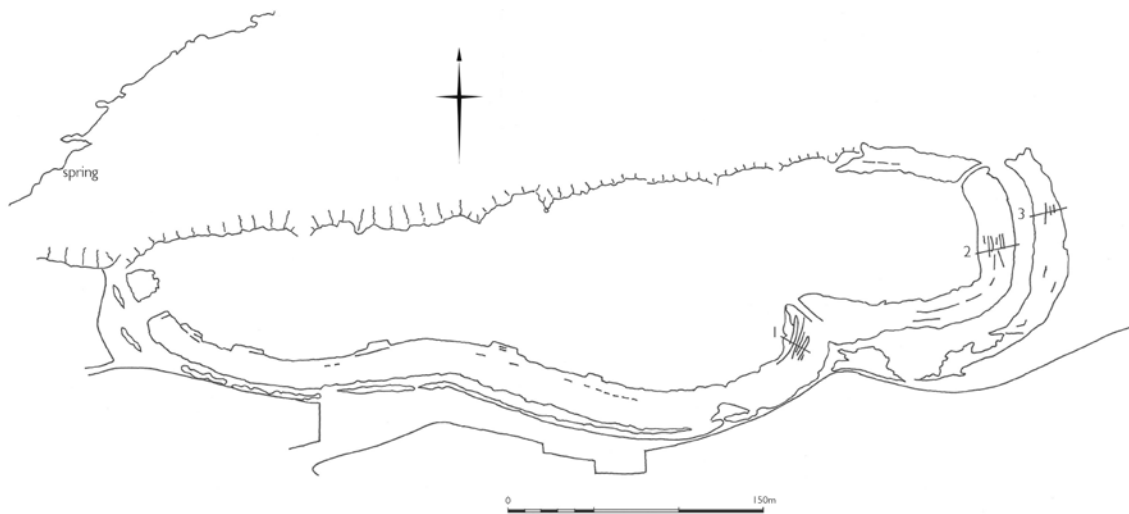
*Fig 8: Plan showing locations of the structural elements found by Dymond within the ramparts; sections 1-3 are shown in Fig 9. The location of the spring below the western end of the hillfort is also shown. (Re-drawn from Dymond 1902, pl III)*

The three outer ditches occupy the relatively narrow top of the ridge and do not descend very far down the slope on the northern side and not at all on the southern side. The main ramparts and ditches turn back westwards on both sides of the ridge. On the north side they do not extend very far, neatly filling an available triangular space to link up with the cliff which forms most of the northern side of the hillfort, as noted by Carpenter (2018, 81-2). The inner rampart (j) can be traced on the north just as far as the cross-ditch, though its terminal is currently obscured by dense vegetation. Towards the western end of the hillfort, however, slight traces of a bank (k, k) up to 0.4m high can be seen on top of the cliff, suggesting that a vestigial rampart did originally extend all the way along the north side. Dymond made much of the 'talus' of loose stone below the cliffs along the northern edge of the fort and even cut three sections through it (1902, 43-5, 120, pl III 33, 34 and 35, pl VI fig 15), though he was apparently convinced of its natural origin. It was not examined closely during the current survey. On the southern side of the fort, where the natural slopes are somewhat shallower (though still steep) the main ramparts extend further, the inner one (j) along almost the whole length of the fort; their configuration is somewhat complex, though they now appear superficially as mounds of bare stone with very little soil cover. Dymond's excavations revealed that the inner rampart consisted of a massive central wall of rubble with battered drystone faces and revetted on both sides by continual buttresses of rubble, also faced in drystone (Figs 8 and 9); he referred to these as 'compound walls' (1902,

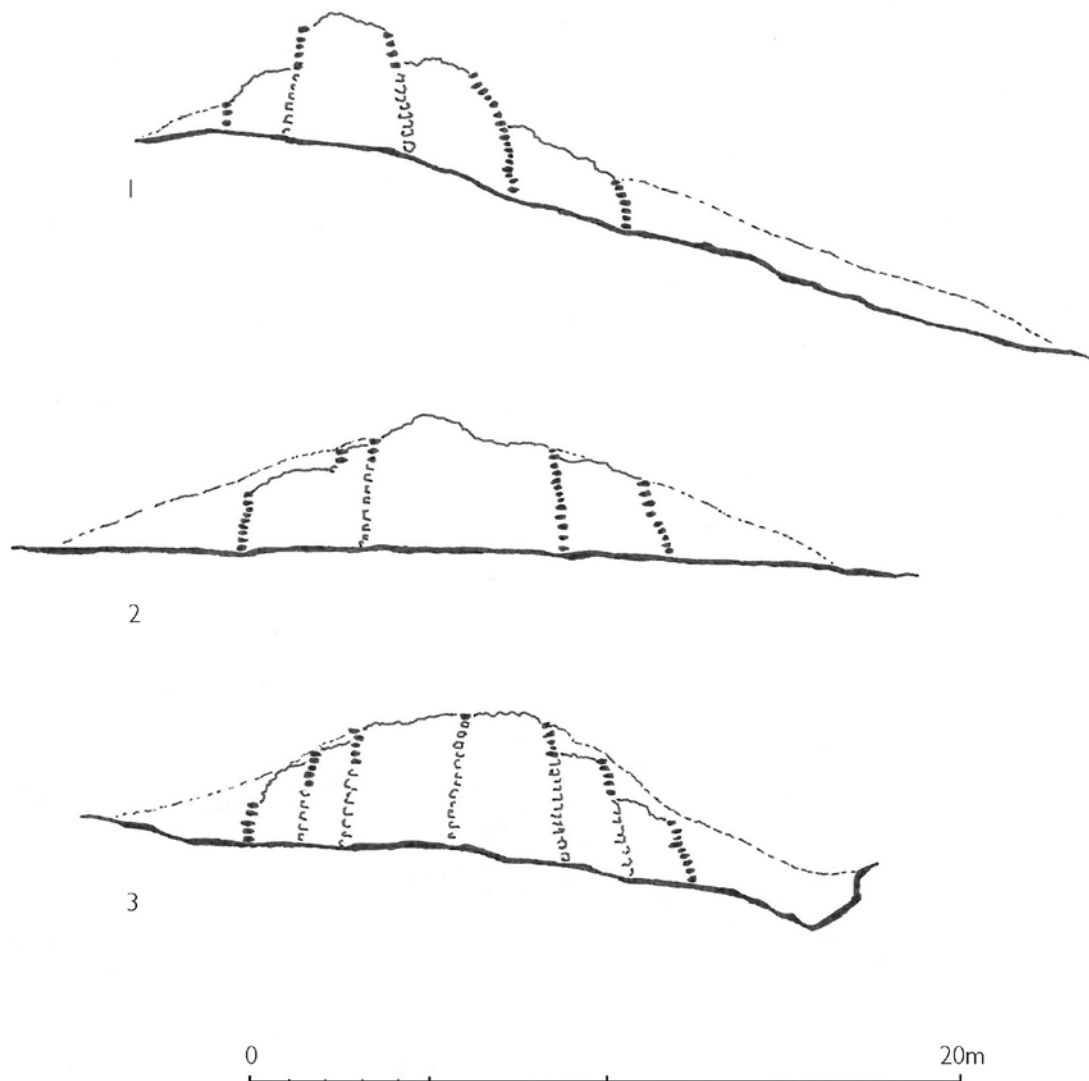
*Fig 9: Sections recorded by Dymond; the locations are shown on Fig 8. The facing stones shown in solid black 'were actually traced on the ground'; Dymond had no doubt that those shown in outline 'are similarly founded, although they have not been traced below the black portions' (Dymond 1902, 118). Dymond seems to have assumed that these structures were all of one phase (1902, 22-3). (Re-drawn from Dymond 1902, pl V, figs 2, 4 and 5)*

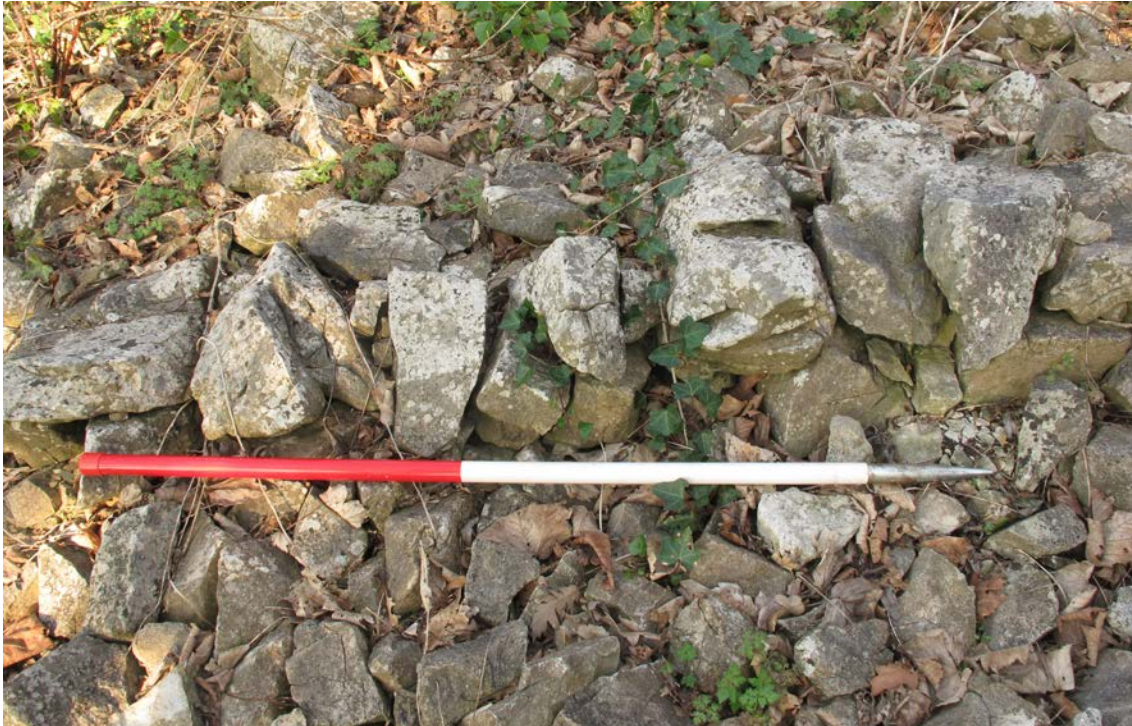
*Fig 10: Detail of exposed rampart structure to the south of the south-eastern gateway (m); February 2019*

22). The only place where any trace of this structure is now visible is immediately to the south of the south-eastern entrance (**m**) where short lengths of the drystone facings protrude slightly from the mass of tumbled material (Fig 10).

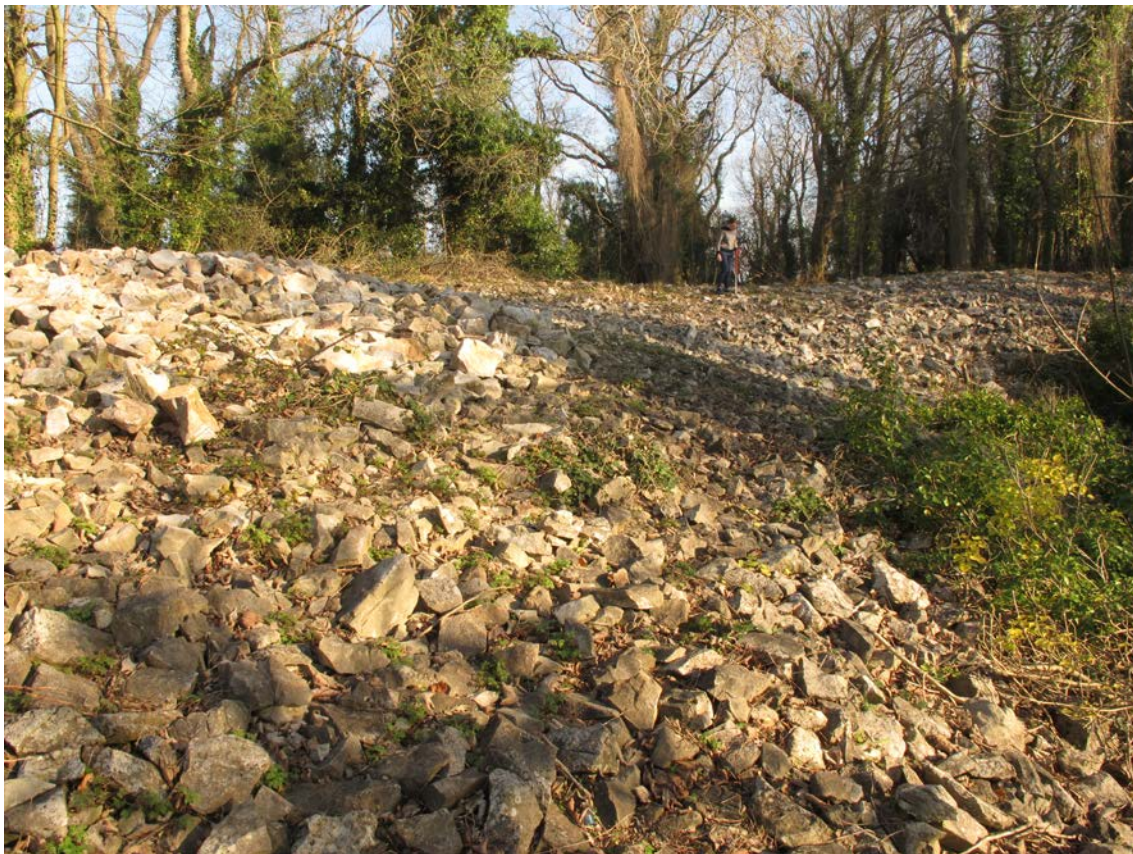
*Fig 11: Looking up into the south-eastern entrance (m), barely recognisable as a hillfort gateway: the figure with the ranging rod marks the approximate centre of the roadway; to the right is the rampart forming the north side of the gate passage, to the left the pale stones are the remains of the dismantled modern cairn that was built over the southern side of the gate passage; February 2019*

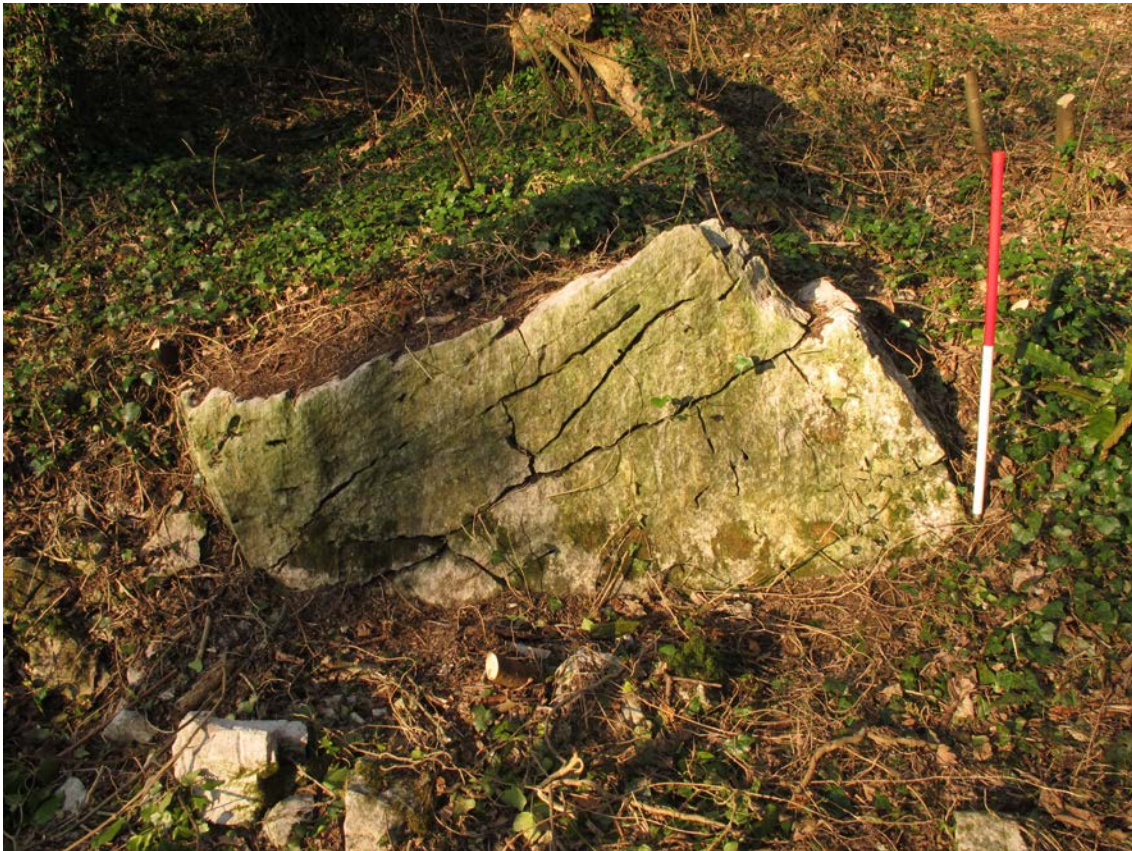
*Fig 12: Exposed bedrock in the west side of the cross ditch (v), in the deeper part close to its southern terminal; February 2019*

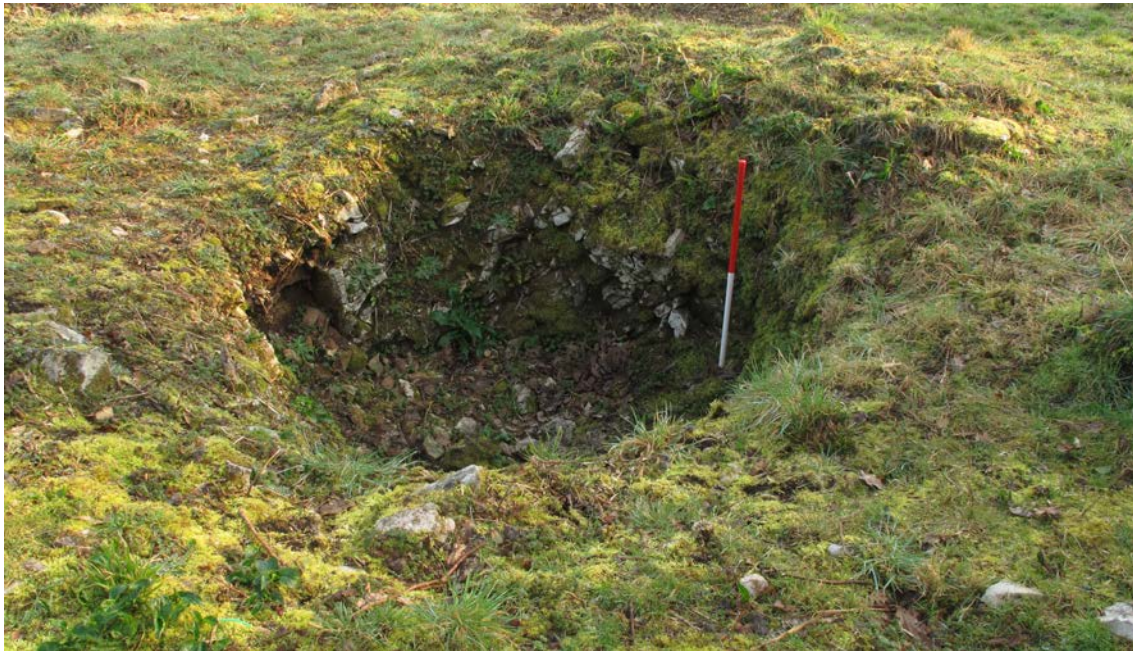
*Fig 13: One of the smaller excavated pits; February 2019*

The pits are an extraordinary feature of Worlebury (Fig 13). Those that were excavated in the mid-19th century remain as vertical-sided, rock-cut pits. Many of them have modest spoilheaps up to 0.4m in maximum height, in some cases forming complete halos, the result of the 19th-century excavations (Fig 14). We have not measured the depth of each individual excavated pit for this survey but the minimum is about 1.0m and the maximum about 1.8m. There are a number of

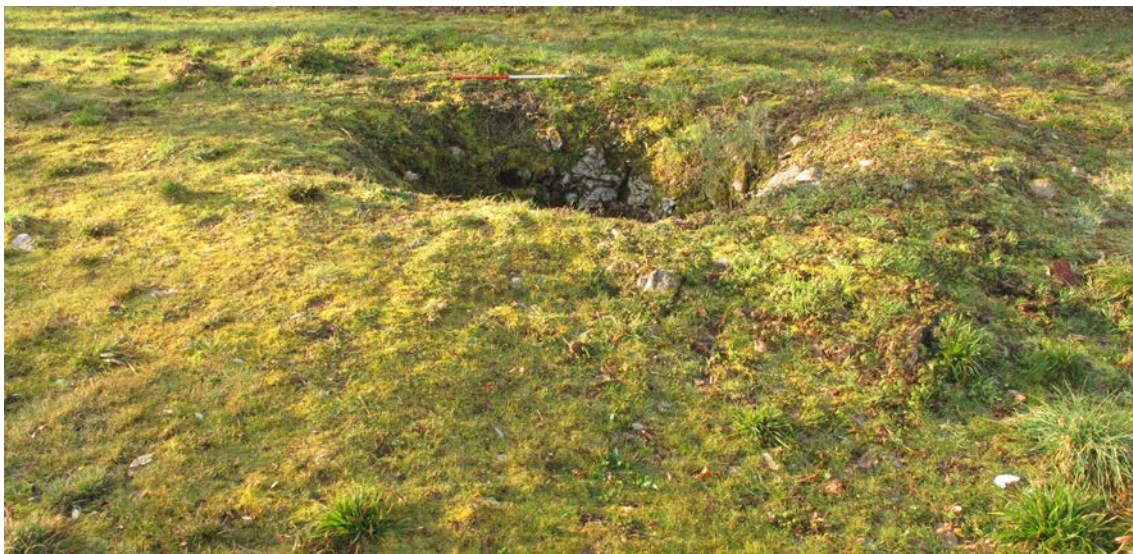
*Fig 14: Excavated pit with a halo of spoil; February 2019*

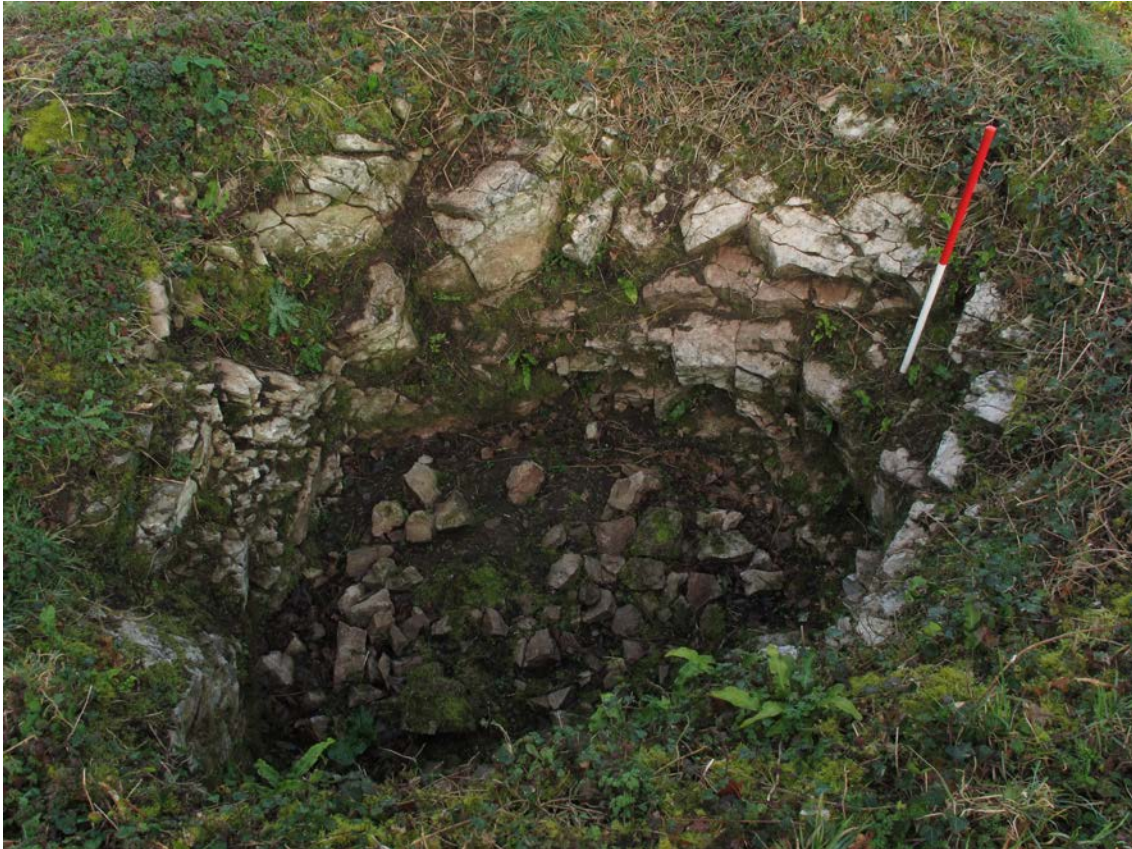
*Fig 15: The 'steened' pit (x); February 2019*

Dymond discusses some of the 93 excavated pits (1902, 45-7, 120-1, pl III 8, 9 and 13, pl VII) but unfortunately there is little information to be gleaned. Many objects were found in the pits in the 1851 excavations but relatively few of them were assigned to a specific pit or context. Only nine pits were described and the location of only one of these is known (**x**). This is the 'steened', or stone-lined, pit, marked as 9 on Dymond's index plan (ibid, pl III) and illustrated (ibid, pl VII), in which were found charred wood and grain, beach pebbles, ochre and three human skeletons, one of which had a wound in the skull (ibid 77-9, pl XI). The 'steened' pit is 1.6m deep (Fig 15).

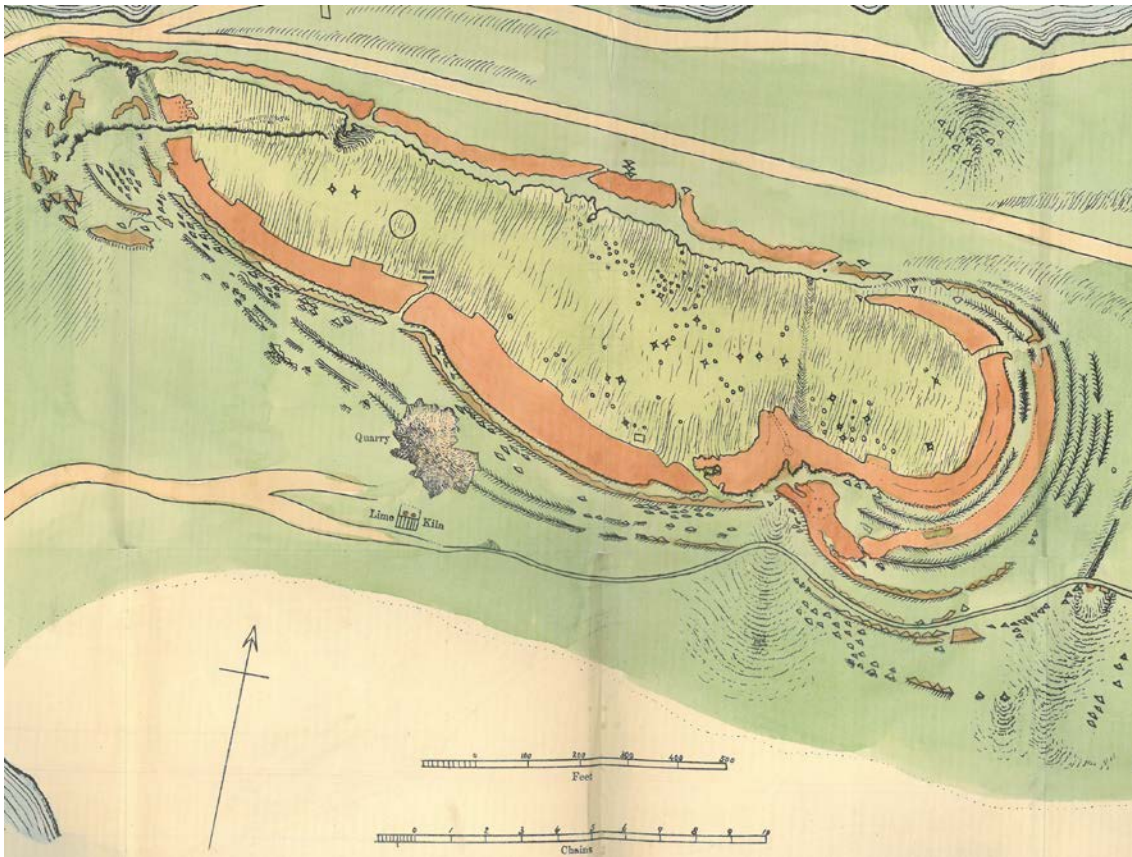
Fig 16: Extract from Edwin Martin Atkins’ survey of Worlebury, 1852 (Warre 1852, facing p64)

As noted, the main south-eastern entrance of Worlebury opens onto a steep slope but it is covered by a scree of fallen stone and dense vegetation. Aitken mapped a road along the southern slope below the ramparts (see Fig 16) which Dymond was prepared to accept as 'ancient' (1902, 34, pl III) but there is no reason to suppose that this is related to the hillfort. Another notable aspect of the archaeology of Worle Hill is the number of Iron Age burials that have been found along the southern slopes of the hill, mainly during late 19th-century and early 20th-century development (Davies 1905; Evans 1980, 16; Bateman and Russett 1999, 13-18, map A; Broomhead 2007; Aston *et al* 2013, 163). This is an unusual grouping and being almost certainly contemporary with the hillfort must be considered as potentially relevant to it; it would perhaps be reasonable to assume that the

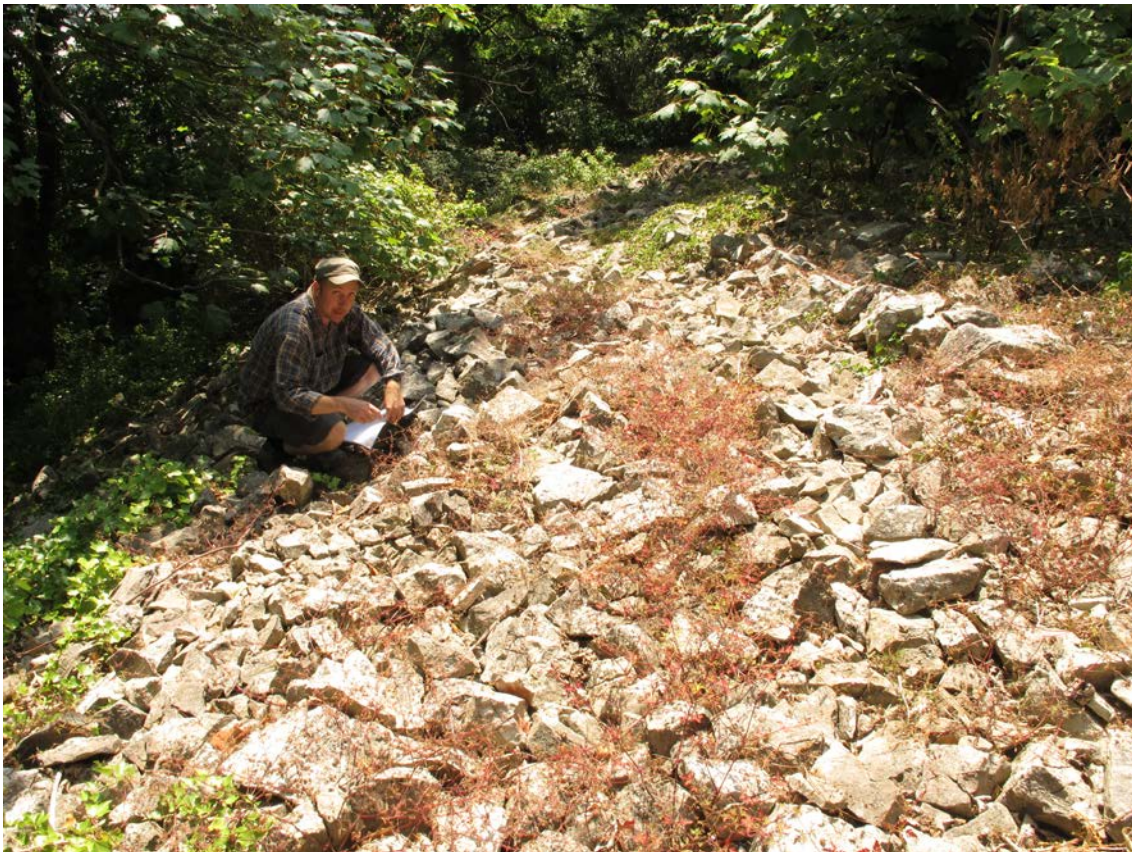
*Fig 17: The only visible remains of the rampart structure, south of south-eastern entrance (m); July 2018*

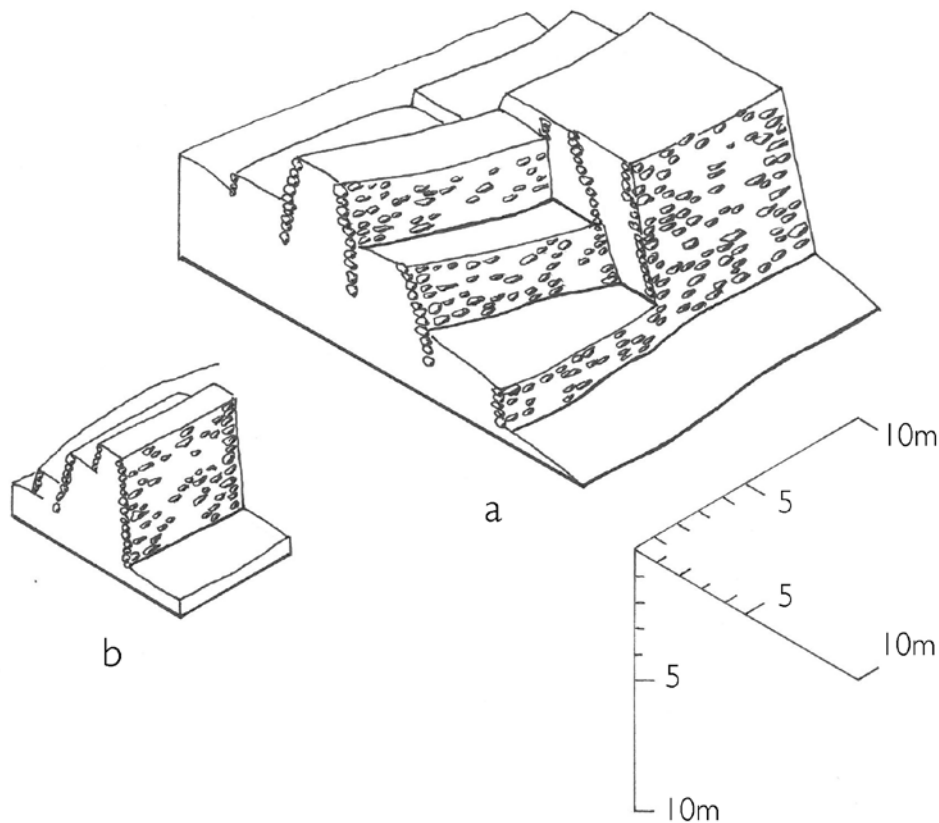
Fig 18: (a) The main rampart of Worlebury: the left portion shows the rampart as recorded by Dymond, the right portion shows a possible reconstruction of its original form by AHA Hogg; (b) reconstruction of the ramparts of Tre'r Ceiri at the same scale, emphasising the massive proportions of the ramparts at Worlebury. It is interesting that Hogg has reconstructed Worlebury's ramparts without a parapet. (Re-drawn from an isometric diagram by Dylan Roberts, which was based on an original draft by AHA Hogg (Hogg 1984, fig 4))

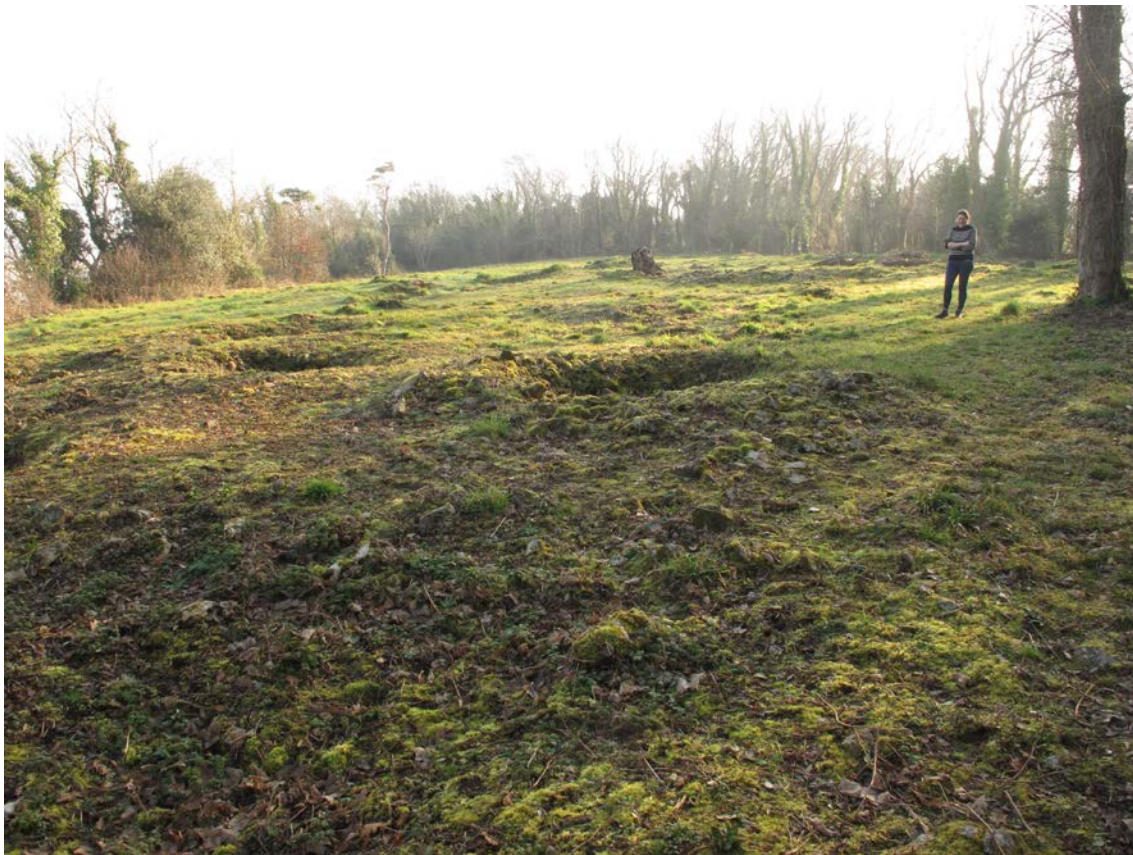
*Fig 19: An array of pits in The Glade; February 2019*

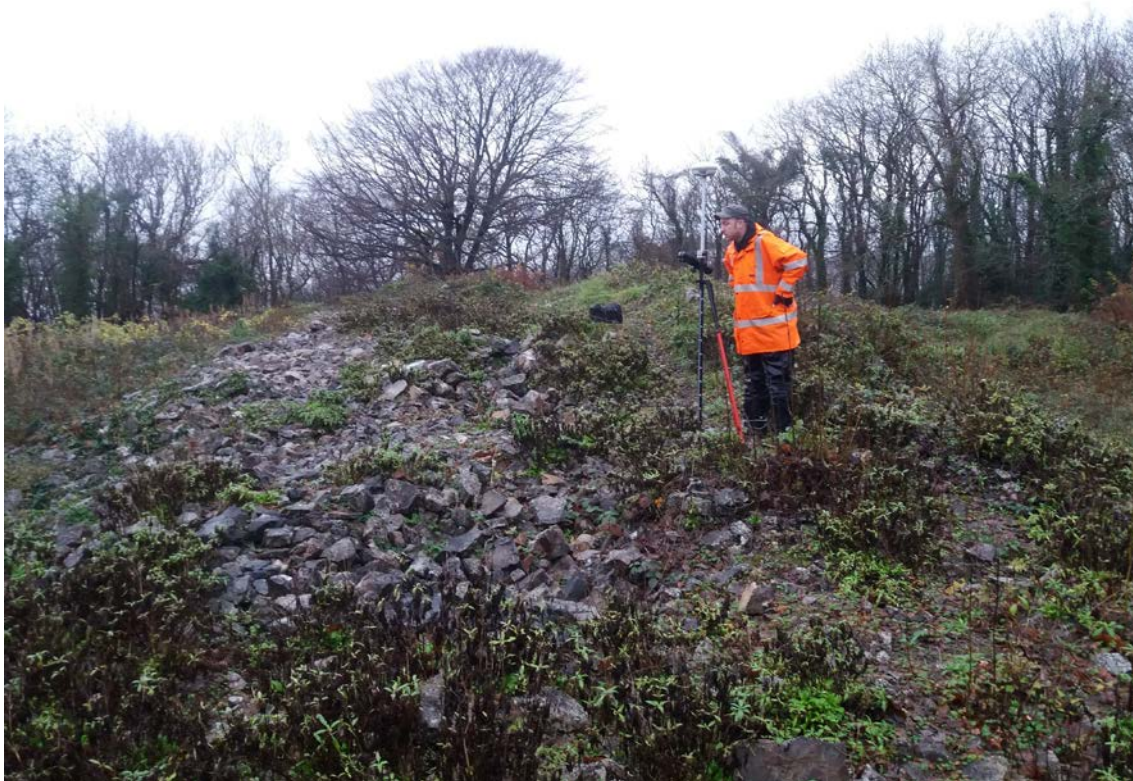
*Fig 20: GNSS receiver on the main outer rampart (h) at the east end of the hillfort; December 2018*

Survey of the linear earthworks to the east of the hillfort utilised a combination of digital and analogue techniques. Four control points were established in open ground on the hillfort's eastern ramparts. These were located to within +/- 0.1 to 0.15m of the Ordnance Survey National Grid using a Trimble R8 survey grade differential Global Navigation Satellite System (GNSS) receiver (Historic England 2015), connected to the Ordnance Survey's correction network (OSNet) via the Trimble 'VRS Now' service (Fig 20). Referencing these control points, a Trimble S7 robotic total station theodolite (TST) was then used to create a closed traverse of survey stations surrounding the linear earthworks (Historic England 2016). Detailed survey was completed using standard tape-and-offset and plane tabling techniques (Historic England 2018), referencing these stations.

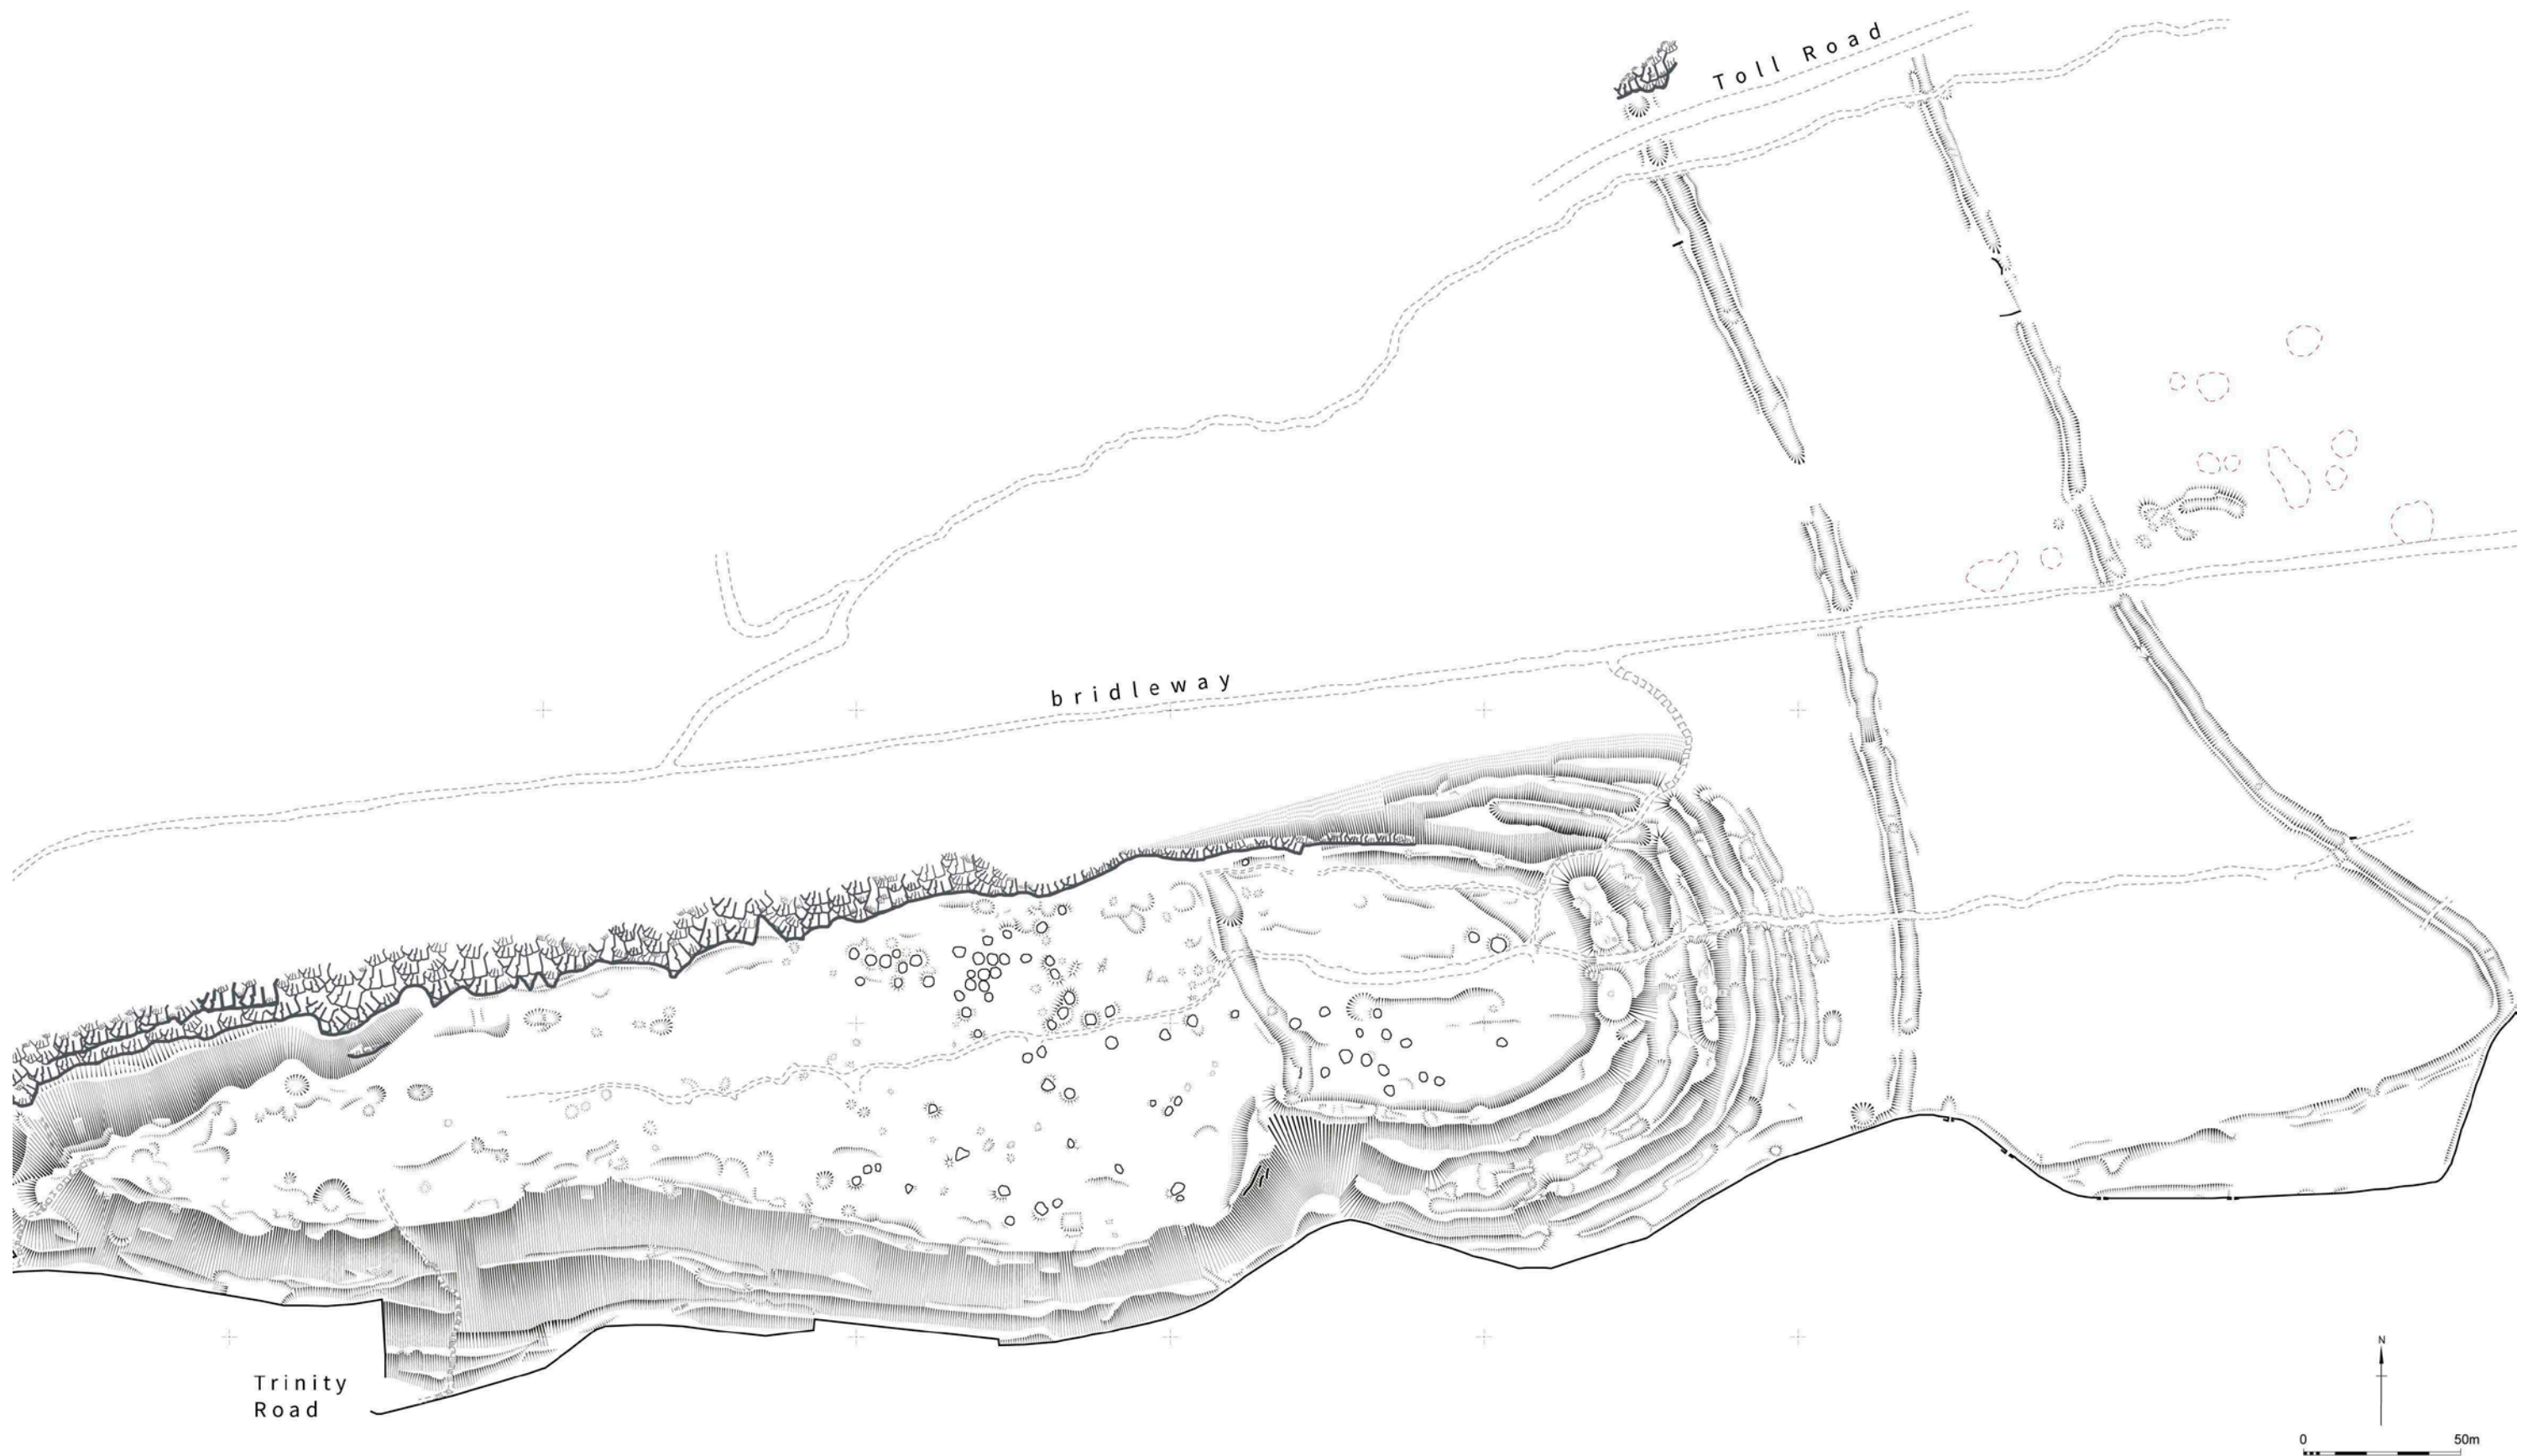
Fig 2: Survey plan of hillfort and linear ditches, reduced to 1:2000 ©Historic England

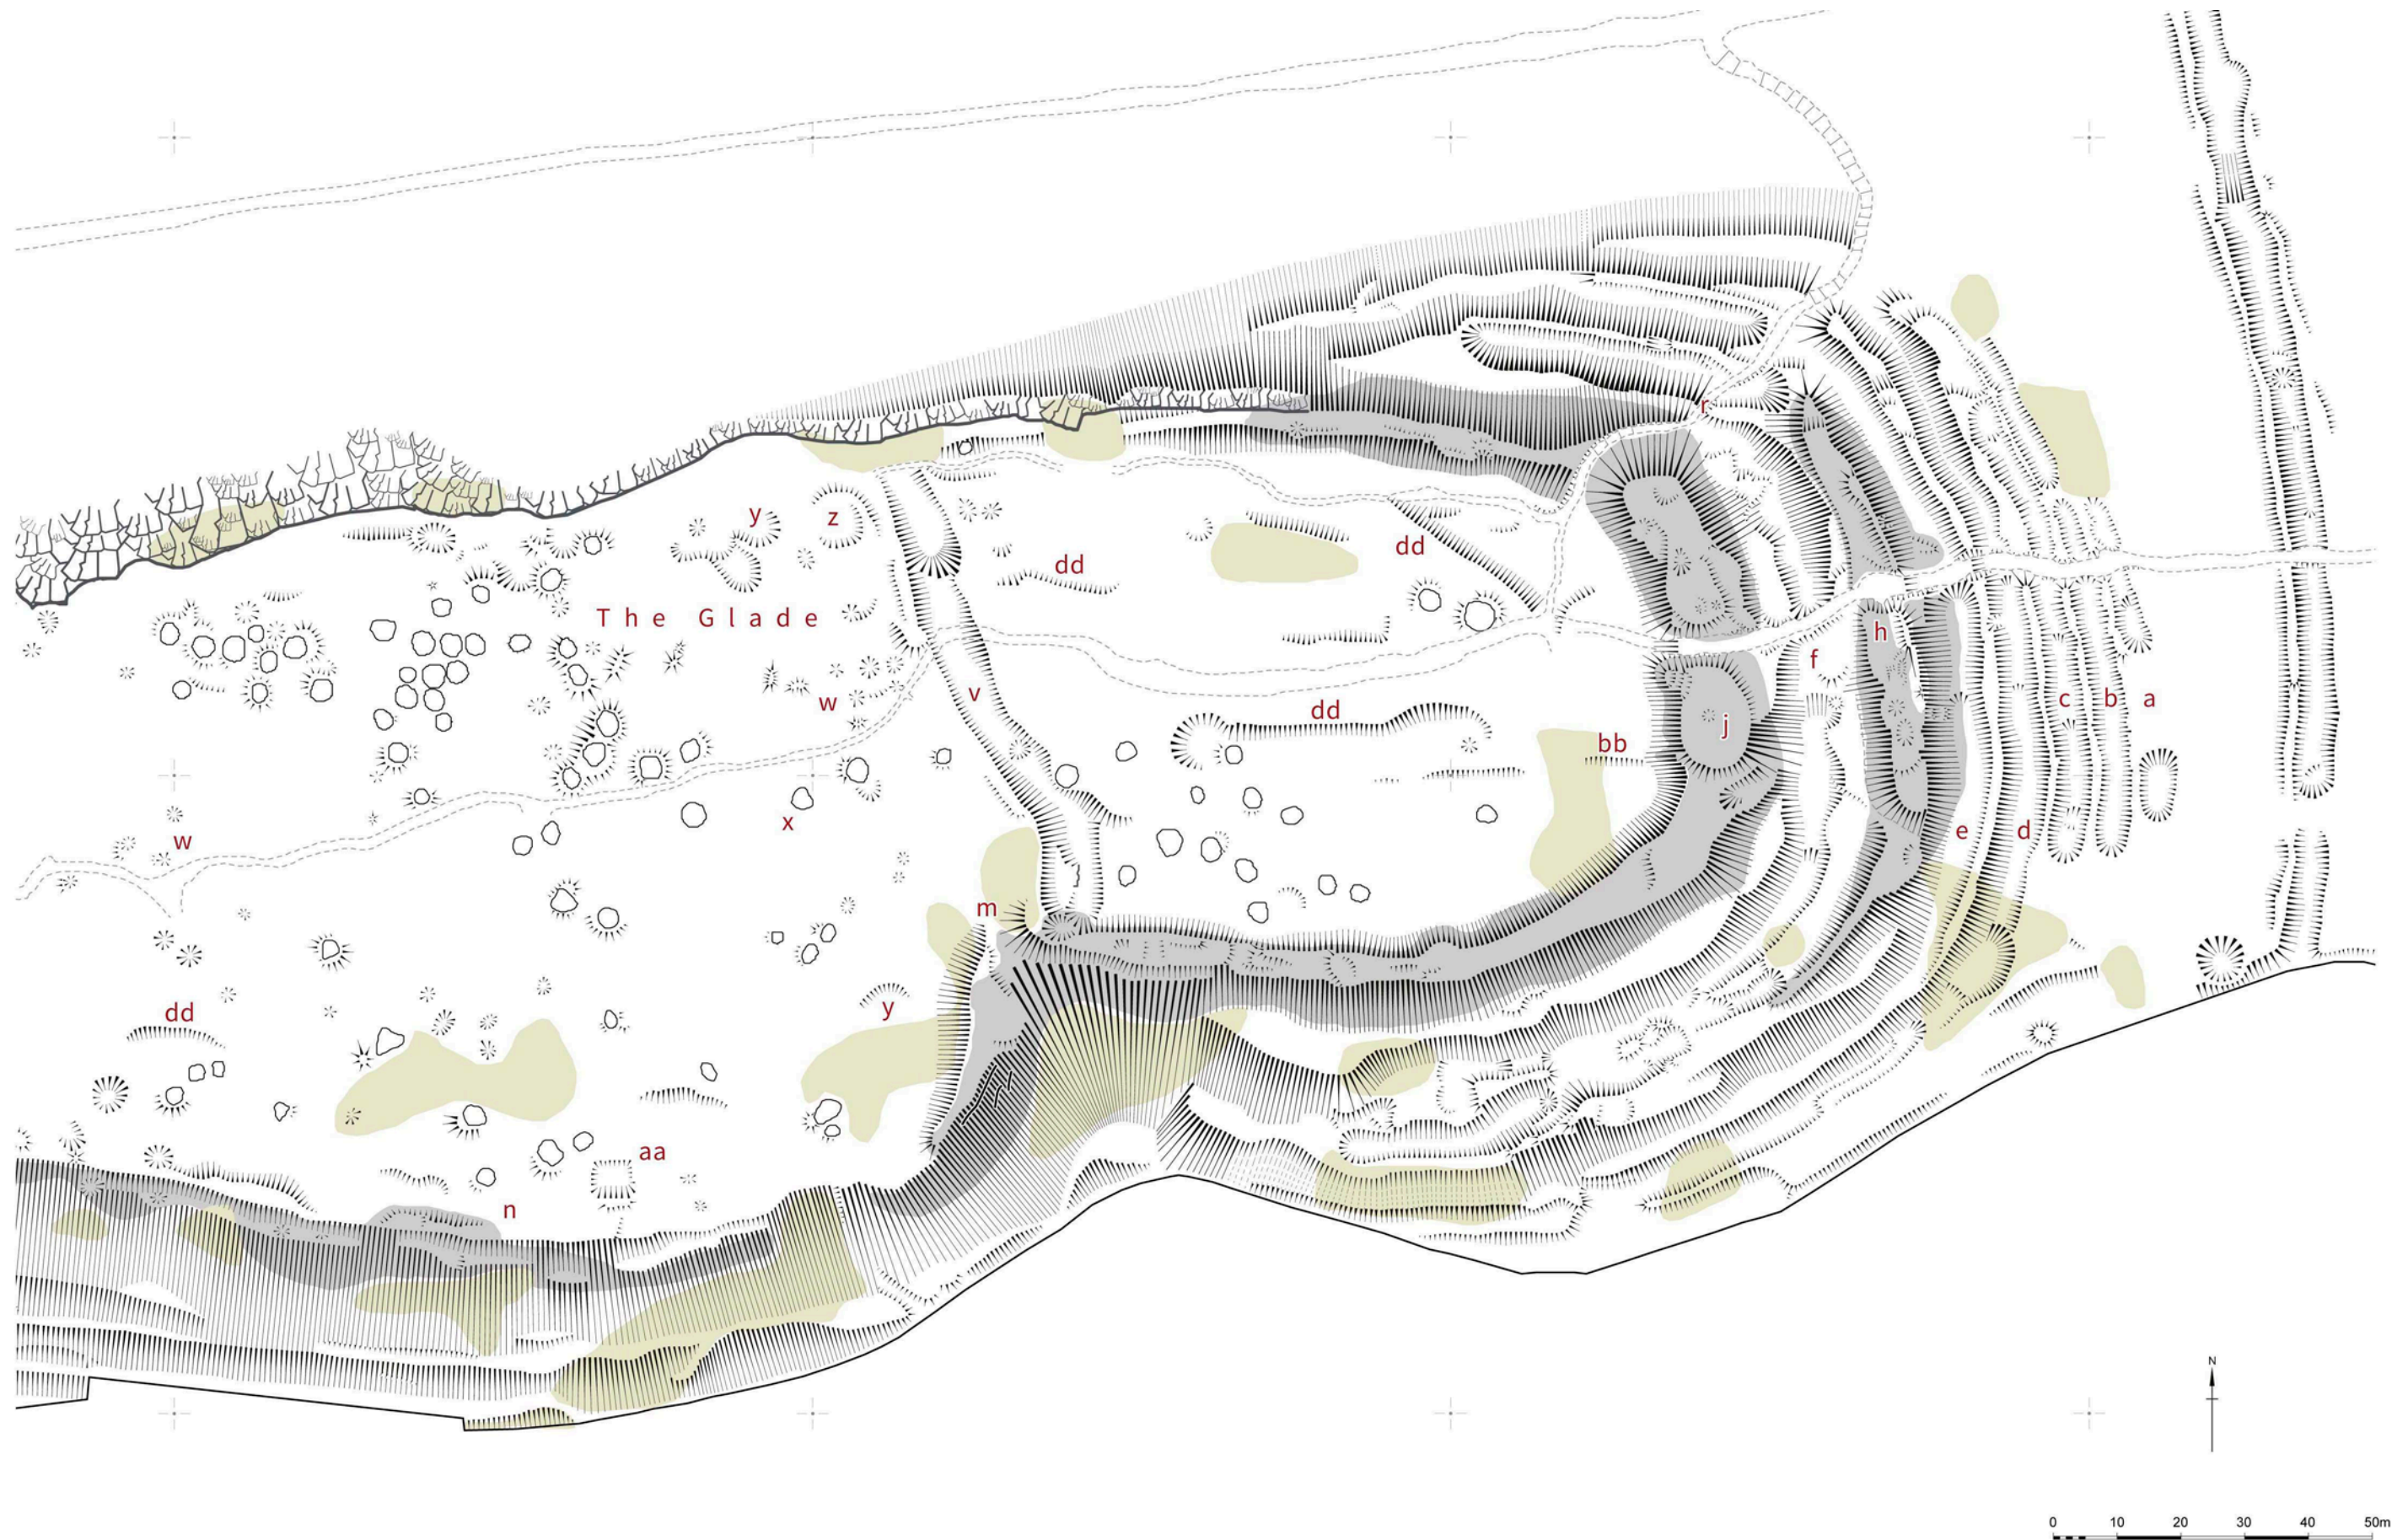
Fig 4: survey plan of the hillfort, eastern part, 1:1000. For key see Fig 3 ©Historic England

Worlebury occupies what is in effect a promontory and this is reflected in the form of the ramparts which are multivallate to the east and bivallate along part of the southern side; at the western end they appear to be rudimentary (though an unknown portion has been lost to erosion and damage); along much of the northern side high cliffs seem to have rendered any serious rampart building unnecessary. There is one undoubted original entrance, to the south-east, though its passage is choked by rubble and its original form difficult to appreciate. Other entrances are probably relatively recent, though a path through the north-eastern ramparts has been seen as an original entrance by previous commentators, and there was possibly a western entrance. The hillfort interior is divided into two unequal parts by a rock-cut ditch. The remains of numerous pits excavated in the 19th century are clearly visible and there are some other features of potential interest in the interior. The ramparts and entrance(s) will be described first, followed by the interior features. Letters refer to the plan (Figs 3 and 4, inside rear cover).
