# Worlebury hillfort and the linear earthworks to its east, Weston-super-Mare, North Somerset

Archaeological Survey Report

NGR: ST 312 624

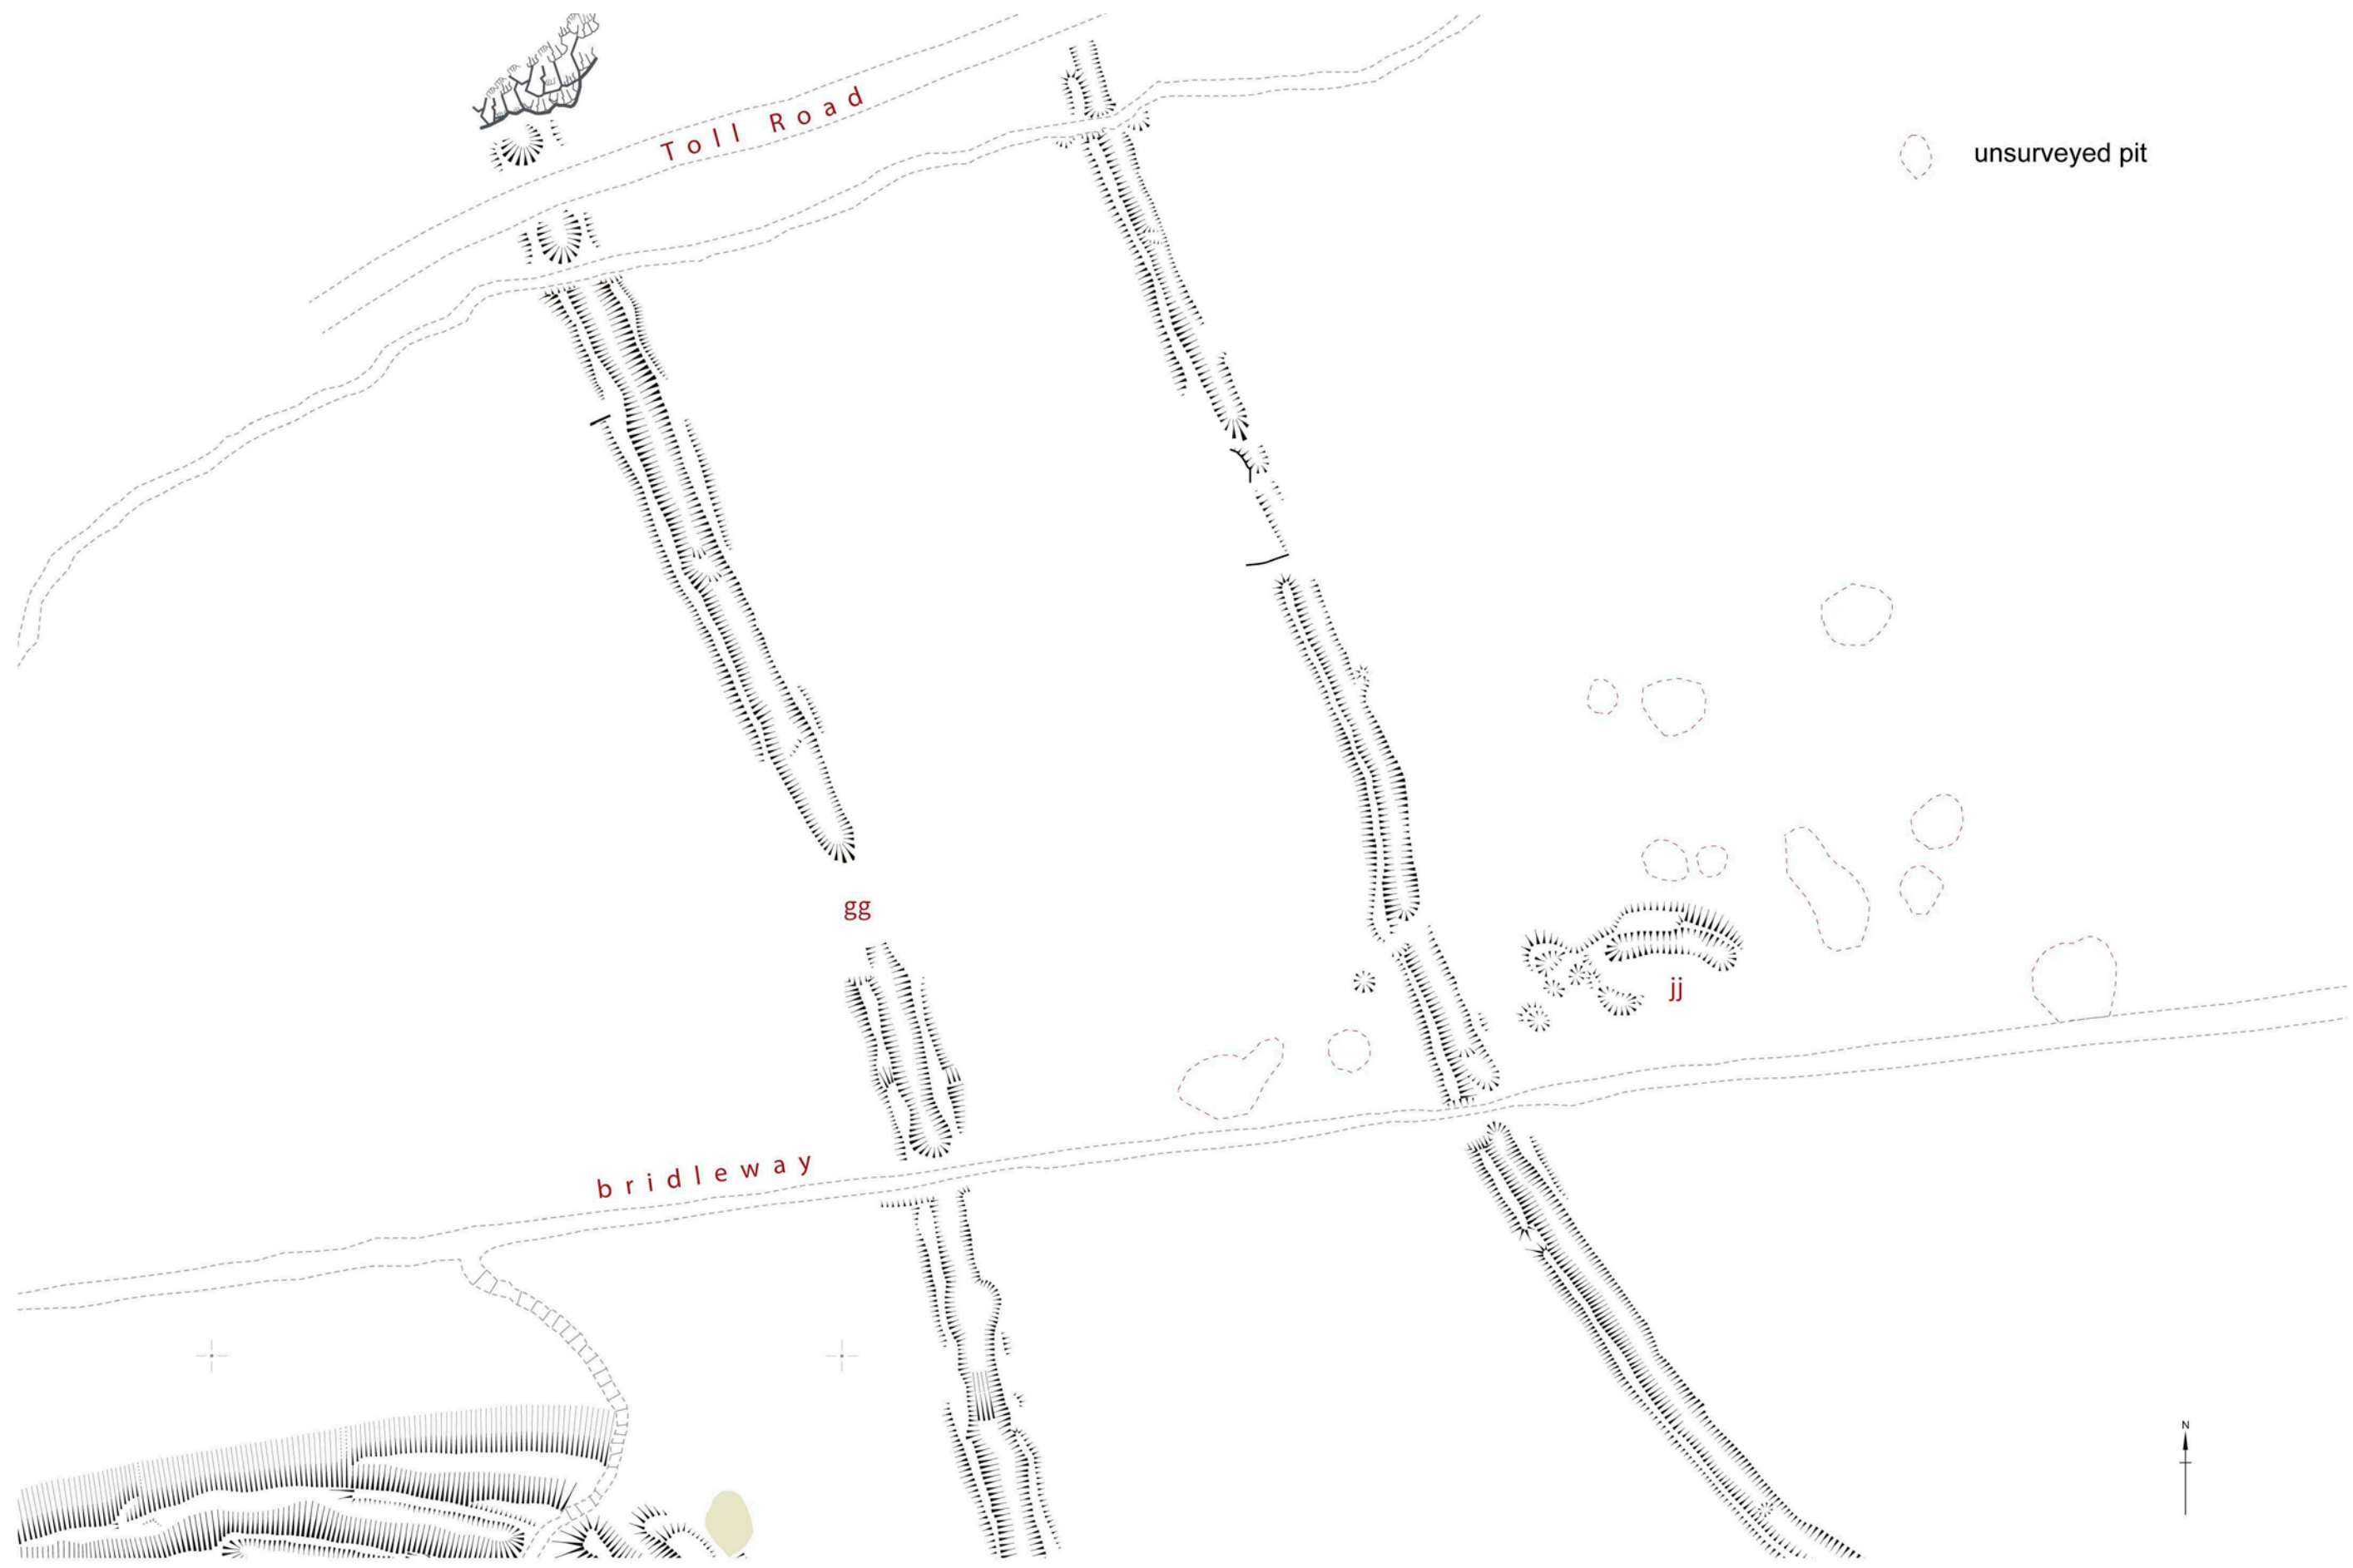
Fig 6: Survey plan of the linear ditches, northern part, 1:1000 ©Historic England
