# Former Bishop Auckland Mechanics' Institute

## 27 Victoria Avenue, Bishop Auckland

### Historic Building Report

Alastair Coey Architects

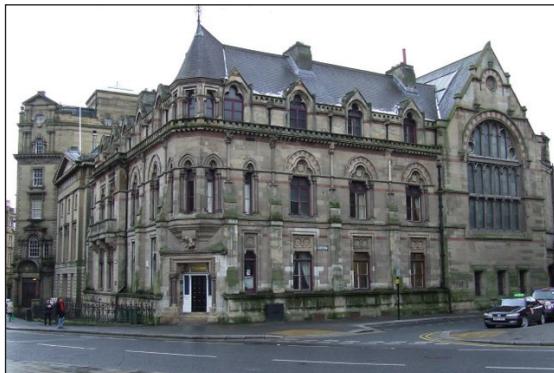
*Figure 9: The North of England Institute of Mining and Mechanical Engineers, designed by Archibald Dunn, 1869-1872 (© Copyright Thomas Nugent and licensed for reuse under Creative Commons Attribution-Share Alike 2.0 Generic license – geography.org.uk/p/1111333)*

was investigated for bankruptcy in 1884-85.<sup>61</sup> In a broader context, it is also worth noting the design of the North of England Institute of Mining and Mechanical Engineers, Newcastle, (1869-72) by Archibald Dunn which was executed in a Ruskinian Gothic style (Figure 9).<sup>62</sup> Although larger and more elaborate than the Bishop Auckland Institute, it was a grand local example of an institutional building, recently completed, from which to take inspiration.

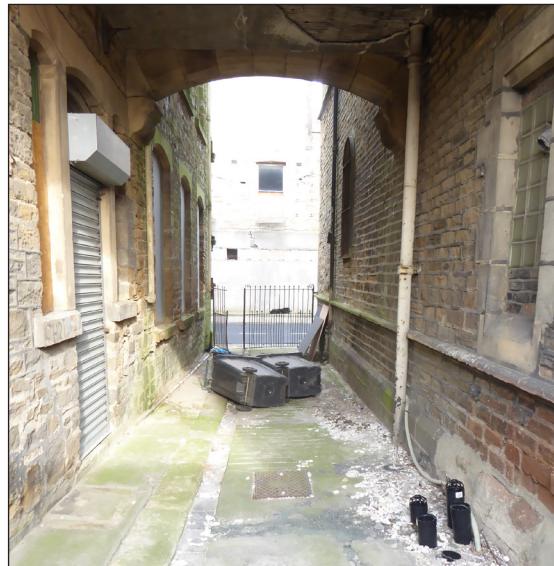
*Figure 14: The passageway to the east of the Mechanics' Institute building (© Historic England, photograph: Alastair Coey Architects 2019)*

in the flat from four in 1891 to three in 1901.<sup>74</sup> This may relate to the construction of the bridged extension abutting the Masonic Hall (formerly the Temperance Hall) at first- and second-floor levels (discussed in more detail below), although this is not clearly present on the Ordnance Survey maps until 1980. The primary change created by this extension was the removal of the upper flights of the staircase (which Thompson's drawings from 1880 show was designed to rise the full height of the building) allowing for a single room extending the whole depth of the second floor, used for billiards and amusements (Figure 13). It may be that the lane running past the east of the building and along the back was required for access of some sort, meaning that the Institute had to leave a passage at ground-floor level, resulting in the archway bridge (Figure 14).<sup>75</sup>

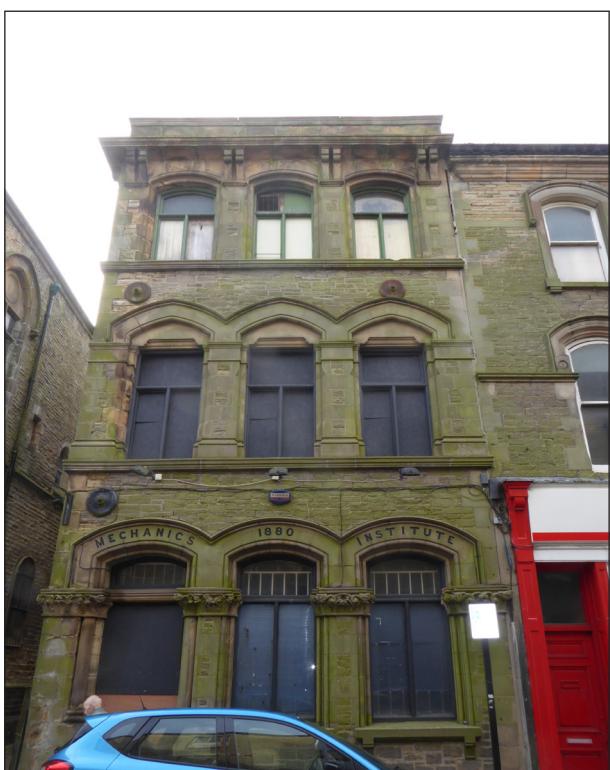
*Figure 20: Front elevation of the Mechanics' Institute (© Historic England, photograph: Alastair Coey Architects 2019)*

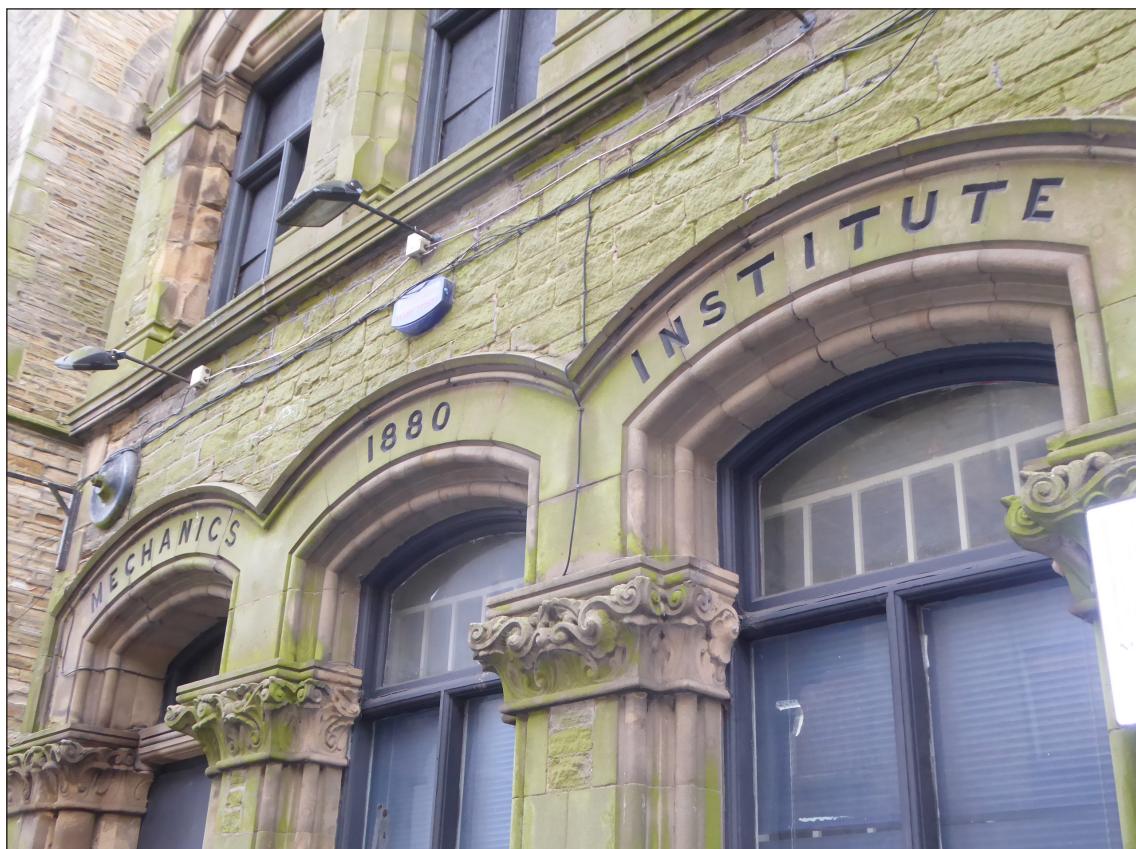
*Figure 21: Name and date stones above the entrance of the Mechanics' Institute  
© Historic England, photograph: Alastair Coey Architects 2019)*

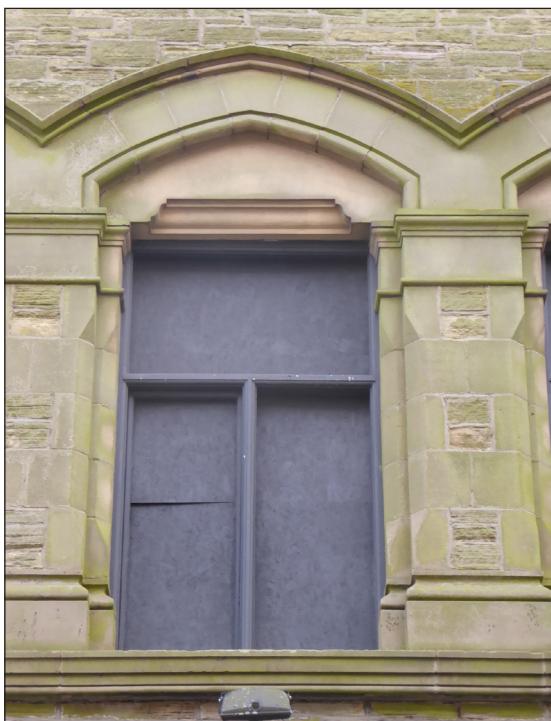
*Figure 22: Second-floor window of the Mechanics' Institute (© Historic England, photograph: Alastair Coey Architects 2019)*

At first-floor level, a moulded sill course spans the elevation with three square-headed window openings above. Each window lintel forms a smooth tympanum recessed below a smooth-faced shallow-pointed arched frieze with roll-mouldings that follows the line of the arches surmounted by a label moulding (Figure 22). At second-floor level, the three segmental-headed window openings sit on a continuous moulded sill course and have simple splayed jambs and roll-moulded heads. Flanking each window, pairs of moulded stone consoles carry a projecting cornice above which is a plain parapet surmounted by a moulded coping (Figure 23). All windows on the front elevation are painted timber plain-glazed casements consisting of two vertical lights below a transom with a single light above. Circular iron pattress plates have been introduced at first and second-floor levels and steel tie rod retaining plates can be seen on the rear elevation, presumably to prevent bulging of the elevation.

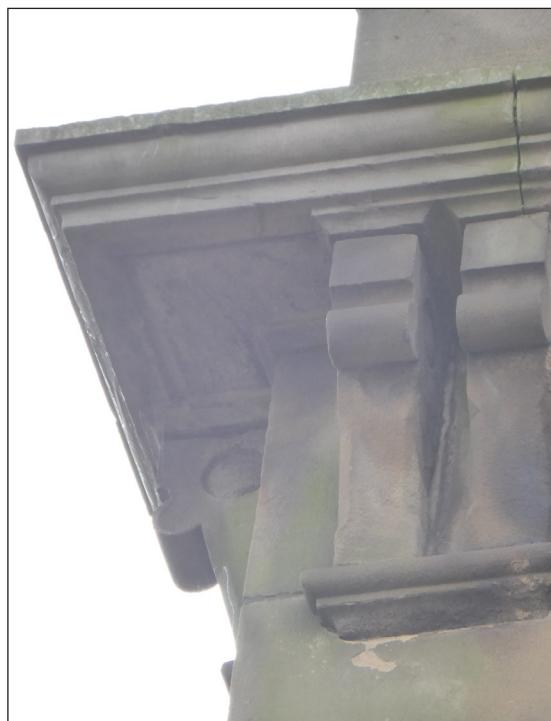
*Figure 23: Detail of cornicing and eaves brackets of the Mechanics' Institute (© Historic England, photograph: Alastair Coey Architects 2019)*

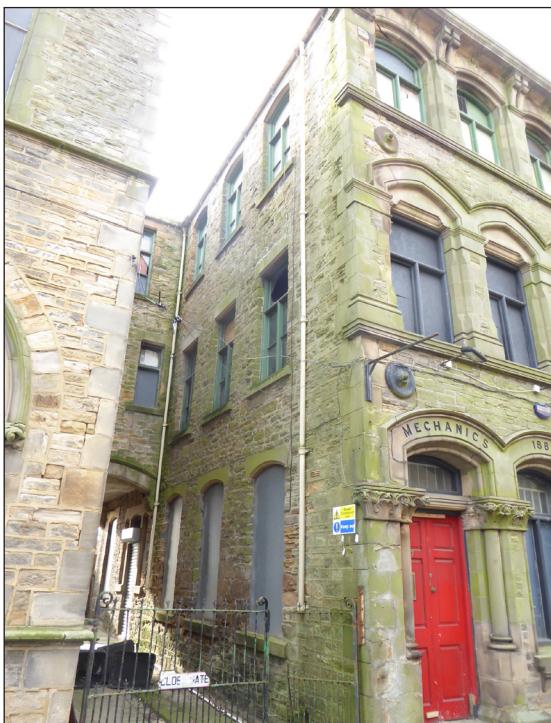
*Figure 24: Front (north) and east elevations of the Mechanics' Institute  
© Historic England, photograph:  
Alastair Coey Architects 2019)*

Thompson's proposals show that the east elevation was designed to be fully detached from the pre-existing Masonic Hall (then the Temperance Hall) (see Figures 7 and 11]. This elevation was constructed in uncoursed rubble stonework with plain ashlar sandstone sills and lintels to the window openings, segmental at ground and second floor and square-headed at first floor (Figure 24). The fenestration on this elevation originally comprised five openings per floor, with the three northernmost windows placed to light the principal room on each floor, the

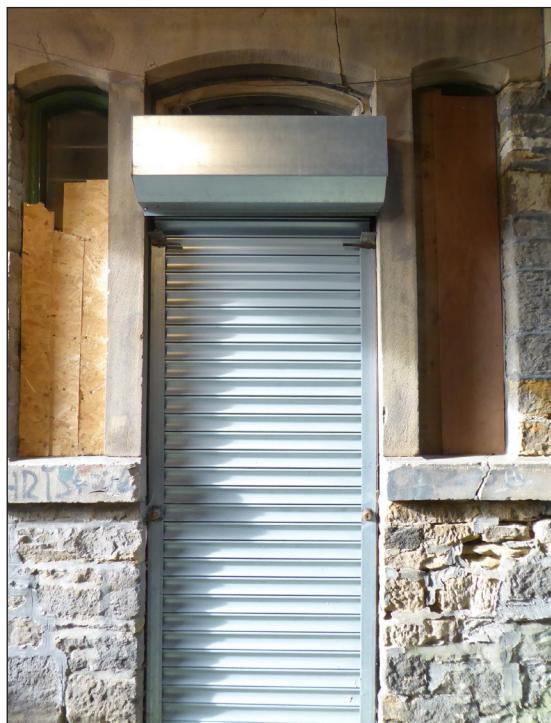
*Figure 25: Secondary (alleyway)  
entrance of the Mechanics' Institute  
© Historic England, photograph:  
Alastair Coey Architects 2019)*

fourth bay was aligned with the staircase and the fifth window was placed to light the smaller rooms to the rear. The surviving casement windows here are similar to those on the front elevation. On the ground floor is a secondary entrance (the second opening from the south) consisting of a segmental-headed central doorway flanked by tall narrow segmental-headed sidelights with plain ashlar lintels, side jambs and sills (Figure 25). Thompson's plans show that this opened directly onto the foot of the staircase. It was presumably intended both as a service entrance (the ground-floor plans show this area at the back of the ground floor lay over a coal cellar) and as a private entrance for the caretaker whose flat formed the rear rooms of each floor in the 19th-century layout (see discussion on interiors below) (Figure 26).

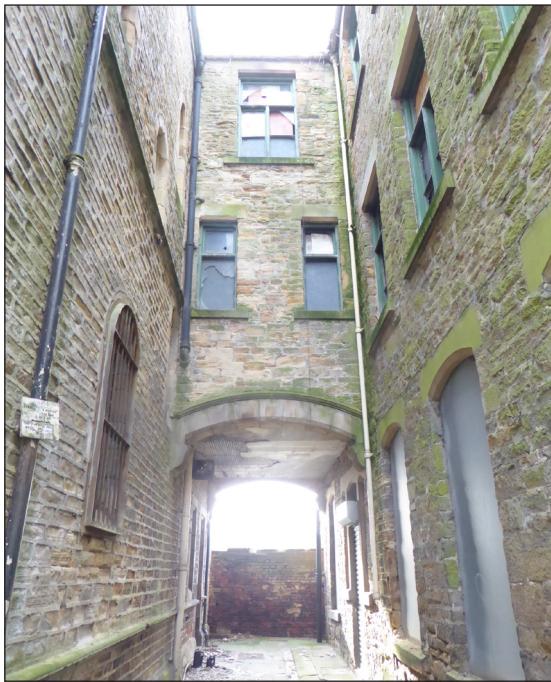
*Figure 27: View of the alleyway bridge of the Mechanics' Institute* (© Historic England, photograph: Alastair Coey Architects 2019)

Sometime after the completion of Thompson's 1880 building the archway bridge extension was built between the east elevation and the Masonic Hall (Figure 27). The execution of this extension so closely follows the 1880 building in terms of construction and the form of windows, suggesting that it was constructed not much later than the original building. It is proposed that this work was undertaken *circa* 1900 as census records in 1891 and 1901 record a change in room numbers which indicate that alterations had taken place.<sup>95</sup> The north elevation of the archway bridge is also constructed of uncoursed rubble stonework with two square-headed window openings to the first floor and one to the second floor, all following the

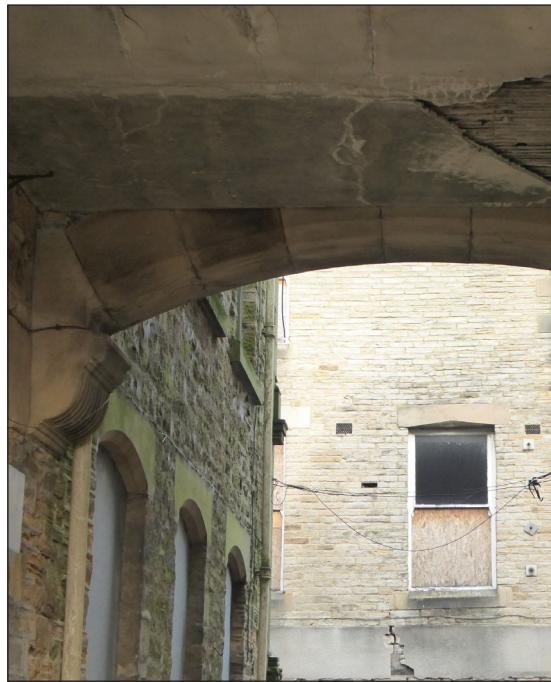
*Figure 28: Detail of the brackets on the underside of the bridge* (© Historic England, photograph: Alastair Coey Architects 2019)

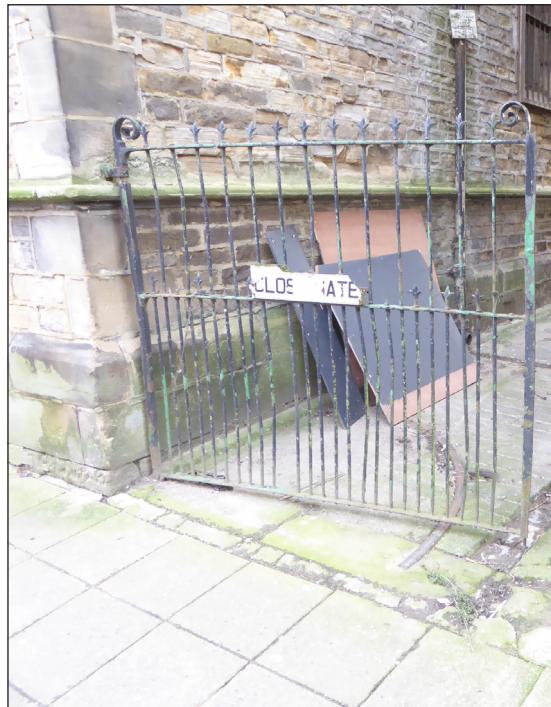
*Figure 29: Detail of the gates and alleyway entrance of the Mechanics' Institute* (© Historic England, photograph: Alastair Coey Architects 2019)

The alleyway which runs below the arch is surfaced with the original stone flags along the foot of the wall noted on Thompson's plans to a width of 2'6", beside which runs a stone gutter. The coal shoot marked on the plans is still visible in the alley (now blocked up with cinder blocks) immediately south of the door opening. The rest of the alley appears to have been largely resurfaced with concrete. It is closed at the north end by wrought-iron gates, the gate to the west spanning the flagged pavement and the wider one to the remaining width. The gate runner of the west gate remains inset into the surfacing beneath (Figure 29).

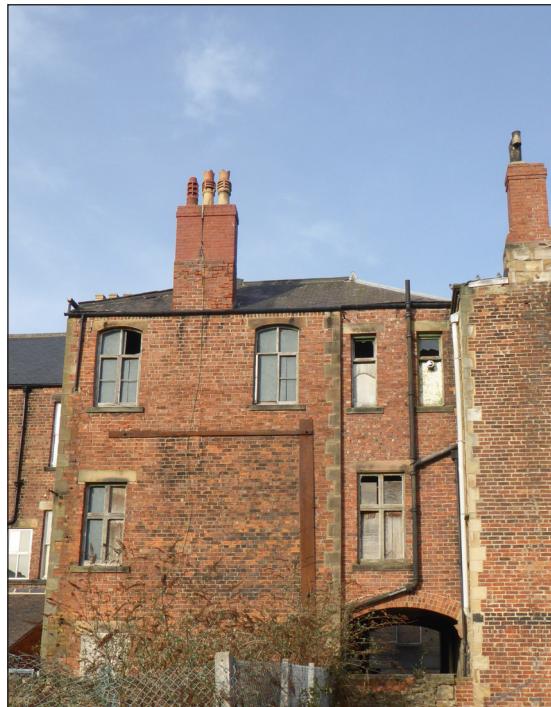
*Figure 30: Rear elevation of the Mechanics' Institute from the brownfield site to the south* (© Historic England, photograph: Alastair Coey Architects 2019)

The south elevation of the main building is constructed in red brick laid in English Garden Wall bond, of five stretcher courses between header courses, with plain sandstone quoins flush with the brickwork on the corners (Figure 30). The south side of the archway bridge is also constructed in red brick with an arch of brick

vousoirs resting on ashlar stone kneelers which bear on fluted stone corbels. The soffit of the archway is level lath and plaster. On the archway bridge, the bricks are laid in simple stretcher courses and are of a slightly different colour and texture to those of the main volume. This suggests, alongside the fact that the archway is fitted between the external side of the main building's quoins and west wall of the Masonic Hall, that the insertion of the bridge took place at a later date. At the west side of the rear elevation, on the ground and first floor, are single square-headed window openings each with plain sandstone sills and lintels and containing 19th-century two-over-two painted timber casements. On the second floor, a pair of segmental-headed windows, also with sandstone sills and lintels below the central brick chimneystack, the upper portion of which has been rebuilt (probably in the late 20th century) in smooth red brick and is capped with three louvred clay chimney pots (Figure 31). The west elevation of the main building, where it projects behind the adjoining building, has at ground-floor level one square-headed window opening with sandstone lintel and sill. This opening has been blocked with concrete blocks.

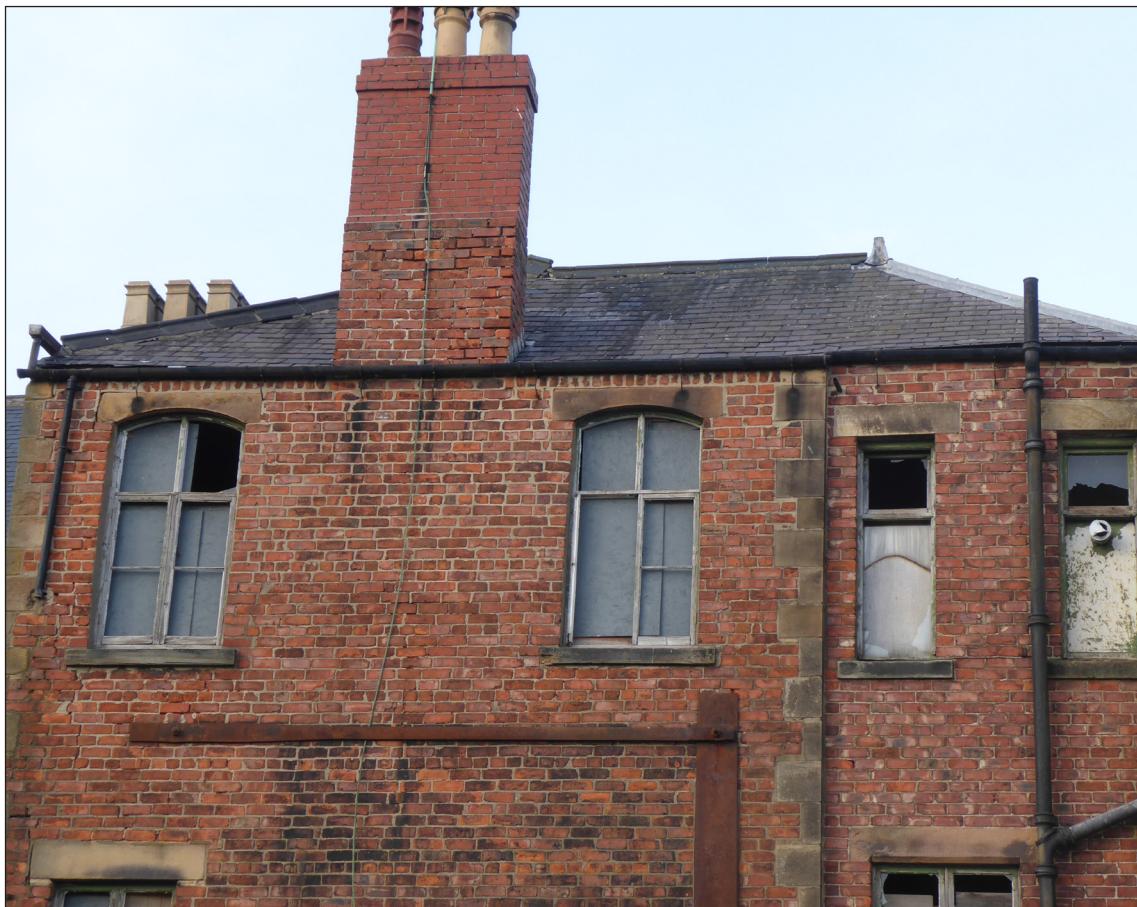
*Figure 31: Detail of the rear roof and second floor of the Mechanics' Institute (© Historic England, photograph: Alastair Coey Architects 2019)*

The building's plan is 'L'-shaped, including the archway bridge, and the roof is hipped with roll-top angled clay ridge tiles and slated slopes. The front hip drains to a parapet gutter, the east and south slopes to half-round cast-iron gutters and the west slope to a cast-iron box gutter. The 1880 roof was originally a simple rectangle on plan with ridge and hips, and a large part of this roof structure is presumed to survive over the main volume, although it has not been possible to undertake an inspection of the roof as part of this investigation. With the construction of the archway bridge, the roof in the south-east corner must have been reorganised and extended to provide a new hipped projection. This change is clearly evident from the brownfield site to the south of the Mechanics' Institute where the top of the original ridge and hip line can be seen (see Figure 31). It was also probably at this time that the timber-framed raised lantern (pitched parallel to the main roof slopes) was added to the centre of the ridge on the main roof (Figure 32). Although Thompson's proposals do not include a roof plan, each floor plan contains an internal wall around the centre of the building to partition off the staircase, suggesting that this roof lantern was not part of the original building (see Figure 11). If the roof light was original, it would have had room partitions cutting across the space below it which seems a very poor design solution. Furthermore, the roof light extends its length north to south and not east to west as would be expected if it was indeed associated with the original staircase arrangement. At the time of the extension the upper stairs were relocated to create a larger billiard room on the second floor and so the lantern may have been installed to improve lighting to the billiard tables.

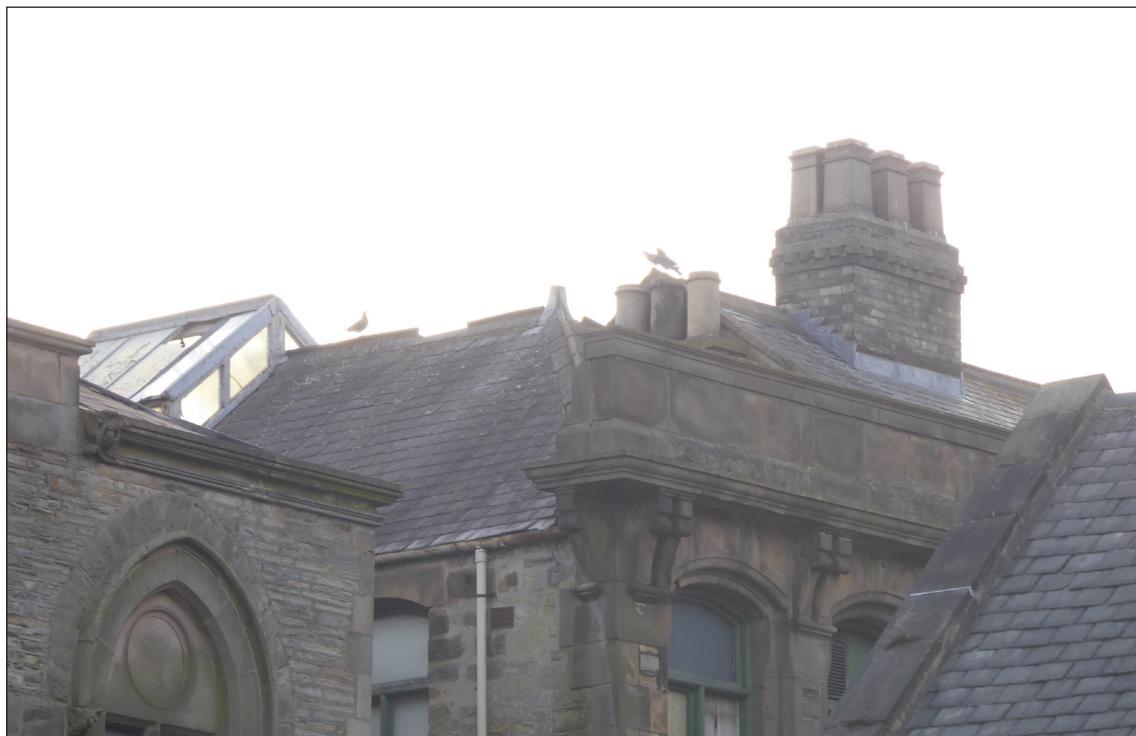
*Figure 32: Detail of the parapet and roof lantern of the Mechanics' Institute (© Historic England, photograph: Alastair Coey Architects 2019)*

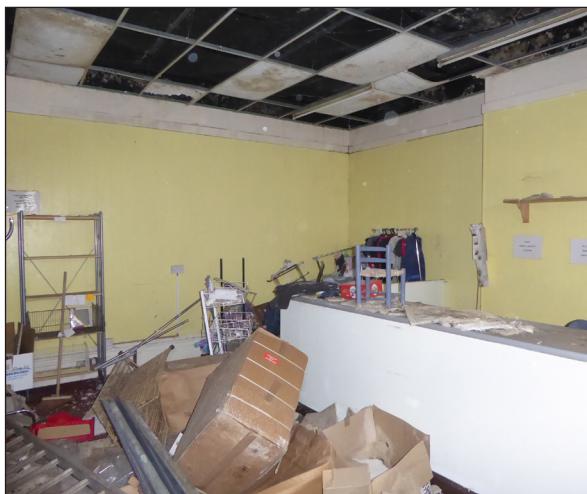
Figure 33: View of the ground-floor front room (© Historic England, photograph: Alastair Coey Architects 2019)

The ground floor is entered through a square lobby from the main entrance in the north elevation. The lobby has a polychromatic tiled floor and lime plastered walls and ceiling. Within, the main front room has a timber boarded floor, plain plastered walls and a late-20th century suspended ceiling, set just above the tops of the segmental-arched windows, above which can be seen the original ceiling and its moulded cornice (Figure 33). The east and north walls are clad with vertical timber sheeting, probably dating to *circa* 2000, behind which can be seen evidence of an earlier wallpaper over anaglypta dado lining (Figure 34). The skirtings and

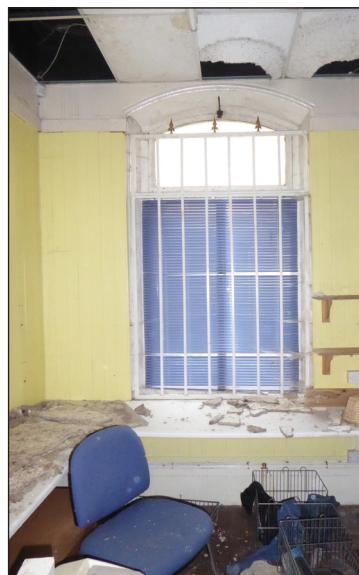
segmental-headed windows with inward-opening bottom-hung casements (Figure 35). The windows on the east wall are covered by inset timber sheets and are blocked externally by steel sheets. A fireplace, shown on Thompson's plan, has been removed from the chimneybreast on the west wall.

*Figure 35: Internal detail of ground-floor window (© Historic England, photograph: Alastair Coey Architects 2019)*

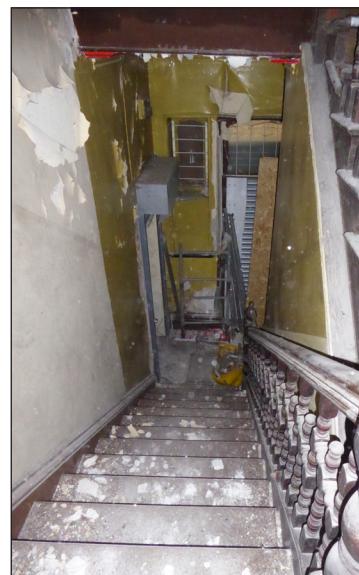
*Figure 36: View down the staircase from the first-floor half-landing (© Historic England, photograph: Alastair Coey Architects 2019)*

A flush door on the east side of the south wall leads to the side entrance hallway from which a timber staircase rises to the first floor via a half-landing (Figure 36). The walls here are plastered and the ceiling has a simple moulded cornice. The staircase has wooden treads and risers, closed strings, spindle moulded balustrades in a cruciform pattern, substantial moulded handrail and square decorative newel posts with turned features and moulded finials (Figure 37). The staircase originally rose through the building to the second floor but, at the time of construction of the alleyway bridge (proposed as *circa* 1900) the upper flights were removed in order to create the second-floor billiards room which now extends to the full depth of the main building. The exposed edge of the landing, where the upper staircase has been removed, is closed by a much simpler short balustrade (Figure 38).

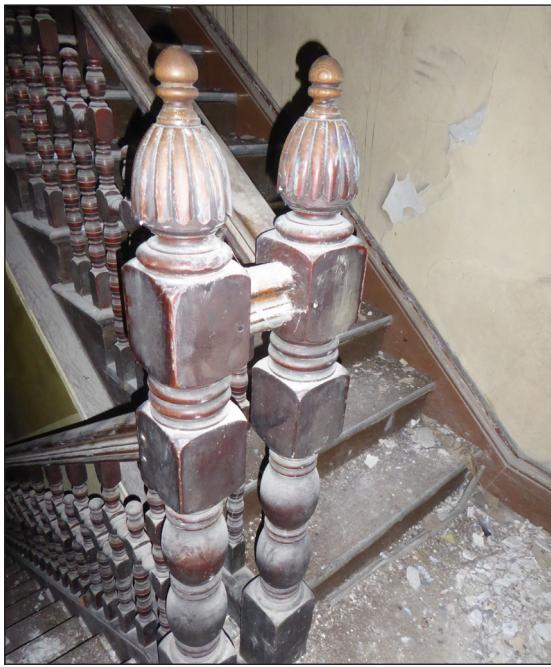
*Figure 37: Detail of newel posts on the mezzanine landing (© Historic England, photograph: Alastair Coey Architects 2019)*

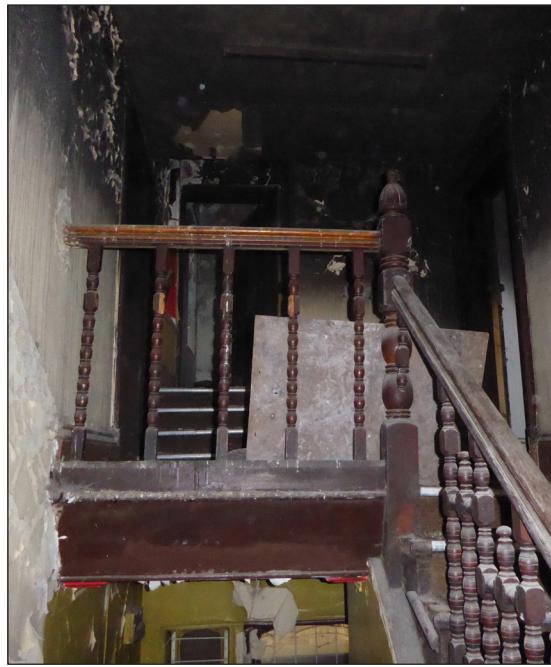
*Figure 38: The first-floor landing with the altered stairs continuing to the second floor in the extension behind (© Historic England, photograph: Alastair Coey Architects 2019)*

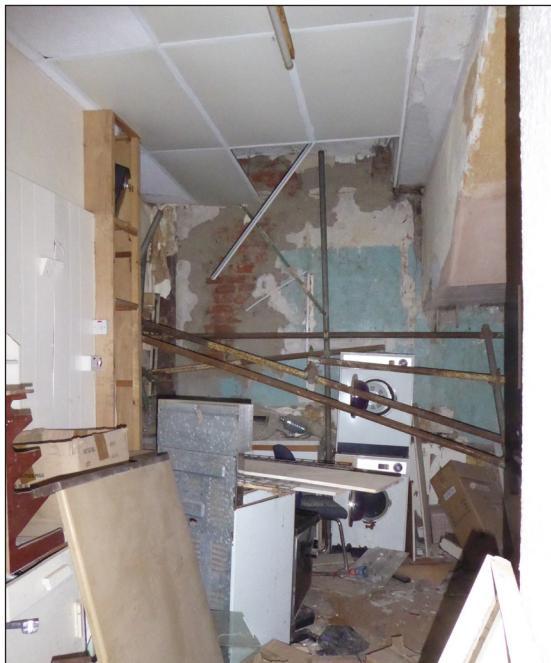
The ground-floor room to the south of the staircase has been reconfigured from the late 19th-century arrangement designed by Thompson. Although the door into the staircase hall remains in the same place today, his plans show a small rectangular room labelled 'Caretaker's Room 13.0 x 8.0' with a central chimneypiece and lit by the southerly window in the east wall (see Figure 26). Outside the room, in the hall, a corridor ran beneath the return flight of stairs opening into a small WC in the south-west corner, and possibly accessing another flight of stairs leading down

*Figure 39: View of the ground-floor rear room (© Historic England, photograph: Alastair Coey Architects 2019)*

to the coal cellar. Today, however, the east end of this corridor has been closed and the area of the corridor and WC incorporated into the former Caretaker's Room to form a single space. Although the fireplace has been removed, the central location of the chimneybreast indicates that it was either relocated to be central to the new larger room at the time these alterations took place or that the proposed plans were not executed (Figure 39). The recess shown to the east of the chimneybreast on Thompson's drawings is closed with a late-20th century timber partition and door. A cupboard door in the north-west corner may still access basement stairs but this was not accessible for investigation.

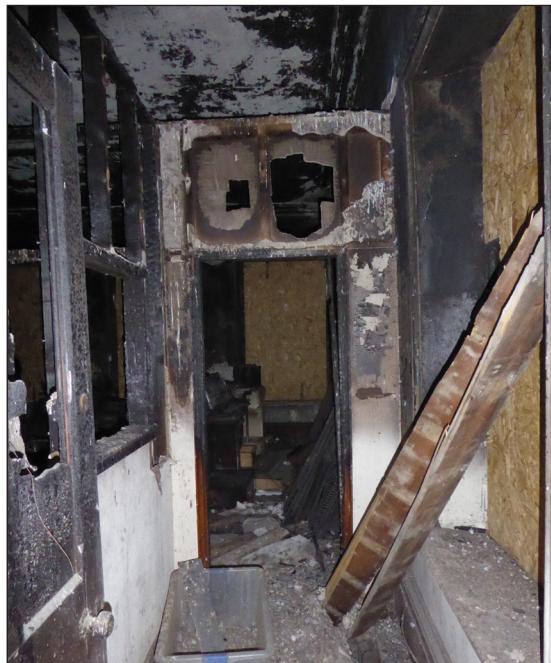
*Figure 40: View of the first-floor glazed and timber lobby (© Historic England, photograph: Alastair Coey Architects 2019)*

At first-floor level, a four-panel door on the north side of the landing leads to the front room via a crudely inserted glazed and timber lobby around the window closest to the door (Figure 40). This front room has suffered extensive fire and smoke damage, although the original lime wall plaster, lath-and-plaster ceiling and moulded cornicing survive substantially intact (Figures 41 and 42). The area south of the chimneybreast has also been partitioned off and is entered independently from the lobby. A stone fireplace surround survives on the chimneybreast projecting from the west wall, with flanking jambs containing inscribed circular bulls eyes and a substantial bull-nosed mantle (Figure 43). The firebox opening is blocked with timber boarding and contains an inserted late 20th-century electric fire. Again, there is no indication of the use of the room, but its size, decoration and first-floor position overlooking the street suggests it was the principal room in the building, perhaps the Institute library. The description of the opening of the Institute records that the gathering was held in the library which suggests that this room doubled up as a meeting or lecture room as well.<sup>98</sup>

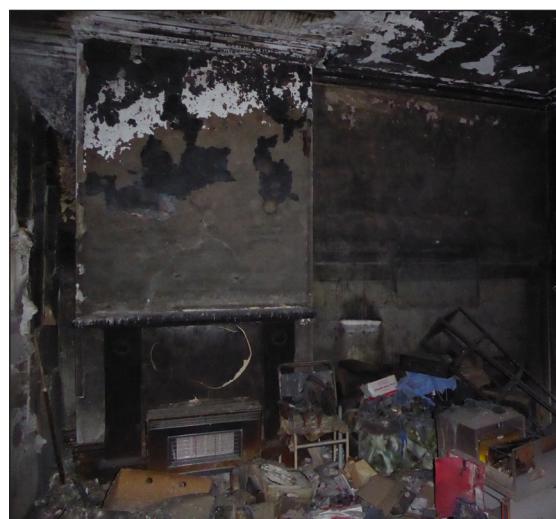
*Figure 42: View of first-floor front room (© Historic England, photograph: Alastair Coey Architects 2019)*

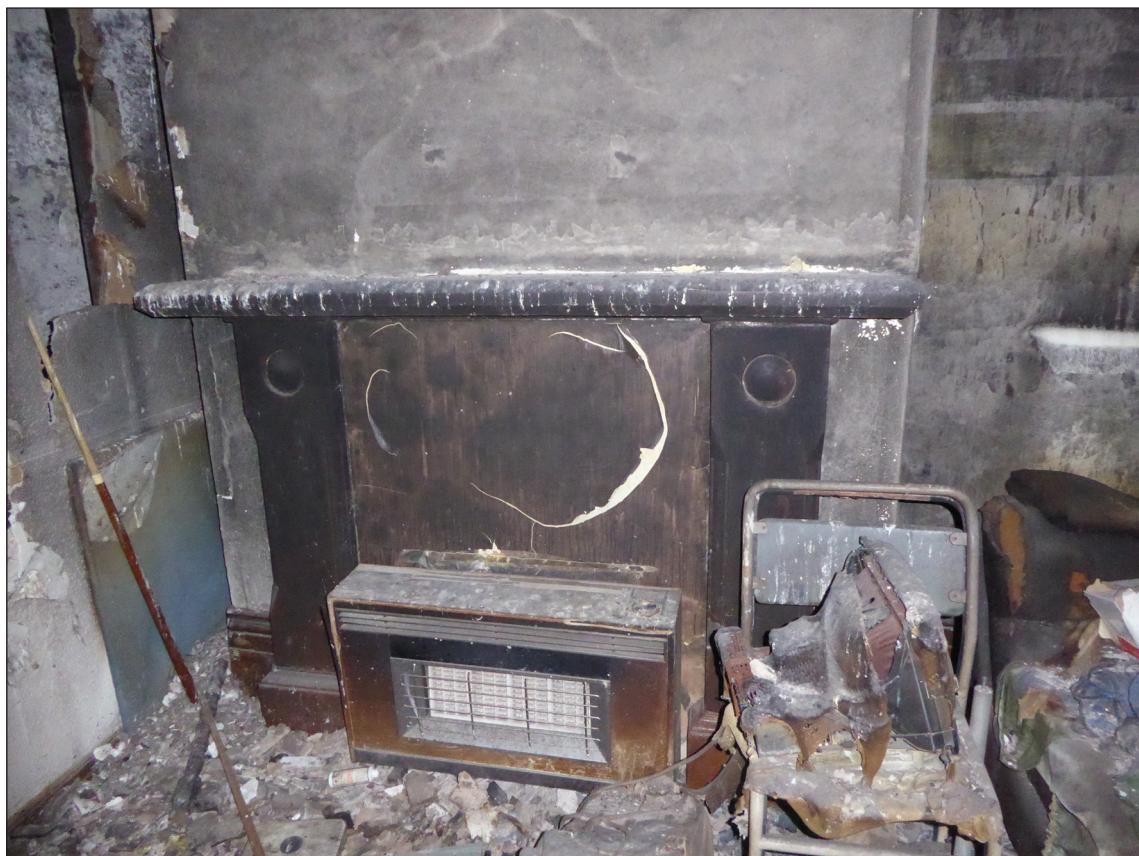
Figure 43: Detail of first-floor front room fireplace (© Historic England, photograph: Alastair Coey Architects 2019)

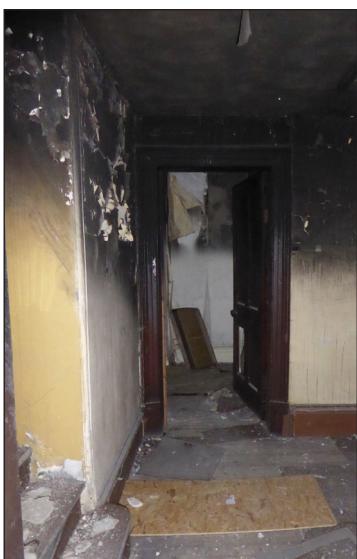
Figure 44: View of first-floor landing looking to the rear rooms (© Historic England, photograph: Alastair Coey Architects 2019)

To the south of the landing, a four-panel door opens into a short corridor which leads to a room in the south-west corner of the main building and another room at the back of the archway bridge beneath the flight of stairs to the second floor (Figure 44). The landing door has a plaque reading 'Office/Enquiries' and appears to date from the mid-20th century, indicating that the rooms had an administrative use, at least towards the end of the Institute's life. Both rooms have plain plastered walls and lath-and-plaster ceilings in very poor condition and the windows in each room are blocked with timber boards. The south-west room has a simple painted slate fireplace with consoled mantle but the condition of the room prevented further investigation (Figure 45). These rooms may have formed part of the caretaker's flat which was located within the Institute building. As noted above, the room in the archway bridge contains a series of the caretaker's account books from the mid-20th century as well as several portraits of Institute presidents (Figure 46). These and the door plaque suggest that some sort of caretaker remained in charge of the running of the building, although it is unclear whether they were still resident.

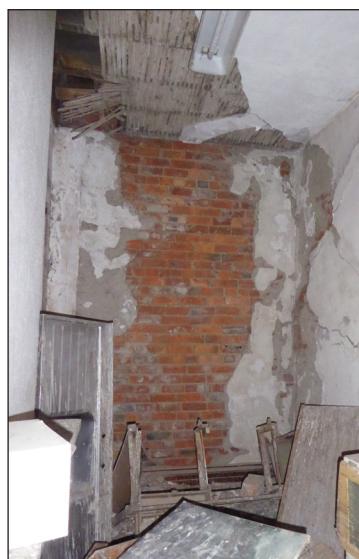
Figure 45: View of first-floor south-west room (© Historic England, photograph: Alastair Coey Architects 2019)

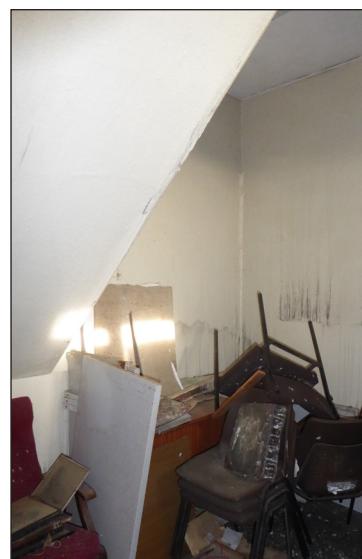
Figure 46: View of first-floor south-east room (© Historic England, photograph: Alastair Coey Architects 2019)

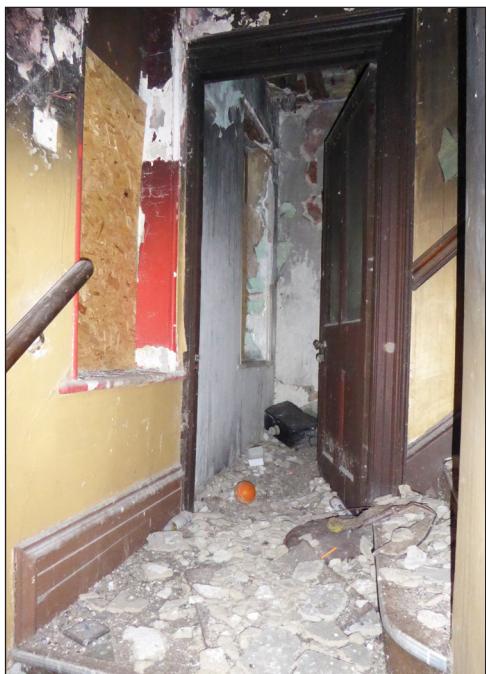
*Figure 47: View of first-floor alleyway bridge landing looking into the small room to east (© Historic England, photograph: Alastair Coey Architects 2019)*

From the main landing four steps lead up through an opening in the east wall into the archway bridge extension. A smaller landing with a door on its east side opens into a small room, each lit by a single timber casement window, boarded up on the inside (Figure 47). A gas mantle is mounted on the south wall of the small room suggesting that the building was lit by gas from an early stage (Figure 48). The opening from the main landing is likely to be an original window, lowered to provide an entrance from the landing into the extension.

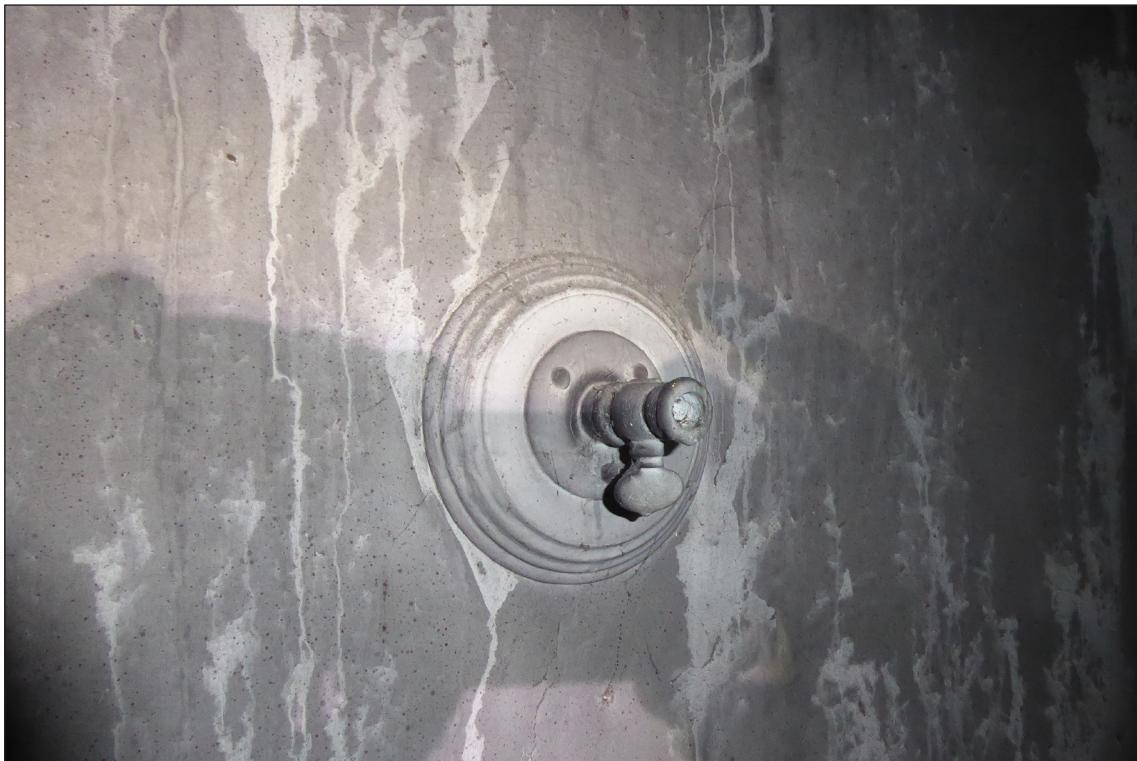
Figure 48: Detail of gas sconce in small room in archway bridge (© Historic England, photograph: Alastair Coey Architects 2019)

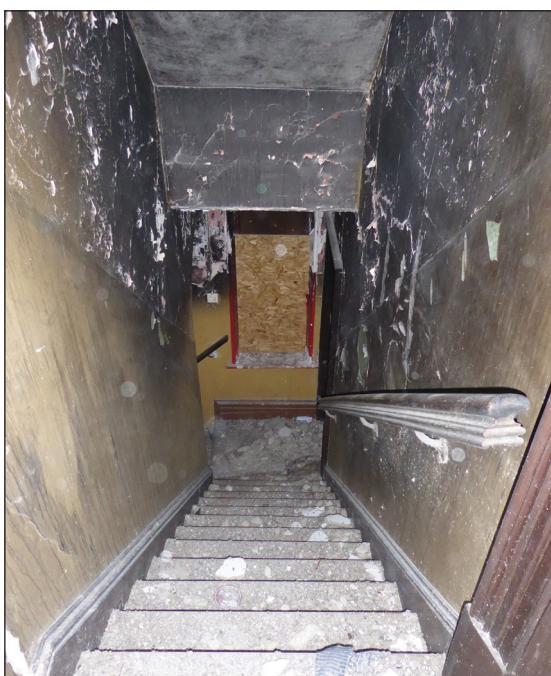
Figure 49: View of archway bridge staircase from second floor (© Historic England, photograph: Alastair Coey Architects 2019)

The staircase in the archway bridge between the first and second floors is presumed to have been inserted to compensate for the top two flights of the original staircase which were removed to create extra space in the second floor of the 1880 building (Figure 49). Rising from the small first-floor landing, the replacement staircase has a moulded timber

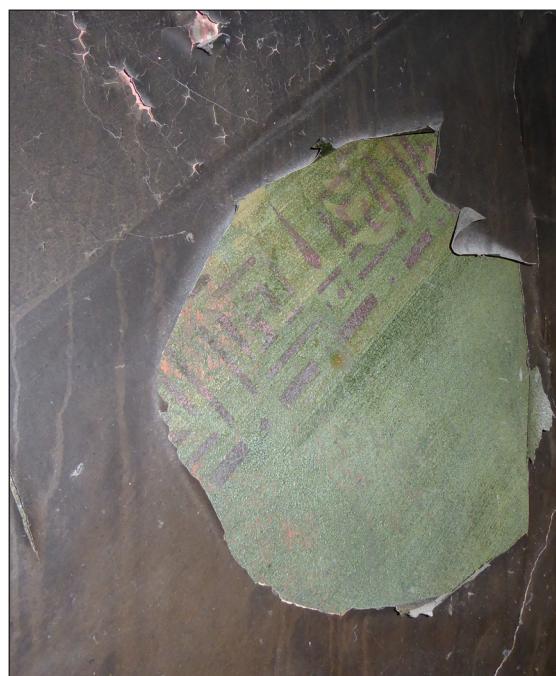
Figure 50: Detail of stencilled geometric wall decoration on second-floor staircase (© Historic England, photograph: Alastair Coey Architects 2019)

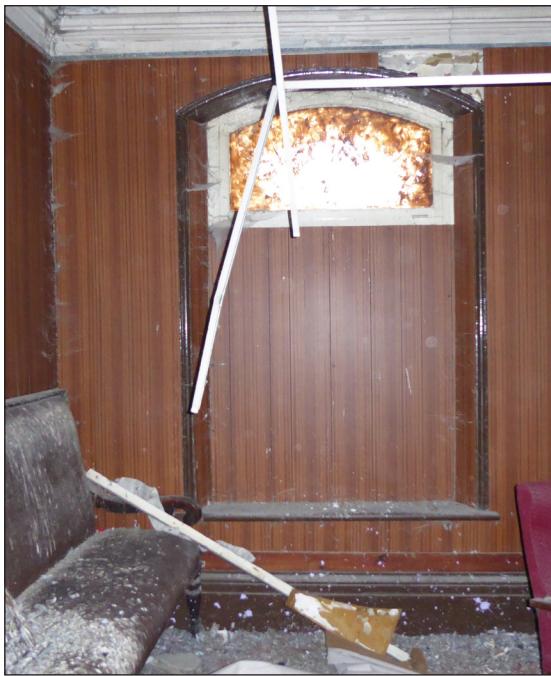
*Figure 51: View of window and internal panelling in billiard room*  
© Historic England, photograph:  
Alastair Coey Architects 2019

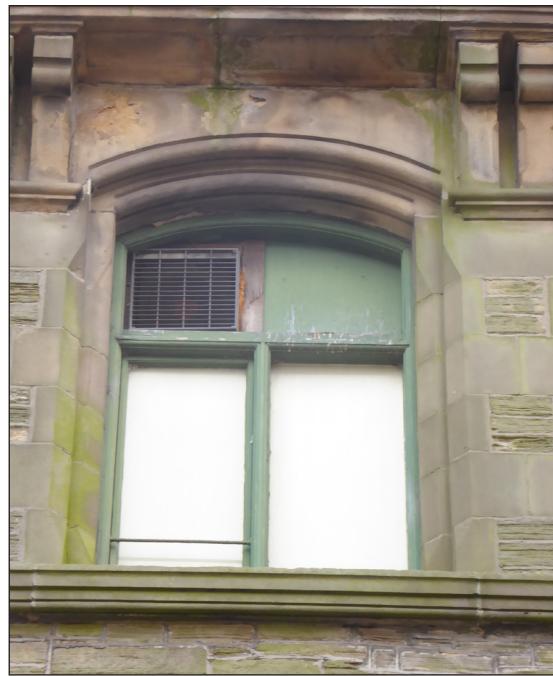
*Figure 52: External view of central second-floor window and vent*  
© Historic England, photograph:  
Alastair Coey Architects 2019

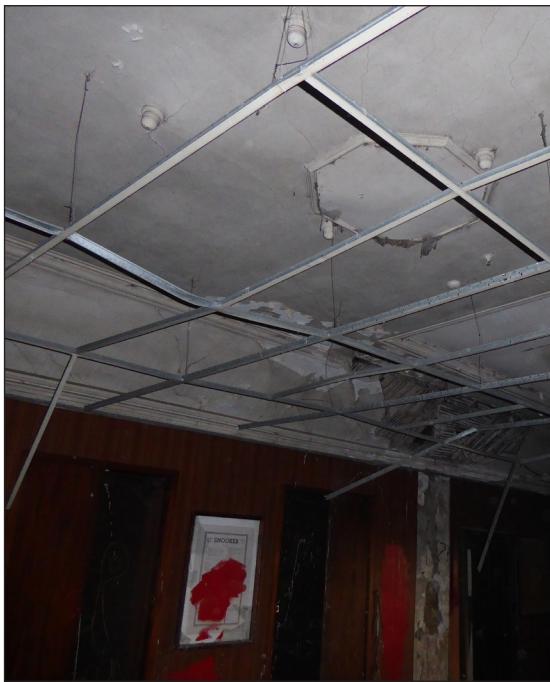
*Figure 53: View of second-floor ceiling above 20th-century suspended ceiling (© Historic England, photograph: Alastair Coey Architects 2019)*

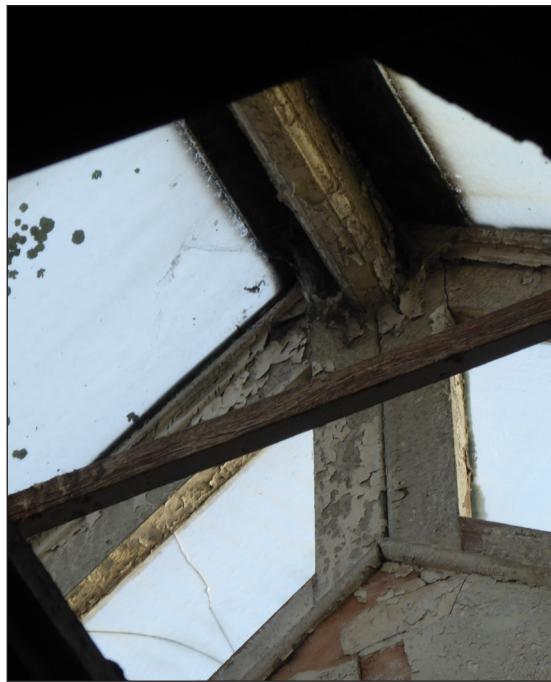
*Figure 54: Internal detail of roof lantern (© Historic England, photograph: Alastair Coey Architects 2019)*

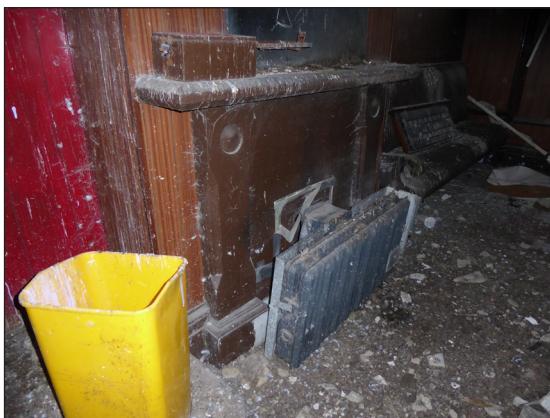
*Figure 55: Detail of billiard room fireplace (© Historic England, photograph: Alastair Coey Architects 2019)*

On the west wall the chimneybreast contains a substantial stone fireplace identical to that in the room below (Figure 55). Upholstered banquets line the remainder of the west wall. Central on the south wall is a second chimneybreast<sup>100</sup> flanked by two windows boarded up but externally retaining the remains of timber casements (Figure 56). These indicate further changes which also probably date to the rearrangement of the second-floor room. On Thompson's plan, the small rear room behind the staircase does not span the full width of the building and its chimneybreast is central to the room itself (Figure 57). In the south-east corner a corridor ran behind the staircase to a WC lit by a window in the south wall. With the removal of the staircase, the rear room, WC and corridor were also removed and the chimneybreast relocated to the centre of the south wall, while a second window was opened to the east of it to form a symmetrical arrangement. Both windows are now blocked with timber boards.

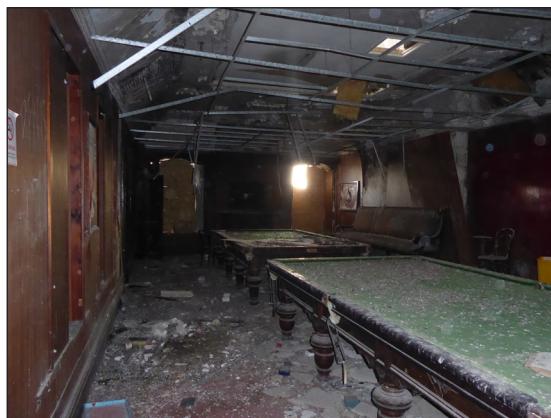
*Figure 56: View of billiard room looking to south wall showing added window (© Historic England, photograph: Alastair Coey Architects 2019)*

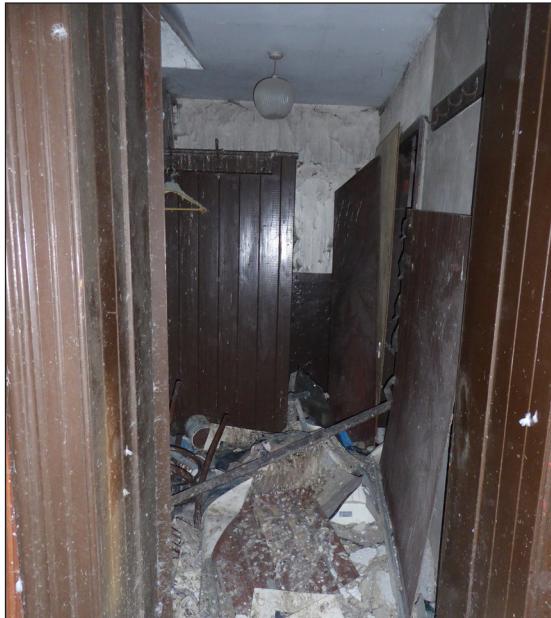
In the east wall of the billiards room, a doorway leads to a toilet containing a glazed vitreous clay corner urinal behind a timber modesty screen (Figure 58). This toilet and the one off the landing must have been installed to compensate for the loss of the 1880 toilet in the south-west corner of the second floor. To the south of this space, another door opens into what appears to have been a cloakroom which retains its coat hooks and shelving (Figure 59).

*Figure 58: View into second-floor toilets and cloak room lobby (© Historic England, photograph: Alastair Coey Architects 2019)*

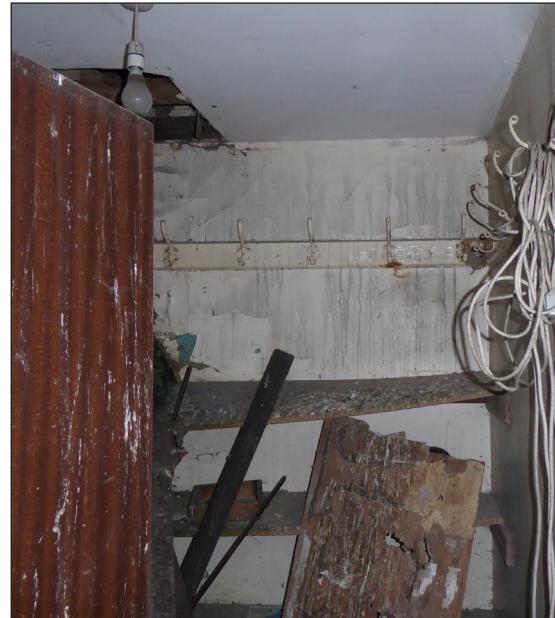
*Figure 59: Detail of coat racks and hangers in second-floor cloak room (© Historic England, photograph: Alastair Coey Architects 2019)*
