# 160 King Street Great Yarmouth Norfolk

Tree-Ring Analysis of Oak Timbers and Conifer Boards

Research Report Series 111-2019

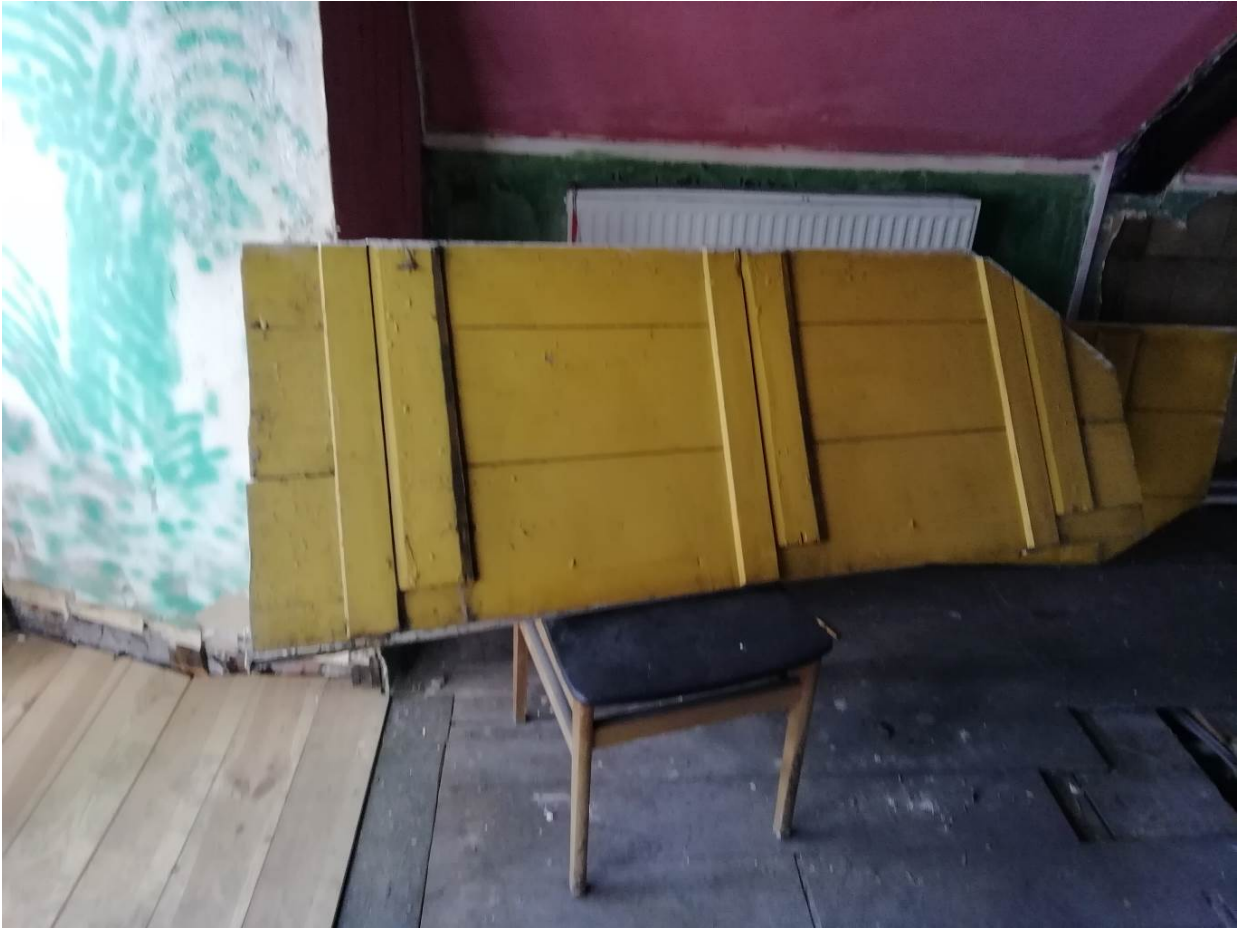
*Figure 4: Ex situ door 1, the inner (hinge side) and middle boards were measured (photo Martin Bridge)*

The property's long axis lies SW-NE but has been taken as E-W for the purposes of this report. The assessment showed that none of the timbers in the east end of the building that were thought to be of nineteenth- and twentieth-century origin had enough rings to make them suitable for reliable dendrochronological investigation. These timbers were, therefore, not sampled. However, core samples were taken from a series of timbers in floor-frames, wall-frames, and the roof, thought to represent the primary construction phase of the building. The oak samples taken, as well as the ring series derived from photographs of the cross-sectional surface of two conifer boards from each of the two three-boarded attic doors are detailed in Table 1. The locations of the sampled oak timbers are illustrated in Figures 2 and 3, whilst one of the conifer doors investigated is shown in Figure 4, the other door being its mirror image.

Although one of the three conifer doors assessed was rejected as unsuitable for analysis, two boards from two of the doors were included in this analysis. The photographs taken of the boards yielded relatively short sequences for each board and they did not show any similarities with each other. Formal identification of the wood type was not undertaken as this would have required the removal of a small section from each board for microscopic analysis. They were, therefore, compared individually to a series of both pine and other conifer species reference chronologies available in the database but none of the board sequences could be reliably dated.

The four conifer boards analysed from the two doors could not be dated. No relative dating was established between their ring series and, thus, whether the boards are coeval can neither be confirmed nor refuted by this analysis. Although formal wood

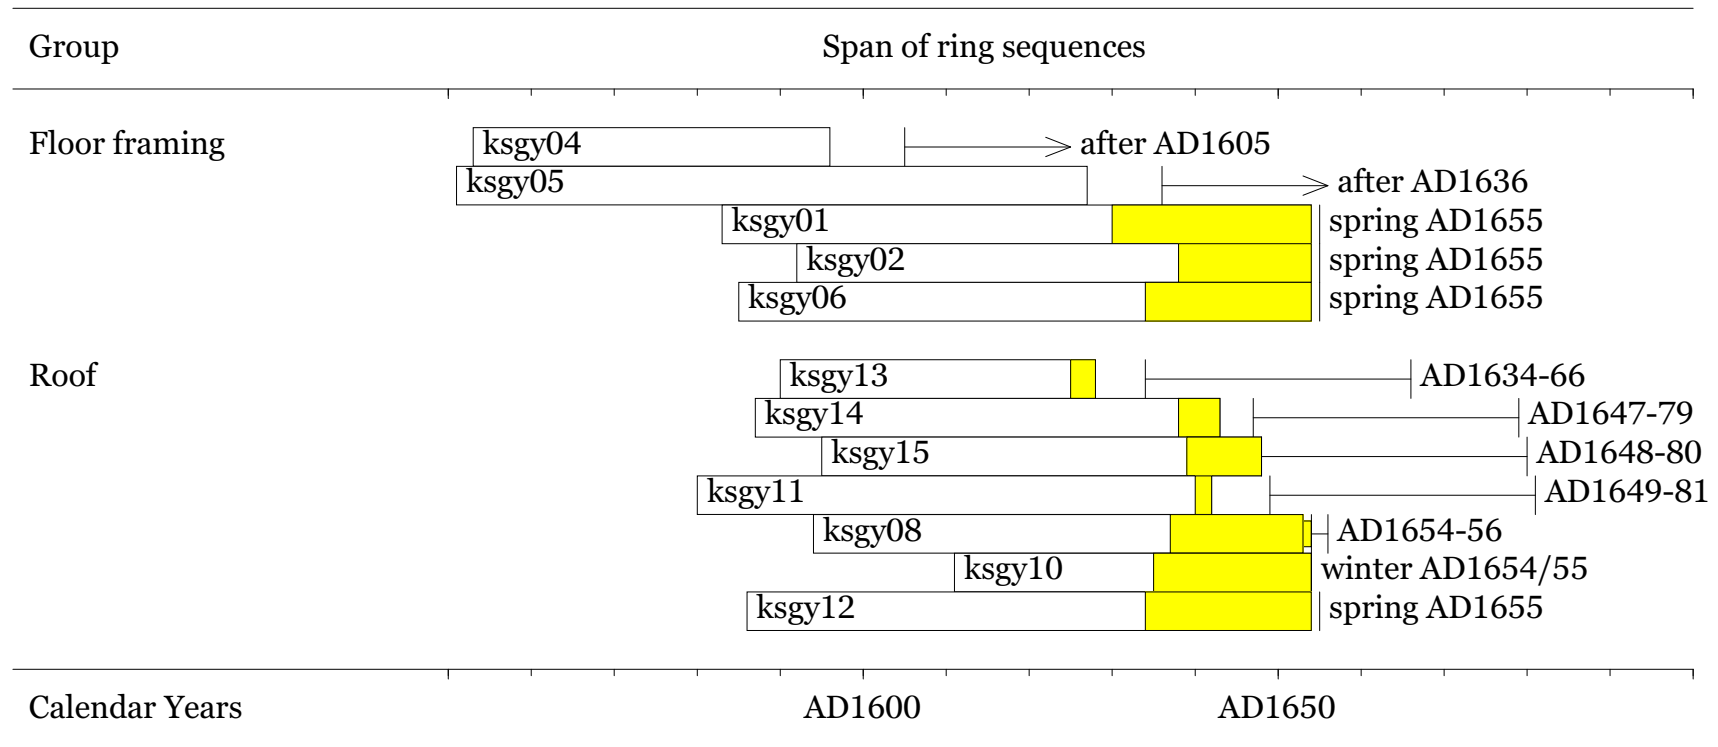
Figure 5: Bar diagram showing the relative positions of overlap of the dated samples, along with their actual or likely felling date ranges. White bars represent heartwood, yellow bars represent sapwood, narrow yellow bars represent additional unmeasured rings

Three oak samples, including the only one from a wall-frame timber, were found to have ring sequences of less than 30 years and were excluded from further analysis as unsuitable for reliable dating purposes. The measured series from the remaining 12 oak samples cross-match each other (Table 2). Although sample ksgy04 was relatively short, it gave a significant match against one other sample, which was visually good and subsequently supported when it was compared individually against oak reference chronologies. The relative positions of overlap of the 12 cross-

matched series are shown in Figure 5. The 12 cross-matched oak series were combined into a 104-year long site chronology, KSGYt12. This was compared with an extensive database of oak reference chronologies where it was found to cross-date consistently to the period AD 1551–1654, some of the strongest matches being shown in Table 3.

All 12 dated samples are clearly broadly coeval and the analysis suggests that they form a coherent group most likely all felled at the same, or similar, time (Fig 5). Three samples from floor-frame timbers and two samples from roof timbers retained complete sapwood. One of these was derived from a tree felled in the winter of AD 1654/55, whilst the other four were derived from trees felled in spring AD 1655. Complete sapwood was present on another timber but the outermost 1-3 rings were lost from the core during sampling, thus producing a narrow felling date range of AD 1654–6 for this timber. Four of the remaining dated samples have some sapwood and produce felling date ranges compatible with the precise felling dates obtained. The remaining two samples have no sapwood but the analysis suggests that these are likely to be coeval and hence felled as part of the same felling event, with the joist, ksgy04, appearing to represent the trimmed down inner part of a longer-lived tree.
