MILTON ABBEY DEER PARK: ARCHAEOLOGICAL INVESTIGATION

MILTON ABBEY DEER PARK, MILTON ABBAS, DORSET

ARCHAEOLOGICAL INVESTIGATION

NGR: ST 820025

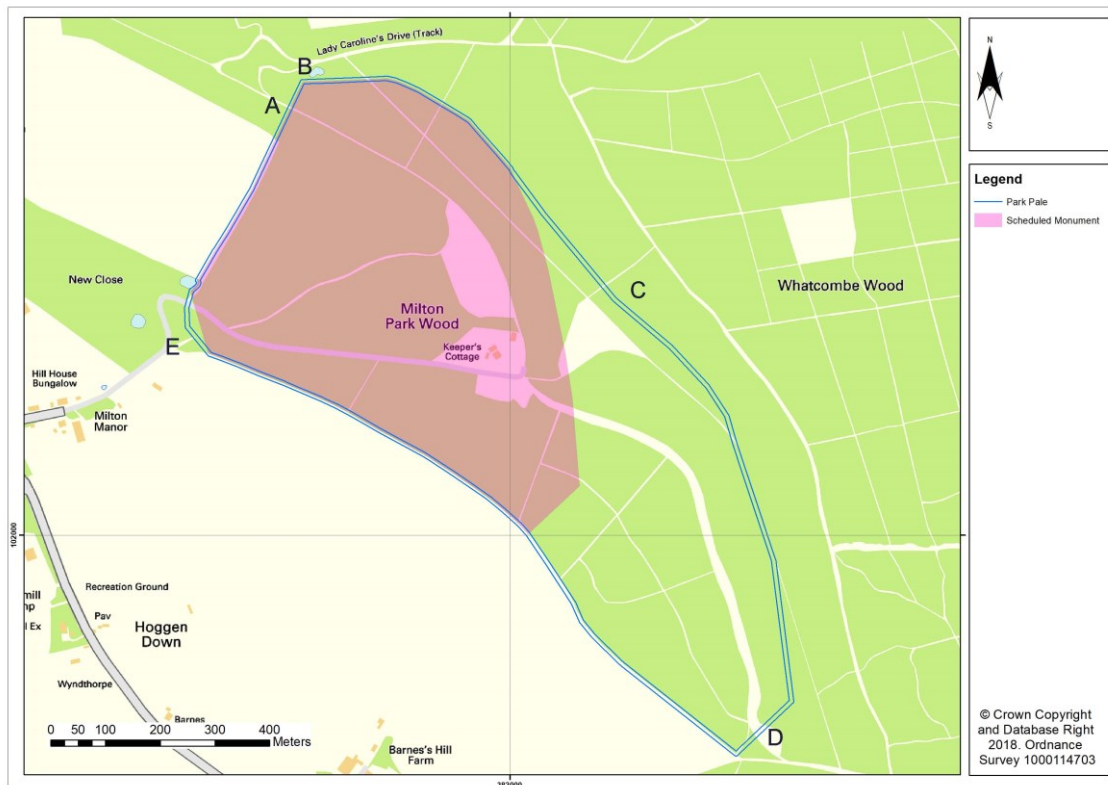
and found to be a substantial earthwork of consistent form and profile for the majority of its extent, comprising a linear bank flanked by internal and external ditches. It forms a complete circuit taking the course shown on Cantor and Wilson's sketch plan (blue line on Figure 1) and thus extends well beyond the current scheduled monument area (red on Figure 1). The interior of the park is mostly wooded and was not examined.

Figure 1: Scheduled ancient monument map, with letters referred to in the description below

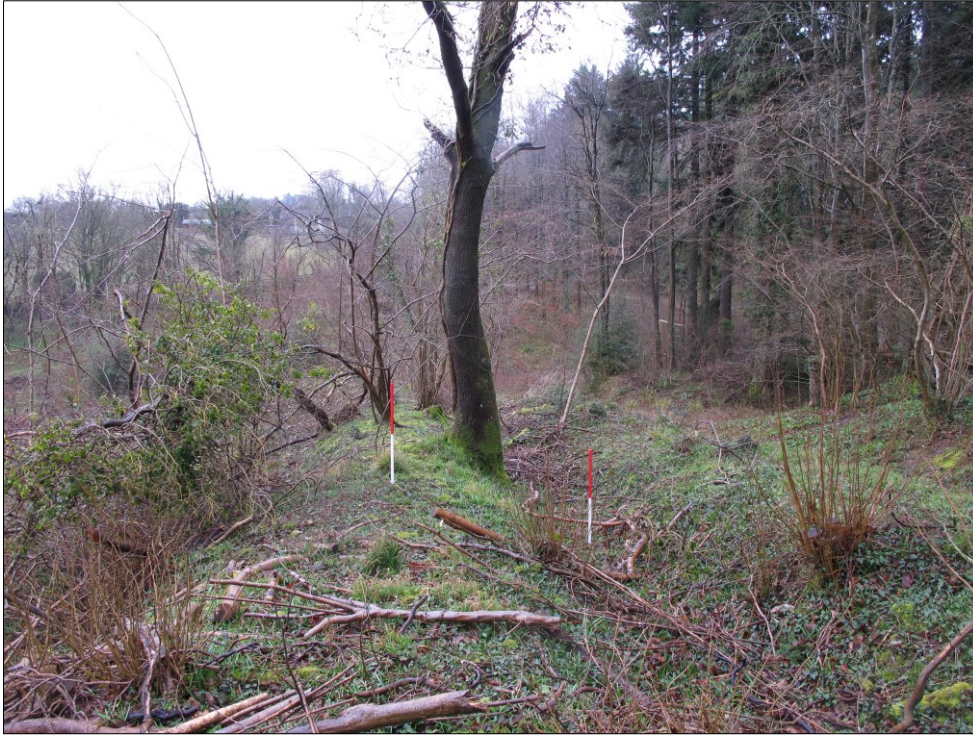
Running north uphill from the main forestry track which bisects it just north of E, the boundary consists of a sharply defined bank with inner and outer ditches. It is 0.8m high, with an inner ditch 0.3m deep, an outer ditch 0.5m deep and the overall width 8m. Flint inclusions are evident where the surface of the bank is disturbed. This line of the boundary is unbroken except for a gap where the main forestry road enters the park and a small breach opposite a field gate. The bank has also been disturbed in two places where trees have fallen.

Figure 2: Western boundary (E to A) looking south

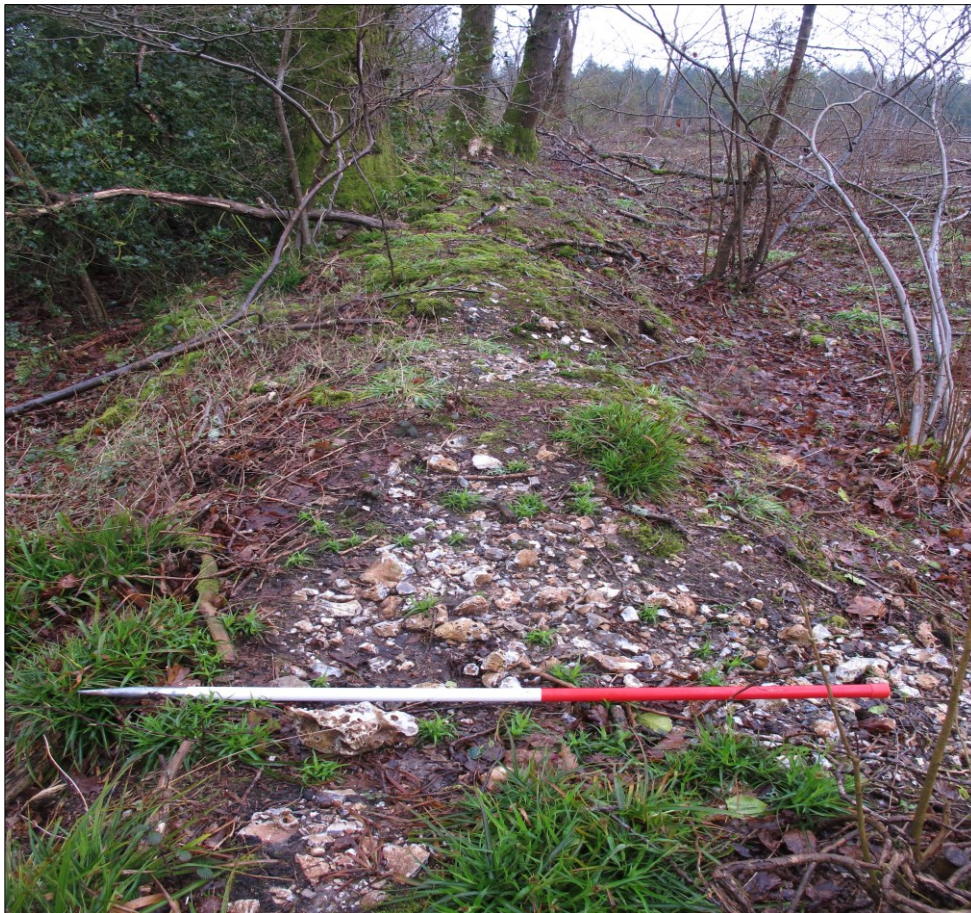
Figure 3: Flint rubble in western bank (E to A)

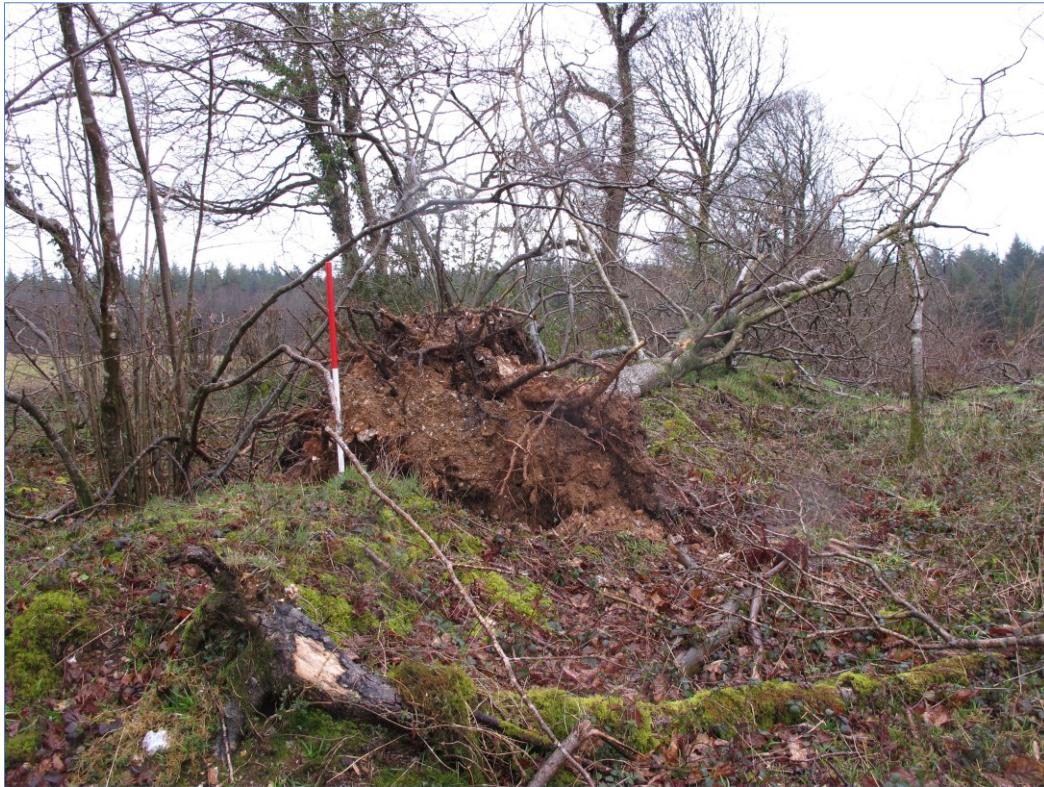
Figure 4: Storm damage to western bank (E to A)

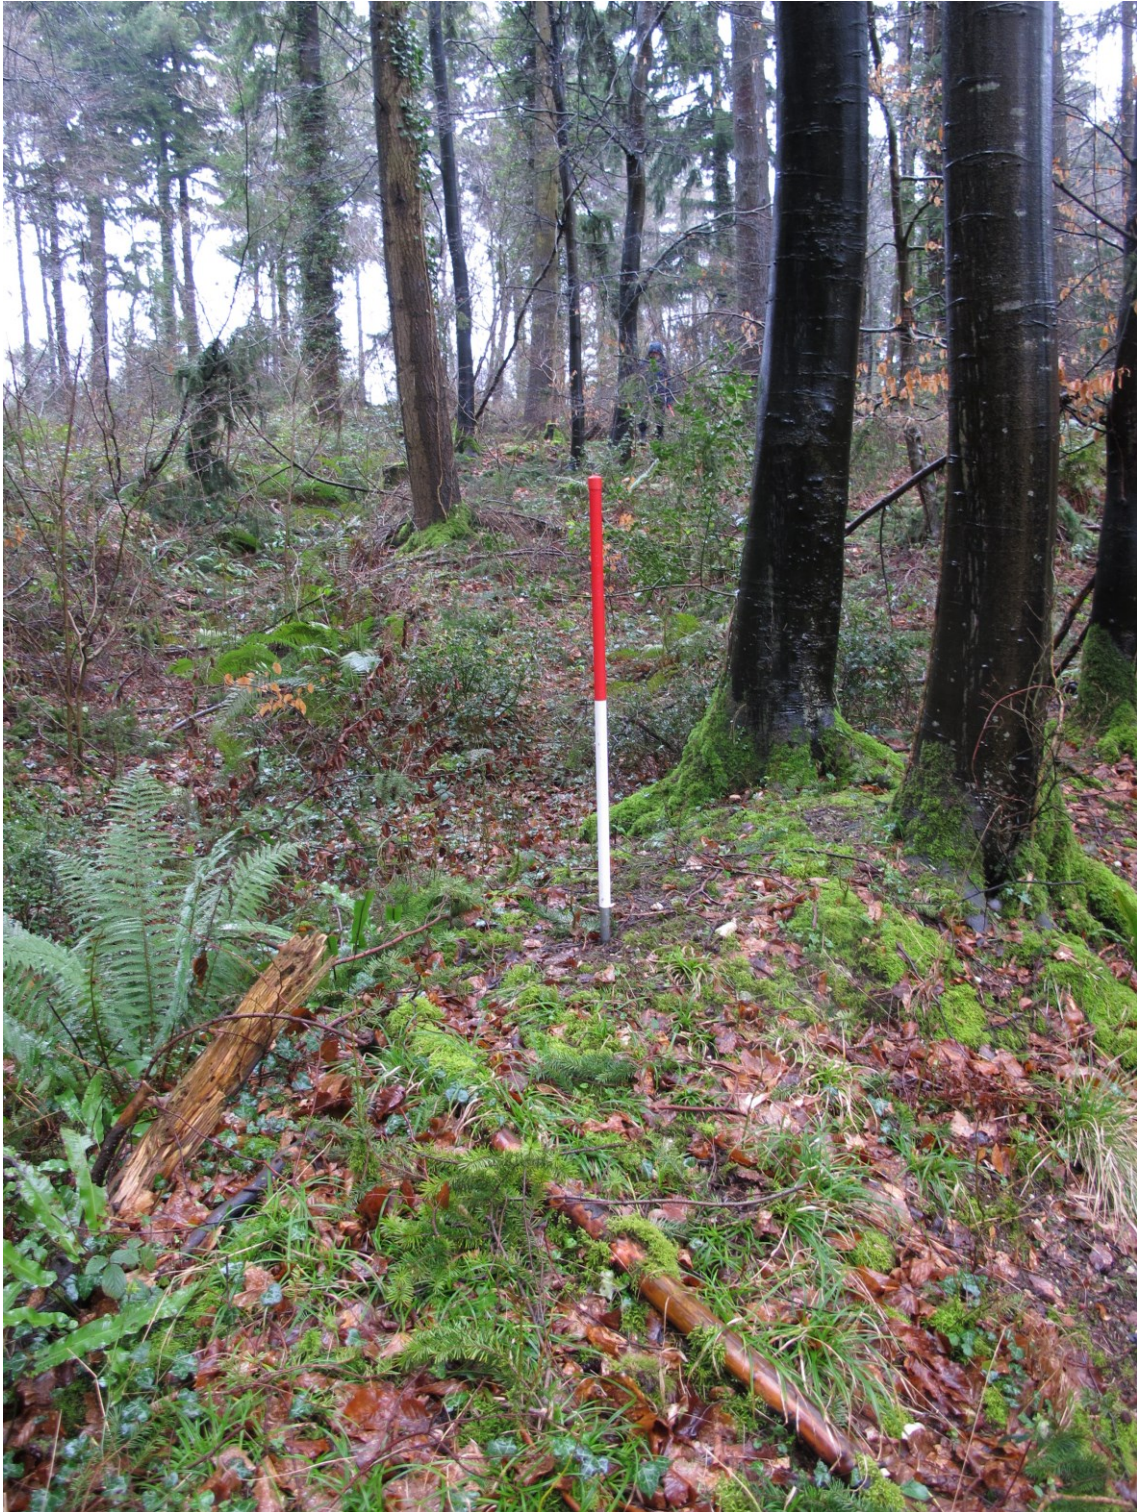
At A a major forestry track cuts through the boundary, but the earthworks immediately resume continuing uphill on the same alignment and of the same form as previously. In this section the bank is more rounded and the ditches less sharply defined. B marks the north-west angle of the enclosure. Here its external ditch is cut by a hollow way leading towards a chalk pit.

Figure 5: Hollow-way cutting external ditch at B continues uphill, while the park boundary turns to the right to run behind the ranging pole

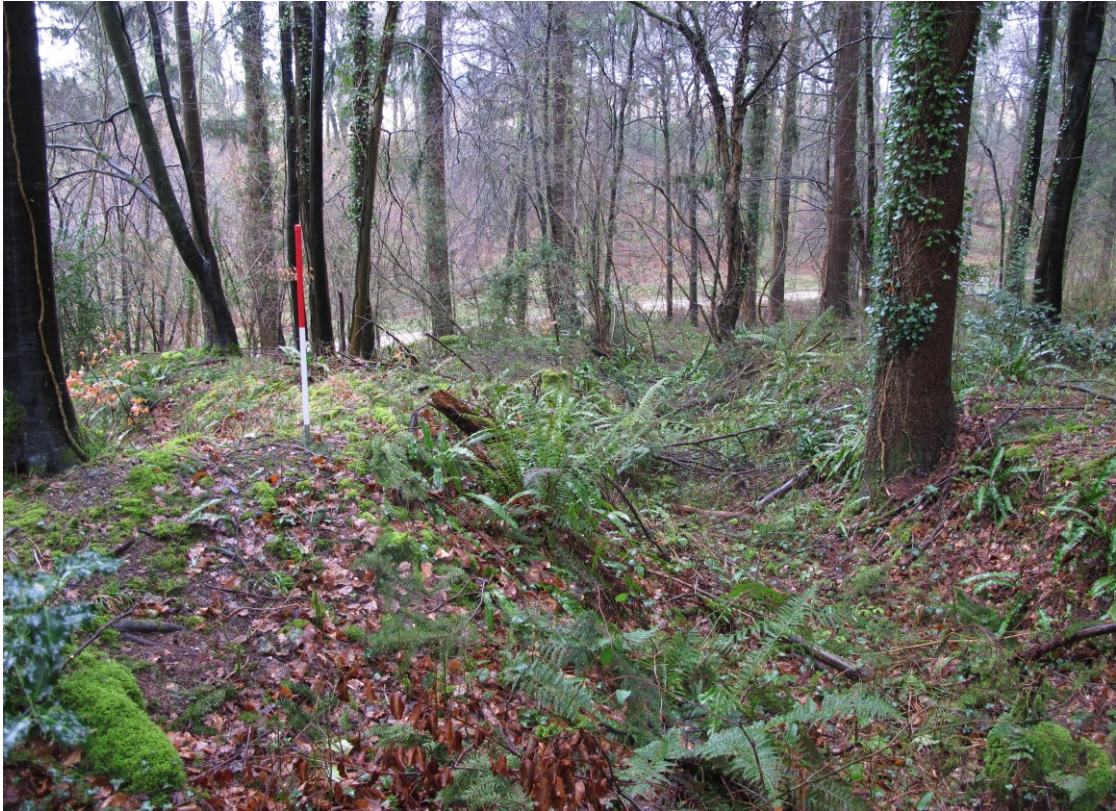
Figure 6: Corner at B, external view with the hollow-way to the right

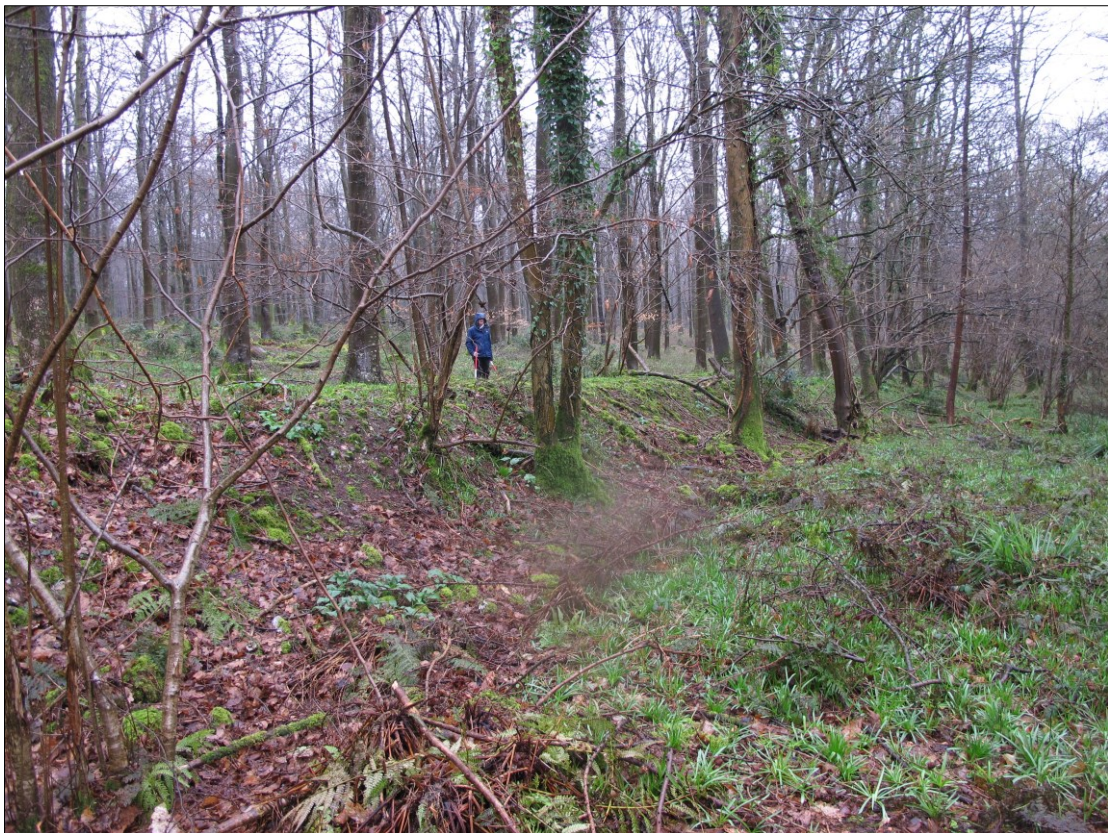
Figure 7: North-eastern section of park pale, viewed from the park interior

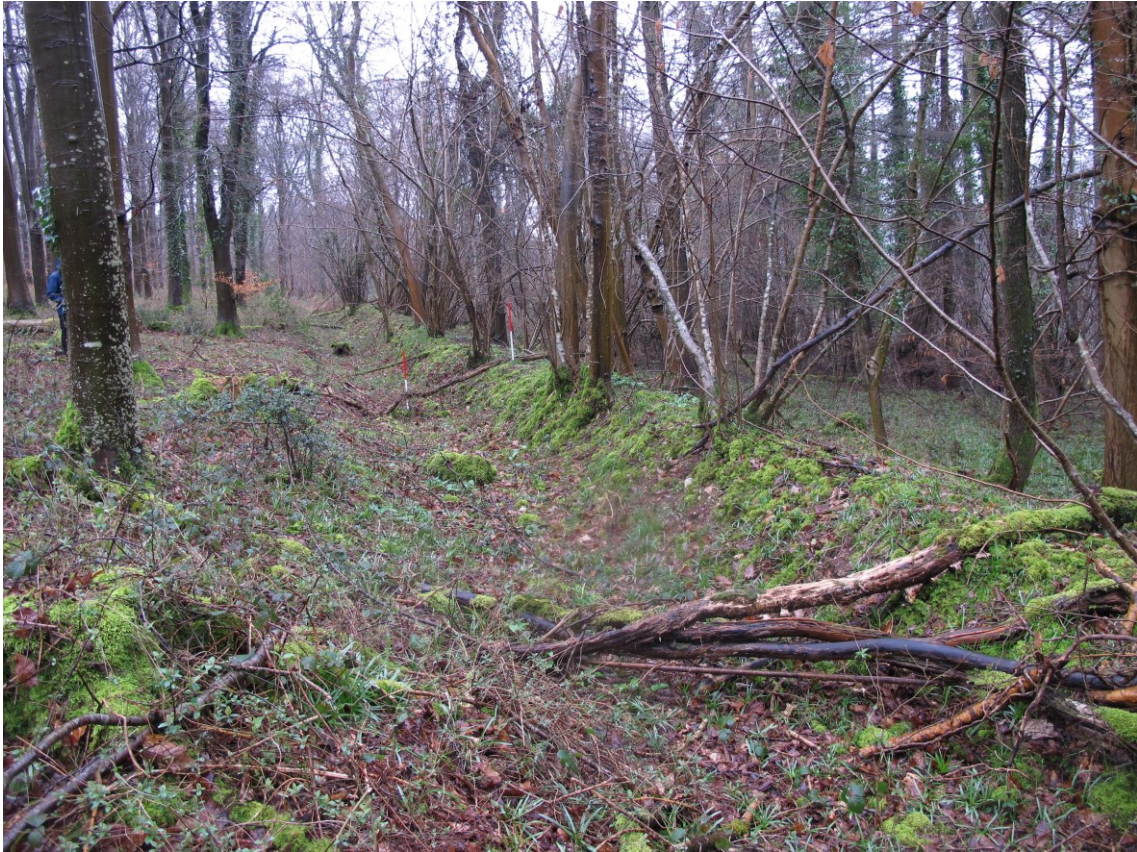
The boundary earthwork turns to an east-west alignment. The earthworks become more substantial, the prominent bank continuing with external and internal ditches as before, but measuring 1.5m high internally and 0.8m externally. The external ditch is 0.8 deep and the internal ditch 0.3m deep, with an overall width of 8m for the banks and ditches. Midway along the north-eastern boundary chalk pits lie just outside the boundary, one adjacent to a gap in the earthworks. As it progresses eastwards the bank becomes increasingly angular in profile with a narrower top, though of the same form and dimensions as previously.

Figure 8: North-eastern boundary (B to C), exterior view

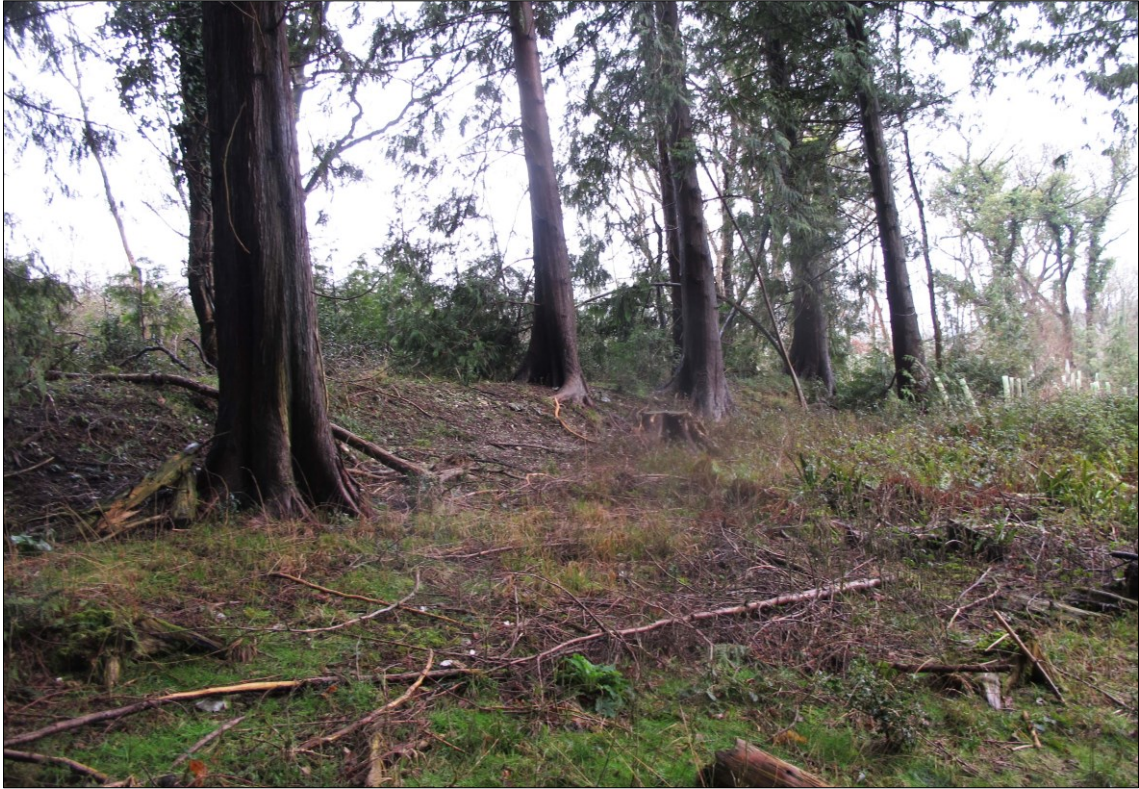
As the earthworks continue eastwards the valley side becomes steeper and this stretch of the boundary follows the break in slope of the natural ridge line. Here the internal ditch becomes a ledge only, with the bank and the external ditch continuing as previously. This part of the boundary includes a section which skirts a conifer plantation. Although supporting some mature conifers, it remains well preserved. It continues into a clear felled area, beyond the scheduled extent, where saplings on its bank form part of a new planting scheme.

Figure 9: Park pale within a conifer plantation beyond the scheduled area

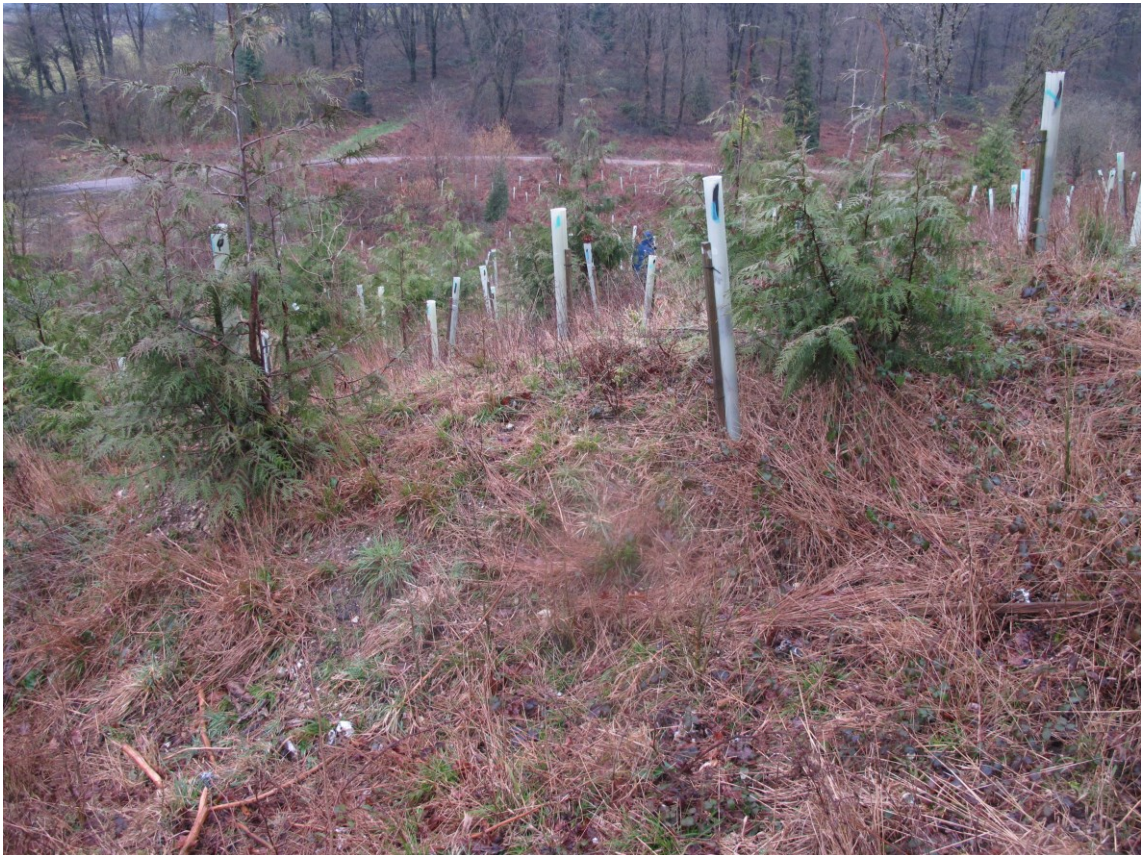
Figure 10: Newly-planted saplings on the park pale beyond the scheduled area

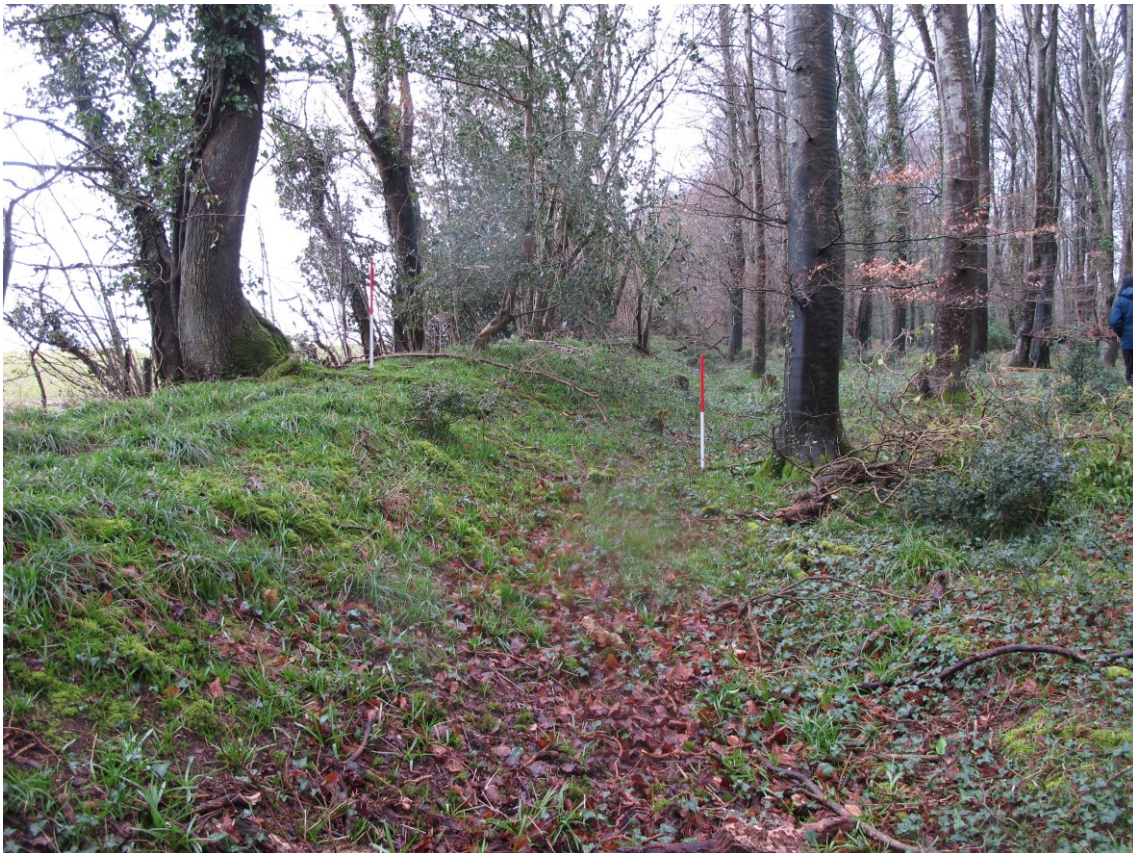
The earthworks delimit the enclosure's south-western side, as depicted on the sketch plan by Cantor and Wilson. For much of this length they traverse relatively level ground rather than following a ridge, forming the boundary between woodland inside the park and arable fields outside. The bank supports outgrown hedgerow trees, some of which appear to have been laid originally. Minor quarry pits are visible just inside the park, but they do not impinge upon its boundary earthworks.

Figure 11: Southern boundary (D to E)

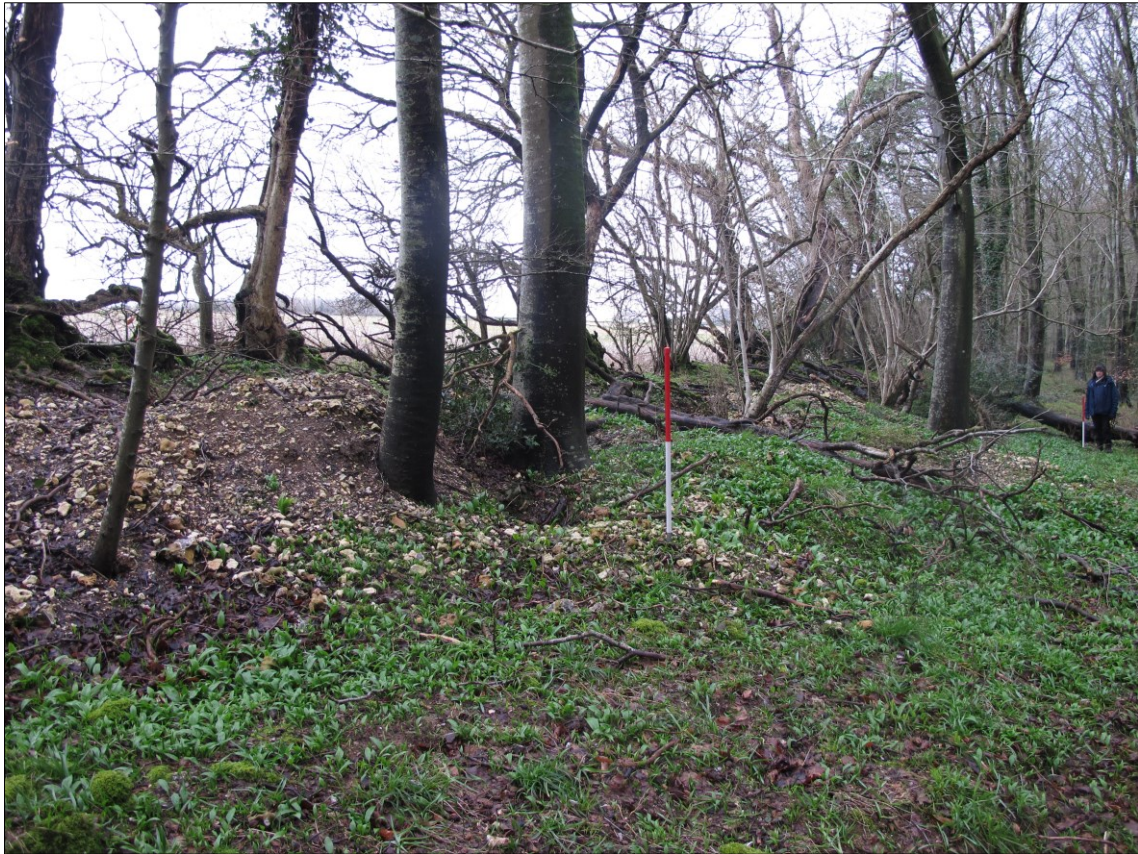
Figure 12: Badger sett on the southern boundary

This section of the boundary, although still substantial, is less well preserved than the other sections. The ditches are intermittent and the bank is diminished in places, measuring just 5.3m wide and 0.5m high at one point. Where present, the external ditch has been disturbed by its use as a field boundary and badger setts have damaged two areas.

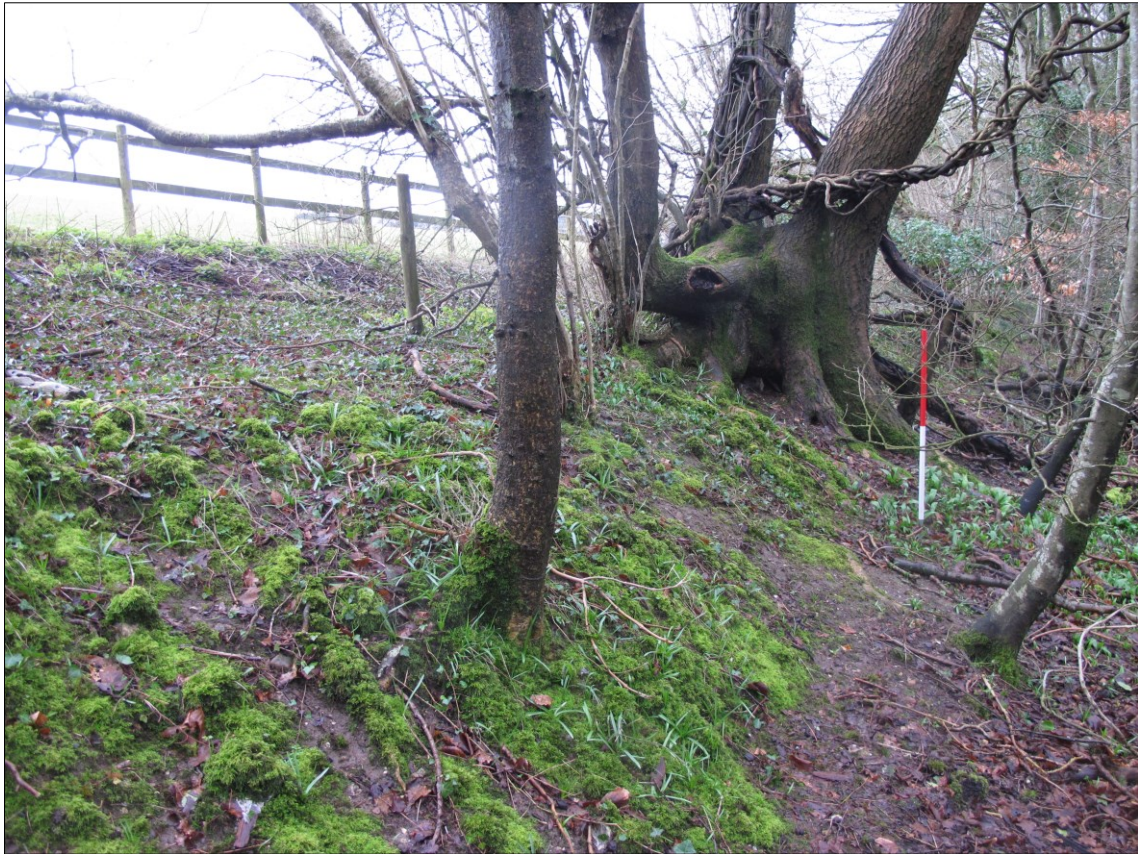
The natural slope becomes steeper as the boundary approaches its westernmost point. It resumes a contour-following alignment and has eroded to the extent that the ditches no longer survive, with the bank becoming a 1m high scarp. This follows the natural break of slope and would be enough, with the addition of a pale, to prevent the egress of deer. From E, the park's westernmost angle, the boundary continues downslope to complete its circuit, with the bank resuming (1m high) flanked internally by a ledge and externally by a ditch.

Figure 13: Southern bank becomes a scarp on the steep valley side east of E
