The Chequers Public House  
9 Goddards Lane  
Chipping Norton  
Oxfordshire

Tree-ring Analysis of Oak Timbers

Research Report Series 2-2020

NGR: SP 31358 27255

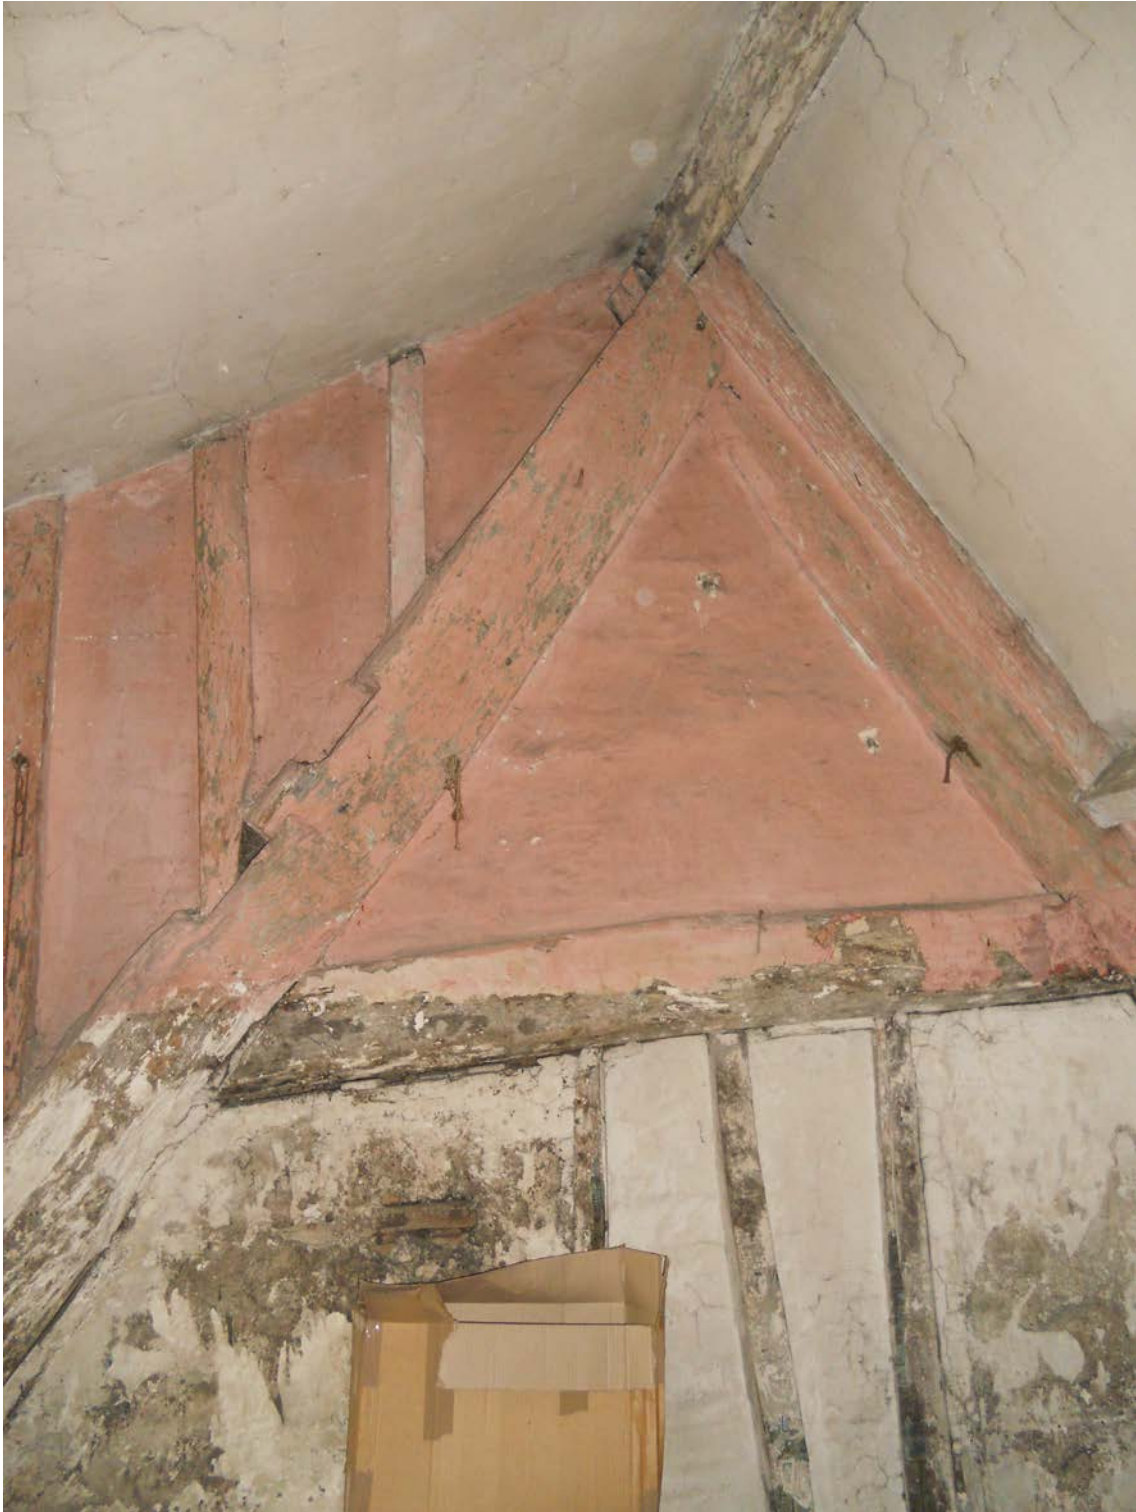
*Figure 4: Photograph (looking east) of the upper part of the truss at the truncated west end of the east-west range (photo Martin Bridge)*

Samples were taken from several areas of the property, and details are given in Table 1, with the sample locations illustrated in Figures 2, 3 and 5, and the ring-width data of all measured samples given in the Appendix. Figure 4 is a photograph of the west truss of the east-west range. Two ceiling beams from the ground-floor bar areas in the north-south range were sampled, but that in the south (front) bar area was found to be of elm (*Ulmus* sp.) and this was rejected from further analysis. Six timbers were sampled from the roof of the east-west range parallel to Goddards Lane, thought to be the oldest part of the building, and five timbers were sampled from the roof of the north-south (front) range, lying parallel to Spring Street. This latter roof had several apparently re-used timbers.

In the east-west range, the ring width series from the two principal rafters cross-matched each other well ( $t = 6.5$  with 71 years overlap). The visual comparison of the ring series plot from the collar with those from the two principal rafters suggested possible cross-matching but no significant  $t$ -values were produced. However the pair of principal rafters and the collar could be dated independently with the database of oak reference material indicating that the relative position identified visually was actually correct. The three series were, therefore, combined to form a 77-year long site chronology, CNCHQ345, which was dated to the period AD 1362–1438, the strongest matches being shown in Table 2a. The mean heartwood/sapwood boundary date of AD 1435 for these three timbers suggests a likely felling date range of AD 1444–76, making this one of the oldest surviving roofs in the town.
