Bunksland Farmhouse East Anstey Devon

Tree-ring Dating of Oak Timbers

Research Report Series 191-2020

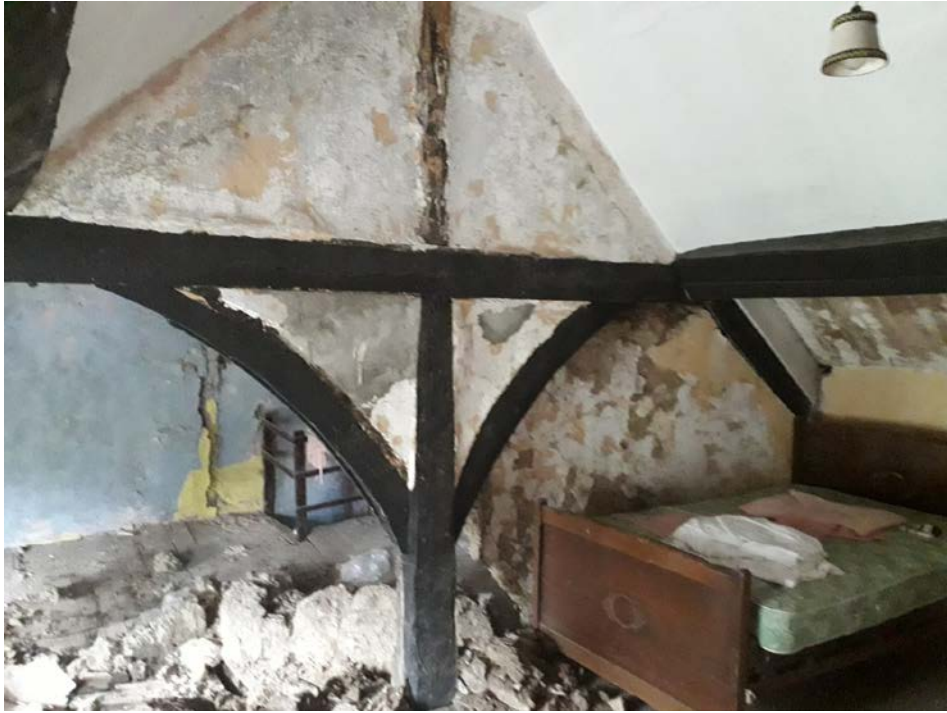
Figure 3: Truss 3, photograph taken from the east (Alison Arnold)

There are three roof trusses over the farmhouse thought to belong to the primary, late fourteenth-/early fifteenth-century construction. One of these (Truss 3) would have originally divided the hall from the high (or western) end. This truss comprises principal rafters, a collar supported by curved braces, and, unusually for Devon, a central post reaching to the ridge, giving the appearance of a king-post truss (Fig 3). It is possible that a horizontal beam (now missing) was positioned at the current first-floor level with further braces curving down to it. Trusses 1 and 2 are of a different form being of jointed cruck type with high cranked collars and, in the case of Truss 1 at least, a yoke supporting the diamond-set ridge piece. Between the trusses are a single set of original purlins and some surviving windbraces (Fig 4).

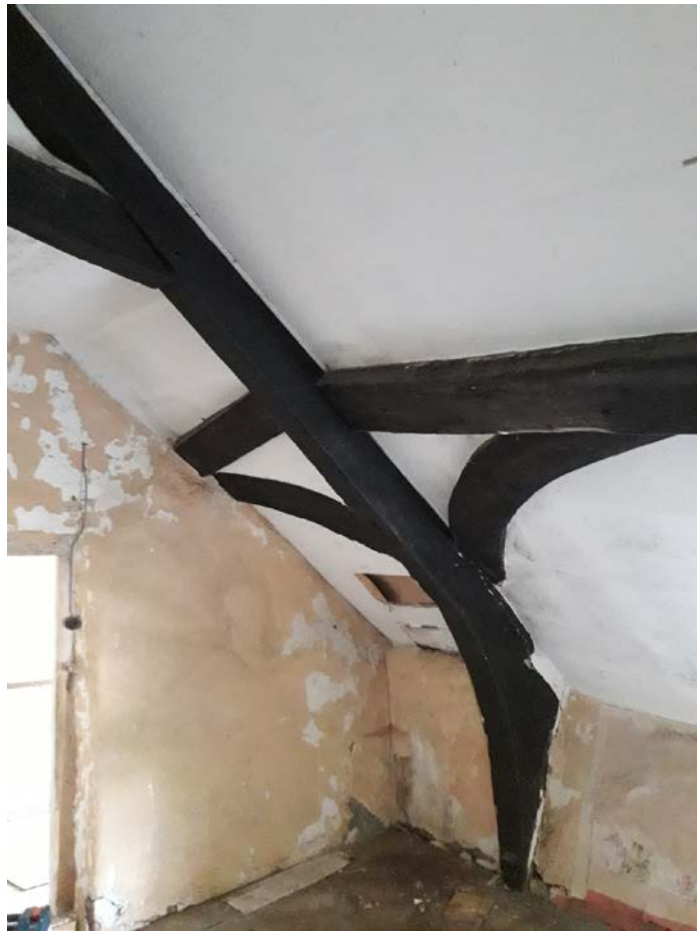
Figure 4: Truss 2, with purlins and surviving windbraces, photograph taken from the north-west (Alison Arnold)

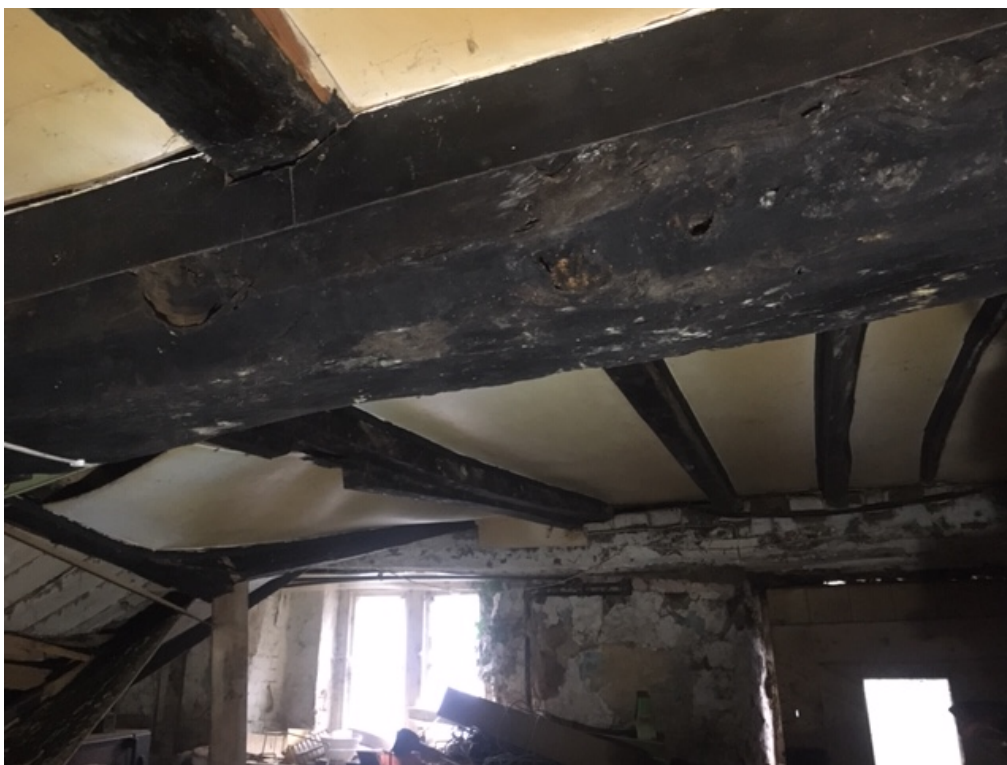
Figure 5: High end (present kitchen) ceiling, photograph taken from the north (Alison Arnold)

Potentially also primary, or possibly a very early modification, is the ceiling of the high-end bay forming a separate, upper chamber. This consists of a central, chamfered spine beam with two, also chamfered, half beams to the north and south and squared joists between (Fig 5).

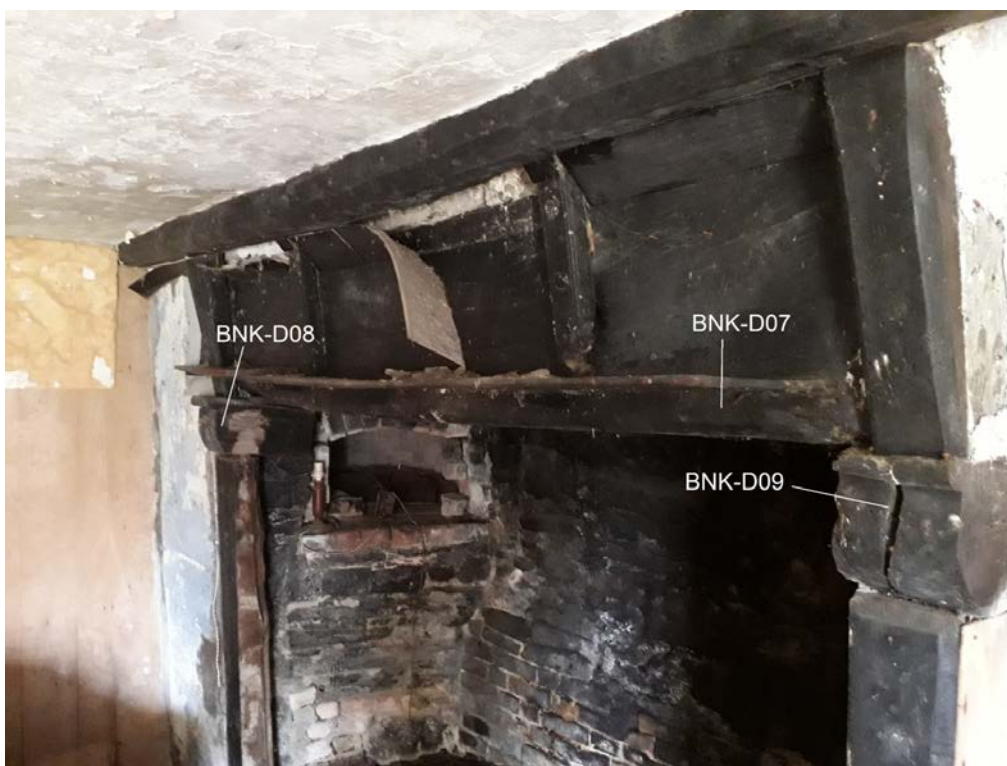
Figure 6: Hall (present living room) fireplace, showing the location of sampled timbers BNK-D07–09, photograph taken from the south-west (Alison Arnold)

A sample taken from the fireplace bressummer in the hall has a date of AD 1479 for the heartwood/sapwood boundary ring. Allowing for the 35 rings of sapwood surviving, an estimated felling date within the range AD 1515–19 can be provided.

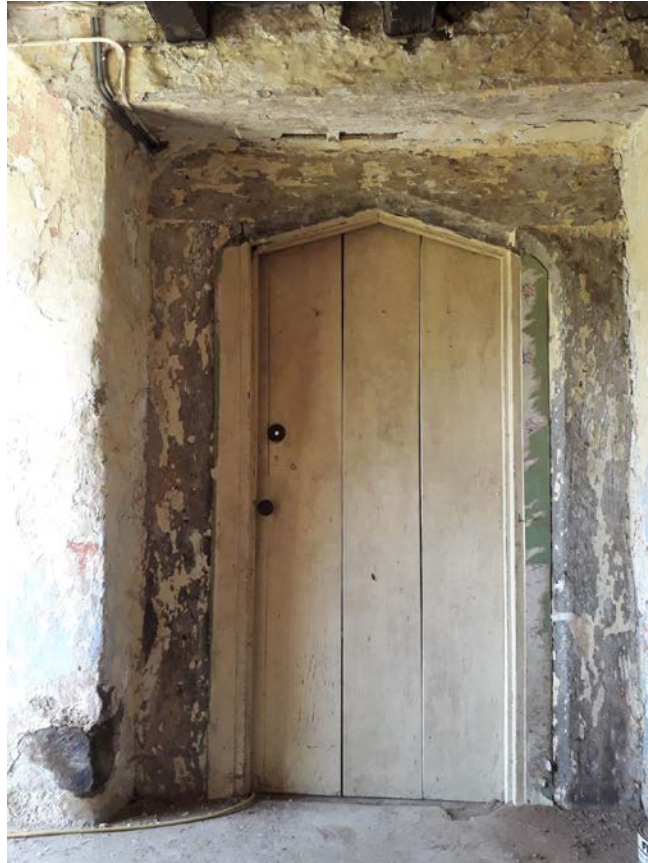
Figure 7: The doorway from the cross-passage into the hall, photograph taken from the east (Alison Arnold)

Three of the dated samples from the ground floor were taken from timbers associated with the doorframe between the cross-passage and the hall. Only one of these has the heartwood/sapwood boundary, the date of which allows an estimated felling date to be calculated for the timber represented to within the range AD 1507–32. The other two samples have *terminus post quem* dates for felling of AD 1450 and AD 1491, which makes it likely that they were also felled in AD 1507–32.

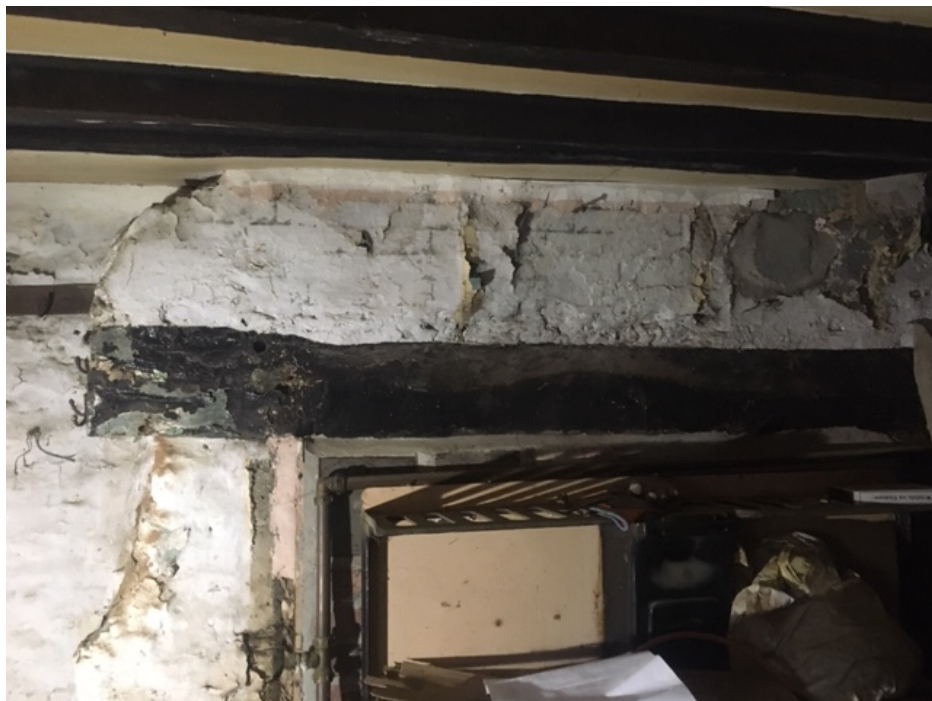
Figure 8: High end (present kitchen) fireplace bressummer, photograph taken from the east (Alison Arnold)

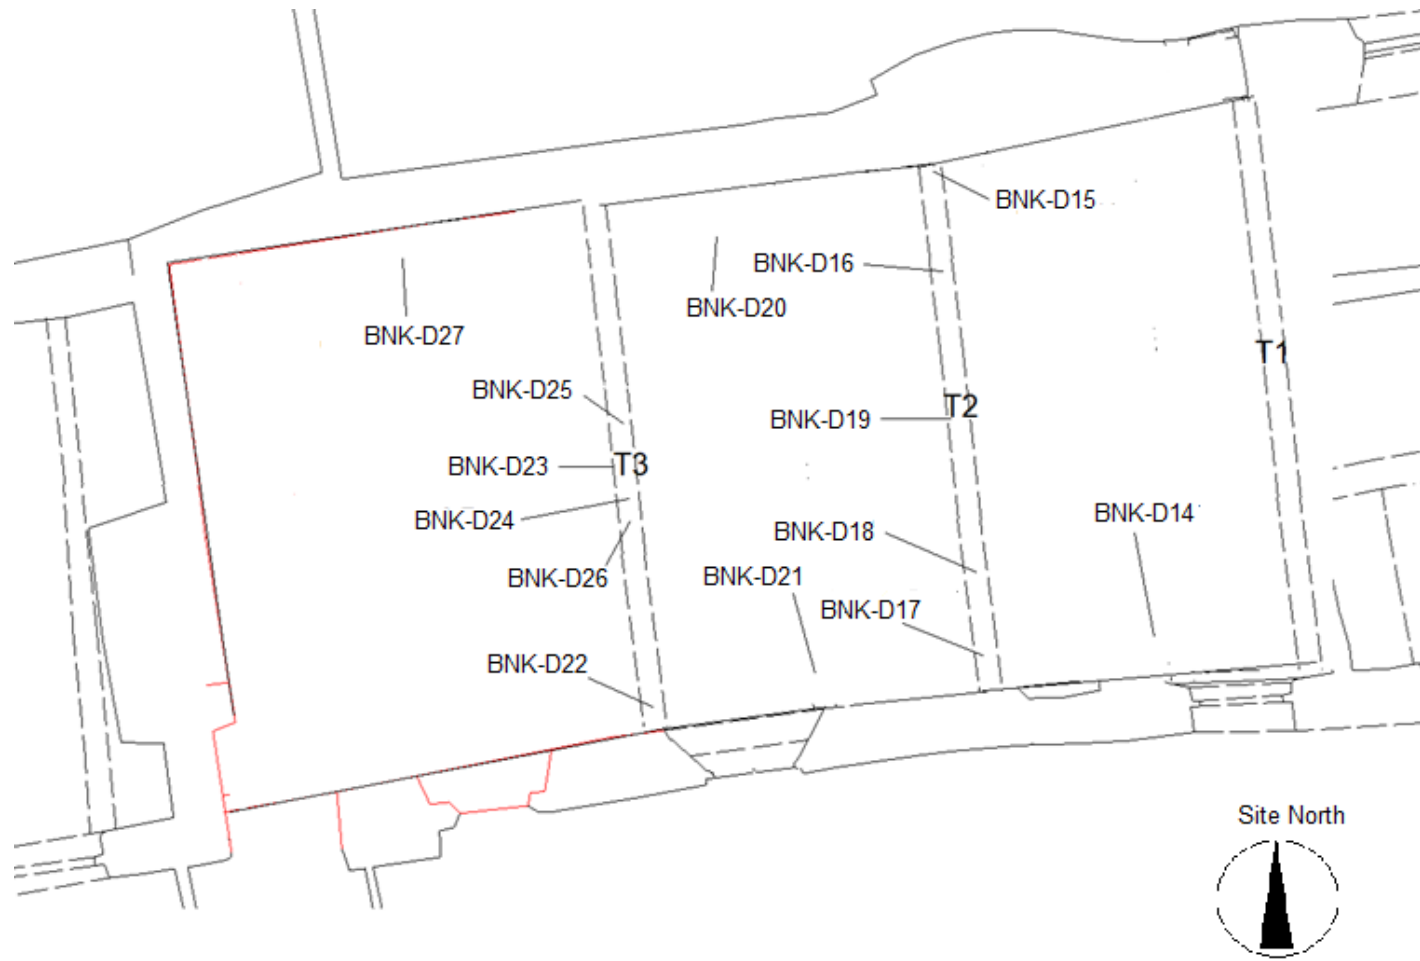
Figure 10: Representative first-floor plan, showing the location of sampled timbers BNK-D14–27 (after Lane, Bayer, and Roethe, Historic England)

The building is currently very unstable, and so sampling was not possible at this time in the lincay, shippon, or in parts of the western and eastern bays of the farmhouse itself. However, thirty oak (*Quercus* spp) timbers were cored from the roof and ground floor of the farmhouse, with each sample being given the code BNK-D and numbered 01–30. One of the common joists of the first-floor frame (BNK-D13) was sampled twice in an effort to get as long a ring width sequence as possible. The two ring-series crossed matched ($t = 5.4$) and were combined to form the 86-year timber series used for subsequent analysis. Further details relating to all samples can be found in Table 1. The location of sampled timbers has been indicated on Figures 6, 9, and 10. Trusses have been numbered from east to west, and ceiling joists from north to south.

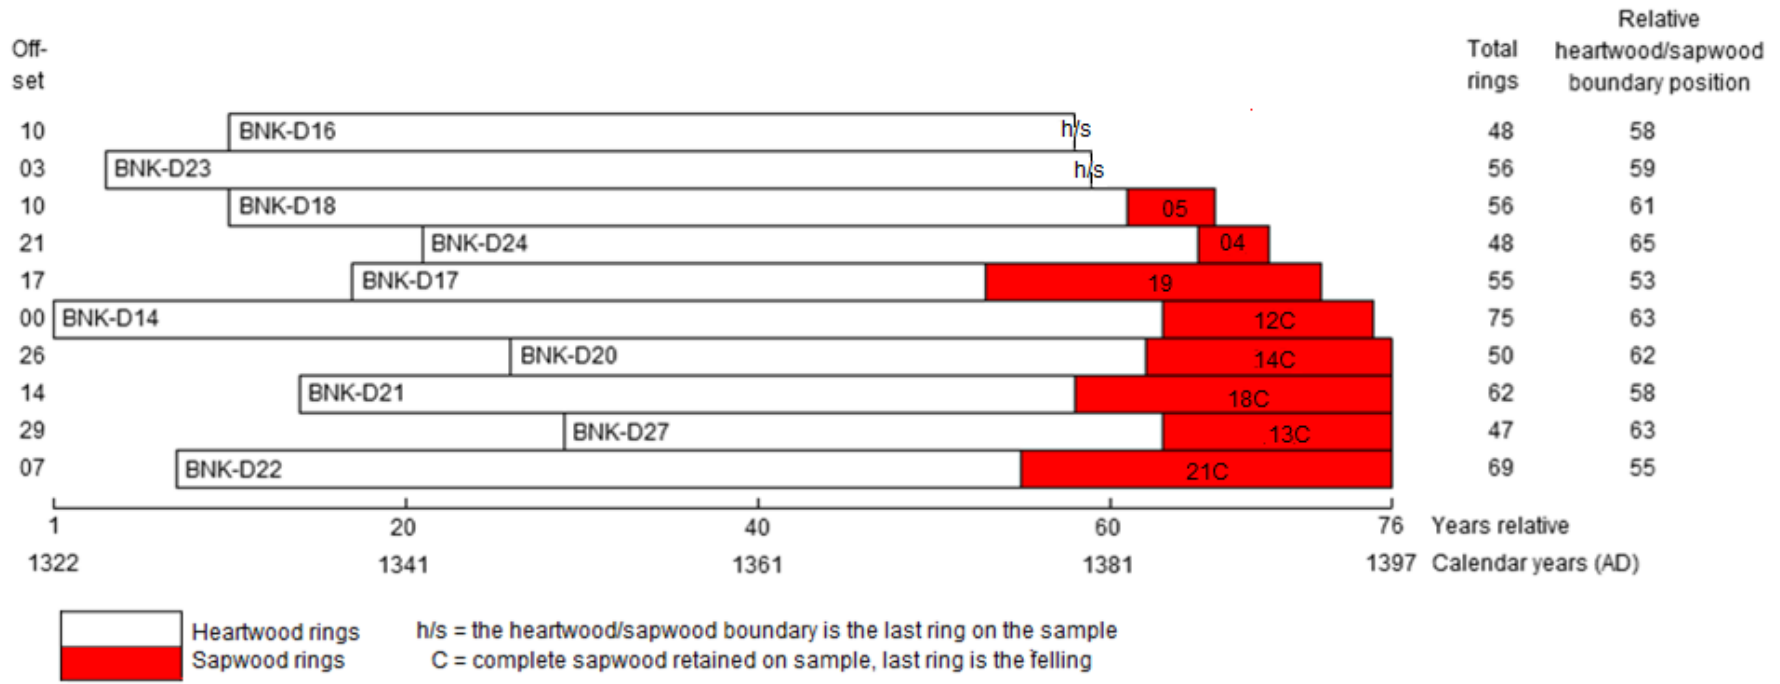
Figure 11: Bar diagram of samples in site sequence BNKDSQ01

Firstly, ten samples matched each other at a minimum value of $t = 3.7$ and were combined at the relative offset positions to form BNKDSQ01, a site sequence of 76 rings (Fig 11). This site sequence cross-dated consistently and securely against a series of reference chronologies for oak at a first-measured ring date of AD 1322 and a last-measured ring date of AD 1397 (Table 2).

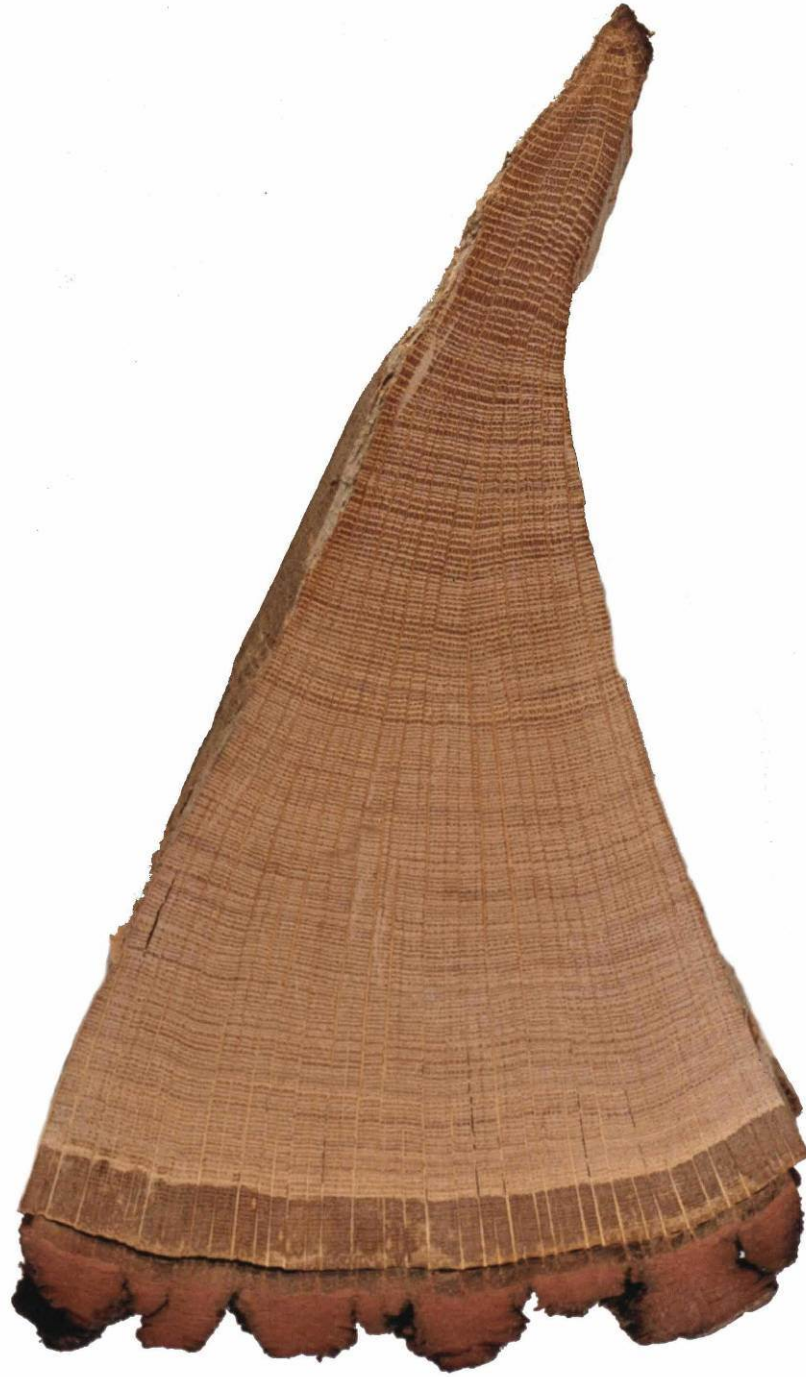
Figure A1: A wedge of oak from a tree felled in 1976. It shows the annual growth rings, one for each year from the innermost ring to the last ring on the outside, just inside the bark. The year of each ring can be determined by counting back from the outside ring, which grew in 1976

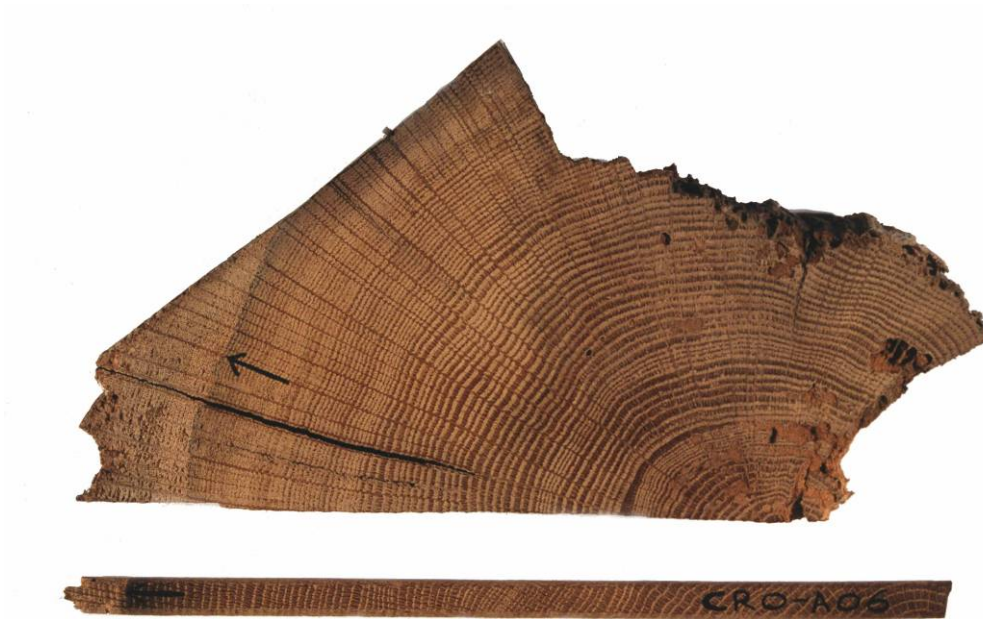
Figure A2: Cross-section of a rafter, showing sapwood rings in the left-hand corner, the arrow points to the heartwood/sapwood boundary (H/S); and a core with sapwood; again the arrow is pointing to the H/S. The core is about the size of a pencil

Quite often some, though not all, of the original outer rings are missing on a timber. The outer rings on an oak, called sapwood rings, are usually lighter than the inner rings, the heartwood, and so are relatively easy to identify. For example, sapwood can be seen in the corner of the rafter and at the outer end of the core in Figure A2, both indicated by arrows. More importantly for dendrochronology, the sapwood is relatively soft and so liable to insect attack and wear and tear. The builder, therefore, may remove some of the sapwood for precisely these reasons. Nevertheless, if at least some of the sapwood rings are left on a sample, we will know that not too many rings have been lost since felling so that the date of the last ring on the sample is only a few years before the date of the original last ring on the tree, and so to the date of felling.

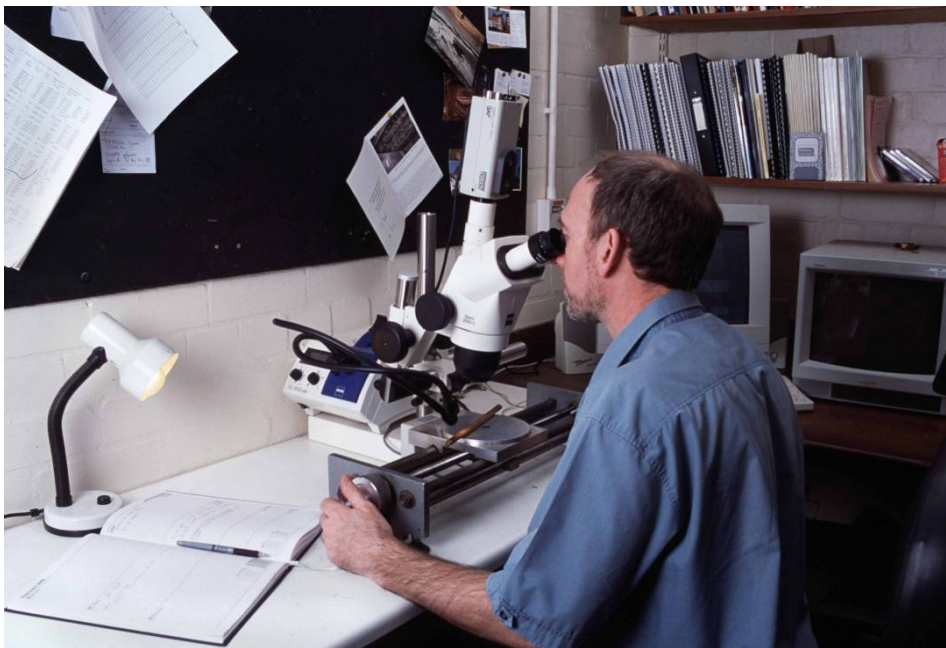
Figure A3: Measuring ring widths under a microscope. The microscope is fixed while the sample is on a moving platform. The total sequence of widths is measured twice to ensure that an error has not been made. This type of apparatus is needed to process a large number of samples on a regular basis

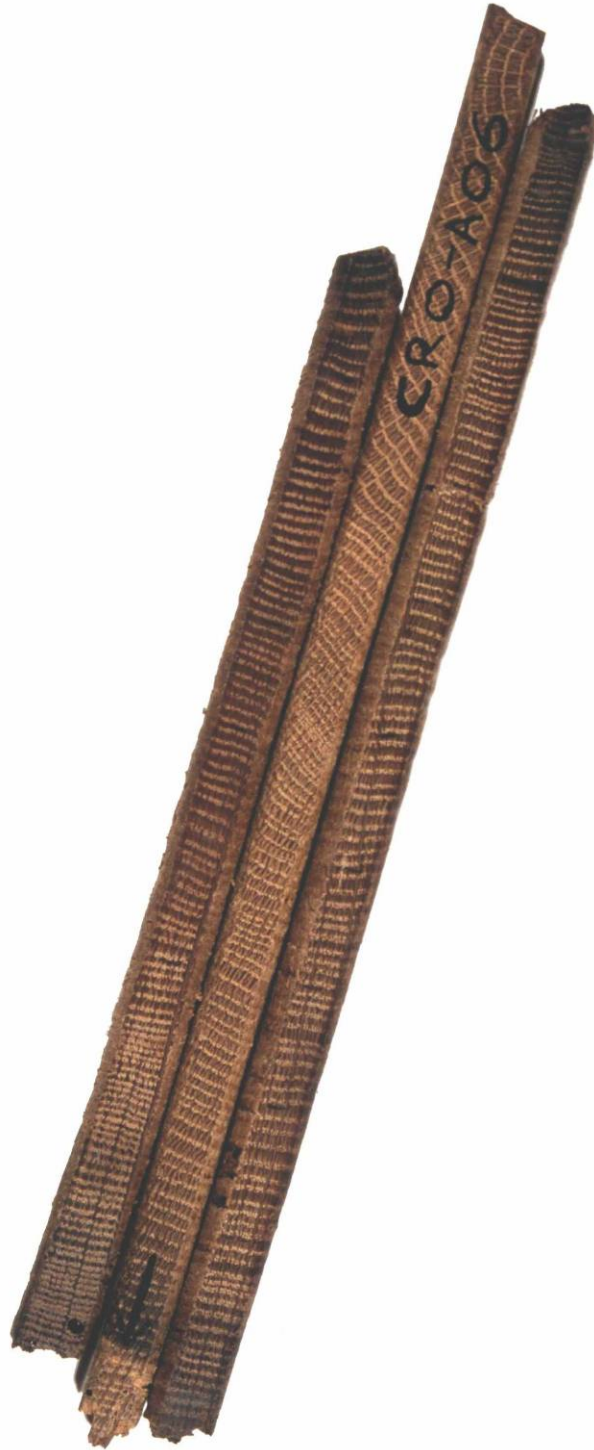
Figure A4: Three cores from timbers in a building. They come from trees growing at the same time. Notice that, although the sequences of widths look similar, they are not identical. This is typical
