Farmstead and Landscape Statement

# Humberhead Levels

**NATIONAL CHARACTER AREA 39**

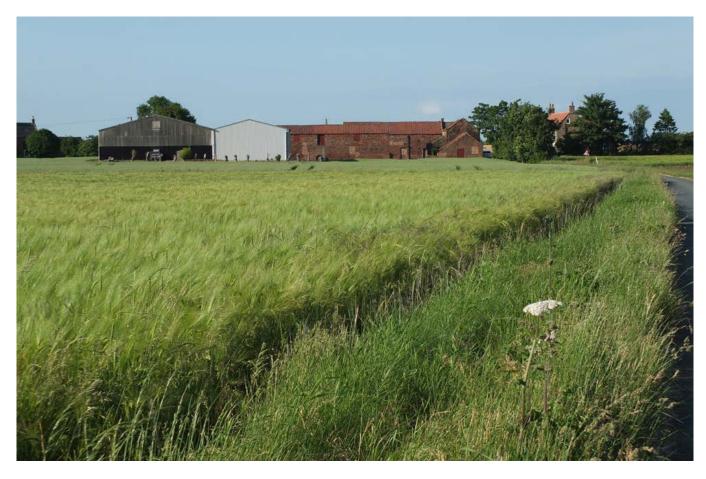
A regular courtyard farmstead, with its early 19th-century house detached from it, in a contemporary enclosure period landscape of dykes and ditches Photo © Jen Deadman

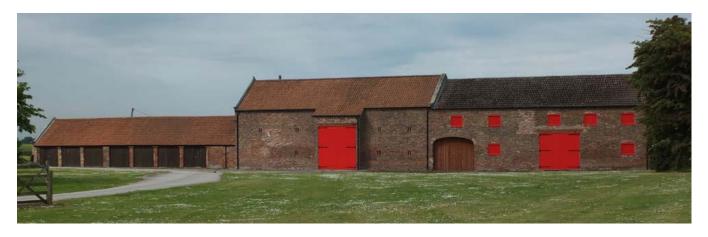
Early 19th-century threshing barn flanked by seven-bay cart shed to left and range with arched entry to farmyard and first-floor granary. Photo © Jen Deadman

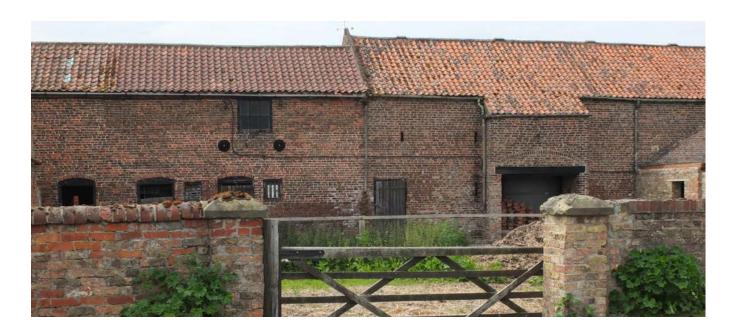
Barns and stables with first-floor granaries might also be built in-line as here, both testifying to the scale of arable farming and associated drainage in this area. Photo © Jen Deadman

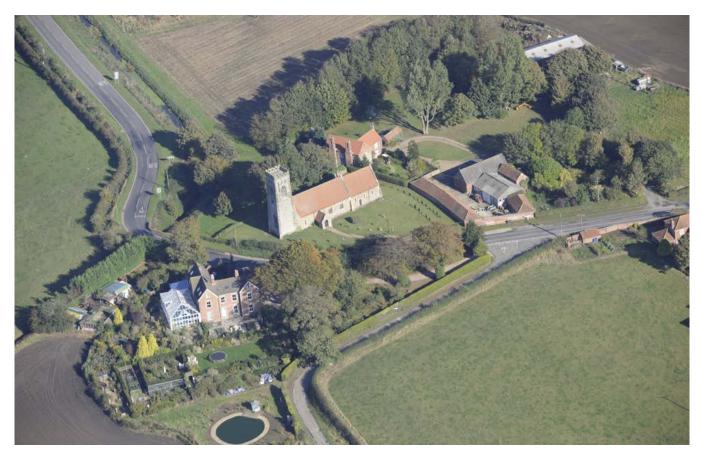
Church End to the west of North Frodingham. The farmhouse, dated 1619, is an exceptionally early example of brick construction, the working buildings being rebuilt around a courtyard in the mid-19th century. Photo © Historic England 28481/034

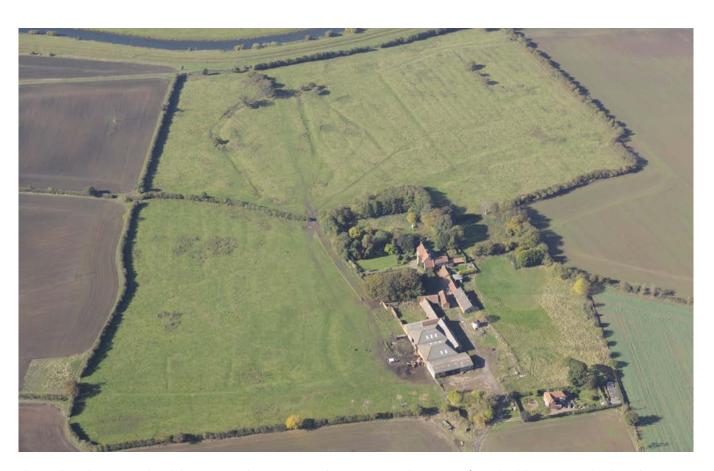
The mid-17th-century brick house at Eske Manor, and surviving 19th-century farm buildings, were built within a medieval village site now surviving as earthworks across low-lying level ground on the east bank of the River Hull. Photo © Historic England 28481/018

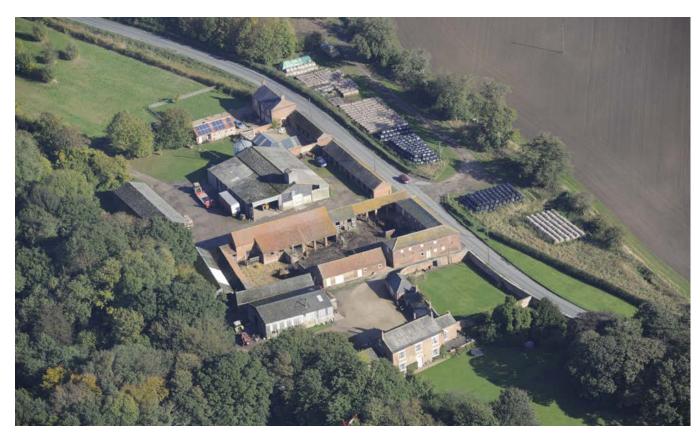
This large farmstead was built just to the north of the Cistercian foundation of Meaux Abbey, the remains of which are which situated on a slight rise in the valley of the River Hull, almost opposite Beverley. The farmstead was clearly rebuilt in about 1840. The farmhouse faces into its own garden, itself an indication of the large scale and status of the steading which is built to a regular courtyard plan with a large-scale threshing barn, shelter sheds for fatstock and a granary/stable range. Photo © Historic England 28480/056

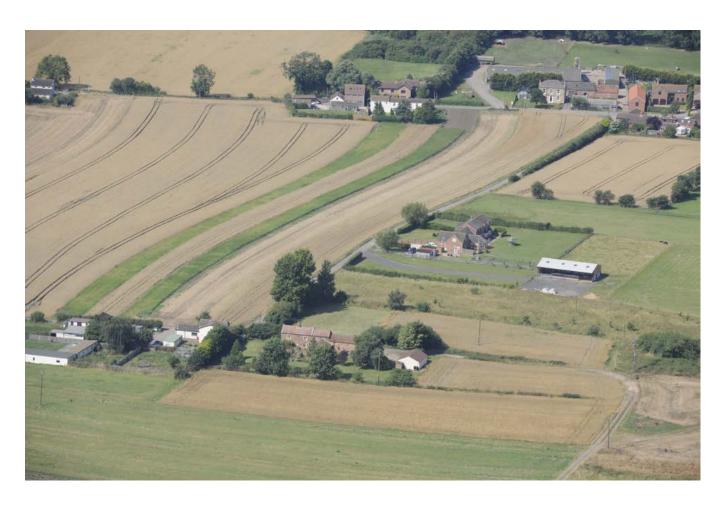
This farmstead was built in the late 18th century in Belton Great Field, and comprises a farmhouse and an attached granary/stable range. It represents an early move of farmsteads out of the village core. Photo © Historic England

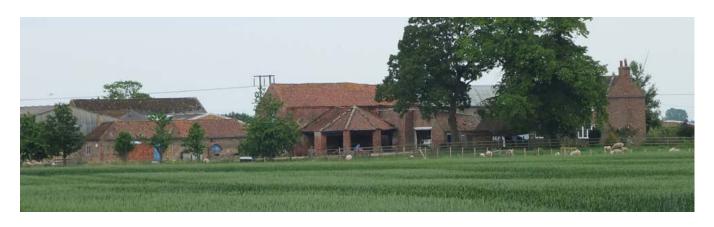
Once a common component of the yard, few horse engine sheds (this having a polygonal roof) now remain. Evidence for them can be found occasionally in roof lines discernible on the rear walls of some barns, while some, as here, still survive. Photo © Jen Deadman
