Farmstead and Landscape Statement

Morecambe Bay Limestones

NATIONAL CHARACTER AREA 20

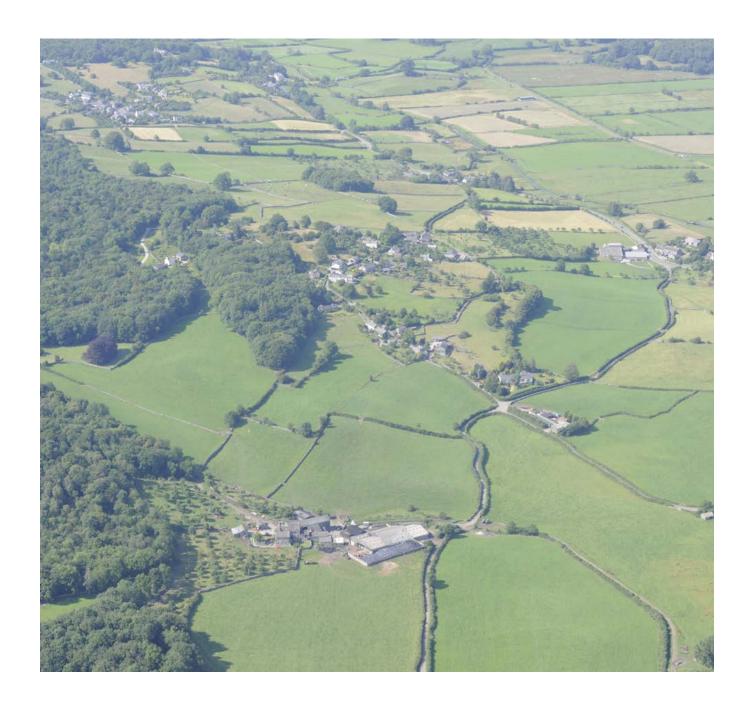
Front cover: A 16th-century gentry farmstead on the west side of the Lyth valley. Earlier more irregular enclosures provide the setting to most of the farmsteads, in the distance being regular early 19th-century enclosure of Lythe Moss. Photo © Historic England 28583/037

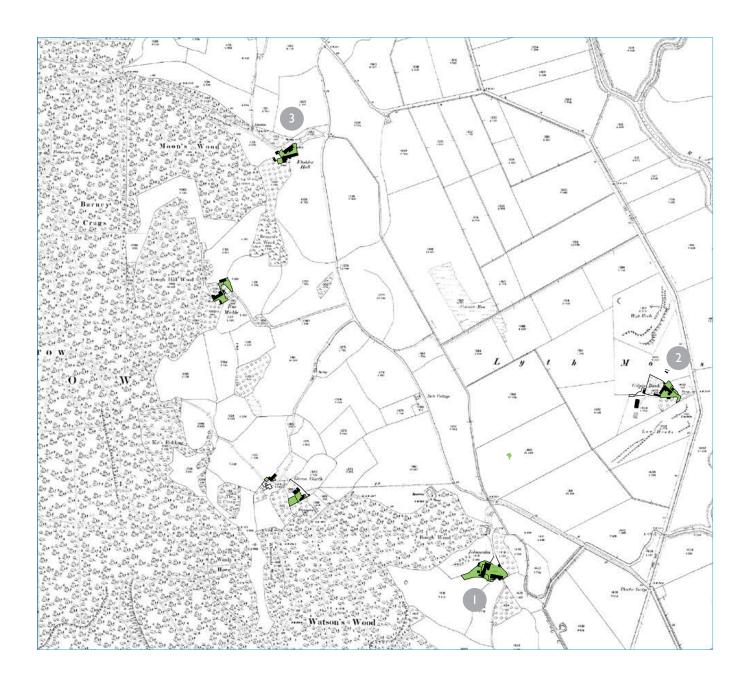
Lyth Valley

This map shows a very clear division between the east, with its regular enclosures resulting from the drainage and improvement of Lyth Moss (previously used as a source of fuel and grazing land) in 1803 and 1838, and the ancient, irregular enclosures set under Whitbarrow Fell to the west. The woodlands were exploited for charcoal and household goods, such as baskets and tool handles. The dispersed plans of the farmsteads in this latter area, such as Johnscales to the south (1), contrast with the regular courtyard layouts of the late enclosure landscape (2). Flodder Hall to the north (3) dates from the 16th century.

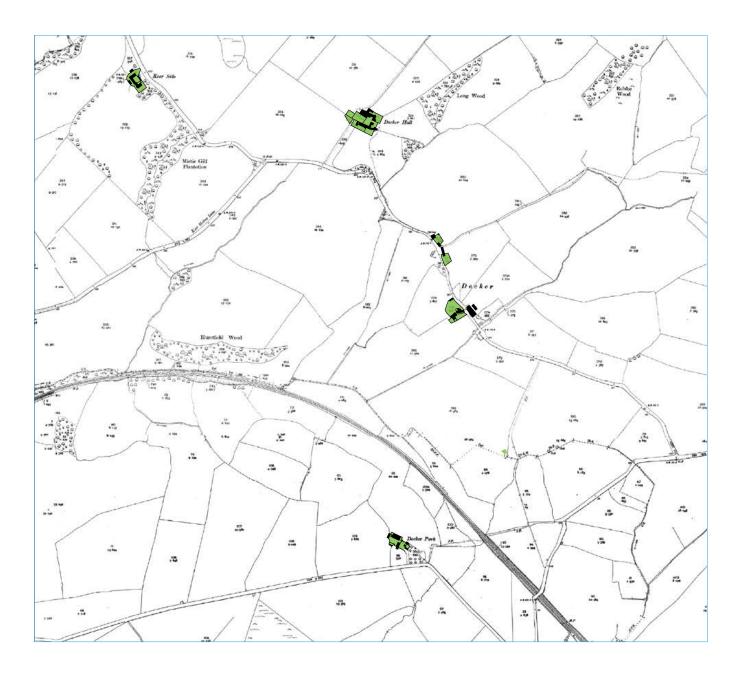
Docker, south-east of Kendal

This is an estate landscape of large fields reorganised from earlier enclosure, centred around the hamlet of Docker, Docker Hall and Docker Park. Docker Hall (1), with its early 17th-century house and attached early 18th-century barns is a high-status site, reflected in the large size of the fields around it and its reorganisation into a regular multi-yard plan in the 19th century, most probably after the moor to its north was enclosed and improved for agriculture. Keer Side (2) to the west similarly reflects agricultural improvement in its U-shaped, regular courtyard plan. There are three farmsteads which developed from linear farmsteads within Docker, two of which are centred around dated farmhouses of the late 17th century.

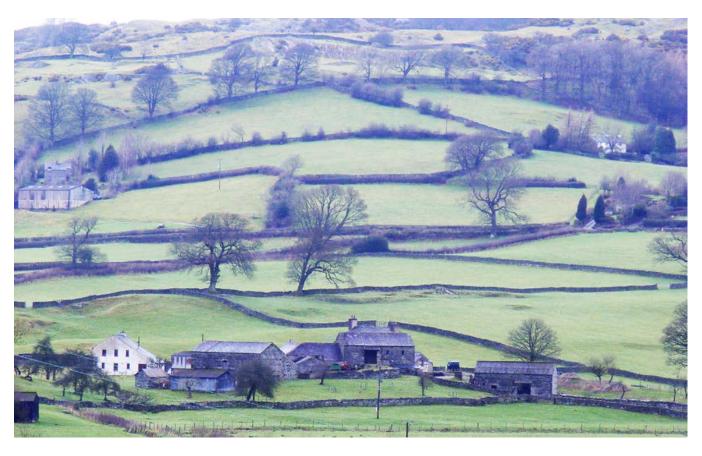
This farmstead, rebuilt around an earlier house in the mid-19th century, is sited within regular enclosed fields. Photo © Jen Deadman

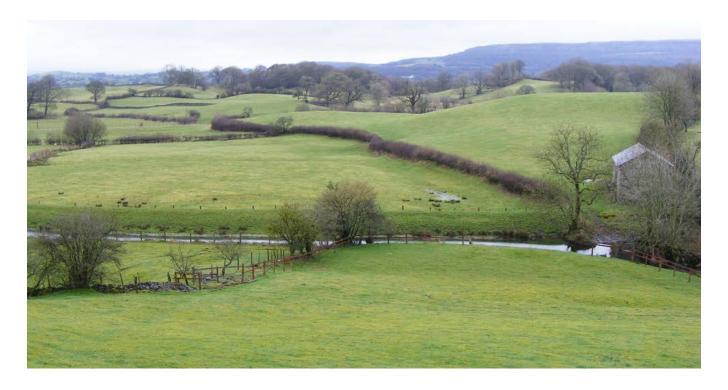
Field barn situated close to a dyke in the broad, wide stretch of the Lyth valley as it begins to level out. Photo © Jen Deadman

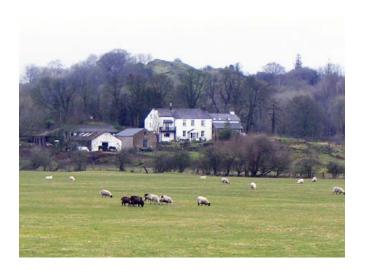
Farmstead on the edge of reclaimed mossland on the Cartmel peninsula, where drained marshland is crisscrossed by large drainage dykes and large rectilinear fields of late enclosure. The mid-19th-century farmhouse faces towards the drained mosslands. Farmsteads sited on the mosslands are frequently 20th century in date. Photo © Jen Deadman

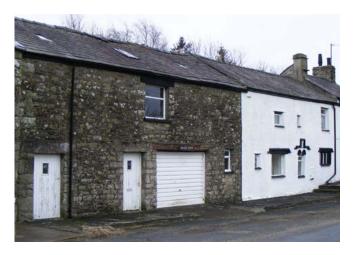
Linear plans A 17th-century, linear farmstead in the hamlet of Docker, south of Hutton Roof. The farmhouse is dated 1668 and has a later 18th-century addition to the right. The attached combination barn is of a later date. A similar linear farmstead, built twenty years later, is sited immediately to the left of the picture, and also lies hard against the road side. The hamlet is set in fields evidencing piecemeal enclosure from medieval strip fields. Photo © Jen Deadman

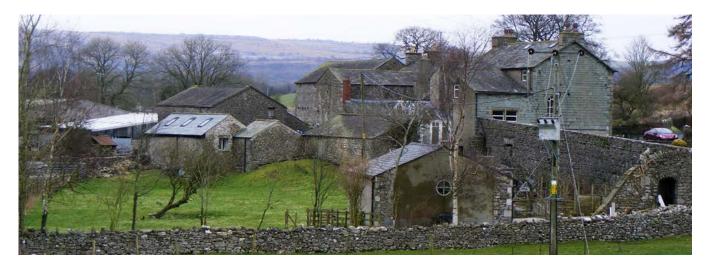
Courtyard plans. Large complex set on the edge of Hilderstone Moss, west of Burton-in-Kendal and the M6 motorway. Individual early to mid-19th-century buildings are set around three sides of a yard with smaller buildings detached from the yard. The house looks away from the group, this being found on larger and high-status farmsteads. The surrounding land mossland has been drained and divided up into neat, rectilinear parcels. Photo © Jen Deadman

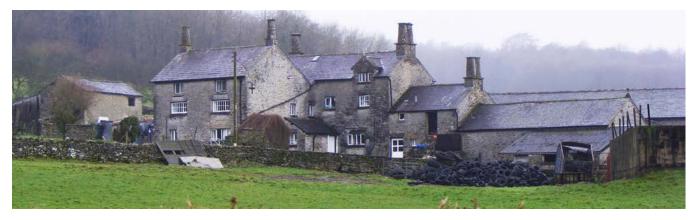
Flodder Hall. Large, gentry farm of 16th-century origins with later additions. This is one of a string of farmsteads, some of which are very large, which lies below Whitbarrow Fell on the west side of the Lyth valley, above the River Gilpin. The land immediately below, on which the majority of the farmsteads sit, is comprised of small, irregular fields of earlier enclosure. The land below (Lyth Moss), has been drained and presents a landscape of rectilinear fields of late enclosure. The high-status house looks away from the loose courtyard group of buildings and towards the mosslands. Photo © Jen Deadman

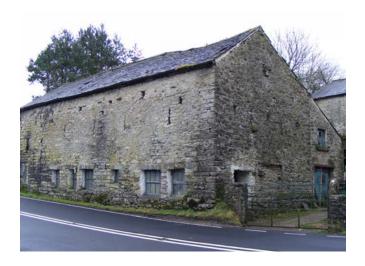
Dawson Fold. The loose courtyard plan steading comprises three large combination barns, two set close to the roadside and a third, a bank barn, lying in parallel behind. There is a yard area between. This large dairy farm is set amongst fields of piecemeal enclosure on the edge of the Lyth Valley. This dispersed farmstead straddles the roadside, with the farmhouse on one side and working buildings on the other. The house, which has 16th-century origins, was altered and extended through to the 19th century when it was bought by a businessman from Manchester. The working buildings are 18th century, although the farm is documented to have been worked in the 16th century. Photo © Jen Deadman

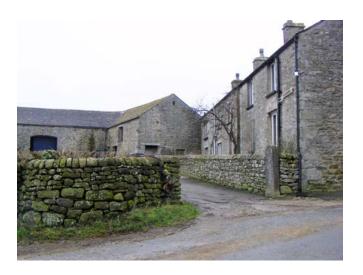
Regular L-plan farmstead in Docker. The substantial 18th-century farmhouse, set back from and attached to the yard buildings, lies on one side of the road, the combination barn on the other. Photo © Jen Deadman

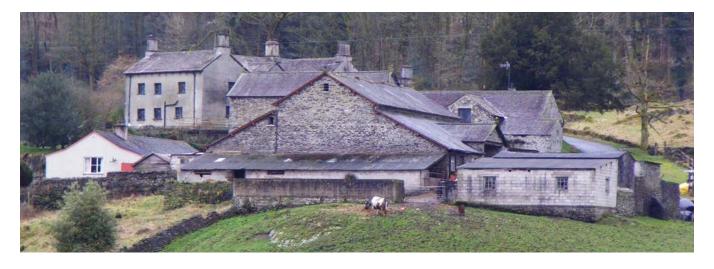
Large, dispersed farmstead sited on both sides of the road in fields of piecemeal enclosure on Cartmel Fell. The sloping site comprises a series of working buildings set one below the other. The farmhouse sits at the highest point and is a large complex with 16th-century origins. Photo © Jen Deadman

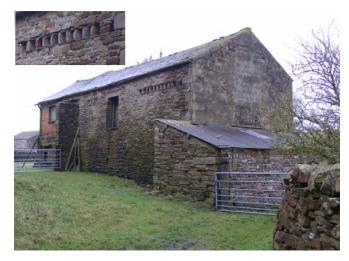
Combination barns Combination barn set on a yard curtilage. Extended in brick, the barn is of indeterminate age and possibly predates the 19th-century farmhouse lying on the far side of the yard. Cattle would have been housed at ground-floor level with storage for hay or corn above. A row of small openings at first floor level would suggest air vents or possibly pigeon holes. Photo © Jen Deadman

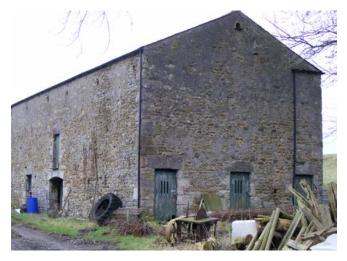
Greenbank. Large, mid-19th-century combination barn ramped to the rear. In this example, cattle entries flank the feeding passage in the gable end. This plan form is less common in this area than in other areas of the Lakes and the West Pennines. Photo © Jen Deadman

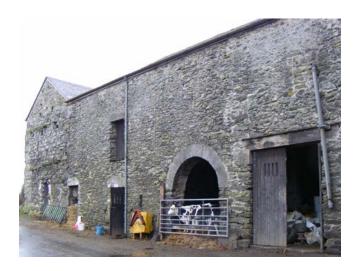
Cartmel peninsula. L-shaped arrangement with a large combination barn and later threshing barn, across the road from the farmhouse and attached combination barn. Immediately beyond the barn, on a level platform, is the site of the open horse wheel. Photo © Jen Deadman

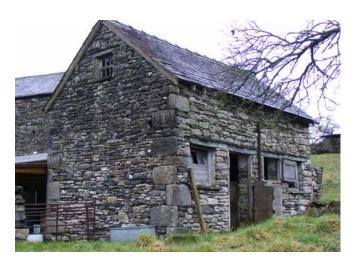
Stables Stables are frequently found as component parts of a combination barn. This mid-19th-century example is a small, free-standing building with a loft over. It is part of the farm complex, but faces out into the field. It has a loft over. Note the slates laid flat over the lintels and the massive sandstone quoins. Photo © Jen Deadman
