Historic England

Farmstead and Landscape Statement

# North East Norfolk and the Flegg

NATIONAL CHARACTER AREA 79

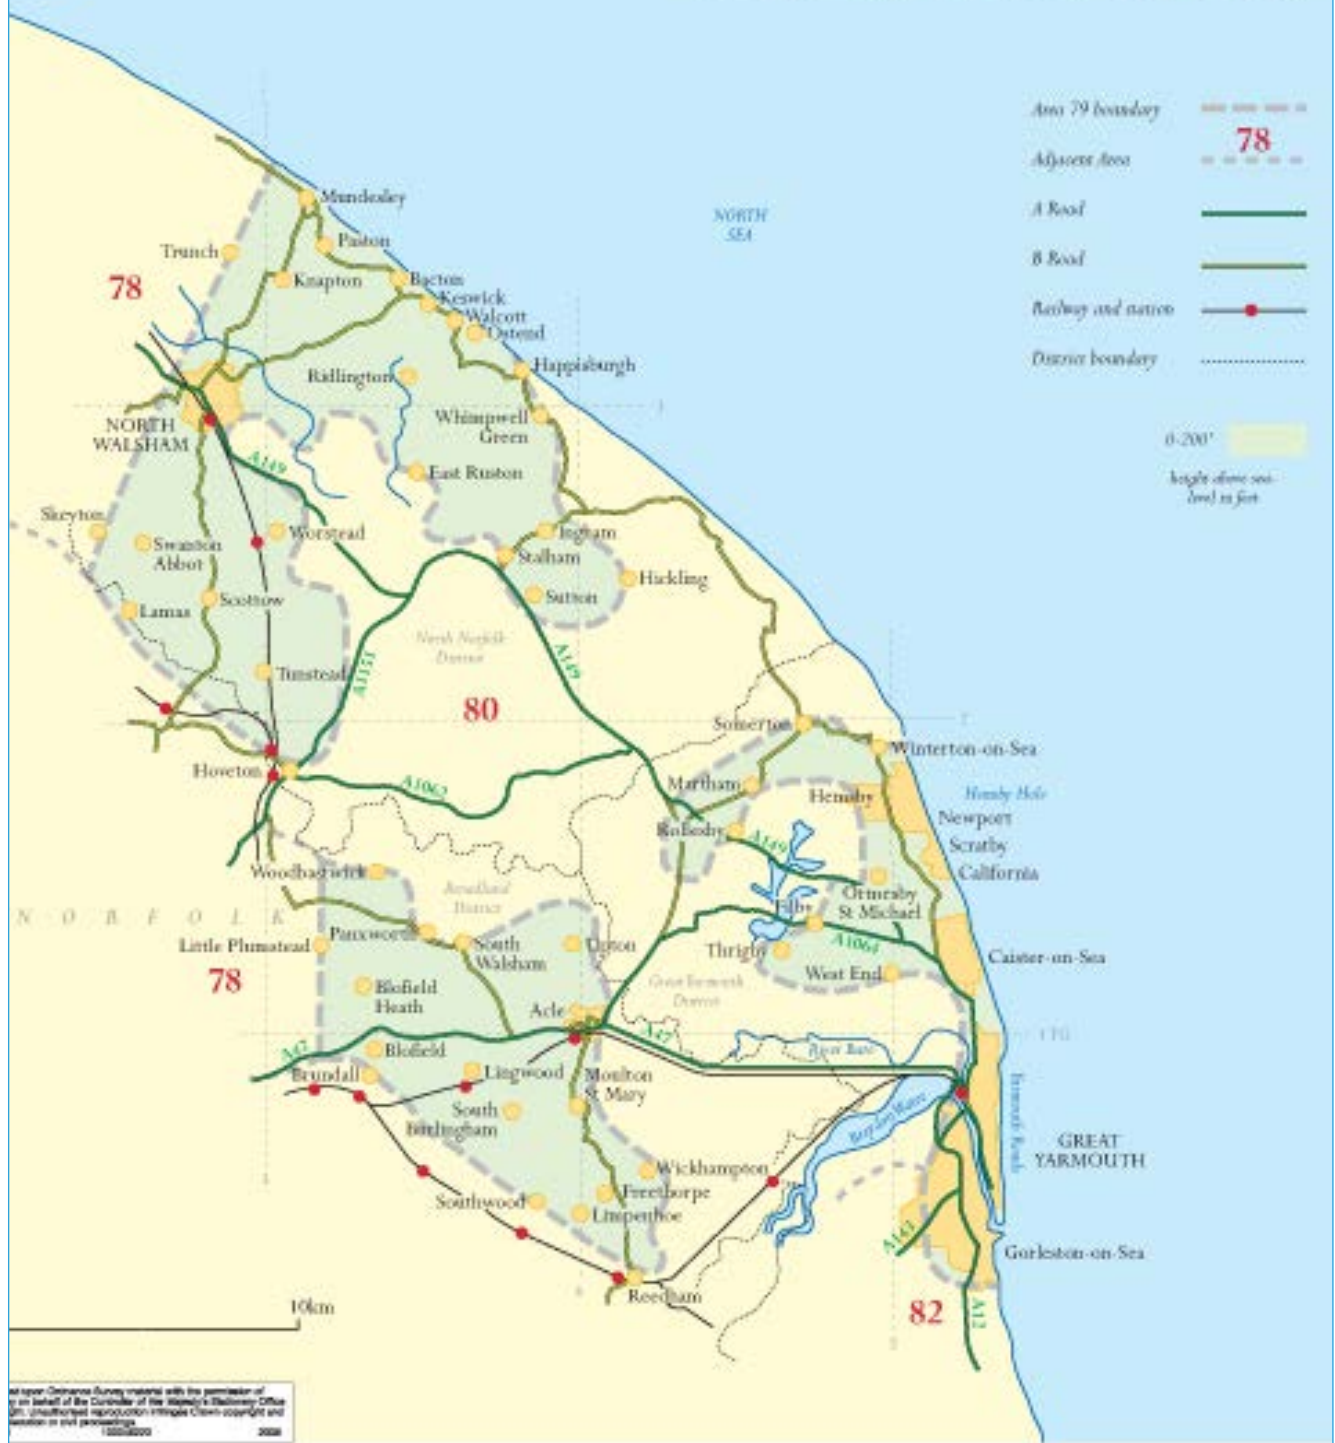
# Character Area 79 North East Norfolk and Flegg

This map shows North East Norfolk and the Flegg, with the numbers of neighbouring National Character Areas around it.

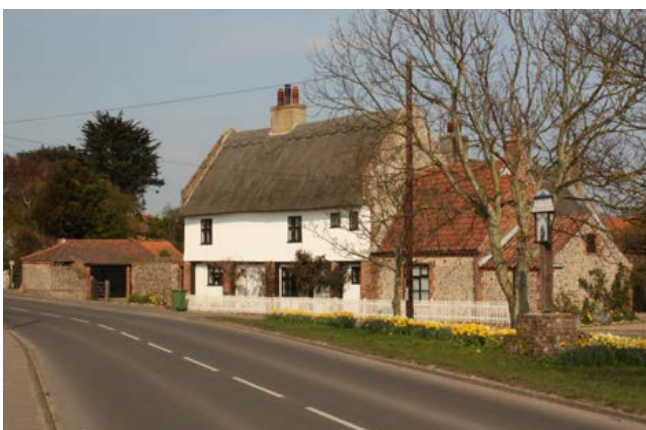
Former farmsteads are often an important element of the character of the villages of the area. Many retain some or all of their former working buildings, although their barns have often been converted to residential use. This house in Bacton dates from a complete remodelling or rebuilding in the early 17th century. Note the early 19th-century kitchen extension to its right. Photo © Bob Edwards

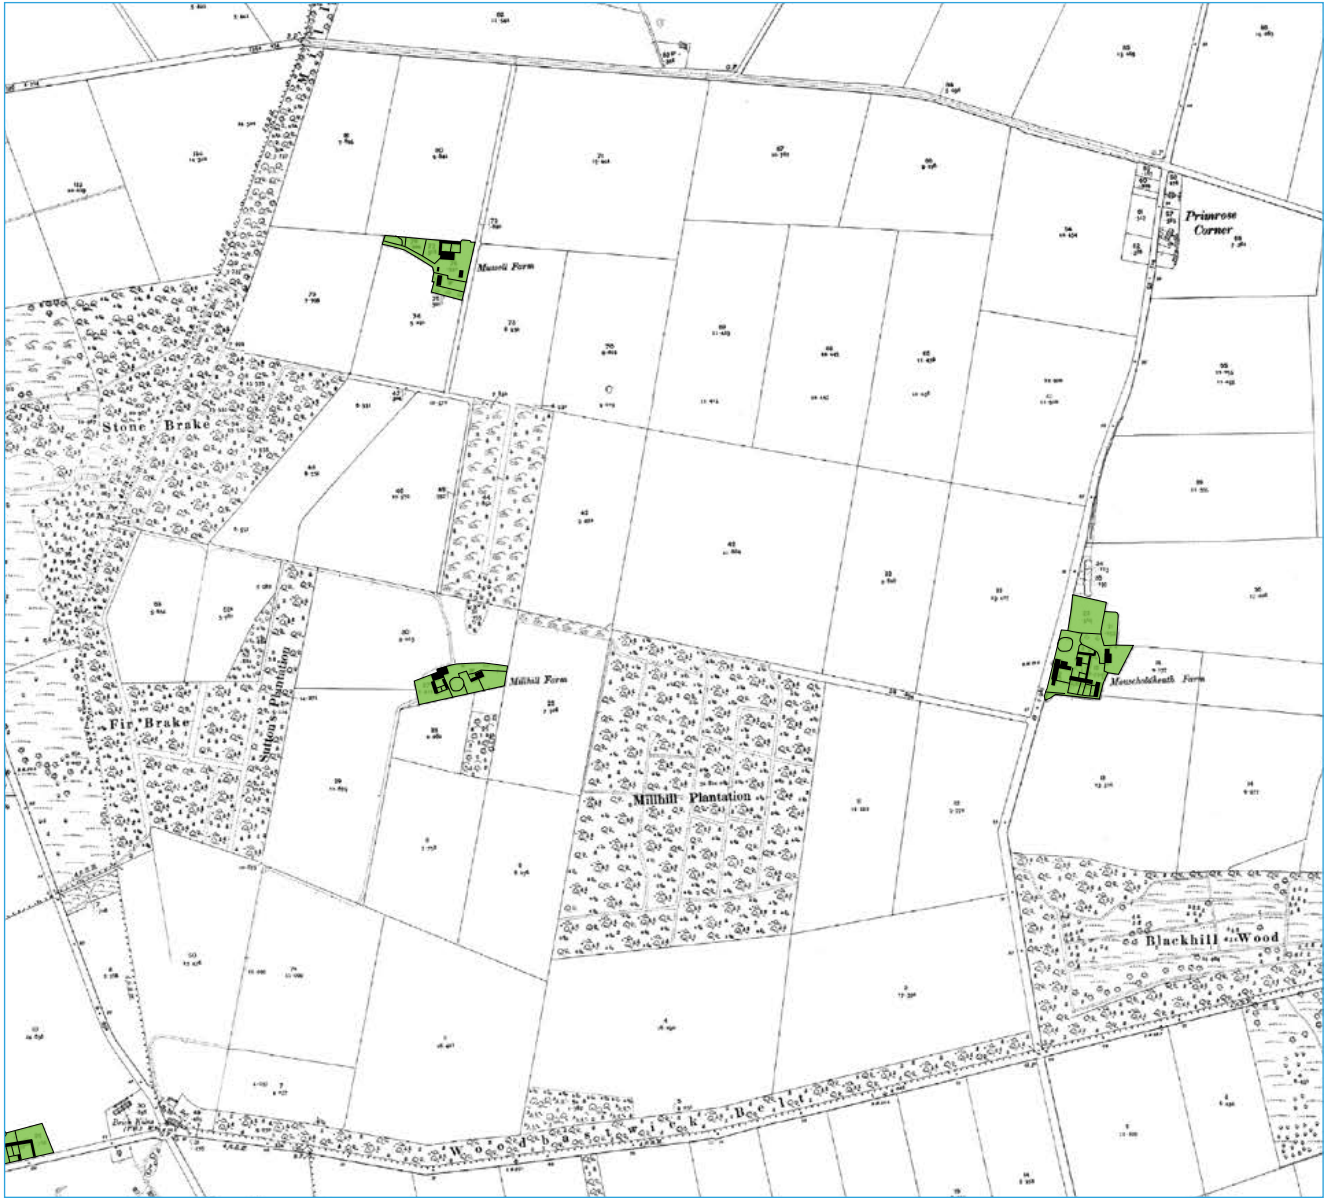
Maps are based on 2nd edition 25" Ordnance Survey maps, which show farmsteads after the last major phase in the building of traditional farmsteads in England. © Crown Copyright (and database rights) 2020. OS 100024900

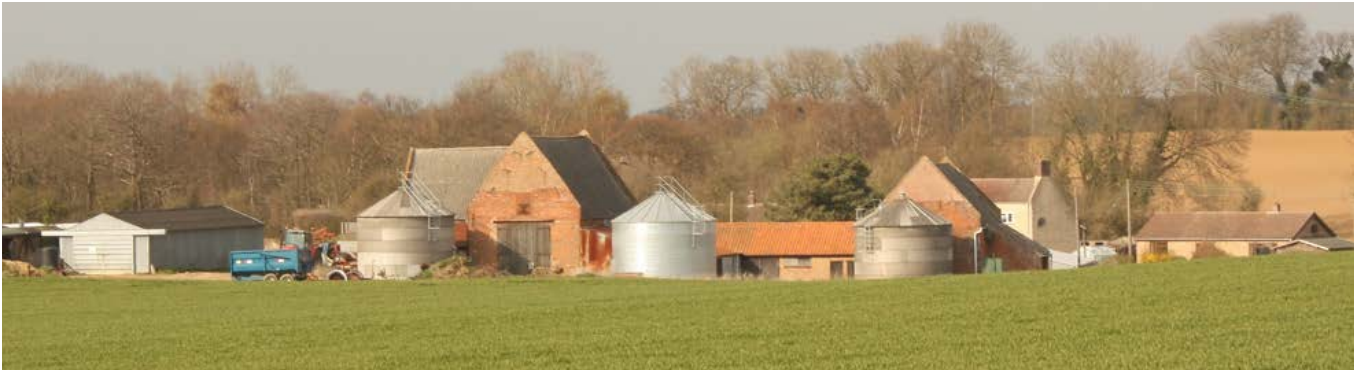
In the central part of the Character Area there is a higher survival of woodland and larger hedgerows, which are more reflective of the medieval piecemeal enclosure of much of the landscape. Farmsteads in this area are the most likely to have retained pre-1700 fabric although many barns – as here – were rebuilt in the 18th century using brick with thatched, steep-pitched roofs. Photo © Bob Edwards

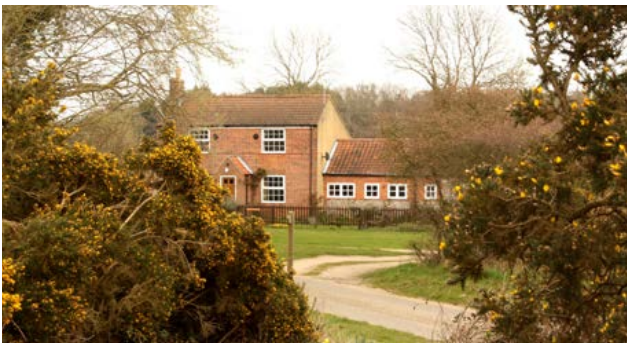
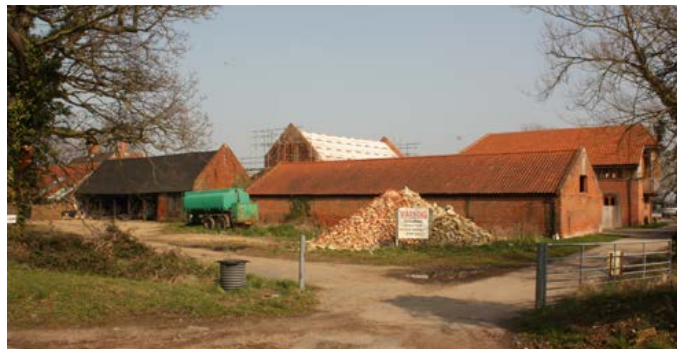
#### Loose courtyard plans

Most farmsteads developed from loose courtyard plan forms which had detached buildings set around a yard area. As these farmsteads developed, buildings were often linked or attached ranges were added. Photo © Bob Edwards

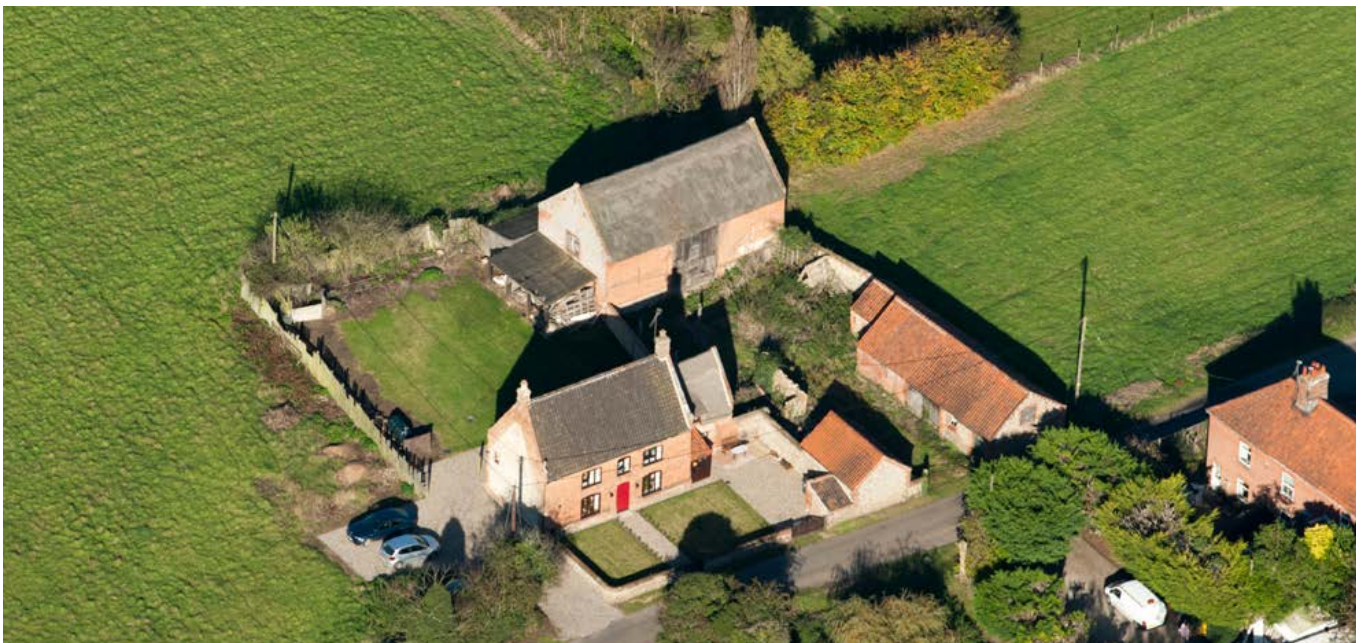
A small-scale early to mid- 19th century farmstead at Ridlington Witton, showing a three-bay reed-thatch barn. Photo © Historic England 29192/038

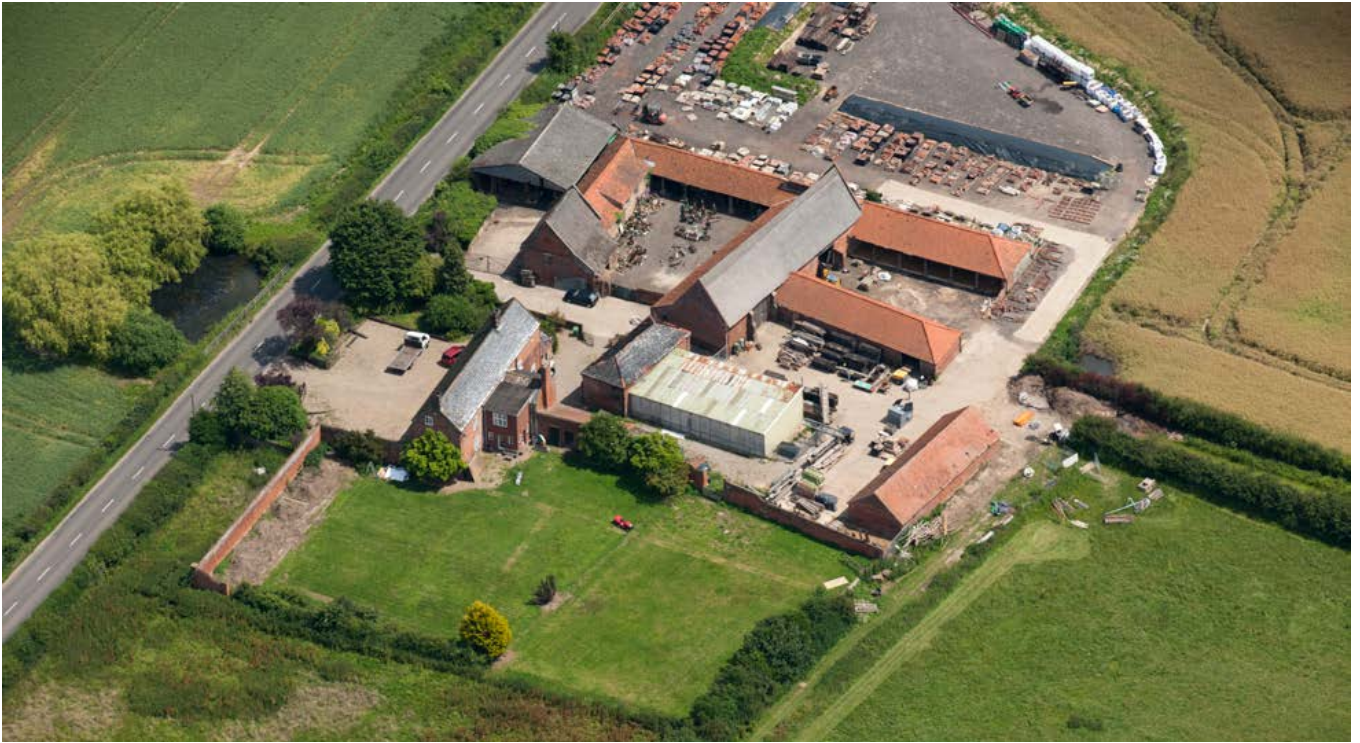
At the core of this large-scale farmstead is a threshing barn with two threshing bays, flanked by two cattle yards. The barn, like the granary/stable to the left, dates from the mid- to late 18th century. Photo © Historic England 29125/050

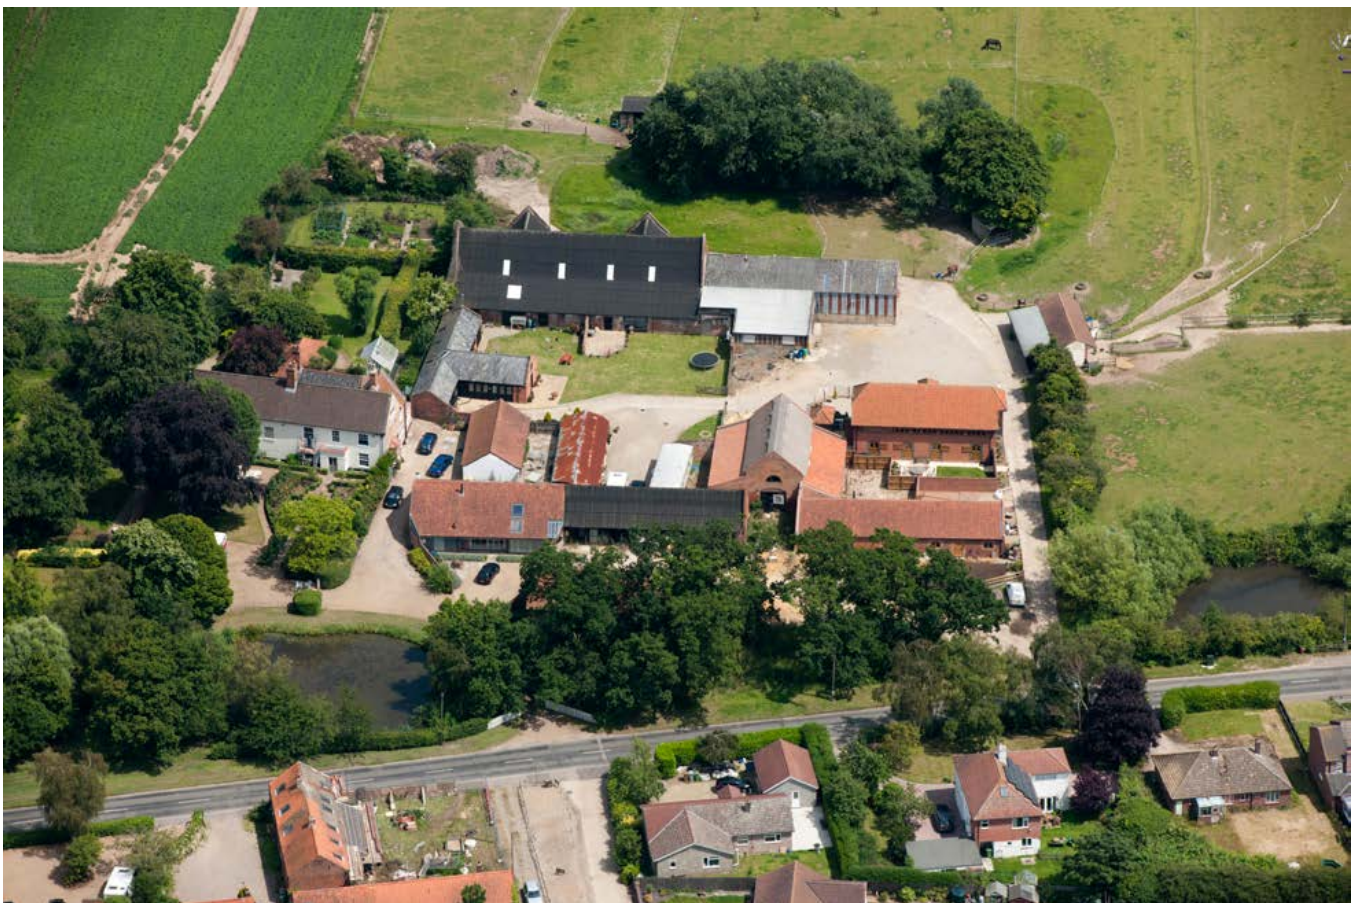
The Manor Farm at Freethorpe was rebuilt in the 18th and 19th centuries. The large threshing barn and the house date from the early 18th century. In the foreground, and shaped like a basilica, is the stock house dated 1828. This is the best-preserved of probably not more than half a dozen surviving stock houses of a type described in this area on the marshland fringe, by William Marshall in his *Agriculture of Norfolk 1787*, vol 2 pp.274-5. Cattle were housed in the aisles, facing into a central turnip house. Photo © Historic England 29128/035

The hipped roof and aisles to this building at Freethorpe (see p. 10), give it a very distinctive form. The double doors provide access to a root store for feeding turnips to cattle which are housed in loose boxes in the aisles. This building type, recorded in the late 18th century but mostly 19th century in date, is confined to The Broads (NCA 80) and the area around it. Photo © Susanna Wade Martins

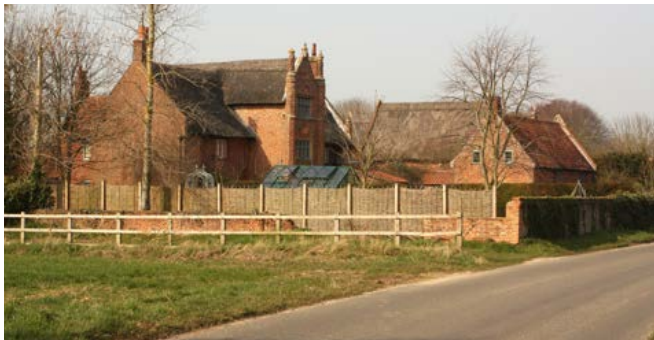
There is a good survival of farmsteads that retain 17th-century and earlier houses and barns in this area. This group consists of a late 16th-century house and barn, a smaller 17th-century barn and an 18th-century building with a granary above a probable stable.  
Photo © Bob Edwards

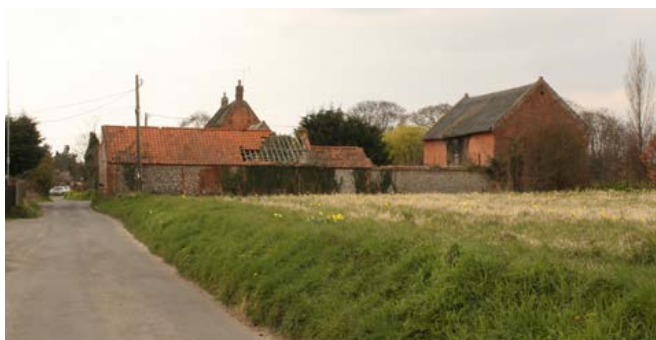
#### L-plan courtyards

Courtyard farmsteads with an L-plan element and a building to the third side of the yard are common within this area. Here, the range attached to the barn has partially collapsed. Photo © Bob Edwards

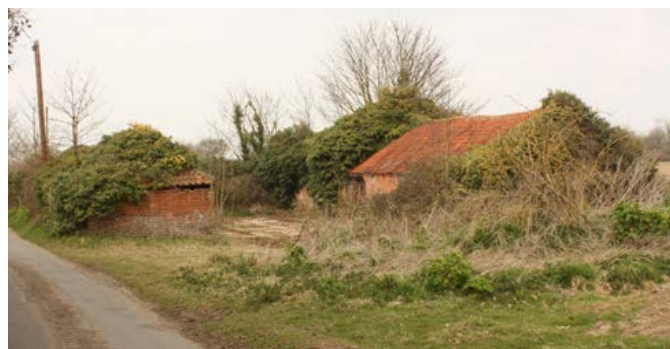
#### U-plan courtyards

This small farmstead was originally a regular U-plan but the central range has partially collapsed. This range may have served a small dairy farm, given that there is no barn. Photo © Bob Edwards

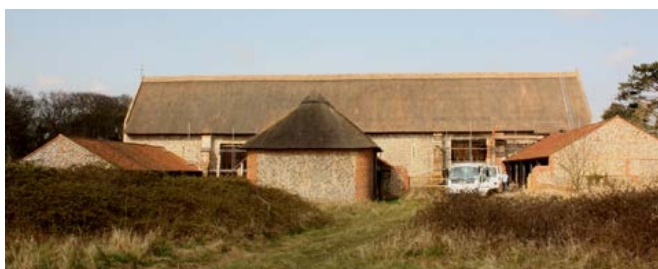
The Great Barn at Paston Hall is one of the important early barns in the Character Area. This large, eight-bay threshing barn was built in 1561. In the 19th century, three ranges of shelter sheds were built against its east elevation, creating two cattle yards. On the opposite side of the barn a stable was built with a horse yard between it and the barn – effectively creating a regular multi-yard plan group. Photo © Bob Edwards

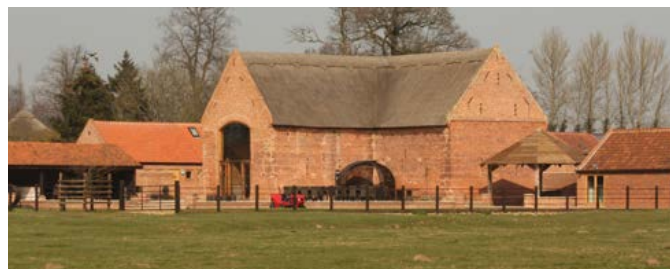
An 18th-century barn which has an extended porch effectively creating a T-plan. Photo © Bob Edwards

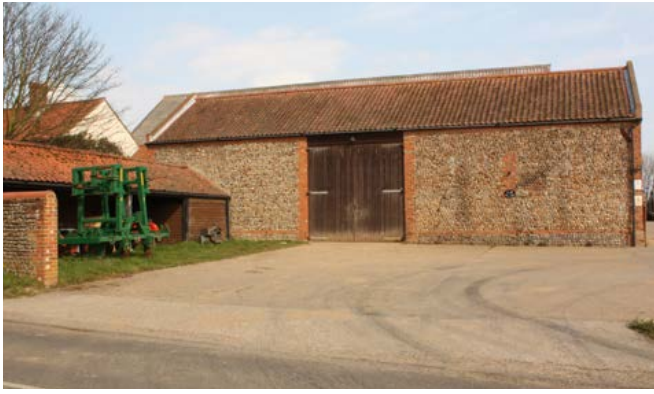
This 19th-century, five-bay barn lies near the coast and is largely constructed from cobbles with brick dressings. Although it has coped gables, it is probable that it has always been roofed with pantiles. As is commonly seen in the area, an attached shelter shed creates an L-plan range. Photo © Bob Edwards

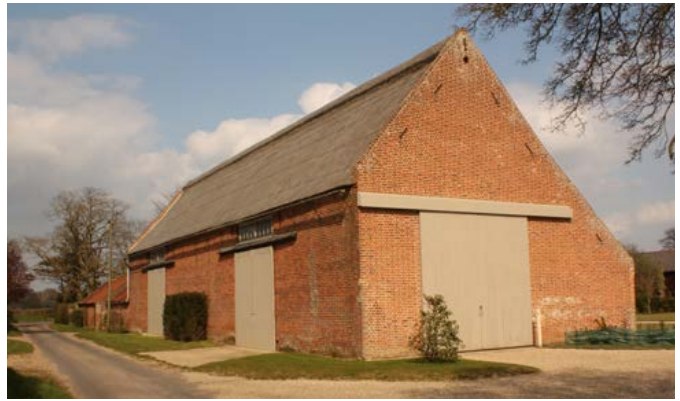
This large 19th-century barn of six or seven bays in length was built with an aisle to the rear, possibly providing additional storage area within the barn rather than animal housing. Aisled barns are extremely rare in this area, although they are a distinctive feature of much of East Anglia. Photo © Bob Edwards

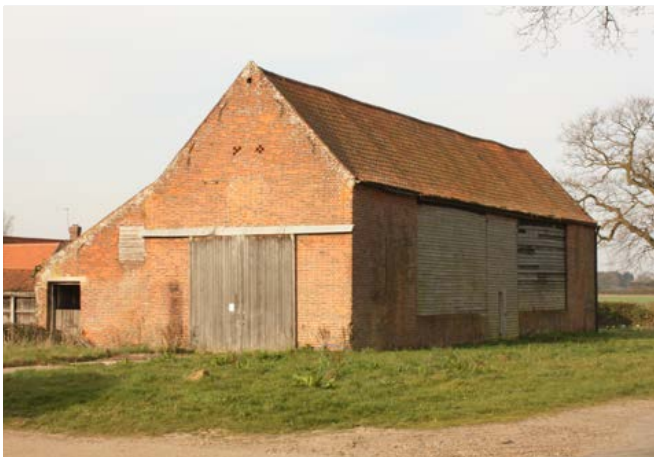
This five-bay barn also has a contemporary aisle to the rear although the end door suggests that the aisle provided cattle housing. As in most cases where the aisle provided animal housing, there is a change in the pitch of the roof over the aisle in order to ensure sufficient headroom for cattle. The barn is one of a relatively small number in the area that incorporate timber-framing in the front wall. The large door in the gable is a later insertion. Photo © Bob Edwards.

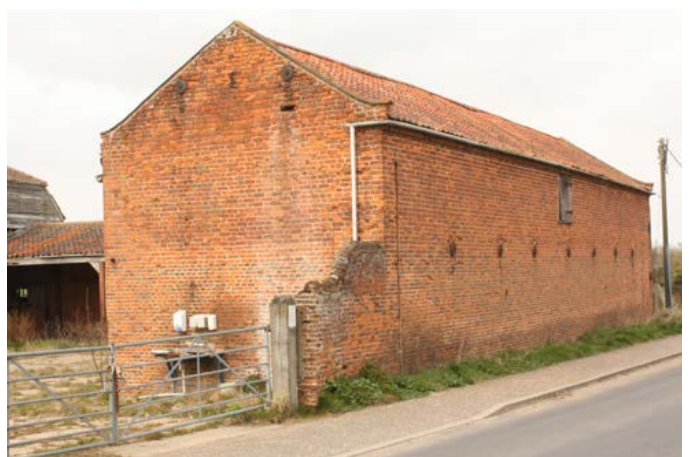
A large, two-storey stable on a Manor Farm. The size of the building indicates that this farm had a large team of horses to work the arable lands. Closer inspection of the building, which initially appears to be 18th or early 19th century in date, shows that it is a building of at least two phases with thinner, early bricks to the lower part of the rear wall and later brickwork above, showing that the stable was raised to two storeys. Photo © Bob Edwards

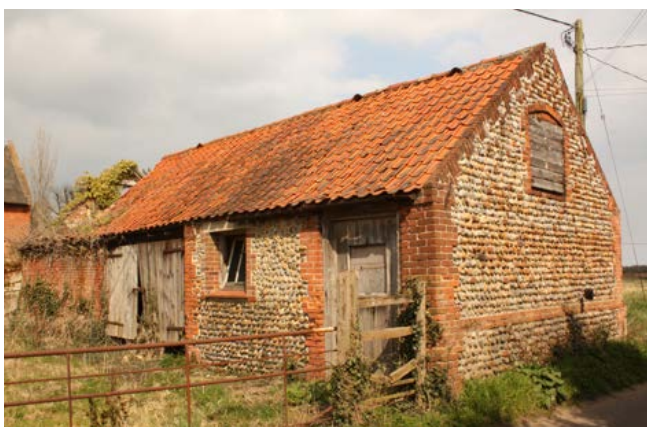
A small stable with an attached cart or trap house. This farm is called Dairy Farm and the small stable may reflect that there was limited arable on this farm. Photo © Bob Edwards

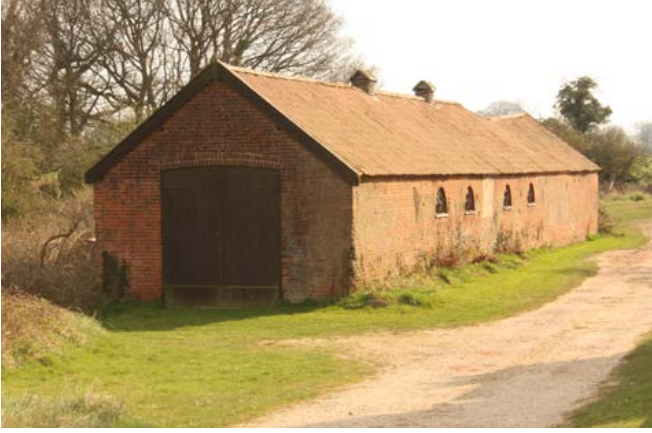
This single-storey stable with a single-bay trap house at the end is typical of stables of the mid to late 19th century when the importance of good ventilation for the horses was better understood. This led to the construction of single-storey buildings without a hay loft and often the use of ridge vents. The use of lunette windows is a feature often found on stables in this area. Photo © Bob Edwards

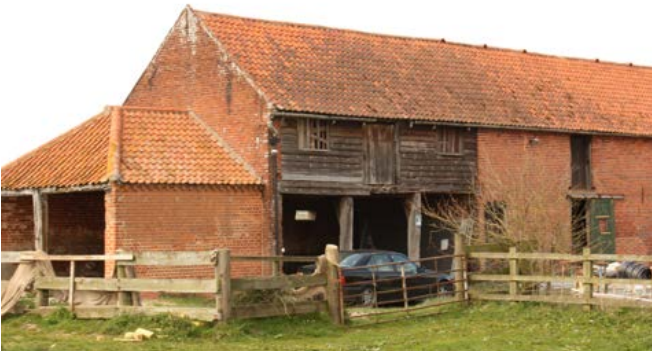
**Granaries** are not a common feature of farmsteads in this area. Where found, they are usually of 19th-century date and located over a cart shed. This example forms part of a long range with stables which have a hay loft over. An additional two bays for carts and equipment have been added against the gable wall of the range. Photo © Bob Edwards

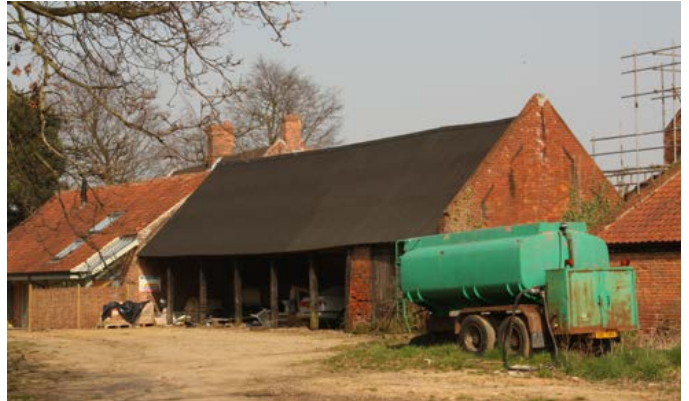
**Cart sheds** Large farms with extensive arable required numerous carts, ploughs, harrows and other implements for working the land. This cart shed lies on one side of a loose courtyard group but typically faces away from the yard and onto a track. Photo © Bob Edwards

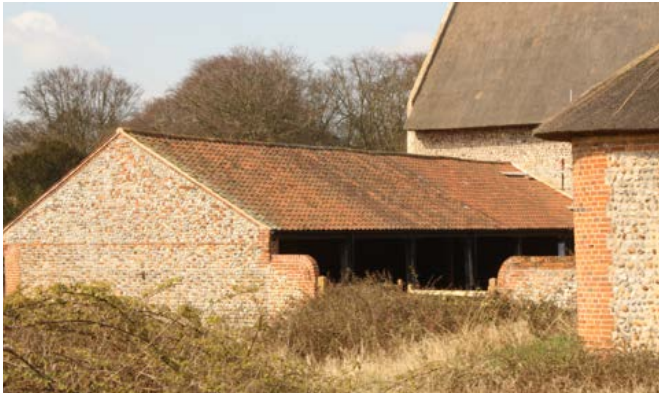
**Shelter sheds** From the 18th century, but more commonly in the 19th century, single-storey, open-fronted buildings were constructed for cattle. These shelter sheds usually faced into cattle yards and were often attached to an earlier barn, resulting in regular courtyard plan types. Photo © Bob Edwards

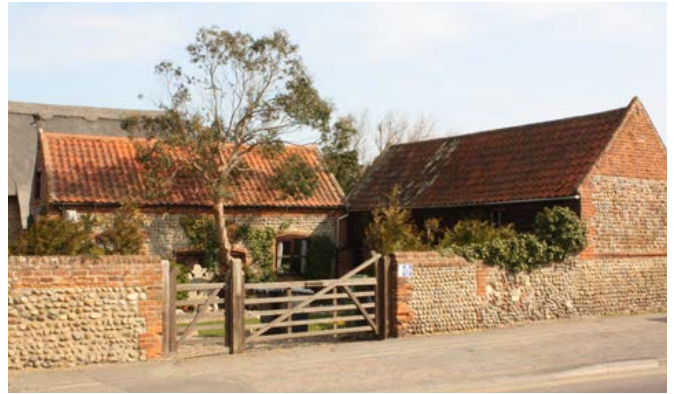
**Other buildings** Two small buildings that probably provided stabling and cattle housing on a coastal village farmstead. Photo © Bob Edwards

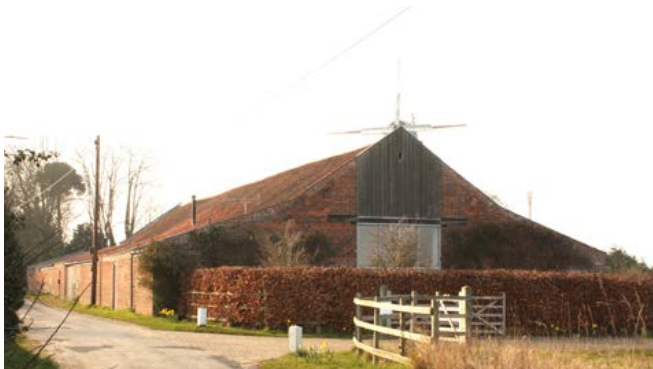
This large, barn-like building provided storage in the main body of the building, probably for root crops, particularly turnips, and cattle housing in loose boxes in the aisles. This is a building type that is characteristic of this area. Photo © Bob Edwards

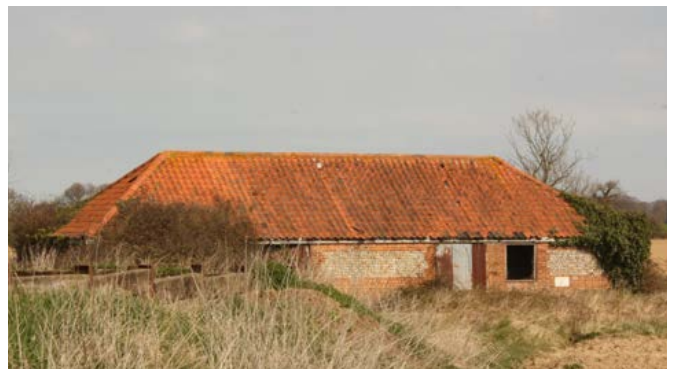
Outfarms or field barns do not appear to have been numerous in the landscape, but there are surviving examples. This building provided housing for cattle near the fields where their manure would be used as fertiliser. Photo © Bob Edwards

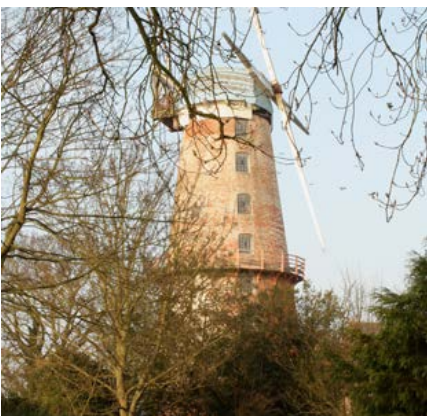
Whilst windmills are a common feature of the adjacent Broadlands where they were used to power drainage pumps, a small number of farmsteads in this Character Area also have windmills which were used for milling grain. These are very rare survivals in a national context. Photo © Bob Edwards

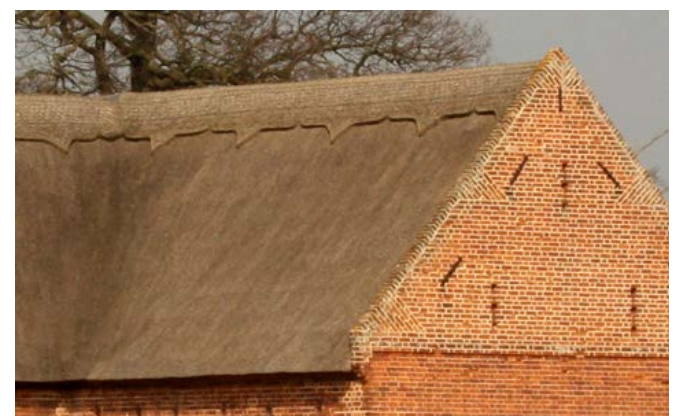
Reed thatch on a brick barn with coped gables incorporating tumbled brickwork, these being highly characteristic materials and features found across the area. Photo © Bob Edwards

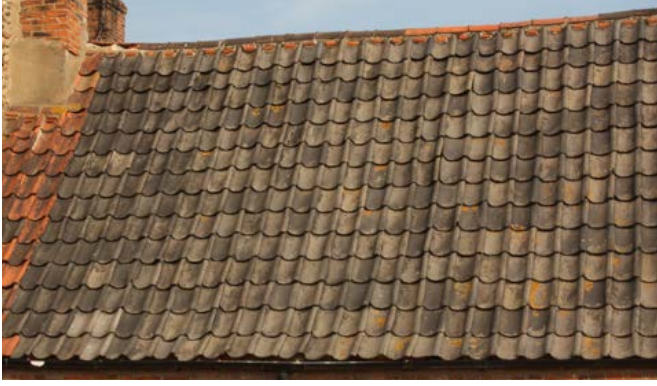
Pantiles, as commonly used from the late 18th century, are now the predominant roofing material on farm buildings. Usually red in colour, there are occasional examples of black glazed pantiles.

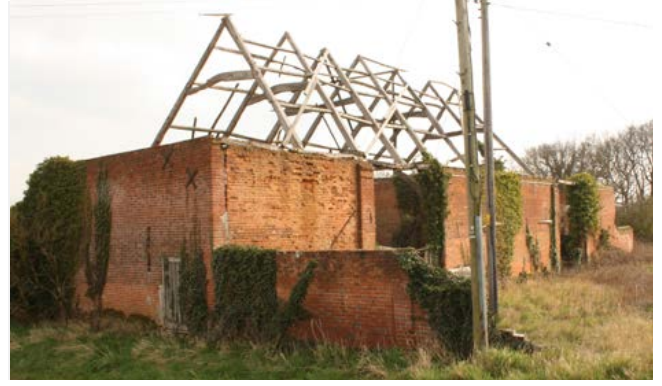
It is not uncommon to find farm buildings in poor condition in this area. Barns in the villages are often converted to residential use but buildings on isolated farms are more likely to be showing signs of structural failure or collapse. This example is of late 17th-century date, listed Grade II and is important in the setting of the listed farmhouse. Photo © Bob Edwards
