# Bellmanpark Limekilns, Clitheroe, Lancashire: Assessment of Significance

Research Report Series 20-2021

NGR: SD 7586 4342

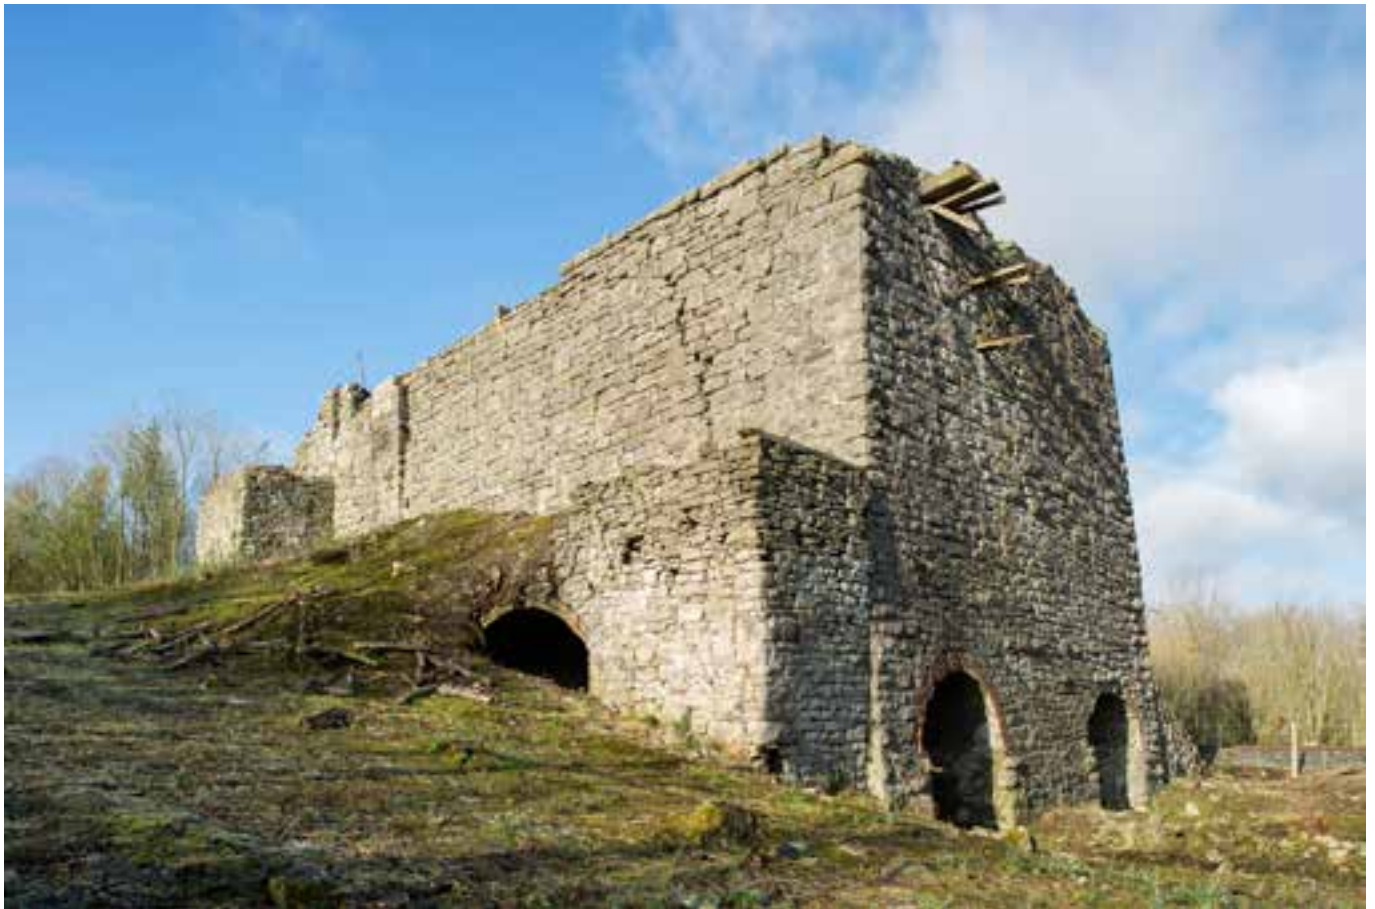
*Cover: The Bellmanpark limekilns from the south-east. The crown of the southern draw arch to kiln 1 is just visible in the bottom centre of frame emerging out of spoil dumped against the block post-disuse. The eastern entrances to the rail tunnels are visible at right of frame. (DP 169493 © Historic England / Alun Bull, 24 February 2016).*

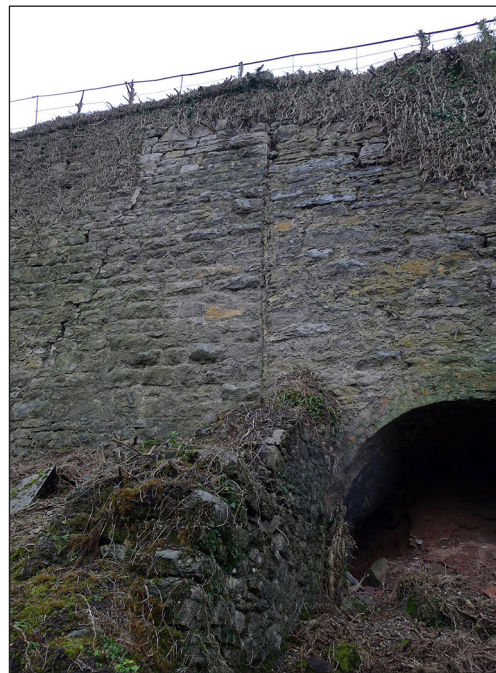
*Fig 1. Construction join in northern elevation of the Bellmanpark kilns, showing that the western kiln (right of frame) is a later addition. (AF00393027 © Historic England / Marcus Jecock, 6 January 2016)*

The new kilns may well have been intended to replace existing kilns inconveniently situated within Peach Quarry (Andrew Collinson, *in litt*). Field evidence (Figure 1) indicates that initially a block of only three kilns was erected and that the fourth (westernmost) kiln is a later addition; map evidence, however, shows all four existed by 1886 (Ordnance Survey 1886). Carter and Rowe also erected a cement kiln near the limekilns. Their partnership was dissolved a short while afterwards in 1879. Thereafter the firm of Carter & Sons worked the limekilns until 1959, while Rowe worked the cement kiln. Rowe died in 1883 but cement production continued, the works being auctioned as a going concern in 1889 when bought by a Mr Smalley. In 1892 the cement operation was incorporated as The Clitheroe Portland Cement Company. That company was dissolved in 1931/2 (Collinson *in litt*). The layout of the works is probably best appreciated on the OS map edition of 1912 (Figure 2).

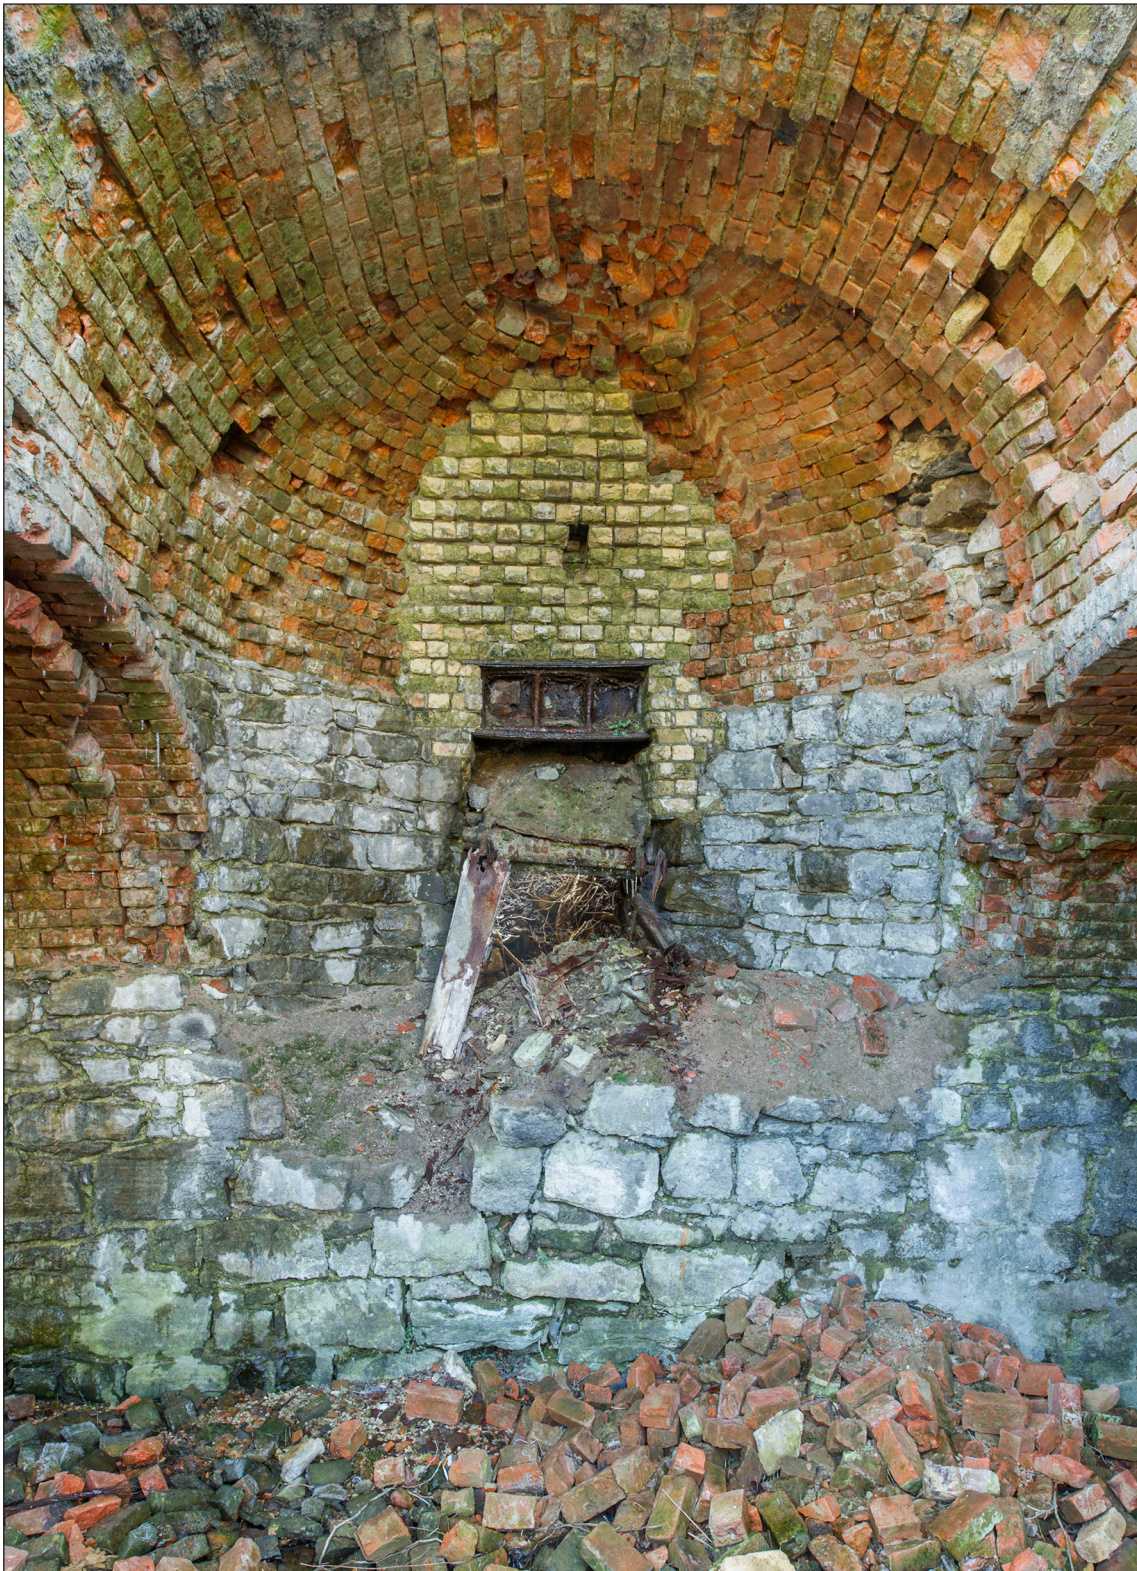
*Fig 3. The collapsing northern draw arch to kiln 1, showing its intersection with the northern rail tunnel and the draw-hole furniture. (Photograph: DP169500 ©Historic England / Alun Bull, 24 February 2016).*

The derelict and collapsing state of the tunnels in 2016, in particular the draw arches, meant it was too dangerous to make a detailed inspection or record of the draw-hole furniture. In addition there was at the time no safe means of access to the top of the kiln block. Nevertheless, enough evidence was visible to show that the block comprises four mixed-feed draw kilns, and that much of the discharge apparatus survived *in situ*, comprising iron-framed draw holes and elements of timber chutes for direct loading of the quicklime into rail wagons within the tunnels (Figure 3). A published photograph suggests the chutes survived relatively intact until recently (del Strother 2008, 26 photo upper right) although in 2016 they were deteriorating rapidly. A number of timbers that extend out from close to the top of the eastern end wall of the block (cover photo) are of unknown purpose, but may be to do with the

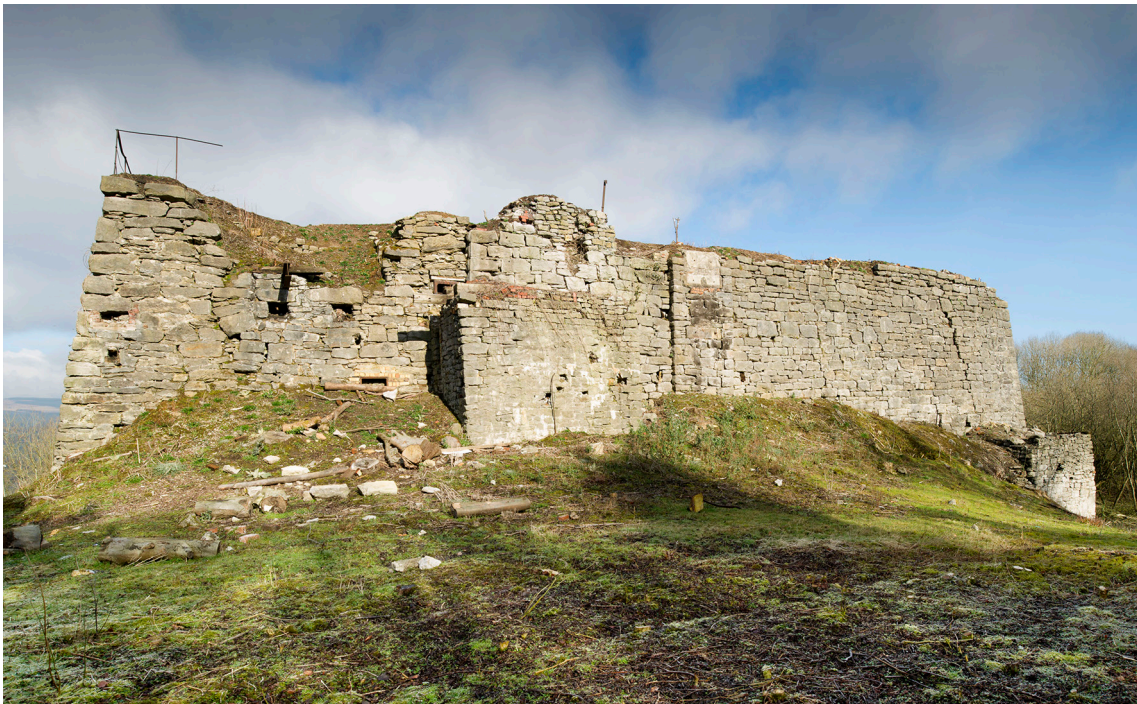
*Fig 4. Bellmanpark kiln block from the south. Note the bridge abutment with its massive stone bearing block just right of centre of frame, and the various wall boxes and apertures towards the west end of the block (above and right of the off-centre stone projection). (Photograph: DP169492 © Historic England / Alun Bull, 24 February 2016).*

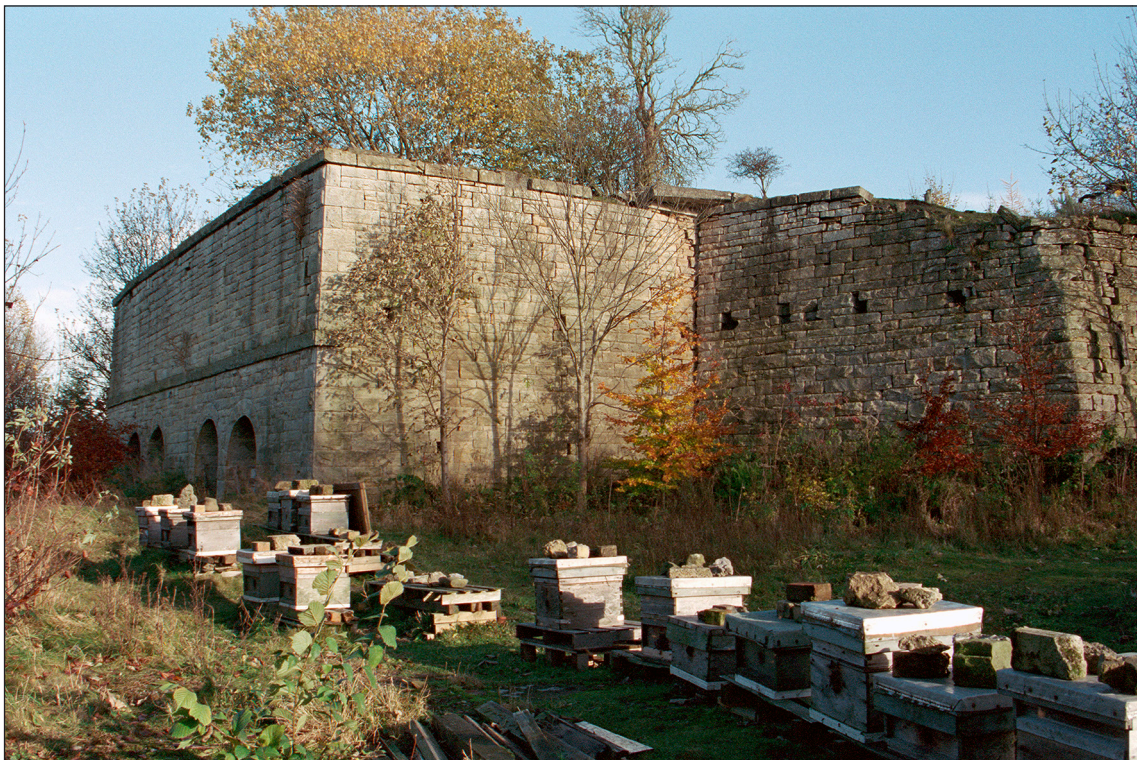
*Fig 7. The Grade II-listed Cocklaw limekiln bank from the west. (© Mr Michael Morrison. Source Historic England, IoE No: 240101 Film: 08039 Image: 16).*

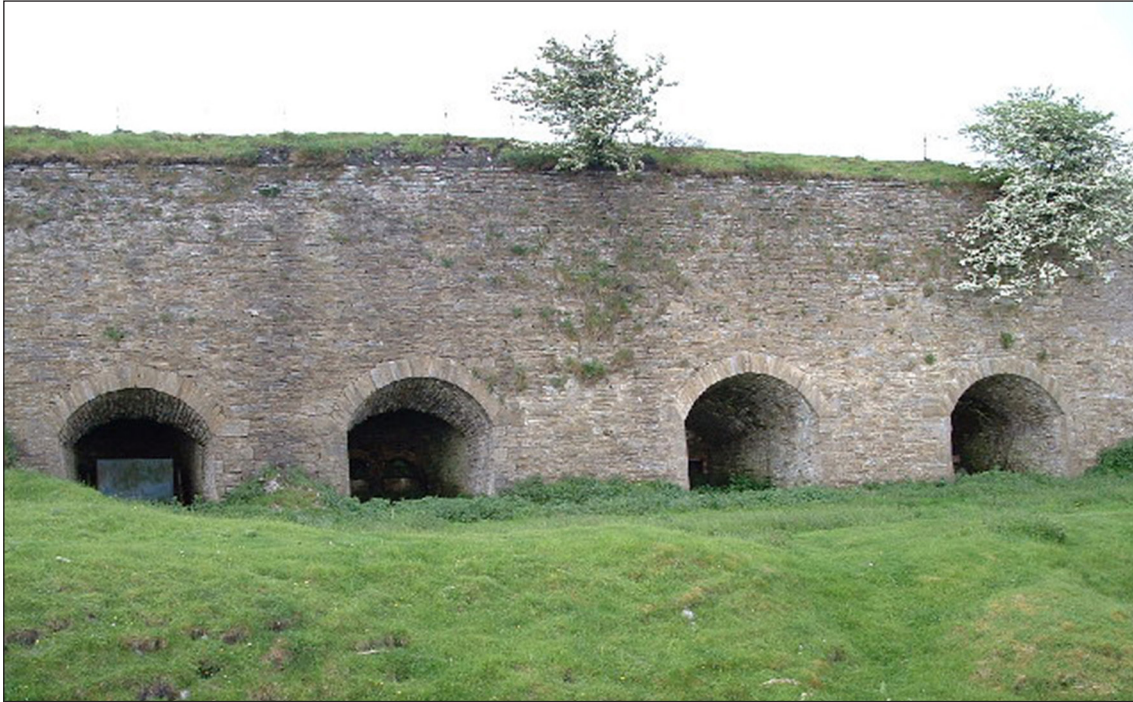
*Fig 17. The scheduled Foresthead limekilns from the north-west. (© Malcolm Jones, <https://www.cumbriacountyhistory.org.uk/farlam-1-ny5857-lime-kilns-forest-head-well-preservedjpg> under Creative Commons Licence).*

were demolished by the 1960s anyway; while those at the Perseverance Works in Derbyshire were photographed before 1939 when still in use but have also since been demolished (Williams 1989, 29 plate and caption). The kilns at Foresthead, Brampton in Cumbria, however, do survive in good condition and accordingly were scheduled in 2003 on the recommendations of MPP (Chitty 2001b, Cumbria no. 2; NHLE 1021017); a recent photograph of them is reproduced here as Figure 17.

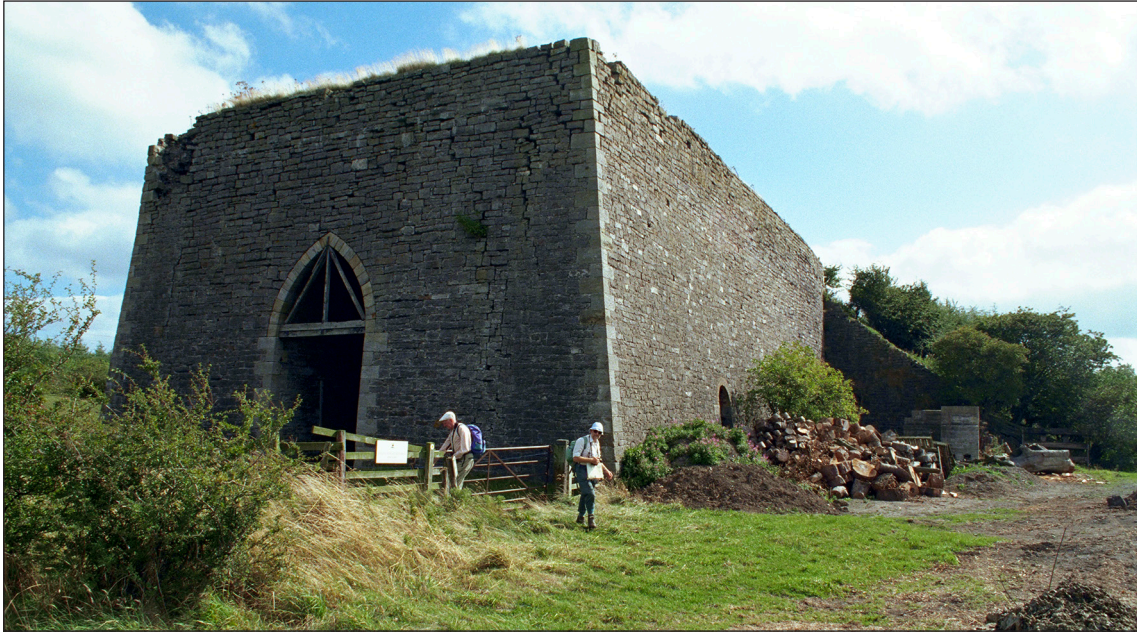
Fig 21. The Grade II\*-listed Littlemill limekiln bank from the north, showing the entrance to the central rail passage. The top of what is probably an interconnecting cross passage can just be seen in the centre of the western (right-hand) wall. (© Mr Peter Oakley Clarke. Source Historic England, IoE No: 237036 Film No: 02000 Image: 31).

of what the demolished covered-loading kiln complex here formerly looked like. The Littlemill kilns, in contrast, are well preserved and were already listed at Grade II\* when assessed by MPP (Chitty 2001b, Northumberland no. 13; NHLE 1041773); a recent photograph of them from Historic England’s Images of England database is reproduced here as Figure 21.
