ALL SAINTS' CHURCH, KINGTON MAGNA, DORSET

TREE-RING ANALYSIS OF TIMBERS FROM THE BELFRY FLOOR

SCIENTIFIC DATING REPORT

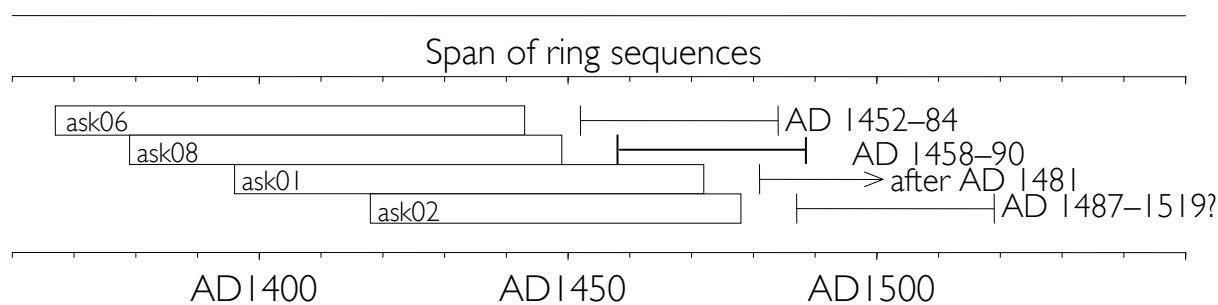
Figure 3: Bar chart showing the relative positions of overlap of the dated timbers along with their derived felling date ranges
