AUDLEY END HOUSE, SAFFRON WALDEN, ESSEX AUDLEY END STABLES

HISTORIC BUILDINGS REPORT

**STABLE BUILDING
AUDLEY END HOUSE
SAFFRON WALDEN, ESSEX
RESEARCH AND ANALYSIS**

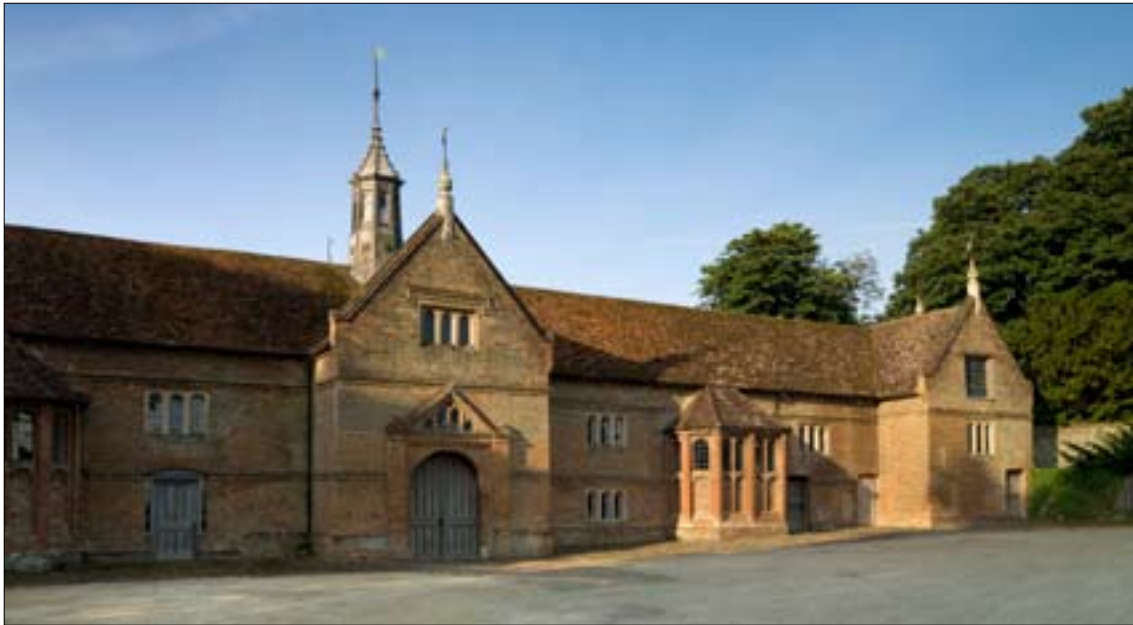
Fig. 2. The north front of the stable building.

The north front (fig. 2) has the same basic nine window layout, arranged 1,3,1,3,1, as the south front, though with a significant number of later alterations. It has no gabled dormer windows to the main range, as these were removed in the late 17th century, though evidence of where their unusual brick kneelers once existed can be found just below the eaves. The windows mainly have square leaded panes. The plinth steps up twice and the attic plat band steps up once to the west. The projecting central crosswing has a round-headed doorway with double doors and a brick surround of flanking pilasters with ogee finials and a pediment. The main ranges to east and west have large central canted bay windows with hipped roofs, all of which are additions. These features are constructed of a redder brick and the courses of brick do not continue through into the coursing of the original brick walls.

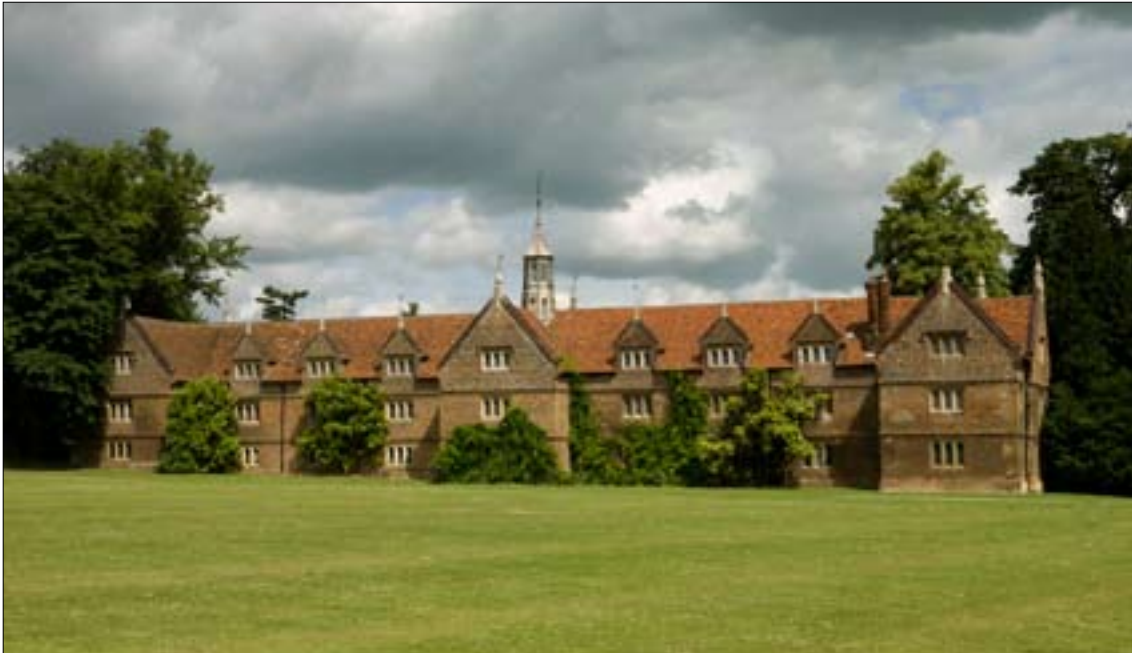
Fig. 4. The south front of the stable building.

east end of the main range, which now forms the entrance to the attic flat. This would agree with the present building if the 'Coach House stable' referred to, occupied the eastern section of the main range, next to the coach house, as seems most likely. This harness room retains a fireplace served by a chimney stack on its south side which does not appear on Winstanley's views of the stable (figs. 23 and 24). Presumably this chimney was inserted at this time, though the elaborate pair of Tudor-style chimney stacks (fig. 4) which serve this fireplace (and a fireplace in the attic) may date from the late 19th century.

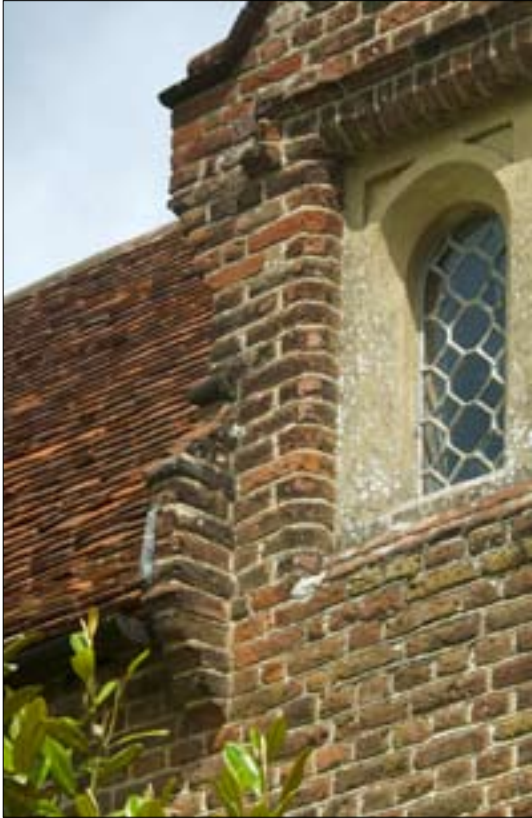
Fig. 5. One of the unusual moulded brick kneelers flanking the dormer windows on the south front.

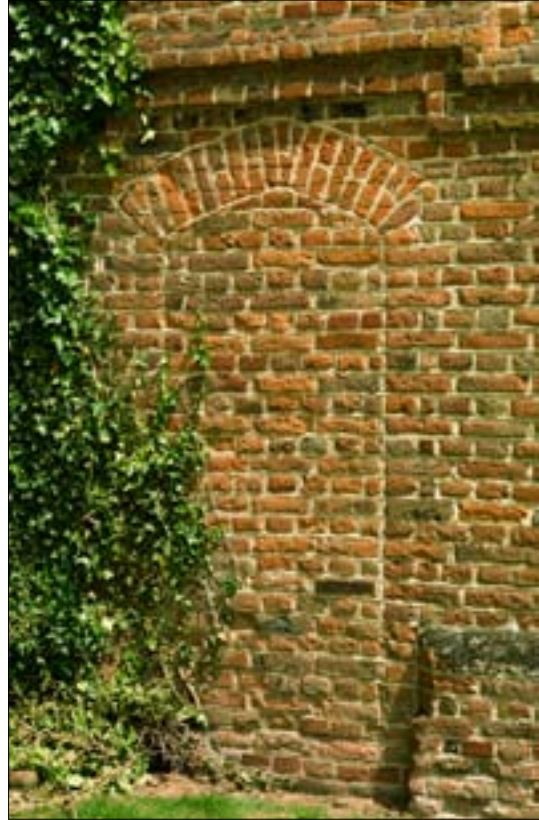
Fig. 6. The blocked doorway on the west return wall of the central crosswing, the south front.

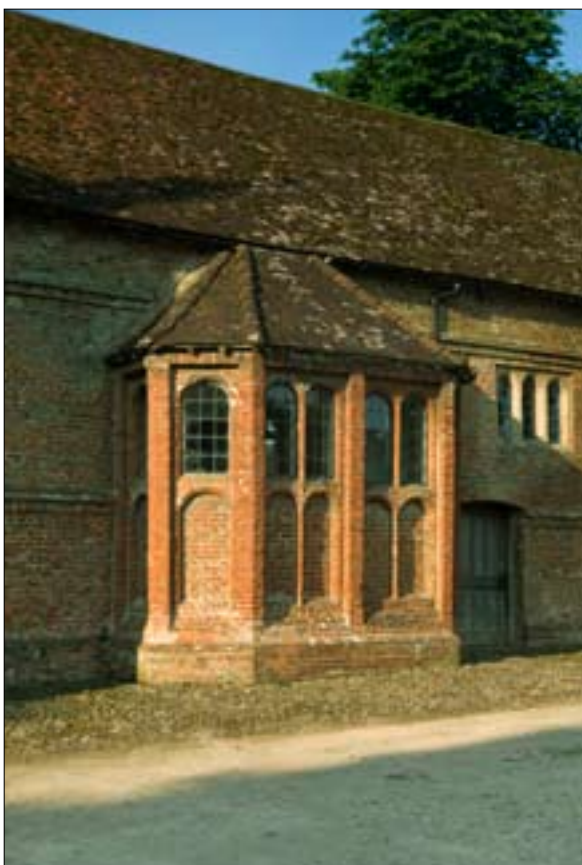
Fig. 7. The east bay window on the north front of the stable building, probably added c.1620.
© English Heritage DP029955

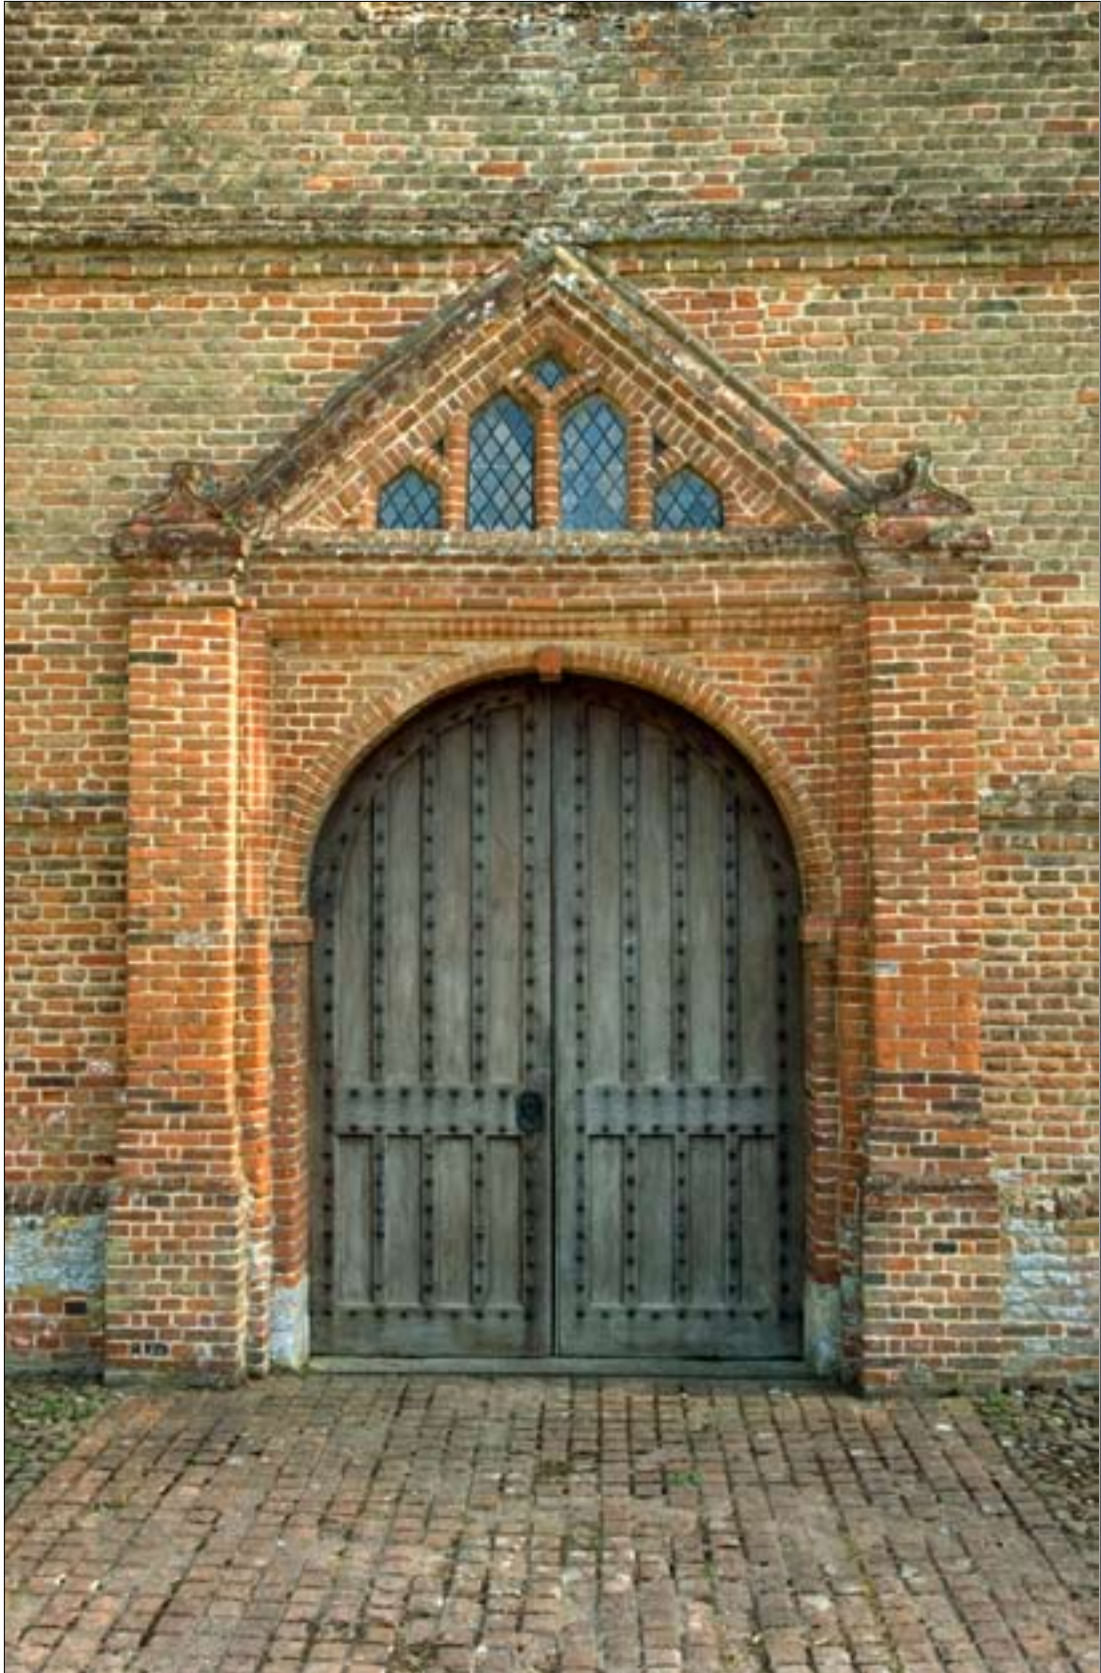
Fig. 8. The central entrance on the north front of the stable building, probably added c.1620.
© English Heritage DP029965

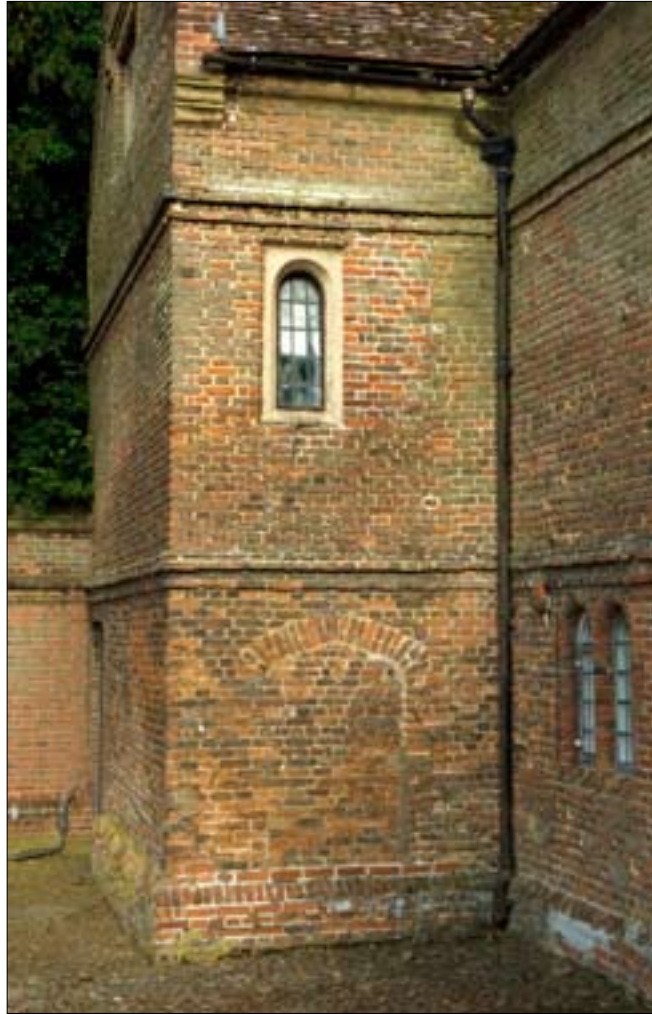
*Fig. 9. The blocked doorway on the west return wall of the east crosswing and the former two light window above, now reduced to a single light window.
© English Heritage DP029964*

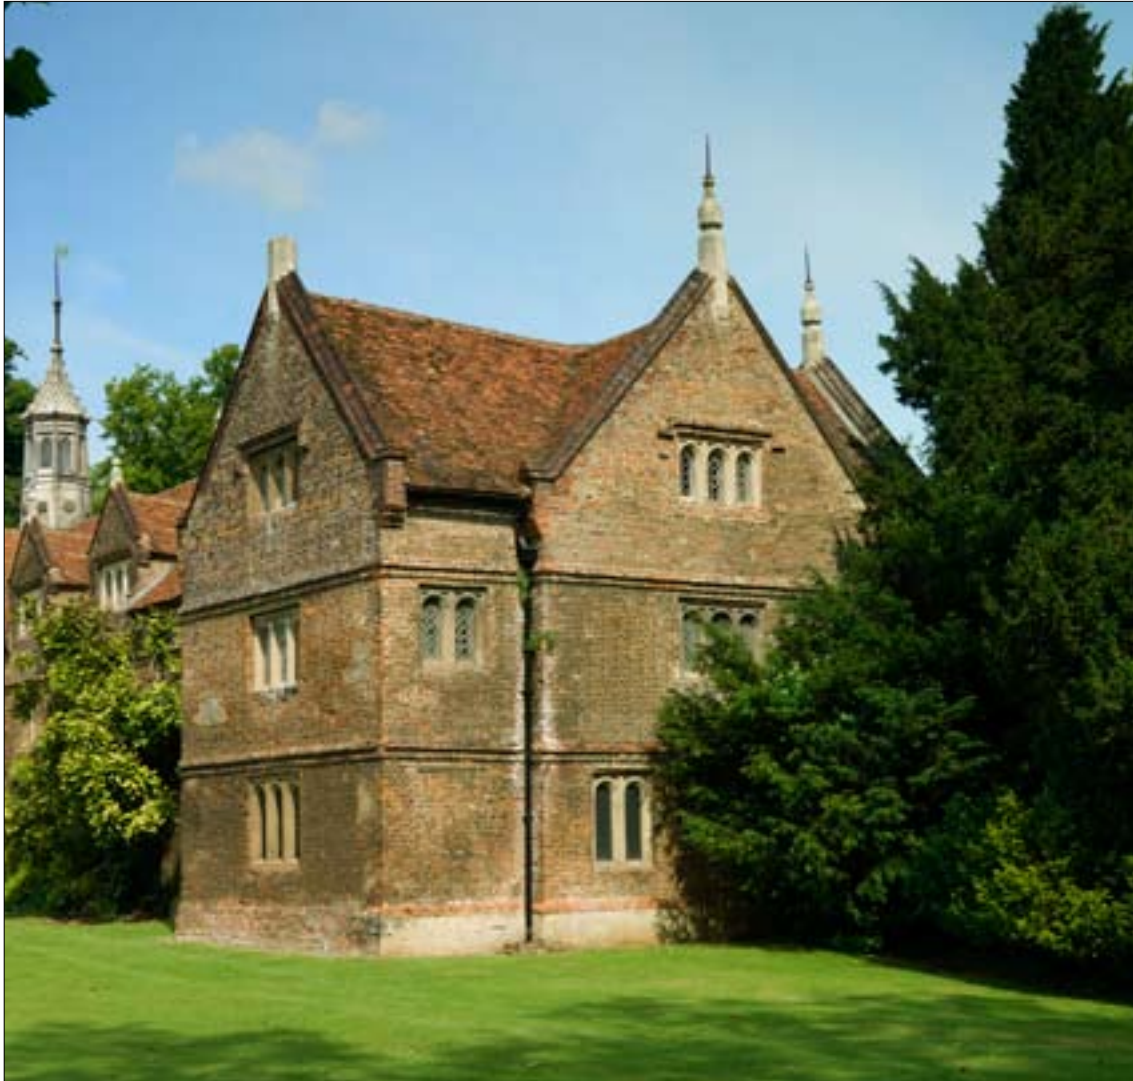
Fig. 10. The east crossing from the south-east.

The east front of the stable building faces towards the house with a symmetrical three window façade (fig. 10). It has a broad slightly projecting central gable and single window wings. The broad central doorway has been blocked (head visible) and the flanking two-light windows have been blocked internally. The outer wings had similar windows, which

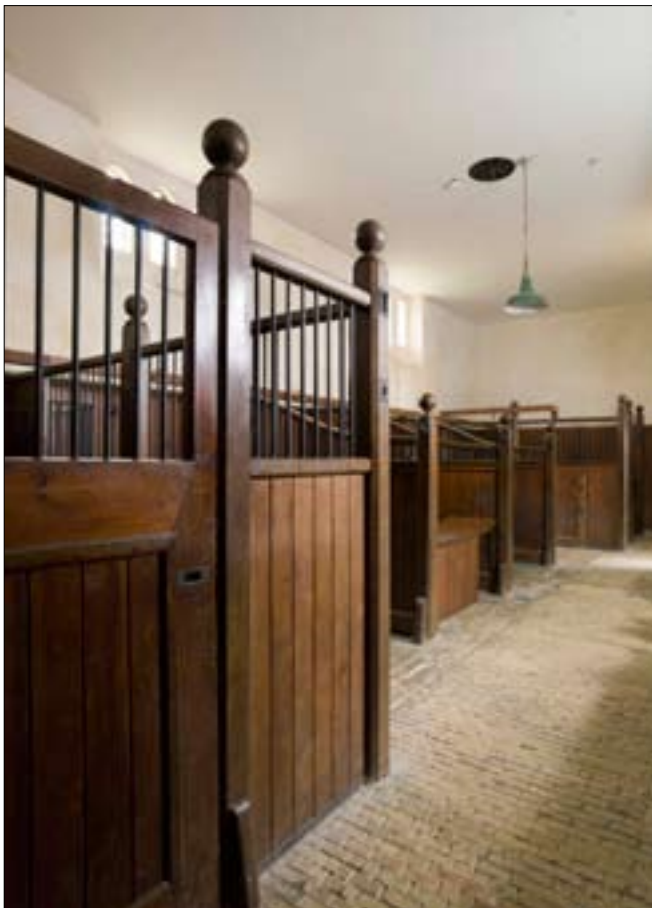
Fig. 13. The coach house stable.
© English Heritage DP029976

This section of the original stable contains stalls for six horses, with four central stalls flanked by single loose boxes with doors at either end (fig. 13). These high timber stalls have plank sides and doors, octagonal posts topped with ball finials and iron grills to their upper divisions. The plank walling continues around the remainder of the room. These well preserved stalls, which appear to date from the early 20th century, were made by Merryweather & Son, Engineers, Longacre & Lambeth, London, with fittings supplied by Cottam & Company, 2 Winsley Street, Oxford Street, London. There is a doorway on the east wall leading into the former harness room and another on the west wall leading into the coach house. This room has a brick or clinker floor, plastered walls and a flat plaster ceiling with a central circular ventilator.

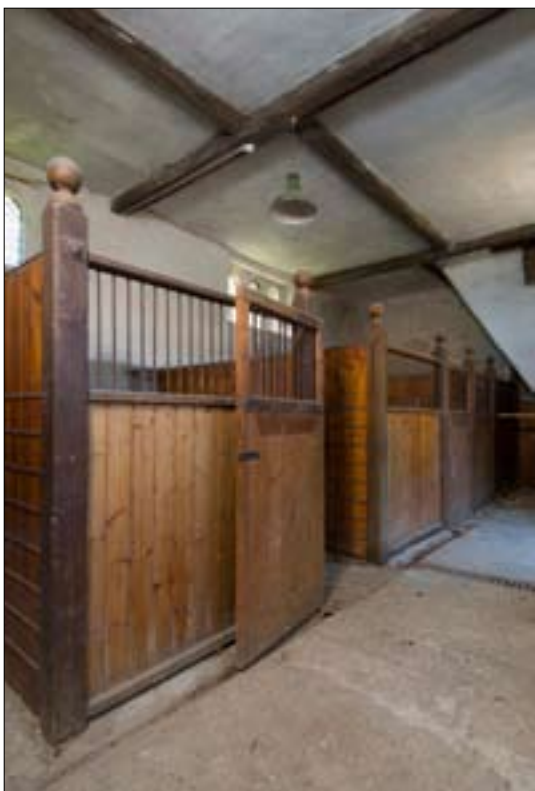
Fig. 15. The west stable.
© English Heritage DP029980

The west stable (fig. 15) contains four 20th-century stalls, including three broad stalls with doors and a single narrower open stall to the east. They have plank sides and doors with upper iron grills and square posts topped with ball finials. The planking continues around all the walls. This room has exposed ceiling beams. The north-west corner of this room contains the present stair to the attic which is partitioned off and accessed from outside. This steep ladder stair is 20th century, though the original was probably installed in 1777 when the corn chamber was created. The west wall of this stair has a blocked doorway between the ground-

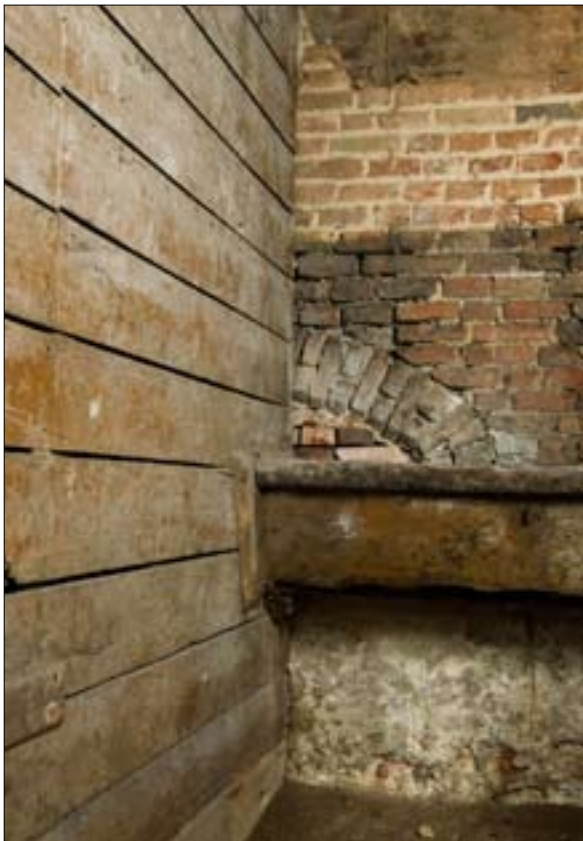
Fig. 16. The surviving blocked fireplace on the ground floor in the west crosswing.

Unfortunately there is no clear evidence of a former first floor identifiable in the surviving fabric. There is a single four-centred arched fireplace partially hidden behind the present stalls on the ground floor of the east wall (fig. 16). This fireplace was served by one of the two chimney stacks shown on Winstanley's engravings (figs. 23 and 24), suggesting that this section of the building probably contained accommodation for the senior grooms. There is no evidence of a surviving second fireplace, though this may well have been sited on the first-floor possibly against the now plastered south wall. Winstanley's engravings appear to show the two chimney stacks emerging from the central ridge of the crosswing which would agree with this interpretation. If this is so then these stacks must have been completely removed when the corn chamber was inserted in 1777.

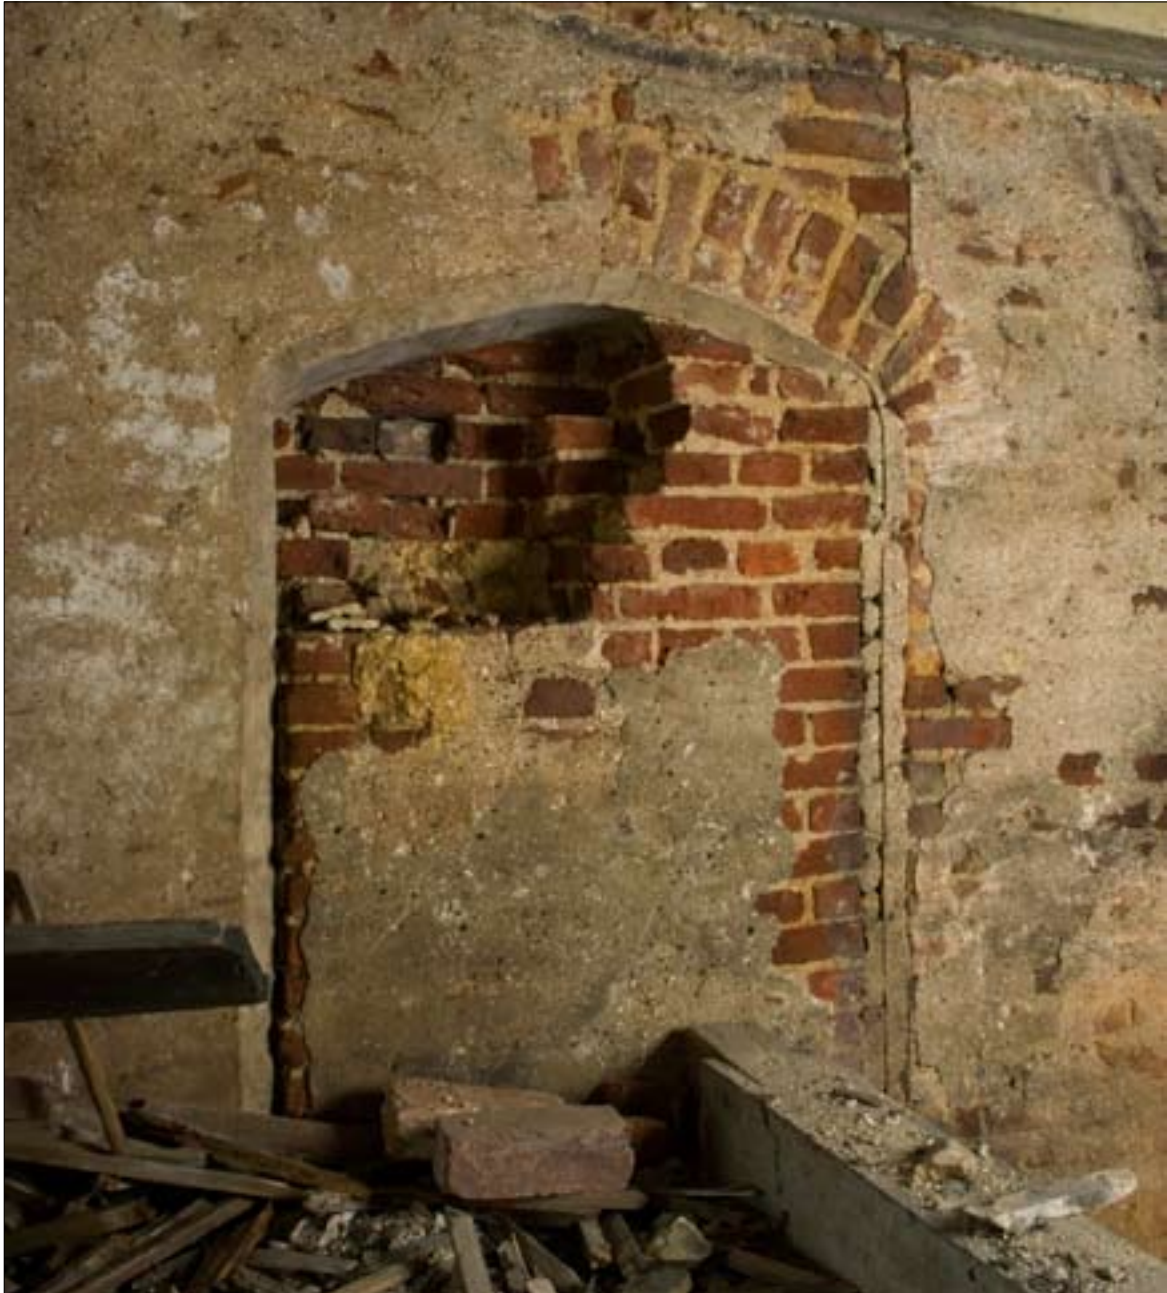
Fig. 17. The blocked doorway on the first floor in the west crosswing.
© English Heritage DP029982

On the east wall between the ground and first floors is a blocked doorway (fig. 17) with a four-centred arched head and plastered surround, set within a recess. This recess has a concrete lintel above supporting a beam inserted to strengthen the floor of the corn chamber above. This doorway was presumably related to the stair shown on Winstanley's plan (fig. 22) which originally gave access, via another lost stair in the west stable, to the attics in the main range (see below 2.2h). There is not enough space between this doorway and the fireplace below to allow for the necessary floor, and it therefore seems likely that they represent two different stages in the complex development of this crosswing. The west wall has a three-light mullion window set between the former floor levels, and there is a shallow recess in the thickness of the

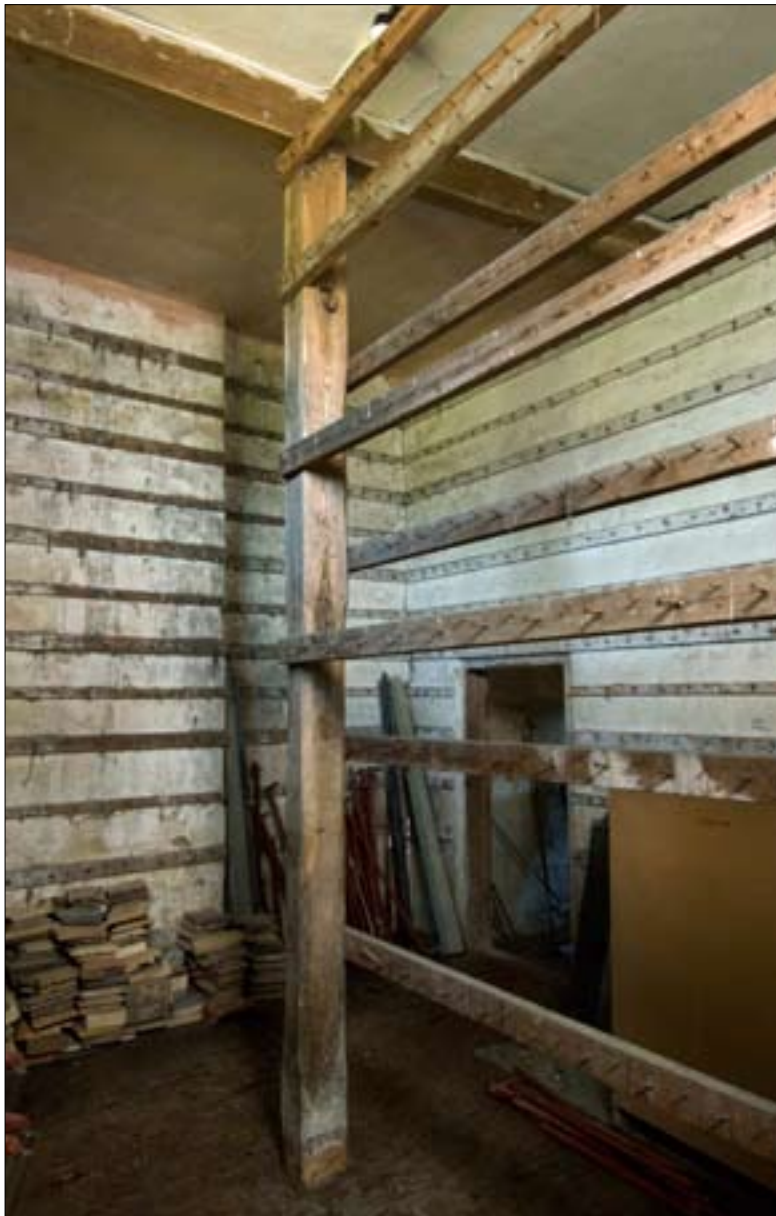
Fig. 18. The game larder in the west crosswing.
© English Heritage DP029985

The double height game larder (fig. 18) to the south is lined from floor to ceiling, around all four walls, with plaster and eleven horizontal timber planks with iron hooks for the hanging of game; these were probably inserted in the late 19th century.

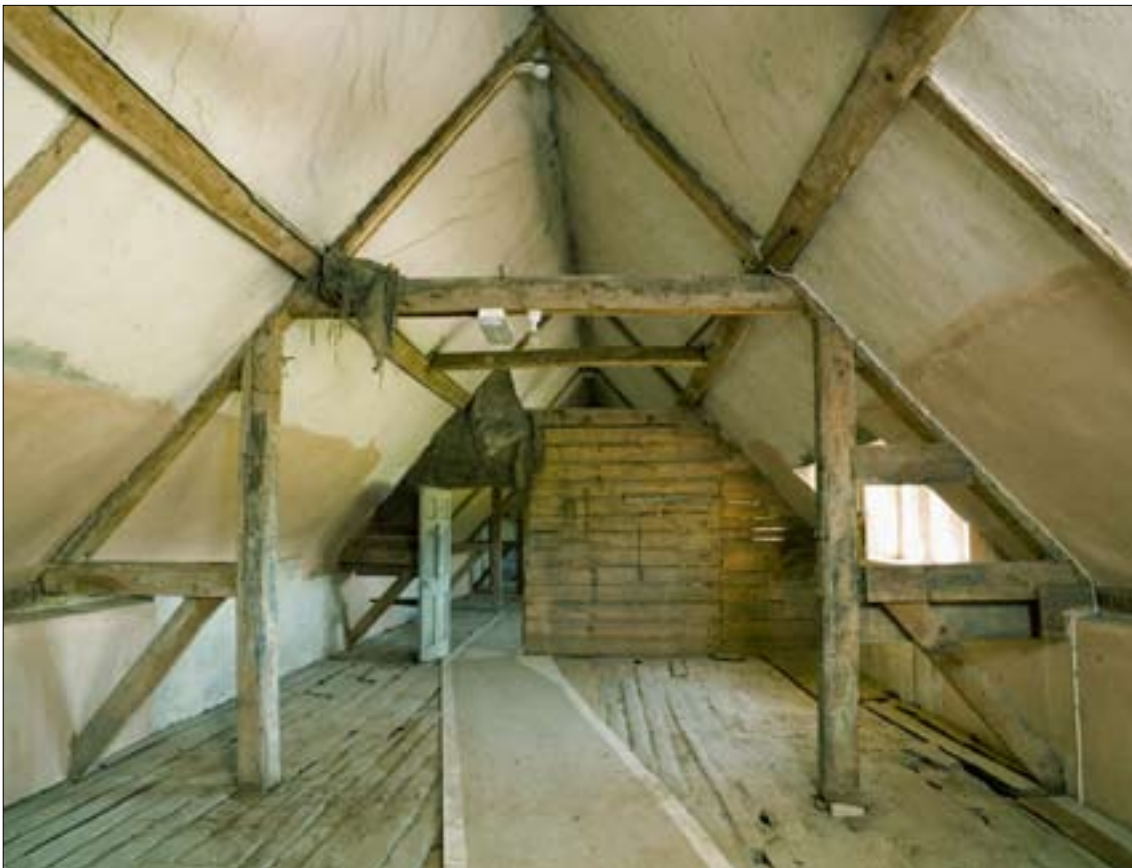
Fig. 19. The roof structure of the stable building.

The present roof structure appears to date from the early 17th century,⁸ though the trusses appear to have been reordered and repaired. The main roof runs east-west

The roof trusses retain a number of legible carpenters' marks. Some trusses have complete sets of a single number, but others have few if any visible numbers. Where they do survive these numbers are not in any logical sequence, suggesting that the roof has been dismantled, repaired and then re-erected. The constant references to the poor condition of this building, and especially its roof, in the late 17th century (see below 3.4) make it most likely that this reconstruction of the roof took place in the early 18th century. There is some evidence of fire damage on a number of timbers, though these appear to have been re-used. The flooring includes some very early broad floor boards. The brick bases to some of the former gabled dormer windows on the north side can be found on the tops of the walls.

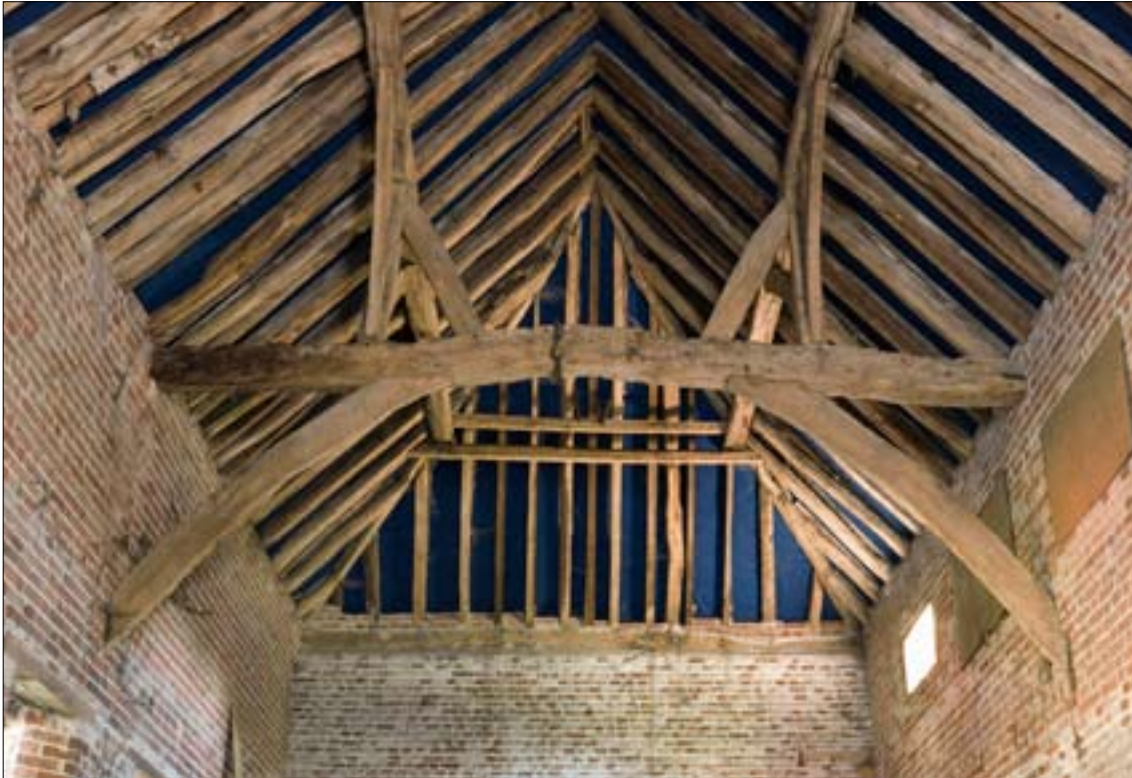
Fig. 20. The 16th century roof structure in the surviving barn. © English Heritage DP029977

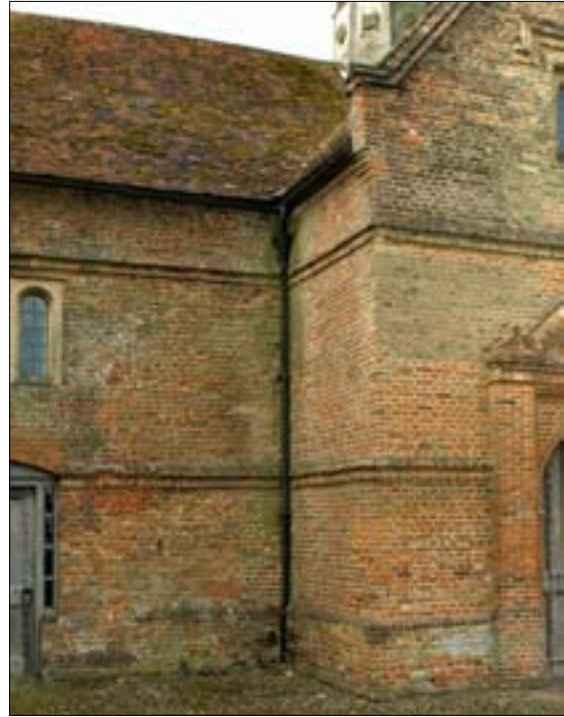
*Fig. 26. The east corner of the central crosswing, where the lean-to addition once stood.
© English Heritage DP029974*

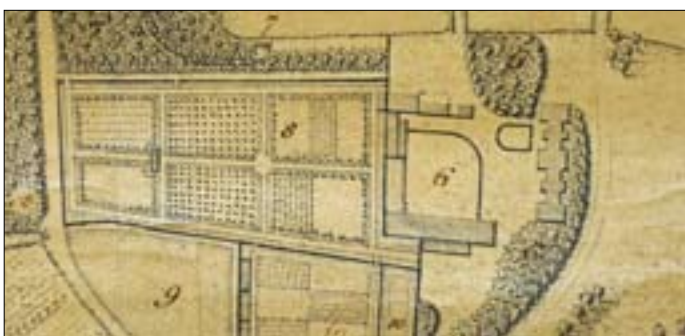
Fig. 31. Thomas Warren. Detail of the stable yard from a survey of the grounds dated 1783.

A further survey plan of the house and the landscape garden (fig. 31) was produced by Thomas Warren for Sir John Griffin in 1783.⁴⁶ It shows that the belt of trees to the south of the stables, planted by Brown, had matured and completely hidden the stable from view from the main house, though there is no sign of the entrance roads into the stable yard that Brown proposed. (This survey is not entirely accurate for it shows the stable building with projections on its south side, which can never have been built.) It does show that the additions at the west end of this building had been demolished by this date. This survey also shows major changes to the layout of the stable yard and barns. The barn on the west side of the stable yard has had its former projection on the east front removed and a new projection added to the west. The barn occupying the western end of the north range has been demolished and replaced by a walled yard. A curved wall has been constructed dividing off the yard in front of the barns to the north-west and a rectangular walled enclosure, with a curved north end, has been added in front of the eastern section of the main stable building. This survey also shows that the walled kitchen gardens to the north, (shown on the c.1755 survey (fig. 29), though not shown on Brown's plan (fig. 30) still survived and had been extended to the north-west.

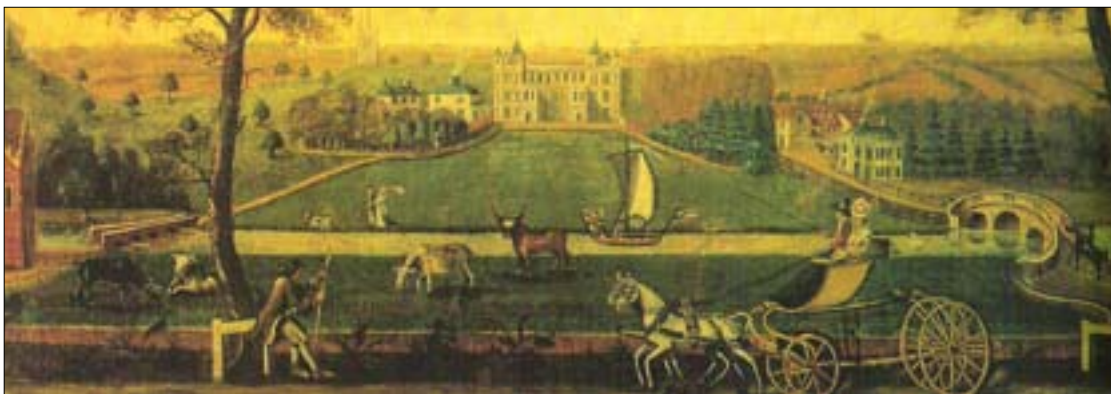
Fig. 32. Anon. Audley End from the west c.1780. This painting shows the stable building (far left) with the crenellated gables added by John Hobcroft, and Lord and Lady Braybrooke in a 'crane-necked' pheaton (right). Stanley Falconer

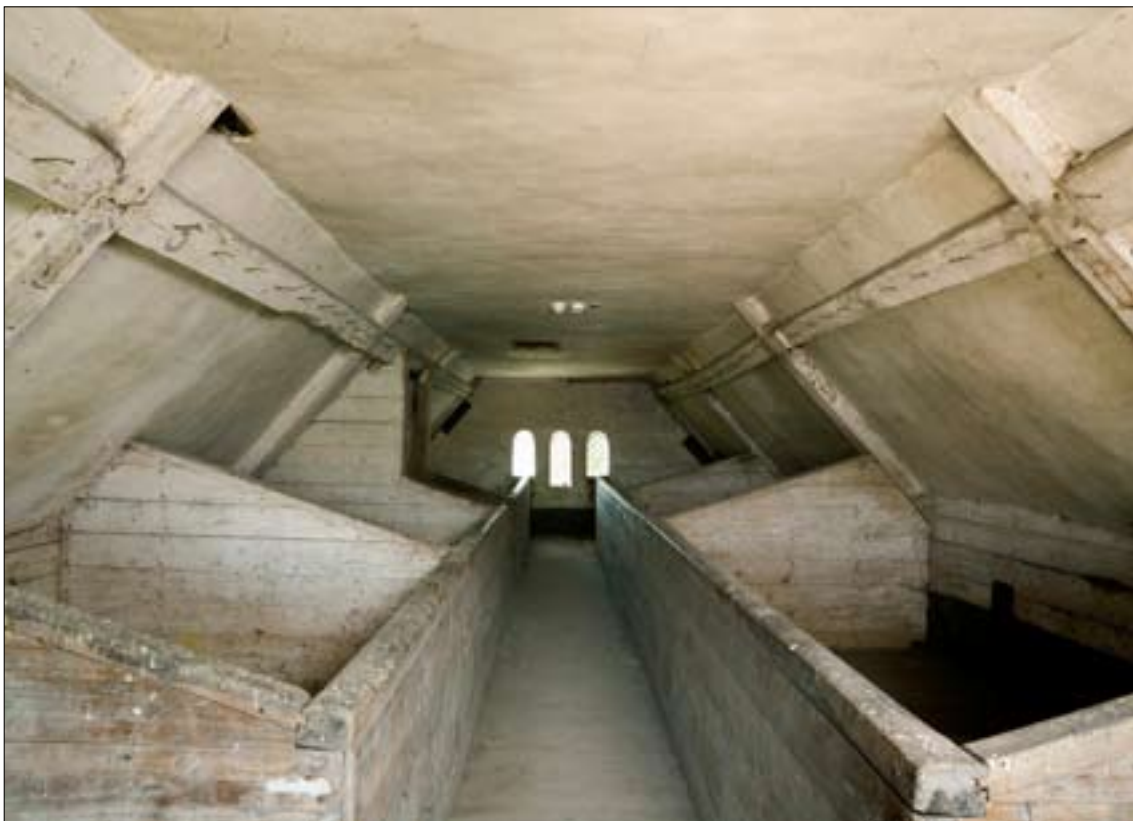
Fig. 33. The corn bins in the attic of the west crosswing, installed c.1777.
© English Heritage DP029979

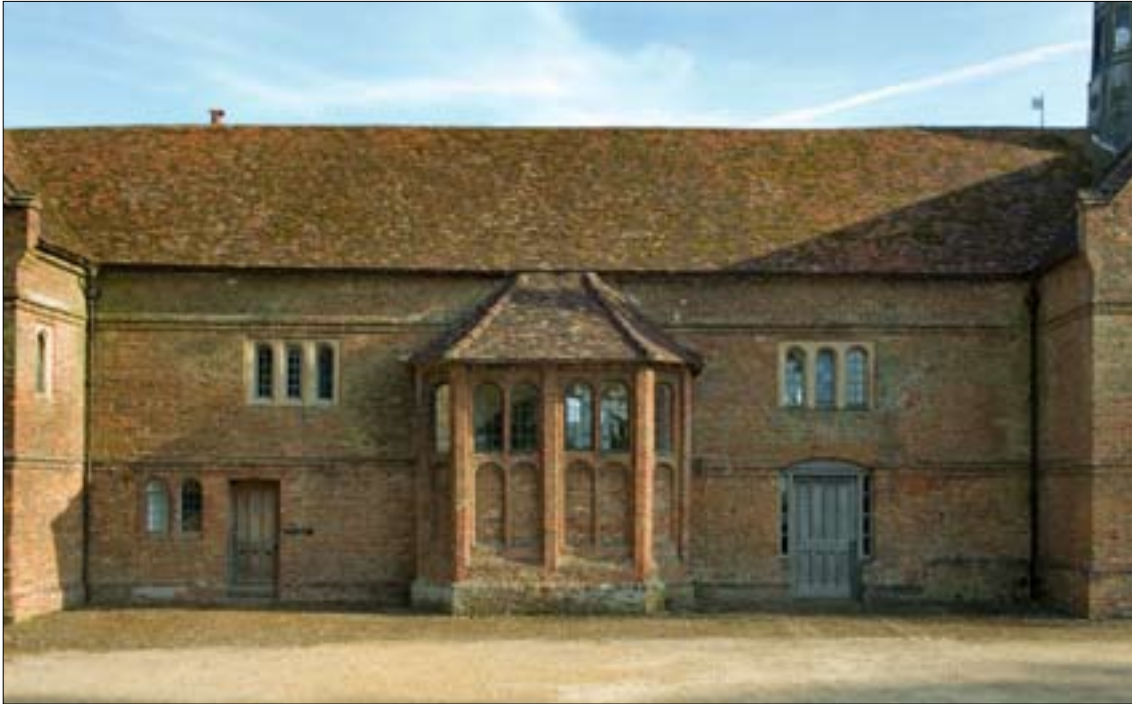
Fig. 36. The eastern section of the north front of the stable building.
© English Heritage DP029968

the harness room and the coach house stable appears never to have taken place, as this door still survives today (fig. 36). Hussey's drawing also suggests that the external doors to the harness room and the coach house stable already existed and that they were both set beneath a section of raised plat band, something which appears to be confirmed by the present structure. The original door to the coach house stable was blocked, though the proposed new door into this stable, through the canted bay window, can never have been inserted, as no evidence of disturbance to the brickwork of this bay is visible today (fig. 7). Presumably the broad doorway with side lights to the west of this bay window was inserted at this time instead. The three-light window on the first floor was not removed as the proposal drawing seems to suggest.

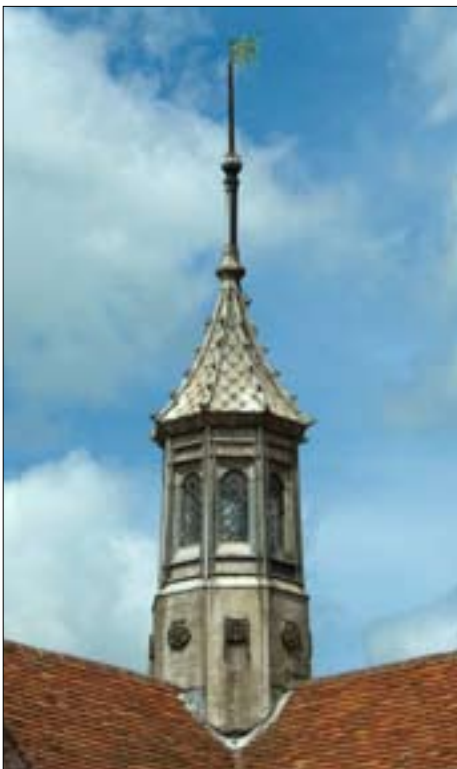
Fig. 37. The central cupola or lantern added in c. 1885, probably designed by Richard Hussey.
© English Heritage DP029962

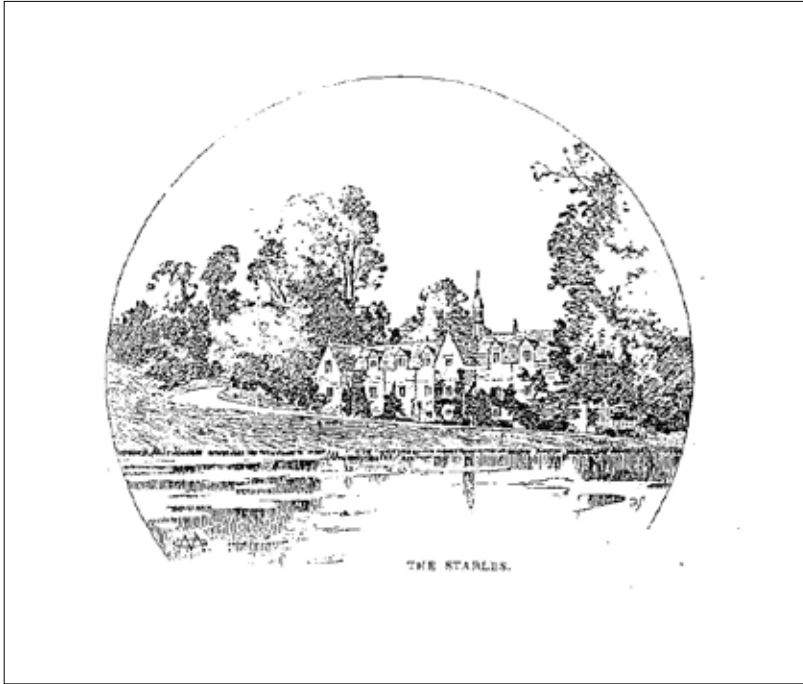
Fig. 38. View of the stable building from the south-east published in the *Illustrated London News*, June 1890, XXIV.

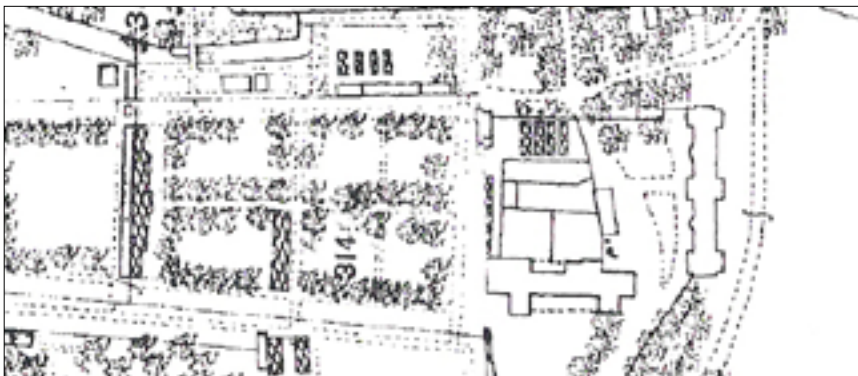
Fig. 39. Detail of the stable yard from the 25" Ordnance Survey map of 1887.

The earliest detailed 25" Ordnance Survey map of 1887 (fig. 39), shows that the belt of trees to the south of the stable building, planted by Capability Brown, had been removed, exposing the building to view once again from the south. No change is shown to the outline plan of the stable building since the survey map of 1783, but this map does show that radical changes had been made to the remainder of the buildings around the stable yard. The north range buildings had been removed and replaced by a wall, and a new head gardener's house, with a date-stone inscribed 1875, had been added at the north-east corner of the stable yard (fig. 40).

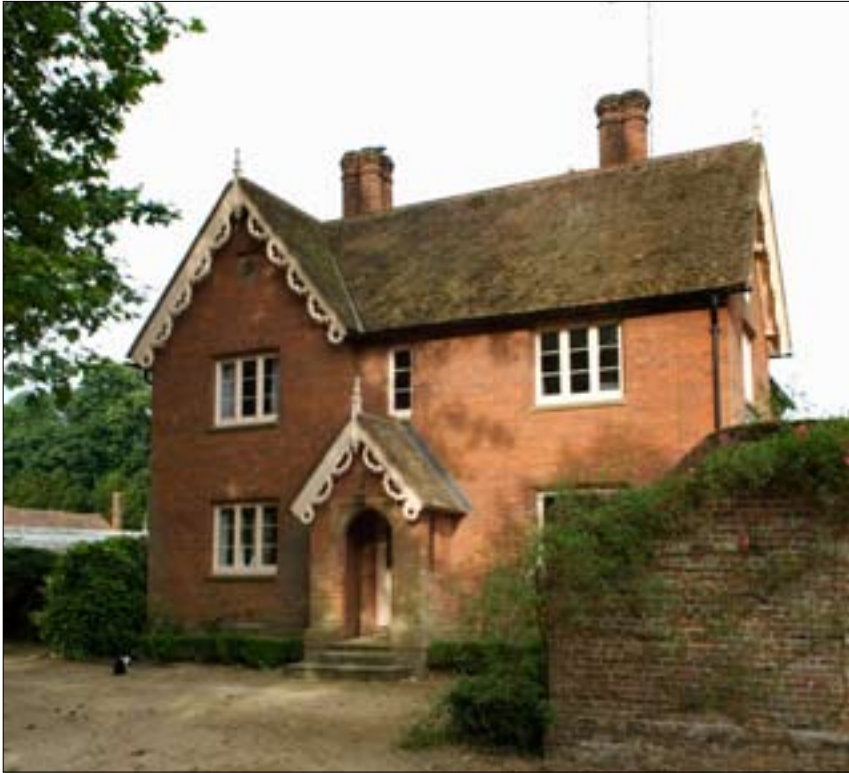
Fig. 40. The head gardener's house, probably designed by Richard Hussey in 1875.

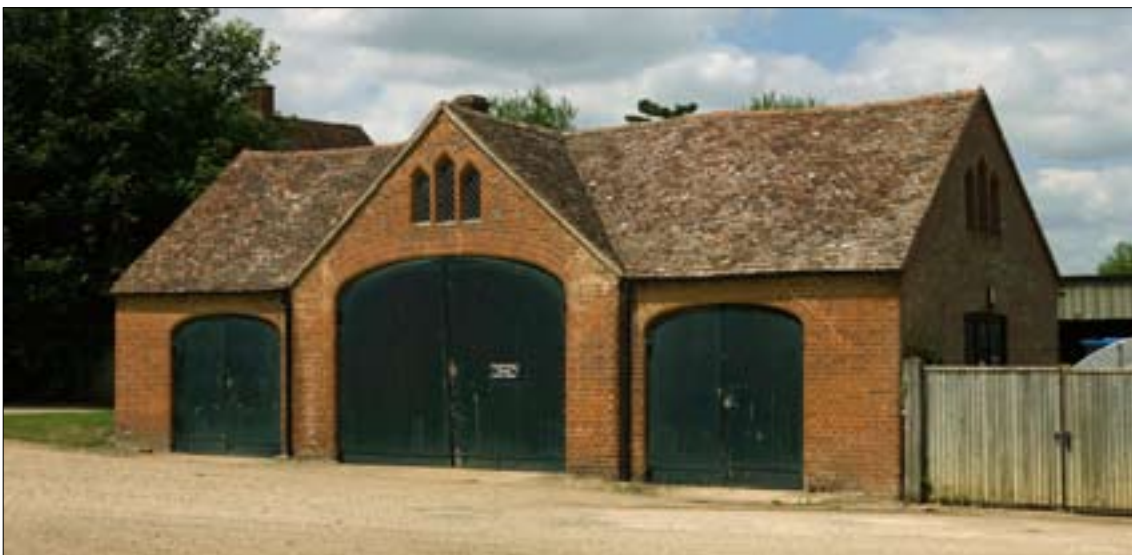
Fig. 41. The new coach house, probably designed by Richard Hussey c.1875.

A new small coach-house building (fig. 41) replaced the former curved wall in the centre of the stable yard, dividing it into two. Two additions are also shown to the west side of the west barns range, and a small (surviving) building, linked by a wall to the north-east corner of the stable building, is also shown for the first time. Richard Hussey was presumably responsible for the design of these additions.

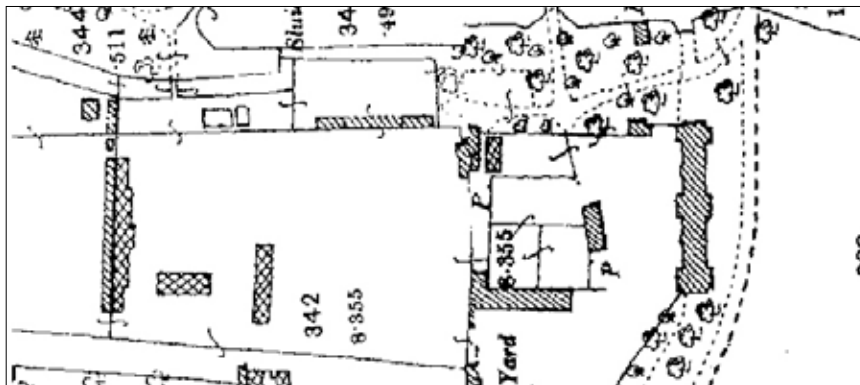
Fig. 42. Detail of the stable yard from the 25" Ordnance Survey map of 1897.

Comparison of the map of 1877 with the 25" Ordnance Survey map of 1897 (fig. 42) shows that the northern section of the original barn on the west side of the stable yard was demolished between 1877 and 1897. This is perhaps not surprising since it was described in the article in the *Illustrated London News* for June 1890 as a 'vast tumbled-down barn [which] is empty'.⁶⁶ The later map also shows an addition to the head gardener's house and changes to the adjoining glasshouses.

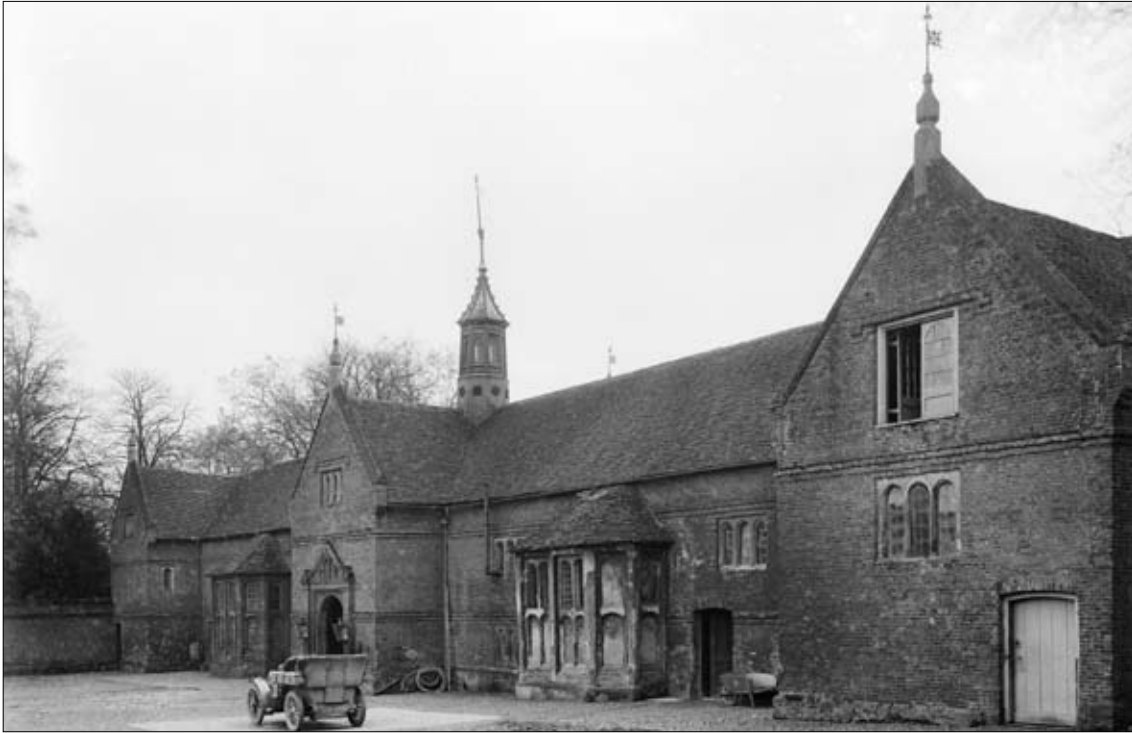
Fig. 43. The north front of the stable building in c.1907.
© Crown copyright, NMR Neg. No. BB76/4250
