HADLEIGH CASTLE, ESSEX EARTHWORK ANALYSIS

SURVEY REPORT

**HADLEIGH CASTLE
HADLEIGH
ESSEX**

EARTHWORK ANALYSIS: SURVEY REPORT

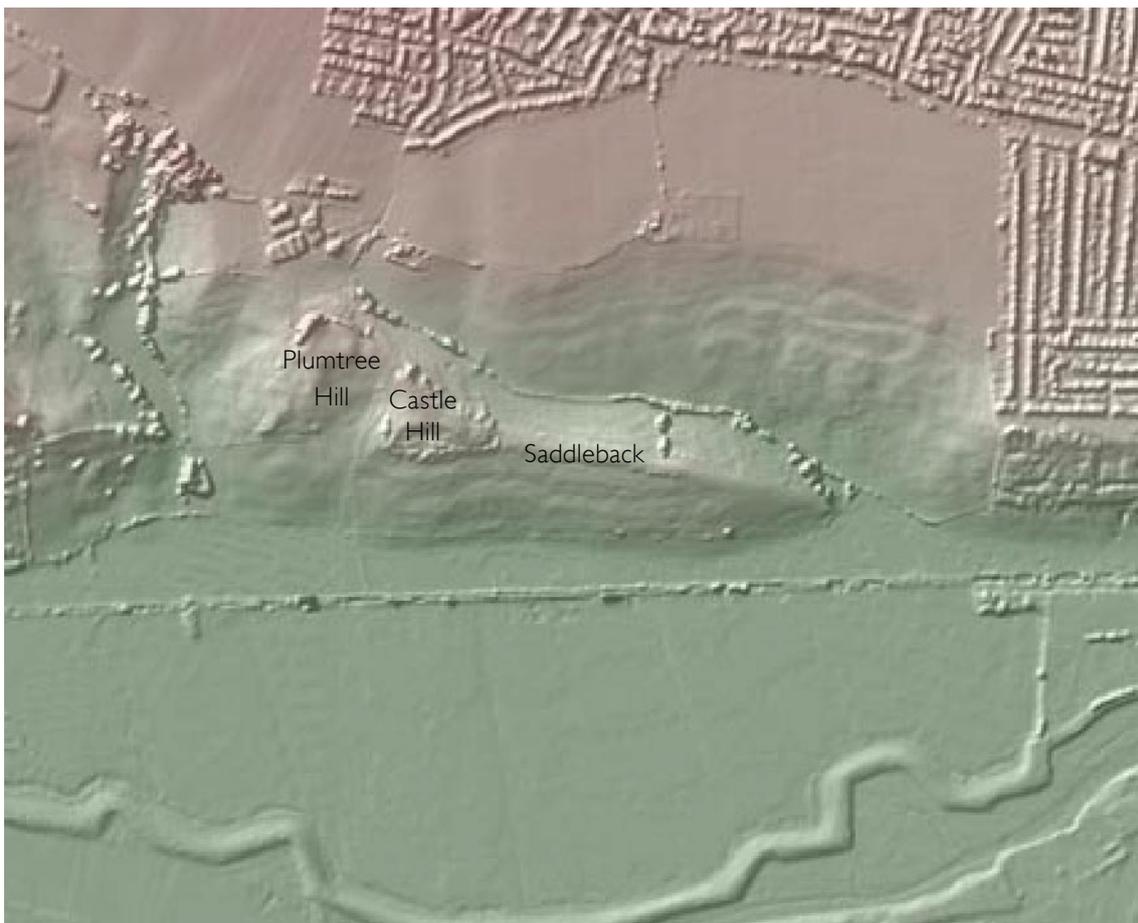
Figure 2 – Topography of the Hadleigh Castle area (based upon height data licensed to English Heritage for PGA, through Next Perspectives™.)

area (see front cover foreground, and Figure 2). The south curtain wall has collapsed and landslips displaced the north-east tower in the 1950s. Erosion and slippage continue today.

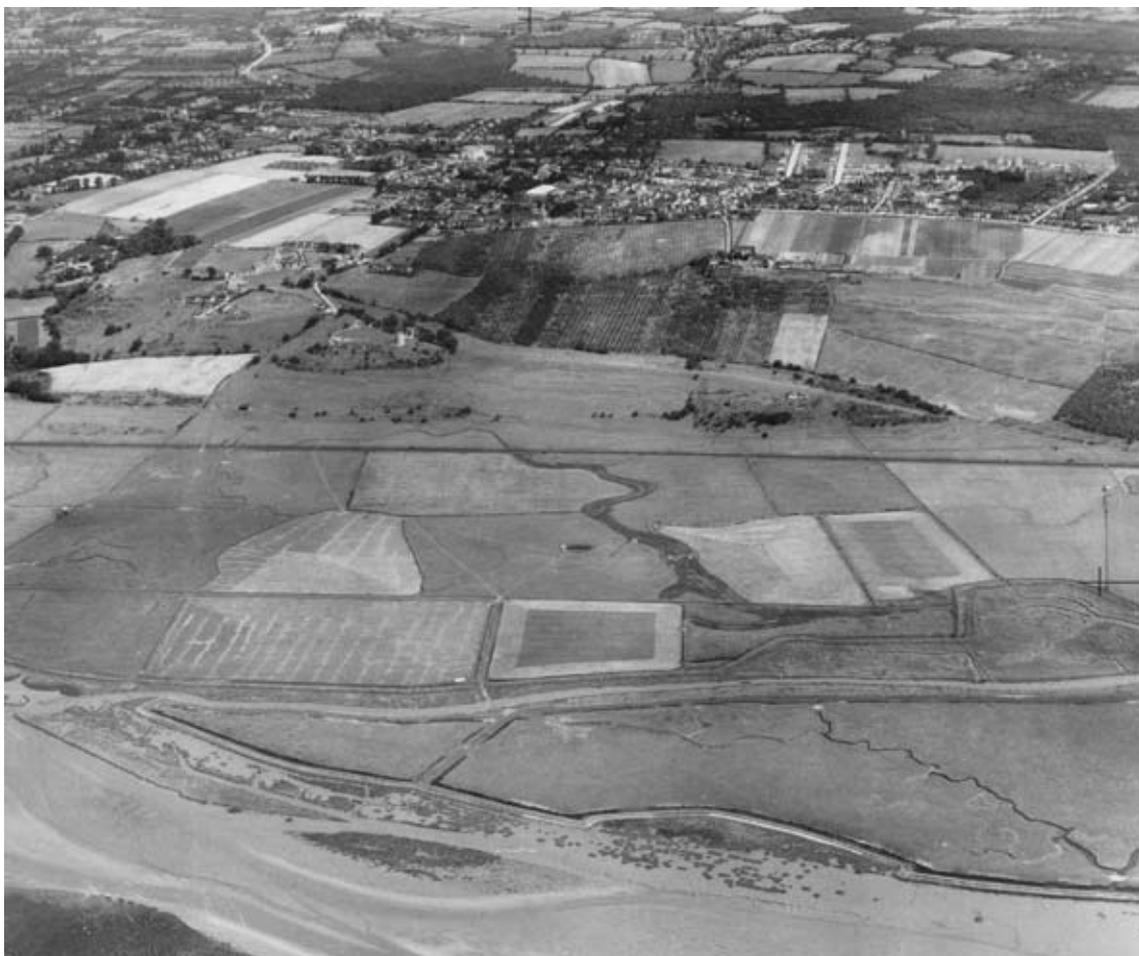
Figure 3 – Aerial photograph of Hadleigh Castle from the south (English Heritage (NMR) RAF Photography, MSO 31007 PO:2534 21 JULY 1940)

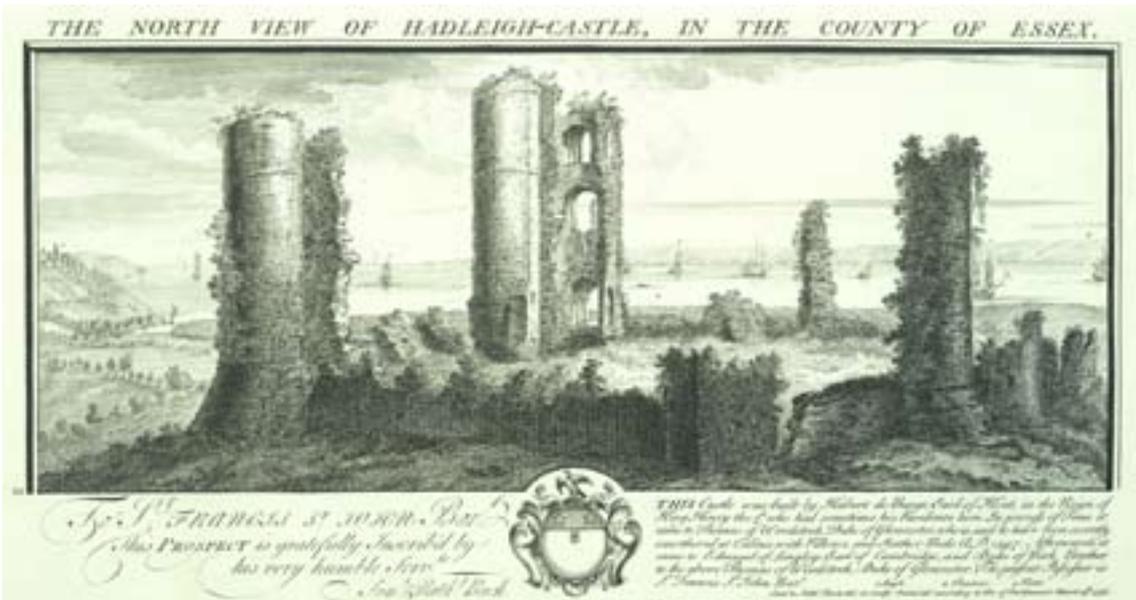
Figure 8 – Engraving of Hadleigh Castle by the Buck brothers, 1738
(Buck and Buck 1774, 92)

The Bucks' engraving of 1738, showing the castle from the north (Figure 8), bears a striking similarity to the anonymous, sketch of the castle dated 1735 (Figure 6) which may be an earlier version of the Buck view.

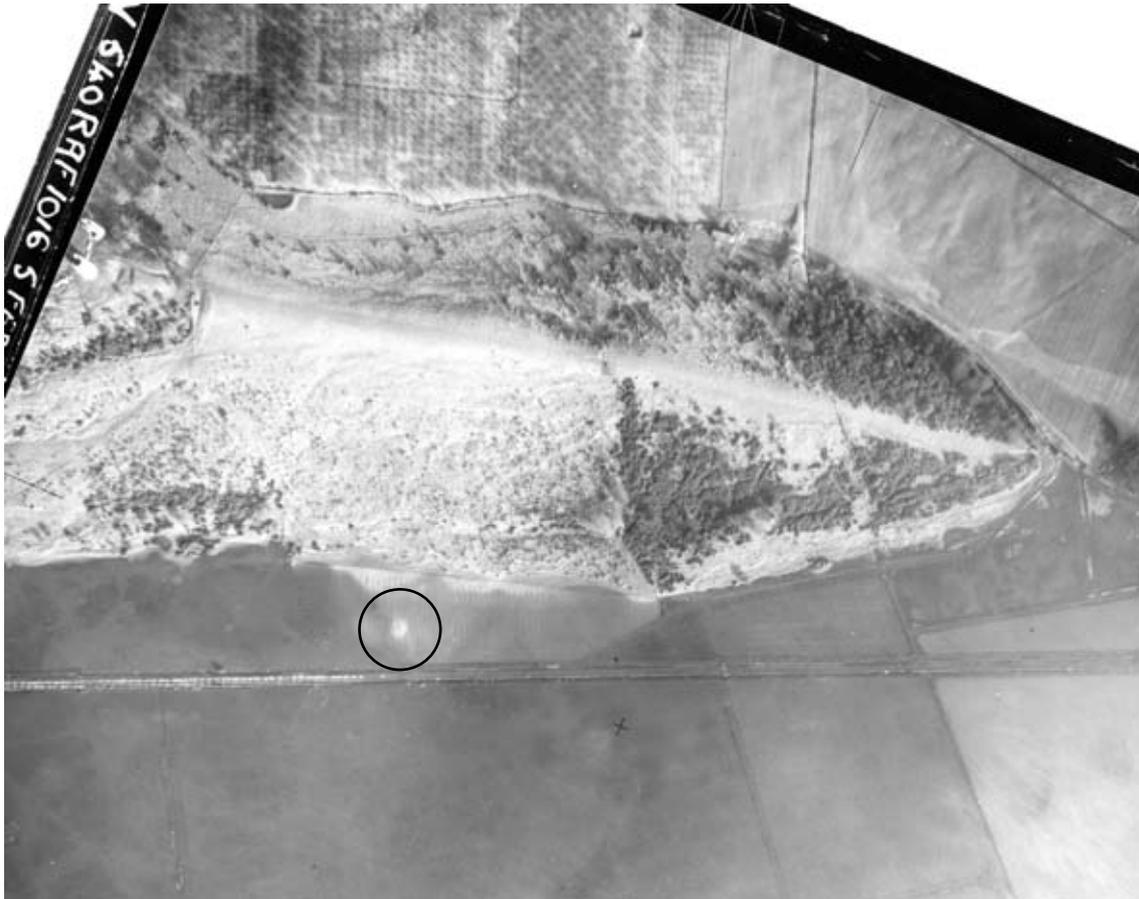
Figure 13 – Aerial photograph showing possible site of mill as pale raised area (circled)
(V540RAF1016 5 February 1953 0037)

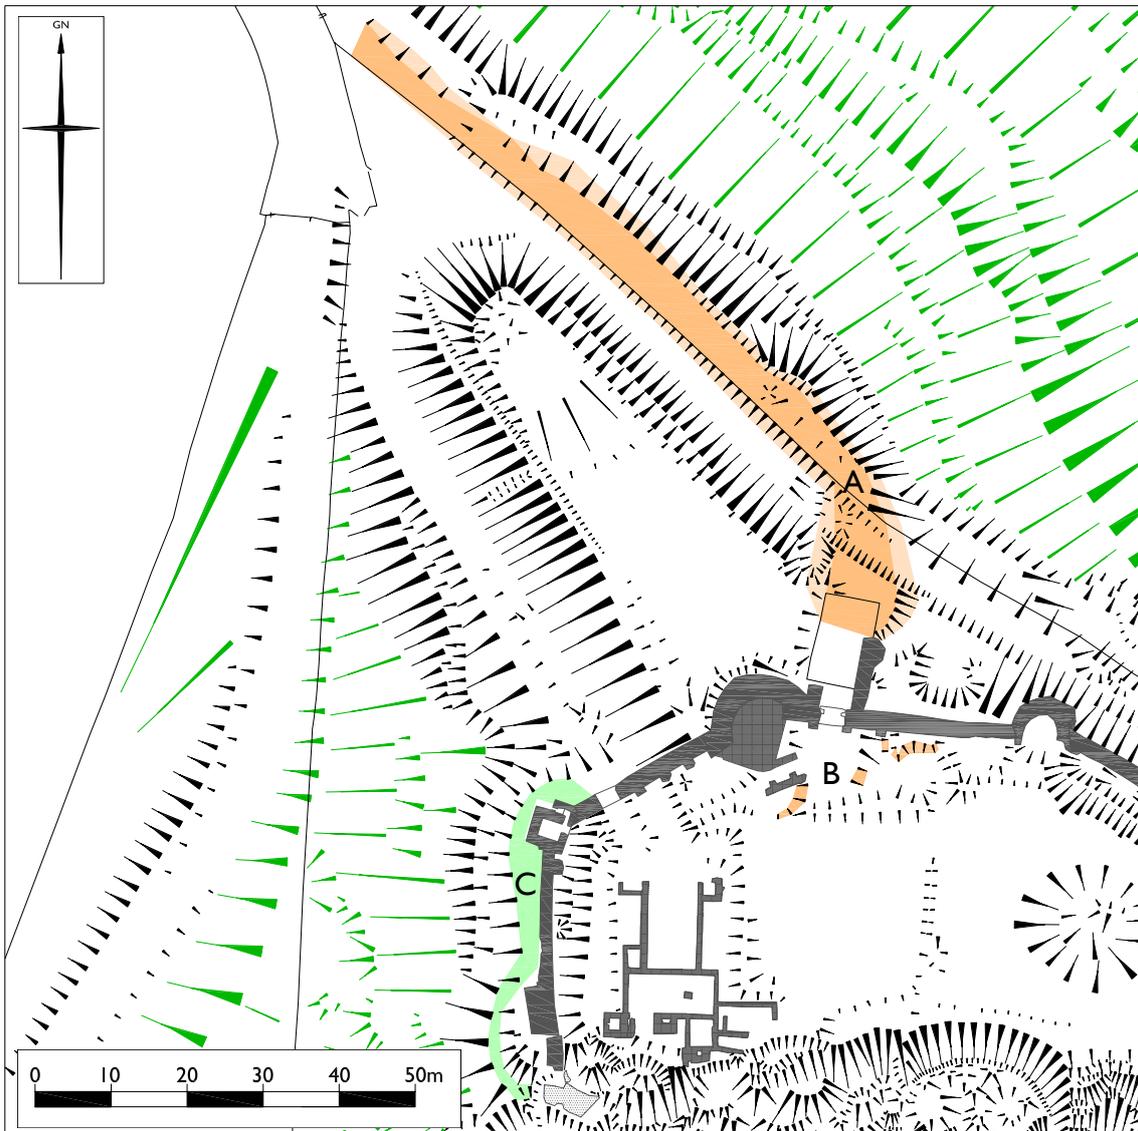
Figure 19 – Period 4 earthworks, west and north-west of the bailey (Extract from Figure 27. Letters refer to text, colour coding explained therein) © Crown Copyright and database right 2009. All rights reserved. Ordnance Survey Licence number 100019088

One of the last works to be undertaken was the construction of the new barbican on the north side of the castle (see 'Castle buildings' above). This was approached by a causeway from the north-west which turned sharply south and rose more steeply immediately in front of the barbican, presumably in order to hamper any direct attack on the gate (A on Figure 19 - shown in orange). This turn has, however, been somewhat eroded by the path running along the north side of the fence here and immediately in front of the barbican the causeway has been cut through, apparently relatively recently, presumably to allow easier access along the south side of the fence. The causeway is

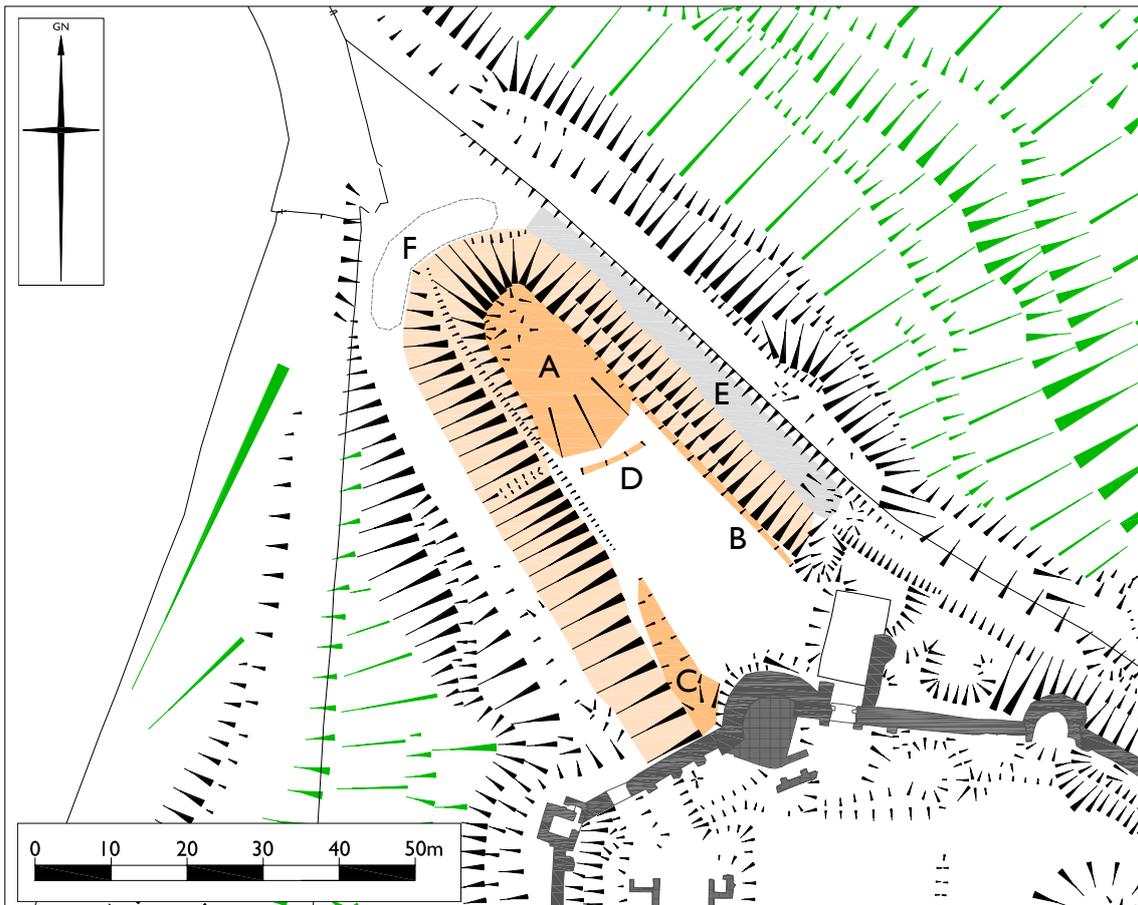
Figure 20 – Period 5 earthworks, north-west of the bailey (Extract from Figure 27. Letters refer to text, colour coding explained therein) © Crown Copyright and database right 2009. All rights reserved. Ordnance Survey Licence number 100019088

The large spur of land running away from the castle to the north-west must predate the castle as the curtain wall can be seen to rise up over it and the highest part of the bailey is in this area. It is most likely to be natural in origin but with its broad flat top and steep, relatively uniform sides it has clearly been sculpted into its present shape (shown as pale orange on Figure 20). When this occurred or if it was all of one period is uncertain. On its top there is some modern erosion around the base of the High Tower and in the area of the barbican, and at the north end some amorphous hollows and mounds are probably the remains of tree throws. Between these there are some earthworks that hint at possible structures (A on Figure 20 - shown in orange). The end of the spur appeared to have been built up slightly and along the top of the main north-east facing scarp was a second faint scarp set about 0.5m back from the edge which suggests a wall line here (B). A second wall line might be represented by the low bank seen at the south end of the spur running parallel to the south-west facing scarp above the current entrance to the castle (C). In the central area there were some other very faint features but these did not form a coherent pattern, apart from one scarp which ran across the spur about half way along its length (D). Taken together these suggest that the top of the spur may have had an outwork of some form on it but the slight earthworks suggest that if this was the case then it was either a short-lived structure, or cheaply built, or

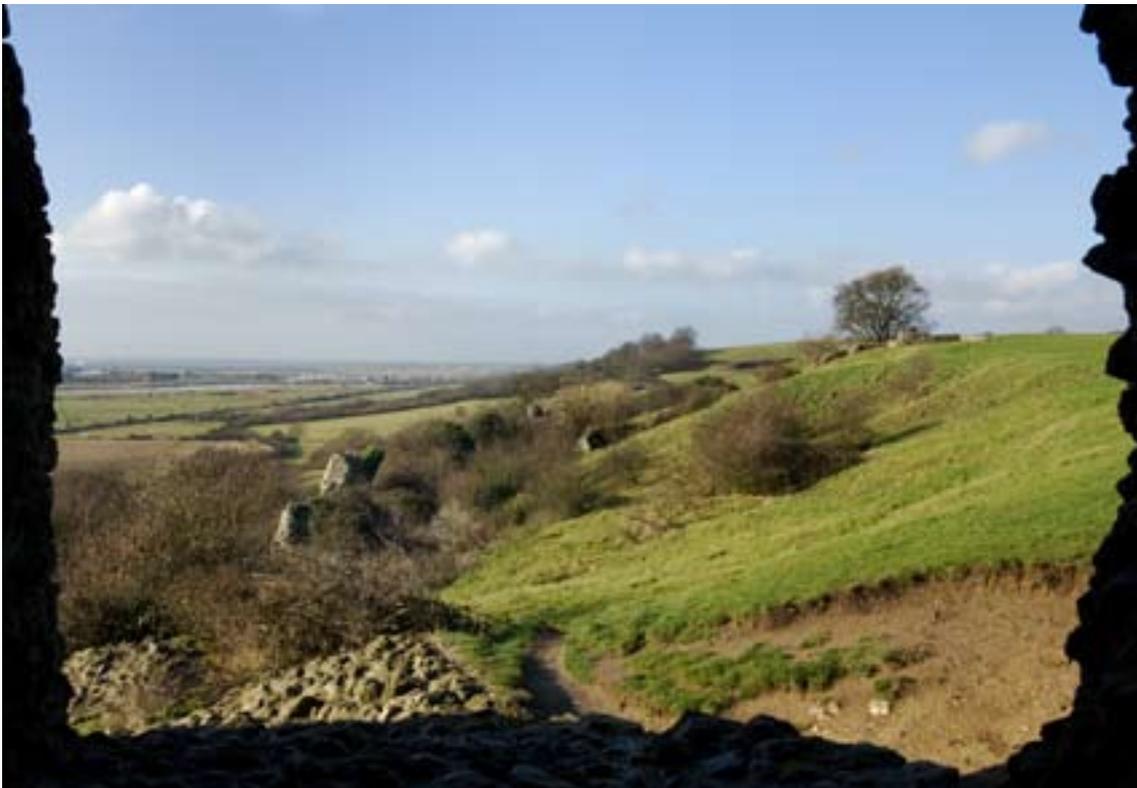
Figure 21 – Slumping on the south side of the bailey, from within the south east tower
(© EH - DP068090, photographer Patricia Payne)

The levelled bailey, retained by the southern curtain wall, survived intact until well into the 19th century. Constable's painting (Figure 10) and sketches based upon a visit made in 1814, show this, and King's commentary on his 1862 plan and report on his son's excavations of 1863 states that the external level adjacent to the South Tower was 12 feet below the bailey (King 1863, 86; King 1889, 72). It is not known exactly when the south curtain failed but it must have been after 1863. The first and second edition Ordnance Survey maps (1876 and 1898) show the apartments along the west end of the southern curtain wall as intact which the third and fourth editions do not. These two later editions (1923 and 1938) also show the line of the curtain wall in this area some way to the south of the former line suggesting that the first significant collapse, along this part of the south curtain wall at least, occurred between 1898 and 1923 (the collapsed area is shaded in green on Figure 22). The RCHME survey of 1923 shows the line of a collapse some way to the south of the current line and records that 'a landslide has carried practically the whole of the S. side of the bailey down the hill for a distance of about 40ft.' (RCHME 1923 64, 65). Several photographs also show the slip which appears to be fresh and still in progress (ibid, plates 64-5). A low level aerial photograph (CPE/ UK/2226 5029 15 August 1947) shows the southern curtain wall as considerably decayed

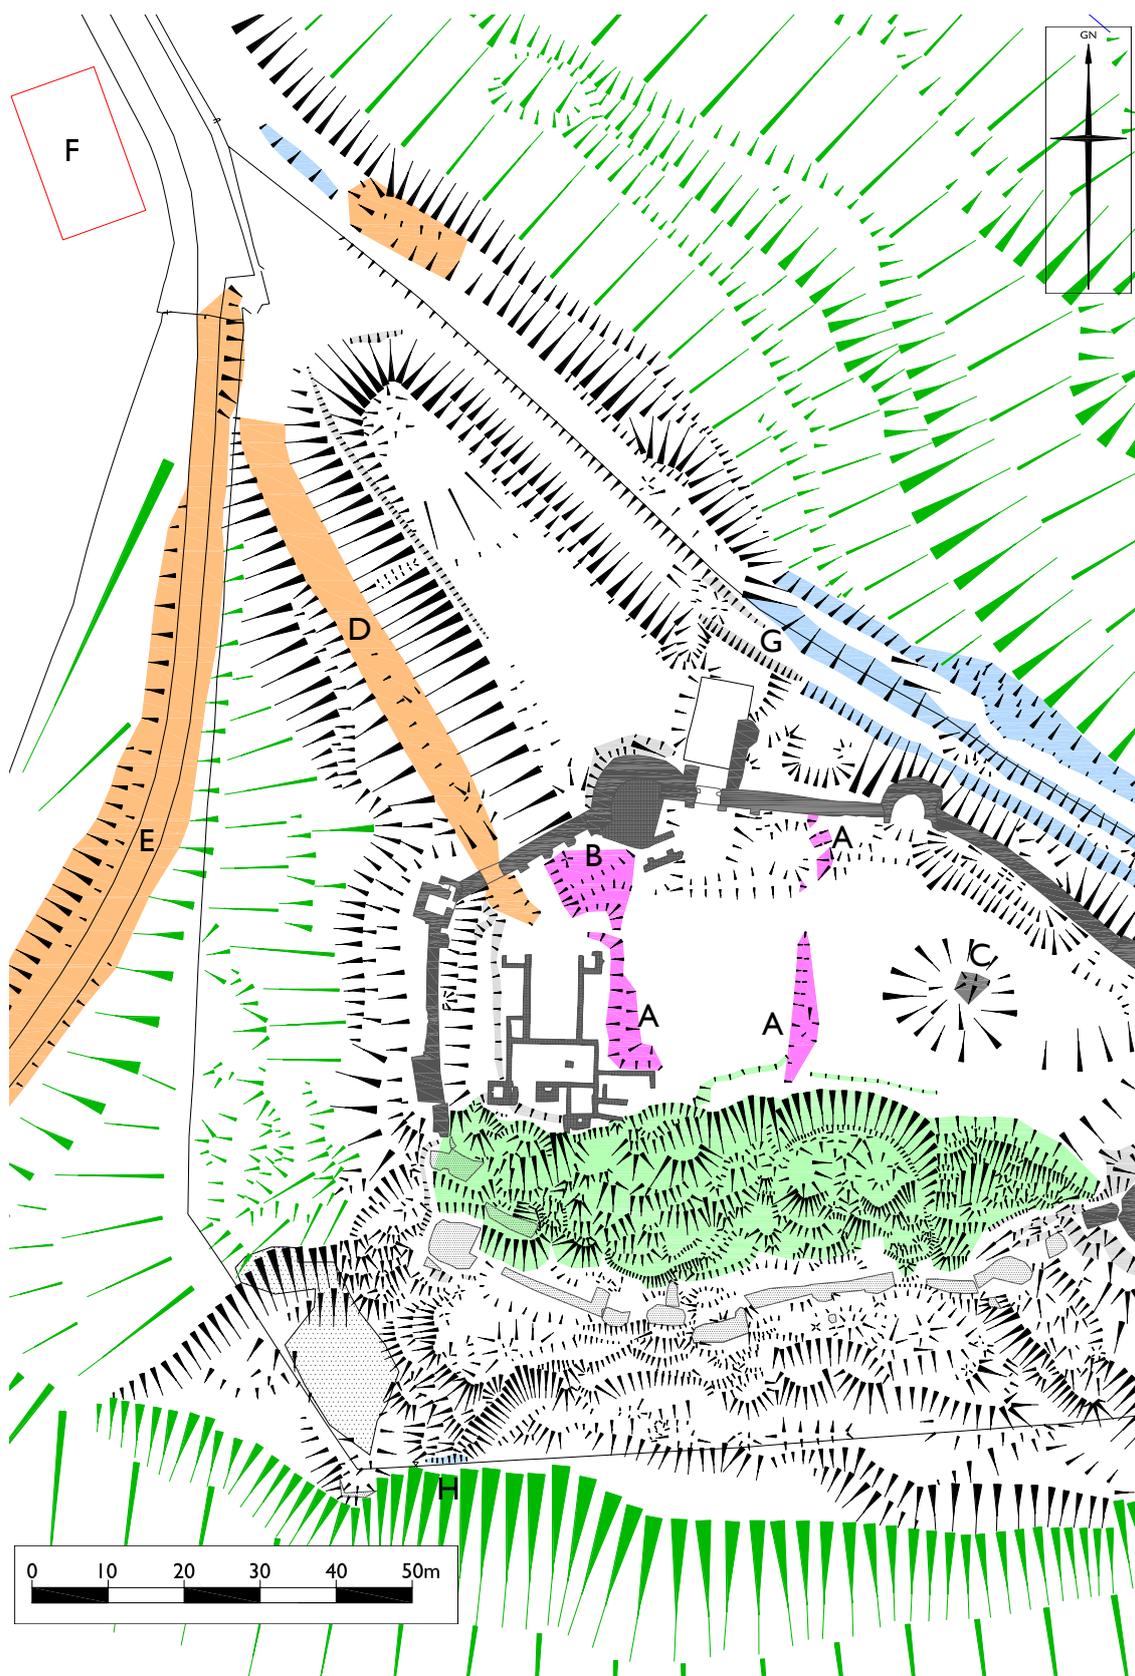
Figure 22 – Recent features (Extract from Figure 27. Letters refer to text, colour coding explained therein) © Crown Copyright and database right 2009. All rights reserved. Ordnance Survey Licence number 100019088

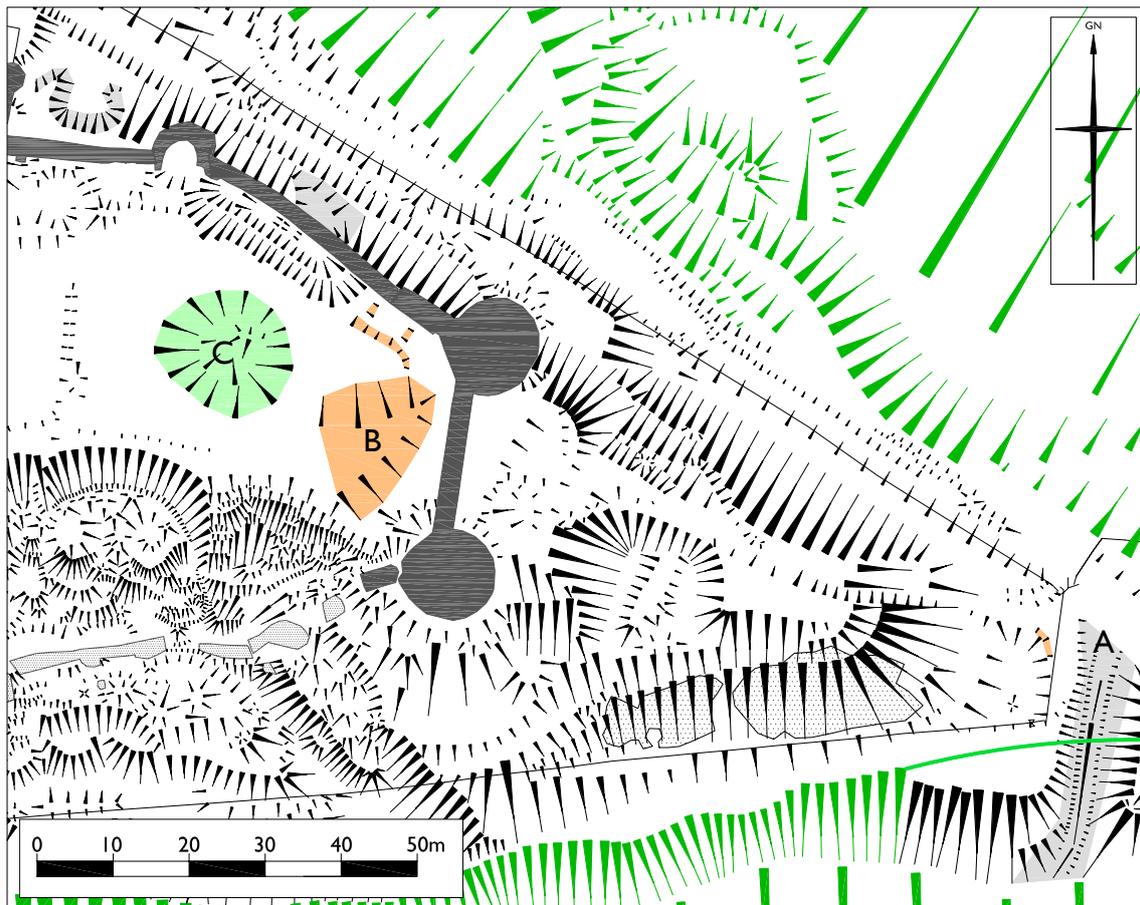
Figure 24 – Undated features (Extract from Figure 27. Letters refer to text, colour coding explained therein) © Crown Copyright and database right 2009. All rights reserved. Ordnance Survey Licence number 100019088

One feature of note is a single mass of masonry, measuring at least 4m by 4m, partly buried just outside the south-west corner of the fenced castle enclosure, about 35m
