# ST ANDREW'S CHURCH, ALWINGTON, DEVON TREE-RING ANALYSIS OF TIMBERS FROM THE SOUTH AISLE AND NAVE ROOFS

SCIENTIFIC DATING REPORT

Alison Arnold and Robert Howard

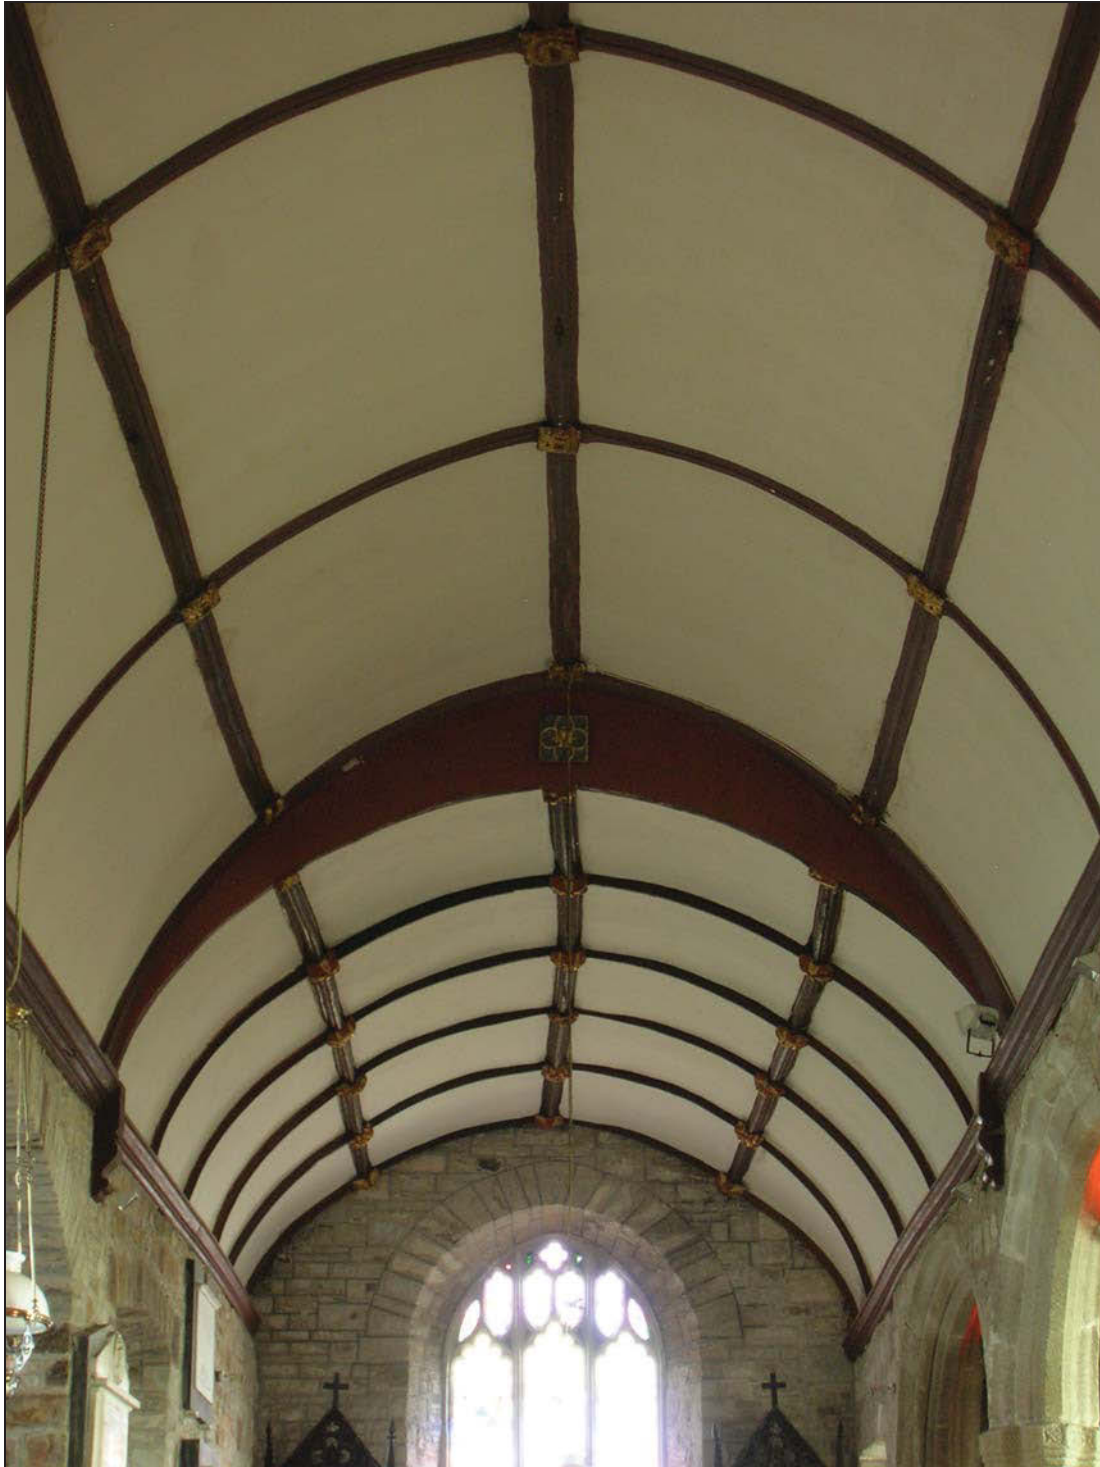
*Figure 4: Nave and chancel ceiling (photograph taken facing east)*

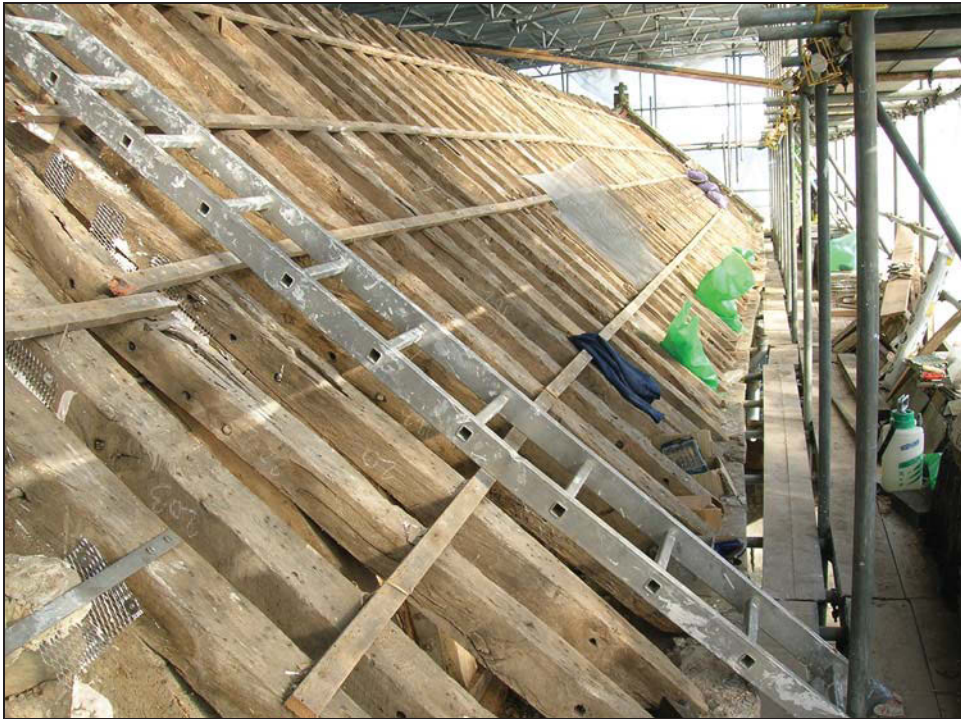
*Figure 5: South aisle roof structure*

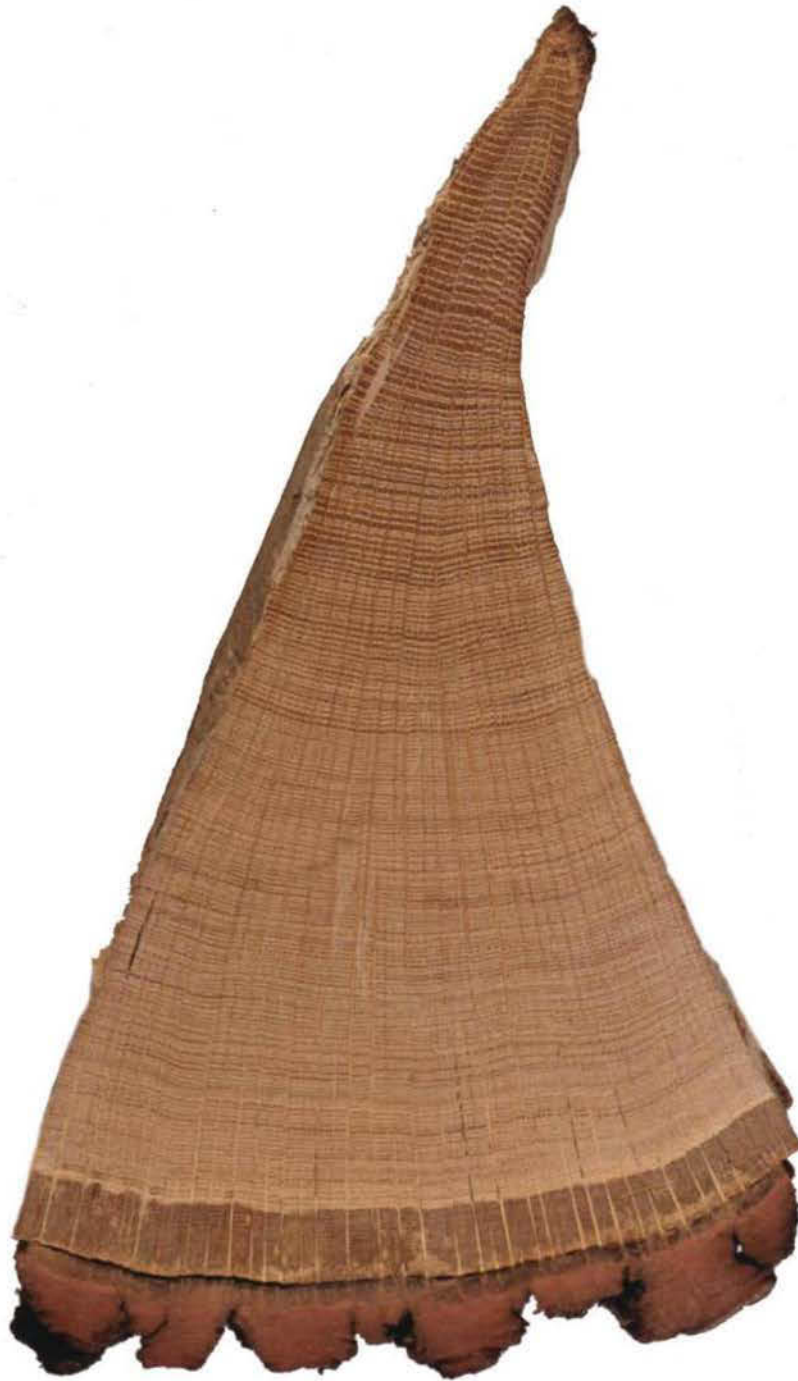
*Figure A1: A wedge of oak from a tree felled in 1976. It shows the annual growth rings, one for each year from the innermost ring to the last ring on the outside just inside the bark. The year of each ring can be determined by counting back from the outside ring, which grew in 1976*

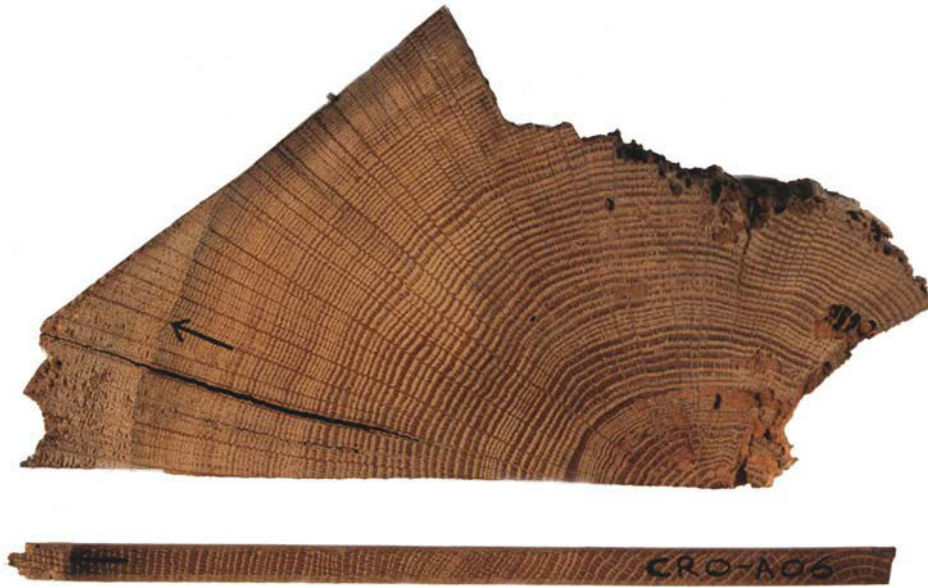
*Figure A2: Cross-section of a rafter, showing sapwood rings in the left-hand corner, the arrow points to the heartwood/sapwood boundary (H/S); and a core with sapwood; again the arrow is pointing to the H/S. The core is about the size of a pencil*

Quite often some, though not all, of the original outer rings are missing on a timber. The outer rings on an oak, called sapwood rings, are usually lighter than the inner rings, the heartwood, and so are relatively easy to identify. For example, sapwood can be seen in the corner of the rafter and at the outer end of the core in Figure A2, both indicated by arrows. More importantly for dendrochronology, the sapwood is relatively soft and so liable to insect attack and wear and tear. The builder, therefore, may remove some of the sapwood for precisely these reasons. Nevertheless, if at least some of the sapwood rings are left on a sample, we will know that not too many rings have been lost since felling so that the date of the last ring on the sample is only a few years before the date of the original last ring on the tree, and so to the date of felling.

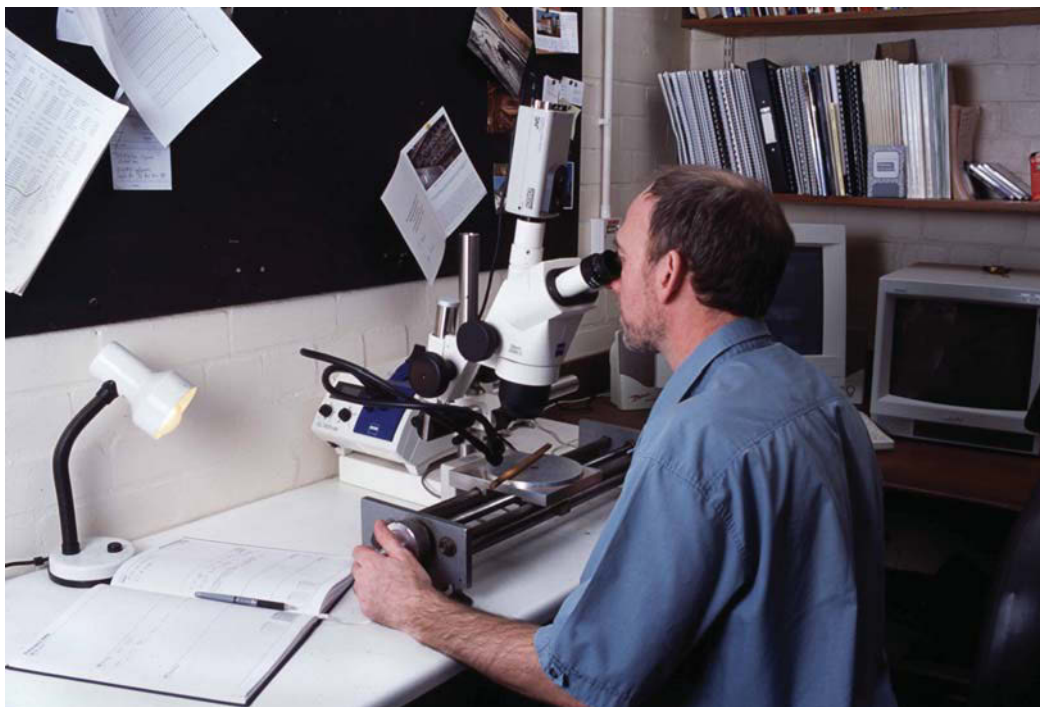
*Figure A3: Measuring ring widths under a microscope. The microscope is fixed while the sample is on a moving platform. The total sequence of widths is measured twice to ensure that an error has not been made. This type of apparatus is needed to process a large number of samples on a regular basis*

**2. Measuring Ring Widths.** Each core is sanded down with a belt sander using medium-grit paper and then finished by hand with flourgrade-grit paper. The rings are then clearly visible and differentiated from each other with a result very much like that shown in Figure A2. The core is then mounted on a movable table below a microscope and the ring-widths measured individually from the innermost ring to the outermost. The widths are automatically recorded in a computer file as they are measured (see Fig A3).

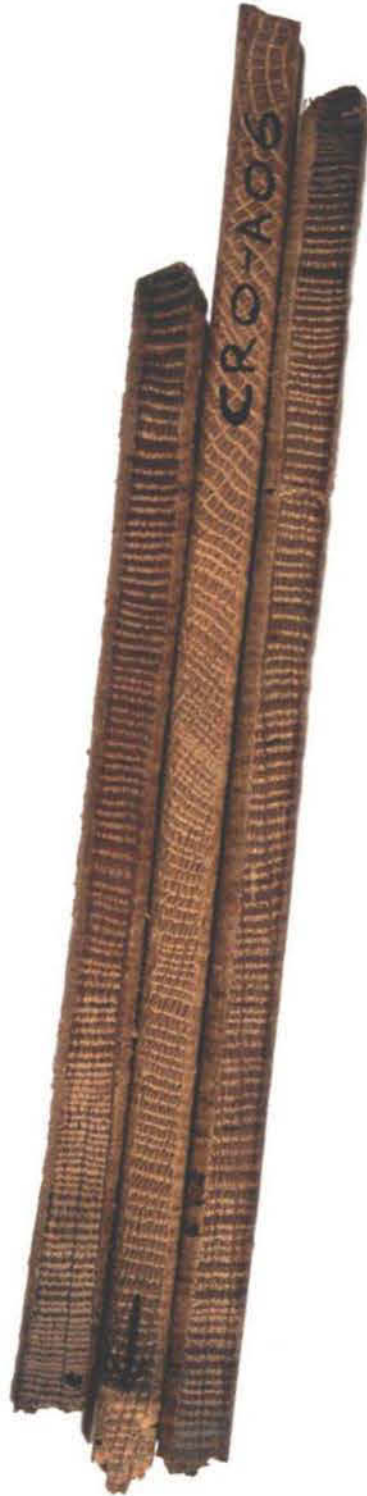
*Figure A4: Three cores from timbers in a building. They come from trees growing at the same time. Notice that, although the sequences of widths look similar, they are not identical. This is typical*
