# ST MARY'S, FELTWELL, NORFOLK TREE-RING ANALYSIS OF TIMBERS

SCIENTIFIC DATING REPORT

**ST MARY'S CHURCH,  
FELTWELL,  
NORFOLK**

**TREE-RING ANALYSIS OF TIMBERS**

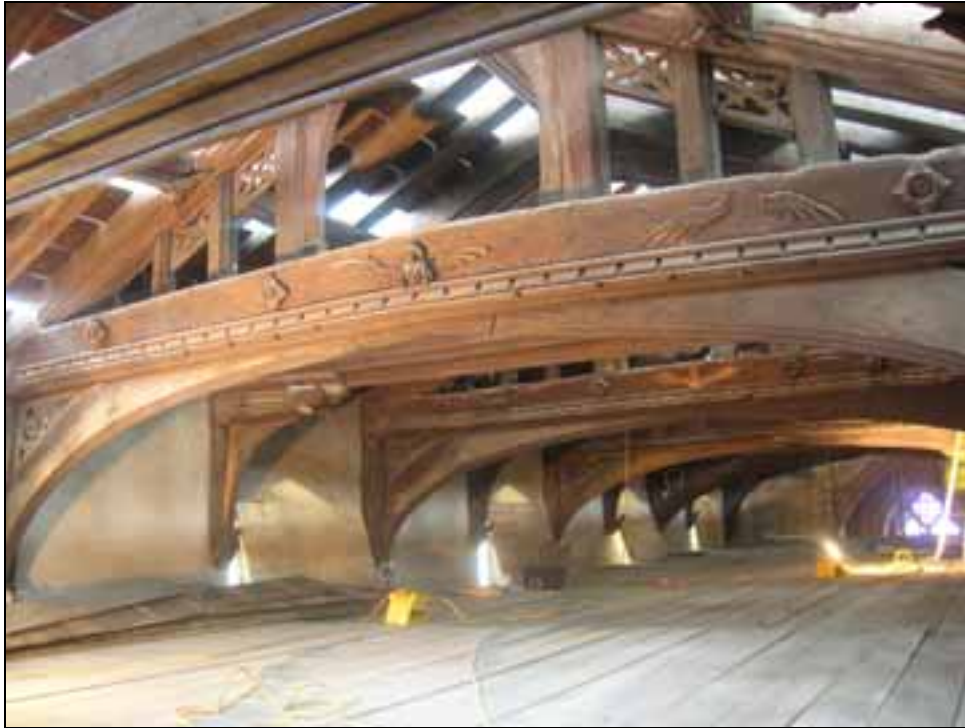
*Figure 4: Nave roof; principal truss 3 in the foreground*

This is of 11 trusses; major and intermediary ones with roll-moulded tiebeams on arched braces and wall posts to corbels. The corbels to the north are thought to be nineteenth-century, and those to the south, fifteenth-century angel figures. The major trusses have pierced spandrels and queen-post struts to moulded principals (Fig 4). The tiebeams of the intermediate trusses are supported on shorter arched braces with the figure of an angel on each side (Fig 5). There is one set of moulded butt purlins to each side and a ridge piece. This roof was thought to date to the fifteenth century ([www.imagesofengland.org.uk](http://www.imagesofengland.org.uk)).

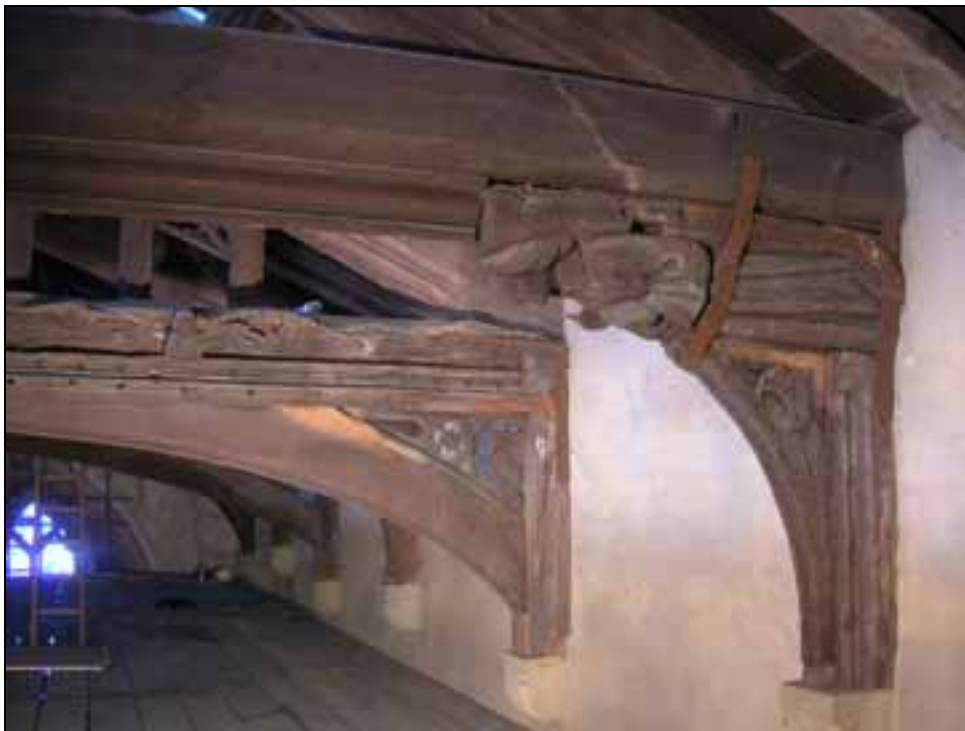
*Figure 5: Nave roof; intermediary truss 6*

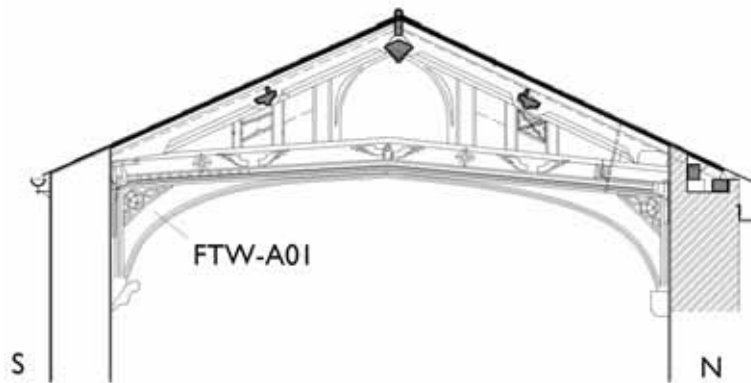
*Figure 7: East elevation of principal truss 1 (based on truss 11), showing the location of sample FTW-A01 (Freeland Rees Roberts Architects)*

A total of 24 timbers was sampled. Each sample was given the code FTW-A (for Feltwell) and numbered 01–24. The location of samples was noted at the time of sampling and has been marked on Figures 6–16. Further details relating to the samples can be found in Table 1. Trusses and bays followed the numbering on the architect's survey drawings from east to west.

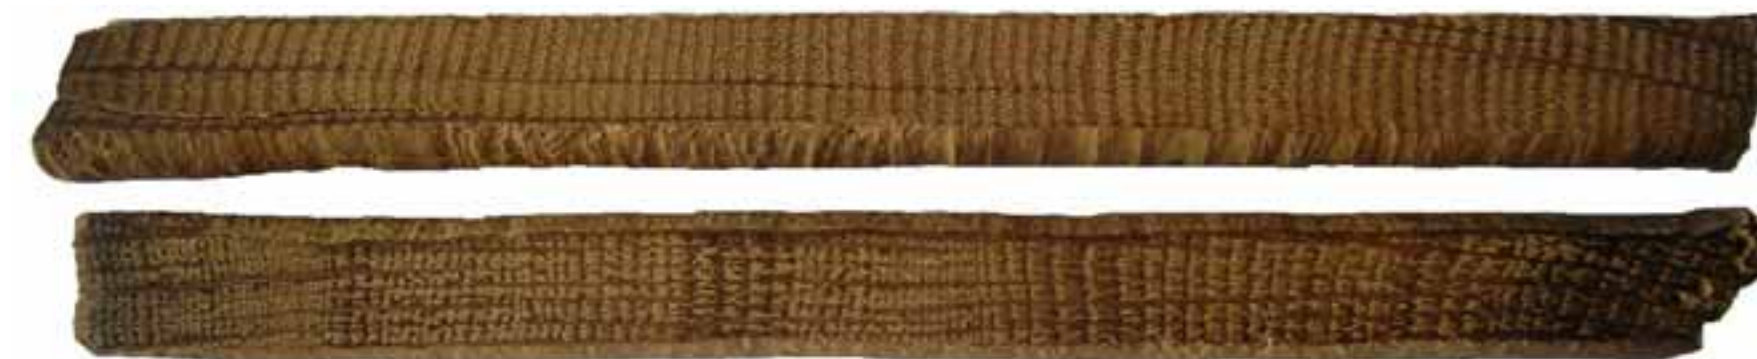
Figure 19: Superficially the samples fell into two groups, the first (upper sample) where the growth rings appeared to be more regular and generally evenly spaced and the second (lower sample) where they were more varied

Once on site, an initial examination of the timbers was undertaken. At this stage there appeared to be a marked difference in the growth pattern of the timbers used within the construction of the roof, with the timbers falling into two distinct groups. After discussion with the Scientific Dating Section at English Heritage, it was decided to sample each group of timbers as if they were a separate phase. It was hoped that this course of action would give a greater chance for success if there did prove to be a difference in date and/or origin.

The potential differences in timber date and/or source suggested by the surface examination did not materialise upon analysis. Despite the superficial differences in growth patterns exhibited by the samples (Fig 19), the analysis points towards a coherent group of timbers being utilised in the construction of the roof. The intra-site matching of samples is good, with a number of samples grouping at values in excess of  $t=7$  and the possibility of at least one same tree match at  $t=15.8$  between two stud posts from truss 11 (FTW-A23 and FTW-A24). It would appear that the difference in appearance is simply a characteristic of these trees.

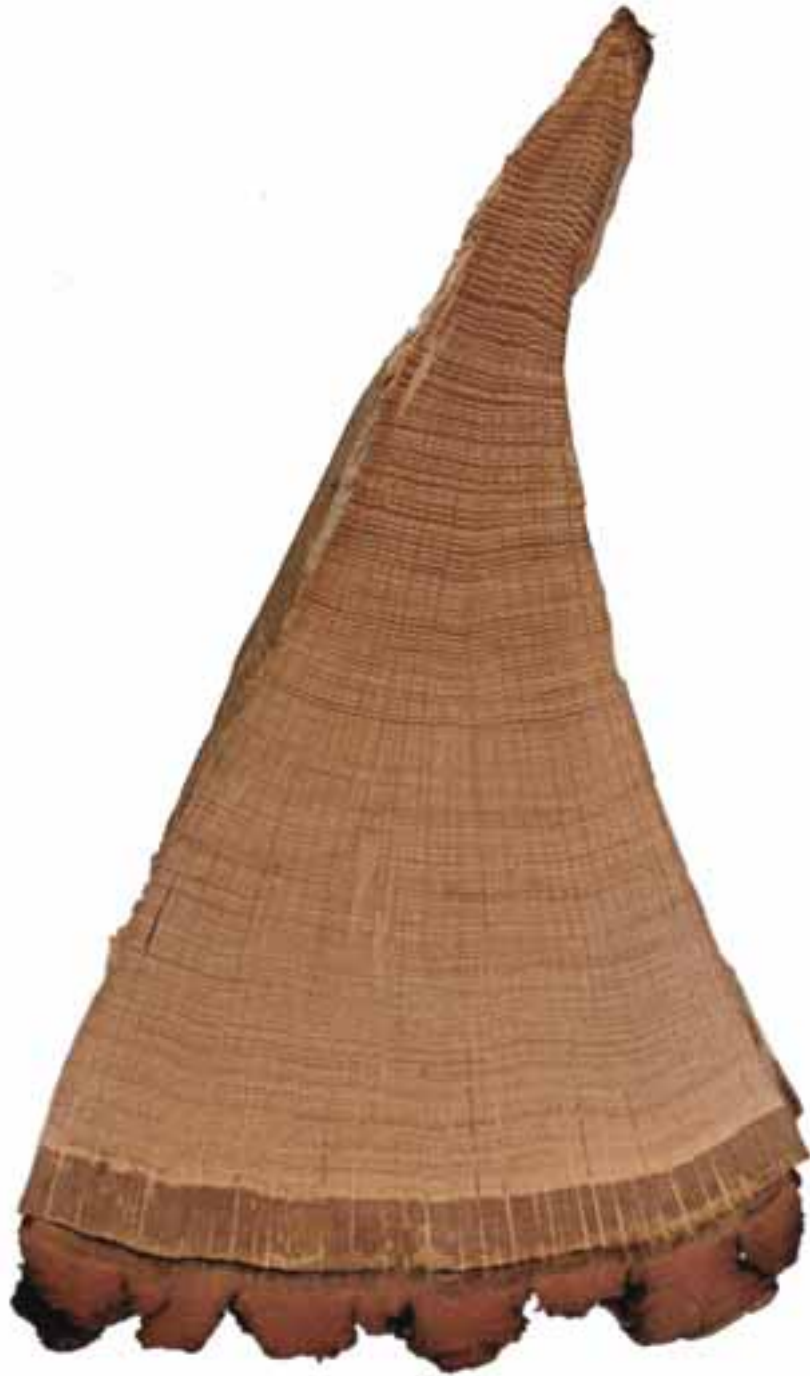
*Figure A1: A wedge of oak from a tree felled in 1976. It shows the annual growth rings, one for each year from the innermost ring to the last ring on the outside just inside the bark. The year of each ring can be determined by counting back from the outside ring, which grew in 1976*

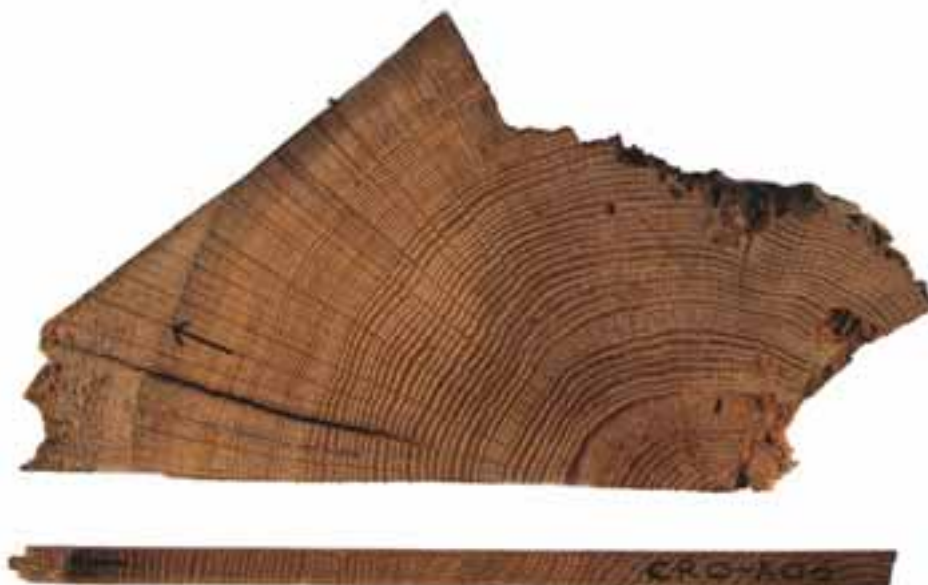
*Figure A2: Cross-section of a rafter, showing sapwood rings in the left-hand corner, the arrow points to the heartwood/sapwood boundary (H/S); and a core with sapwood; again the arrow is pointing to the H/S. The core is about the size of a pencil*

Quite often some, though not all, of the original outer rings are missing on a timber. The outer rings on an oak, called sapwood rings, are usually lighter than the inner rings, the heartwood, and so are relatively easy to identify. For example, sapwood can be seen in the corner of the rafter and at the outer end of the core in Figure A2, both indicated by arrows. More importantly for dendrochronology, the sapwood is relatively soft and so liable to insect attack and wear and tear. The builder, therefore, may remove some of the sapwood for precisely these reasons. Nevertheless, if at least some of the sapwood rings are left on a sample, we will know that not too many rings have been lost since felling so that the date of the last ring on the sample is only a few years before the date of the original last ring on the tree, and so to the date of felling.

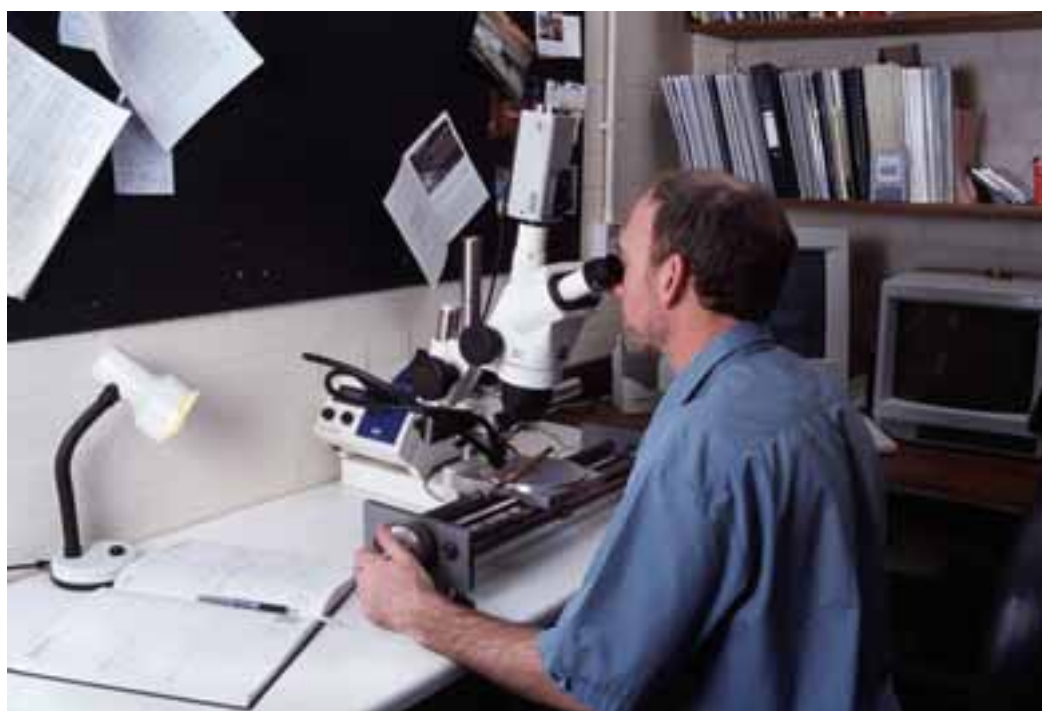
*Figure A3: Measuring ring widths under a microscope. The microscope is fixed while the sample is on a moving platform. The total sequence of widths is measured twice to ensure that an error has not been made. This type of apparatus is needed to process a large number of samples on a regular basis*

**2. Measuring Ring Widths.** Each core is sanded down with a belt sander using medium-grit paper and then finished by hand with flourgrade-grit paper. The rings are then clearly visible and differentiated from each other with a result very much like that shown in Figure A2. The core is then mounted on a movable table below a microscope and the ring-widths measured individually from the innermost ring to the outermost. The widths are automatically recorded in a computer file as they are measured (see Fig A3).

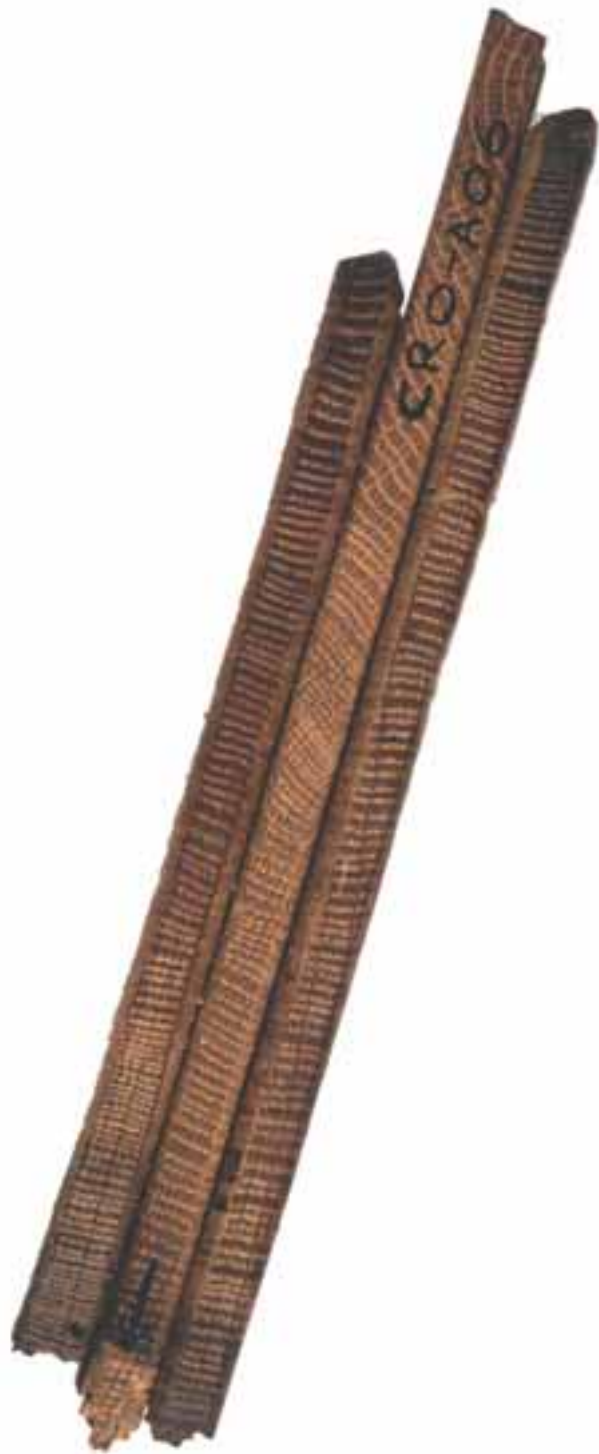
*Figure A4: Three cores from timbers in a building. They come from trees growing at the same time. Notice that, although the sequences of widths look similar, they are not identical. This is typical*
