# STRATTON PARK MOATED ENCLOSURE, STRATTON, BIGGLESWADE, BEDFORDSHIRE A LANDSCAPE SURVEY AND INVESTIGATION SURVEY REPORT

**A Landscape Survey and Investigation**

NGR: NGR TL 2070 4376

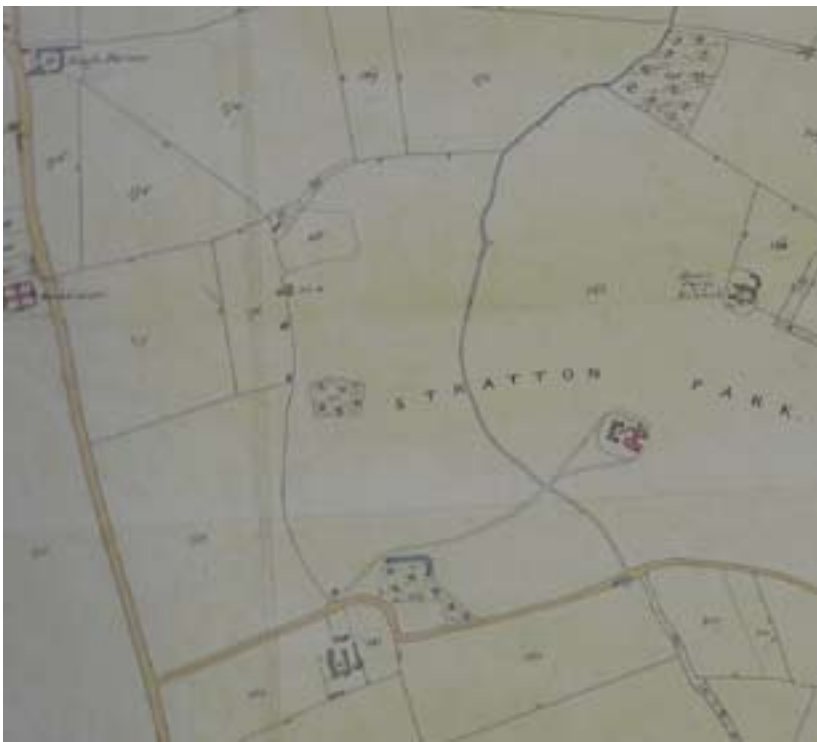
Figure 4: Extract of 1838 Tithe Map

Bryant's map of 1826 depicts the complete circuit of the walled garden but the moated enclosure is absent and it is only partly depicted on the Tithe Map dating to 1838 (MAT 5/1) (Figure 4). On this, Stratton Park and House are evident but the area of the moat is shown as a wooded area with just a water-filled northern arm depicted. It may well be that at the time of survey, the rest of the moat was dry, infilled or simply too inaccessible due to overgrown vegetation. The walled garden is, again, formally depicted on the Tithe Map and the Award describes the area of the moat as being a garden and orchard.

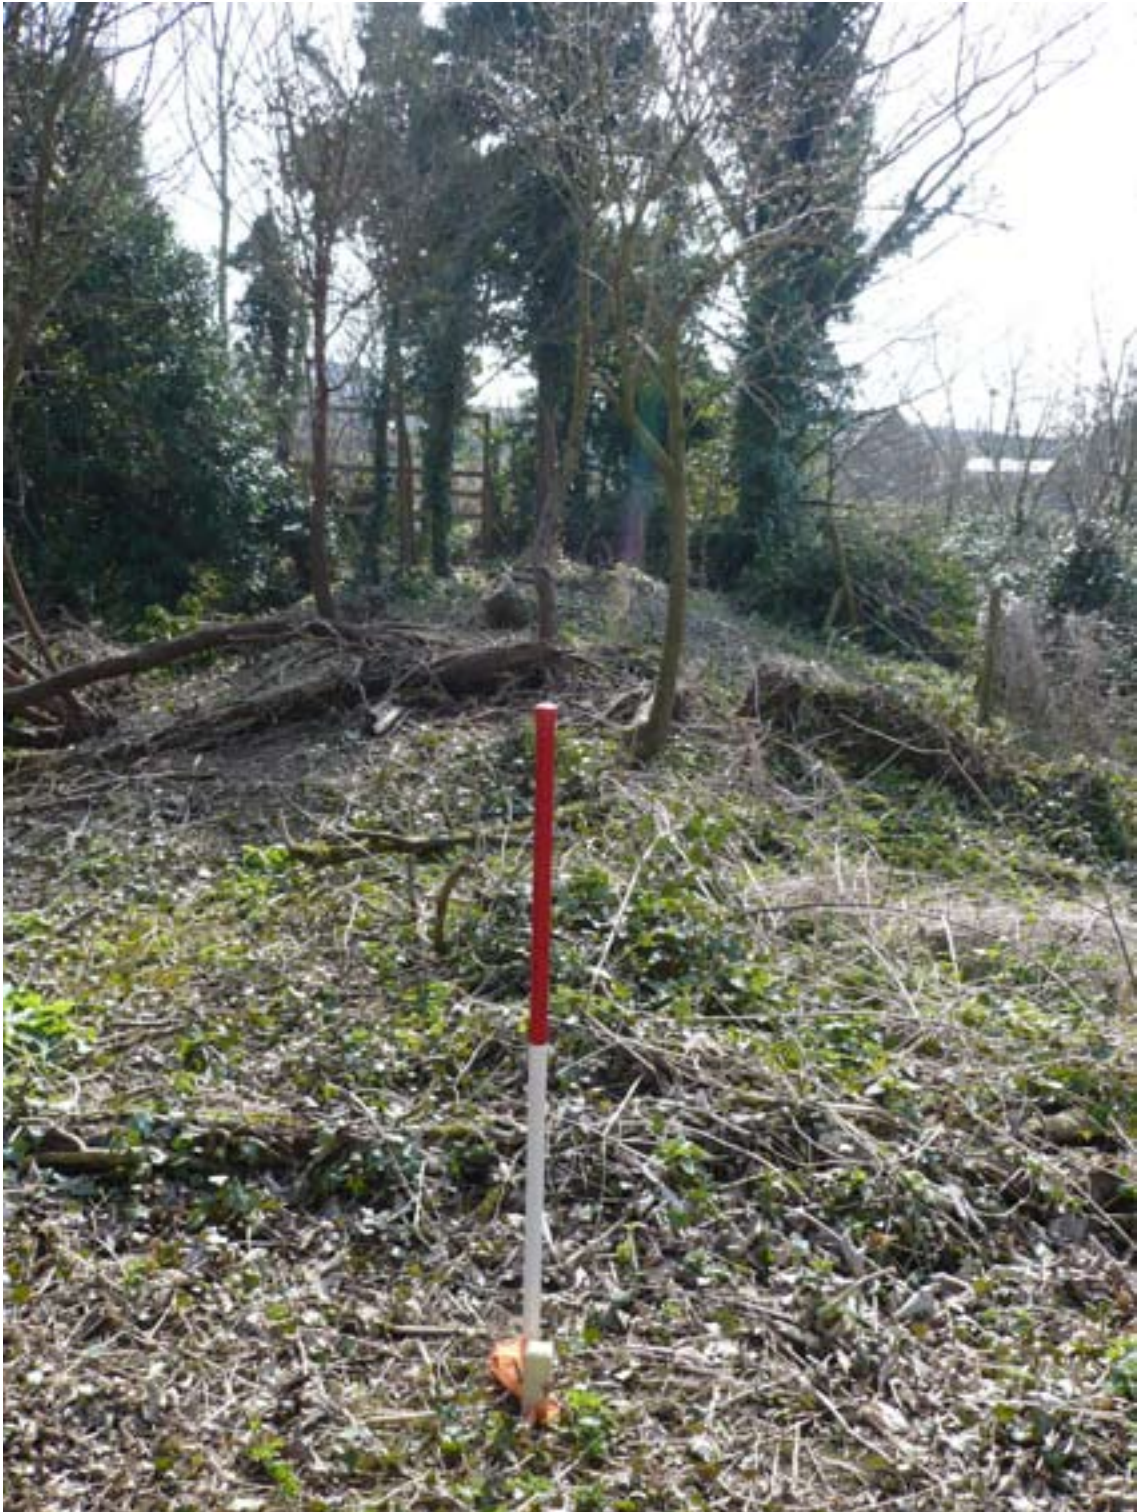
*Plate 1: View, looking to the south, along the crest of the counterscarp bank on the western side of the enclosure © David McOmish*

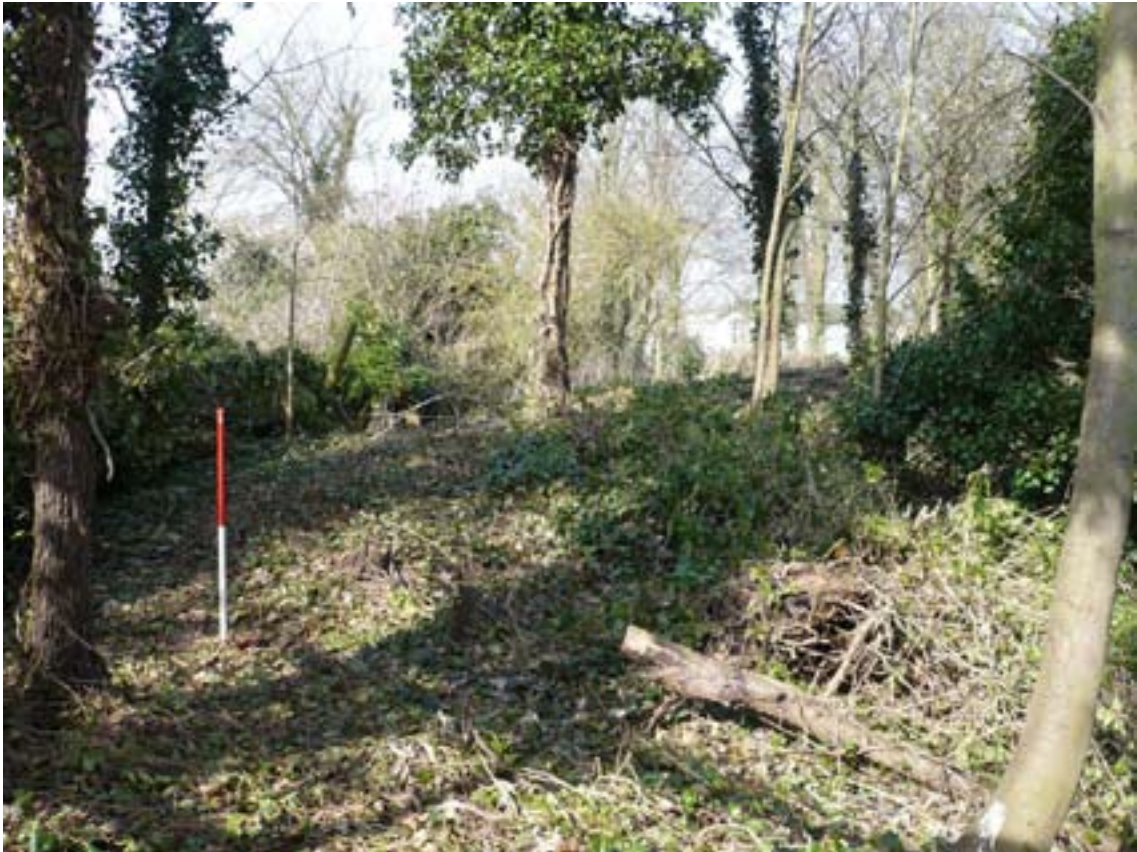
*Plate 2: The remains of a slight ledge, presumably a negative lynchet resulting from cultivation to the west, can be seen close to the south-western corner of the counterscarp bank © David McOmish*

flank, however, and it may well be that the form of earthworks recorded has been heavily altered by the impact of later cultivation to the west of the enclosure. Slight traces of ridge-and-furrow cultivation were noted here, with the ridges set perpendicularly to the axis of the counterscarp. Indeed, it is plausible that the apparent sequencing noted with the counterscarp bank is, in fact, an artefact of later cultivation: ploughing impacting and eroding the form of the bank: the bank may well have been used as a headland within this later field layout (Plate 2).

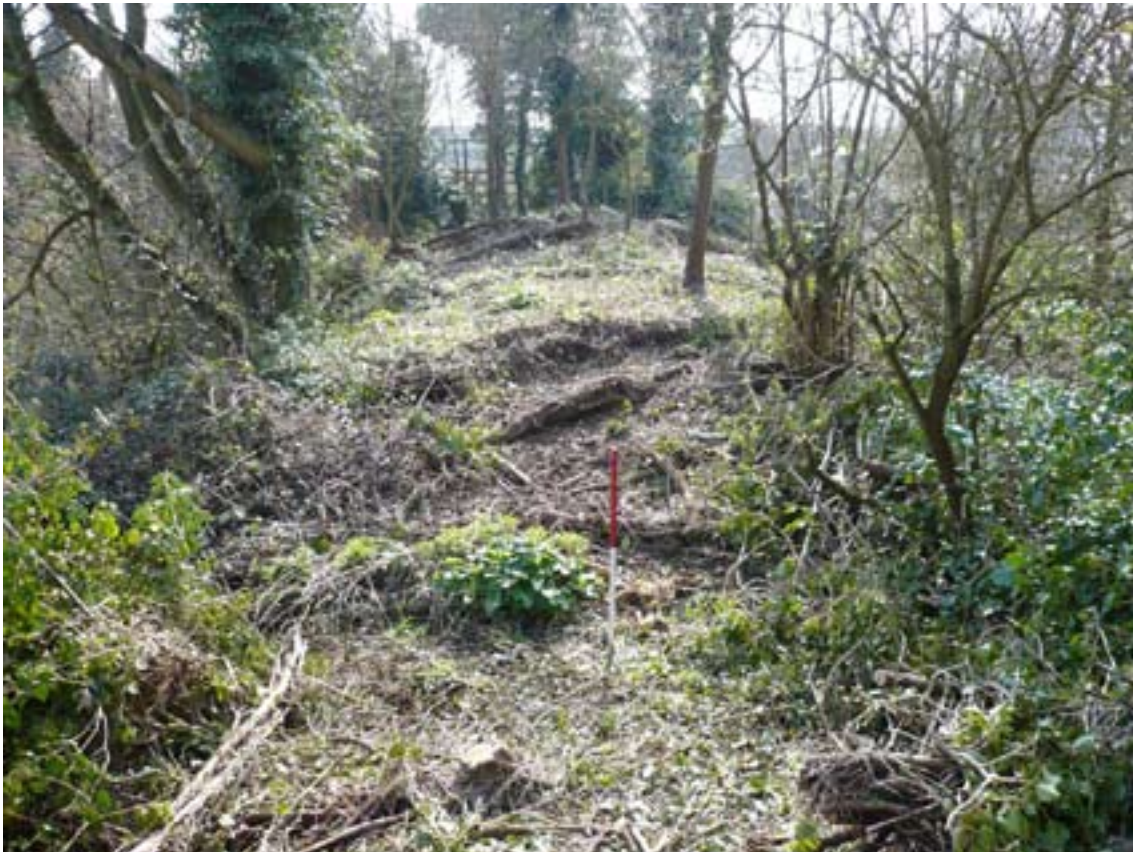
Plate 3: The original entrance to the moated enclosure, close to the midpoint on the western flank © David McOmish

The breach between the two segments is noticeably wide, well developed and has the appearance of a formal interruption (Plate 3 and Figure 9).

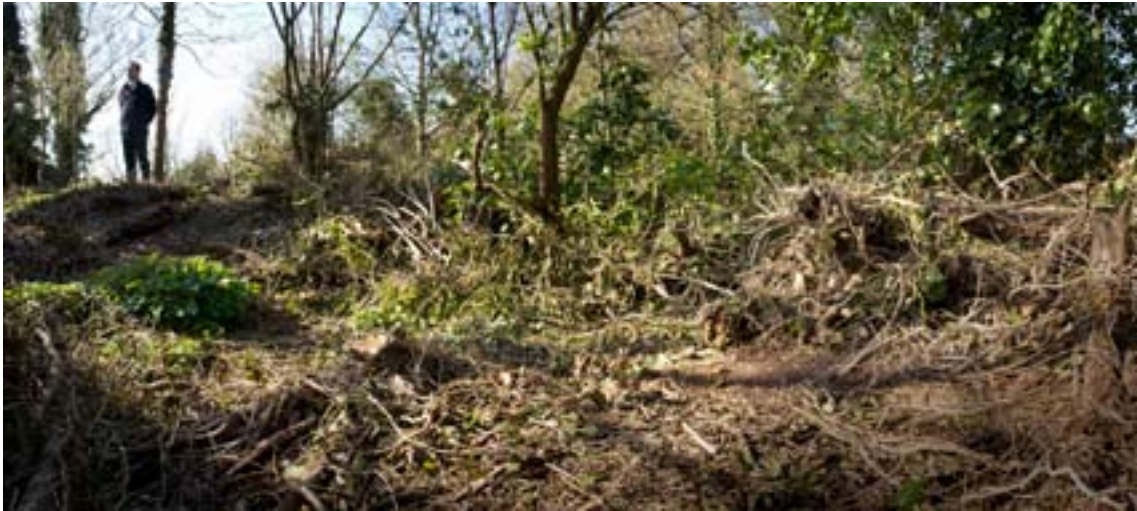
*Plate 4: The hollowed approach track to the western entrance is deeply buried in dense undergrowth and recently cleared scrub © Alun Bull*

Nonetheless, the form of the trackway is clear and consists of a spread bank 0.4m high and 6.0m wide extending perpendicularly from the southern terminal of the counterscarp gap. The bank is flanked on the north by a shallow but flat-bottomed track, 0.3 deep and 5.5m wide, the northern side of which extends from the northern terminal of the counterscarp bank. It is clear that this gap and hollow way are part of an earlier, formal, entrance to the moated enclosure replaced, subsequently, by the causeway built close to the south-western corner. If correct it obviously implies that the earlier entranceway was connected to the central platform via a bridge or timber structure and it is suggested here that the sharply defined ledge noted immediately to the west of the gap was part of the constructional layout of the bridge; it may well have provided level ground for a timber bridge support or, even, hosted a timber gateway.

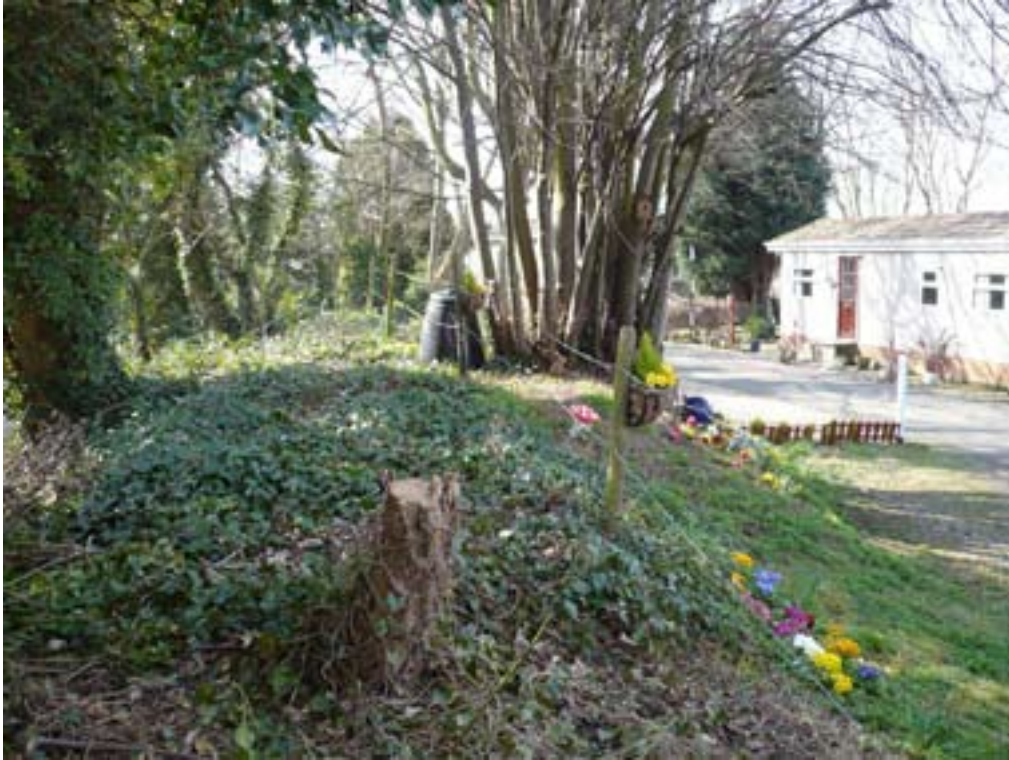
*Plate 5: The counterscarp bank on the north-facing flank is well preserved but in places it has been used as a dumping ground for later building detritus © David McOmish*

The counterscarp bank along the northern side of the moat, although still largely mirroring the form on the west, has been heavily altered by later activity (Plate 5). Vegetation cover prohibited survey at the north-western apex but it would appear from those remains visible that the substantially heightened elements noted further to the south, especially in the area of the earlier entrance, are not universally present. Indeed, from the corner and eastwards, the outer scarp of the counterscarp bank has been truncated and re-modelled due to the construction of narrow garden terraces as well as the creation of small parking bays by residents of the adjacent mobile homes (Plate 6). Close to the corner of the moat, relatively unaltered fragments of the counterscarp survive to a height of 0.3m above ground level. Internally, the bank stands to a height of 2.5-3.0m above the current water level but breaks in slope observed on this side may well relate to earlier, and higher, water levels. Alternatively, they may represent episodes of re-cutting the moat and embellishment of the accompanying external bank.

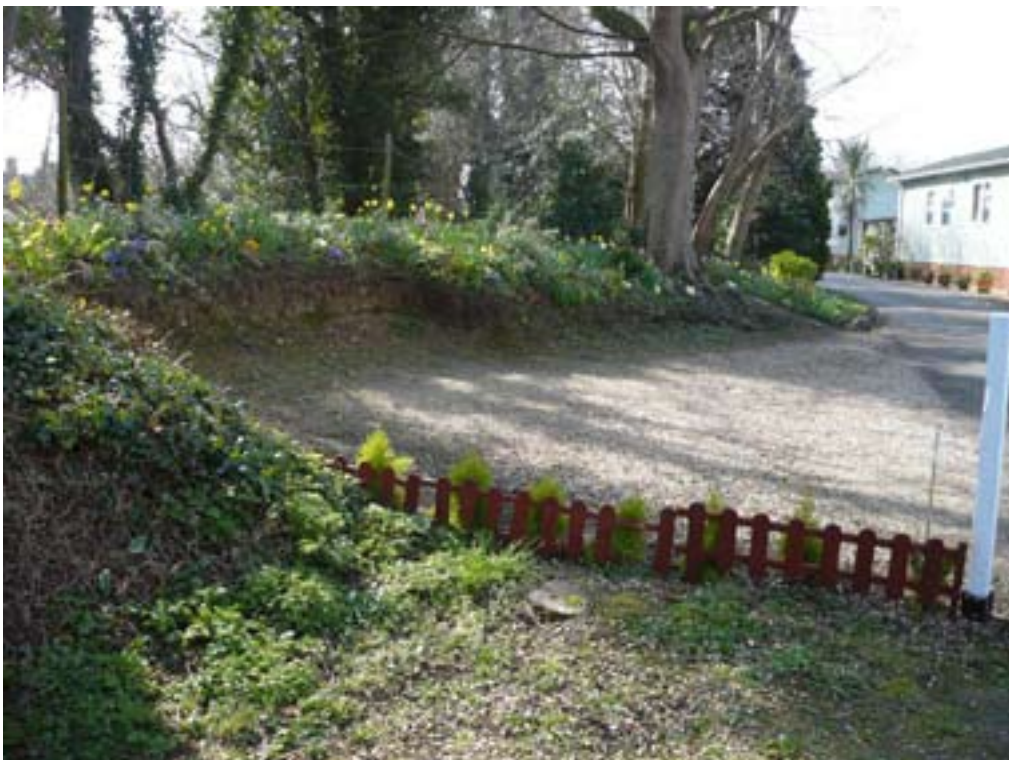
*Plate 6: Along the northern stretch, on the external face, the counterscarp bank has been severely truncated. This is due to either the creation of residents' parking spaces or the creation of small garden plots © David McOmish*

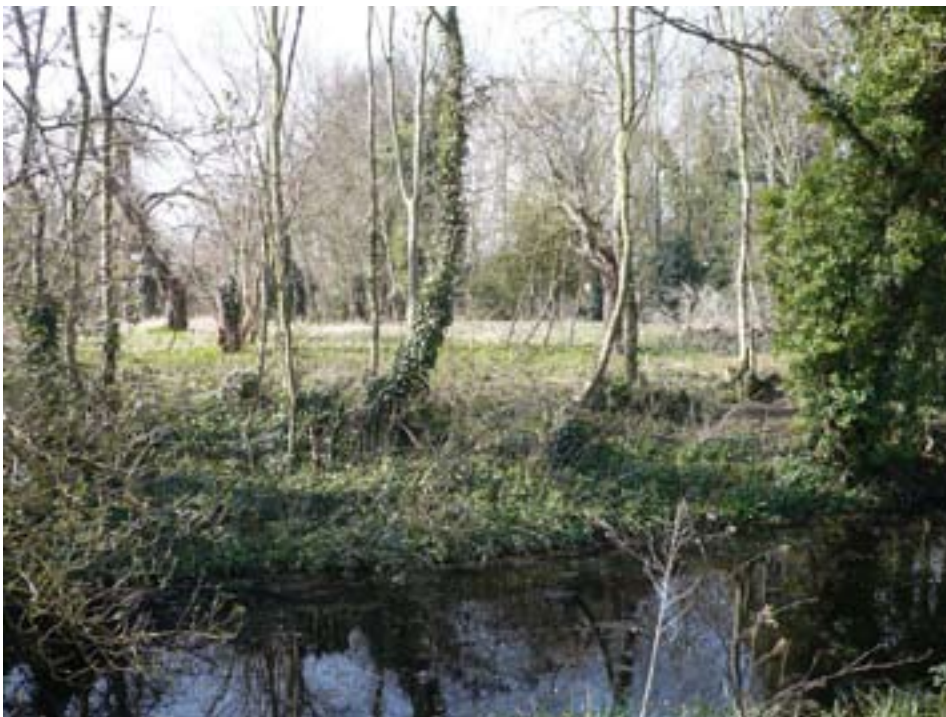
*Plate 7: View of the central island from the crest of the counterscarp bank on the east. In contrast to that on the west, the counterscarp bank here is approximately at a similar level to the island © David McOmish*

A belt of deep vegetation extended along the northernmost segment of the eastern flank of the moat and so it was not possible to undertake detailed recording here. The previous survey (Kenney 1993) did, however, assess the area immediately contiguous with moated enclosure at this point and noted the presence of a wide and spread bank flanking the ditch. Although the previous work suggested that this feature was a component in the local field system, it may well be that it was originally part of the counterscarp bank subsequently used as a field boundary, in all likelihood a headland. The counterscarp bank does, however, stand to a height of 1.5m above the current water level and, in marked contrast to the western element and the western section of the northern flank, it is approximately level with the ground surface on the central platform (Plate 7).

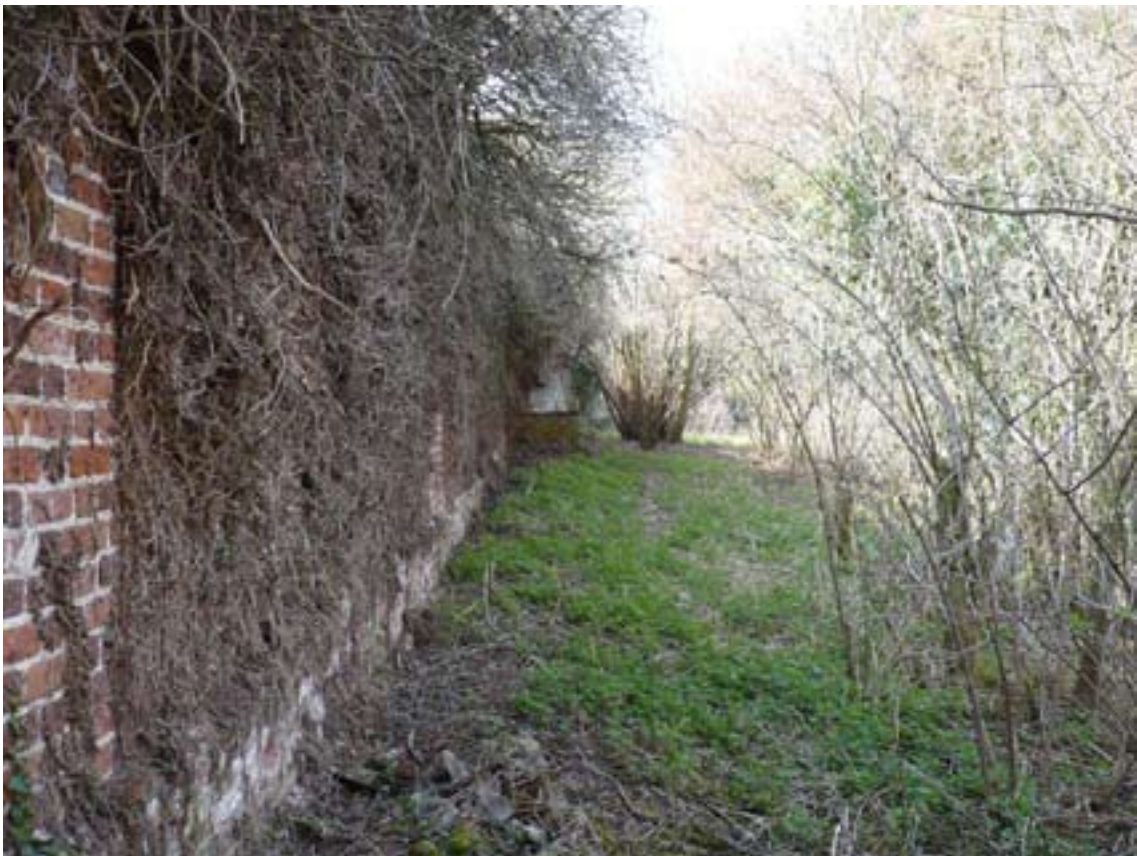
Plate 8: View of the garden wall and brick rubble (foreground) looking west from the south east corner of the moated enclosure. The wall rests of a wider plinth and there are suggestions of later modifications and episodes of re-building © David McOmish

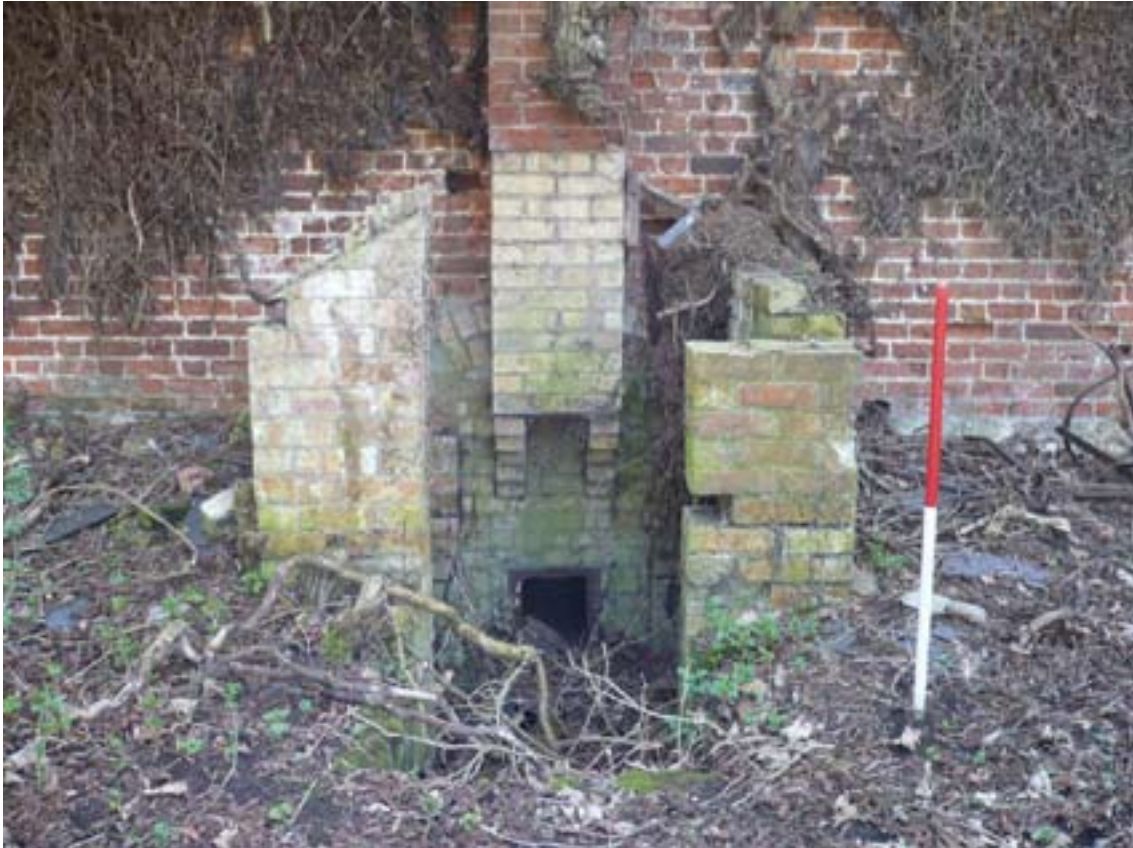
*Plate 9: Brick-built furnace attached to the external face of the garden wall close to its midpoint. This probably provided heat for a series of hot- and greenhouses placed along the interior face of the walled garden © David McOmish*

possibly very recent in origin, and the marked outlines of now demolished structures built along the walls. These, presumably, included buildings designed as hothouses or heated greenhouses ranged along the south-facing section of the wall, i.e. that stretch superimposed on the counterscarp bank. The remains of what appear to be a brick-built furnace can be seen on the external face of the wall c.20m from its western corner (Plate 9).

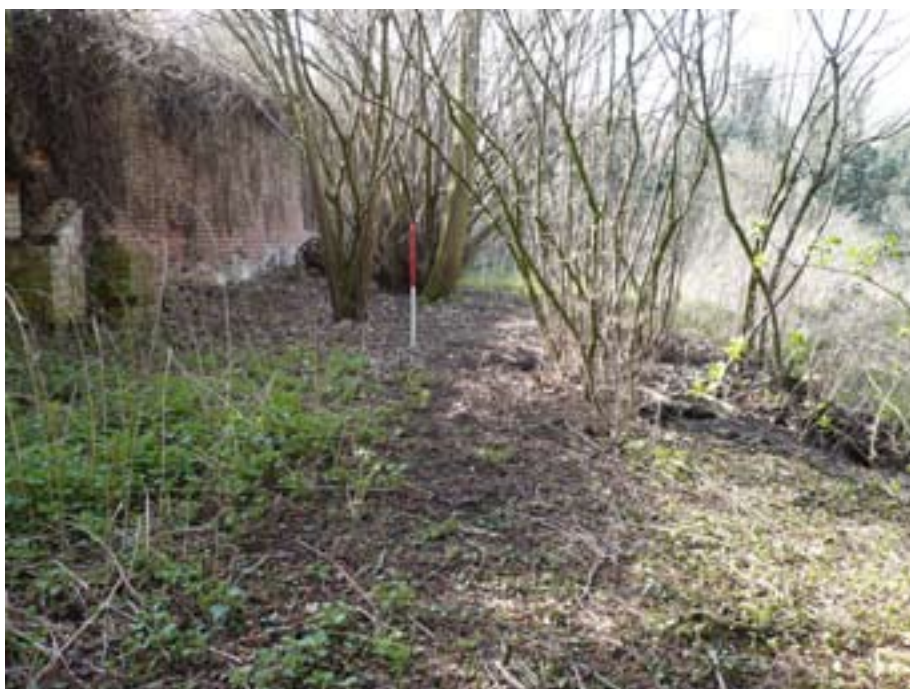
*Plate 10: A talus-like deposit of coal, ash, and slate spread from the furnace towards the edge of the moat ditch, obscuring the counterscarp bank and walkway here © David McOmish*

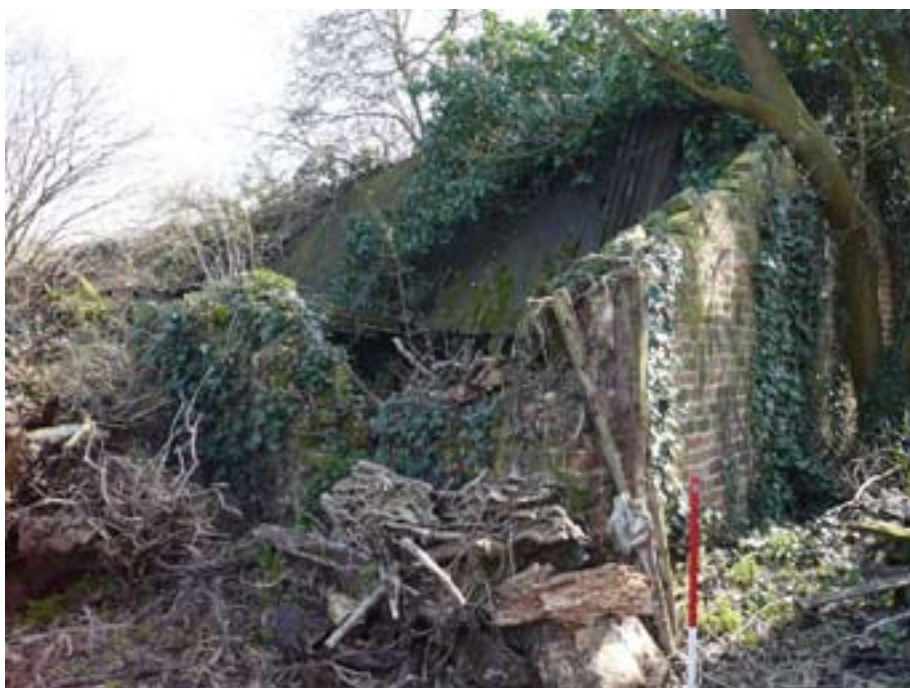
*Plate 11: Partly collapsed tool shed/fruit store at the north-western corner of the walled garden © David McOmish*

in the mid-19th and early-20th centuries (Plate 11).

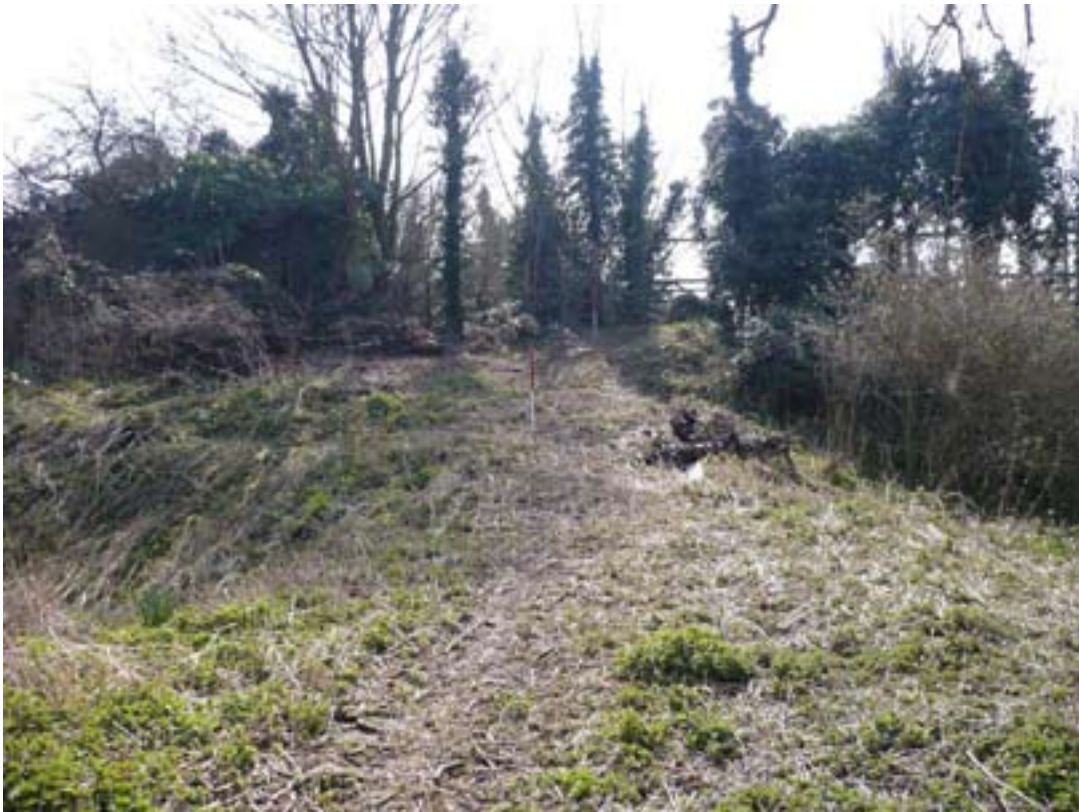
Plate 12: View, from the centre of the island, of the entrance causeway close to the south-west corner. This is likely to be secondary to that on the western flank of the moated enclosure and may well date to the construction of the walled garden immediately to the east © David McOmish

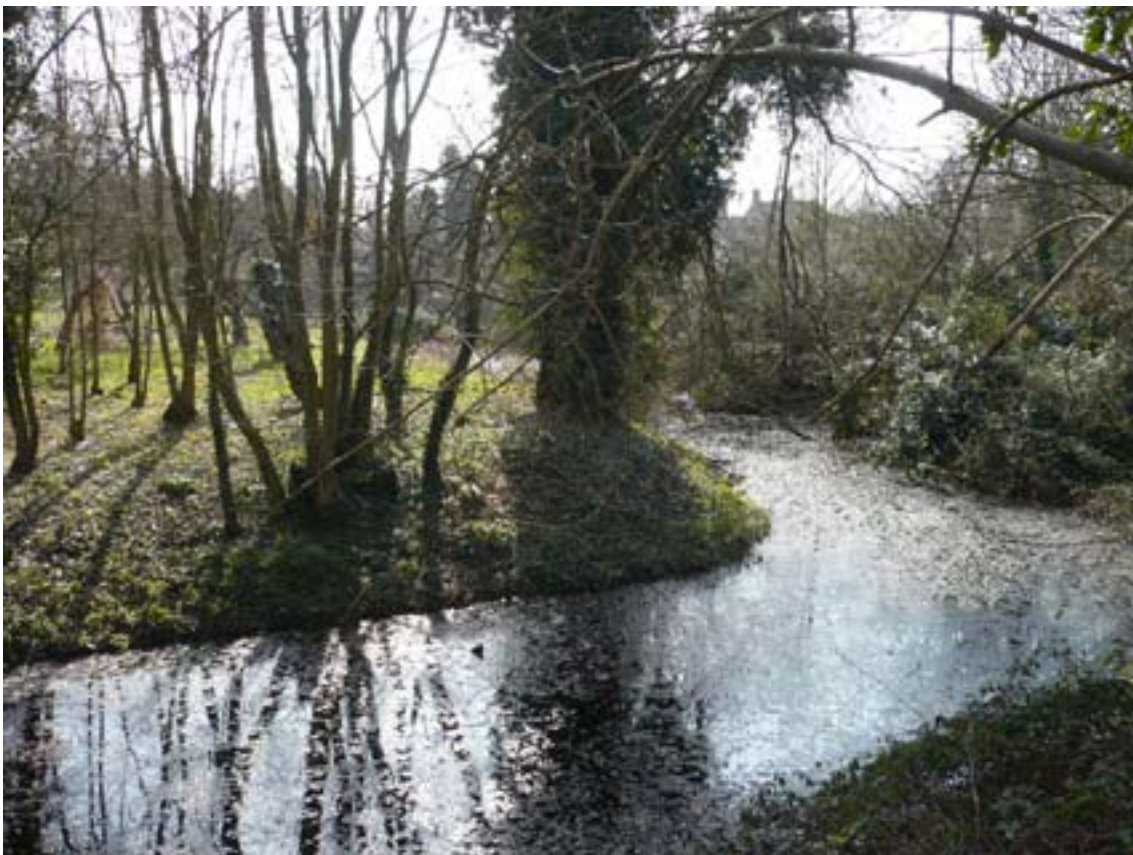
*Plate 13: The north-western apex of the moat ditch viewed from the counterscarp bank on the north. The moat ditch is at its widest on the north and east © David McOmish*

Here, the fluctuating water level lies some 3.5m below the crest of the counterscarp bank. The moat narrows somewhat along the east and even further on the south at which point the heavily silted causeway terminal is barely 3m wide. Slight steps in the profile of the outer face of the moat along the southern stretch do indicate, however, previously higher water levels.

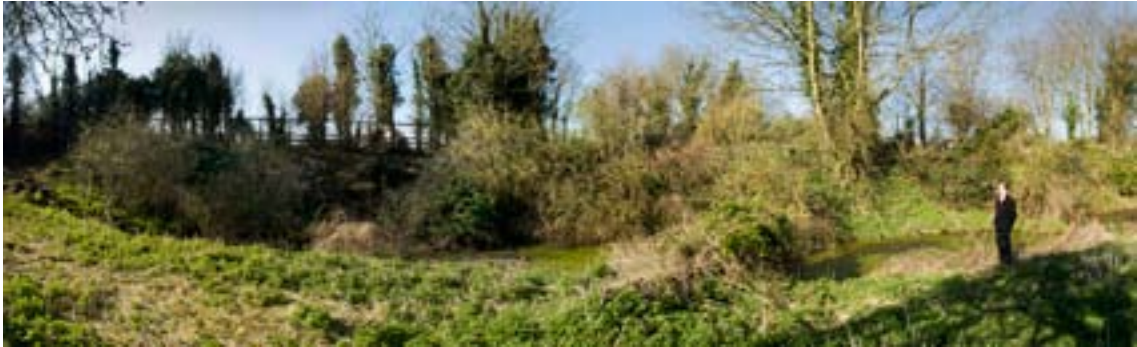
*Plate 14: The western terminal of the entrance causeway at the south-west corner. The counterscarp bank dwarfs the moat and island at this point: largely due to a rise in the height of the underlying topography along this section © David McOmish*

entrance) is of a very different character to its near neighbour. Although, silting has again occurred, the moat ditch is of much greater dimensions at this point, varying between 7m and 11m in basal width. It is, furthermore, dwarfed by the counterscarp bank/ external terrace at the corner but, unlike its eastern counterpart, the moat terminal has an angular, regular, appearance (Plate 14). It may well be that this form reflects the impact of successive re-workings of the enclosure ditch as well as the construction and maintenance of the causewayed entrance.

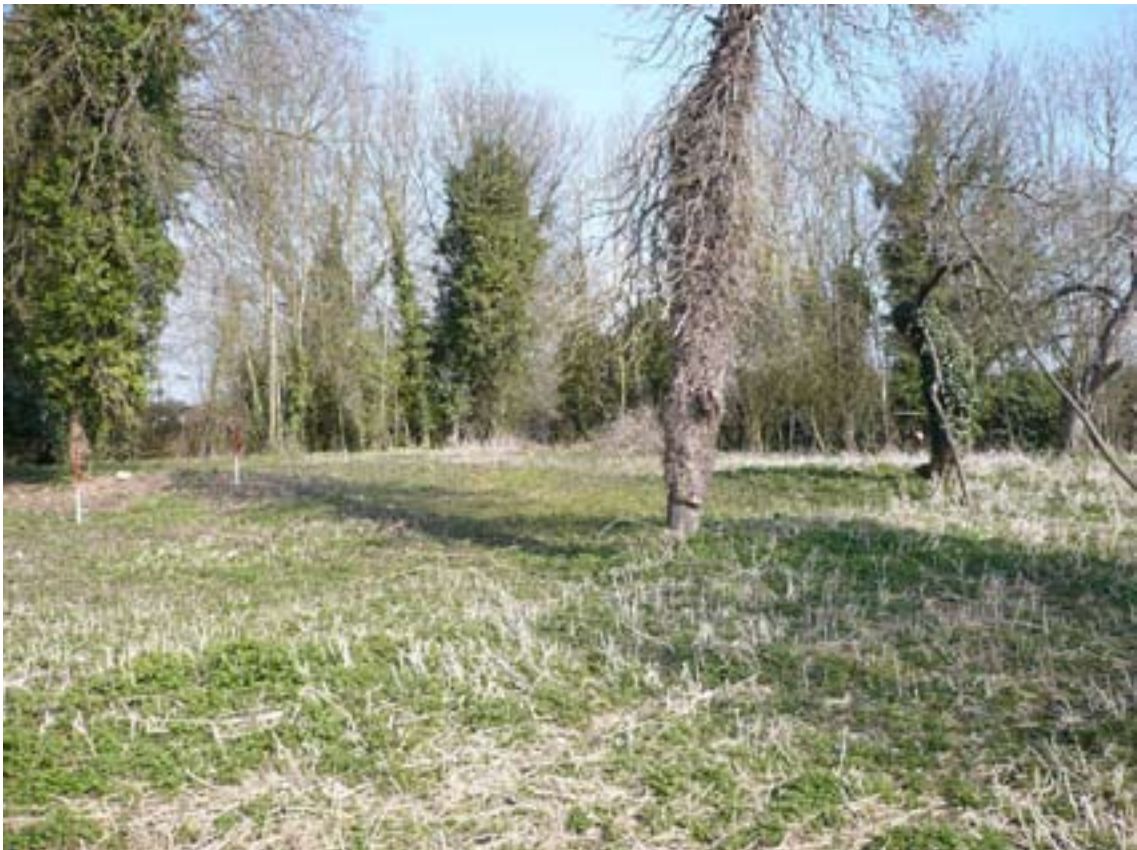
*Plate 15: View of the central island looking north-east. The raised terrace hosting a rectangular building platform (centre) can be seen, and the drawing board (centre right) rests on the top of the building platform close to the centre point of the island. The south-west facing edge of the terrace is marked by the ranging poles © David McOmish*

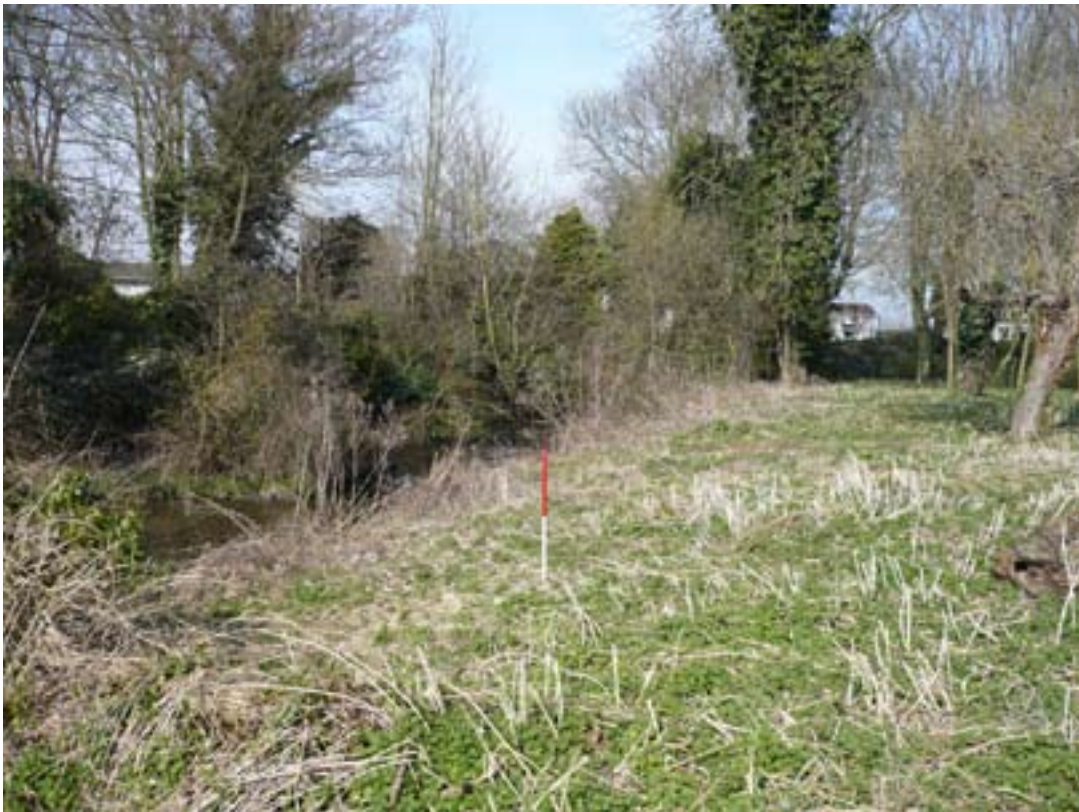
Plate 16: The western edge of the moat island, in contrast to the remainder of its circuit, is ill-defined and has the appearance of having been heavily worn, perhaps by stock accessing the water © David McOmish

a more 'rounded' decline into the moat. A very slight ledge can be observed here, and although this replicates the form elsewhere, it appears to have been heavily modified

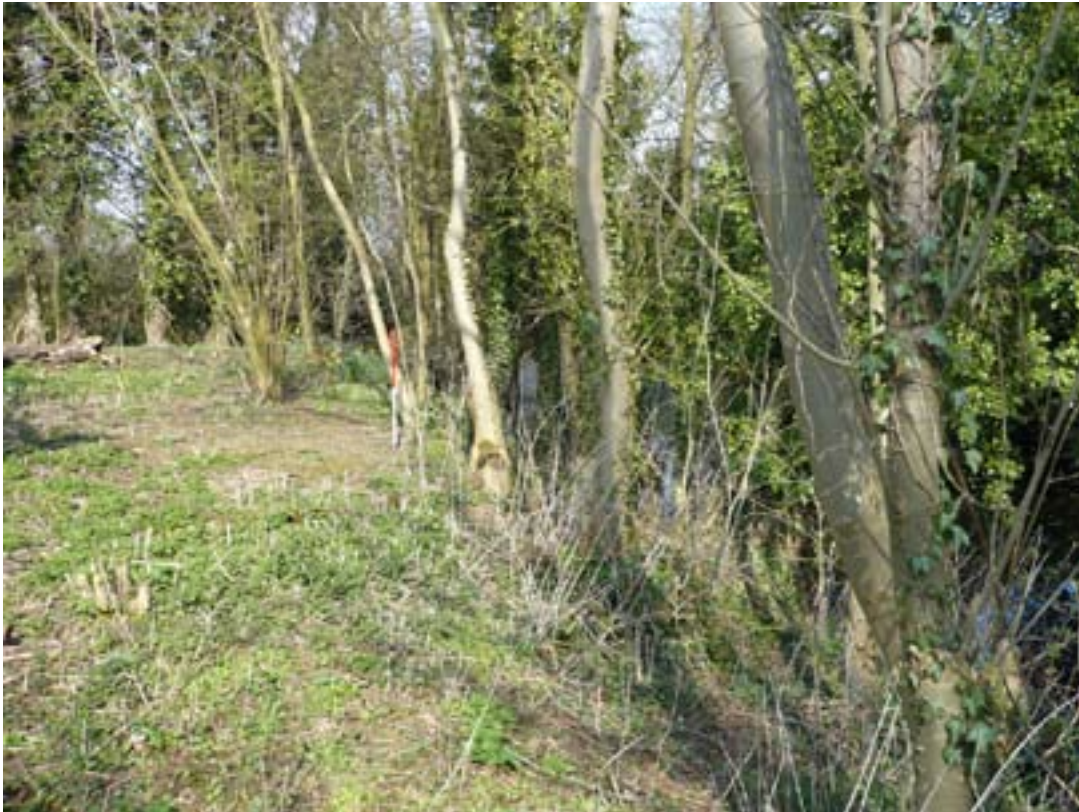
Plate 17: The eastern (and northern) edge of the moat is sharply defined by a ledge or break of slope. This may well reflect the former presence of a hedge or fence/stockade boundary around the island © David McOmish

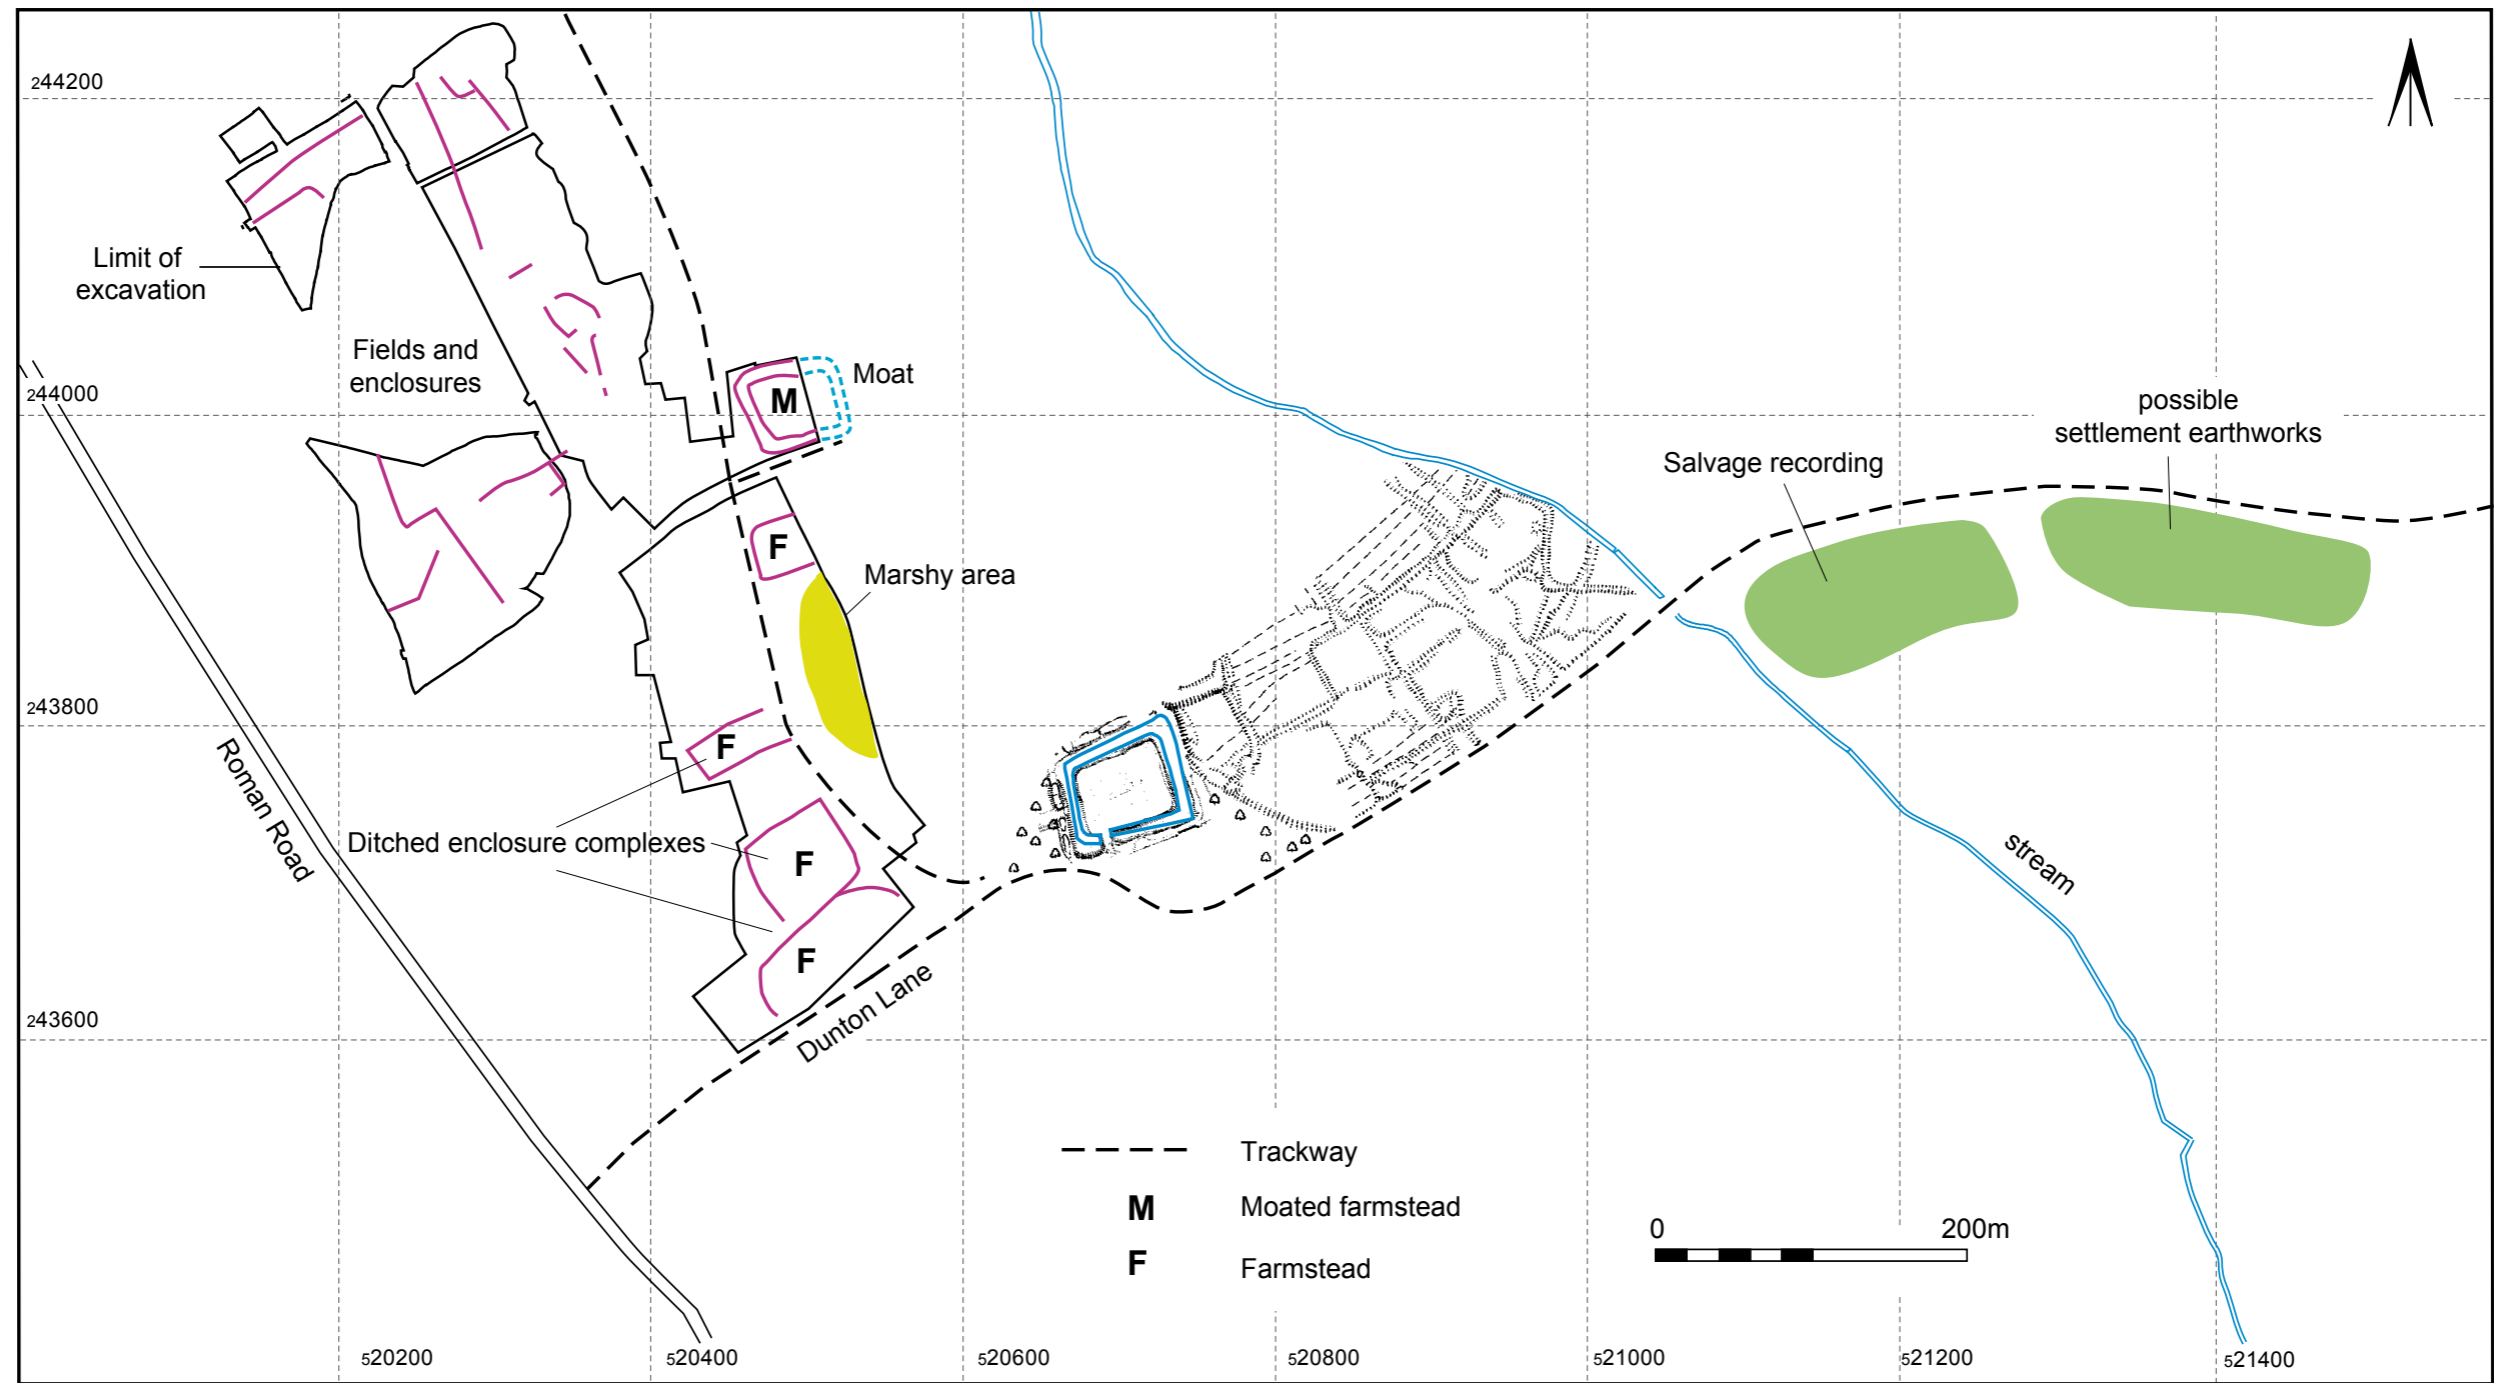
Figure 6: Stratton Park moated enclosure in its wider context as revealed by excavation © Albion Archaeology
