# SHAW HOUSE, NEWBURY, BERKSHIRE AN INVESTIGATION OF THE WINDOW GLASS

## TECHNOLOGY REPORT

David Dungworth and Amanda Loaring

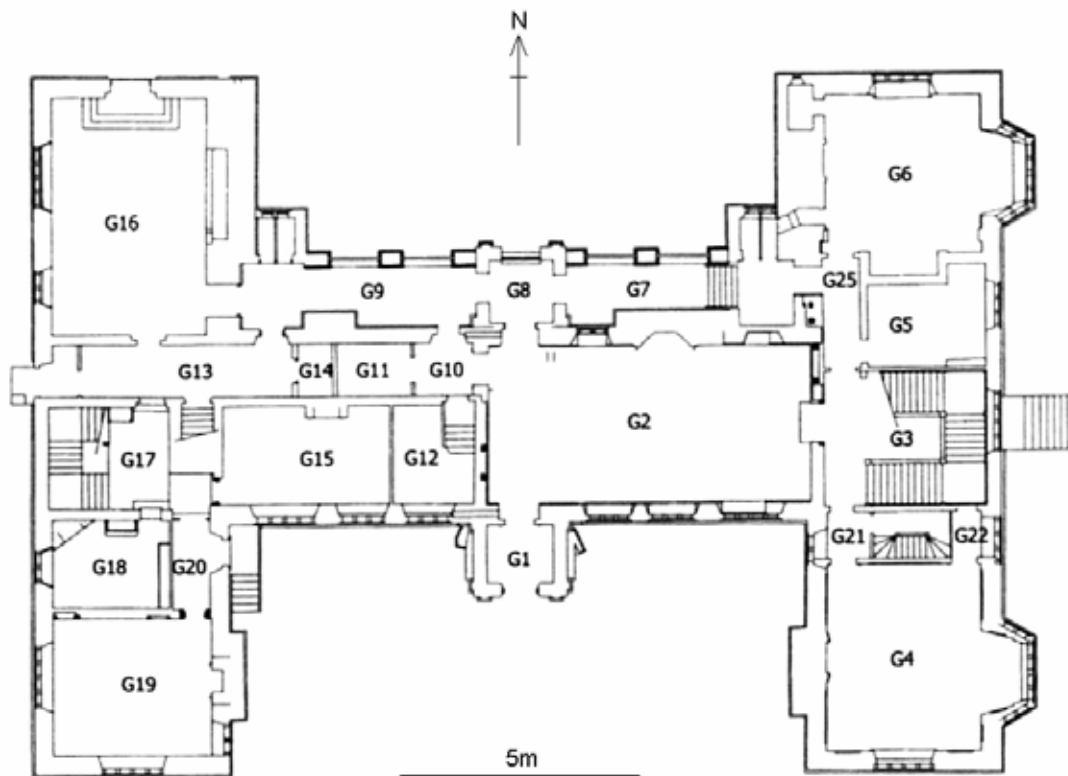
*Figure 1. Plan of Shaw House (Ground floor) (Historic Building Surveys Ltd, 2003)*

For the room numbers refer to Figures 1 and 2.

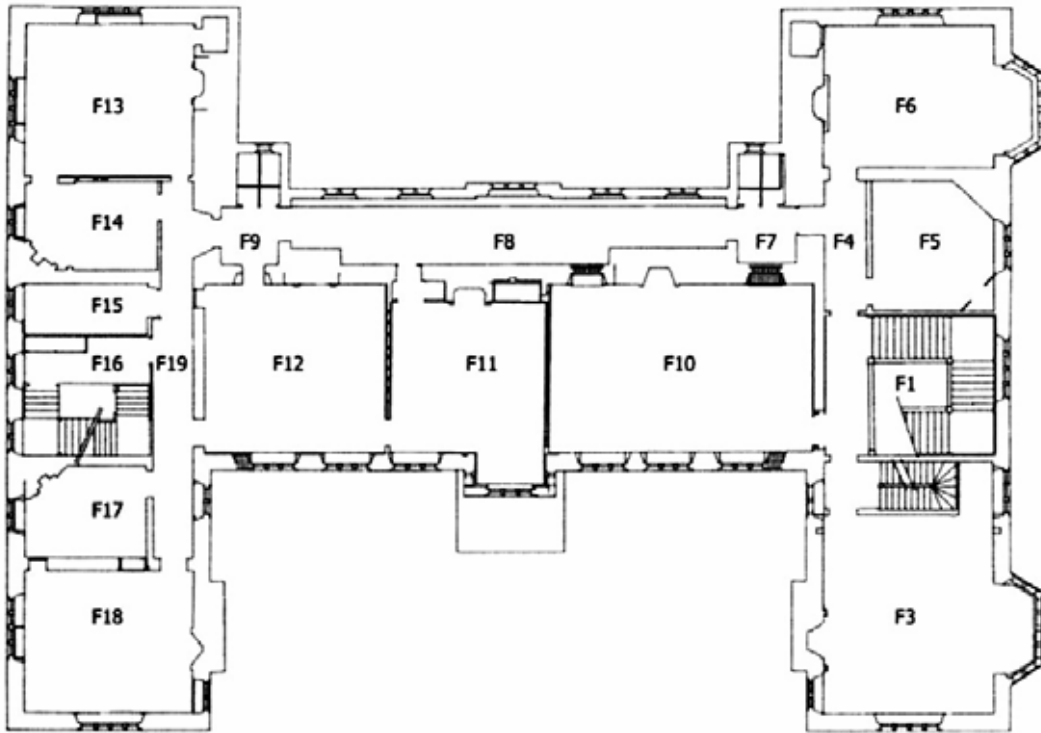
*Figure 2. Plan of Shaw House (First floor) (Historic Building Surveys Ltd, 2003)*

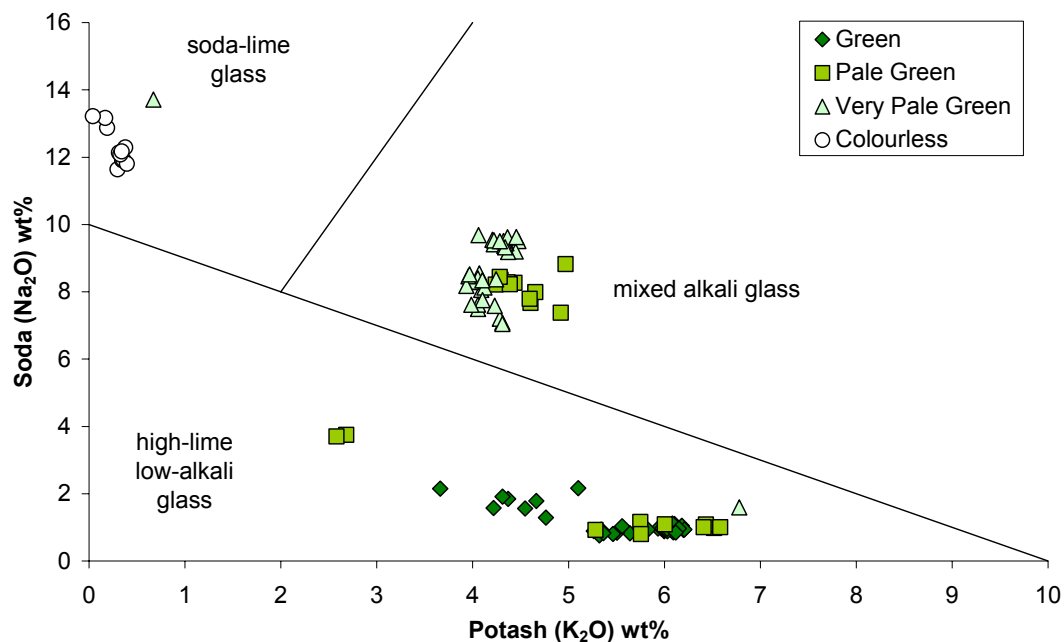
Figure 3. Plot of soda and potash content of all glass fragments analysed

The analysis of 104 fragments of window glass from Shaw House showed the use of three distinct types of glass (Figure 3). The first, and earliest, type of glass is a high-lime low-alkali (HLLA) glass which contains low concentrations of potash (3–7wt%) and very low concentrations of soda (1–4wt%). This glass is always has a distinct green tint (mostly described as green but also pale green) and is usually present as square- or diamond-shaped panes with grozed edges. The green tint is due to the presence of iron oxide (Figure 4) which may derive from the sand, the flux or both. The panes have sides up to 116mm in length, with an average thickness of 1.5mm (standard deviation of thickness 0.3mm). The production of HLLA glass in Britain starts in the late 16th century shortly before Shaw House was first built, and it continued to be produced until the end of the

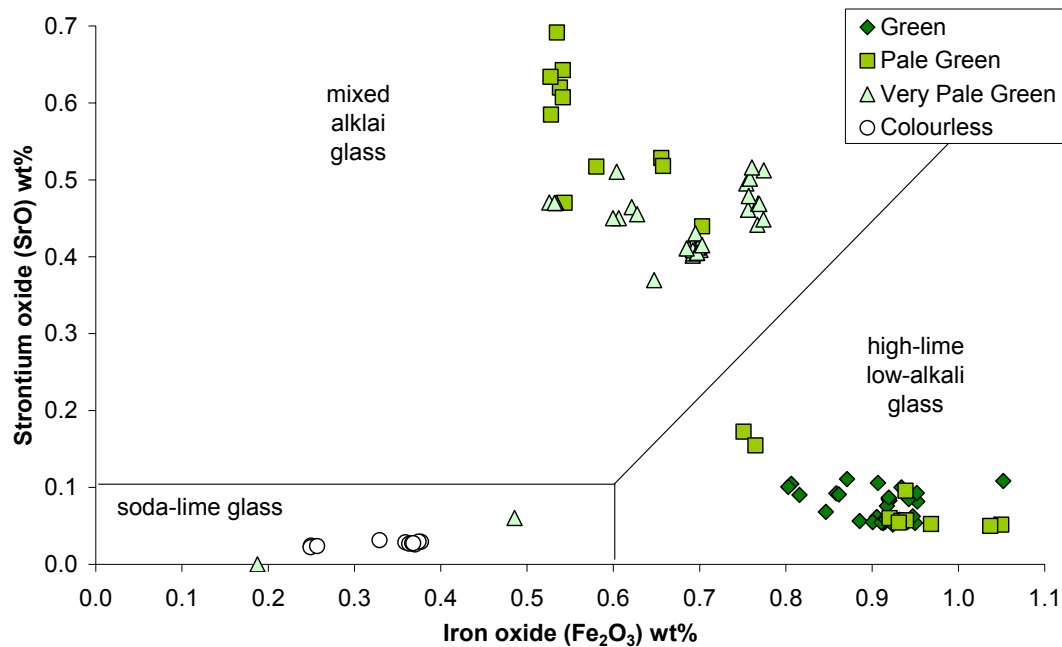
Figure 4. Plot of iron oxide and strontium oxide content of all glass fragments analysed

The final type of glass is a soda-lime glass of a type manufactured after the development of synthetic soda in the early 19th century. This glass contains high concentrations of soda (12–13wt%) and low levels of potash (<0.4wt%). The Leblanc process for transforming sodium chloride (eg sea salt) into soda ash (sodium carbonate) was introduced on an industrial scale in Britain c1830 and soda ash quickly supplanted the use of kelp and other plant-based fluxes. This glass contains very low concentrations of a range of oxides that are present in the two earlier (plant-based) glasses (especially phosphorus oxide). The soda-lime glass is mostly present as diamond panes and these appear to have been deliberately cut to fit into an existing glazing scheme (ie repairs). The soda-lime glass is

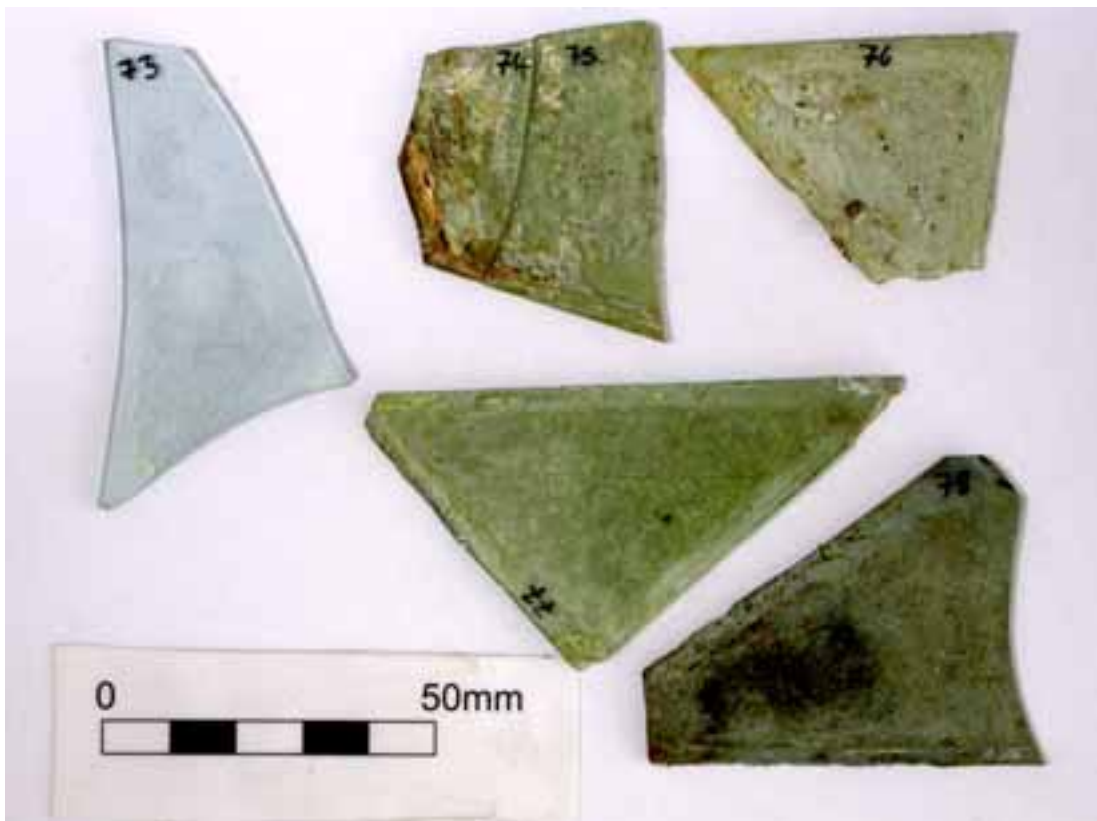
B6 is not marked on the plan (Figure 1) but is a basement room underneath G7 and G25 (which are marked). Six fragments of glass were recovered *in situ* from a blocked window on the east side of B6 (Figure 5). This window was inserted towards the end of the 17th century but was blocked by 1730 (Morris 2006). The six fragments of glass from B6 included a single fragment (73) of mixed alkali glass and five (74–78) of HLLA glass. The mixed alkali glass fragment has a composition which does not provide a close match with any of the window glass fragments from any other rooms. The five fragments of HLLA glass include two joining fragments, which have almost identical compositions. The remaining samples, however, are sufficiently different from each other and from window glass fragments from other rooms to be sure that they do not relate to a single pane or batch.

Figure 5. Window glass from the blocked window on the east side of B6

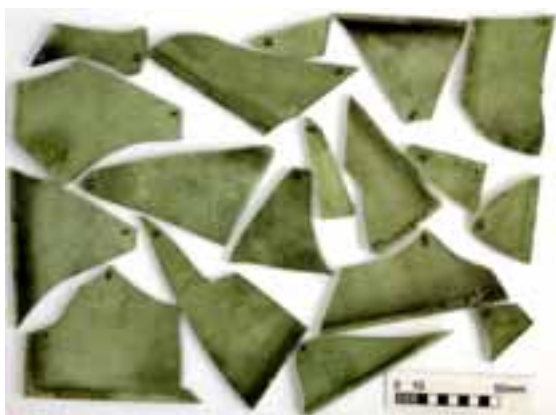
Figure 6. Green glass from G2

This room was completely refitted between 1680 and 1700; there are no later records of building/alteration. In total, 28 fragments of glass were collected from near the windows (having been revealed after the removal of the wooden wall panelling). Eighteen of these fragments were distinctly green in colour (Figure 6), eight were pale green, one was very pale blue-green and one was colourless (Figure 7). All of the green glass was HLLA glass. Despite having almost identical compositions, the pieces show subtle differences indicating the presence of two batches of glass (Figure 8). The first group (samples 1, 4, 7, 8, 10, 11, 14, 15 and 16) contains less silica and more lime than the second group (2, 3, 3, 5, 6, 9, 12, 13, 17 and 18). The fragments were collected from the vicinity of several windows in G2 and no joins were found between any of the fragments; it is therefore unlikely that these two groups derive simply from two panes of glass. The similarities between the two groups suggest that were made in the same workshop, while the differences suggest they were made from different batches of glass on different days.

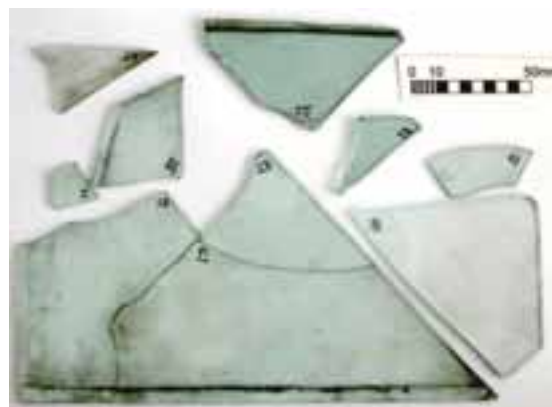
Figure 7. Other glass from G2

The remaining glass from G2 includes six fragments of mixed alkali glass (19, 21, 23, 25, 26 and 27) with virtually identical compositions: none of the samples varies from the average by more than the analytical precision. Three of these fragments clearly join each other (19, 21 and 23) and the other three fragments are small enough that they may derive from the same pane. Two of the remaining fragments are mixed alkali glass but with compositions that are distinct from the first mixed alkali glass. The final two fragments of glass from G2 (20 and 24) are soda-lime glasses. One of these (24) contains negligible concentrations of magnesia but is decolourised with arsenic. The use of arsenic as a decolouriser probably places manufacture between c1820 and c1900. The second fragment of glass (20) contains several weight percent of magnesia (and lower lime) but no arsenic. The use of a soda-lime glass recipe with reduced lime but some magnesia (as in this sample) is a characteristic of cylinder glass produced by automated processes (Cable 1991; 2004) and this glass was probably produced after c1920.

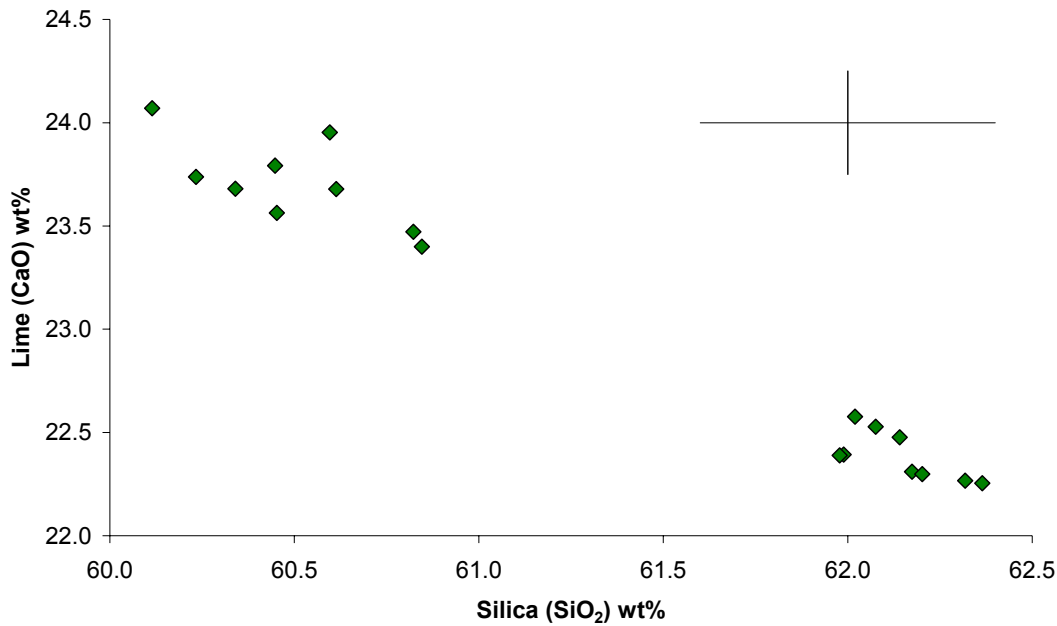
Figure 8. Silica and lime content of the HLLA glass from Room G2 (the cross indicates the precision of the analytical technique for the two oxides displayed)

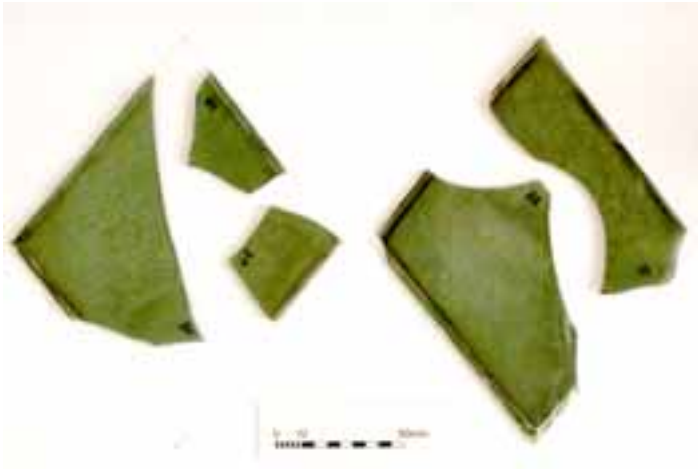
In total, eleven fragments of glass were collected from near the windows (having been revealed after the removal of the wooden wall panelling). Six of these fragments were distinctly green in colour (Figure 9), while the remainder were pale green (Figure 10). Most of the green glass fragments derived from diamond panes (Figure 9) with internal angles of 75° and 105° and sides of 105–125mm (4 to 5 inches). All of the green glass (30, 31, 32, 33, 34 and 40) was HLLA glass, with sufficient differences between fragments to suggest that none derived from the same pane or batch. Despite this, all samples shared compositional similarities that contrasted with the HLLA glass of G2 to suggest a different source. In particular, the G2 HLLA glass contains much higher concentrations of manganese oxide, titanium oxide and zirconium oxide. The first of these oxides probably derives from the plant ash flux while the second two reflect the composition of the sand used. The differences are sufficient to suggest very different locations for the relevant HLLA glass houses (assuming that the two putative glasshouses employed local resources).

*Figure 9. Dark green HLLA glass from G3*

The remaining fragments (37–39) are pale green glass from panes of similar size and shape as the green HLLA glass from the same room (Figure 9). The mixed alkali glass was made using kelp as a flux but the compositions of each fragment are sufficiently different to suggest that none were from a single pane or batch. Nevertheless these three

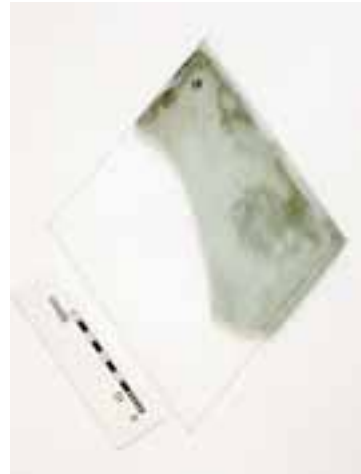
*Figure 10. Pale green mixed alkali glass from G3*

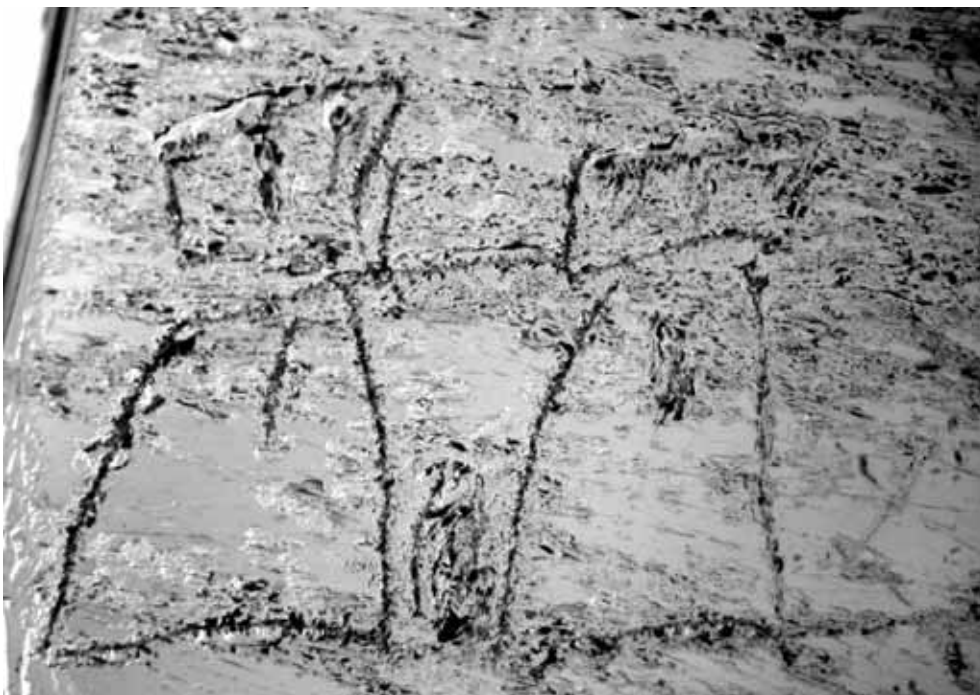
The five fragments of pale glass from G3 include two fragments (35 and 36), which while being HLLA glass, have rather unusual compositions. These fragments contain more soda and strontium oxide than any of the other HLLA glass fragments suggesting that the flux included a proportion of kelp. One of these fragments of glass has an inscribed image (Figure 11). This appears to show a castle or other major building with an entrance

*Figure 11. Inscribed design on fragment 35 showing a stylised castle or grand house with two towers or wings flanking an entrance (image width = 13mm)*

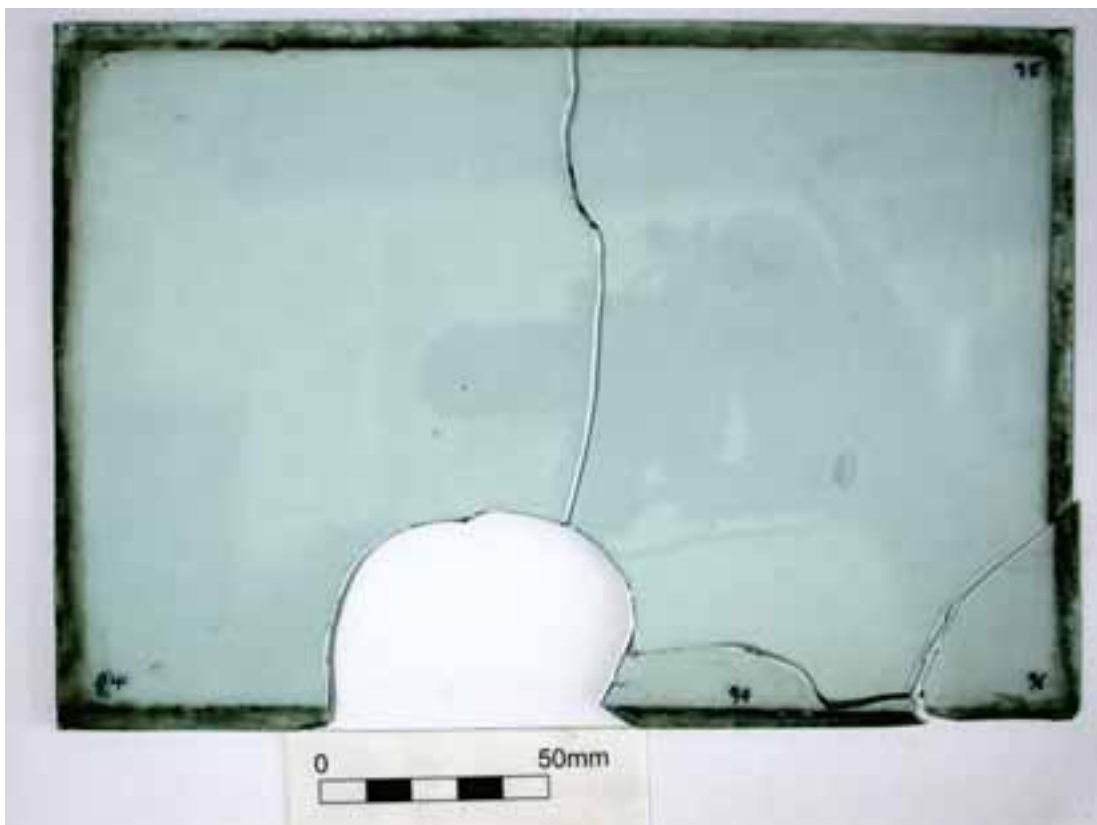
Room F1 was significantly altered by the changes which occurred at the end of the 17th and beginning of the 18th centuries. The twenty fragments of very pale green glass were recovered *in situ* from six panes (Figure 12, rectangular 150 by 225mm, 6 by 11 inches, and 1.6mm thick). It is most unlikely that any of these panes predate the c1690–c1720 alterations.

Figure 12. Window glass pane number 2 from Room F1

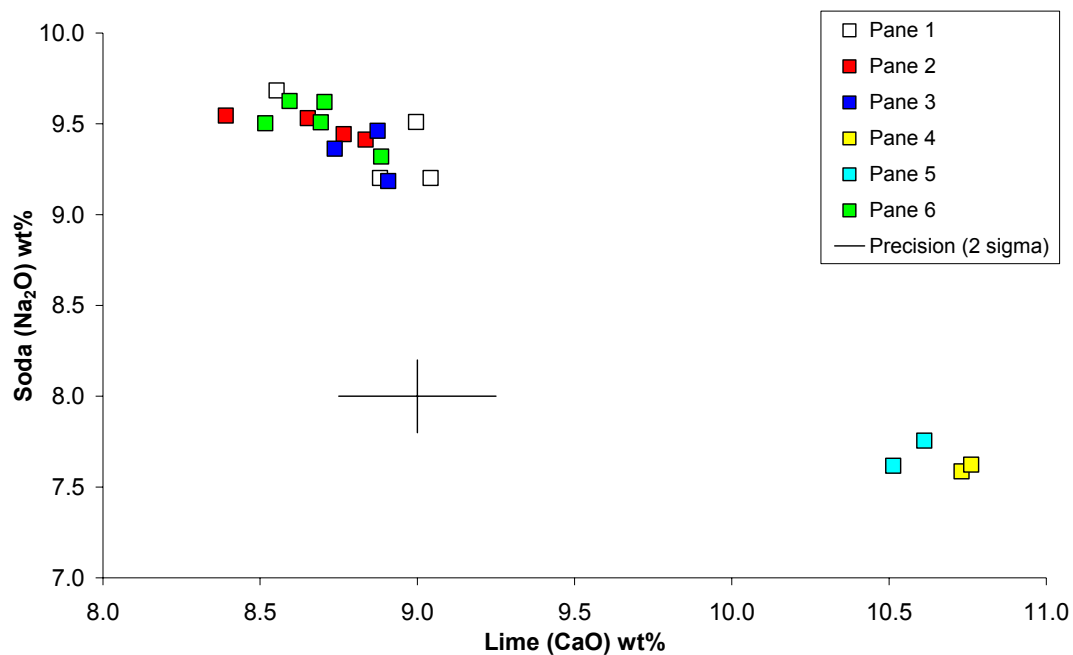
The chemical analysis of the twenty fragments of glass from six panes indicates that all were made from a mixed alkali glass and that there are two distinct compositional groups present. Panes 1, 2, 3 and 6 all share virtually identical compositions: the variation in composition between the different panes is similar to the variation between fragments from a single pane, and in both cases the variation is barely more than the analytical precision (Figure 13). Panes 4 and 5 share a similar composition but this is distinct from that of the other panes.

Figure 13. Plot of potash and soda concentrations for the 20 fragments of glass from Room F1

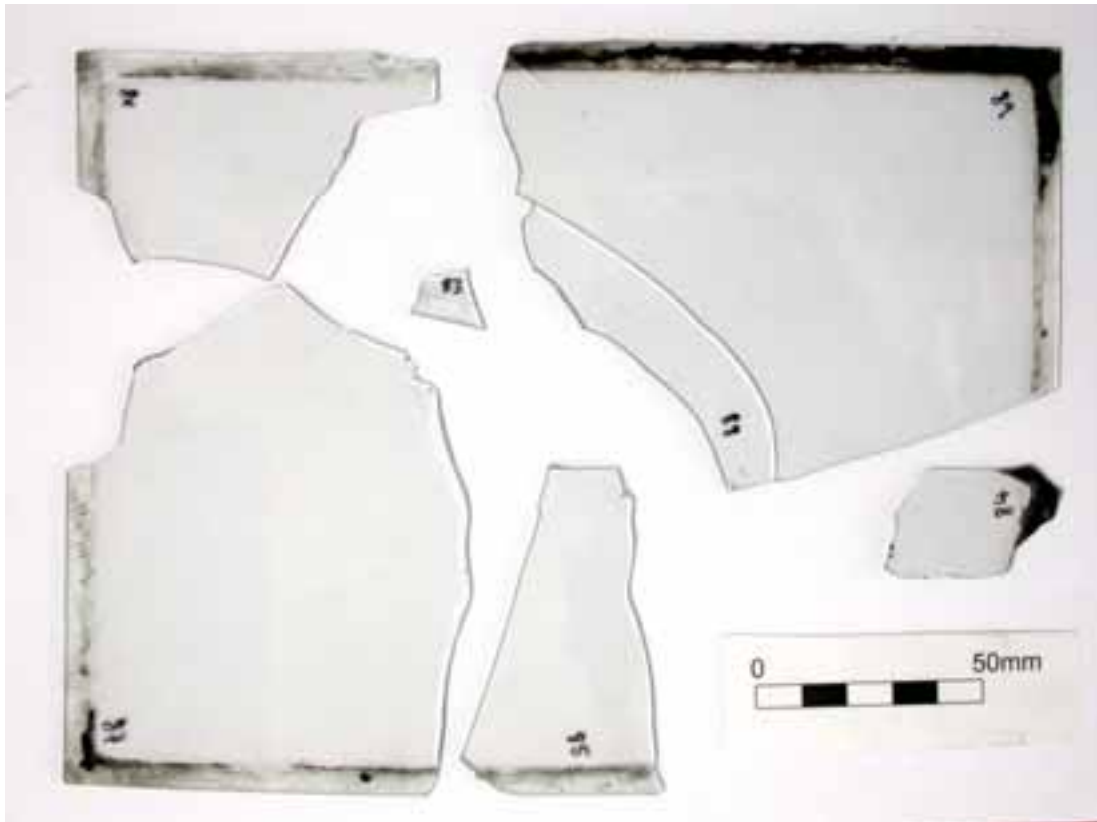
Room F3 was significantly altered in 1728–30. Seven fragments of colourless glass from square or rectangular panes (with at least one side in excess of 125mm) were recovered from this room (although none were *in situ*). All seven fragments are soda-lime glasses which share virtually identical chemical compositions (the samples vary from the average composition by less than the analytical precision). Although only two fragments were found to join, it is possible that all seven fragments derived from a single pane of glass. The fact the glass is a soda-lime glass with low levels of oxides (especially phosphorus oxide) usually associated with plant ash fluxed glasses (such as HLLA and kelp mixed alkali glass) makes it certain that the glass was manufactured after the introduction of the Leblanc process soda ash (c1830). The low levels of magnesia indicate that the glass was probably produced before c1920 when the automated cylinder process was introduced. The presence of arsenic in this glass indicates that it was probably produced before c1900.

*Figure 14. Window glass from Room F3*

Despite the visual similarity between the colourless soda-lime glass from rooms F3 (Figure 14) and F6 (Figure 15) there are sufficient differences in the composition to suggest that they do not belong to a single batch and probably do not indicate a single phase of re-glazing in the 19th century.

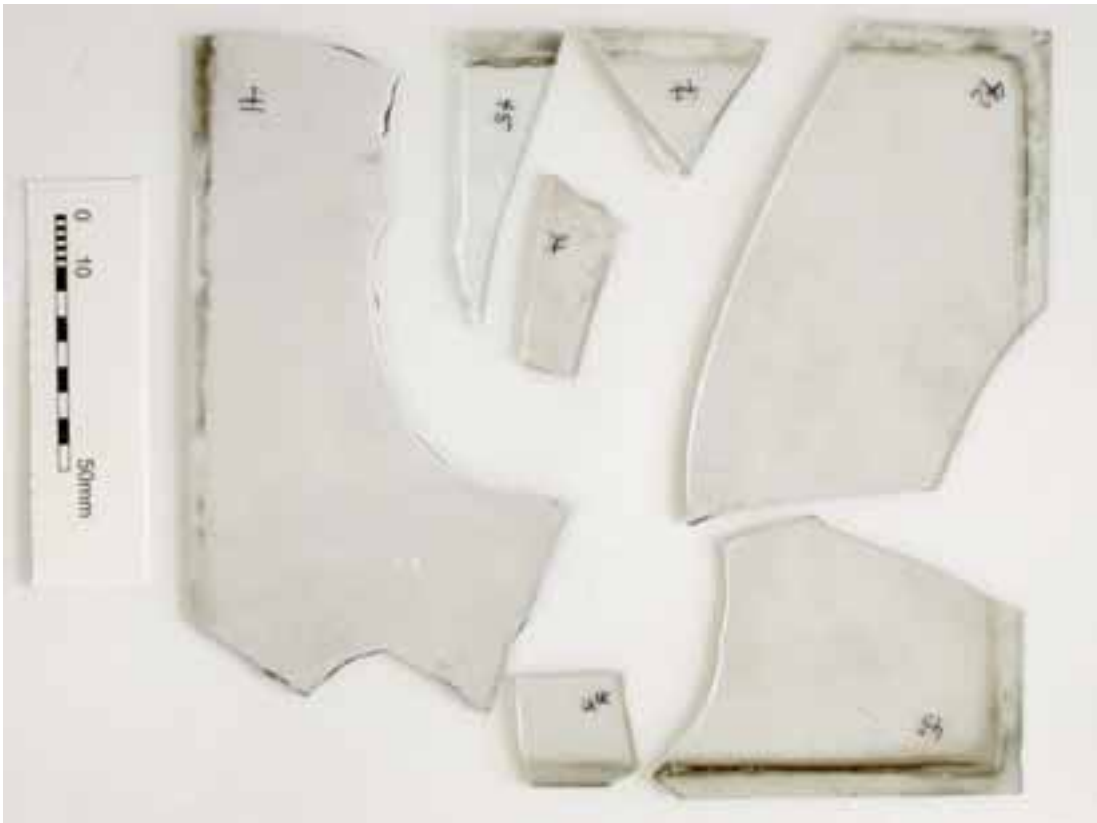
Room F6 is known to have had sash windows installed in the 1730s. Seven fragments of glass were recovered from this room (none *in situ*). The analysis of three fragments showed them to be soda-lime glasses. The three samples share very similar compositions and could easily be the product of a single batch (or possibly a single pane). The glass composition clearly places manufacture after the introduction of the Leblanc process (c1830). The low levels of magnesia make it almost certain that manufacture occurred before the introduction of automated cylinder production (c1920). In addition the use of arsenic as a decolouriser would place manufacture before c1900.

*Figure 15. Window glass from Room F6*

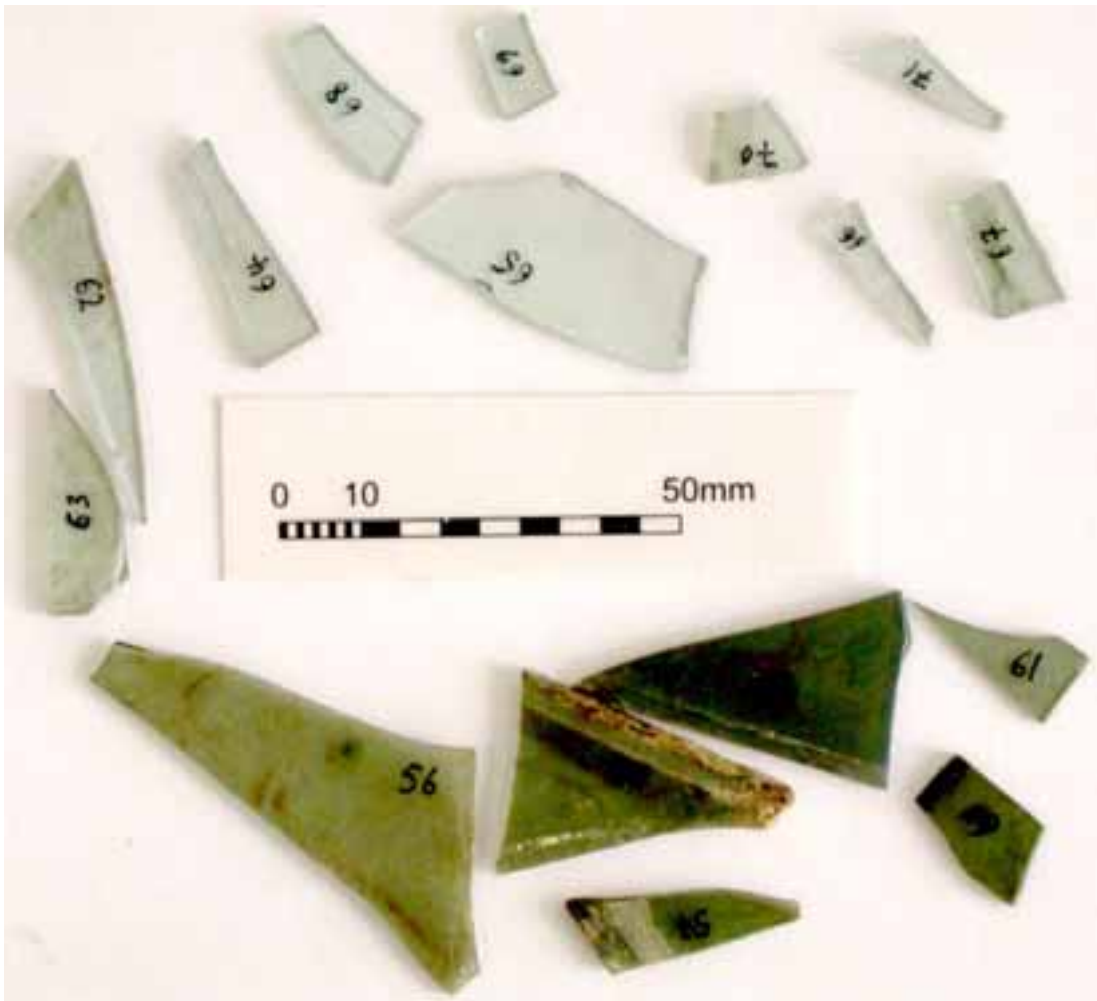
*Figure 16. Green and very pale green glass from Room F13*

The documentary evidence indicates that Room F13 (in the western wing) was not included in the 1730s alterations (including the re-glazing of most of the rooms in the eastern wing). Sixteen samples of glass were recovered from Room F13: six green (or blue-green) and ten very pale green fragments. The green glass was all HLLA glass with a slight spread of compositions suggesting several batches (but probably from a single source or production centre). In general, the F13 HLLA glass has compositional similarities with the first group of HLLA glass from G3, including relatively high concentrations of manganese oxide, titanium oxide and zirconium oxide.

All of the very pale green glass fragments from F13 are mixed alkali glass which share virtually identical compositions (the variations from the average are less than the analytical precision). No joins were noted among these fragments but they are all small (Figure 16) and could possibly derive from a single pane. The F13 mixed alkali glass has a similar

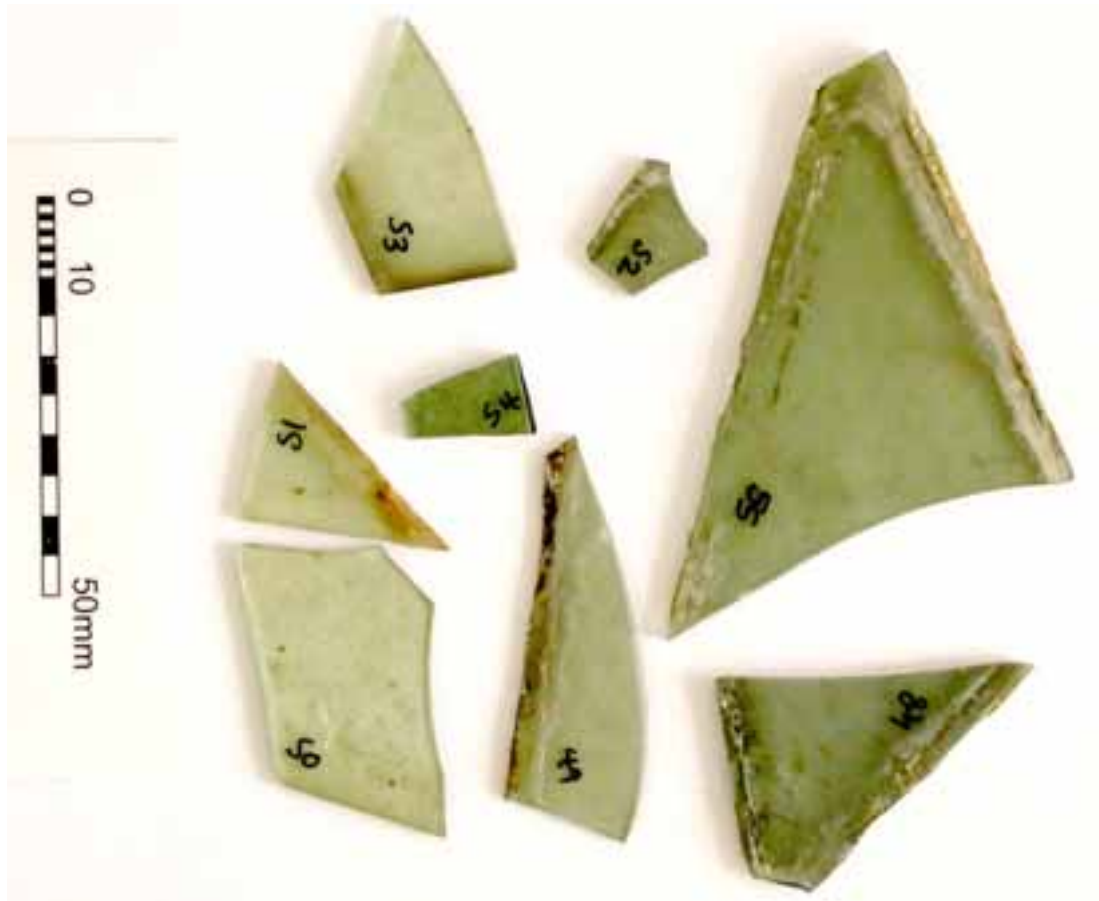
Figure 17. Window glass from Room F18

Room F18 is recorded as having sash windows installed in the 1730s. Eight samples of green and pale green glass were recovered (none *in situ*) from this room and all were HLLA glasses. Three of the samples (50, 51 and 53) share virtually identical compositions, however, none of the remaining fragments have sufficiently similar compositions to be regarded as belonging to the same batch. None of the HLLA glass from Room F18 matched closely to any of the HLLA glass from other rooms.

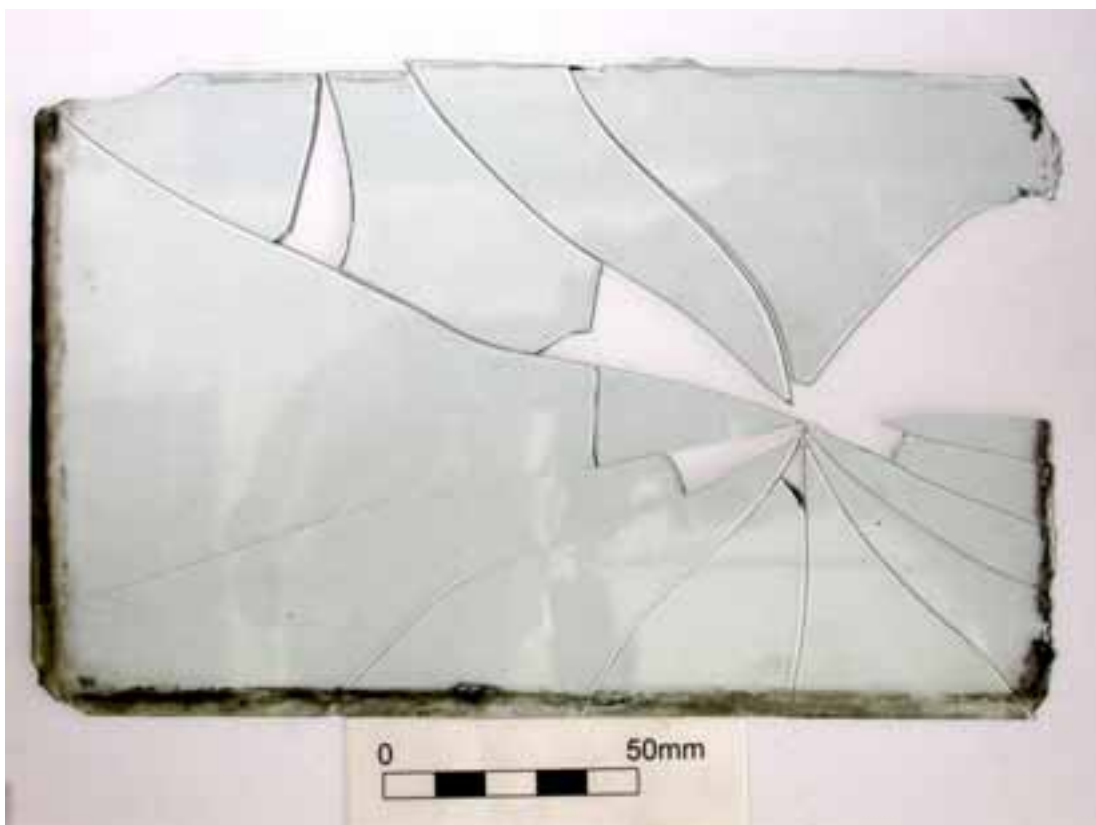
Figure 18. 14 of the 26 window glass fragments from a single pane from Room S18

Twenty-six fragments of very pale blue-green glass from a single pane were recovered from Room S18 (second floor plan not available). The analysis of four fragments showed that the pane was made from a mixed alkali glass but with a chemical composition which did not exactly match that of any of the other rooms.
