DOLEBURY HILLFORT, CHURCHILL, NORTH SOMERSET ANALYTICAL EARTHWORK SURVEY

**DOLEBURY HILLFORT
CHURCHILL
NORTH SOMERSET**

ANALYTICAL EARTHWORK SURVEY

NGR: ST 450 590

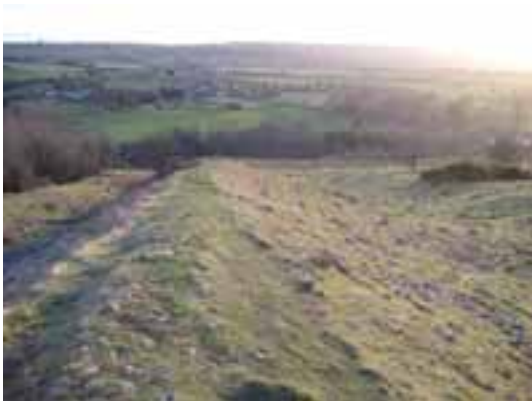
Fig 8: the eastern rampart, with internal quarry, looking south

Perhaps because of internal quarry scoops or later quarrying, the interior of the fort here is actually lower than the exterior: the internal height of the main rampart is 5.0m and its external height 3.6m; the inner ditch is 2.0m deep, the outer ditch 2.0m deep internally and 1.2m externally. The external height of the rampart on the south side of the fort is only 2.6m and the internal height about 1.8m, though it appears greater because of internal quarry scoops and other disturbances.

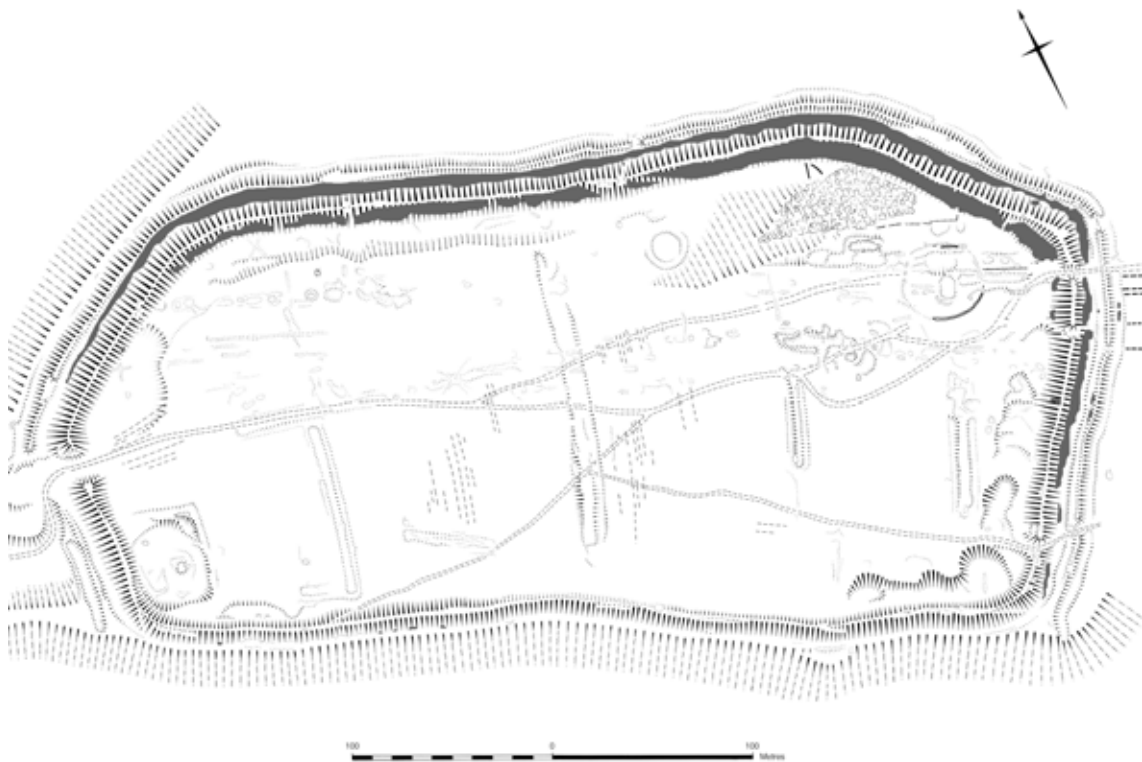
Fig 9: the main areas of bare stone on the ramparts, shaded

One curiosity is the extensive areas of bare scree-like stone on the main rampart, particularly on the north side (Fig 9). The reason for this is unclear but it is unfortunate as the loose stone affords an opportunity for casual vandalism by visitors to the site, something noted by Burrow three decades ago (1981, 207). Dymond noted wall faces at several points around the northern part of the circuit in the outer side of the main rampart (1883, 108, with the elevation of a small part illustrated – see inset on Fig 5) but no trace of this was seen during the 2008 survey. Dymond compared the style of masonry he saw here to that at Worlebury, concluding that though the building differed slightly this was no indication, necessarily, of chronological difference (*ibid*, 108-9). As no wall facing is currently visible at either site, no further comment can be made.

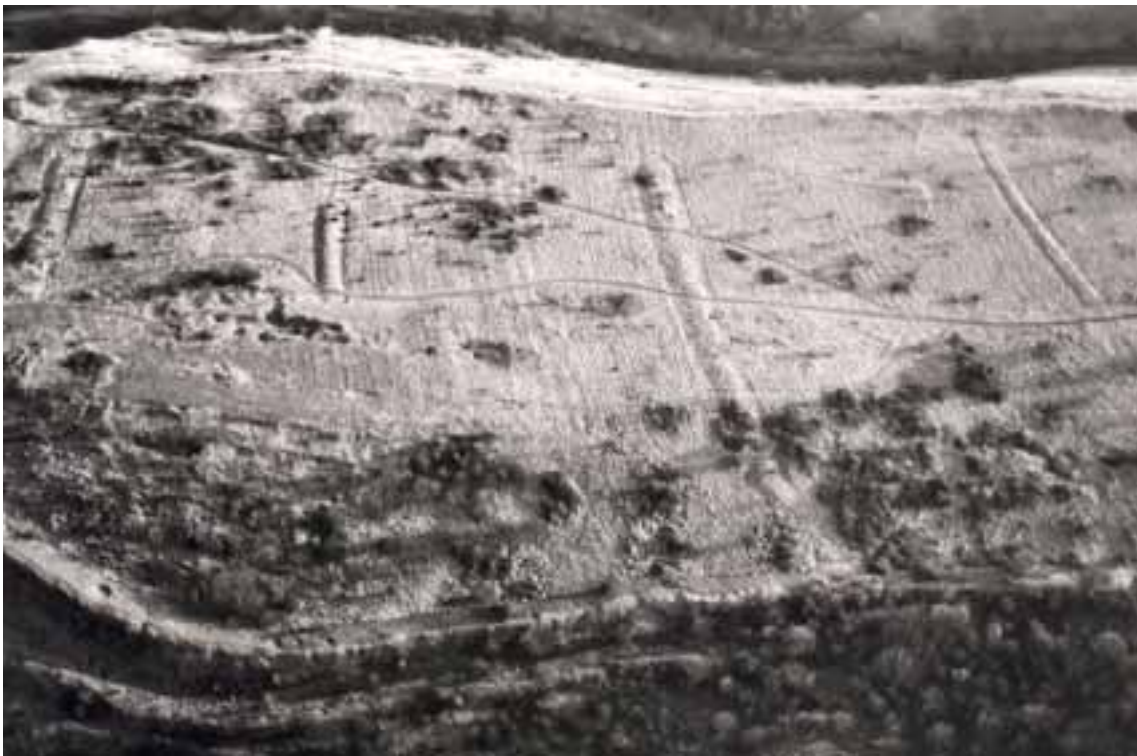
Fig 10: central part of the hillfort showing pillow mounds, vermin traps, ridge-and-furrow and quarries; 7th March 1979 (NMR ST 4559/1/105)

The most prominent features within the hillfort are a number of pillow mounds (Fig 10). Some of these (**h**, **j**, **k**, **m** and **n**) are extremely large and well formed features with steep sides and comparatively wide and deep drainage gullies along their sides; the mounds are up to 0.6m high and the ditches 0.4m deep. Others are altogether slighter (**p**, **q**, **r** and **s**), and in some cases doubtful (**t**, **u**), features without such clear side gullies; these mounds are no more than 0.4m high at most. While there are no definite chronological relationships between these features the spatial relationship of (**q**) to (**m**) and the fact that (**q**) fades out towards (**m**) suggests that the smaller mounds represent an earlier phase of activity. Certainly there is nothing that contradicts this suggestion. An added piece of evidence in support is the presence of a vermin trap, one of several on the site (see below) which is cut into the top of one of the smaller mounds (**r**); this shows that the

The ridge-and-furrow was noted by Skinner (Hollinrake and Hollinrake 1986, 8-9, fig 6) but does not seem to have been mentioned by later antiquaries. Skinner thought that the ridge-and-furrow ran over some of the slighter east-west aligned pillow mounds but, as stated above, no trace of this was noted in 2008. However, the ridge-and-furrow is clearly shown in some aerial photographs (e.g. Fig 10) and this tends to support Skinner's observation.

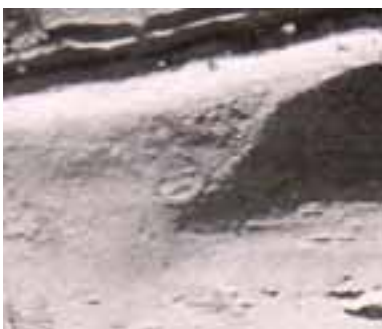
Fig 11: detail from Fig 3

A feature not noted by previous surveys (though it is partly visible on some historic aerial photographs, e.g., Fig 11) is the low circular ditched mound (w). This is believed to be another pillow mound. It is up to 0.4m high and its surrounding ditch 0.2m deep.

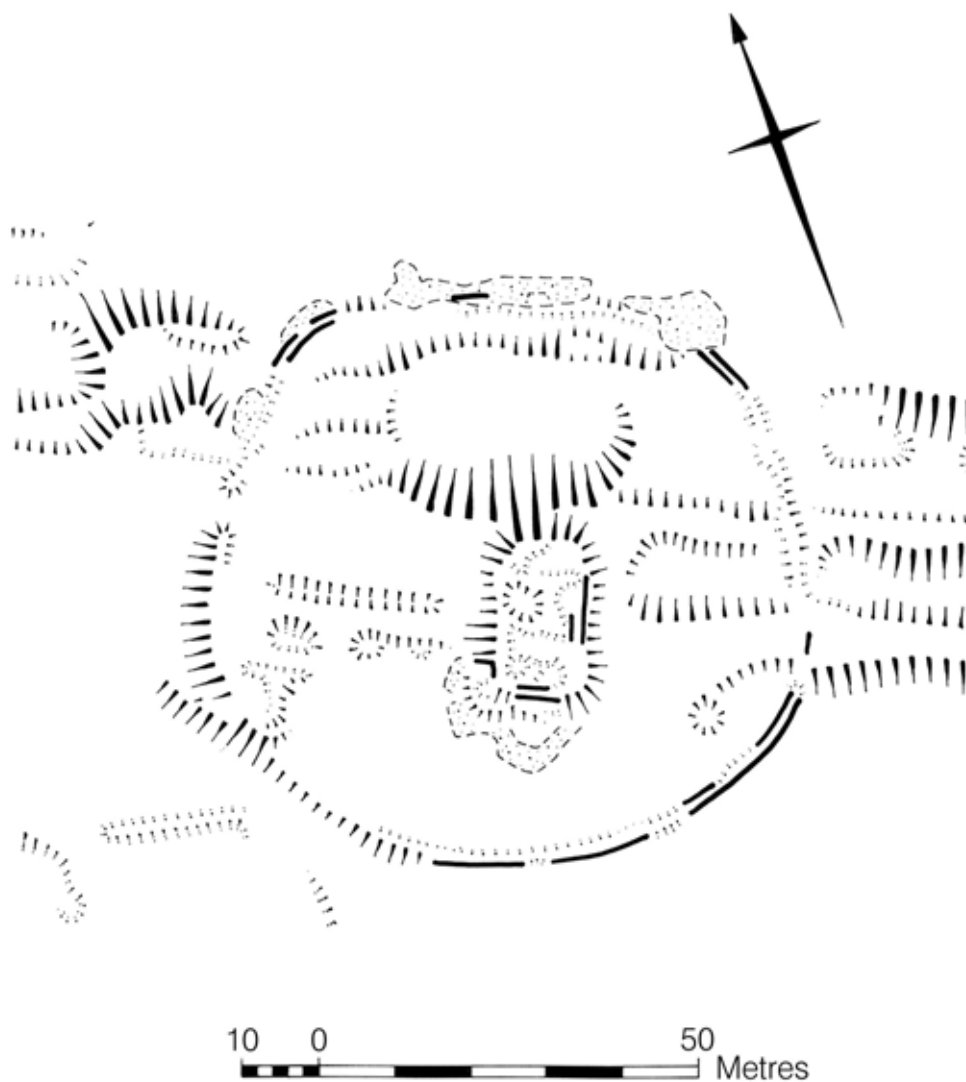
Fig 12: detail of the circular enclosure, the probable warrener's lodge and garden

The circular enclosure (x) (Figs 12 and 17) consists of a drystone wall, surviving to a maximum of 0.5m high, surrounding a knoll on which stand the remains of a well-built rectangular masonry structure. This structure survives to a height of 1.5m.

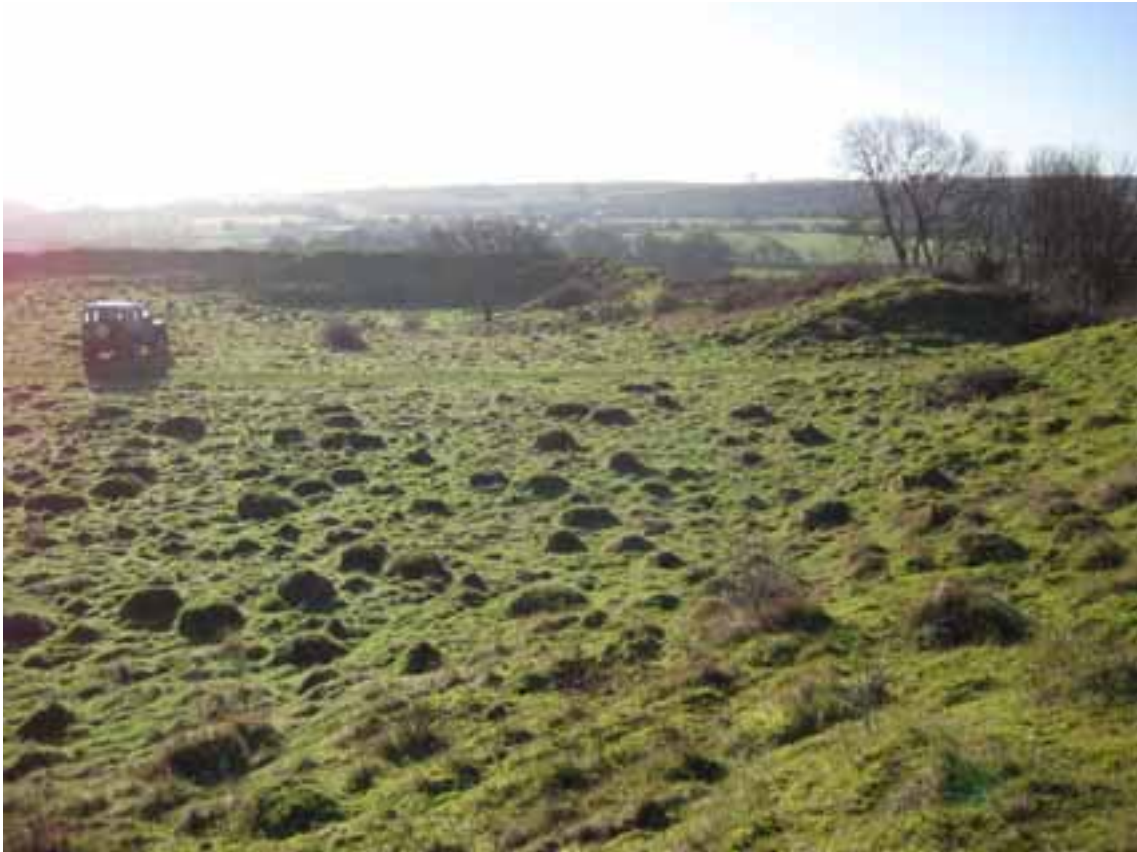
Fig 13; rectangular sunken enclosure in the south-west corner of the hillfort, beyond the western entrance (right)

Enclosure (y) is an unusual, if not unique, feature. It consists of a sunken area demarcated by a regular scarp occupying the south-western corner of the hillfort (Fig 13). The overall depth of the feature is 2.4m. On the floor of the depression is a small circular mound, 0.5m high, with a surrounding gully up to 0.2m deep and, lying against the internal foot of the western hillfort rampart, the footings of a rectangular building, standing up to 0.4m high. It is possible that it is the southern end of this building that Dymond and the Hollinrakes have interpreted as a vermin trap (Hollinrake number 21). Dymond's plan (see Fig 5) indicates a possible entrance to this enclosure in its north-western corner and this accords with what is visible on the ground now, though it is less clear than Dymond's plan indicates.

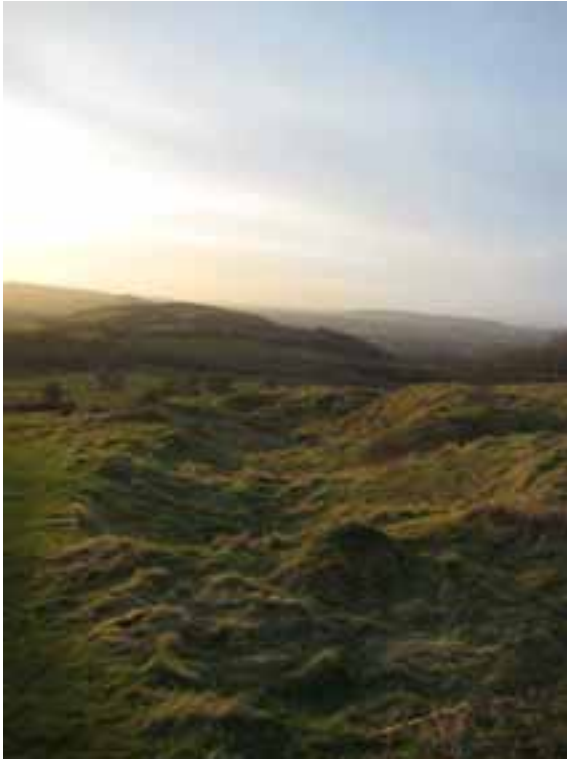
Fig 14: quarries

Quarries of various sizes are apparent in many parts of the interior of the hillfort and outside it. Most of these are grass covered (Fig 14) but a few quarry faces are visible, especially in the area near enclosure (x) and here some are of considerable depth, up to 1.7m. Some of the turf-covered quarry pits are also up to 1.5m deep but most are less than 0.5m. In all cases where chronological relationships can be seen the quarries are shown to be relatively late features. There are examples of both pillow mounds and ridge-and-furrow that are cut by quarries. There is an extensive area of exposed bedrock on the northern shoulder of the ridge within the hillfort and above vermin trap 7; this has presumably been quarried but no definite quarry faces can be identified.

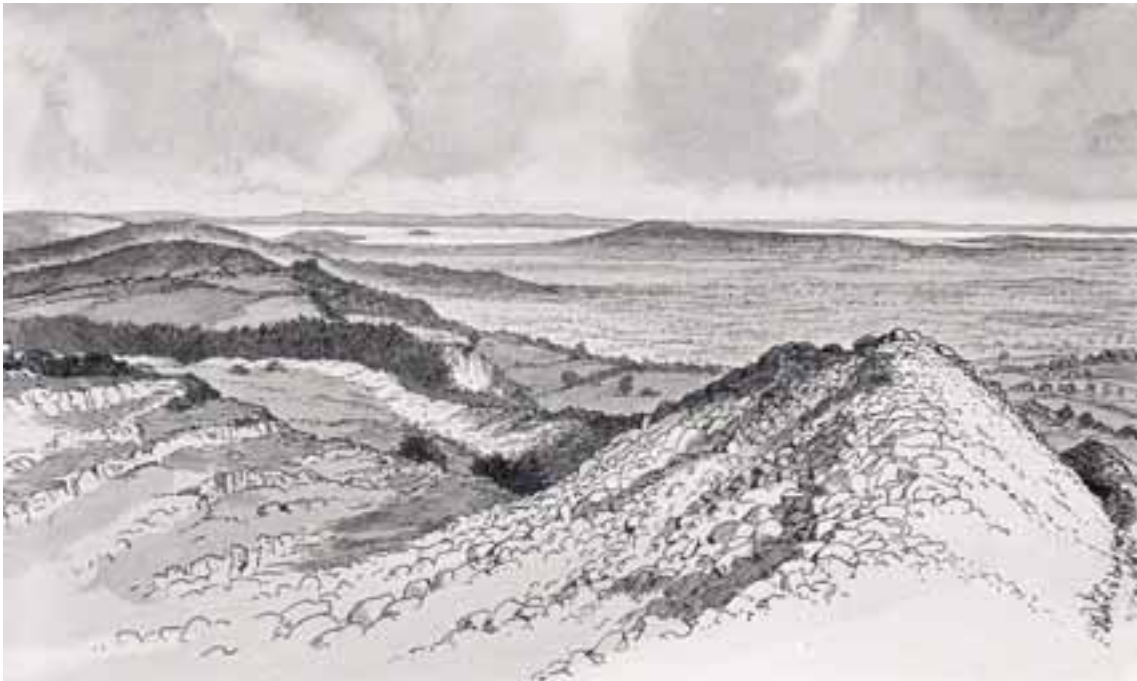
Fig 16: Edward Burrow's evocative drawing (1924) shows the northern rampart and the low ground to the north and west, with Brean Down and Worlebury in the distance; Dinghurst is on the ridge immediately beyond the 'Churchill Gap' with Banwell Camp beyond

The relation of the hillfort to other Iron Age sites in the vicinity needs to be explored. Unfortunately, though there are other enclosures nearby, at Dinghurst immediately to the west with Banwell Camp beyond (Fig 16), and at Burrington to the east, for instance, none of these is securely dated so whether they are strictly contemporary is unknown; a more interesting relationship may be to some of the caves and swallets in the area, such as those in Rowberrow Bottom, for instance. Read's Cavern and Rowberrow Cavern, like other Mendip caves, have both yielded Iron Age artefacts (Tratman 1931 and refs therein; Taylor 1926). In summing up this material, Fowler was inclined to view it as evidence of occupation and remarked that caves were a 'significant part of the settlement pattern' (1970, 21). It is, however, unlikely that caves were occupied as part of the normal pattern of Iron Age domestic or agricultural life. More probably the artefacts found there, which include bronze brooches, are the result of special ritual or religious activities. If there was 'occupation' it may have been by seasonal herders bringing domestic animals up into the hills for the summer grazing. The hillfort itself may also have played a role in such a transhumant system, though precisely what that role might have been remains obscure.

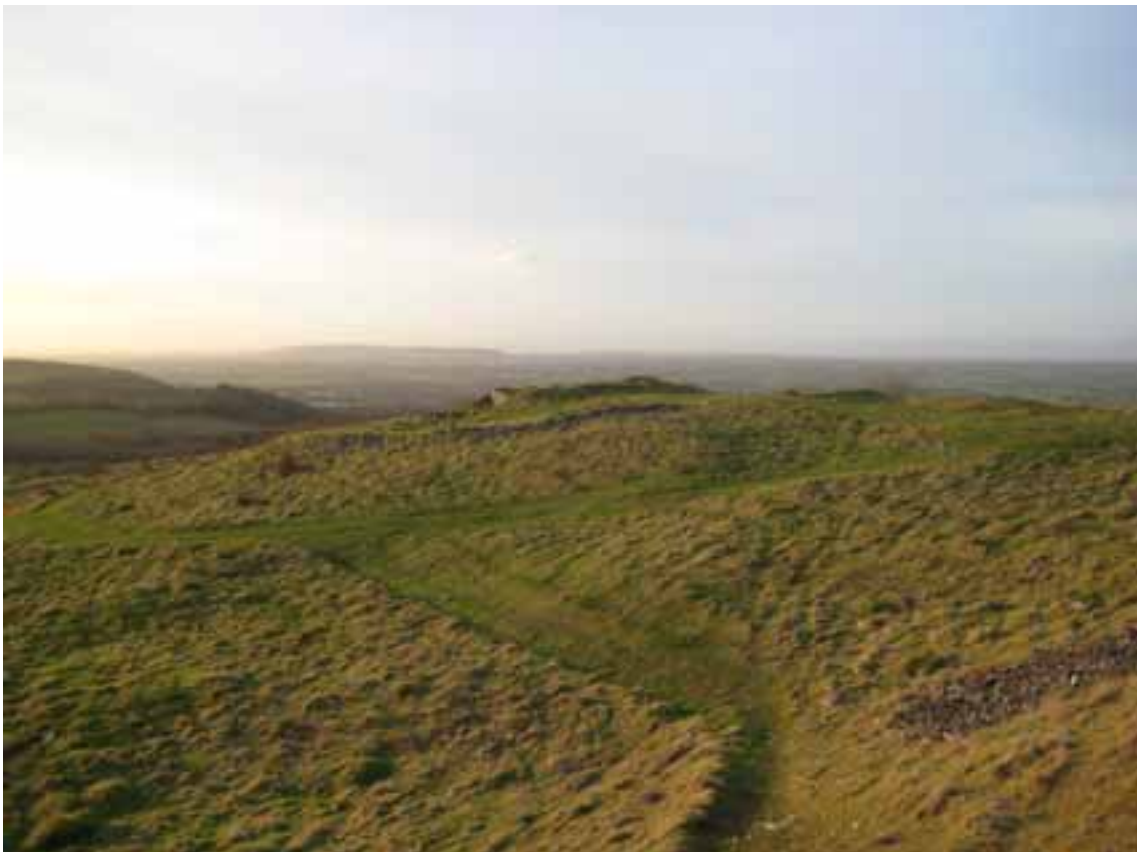
Fig 17: the warrener's lodge and its enclosure

The Hollinrakes accept what appears to be the traditional interpretation, reported by Dymond (1883, 106), of the circular enclosure and its building, that this was the warrener's lodge and garden (Fig 17). They suggest that it was a three-storey building with storage on the ground floor and living accommodation above 'and a lookout over the warren and ridgetop' (1986, 9). Its date is unknown but it was in ruins by 1830 (*ibid*). The tower-like form of the building might suggest more than just a warrener's lodge – possibly a beacon or folly – but medieval and early post-medieval warreners' lodges could be elaborate buildings, often adopting a tower form and often occupying commanding positions with wide views (Williamson 2007, 26, 82-8). The position is similar to that of a hunting lodge in a deer park – and for similar reasons: the warrener needed to be able to oversee his stock and keep watch for intruders; and warrens, like parks, were symbols of lordly authority (*ibid*, 155ff). There is no evidence for a deer park at Dolebury, except possibly for the outer earthworks ascribed by the Hollinrakes to the Iron Age; however, these do not conform to the typical 'signature' of a park pale. The circular stone-walled enclosure in which the tower sits could have been for the warren dogs, as well as a garden.

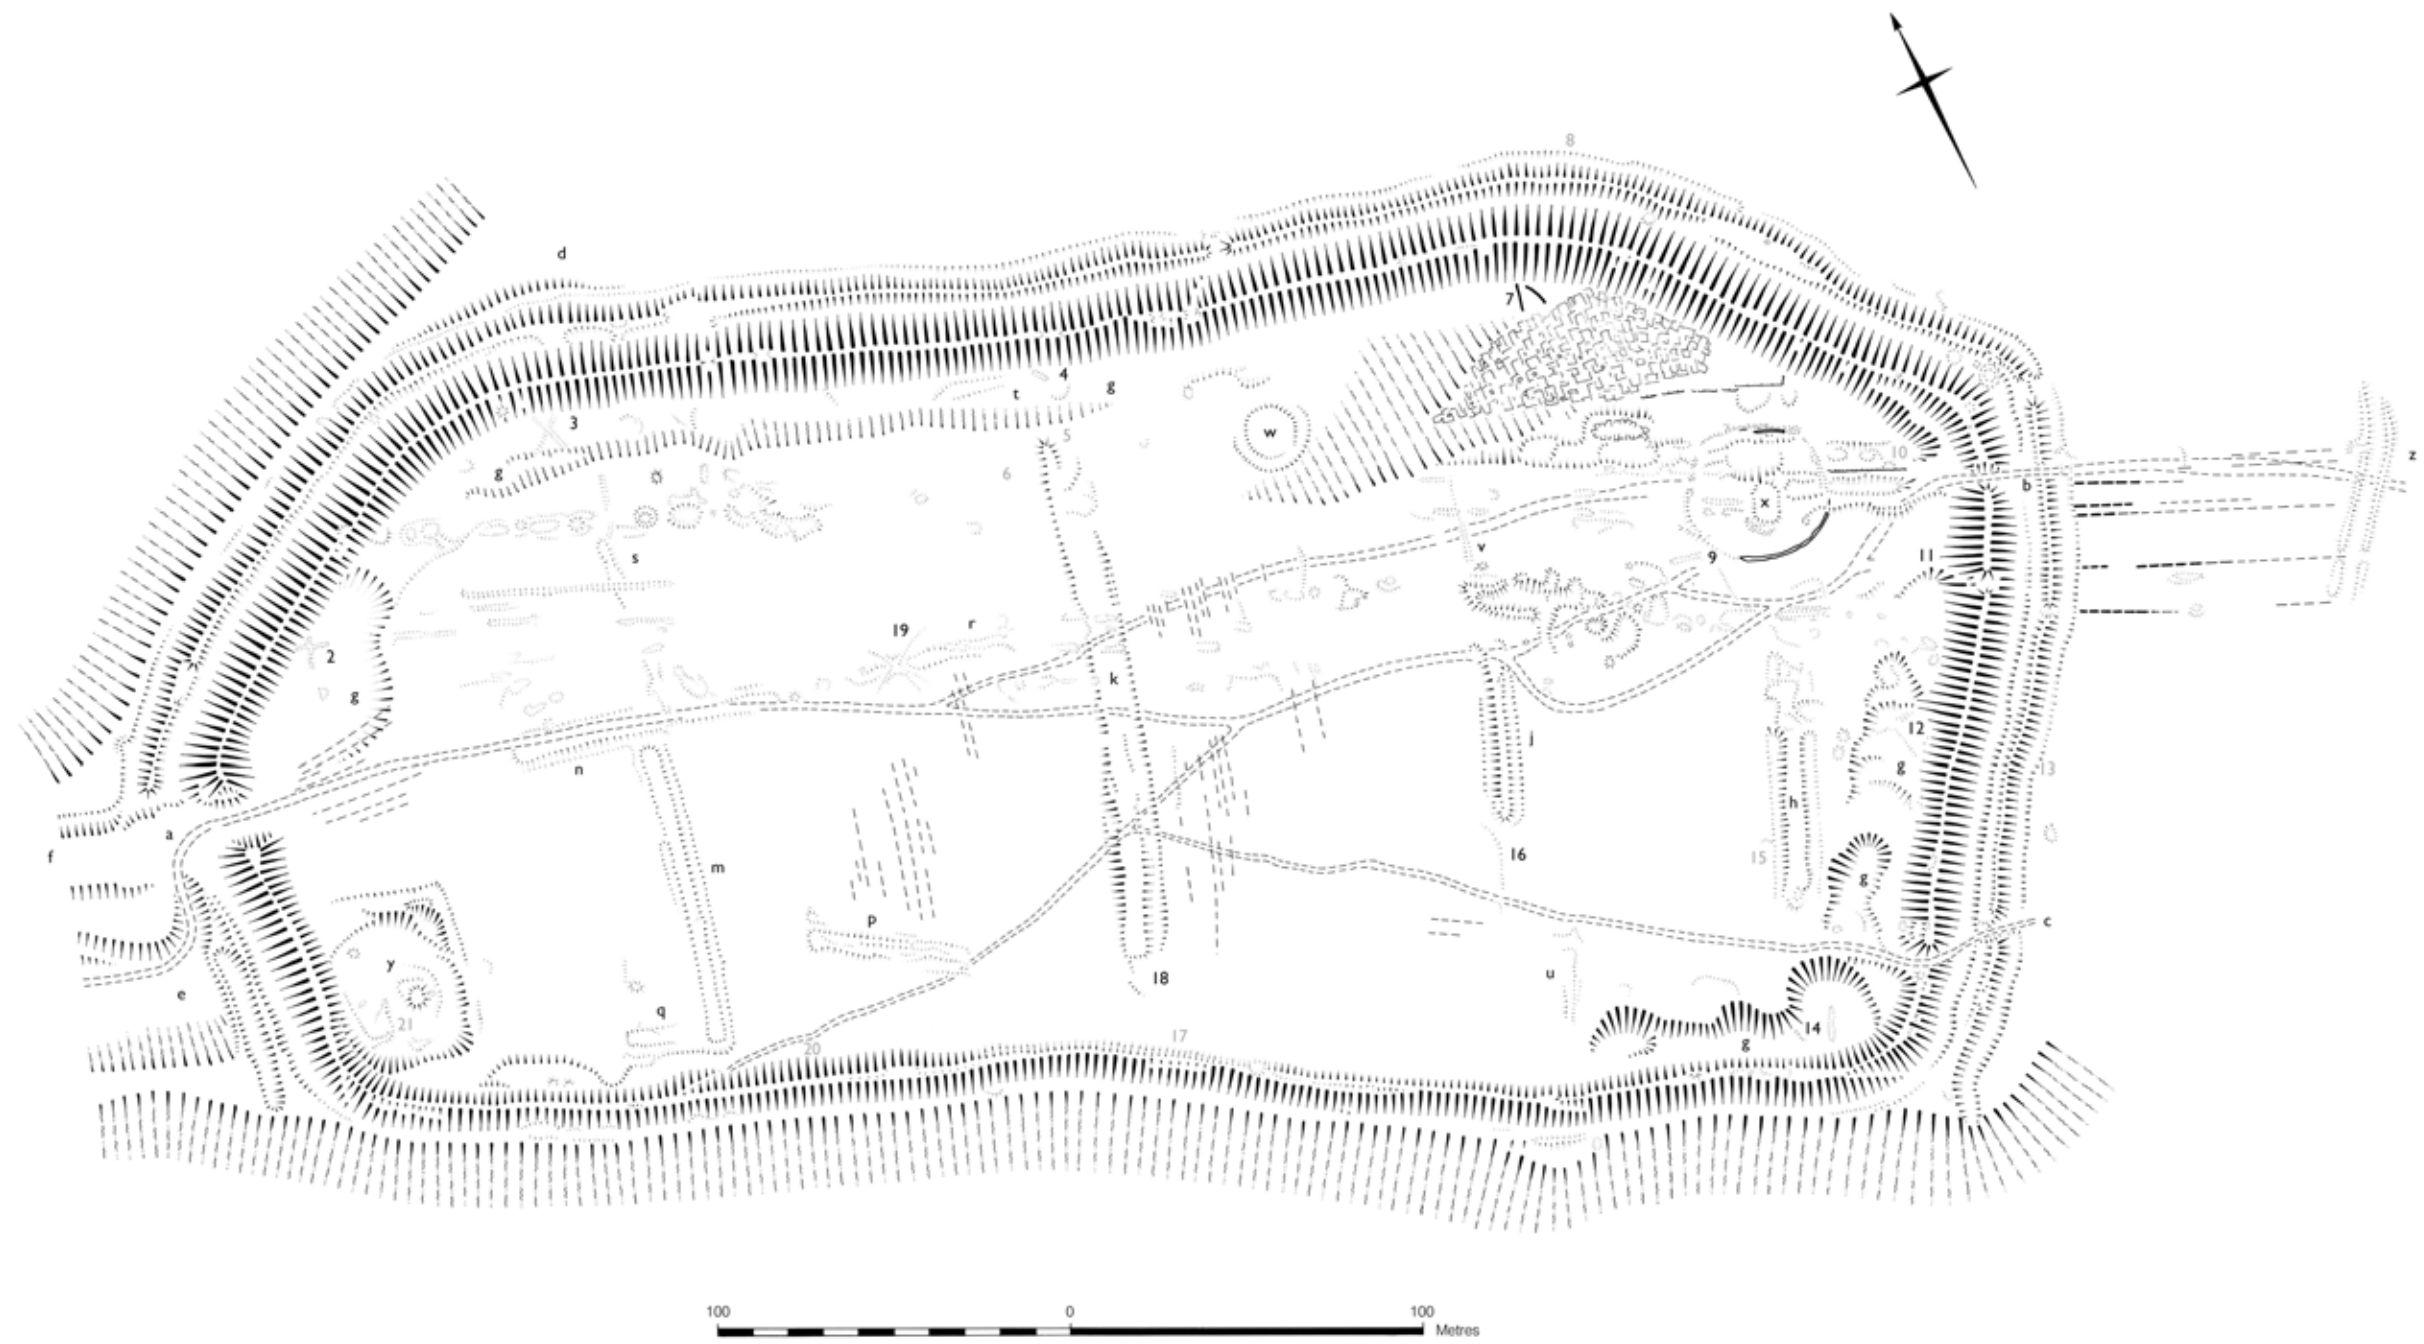
Fig 7: survey plan reduced from 1:1000

The letters and numbers in the text refer to Fig 7 (inside back cover).
