AUDLEY END HOUSE,  
SAFFRON WALDEN, ESSEX  
SUPPLEMENT TO AUDLEY END STABLES  
HISTORIC BUILDINGS REPORT

**SUPPLEMENT TO AUDLEY END STABLES  
AUDLEY END HOUSE  
SAFFRON WALDEN, ESSEX  
HISTORIC BUILDINGS REPORT**

This supplementary report has been compiled in response to a request for further information from Andrew Hann, Senior Properties Research Historian in Research & Standards, Properties Presentation, about a number of minor buildings, which form part of the stable complex at Audley End House. These include the New Coach House, the Tack Room and the Steam Engine House, plus the surface of the stable yard.

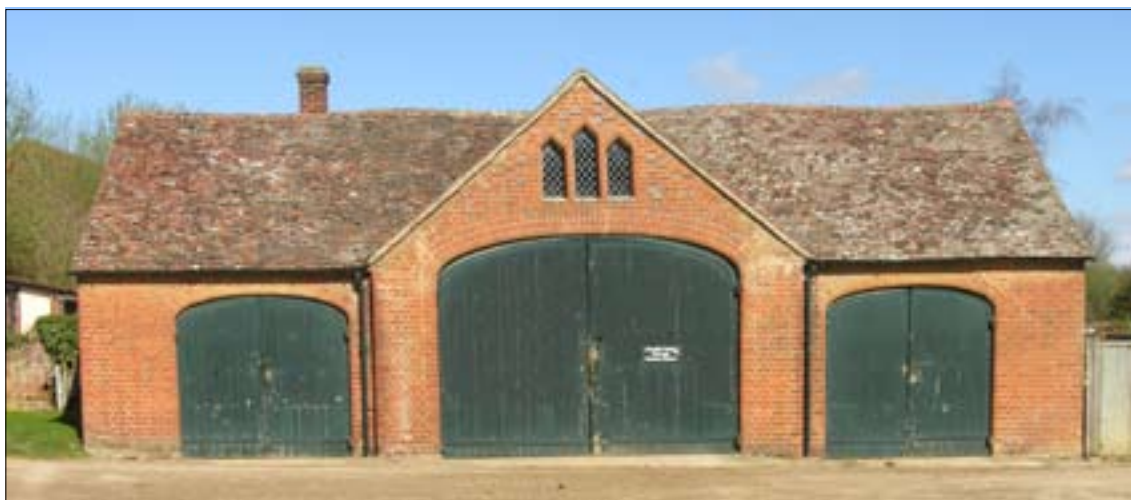
*Fig. 1. The New Coach House probably designed by Richard Hussey c.1875.*

This detached building is constructed of brick in a variety of bonds. There is evidence under the eaves that this building was originally lime-washed. It has a slightly projecting central gabled section with a broad segmental arched doorway and double plank doors. Either side are single similar though slightly smaller segmental arched doorways with double plank doors. In the gable above the central archway is a three-light brick mullion window with graduated and pointed lights and leaded diamond panes. There are similar windows in the gables to the east and west, which each have a three-light casement window as well. The rear façade (fig. 3) is blank with a tall external brick chimney stack which served a forge in the western section of the building. This stack is not keyed into the rear wall suggesting that it is a later addition. It is stepped with cut brick off-sets; the upper section of this stack has been rebuilt and extended.

The new coach house (fig. 1) is situated on the north side of the present stable yard. It does not appear on any of the 18<sup>th</sup> century surveys or garden plans, though it does appear on the Ordnance Survey Map of 1877 (fig. 2). It was therefore probably built for the 5<sup>th</sup> Lord Braybrooke and designed by his architect, Richard Hussey. The brickwork and the architectural detailing are similar to the gardener's house which is dated 1875.

This new coach house is prominently sited immediately opposite the north front of the main stable building, and the architectural details, especially the brick mullion windows were consciously designed in imitation of the original stable. This relatively plain and functional late 19<sup>th</sup> century building contributes successfully to the larger group of buildings which form this stable yard.

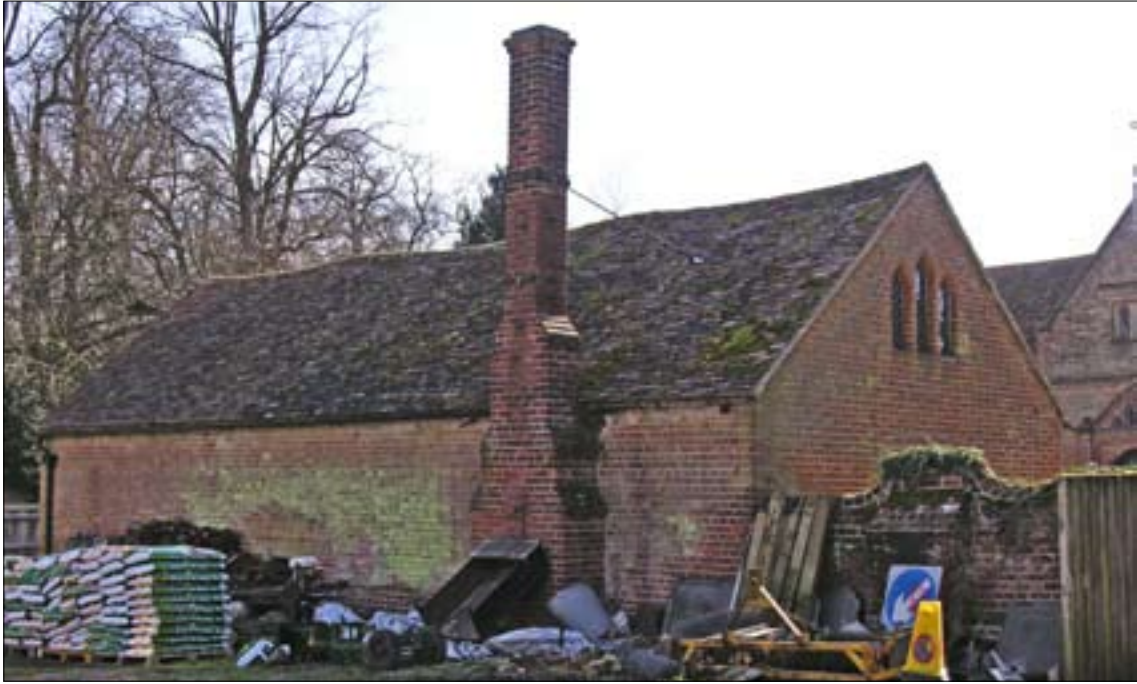
Fig. 3. The north and west fronts of the New Coach House showing the external brick chimney stack to the former forge.

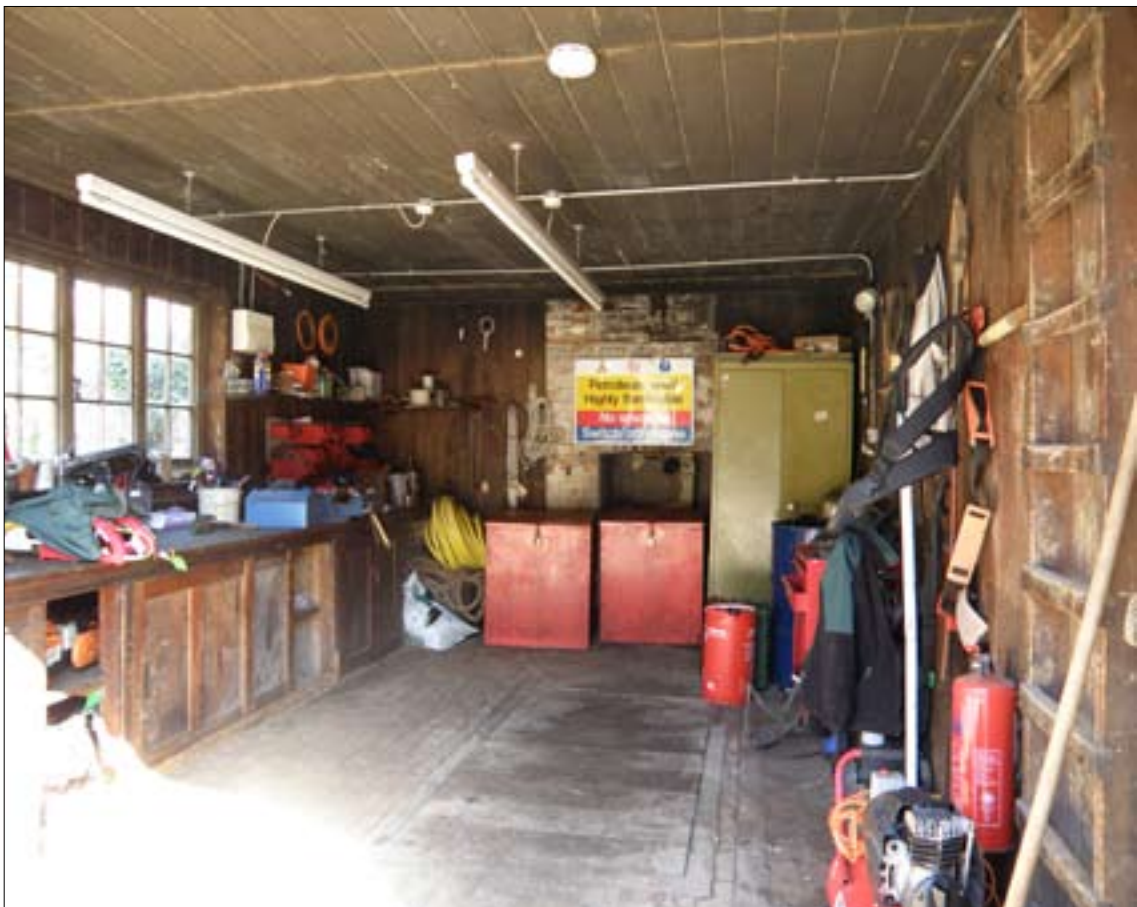
Fig. 4. The interior of the New Coach House converted into a motor garage in the early 20th century.

The building is divided into three internally. The central section with its large doors was intended to house grand coaches. It has a concrete floor and the walls are lined with plank panelling. The eastern section was presumably designed to house smaller coaches or possibly carts. It has a brick floor and an attic. The western coach house appears to have been converted at sometime into a forge or smithy, though only the chimney breast survives as evidence of this (fig. 4). The brick floor has a central 'inspection pit' which was inserted in the early 20<sup>th</sup> century for the servicing of motor cars. The walls are lined with plank panelling and there are fitted cupboards and work benches along its western wall; these too were presumably added when it became a motor house. There is a permanent ladder against the eastern wall giving access to an attic. The double doors to all of these coach houses are embossed 'MOW' suggesting that they were renewed in the mid-20<sup>th</sup> century after Audley End became the property of the Ministry of Works.

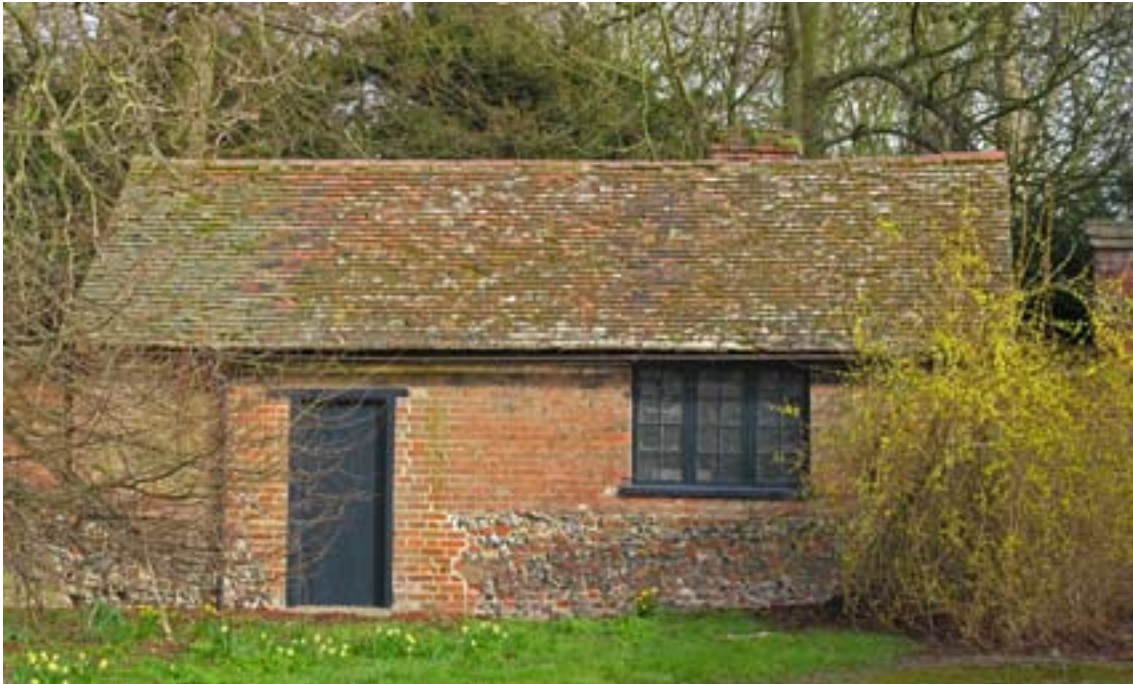
*Fig. 6. The west front of the Tack Room.*

The single storey tack room was constructed in two phases; the larger southern section and a small addition to the north. It has a plank door and a three-light casement window, similar to the casement windows surviving on the coach house (see above), on the west front (fig. 6). The south front has a single plank door; the north front has a plank door and a two-light window and the east front has a small window and a single external chimney stack. The building has a plain tile roof.

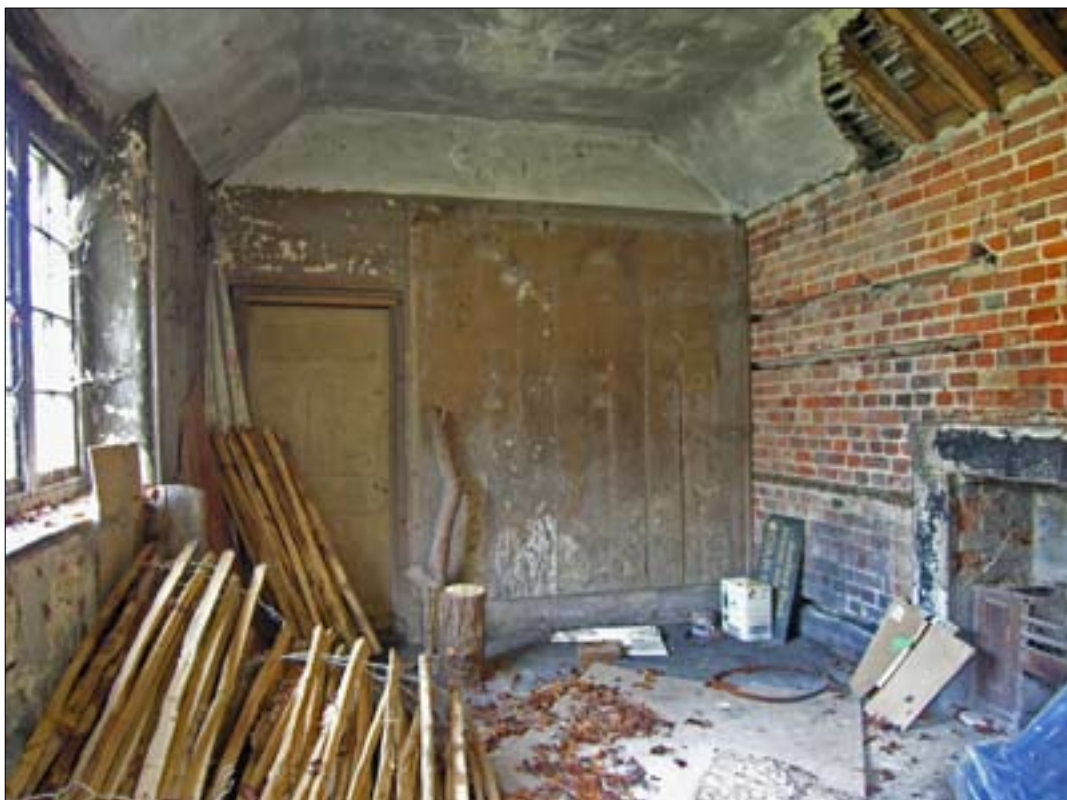
Internally this building is divided into three rooms. The additional northern room, only accessed from the north, now contains a W.C. The remaining two rooms which formed part of the original building are divided internally by a timber partition wall. The smaller northern room, accessed from the west doorway, which appears to have been a storeroom, now contains oil storage tanks. The larger room to the south (fig. 7) is accessed from the south doorway. It has a fireplace on its east wall with a stone fireplace (fig. 8) which may well have been re-used, and an iron basket-grate which may well also have been re-used. This east wall has had its plank panelling removed though the timber ties buried in the wall, to which the former panelling was attached, are clearly visible.

*Fig. 7. The interior of the Tack Room.*

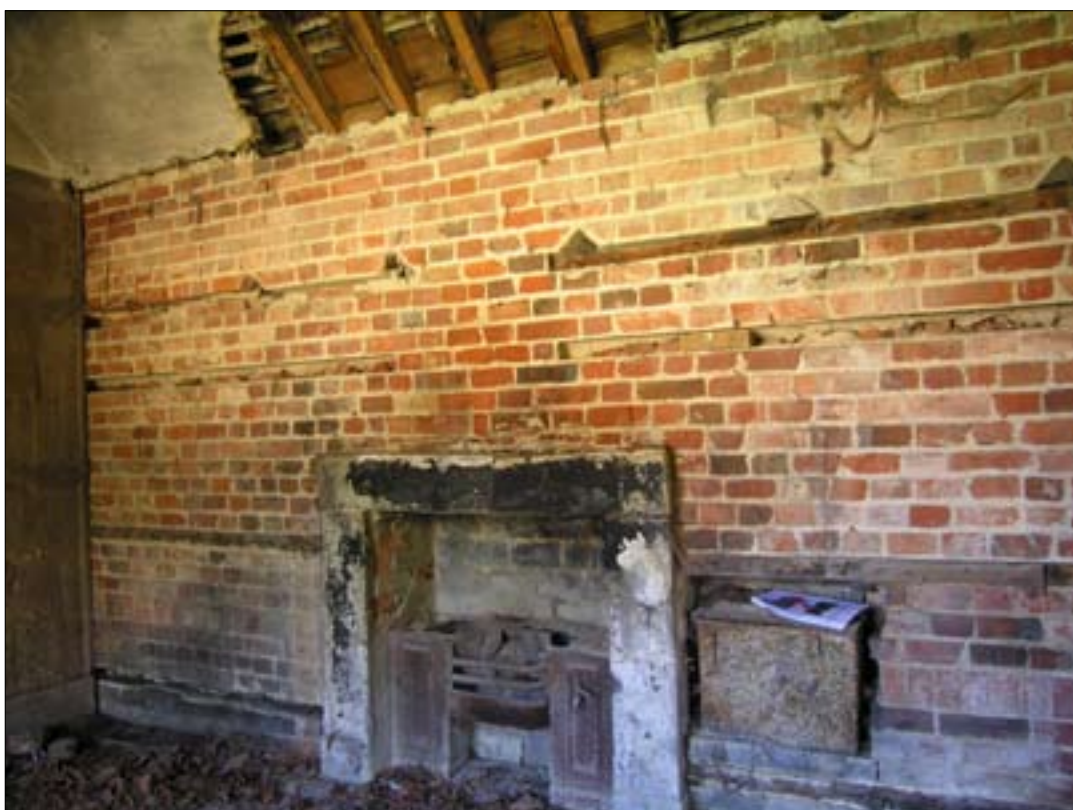
*Fig. 8. The fireplace in the Tack Room.*

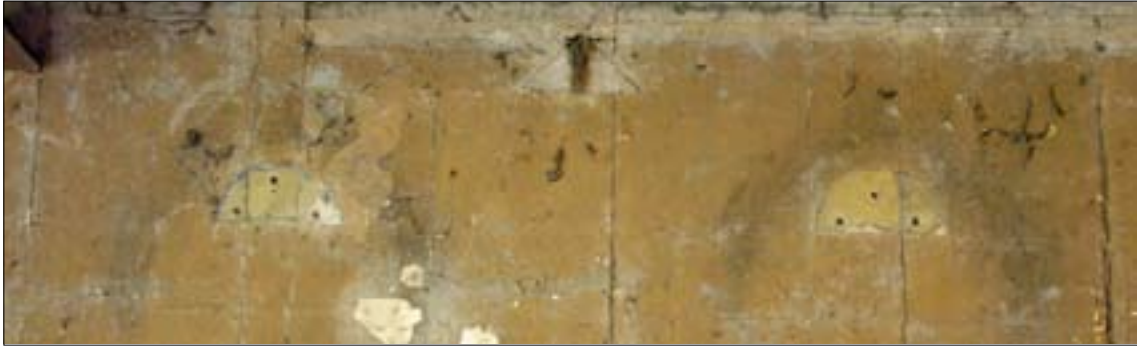
*Fig. 9. The scars for fittings to support saddles in the Tack Room.*

On the surviving plank panelling on the north wall there are the scars of two rows of round headed fixings and the scars of saddles which once sat upon these fittings (fig. 9). Probably further fixings to support other pieces of riding tackle once existed on the lost panelling on the east wall. All this confirms the suggestion that this was the tack room before the later tack room was inserted into the western end of the coach house within the main stable building in the early 20<sup>th</sup> century (see main report pages 16 and 44).

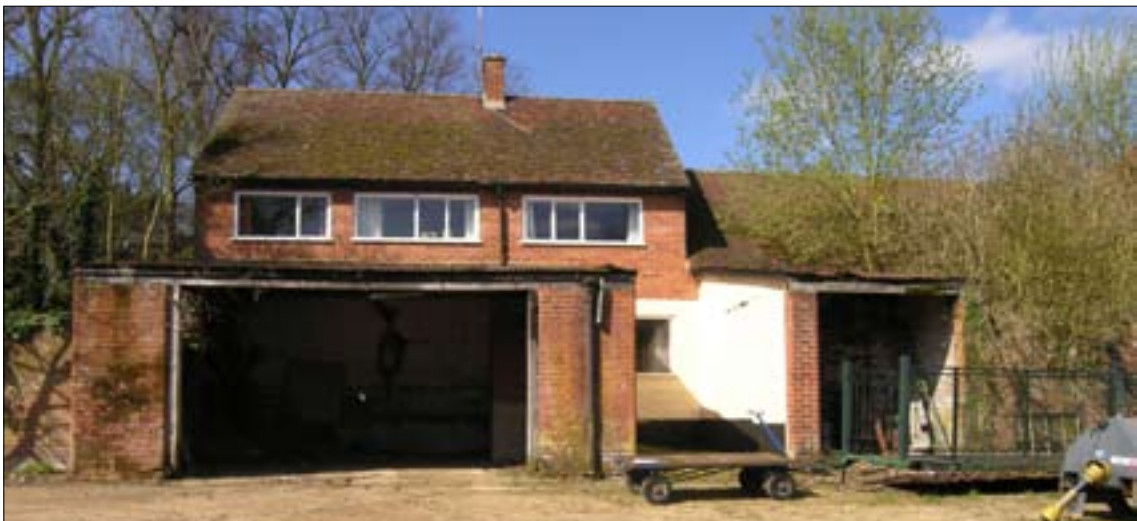
The steam engine house (fig. 10) is a lean-to structure attached to the north wall of the house at the south end of the barn range, on the west side of the stable yard. It was built as part of a longer lean-to structure originally, which extended further to the north. The lean-to to the north had its roof removed when the house was converted in the late 20<sup>th</sup> century, though its walls still survive. The final section of this lean-to survives further to the north.

*Fig. 10. The Steam Engine House.*

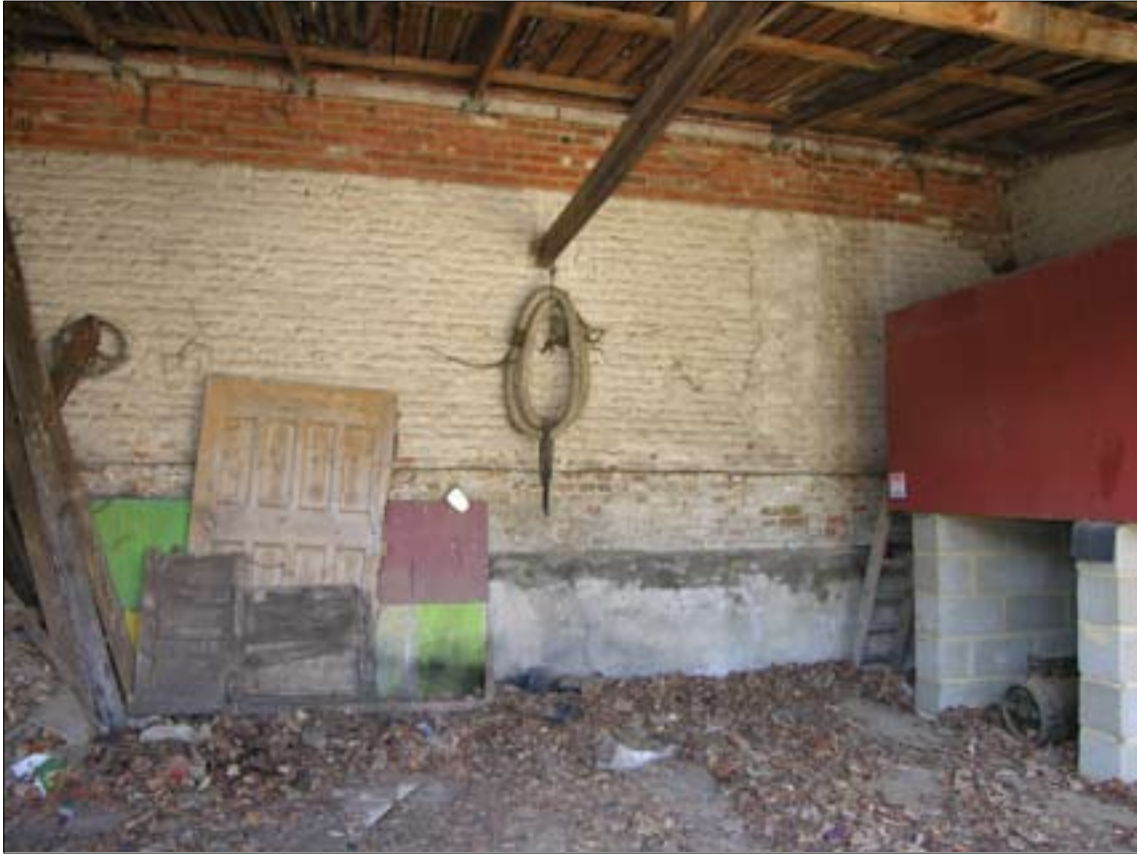
Fig. 11. The interior of the Steam Engine House.

The steam engine house consists of two brick side walls with a very large opening occupying almost its entire eastern front. The side walls and the small sections of walling to the east front are constructed of large bricks laid in Flemish Bond. It has a single pitch corrugated iron roof and a concrete floor. The walling against which this building is built is 17<sup>th</sup> century brick walling, part of the barn demolished in the late 19<sup>th</sup> century. There is no surviving evidence of a chimney stack, nor is there any evidence of footings for an engine (fig. 11). The roof was replaced in the 20<sup>th</sup> century.
