APETHORPE HALL,
APETHORPE,
NORTHAMTONSHIRE
THE LONG GALLERY PANELLING
RECORDING AND ANALYSIS REPORT

Research Department Report Series 67-2009

**THE LONG GALLERY PANELLING
APETHORPE HALL
APETHORPE, NORTHAMPTONSHIRE
RECORDING AND ANALYSIS REPORT**

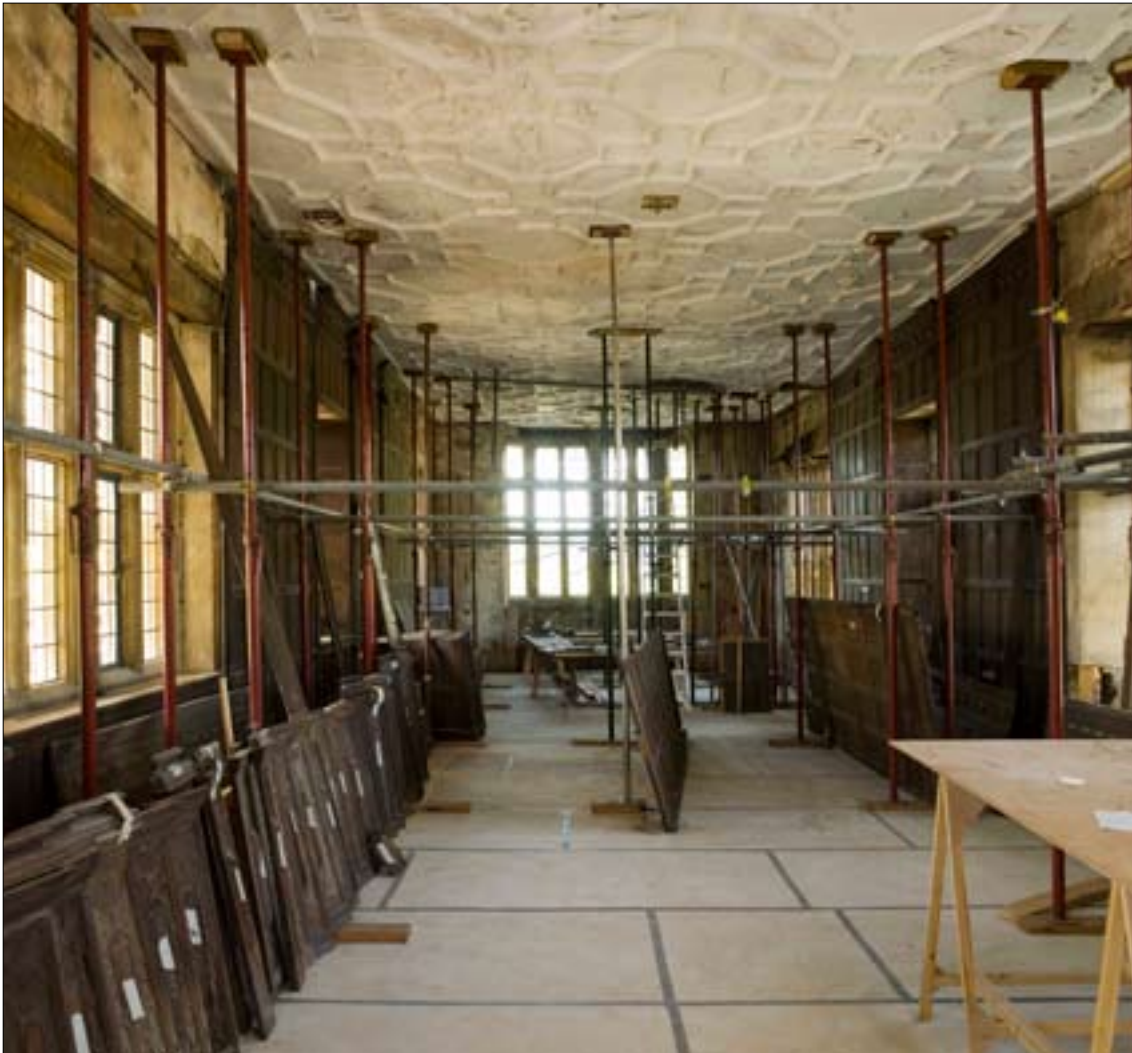
Figure 1. The Long Gallery during repair works in 2006.

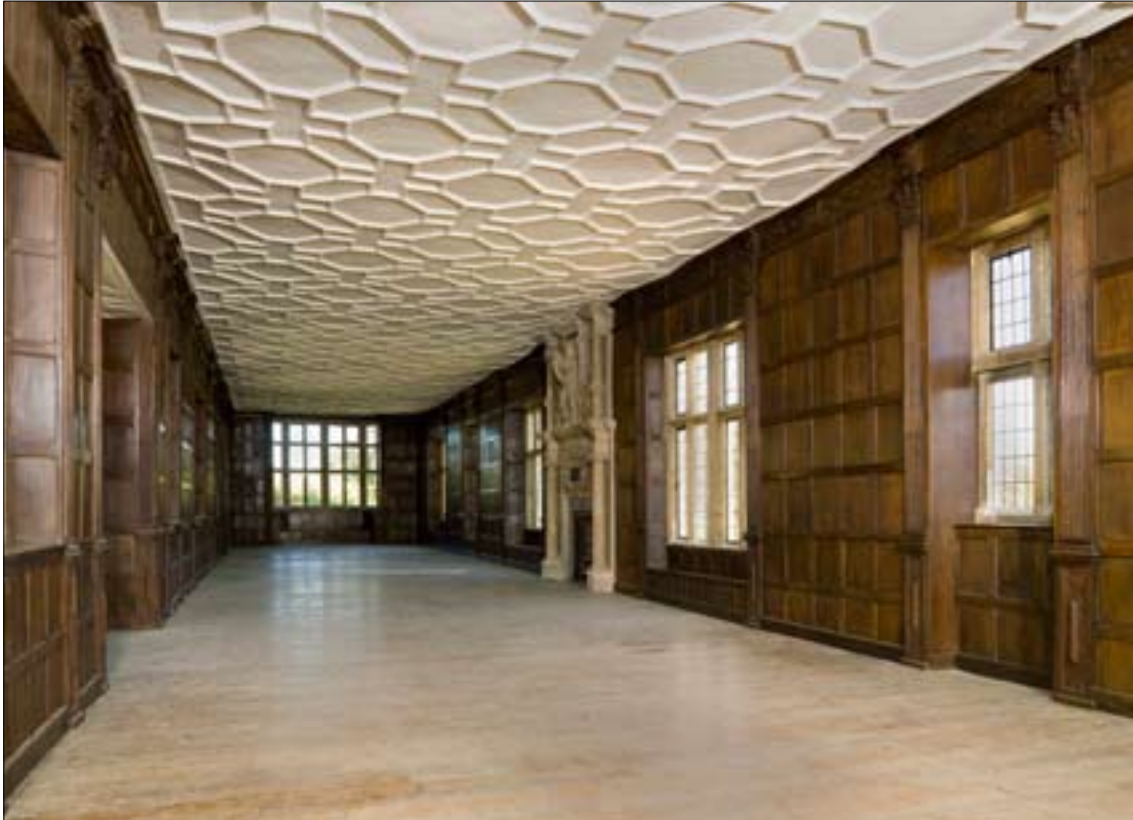
Figure 2. The Long Gallery at the completion of repairs works in 2008.

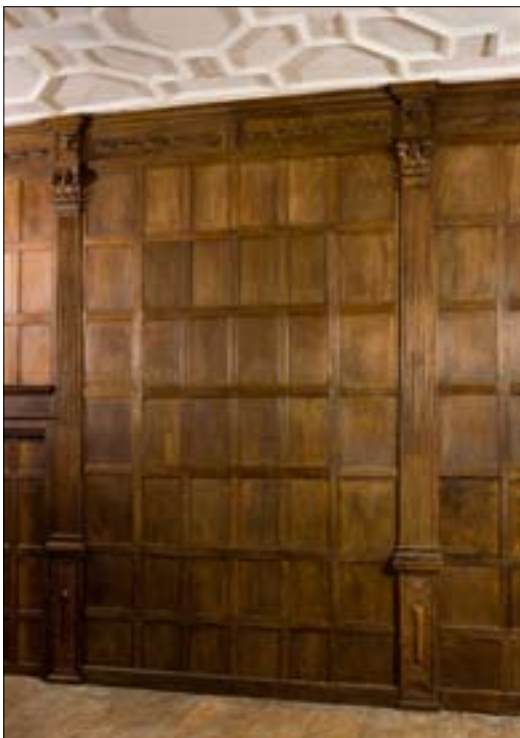
Figure 3. Typical section beside the north-west doorway in 2008.

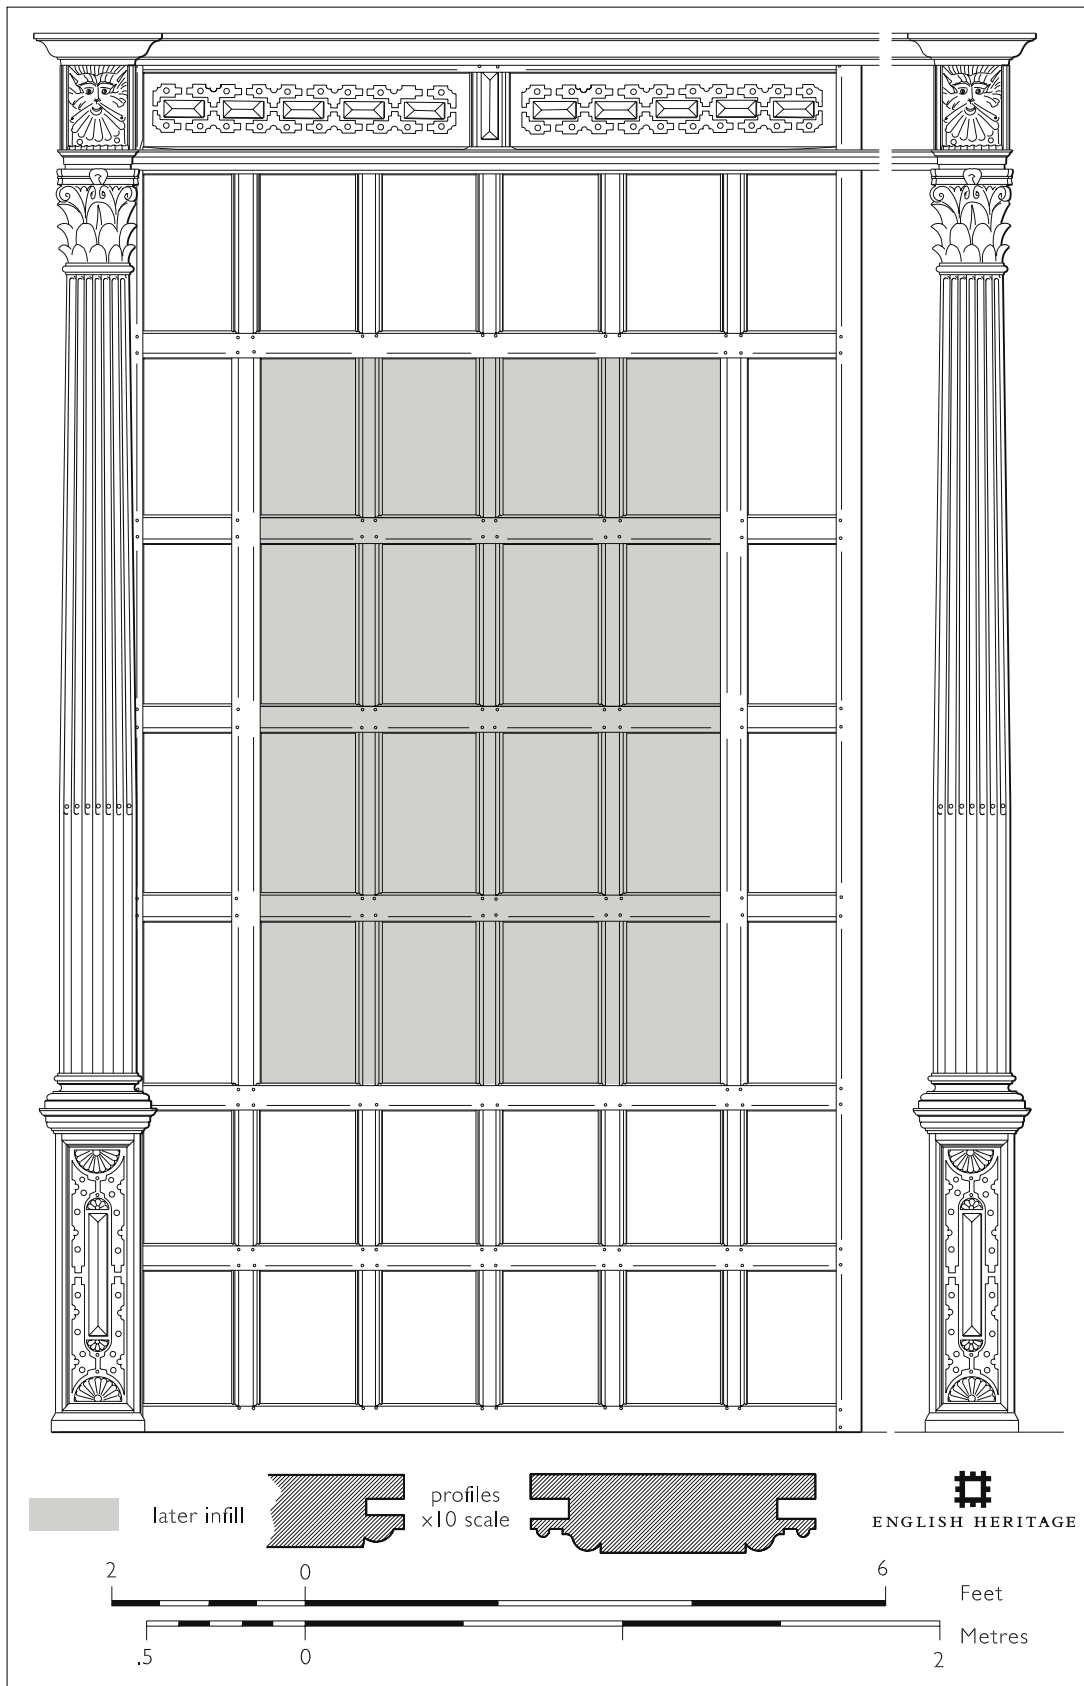
Figure 4. Record drawing of a typical panel section (27/28).

Dimensions for timbers all vary slightly, the figures given here being taken from a typical, well-preserved panel section, no. 27/28. The outer frame has stiles c.75mm wide by c.29mm thick, the top rail c.80mm wide by c.25mm thick, and the bottom rail c.90mm wide, by c.25mm thick. The inner stiles are c.80mm wide and c.25mm thick. The short vertical muntins and the horizontal rails are c.85mm wide and c.22mm thick. The thickness of each member is clearly graded with care and economy, to suit its purpose. All these members have original joints of mortice and tenon type, with two oak dowels of c.5mm diameter. The panels have flat faces and are set into grooves 5mm wide by 12mm deep in the framing. The rear face has a rather irregular chamfer on all four sides, to form a thinner edge so that the panel can fit into the groove. All original panels are formed of a single piece of oak c.8mm thick in the central part.

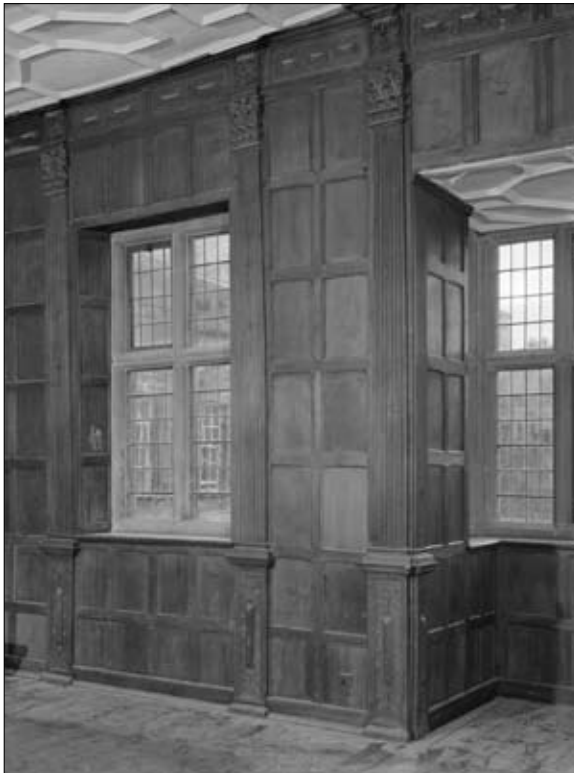
Figure 5. Section of panelling beside western bay window in 1978.
© NMR BB78 8598

panelling was of oak, except for various sections, particularly at lower level, which had been substituted with plywood in the 1950-82 period (replaced in oak in 2006-7).

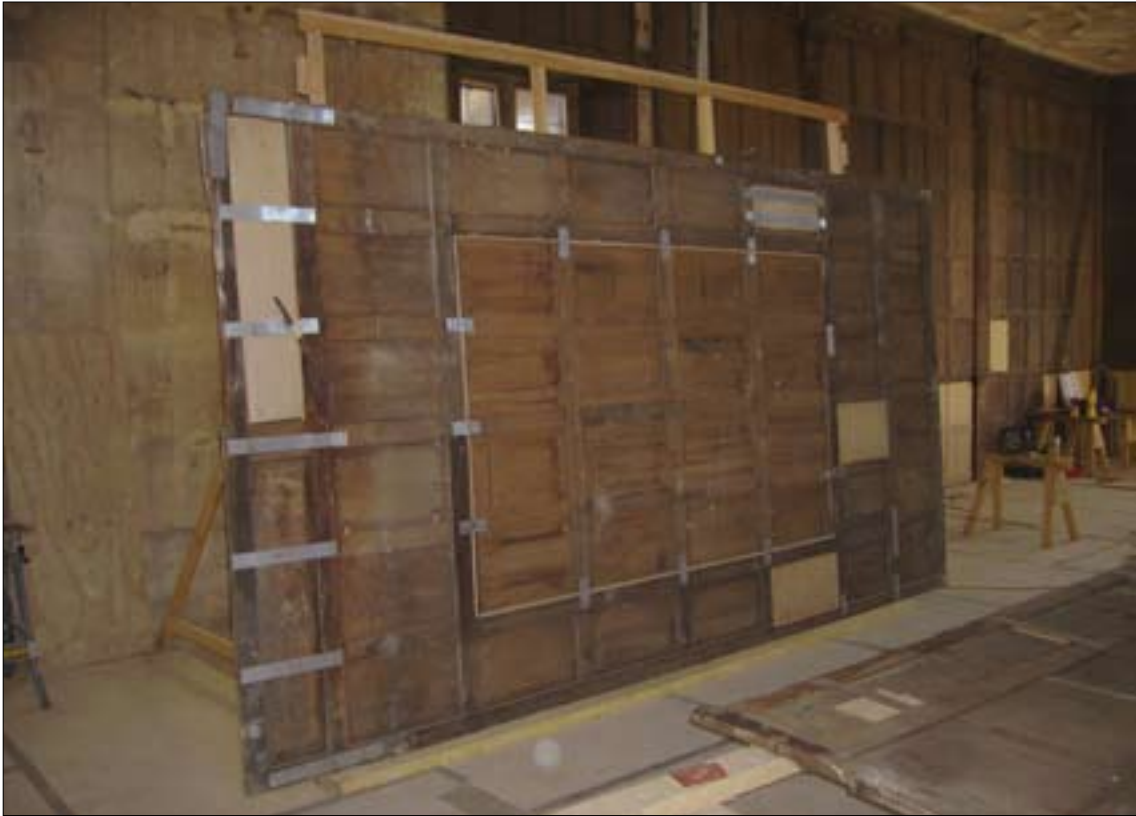
Figure 6. De-mounted section of panelling showing the blocking to portrait opening.

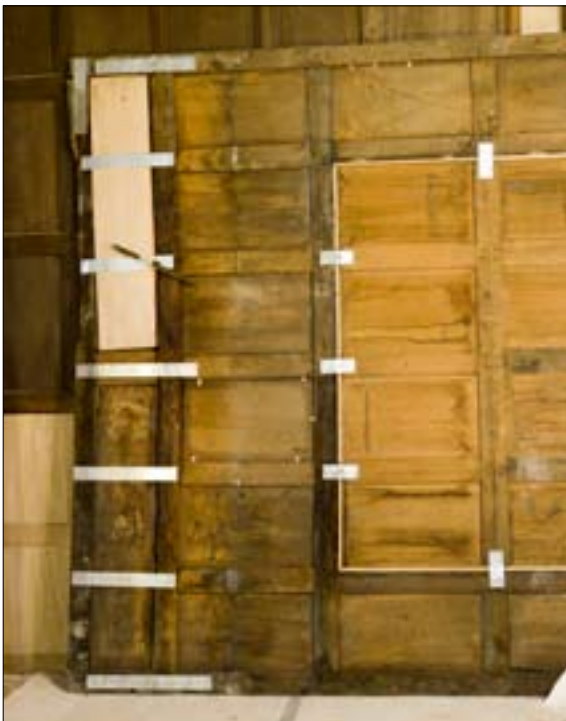
Figure 7. Detail of rear of panelling.
© English Heritage DPO29338

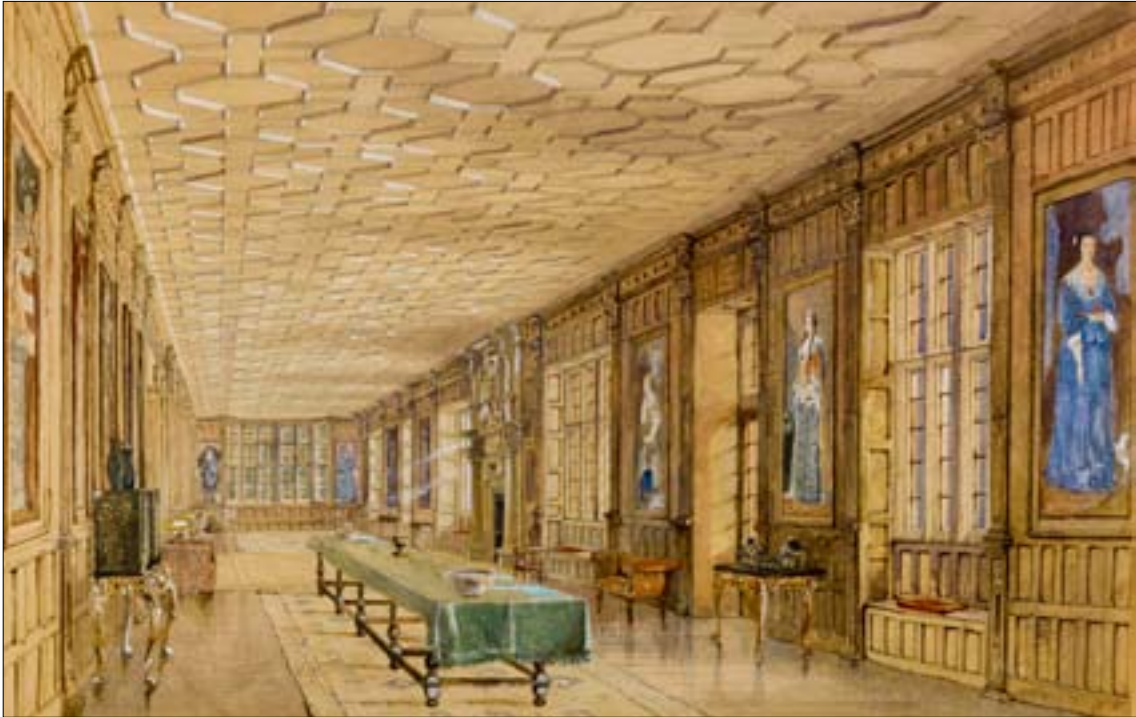
Figure 9. Drawing of the Gallery in c.1846 by Bradford Rudge, looking north-east.

Most of the evidence for the 1703 alteration on the rest of the east side was removed when radiators were inserted into these window openings during the School period. However, the awkward half-height extra panel can be clearly seen on the southern window reveal in a photograph of 1904 (see fig. 10) and also on at least three windows in the Bradford Rudge watercolour of c.1846 (see fig.9).

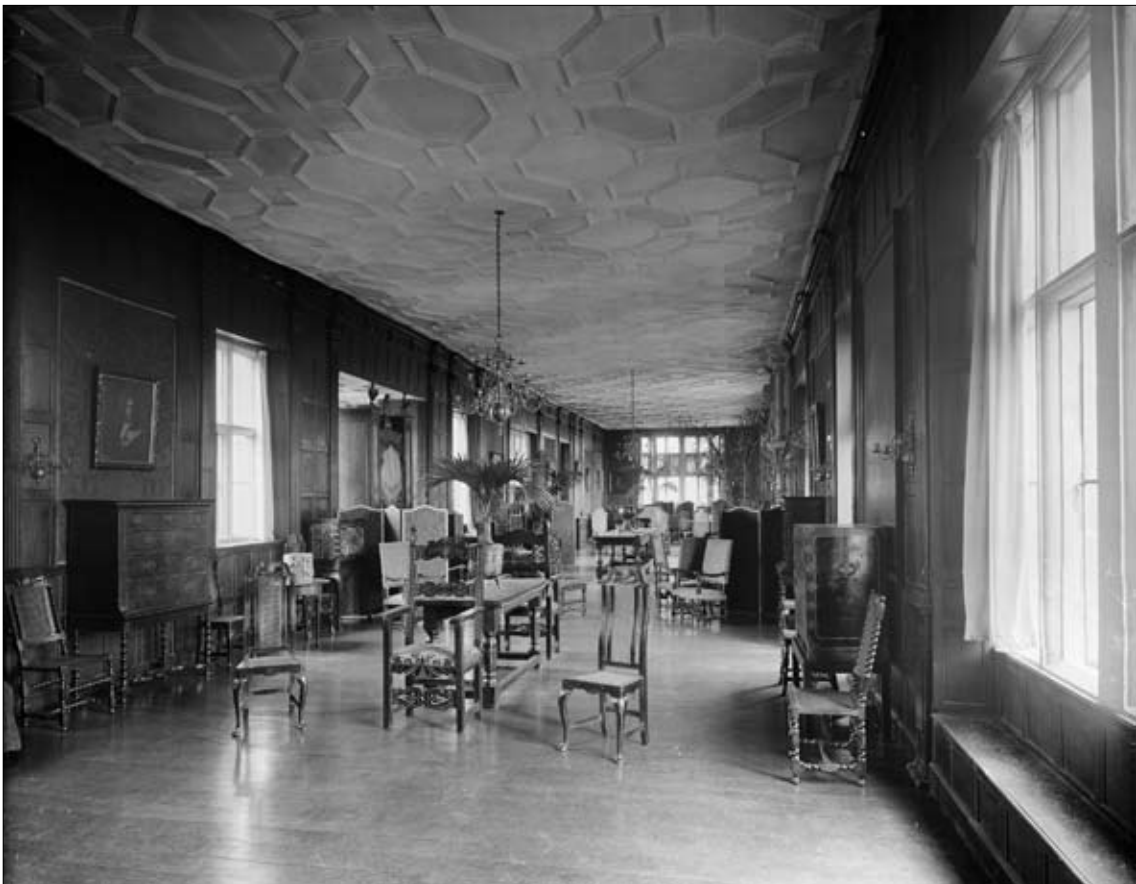
Figure 10. The Gallery looking north-west in 1904 by Bedford Lemere. The original portrait holes are covered with stretched damask.

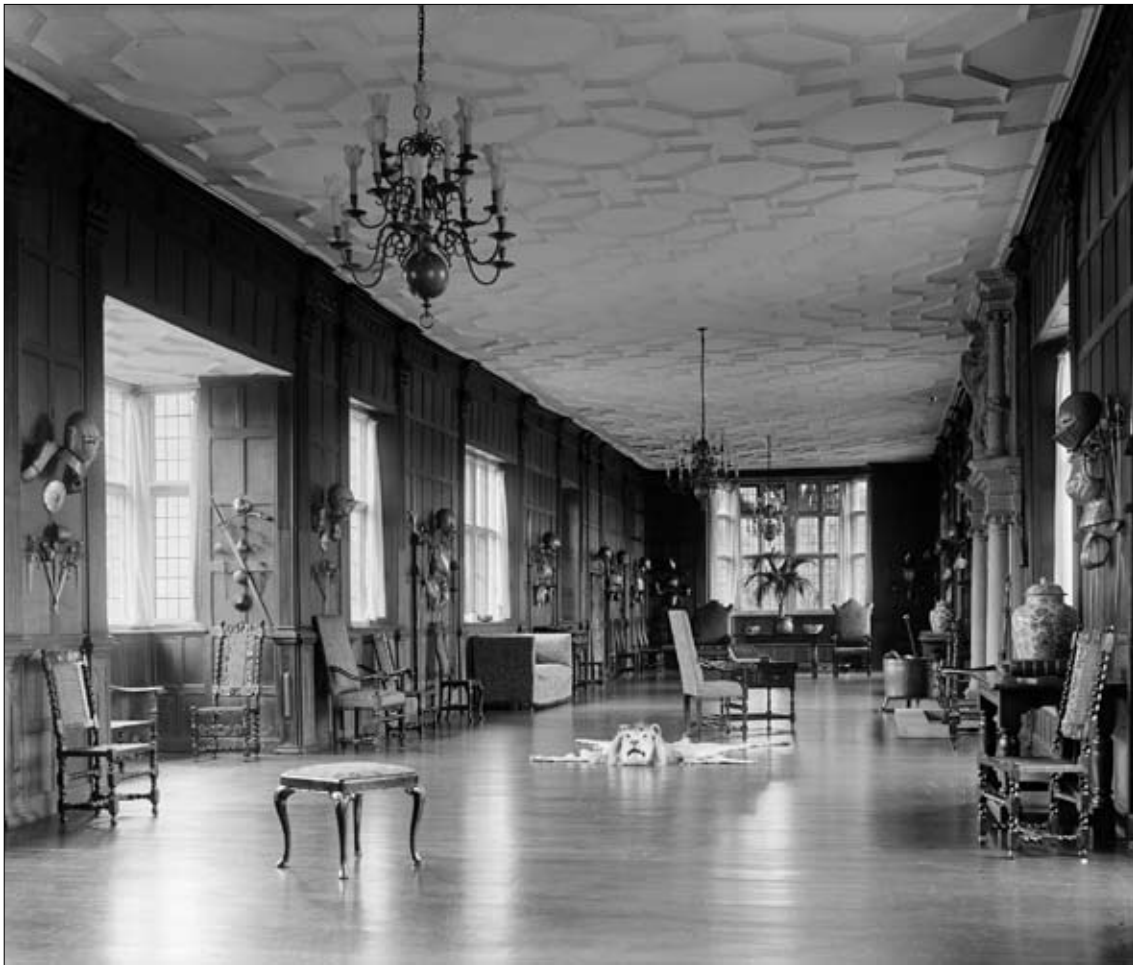
Figure 11. The Gallery in 1909, with new panelling in place of the damask. © Country Life

These openings seem to have been designed from the beginning to hold a total of sixteen full-length portraits, as discussed below. The openings are all four panels high and generally four panels wide. In the 1691 inventory, the Gallery contains seventeen 'great pictures' and in 1705 there were 'Sixteen Pictures drawn at length', as well as other pictures (fig. 8). However, in the 1629 inventory there were only two pictures in the Gallery, suggesting that the scheme was not yet complete. The arrangement of the panelling, hung with full-height family portraits, is shown in a drawing by Bradford Rudge of c.1846 (fig. 9). The earliest surviving photographs of the Gallery, of 1904 by Bedford Lemere (fig. 10), show the openings fitted with stretched damask, after the removal of most of the Westmorland family paintings. By the time of the Country Life photographs of 1909, the openings had been filled in with matching oak panelling (fig. 11).

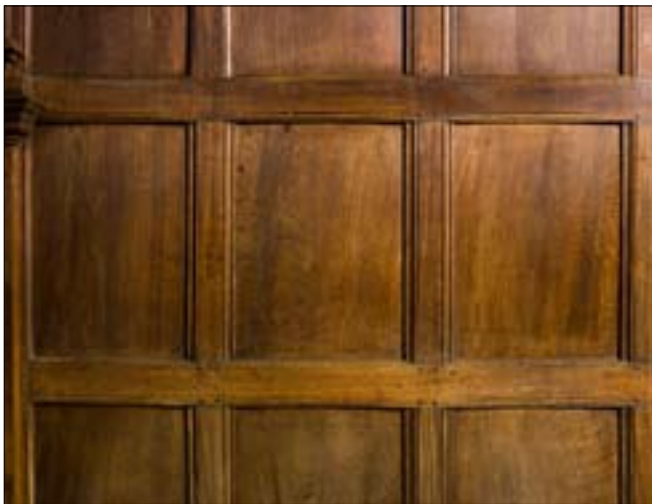
Figure 12. Typical section of panelling, with double-pegged joints and the two types of moulding.
© English Heritage DP029562

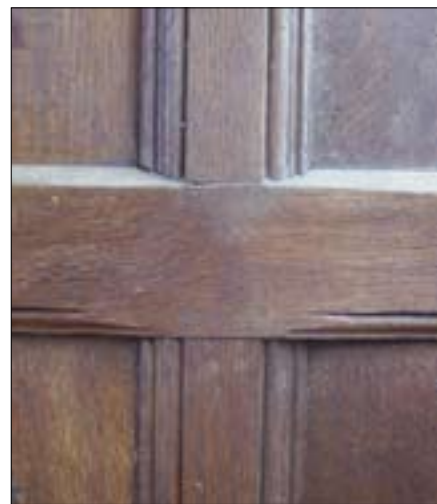
Figure 13. Detail of the two moulding profiles, with run-out stops not mitred joints. © Nick Hill 2007

short muntins all have the ogee and beaded type, which is thus always employed where it can be applied to both edges of the timber. The rails at the bottom of each panel have a plain chamfered dust ledge, as commonly found on panelling of this type. Run-out moulding stops are always formed where necessary in the simpler ovolo moulding, avoiding the need for mitred joints to any mouldings.

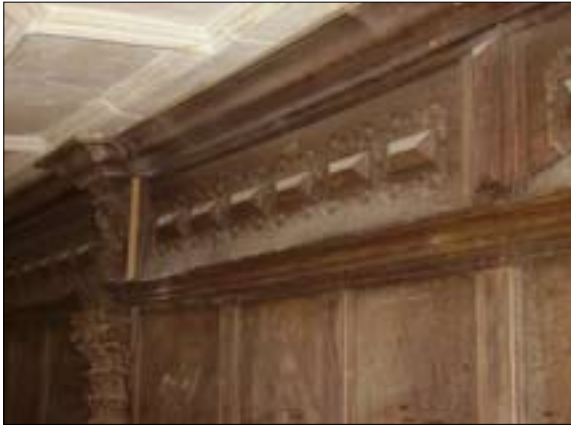
Figure 14. The frieze and cornice in 2006 before dismantling. © Nick Hill 2006

The top frieze is formed of long horizontal panels (figs. 14 and 15). The muntin dividing the sections of the frieze is generally placed to align with the muntins in the main panelling below, but in several places it is instead located above the centre of a panel,

enabling subdivision into sensible lengths. On the face of each dividing muntin is a jewel, fixed with small hand-made nails from the back face. The frieze panels have a recessed cutwork pattern, the edges formed in rectilinear and quadrant pattern, with circular discs to the main field. In some panels, but not in others, the recessed area has close-set punch marks. In the centre is a row of small jewels, again fixed by nails from the back face. The cutwork pattern and jewels are slightly irregular in places, not following a precisely rectangular layout. The recessed

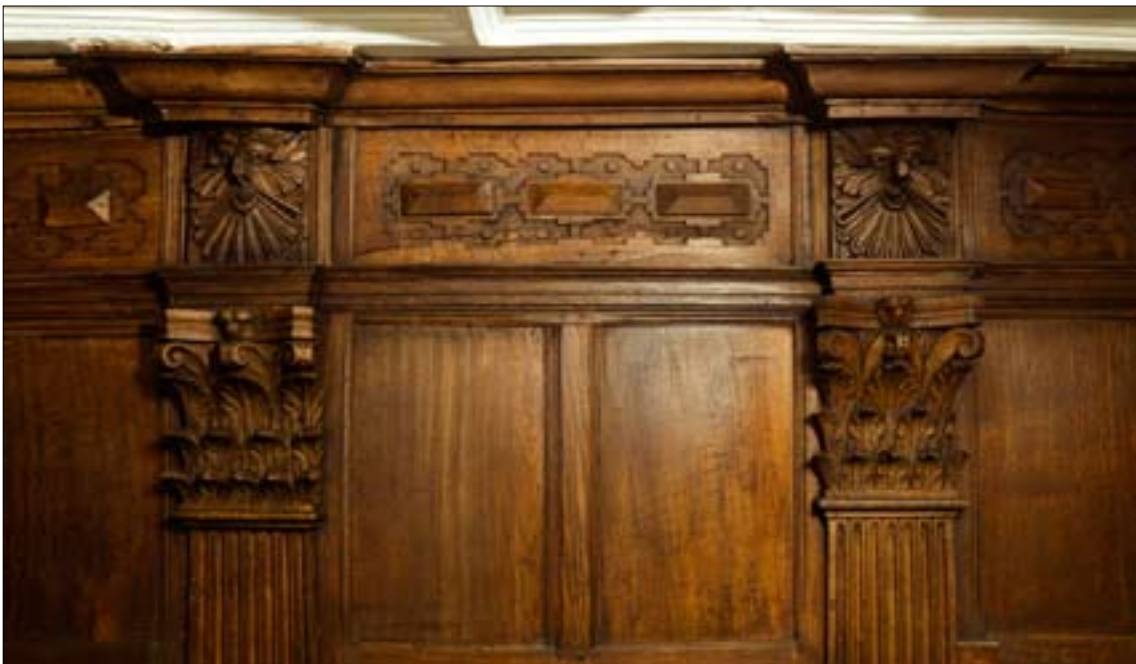
Figure 15. Upper part of the panelling in 2008, after repairs. © English Heritage DPO29546

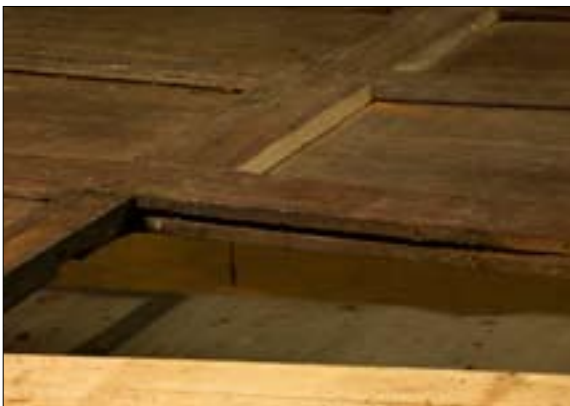
Figure 16. Panelling from bay window WE2.16. The run-out formation of the groove shows that a plough plane was used.

The groove in the framing to receive the panels is c.4.5mm wide by c.10mm deep. It is very precisely formed, with a plough plane, not a chisel. Unmistakeable

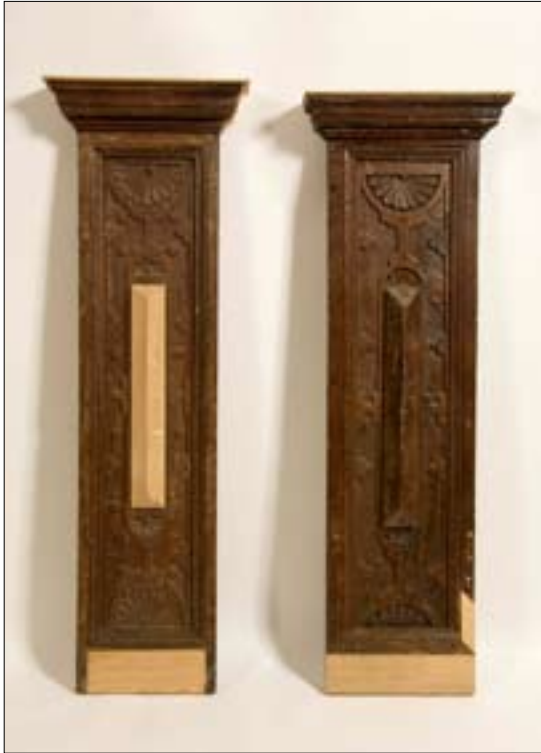
Figure 17. Front view of the two types of pedestal. The first type, to the left, is framed, while the second type to the right is of solid construction. © English Heritage DPO29372

There are two distinctly different types of pedestal (figs. 17-20). The first has a thin (c.5mm minimum) panel set into a frame. The frame in fact does not have properly jointed top and bottom rails; these are face-fixed over the panel, without joints or pegging to the stiles. The second type, instead of being framed, is formed from a solid (c.18mm thick) piece of timber, to which the moulding (c.9mm thick) is surface-fixed around each edge. This results in the same appearance, but may have been less work to form. The cutwork pattern also differs between the two types. The framed type

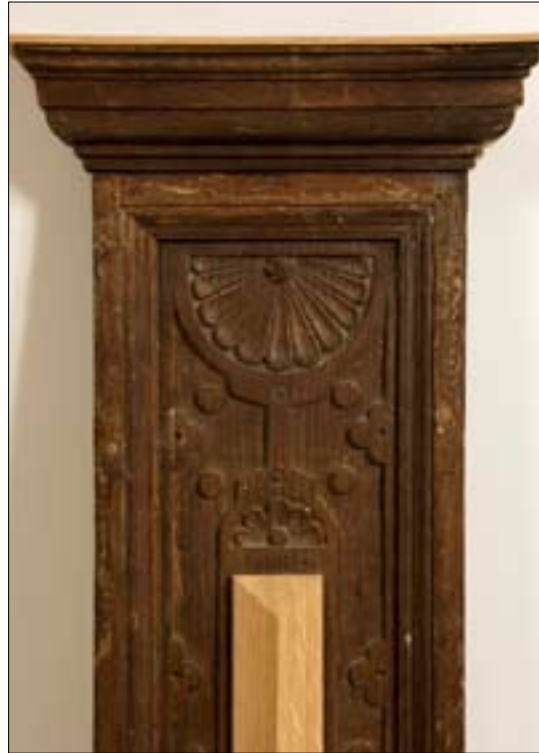
Figure 18. Detail of type one pedestal, with circular discs in the recessed field. © English Heritage DPO29374

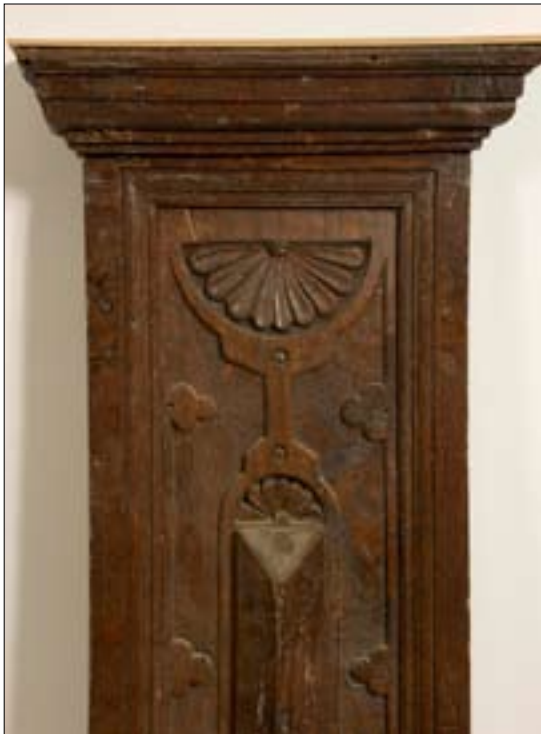
Figure 19. Detail of type two pedestal, without circular discs. © English Heritage DPO29375

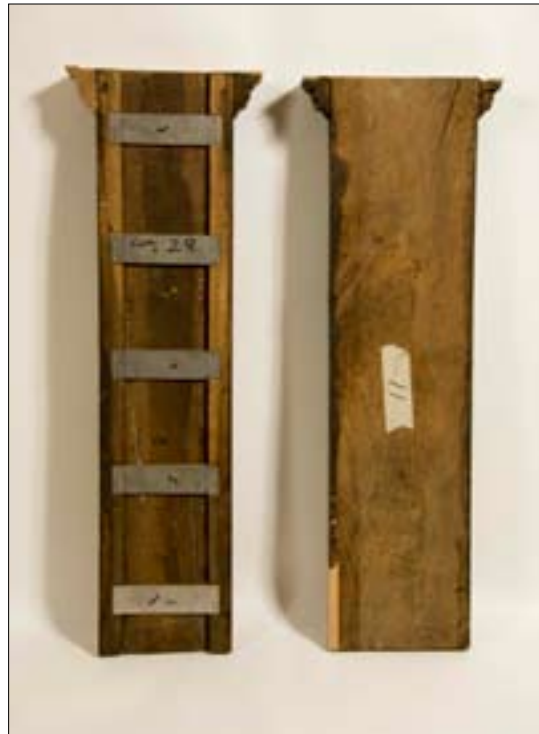
Figure 20. Rear view of the two pedestal types, showing framed and solid construction. © English Heritage DPO29373

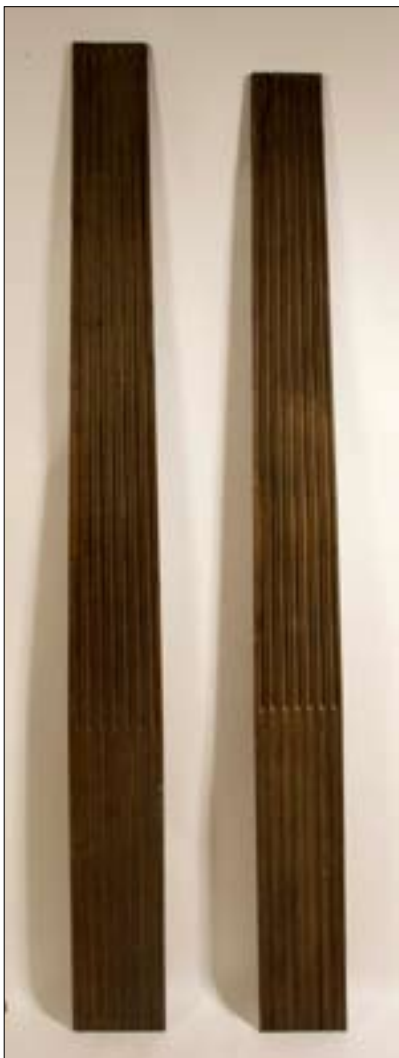
Figure 21. Two of the fluted pilasters.
© English Heritage DPO29365

The pilasters are c.2.5m high and 16-19mm thick, in a single piece of solid oak (fig. 21). All 37 pilasters are original. This component was clearly quite robust, so has survived very well. Two main slightly different

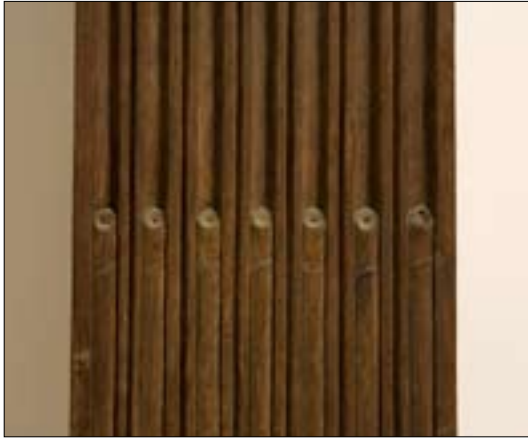
Figure 22. Type 1 pilaster with 'S' shape at the top of the cabling to the fluting.
© English Heritage DPO29370

designs can be distinguished (figs. 22-25). Type 1 is c.220mm wide; has an 'S' shape cut into the top of the cabling on the fluting; and has plain spandrel insets at the top of the flutes. Type 2 is rather wider, at c.240mm; has a sideways 'C' shape at the top of the cabling; and has a two-centred arch cut at the top of the flutes, often also with a circle set to each side. There are 14 pilasters of Type 1 and 15 of Type 2. There are five pilasters of mixed type (Type 3), the same as Type 2 but with the flute tops of Type 1 pattern. These three types are broadly arranged together in groups, with Type 1 predominant in the northern half of the room, Type 2 in the southern half and Type 3 on the west side of the northern half. Pilaster no. 17, in the south-west corner, is an oddity, being formed integrally with its pedestal in a single thin (8mm) piece. Pilasters 22B and 23B to either side of the main west bay are of a slightly different type and shorter, to suit the reduced ceiling height here. Pilaster no 33 is also a minor variant of Type 3, with three sideways 'C' shape marks at the top of the flute cabling, rather than one. As noted above, the use of different types of pilaster coincides generally with the more distinctively different types of pedestal, suggesting that two different teams of joiners were at work.

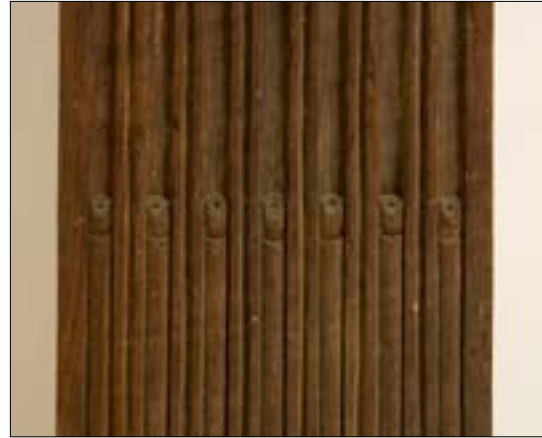
Figure 23. Type 2 pilaster with 'C' shape at the top of the cabling.
© English Heritage DPO29369

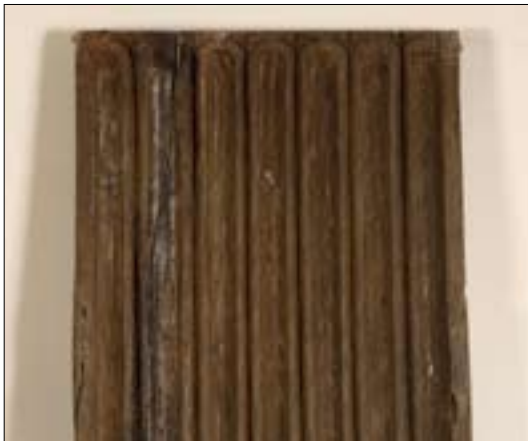
Figure 24. Top of Type 1 pilaster, with plain top to fluting.
© English Heritage DPO29367

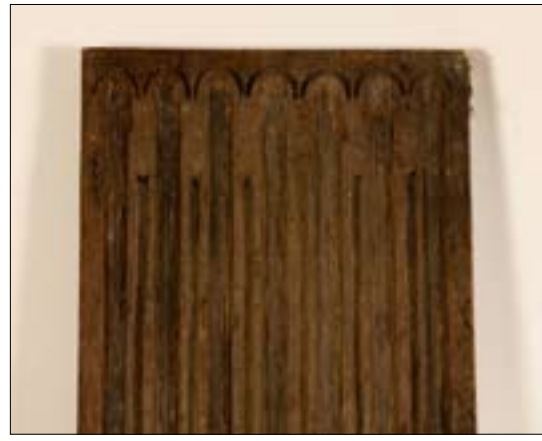
Figure 25. Top of Type 2 pilaster, with two-centred arch at top of fluting.
© English Heritage DPO29368

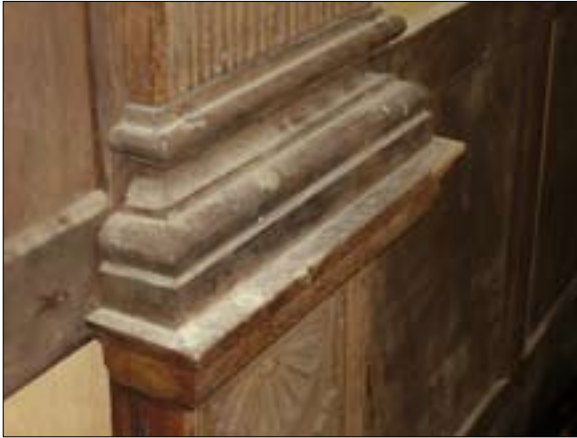
Figure 26. Moulded base to pilaster.
© Nick Hill 2006

At the bottom of the pilasters is a moulded base, which sits on top of the surbase to the pedestals (fig. 26). The moulding is of classical Attic type, with two torus mouldings and an intervening scotia, separated by fillets. It is cut in one piece of timber and is mostly original.

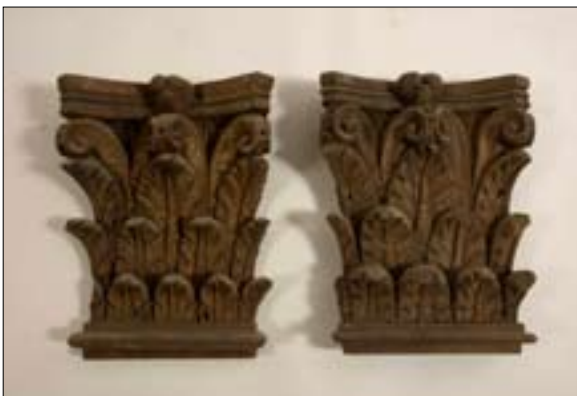
Figure 27 Two Corinthian capitals.
© English Heritage DPO29384

The capitals are of Corinthian type, of rather simplified form (figs. 27-29). There are three rows of acanthus leaves. In the top row three large leaves support a volute to each side and the centre. The abacus is concave, with a fleur-de-lis at its centre, though this is rather crude and closer to medieval ballflower ornament than a classical flower.

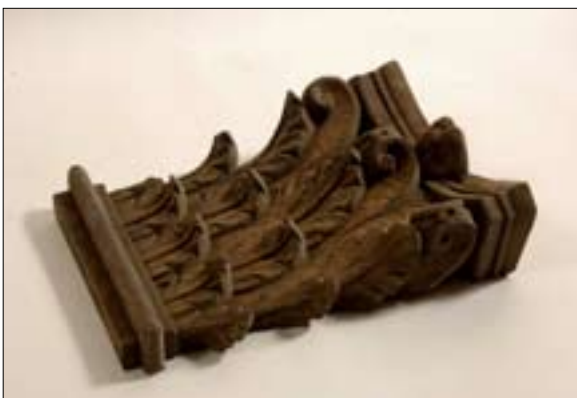
Figure 28. Side view of capital.
© English Heritage DPO29386

The capitals are about 330mm high, 250mm wide and 75mm thick. All except two of the thirty-five capitals are original. The two lost capitals went missing in the period immediately before English Heritage took over the site. Over half of the capitals are formed of a single piece of oak, but the rest are made of two pieces, with a straight vertical joint. This rubbed and glued joint is an original feature, being found on two capitals which have a 17th century tree-ring date. A number of original rubbed and glued joints to

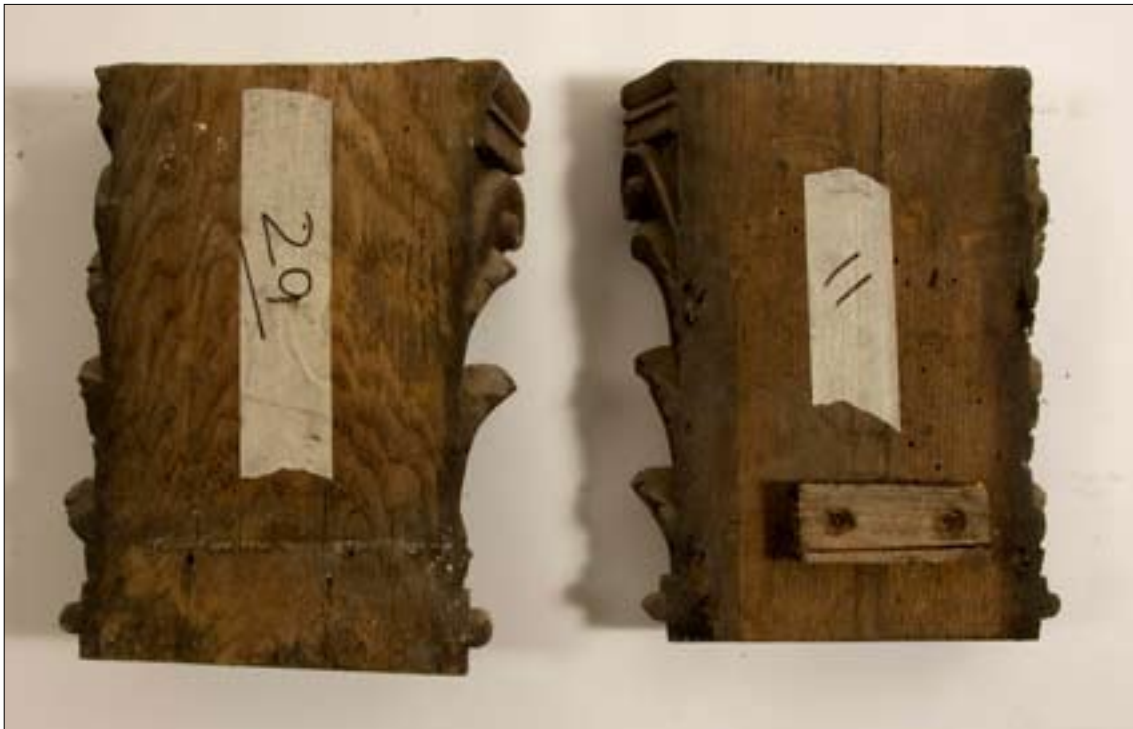
Figure 29. Rear face of capitals. The right hand one is made of two pieces, with a vertical glued joint, later reinforced with a screwed-on batten.

the projecting volutes, acanthus leaves etc are evident. No doubt the original joiners found it useful in some instances to build up these thick sections of oak in two pieces to avoid distortion and cracking. The capitals are all hand-carved, with minor individual differences. The back face is roughly cut in some instances, but smooth in others. On capital no 35 knife-cut setting-out marks were noted on the rear face.

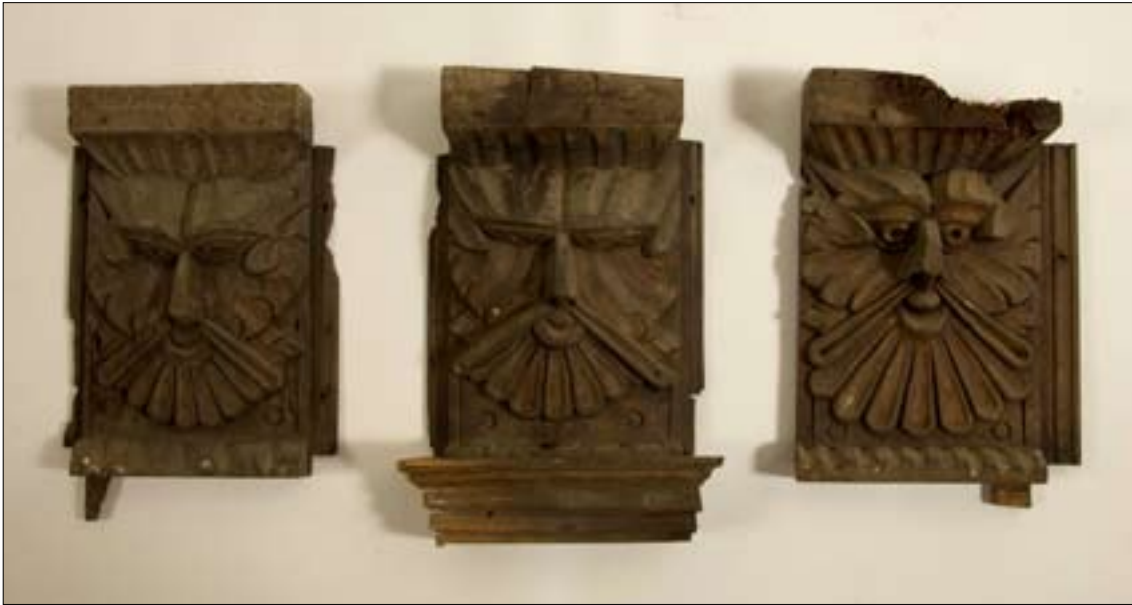
Figure 30. Three of the masks.

The masks are about 300mm high, 200mm wide and 50mm thick. Of the 35 masks, 34 are original. The missing mask was probably only lost during the dismantling undertaken by the previous owners in c.2002. Four masks have a vertical rubbed and glued joint. Like that on the capitals, this appears to be the original technique. The masks are all hand-carved, with minor individual differences. The back face is roughly cut in some instances, but smooth in others.

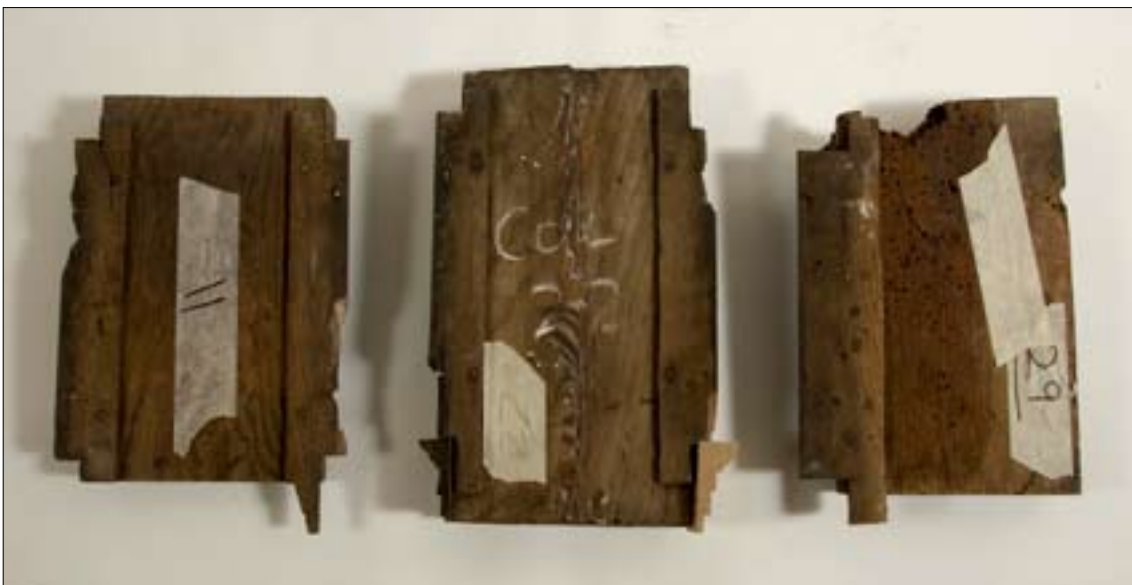
Figure 31. Rear of masks with nailed-on side mouldings.

To either side of the masks are narrow strips of timber, with the ogee and bead pattern moulding. These are needed to pack the masks forward and fill the gap left at the back. They are clearly an integral part of the original design, many still being nailed to the back of the masks, the nails being the original handmade type (fig. 31).

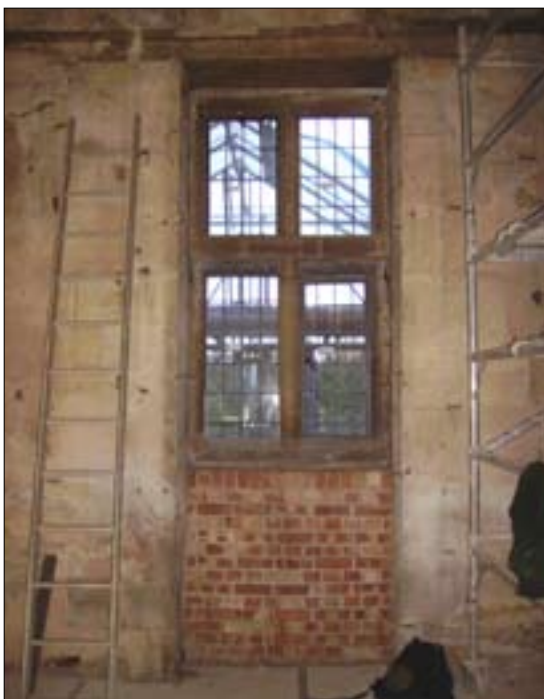
Figure 32. The original doorway onto the east balcony, converted to a window in the early 20th century. © Nick Hill 2006

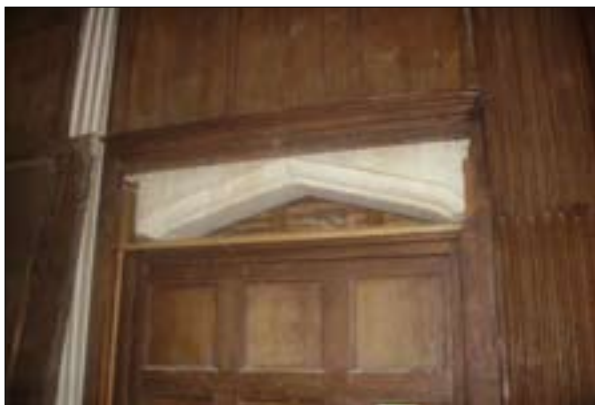
Figure 33. North-west doorway, with original stone doorway covered by the panelling – clearly added later. © Nick Hill 2007

Only the north-west and south-west doorways are original (apart from the east door onto the balcony, now a window). The south-east doorway was cut through later, probably in the mid-18th century, and the south-west doorway was blocked. As noted above, the placing of the original pilasters to either side of the doorways respects the original openings, but not the later insertion. The altered doorways are shown on the plan of 1858.

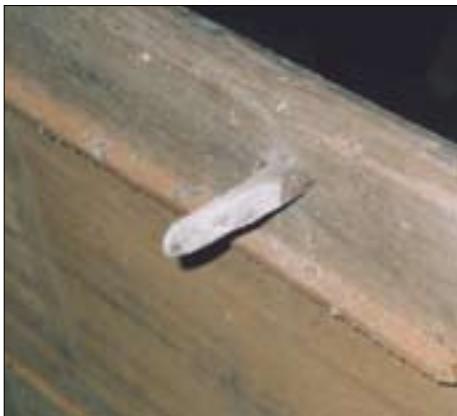
Figure 34. Original oak peg used to fix the panelling. © Nick Hill 2006

wall (fig. 34). This type of fixing occurs quite widely and appears, at least in some places, never to have been previously dismantled. This system has been re-used where possible in re-fitting the panelling. It was found to provide an excellent method of accurately locating the panelling in its correct, original position.

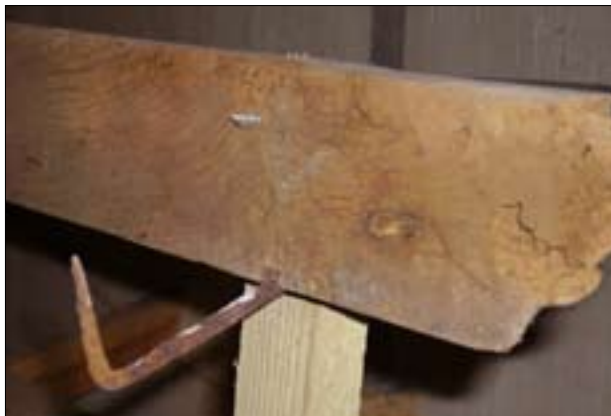
Figure 35. Original iron cramp used to fix panelling around WE2.07. © Nick Hill 2006

In a few areas small iron dog cramps were used, as noted above around window opening WE2.07. The panelling around this window was fixed with five of these cramps on the left side and originally five (one missing) on the right. The cramps were U-shaped, 100mm in length, with 30mm long legs (fig. 35). The iron was c.5mm by 3.5mm in section, hand-forged, with nail-like points to drive into the timber. One leg was fixed into the edge of the panelling, the other leg being driven into an oak dowel, 10mm in diameter and 60mm long.

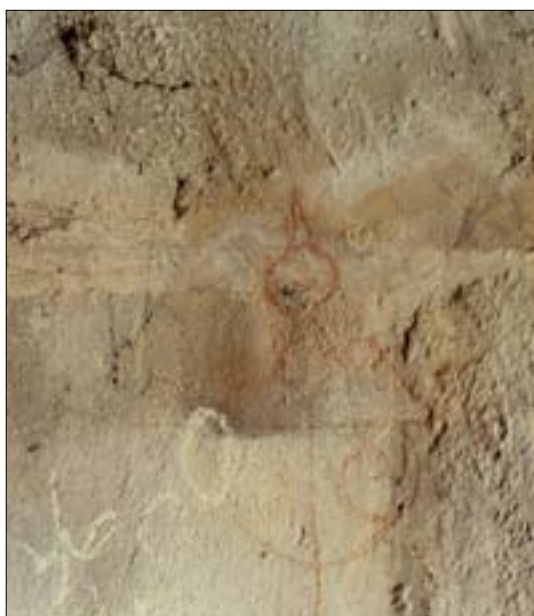
Figure 36. Sketch of a finial design to window reveal. © English Heritage AA051095

A sketch of a finial design, executed rather roughly in red ochre on the face of the ashlar masonry, was discovered on the south window reveal of the window just north of the fireplace (fig. 36). It may have been a design for mason's or carpenter's work, though bears no resemblance to any surviving fabric at Apethorpe.
