APETHORPE HALL,
APETHORPE,
NORTHAMTONSHIRE
THE LONG GALLERY PANELLING
RECORDING AND ANALYSIS REPORT

Research Department Report Series 67-2009

**THE LONG GALLERY PANELLING
APETHORPE HALL
APETHORPE, NORTHAMPTONSHIRE
RECORDING AND ANALYSIS REPORT**

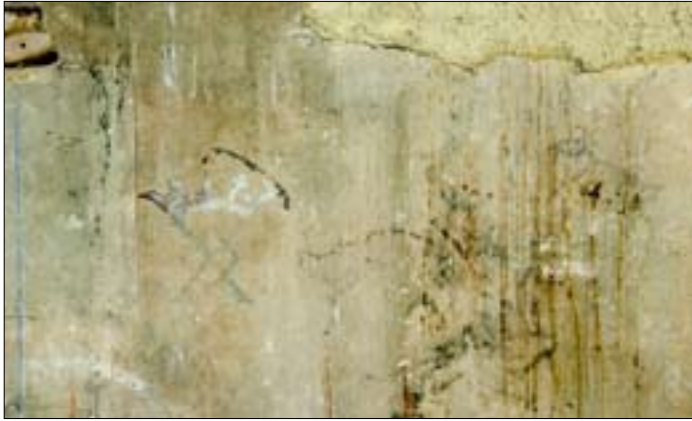
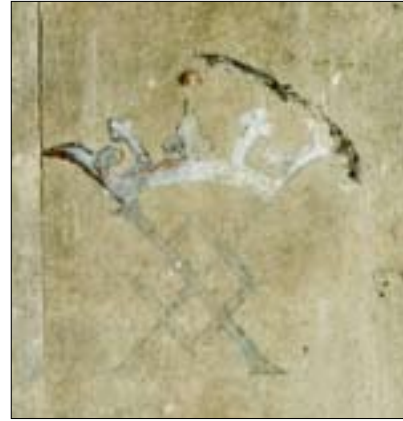
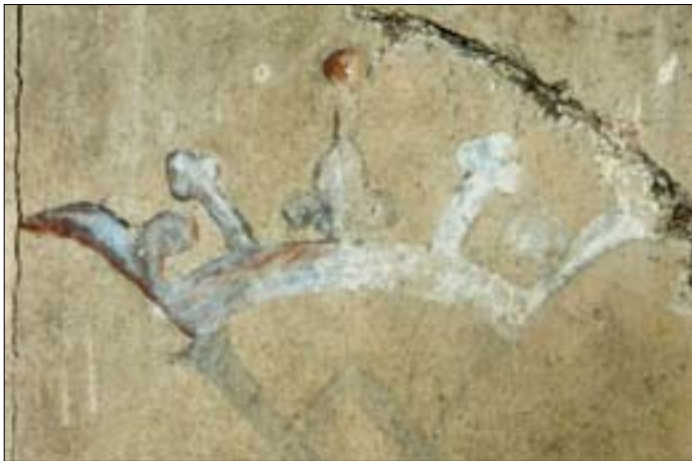
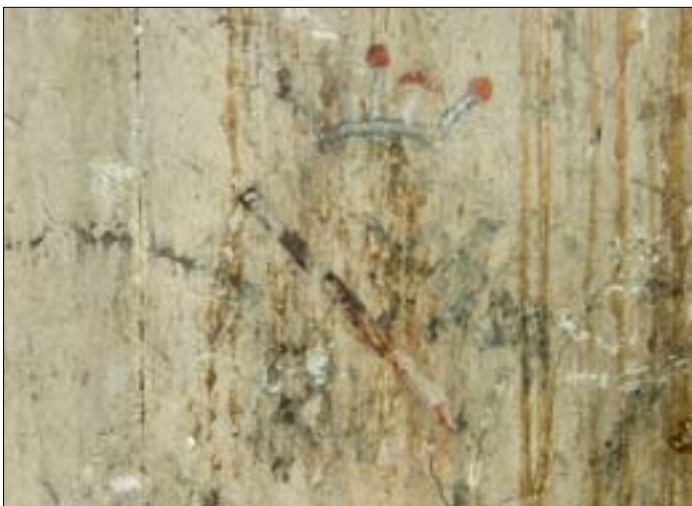
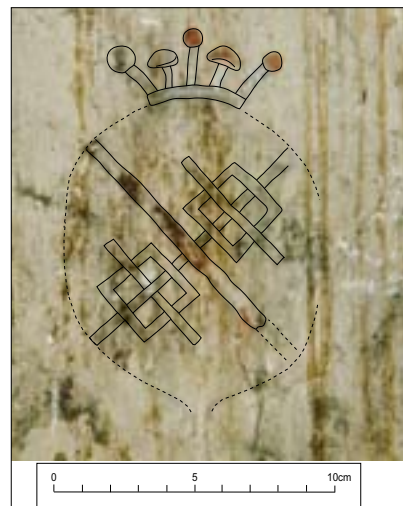
Figure 37. The two armorial badges.
© English Heritage DPO29287

Figure 38. The first badge, with coronet and Despencer fret.
Trent & Peak Archaeology 2007

Figure 39. Detail of first badge.
© English Heritage DPO29292

Figure 41. The second badge.
© English Heritage DPO29291

Figure 42. Photo of second badge with over-tracing.
Trent & Peak Archaeology 2007

An unexpected discovery behind panel section 27/28 on the west side was two small painted armorial badges (figs. 37-42). These are placed side by side at about 1.4m above floor level. The larger and better preserved example is c.180mm high by 170mm wide. It has the Despenser fret, surmounted by a coronet, probably indicating the Earl of Westmorland. The second example is smaller (c.130mm high by 100mm wide) and less clear. It has a shield divided into two by a diagonal line. In each half is a Despenser fret, and above is a coronet. The painting is quite carefully and accurately done, in white and dark paint, with some upper parts of the coronets picked out in red. Given the quality of execution, it is clear that the designs are not merely graffiti. It seems likely that trials were being made

for decorative work which would be applied to the centre of each panel. Stencilled decoration of this type was often used on panelling of the period. Stencilled arabesques survive on panelling at the Little Castle, Bolsover of c.1620. At Canons Ashby, Northamptonshire, the panelling in the Painted Parlour preserves a painted scheme of c.1600 with armorial badges.

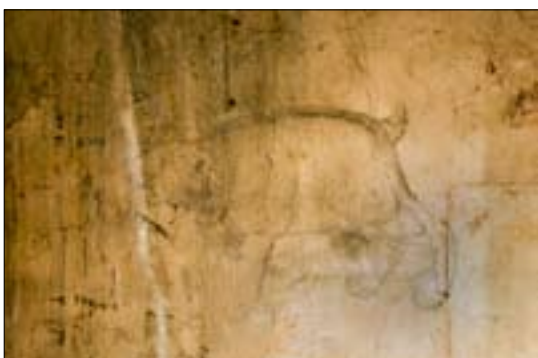
Figure 43. Sketch of a bear, with collar and rope, on the plaster behind the panelling.
© English Heritage DPO29551

Further drawings in pencil or charcoal were found behind panel section 7/8, to the right of the fireplace. Much the best of these was a good quality drawing of a bear – or possibly a dog - , with collar and rope leash (fig. 43). It was placed at c.1.9m height, being c.400mm long and 250mm high. Below were various other cruder curvilinear designs, and a smaller black painted design, reminiscent of Arabic script. At around 1.6m height a compass-drawn circle was scribed into the plaster, with four concentric circles, the outer one being 370mm in diameter (fig. 44).

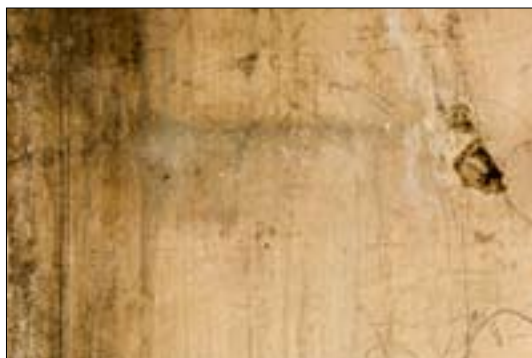
Figure 44. Circles scribed into the plaster.
© English Heritage DPO29554

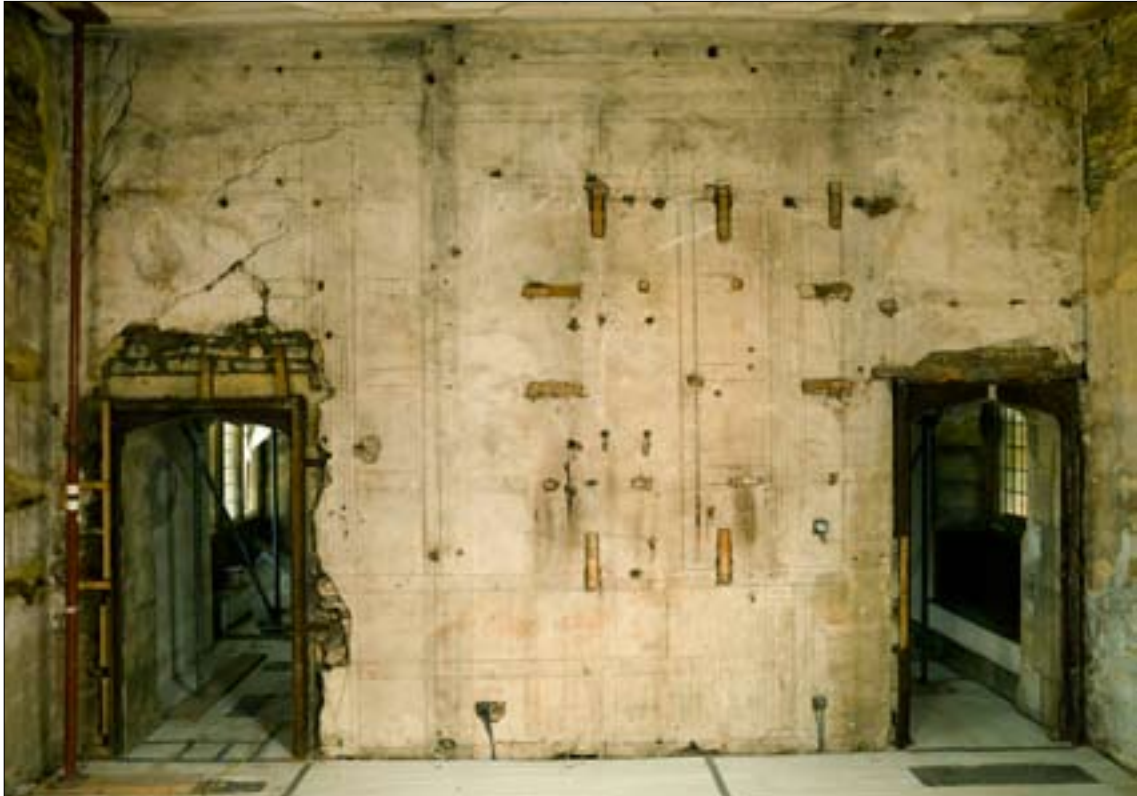
Figure 45. The design on the south wall after removal of panelling.

A major discovery was an entire painted design for panelling across the whole of the south wall (figs. 45-50 and detailed drawings in Appendix 3). The design is similar to the oak panelling as fitted, but also has key differences from it. The design is divided into seven tiers of plain rectangular panels, like the oak panelling. It runs right into each corner of the south wall, but does not turn the corner onto the east or west walls. There is a frieze at the top, but this has only straight lines instead of cutwork panels. There are two fluted pilasters with Corinthian capitals, but these are placed differently, with no column beside the south-west door opening. The columns have lozenges at the base, not cutwork and there are odd-looking diagonal lines at the base of the pedestals. Above the capitals, there are jewels in place of the grotesque masks. Above the jewels, in the cornice, is a further decoration of acanthus leaf type, formed as if breaking forward

The plaster surface on which this design is drawn is rather better finished than on the east, west and north walls. It is around 12-15mm thick, still applied in a single coat, but smoother and without evident shrinkage cracks. The plaster has been painted with whitewash before application of the design. At the right side, the whitewash is partly smeared over the ashlar jambs of the south-west doorway, but the whitewash is not taken right across the stonework, and some design lines beside the door are painted directly onto the stone surface. The plaster is taken over the oak lintol of the south-west doorway. Examination at the corner junctions shows that the wall plaster here was applied after that to the east and west walls. It was also applied before the ceiling plaster, as evident in the floor void above. There is no evidence that a rougher coat of plaster, like that to the other walls, preceded the current plaster.

The design itself is painted in dark brown/blackish paint, perhaps a soot pigment. The straight lines are all very accurately set out, generally around 3-5mm in width, but with a rather fuzzy appearance. It seems likely that the lines were formed by 'snapping' a string line dipped in paint, which would probably create the fuzzy effect, with some

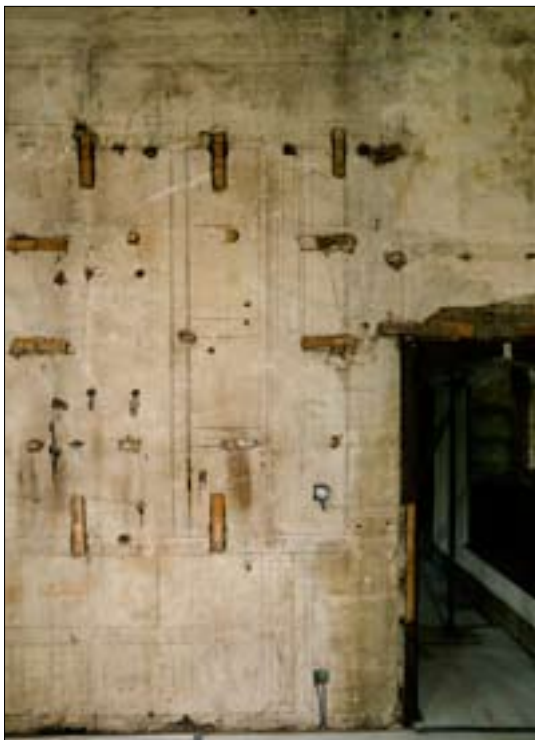
Figure 46. The design beside the south-west doorway, with blank space for portrait.
© English Heritage DPO29360

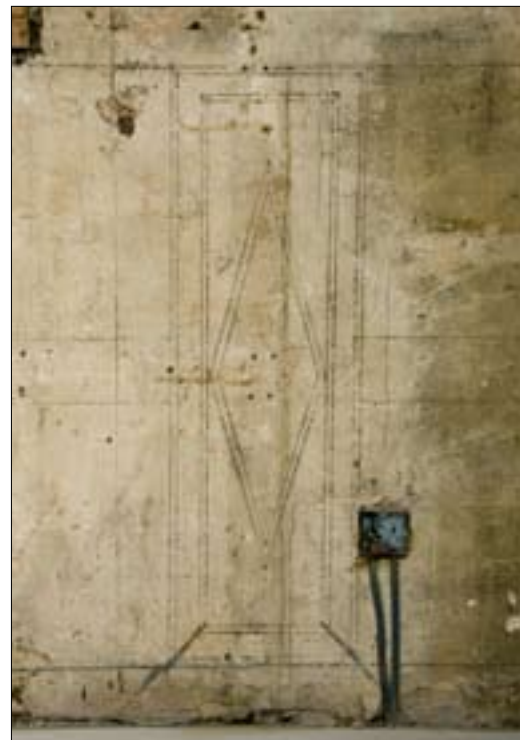
Figure 47. Pedestal base with lozenge.
© English Heritage DPO29402

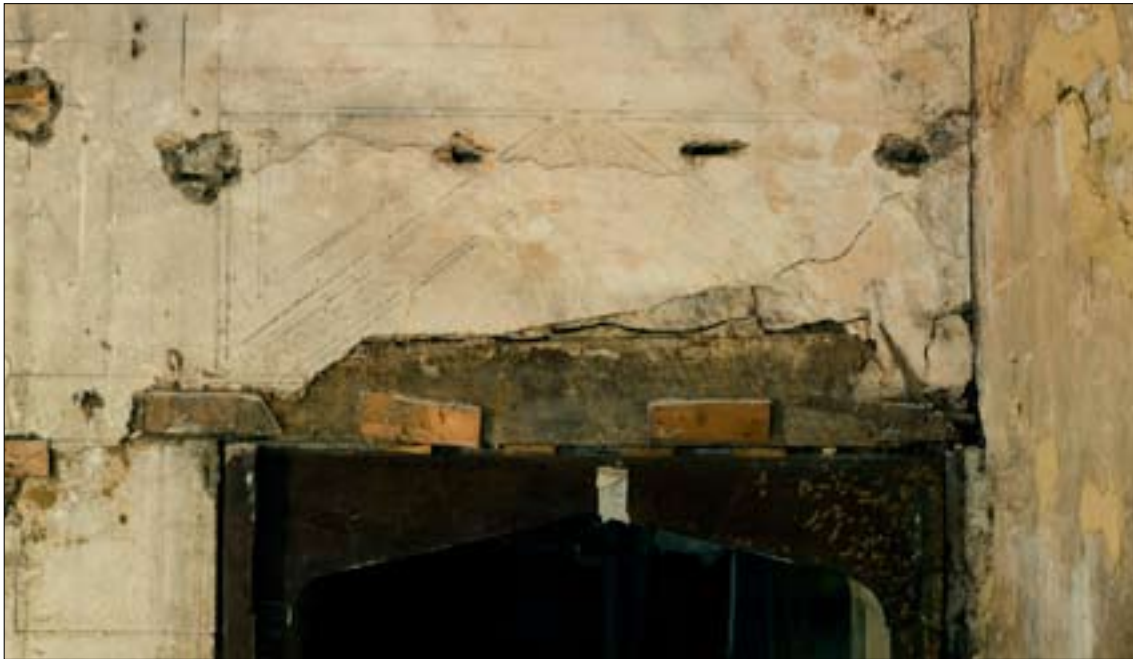
Figure 48. Pediment over doorway with guilloche detail.

over the capital. This is a strange feature, with no proper classical precedent. Over the head of the south-west door is a pediment with a band of neatly formed guilloche. Within the tympanum of the pediment is a much looser representation of swan-neck scrolls, in broken pediment fashion. The use of such scrolls within the tympanum is again an un-classical feature. Perhaps the most interesting feature of the panel design, however, is that it incorporates a blank space, or portrait opening, at the centre. This is 1.45m wide and 2.31m high, almost exactly the same dimensions as the portrait openings in the oak panelling. It is clear that the inclusion of the portraits, of a fixed size, was part of the panelling programme from the outset.

splattering. The detail of the guilloche has been set out very carefully with pointed compasses, scribing the precisely interlinking circles into the plasterwork. The scribed lines have then been drawn over. There is a scribed centre line for the pediment. Looser scribe lines are visible for setting out the swan-neck scrolls in the tympanum. Scribe lines can also be seen to the Corinthian capitals, more evident on the left one. This has a scribed vertical centre line and further setting-out lines for the base, leaves, scrolls and top. There are no scribe lines to the main panel design, though some rougher vertical scribe lines were added later, for setting out the oak panelling.

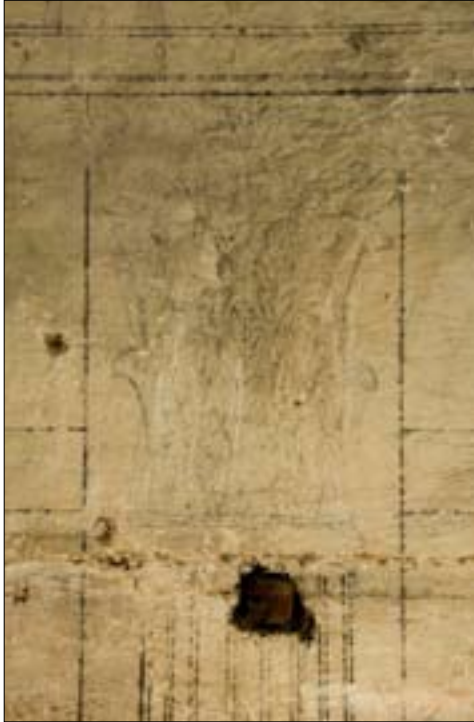
Figure 49. Corinthian capital.
© English Heritage DPO29407

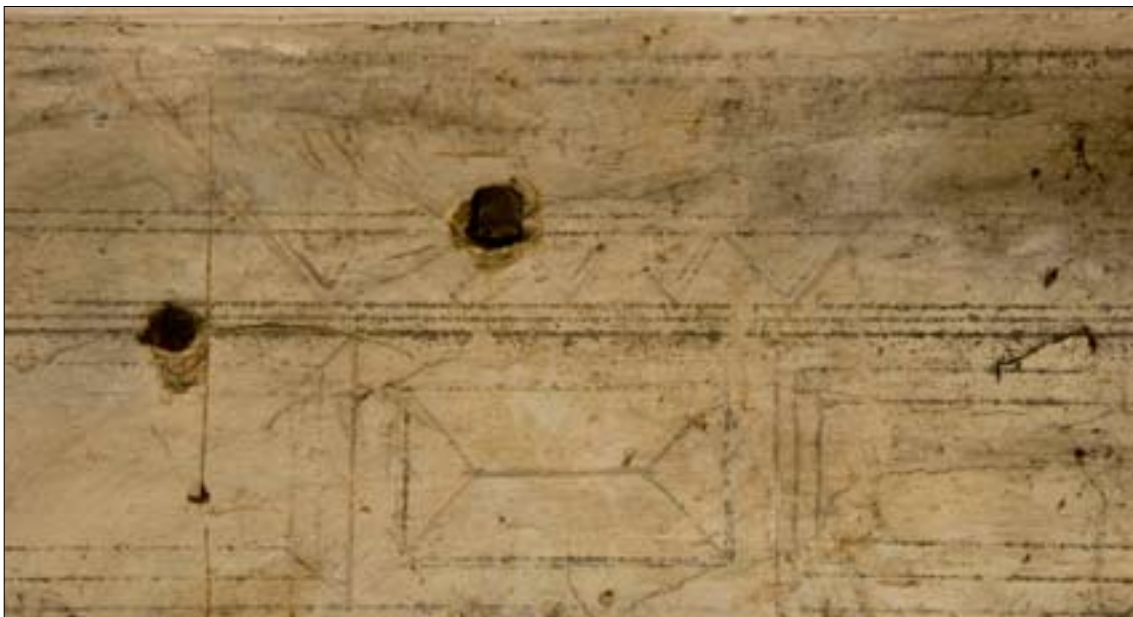
Figure 50. Jewelled frieze and cornice.

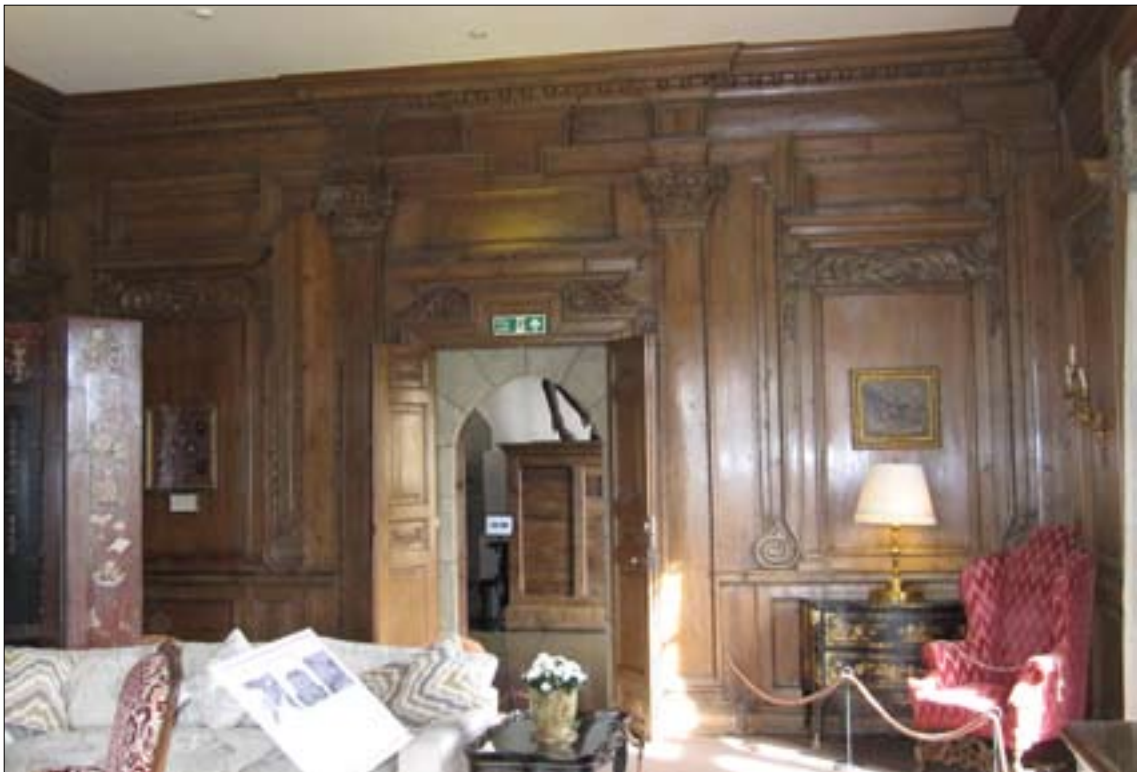
Figure 52. Panelling from the parlour of Thorpe Hall, now at Leeds Castle, Kent. Nick Hill 2009.

from the 1670s. Ham House (Surrey) has a considerable variety of paintings, chiefly Dutch landscapes, inset into the panelling of the 1670s. However, the Long Gallery panelling of 1639 has portraits hung on top of the panelling, in the normal manner. At Holyroodhouse, the Gallery was built in 1671-4 and the panelling forms a 'timber lining on which are planted picture frames' with 111 portraits of Scottish kings, commissioned from Jacob de Witt in 1684². At Sudbury Hall (Derbyshire), the panelling of 1678 in the Saloon was not adapted to take a series of full-length family portraits until the mid-18th century. The parlour at Thorpe Hall, Cambridgeshire, of c.1656, has large blank sections in the panelling to receive paintings (fig. 52), but these would have been hung in front of the panelling, not integral to it.

design⁵. The panelling still has square panels, but the pilasters are panelled not fluted, and there is a fully pedimented doorcase. As Gotch says, 'In the detail of woodwork generally greater refinement and simplicity became apparent, and more successful endeavours were made to adapt classic profiles. At St John's College, Oxford, the work of 1631 illustrates this tendency.' In the long gallery at Ham House, the panelling was made by the joiner Thomas Carter in 1639. Here the square panels are topped by a very classical Ionic entablature, with no remaining traces of Flemish character. By the 1650s, at Thorpe Hall, the small square panels had been superseded by much larger rectangular panels, which became standard in the later 17th century (fig. 52).

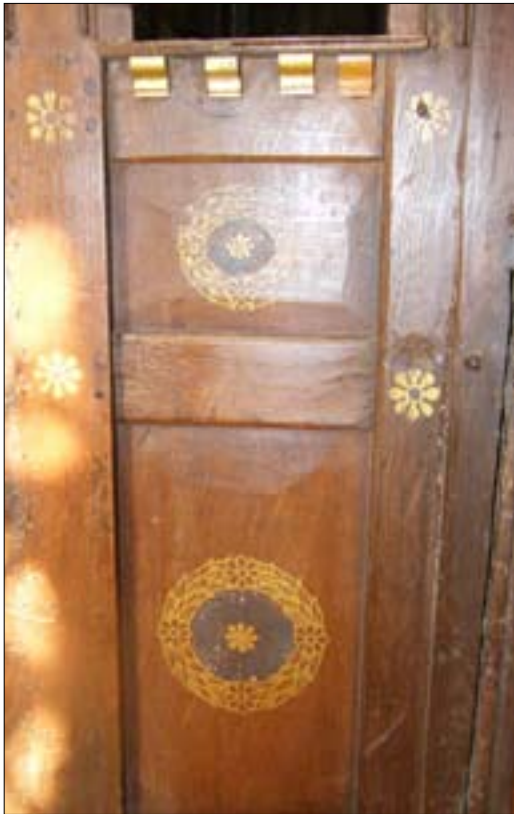
Figure 53. Rycote Chapel, c.1620, with original stencilled paint designs to frame and panel bed, but the remainder of the oak left exposed. © Nick Hill 2008

Elizabethan and Jacobean panelling was frequently fully painted, in highly ornate style. Such gaudy paintwork has often been comprehensively stripped at a later date. Recent research has indicated that the great majority of panelling was probably initially painted. However, this treatment was not universal, as shown by various examples with inlaid coloured woods (eg the Great Chamber at Gilling Castle, Yorkshire, of c.1575; the Inlaid Chamber at Sizergh Castle, Westmoreland, of c.1580). At Burghley House, the 1580s closet off the Long Gallery preserves its unpainted oak panelling underneath the floor, the level of which was raised in the later 17th century. At Apethorpe, it seems likely that heraldic devices of the type found on the plaster surface behind the panelling were painted onto some of the individual square panels, as at Canons Ashby. There could also have been some stencil work on the panel framing, but the evidence indicates that there was no overall application of paint. An example of panelling which shows exactly this type of treatment survives at Rycote Chapel, Oxfordshire, of c.1620 (fig. 53).

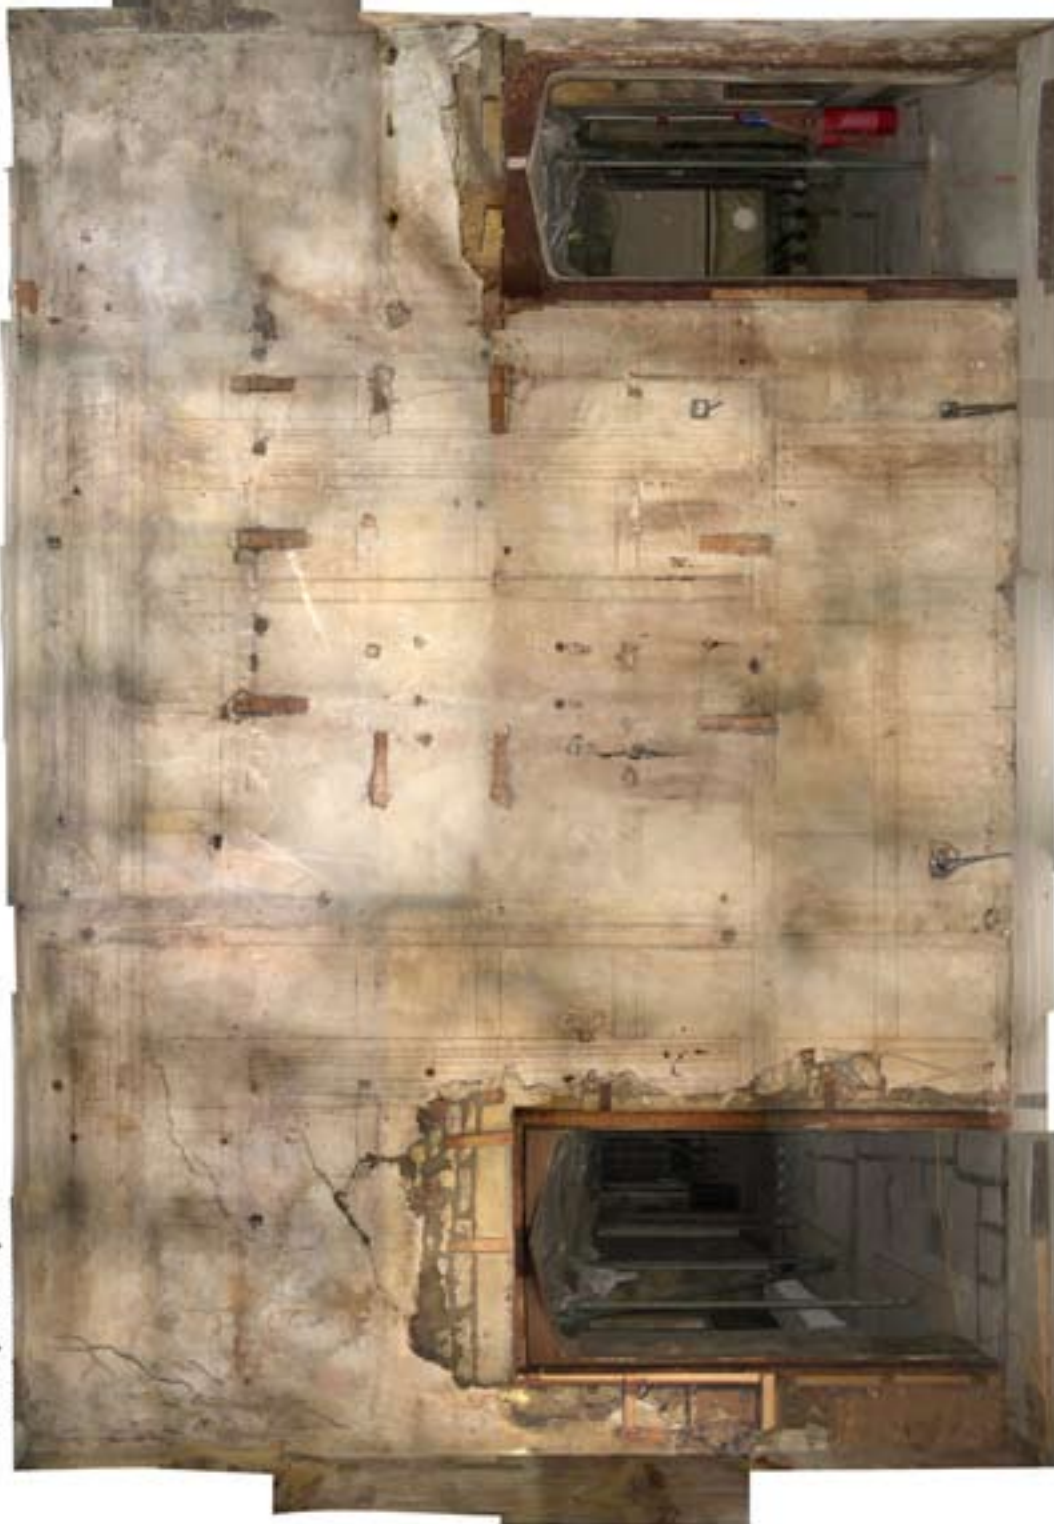
Apethorpe Hall. South wall of Long Gallery

Restored fictive panelling design
