LITTLE DOWARD,
GANAREW, HEREFORDSHIRE
ANALYTICAL EARTHWORK SURVEY OF THE
HILLFORT AND RAPID LANDSCAPE
INVESTIGATION

ANALYTICAL EARTHWORK SURVEY OF THE HILLFORT
AND RAPID LANDSCAPE INVESTIGATION

NGR: SO 539 160

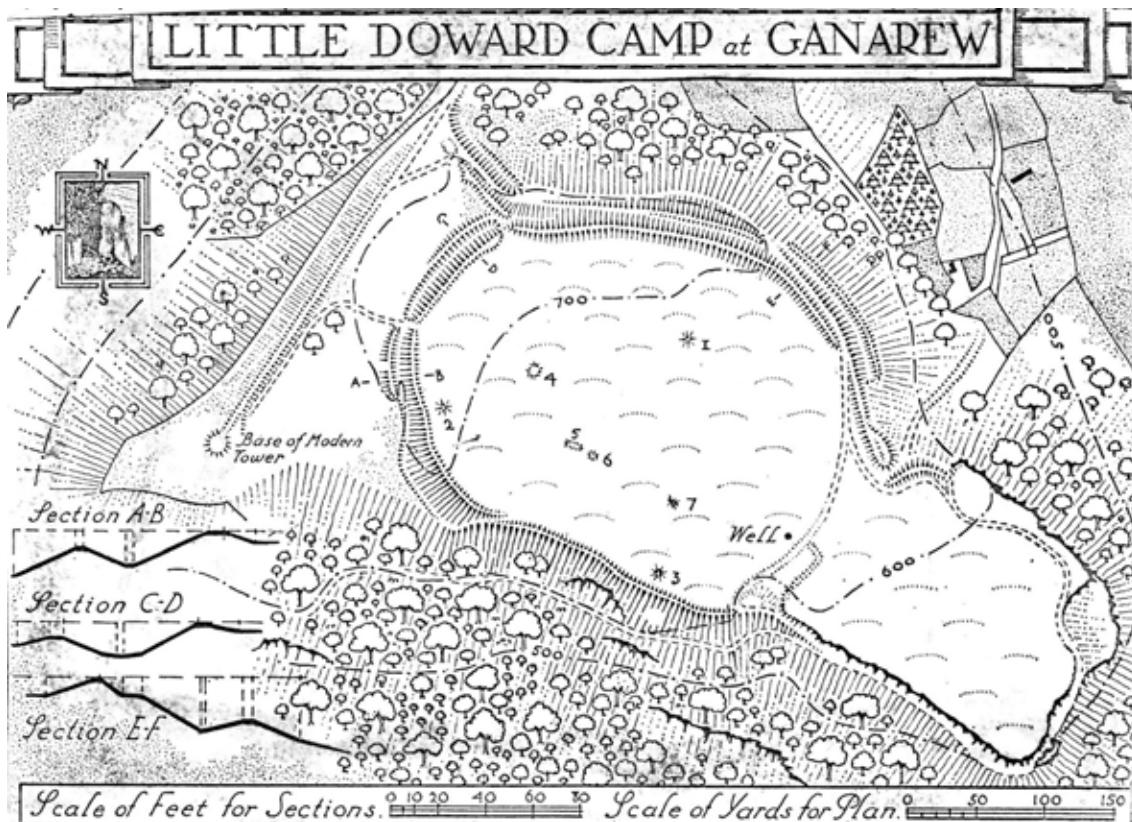
Fig 3: RCHM plan of Little Doward, 1931 © Crown copyright

The Royal Commission on Historical Monuments visited Little Doward in about 1930 and recorded the hillfort and interior mounds briefly (RCHM 1931, 68-9; Fig 3). The Ordnance Survey depiction of the fort was revised by Alan Phillips of Archaeology Division in 1972; unfortunately the Antiquity Model resulting from his work does not survive in its entirety. The site was subject to a 'walk-over' survey by Border Archaeology in 1999 and was then surveyed in the winter of 2007 by Herefordshire Archaeology (Rimmington 2008).

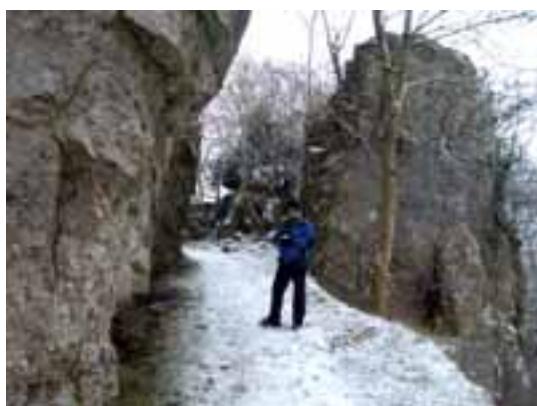
Fig 5: the chasm, with the detached section of the hillfort to the right

The SE enclosure is defended on three sides by sheer natural cliffs, up to 12m high. The NW enclosure is largely open to the SE enclosure and they are divided only by a sunken drive of 19th-century date, part of Blakemore's landscaping. This drive is up to 1.2m deep and leads to a junction of routeways at (k – *see below*); it has been cut near its northern end by a more recent forestry track. There are, however, two short lengths of rampart which may have served to delineate the north-western side of the SE enclosure. The southern of these (a) is up to 1.0m high internally and is fronted in part by a slight ditch, 2.1m below the crest of the rampart and 0.4m deep externally. The small mound occupying the northern end of this ditch is almost certainly spoil from shaft (t – *see below*), cut off from it by the sunken drive. The northern rampart (b) is described below. The cliff along the eastern side of the SE enclosure has been extensively modified by one of Blakemore's carriage drives, which has been cut diagonally down its face. The extreme south-eastern corner of the fort has been detached from the rest by this carriage drive, which is blasted through the cliff to form a picturesque chasm (Fig 5).

Shot holes can be seen in the rock faces. The entrance to King Arthur's Hall cave, though obviously changed radically by Blakemore's work, can also be seen here. As it emerges from the chasm the driveway has had to be massively revetted in stone.

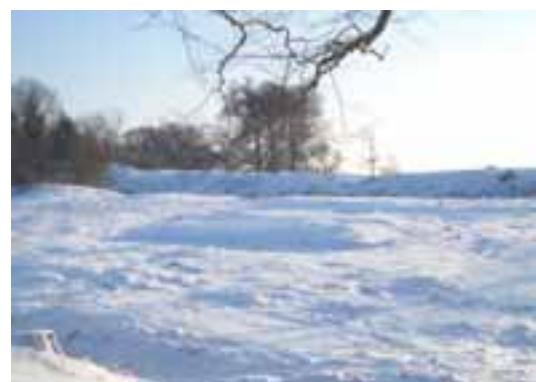
Fig 6: Mound 9 with the hillfort counterscarp, ditch and rampart beyond

No 3 can be seen on aerial photographs of 1946 (e.g. RAF verticals 106G/UK/1355/5041-5042) as a rectangular mound with a slight cut in its southern end but is now barely visible on the ground; one slight scarp perhaps marks its eastern side. Mound 4 is sub-rectangular and 0.8m high; it is surrounded by a ditch which forms an extended hollow at the south (downhill) end. Mound 5 is somewhat similar to 4, in that the mound does not fill the ditched area which has been cut out for it; the mound, which is only 0.6m high, occupies part of the southern side of the rectangular ditched area. Mound 8 is nearly square, 0.8m high, and is surrounded on its north and west (uphill) sides by a slight ditch. Mound 9 is square and up to 1.0m high; it is entirely surrounded by a slight ditch; the whole feature is very regular (Fig 6). There are other slight and amorphous earthworks to the north of (9), partly obscured by brash at the time of survey, which are difficult to interpret (but see below). Mound (10), which is cut by one of Blakemore's drives, is up to 0.8m high; there is no sign of a ditch.

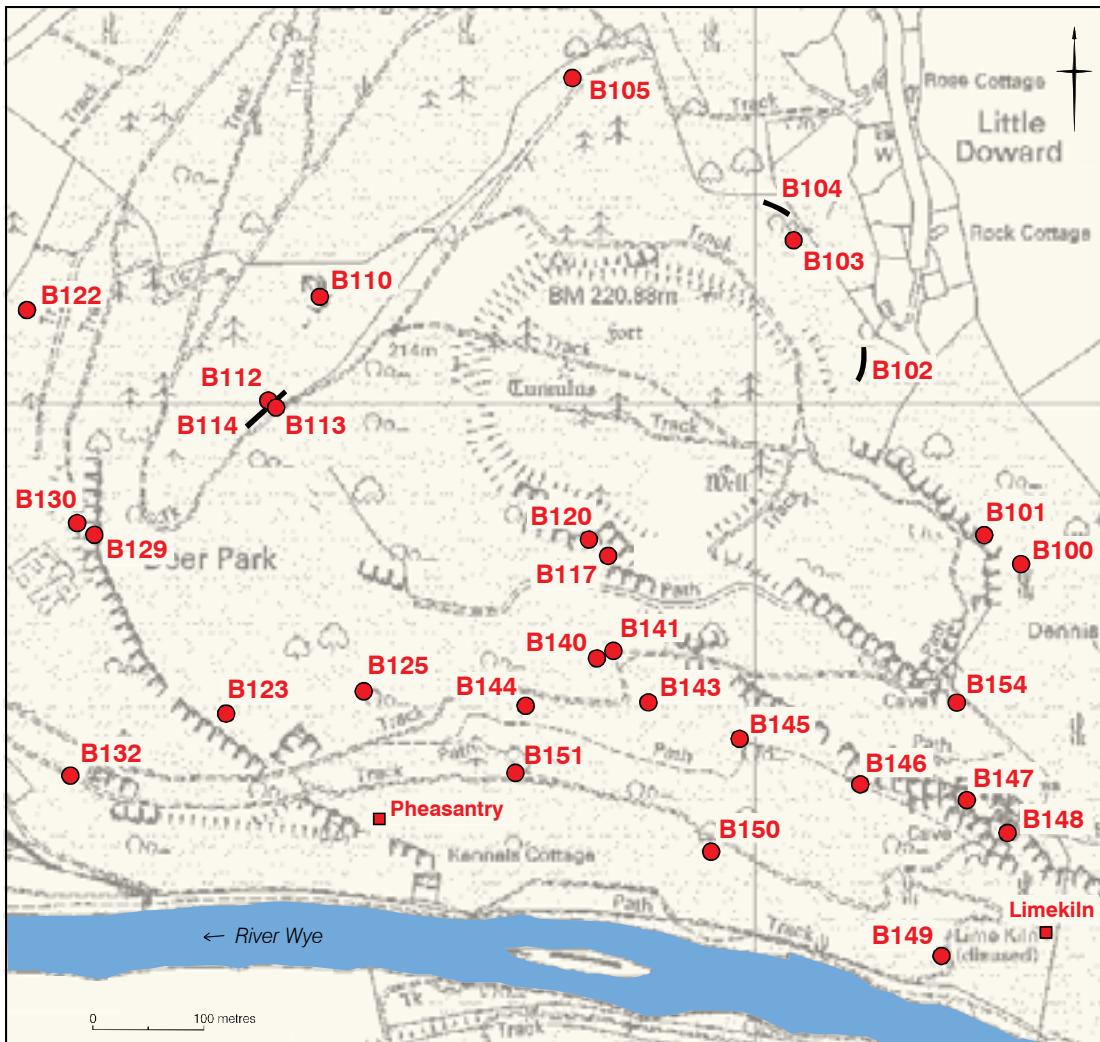
Fig 7: features below the hillfort identified in the Level 1 survey (see Table 1) © Crown copyright. All rights reserved. English Heritage 100019088. 2009

About 30 features outside the immediate environs of the hillfort were recorded by Rimmington (2008, fig 14, 35-50). These were mostly on the western and northern slopes. The present survey included these areas but also extended coverage by including the southern slopes down to the river. These areas were not surveyed in detail but only at Level 1. Feature positions were recorded by hand-held GPS units (Trimble GeoXT or Trimble Juno). The results are therefore presented in tabular form and are shown by symbols on Fig 7.

No	Grid ref	Description
B100	SO 5422 1585	Rectangular 'trough' in limestone bedrock
B101	SO 5419 1587	Natural limestone pillar – possibly partly modified
B102	SO 5410 1603	Track
B103	SO 5403 1614	Quarry
B104	SO 5402 1617	Track
B105	SO 5384 1629	19 th -century viewing platform
B112	SO 5356 1598	Quarry or mine shaft
B113	SO 5355 1598	Finger dump from B112, cut by B114
B114	SO 5355 1598	Track, overlying B113
B117	SO 1386 1582	19 th -century grotto consisting of massive placed boulders
B120	SO 5385 1588	Upright stone
B122	SO 5334 1608	Possible charcoal burning platform, disturbed by animal burrows
B123	SO 5353 1572	Possible charcoal burning platform
B125	SO 5365 1573	Possible charcoal burning platform
B129	SO 5340 1588	19 th -century 'shrine' or seat
B130	SO 5340 1589	19 th -century iron gate to B129
B132	SO 5338 1567	Stone carved bench
B140	SO 5386 1577	Upright stone
B141	SO 5387 1577	Upright stone (and quarry?)

B143	SO 5390 1573	Large upright boulder
B144	SO 5379 1573	Veteran yew tree
B145	SO 5399 1569	Triangular upright stone
B146	SO 5409 1566	Stone pillar
B147	SO 5419 1564	Cave system
B148	SO 5423 1562	'Balcony' alongside path, consisting of large placed boulders
B149	SO 5416 1550	Upright stone
B150	SO 5396 1560	Upright stone
B151	SO 5378 1567	Large N-S boundary bank aligned on B144, cut by 19 th -century track
B154	SO 5418 1572	Rock-cut seat

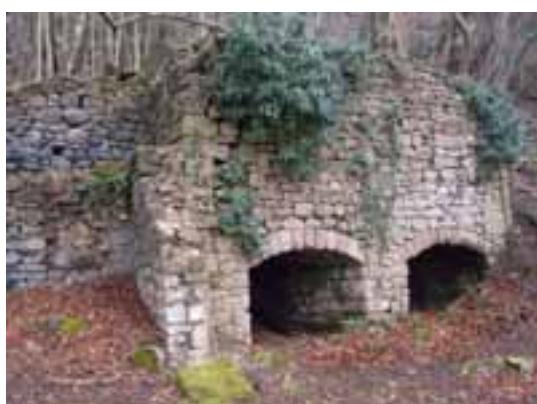
Fig 8: the limekiln

The limekiln (SO 5425 1552; Fig 8), one of several in the area, survives to full height and is generally in good condition, though there are some issues and

conservation is in hand. There are extensive quarries behind the kiln and tracks from quarries to the kiln and beyond were modified into a loop walk in the 19th century, though this is now difficult to discern on the ground. The deer park wall survives for much of its length to full height. Other features encountered were those already noted by Rimmington (2008) and other previous surveys.

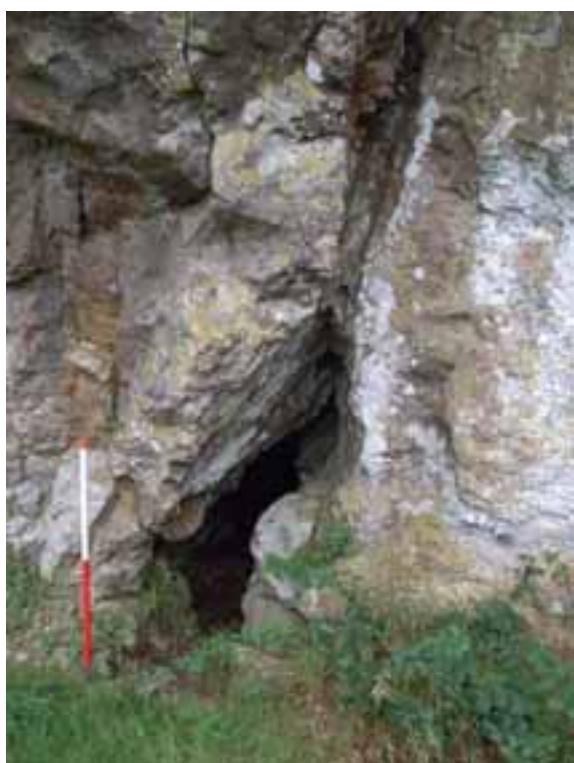
Fig 9: the entrance to King Arthur's Hall

The hearsay evidence from King Arthur's Hall (Fig 9), directly below the south-eastern corner of the hillfort, is of key importance if it is true. The Bronze Age burial with a spear (Edmunds 1874; *Trans Woolhope Field Club* 1884, 216), points very strongly to a funerary and therefore ceremonial aspect to the caves, at this period at least. Unfortunately, the accounts of the discovery are unreliable and there is even doubt over whether the name King Arthur's Hall has migrated from cave to cave over time; ApSimon's attempt (1994) to resolve this issue is marred by the fact that he mis-quotes one source, placing the cave below,

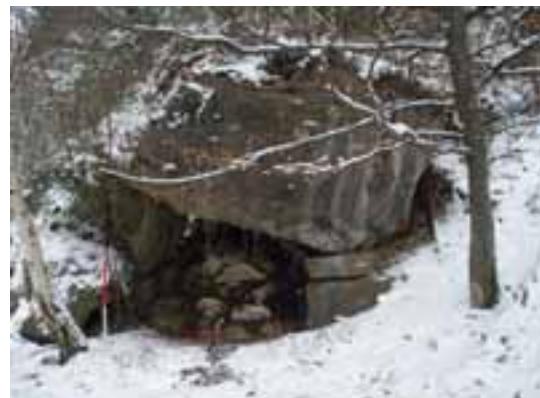
Fig 10: the 'grotto' (B117)

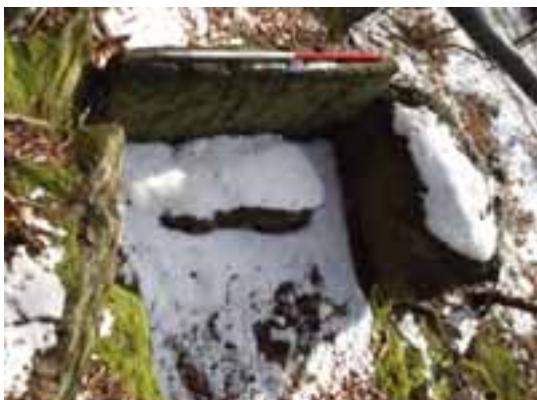
Fig 11: the 'shrine' from above; the ranging rod is lying on the 'reredos'-like vertical stone

The 1861 sale catalogue described the nearly 1000 acre estate, emphasizing that the 'walks on the Little Doward Hill are formed with great taste, and command most extensive and varied views of the surrounding counties, and of the lovely scenery of the river' (quoted by Whitehead 2001, 420). The walks largely survive and many of them are still in use as tracks and paths. At many points, particularly at junctions or prominent bends, the walks are marked by upright stones. Most of these stones have been carefully chosen: some have contrasting smooth and textured faces, presumably having been taken from suitable junctions in the local geological strata (e.g. B120); others have distinct shapes (e.g. B145 and 146). At several points there are more elaborate structures, such as the 'grotto' of massive boulders just below the southern rampart of the hillfort (B117; Fig 10); the immediate surroundings of this are currently cloaked in impenetrable woodland but aerial photographic evidence (e.g. RAF 106G/UK/1355/7045-7046) suggests that this grotto may have been set within a pre-existing quarry. There is also a curious 'balcony' further to the east (B148), an arrangement of stones projecting forward from the side of a path, which would have provided a magnificent view down the river, and the possible gated 'shrine' to the west, at which a stone has been set up like an altar with another behind it like a reredos (B129; Fig 11) – more prosaically this arrangement of stones might have been intended as a seat. Two iron gateposts survive to the west (B130; Fig 12), marking the entrance to this 'shrine' or viewpoint.

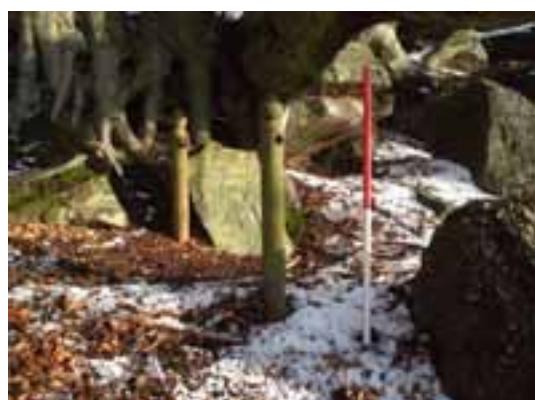
Fig 12: the gate to the 'shrine'

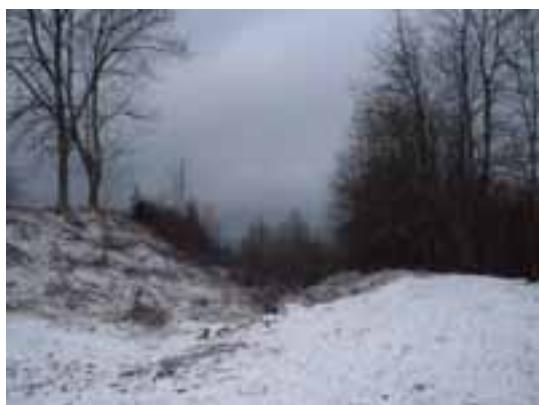
Fig 13: western ramparts of the hillfort partly cleared of scrub

Considerable parts of the ramparts are still obscured by scrub, dense in places, and they support a number of mature trees. It would be desirable for the visibility of the monument if the scrub could be further cleared. The trees should be monitored so that they can be safely felled in due course, rather than being allowed to fall and thereby causing damage to the ramparts.

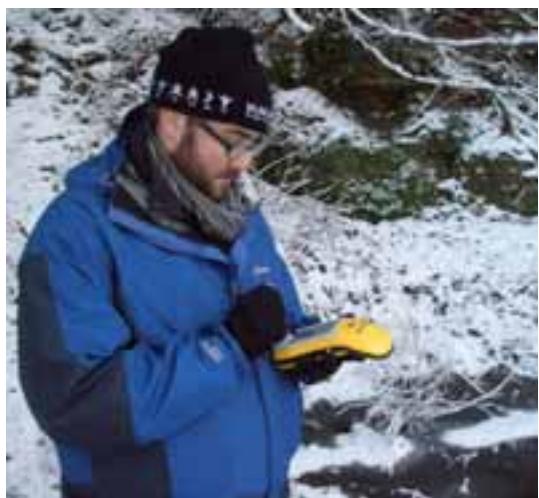
Fig 14: using the Trimble GeoXT

The Level I survey for the area around the hillfort was undertaken at a scale of 1:2500 using Trimble GeoXT and Trimble Juno hand-held GPS with data held in tables held on the GPS in Korec's FastMap Office software.

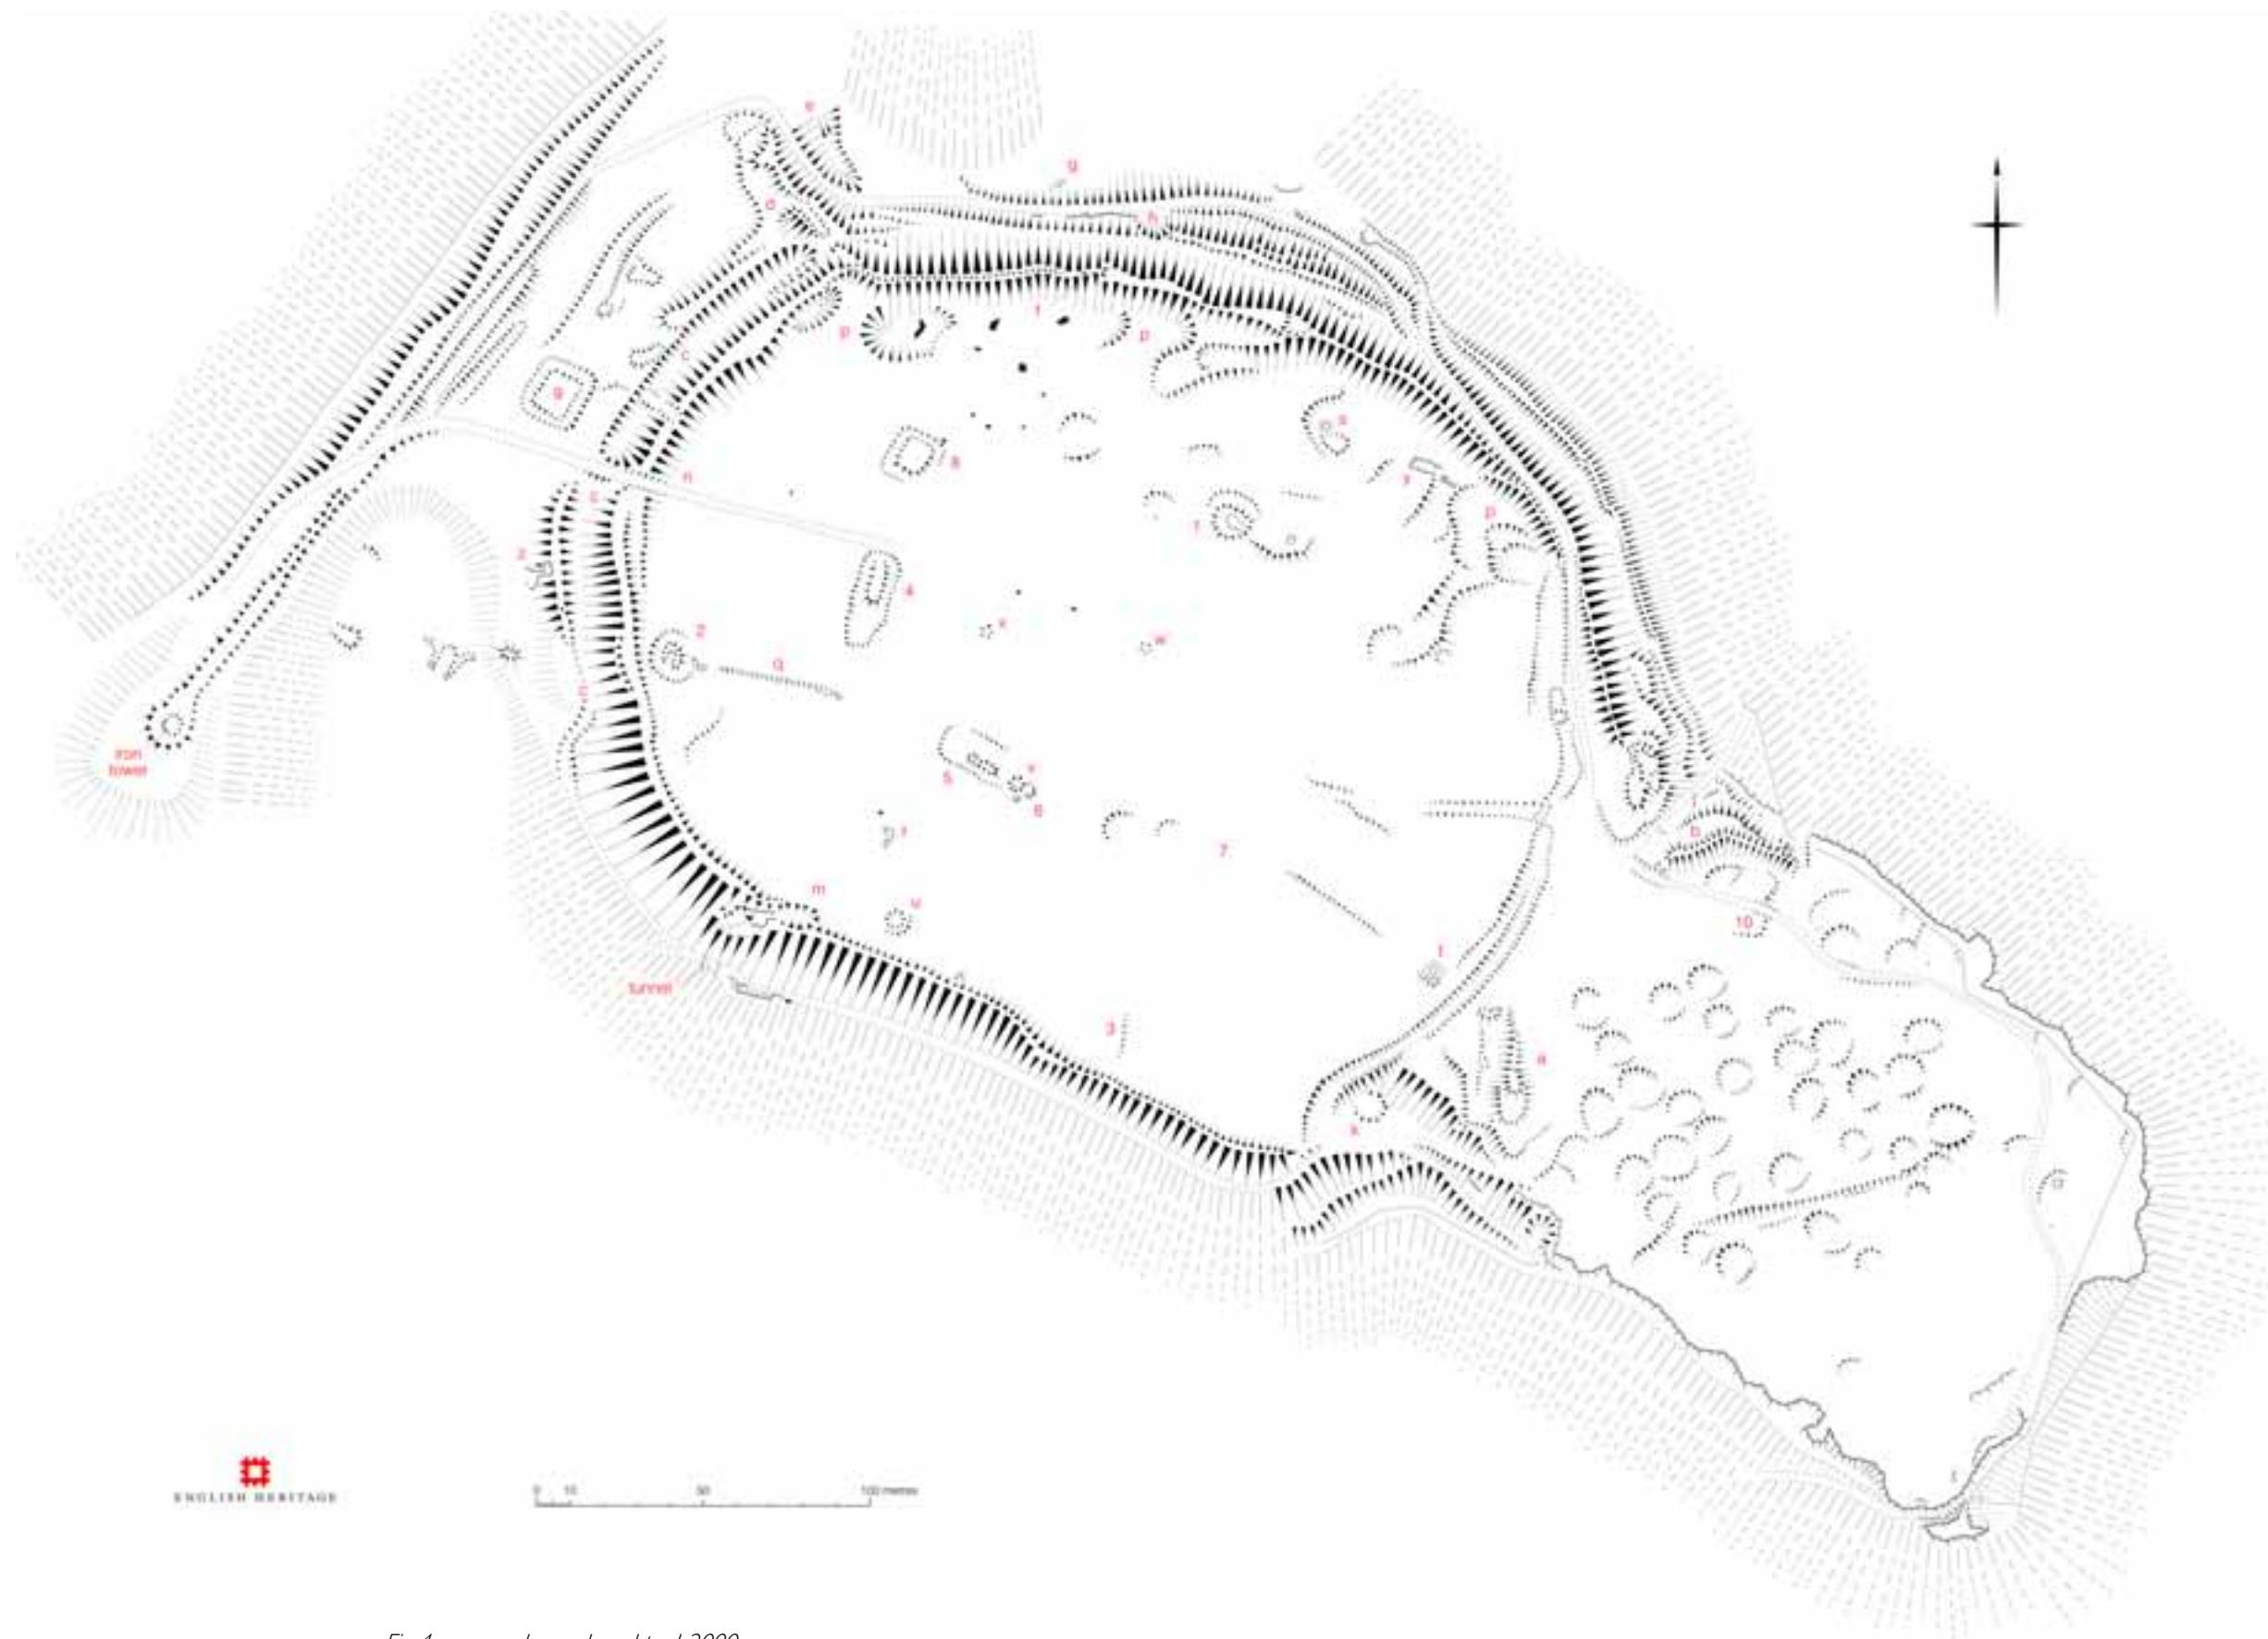
Fig 4: survey plan reduced to 1:2000

The letters and numbers relating to the hillfort, mounds and mineshafts refer to Fig 4 (inside back cover). The numbers preceded by a **B** refer to Fig 7.

The survey plan (Fig 4) was completed at 1: 1000 scale using digital drawing techniques in AutoCad/Adobe CS2 software. Additional report illustrations (Figs 1, 2 and 7) were prepared using Adobe CS2 software.
