ASCOTT PARK,
STADHAMPTON, OXFORDSHIRE
ANALYTICAL EARTHWORK SURVEY OF A
17TH-CENTURY PARK AND GARDEN

Mark Bowden and Anya Rardin

Research Department Report Series 93/2007

Archaeological Survey and Investigation Report

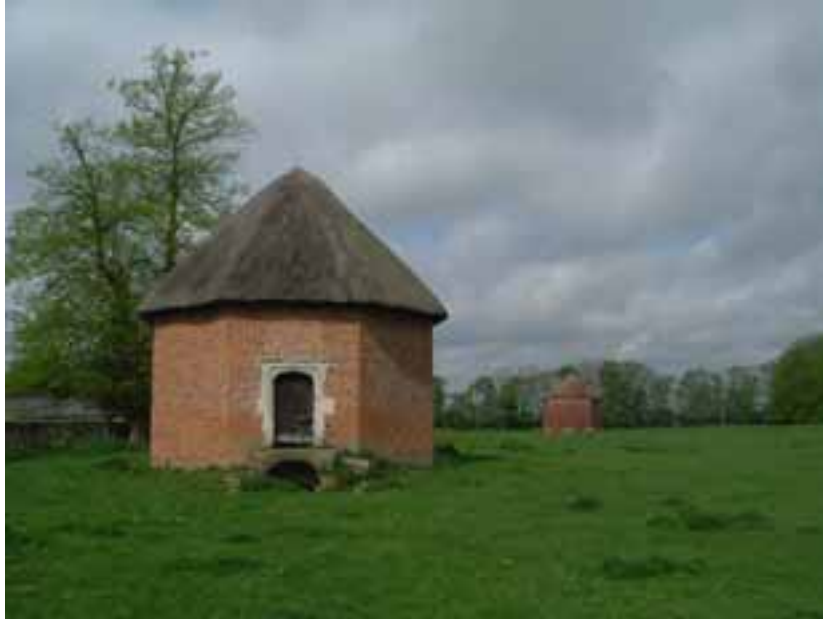
Fig 2 The supposed granary, probably a garden building such as a gazebo (foreground), and dovecote

The final 16th-17th-century features to be mentioned within the park and garden are the remaining structural elements. The first are the two octagonal buildings, one clearly a dovecot with very fine diaper brickwork and a nearly full set of brick-built nesting boxes (33) (Fig 8) and the other which has been interpreted as a two-storey icehouse and granary (34) (see Fig 2). However, the basement of this building is too small and insufficiently deep to be an ice house and, while the upper part might have been used as a granary at some time this is clearly not its original purpose. It consists of two storeys, the upper one truncated and with a modern roof. The ground floor is lit by stone-mullioned windows which match the quality of the doors; the upper storey had a skirting board and an opening above the door (SHS 2001, 126); this, which was probably not an original feature though its detailing appears to have matched the doors below, has been removed and blocked in with plain brickwork. Otherwise the fenestration of this upper storey cannot now be determined. Both structures also contain distinct modern elements. The dovecot has an inserted window and door; the position of the original door is unclear but it must have been either a smaller opening in the current position (facing due south) or in the adjoining face where the window now is. The other building contains a power line, probably for the piece of agricultural machinery now within. It has also had a quadrilateral brick structure of unknown purpose inserted into the basement. The dovecot dates to the later 16th century and the quality of its brickwork and detailing is extremely fine. It retains what seems to be its original roof structure, though with repairs, with dormer entrances for the pigeons to north and south as well as a cupola. The other building is later, a somewhat pale imitation in terms of its brickwork, perhaps dating to the early 17th century. Though its brickwork is plain its doorcases and fenestration are of very high quality. Its purpose is surely as a garden building, the basement, though probably not an ice house, being for cool storage, the upper storeys for recreation; it would perhaps be best described as a gazebo, despite the lack of evidence for fenestration of its upper floor.

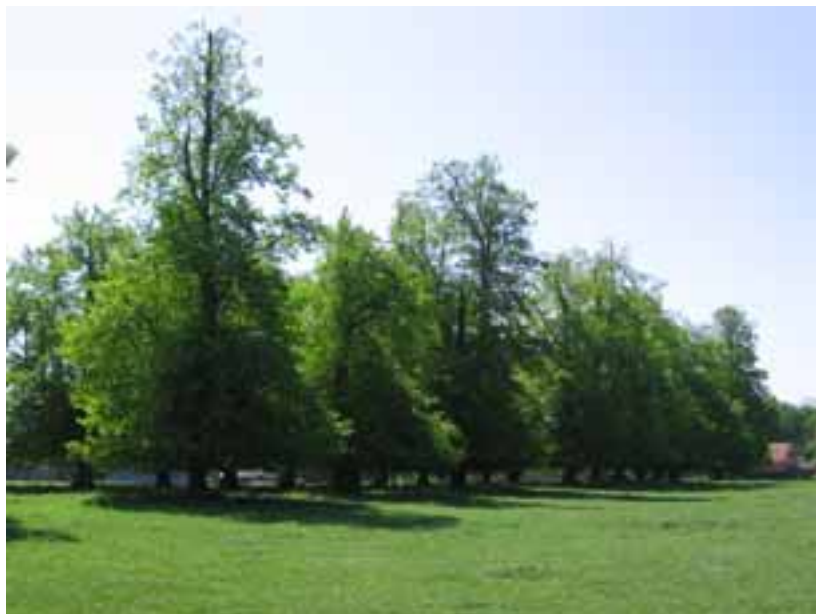
Fig 3 One of the surviving lime avenues

The survey revealed medieval ridge-and-furrow, probably associated with the contemporary nearby hamlet of Ascot. The majority of garden remains are in the form of earthworks, with several small stone and brick intrusions indicating further structures. Three of the designed landscape's lime avenues have survived with indications of the walks and formal areas of the park (Fig 3).

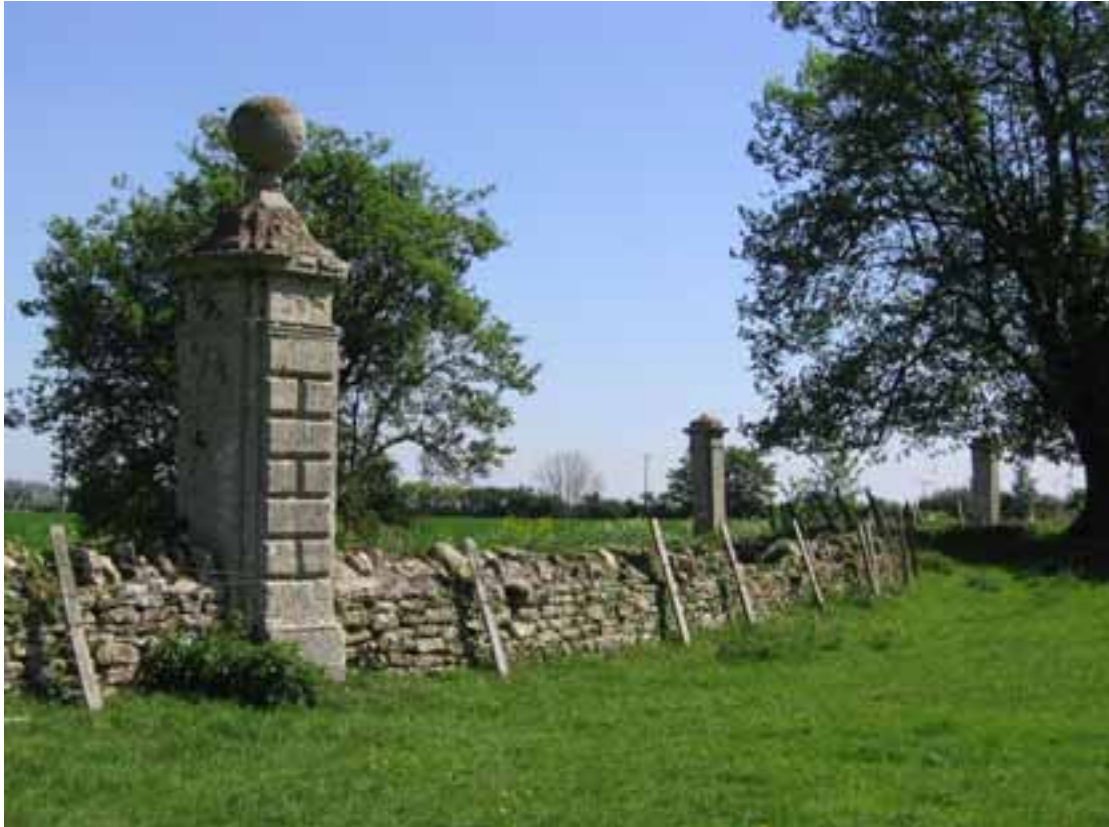
Fig 6 Three of the gate piers

The central approach route of the late 17th-century scheme is bordered on its western and eastern sides by the four lines of lime trees which form avenues for the entrance drive to the 1660s house. The main gate piers (Fig 6) retain their hinge pins and the 10m gap between them probably demands that there were two separate gate leaves. This is supported by the presence of a scarp running south from a central point between the gates, possibly the result of a double entrance drive, though this scarp might also result from the cambering of a single narrow drive. It should be noted that faint cropmarks visible on aerial photographs (e.g. see front cover and Fig 7) indicate that the lines of the avenues were carried out beyond the gates into the wider landscape.

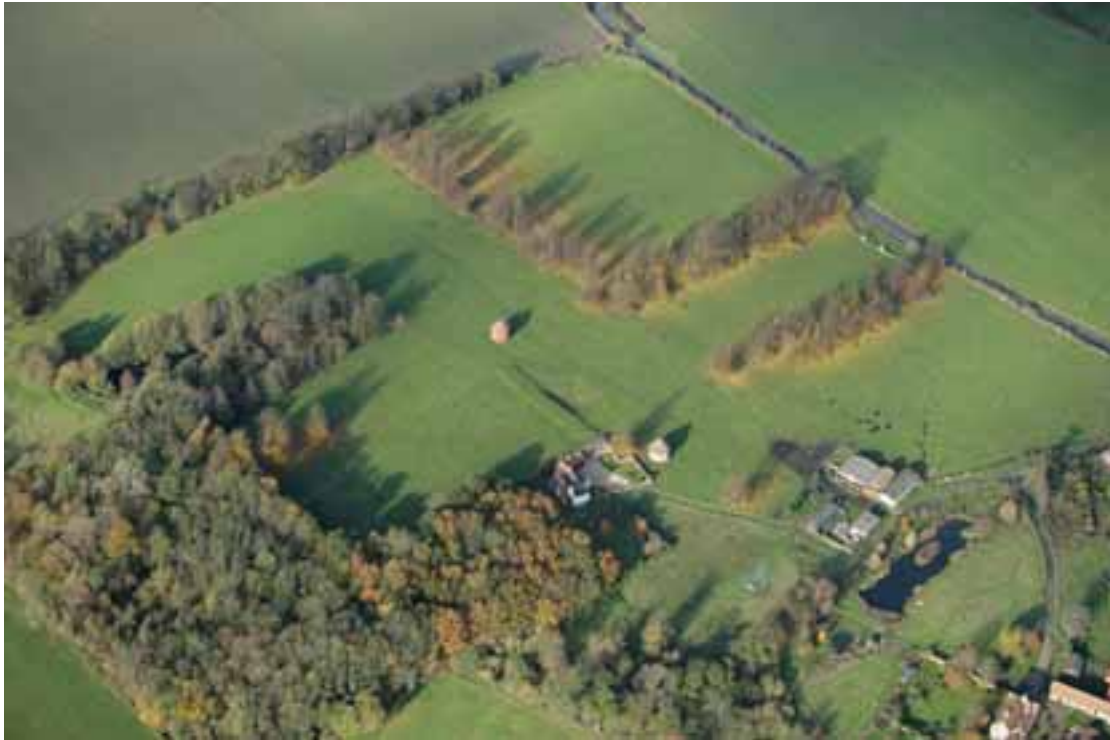
Fig 7 Aerial photograph of Ascott Park, looking north-west; the terrace (22) shows distinctly in the centre with the rectangular hollow of the cellar against its northern edge. The octagonal buildings can be seen to either side. The ponds are in the wooded area to the left (NMR 24480/20)

stonework remains in the eastern edge of the earthworks, the shape and extent of the feature clearly represents a rectangular cellar (lowest depth approximately 3.2m below present ground level), while shallower hollows to the east and west probably show the extent of the building. Immediately to the south is the most notable earthwork on the site (22), a raised terrace (Fig 7). The northern scarp of this terrace is flush with the southern edge of the cellar. This terrace overlooks the southern garden area. The terrace itself contains several modern intrusions, including erosion pockets, partly created by burrowing animals, on the western terminus, a recent path and a scar which probably marks the location of the 1969 excavation trench. The remains of a brick-built structure are located at the north-east corner of the terrace; an L-shaped structure at least three bricks wide emerges to the north from the existing wall and turns west into the foot of the terrace itself where it is obscured. It probably forms part of the structure of the terrace. (A profile across the cellar and terrace is included in the plan.)

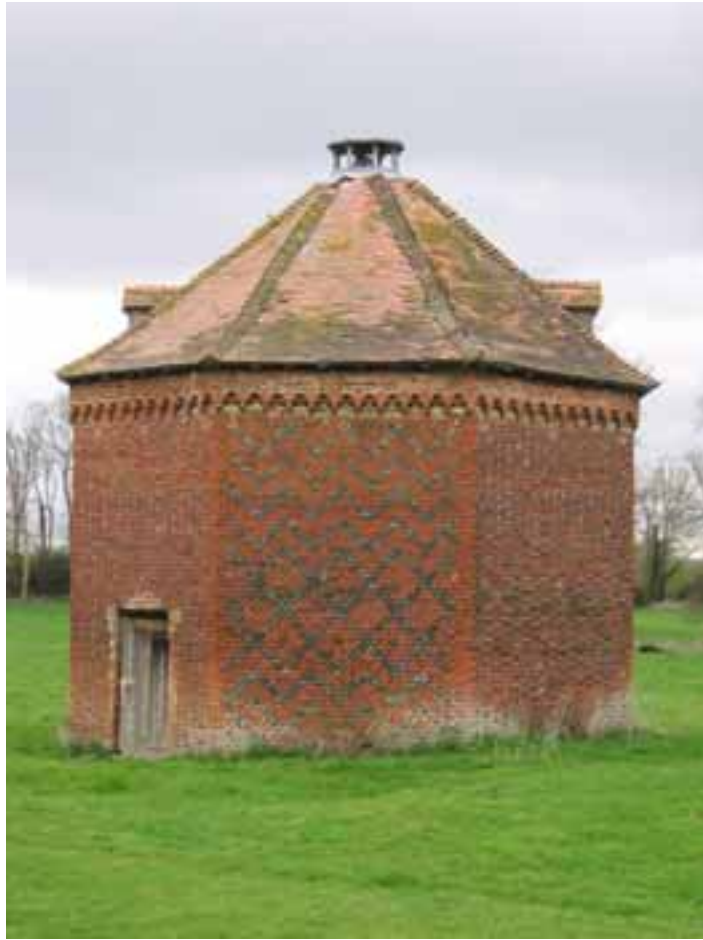
Fig 8 The dovecote

The very fine dovecote with its diaper brickwork (see Fig 8) and quasi-gothic cornice dates to the late 16th century. The vitrified headers forming the diaper have been fired to extremely high temperatures, almost melting in some cases. It is a building which proclaims high status – 'dovecotes were expensive prestige buildings whose only economic function was to provide an additional delicacy for those who already had plenty of other fresh meat' (McCann 1991, 95). It is designed to be seen but not too close to the principal dwelling; dovecotes need to be sufficiently far from domestic buildings that the pigeons are not unnecessarily disturbed and to have a clear field of view so that the pigeons can see birds of prey approaching (*ibid*, 125) – this suggests that the dovecot had ceased to be used by the time the lime avenue was planted up against it, as shown on early OS maps and by the existing tree holes. In fact, if

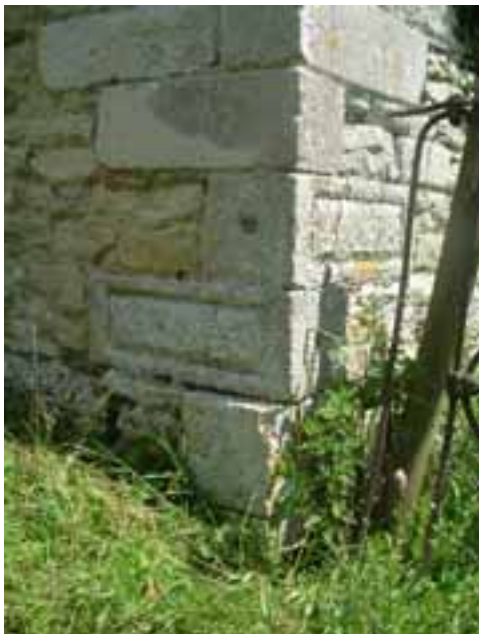
*Fig 9
Dressed
stone blocks
built into the
garden wall of
Ascott Manor*

The stone walls surrounding the park have not been studied in detail as part of this project. However, some dressed and carved stone blocks have been built into the corner of the garden wall of the present Ascott Manor (Fig 9); these are probably derived from the 1660s house.

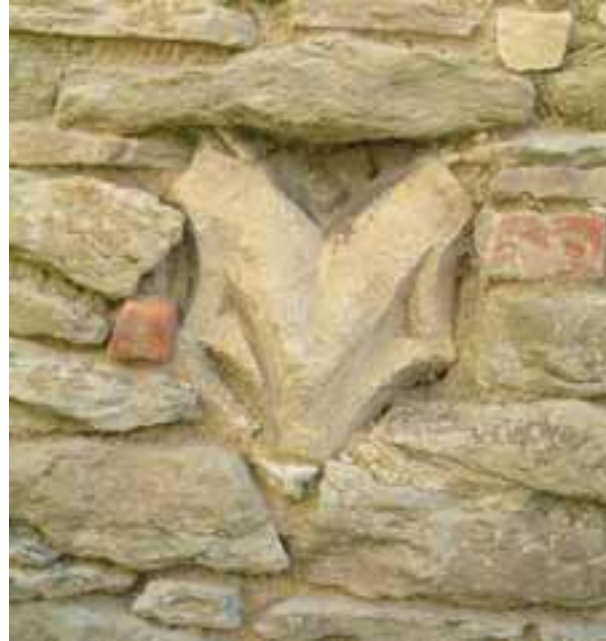
*Fig 10
Fragment of
window
tracery,
probably of
14th-century
date; it may
have come
from the
chapel though
it might also
have been
part of a
secular
manorial
building*

John Osborne, pers comm). Though the chapel no longer exists its position can be pin-pointed with a degree of confidence and a fragment of window tracery, probably of 14th-century date, is incorporated in the wall of an outbuilding at the current Ascott Manor (Fig 10); this is likely to have come from the chapel.
