MANOR FARM, RUISLIP, LONDON BOROUGH OF HILLINGDON

HISTORIC BUILDINGS REPORT

Research Department Report Series 63–2008

**MANOR FARM, RUISLIP,
LONDON BOROUGH
OF HILLINGDON
HISTORIC BUILDING REPORT**

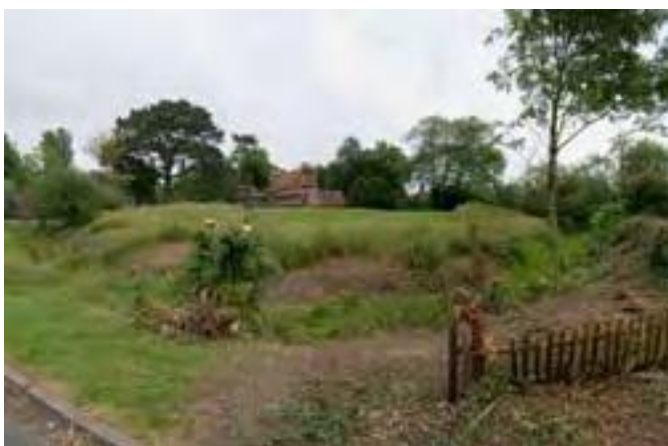
Fig. 2: The motte and bailey earthworks southwest of Manor Farm. Photograph by Derek Kendall (DP042428).

Manor Farm lies within a motte and bailey complex of early Norman date. It probably had a small wooden castle. The motte is c.45m (c.150ft) across, now a low mound rising to some 3m (10ft) above the base of the bailey ditch, which is some 4m (13ft) wide at its widest point. The sub-rectangular course of the bank and ditch enclosing the bailey still be made out, despite extensive landscaping and infilling of its northern circuit in

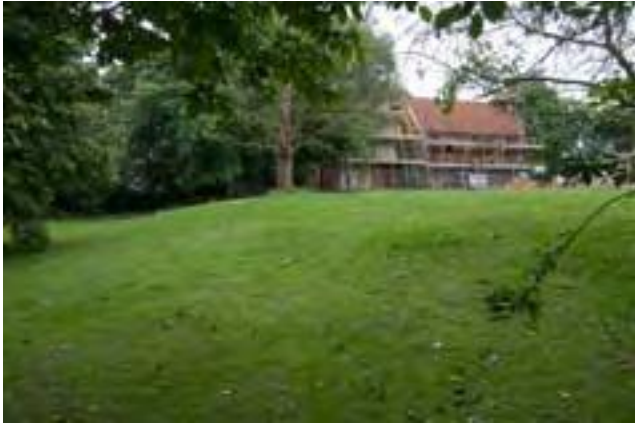
*Fig. 6: The ditch circuit to the northwest of Manor Farm, infilled in 1888, but still visible.
Photograph by Derek Kendall (DP042389).*

Manor Farm is located to the northeast of the bailey of a motte and bailey castle, on ground sloping down to the former ditch circuit, located to the north and east of the house. The motte and bailey is a scheduled monument, and the wider farm complex contains five listed buildings, (one Grade II* and four Grade II, including Manor Farm). The site lies within Ruislip Conservation Area and an Archaeological Priority Area, as designated in LB Hillingdon's Unitary Development Plan.¹

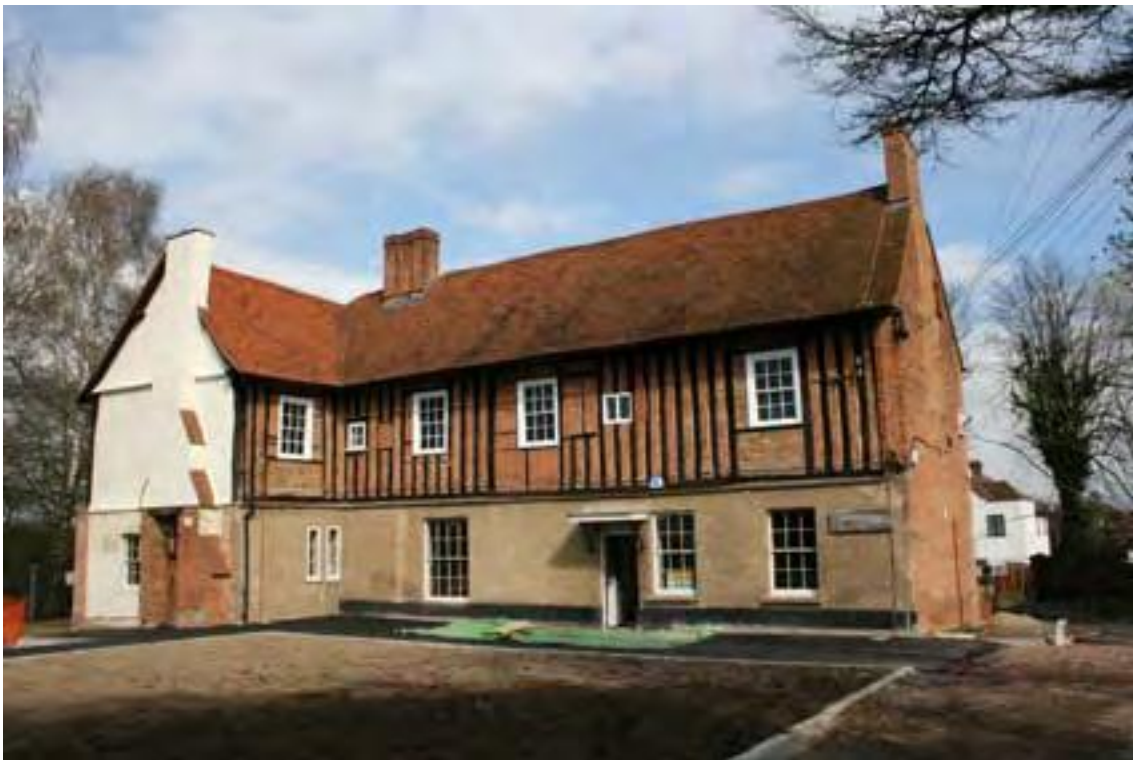
Fig. 7: West elevation of Manor Farm in 2007 (DP040077).

Manor Farm is a two-storeyed house with attics, orientated north-south and facing west. The ground floor is of brick on foundations of mortared flint and ragstone rubble, with a timber-framed upper storey, plain tile roof and brick stacks.² The building comprises a three-bay hall range with a coeval cross wing at the north end, giving an L plan. There are minor and later extensions.

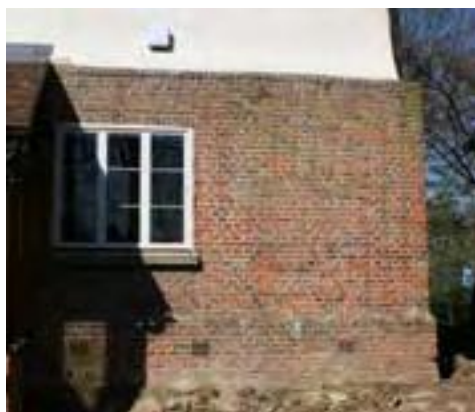
Fig. 8: The west wall of the parlour, showing diaperwork (DP040083).

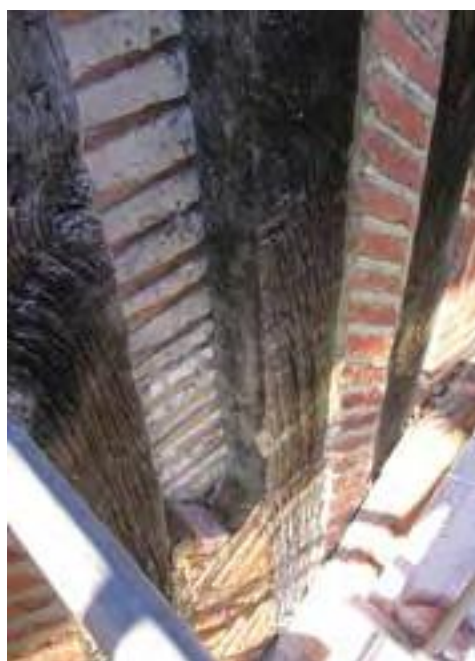
Fig. 9 The partial removal of nogging during conservation works in 2007 showed that the reveals of the studs were hollowed to provide a mortar key (DP040076).

Scribing marks surviving on the west elevation show how the intervals between studs and infill were calculated during framing (figure 10). Carpenters' marks are not visible on the exterior.⁴ The sides of the studs are hollowed to provide a mortar key, confirming that the nogging is part of the original design (figure 9)⁵. Despite the narrowness of the panels, the brick nogging has been arranged in a variety of patterns, with five recognisable designs (not counting mirroring, variants and horizontally-set bricks).⁶

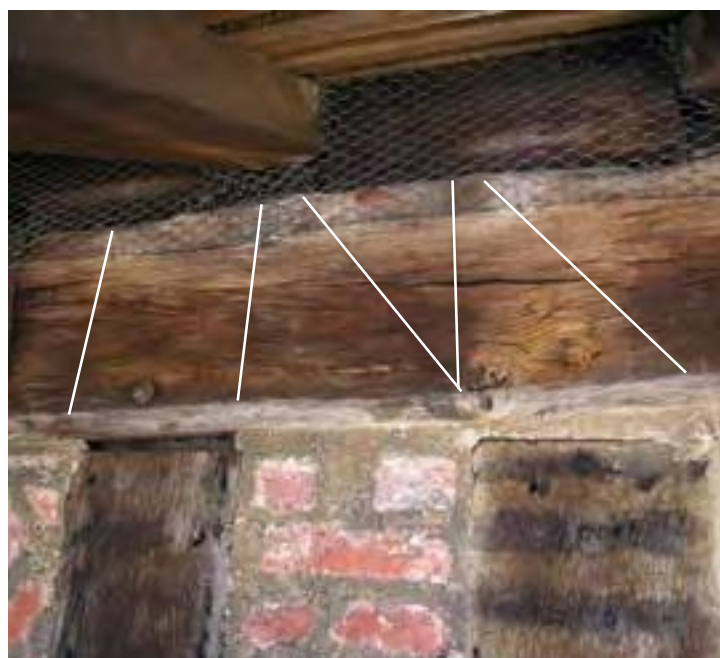
Fig. 10: Scribing marks on the wallplate of the west elevation (highlighted in white), inscribed during the 'setting-out' of the timber frame to indicate the position of the adjoining studs (DP040078).

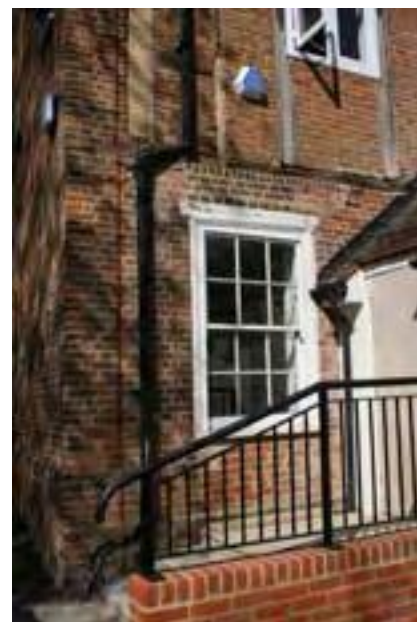
Fig. 11: Detail of east elevation, showing inserted sash window (DP040080).

The east elevation (figure 12) has been extensively altered and repaired, resulting in irregular and varied fenestration. The brick ground floor is largely obscured by single-storey service extensions: a 20th century rebuilding of an earlier extension and a single-storey lean-to corridor. The only uncovered part of the ground floor contains a sash window of 19th century date. A small area of close studding and

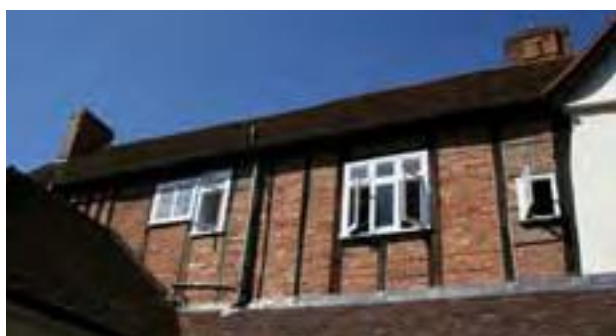
Fig. 12: First floor of east elevation (DP040081).

brick nogging⁸ survives on the upper storey, where it has been protected by an earlier two-storey extension. An inserted and sawn-off beam end in this area relates to the former extension. Evidence for original windows, pegged into adjacent studs, survives in the southernmost bay and the quarter bay.

earlier windows of similar sizes and locations. Above the extension are grouped a two-light cross window, a two-light casement with thin glazing bars, and a narrow single-light window. Immediately to the north of the latter is a blocked doorway to a former single-bay two-storeyed extension of possible 16th century date. There is a large 20th century three-light cross window in the northern bay.

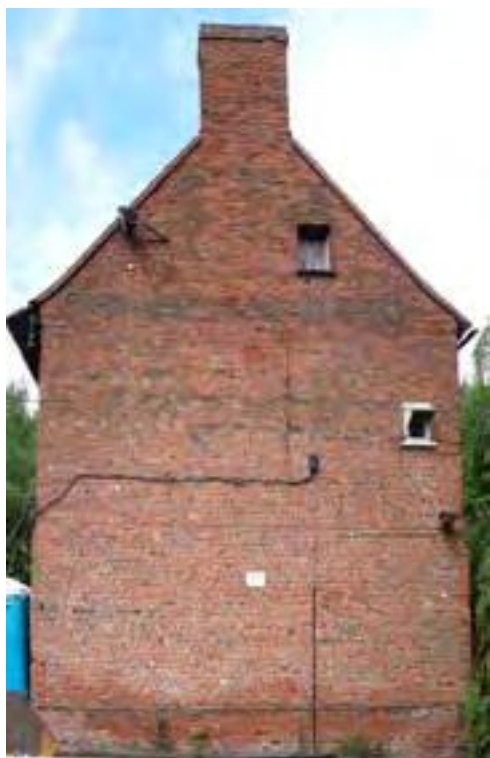
Fig. 13: South elevation (DP040079).

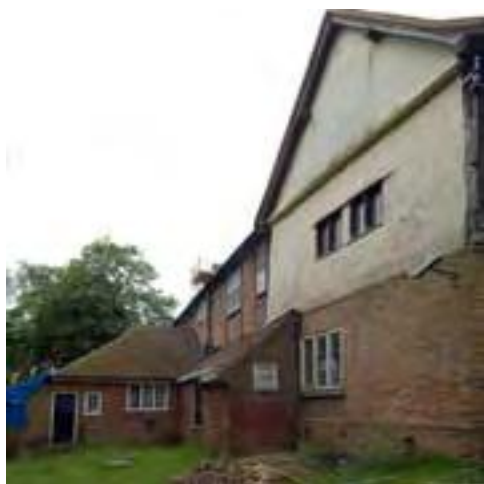
Fig. 14: East elevation of cross wing (DP040082).

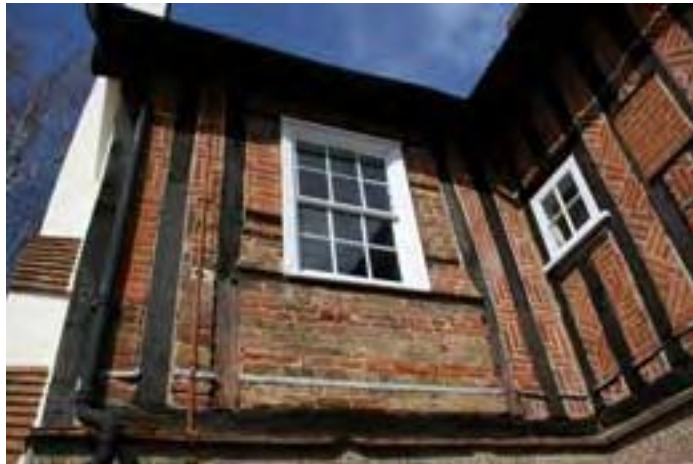
Fig. 15: South elevation of cross wing at first-floor level, showing replacement infill and window in position of the original window (DP040084).

In its construction and materials, the south elevation of the cross wing resembles the hall range west elevation, which it adjoins to form the internal angle of the building's L plan. The ground floor is pebble-dashed, with two off-centre narrow casements of 19th-century date. The recessed, timber-framed upper storey contains two pairs of studs with intervening narrow panels of nogging¹¹. These flanked a large central window which has been replaced with a sash window within a moulded architrave, and infilled below with yellow bricks.

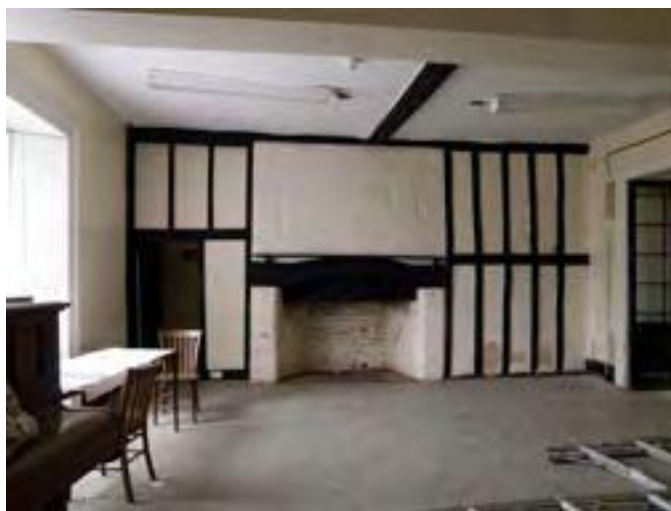
*Fig. 16: North elevation of hall.
Photograph by Derek Kendall (DP042331).*

Hall (room 11)

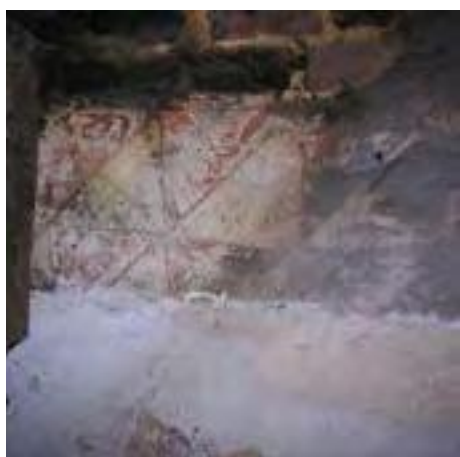
Fig. 17: Traces of a geometric decorative scheme of probable 17th century date surviving on the plasterwork lining of the hall fireplace jamb. (DP040085).

The hall fireplace, which has been much altered, has a 20th century wooden lintel and mantelshelf, with a five-sided hearth of brick. The opening has brick jambs with an ovolo moulding on the west side, with a converging stop; the other jamb has been rebuilt with a chamfer. Traces of a decorative scheme has survived on the plasterwork lining of each inner jamb. This comprises a geometric pattern of diagonally-divided squares marked out by faint incised lines and painted half red and half cream. Further traces of the incised lines can be made out beneath 20th century white paint.¹⁴ Flanking the stack are stud partitions of 19th or 20th century date, separating the hall from a closet (room 12) and stairwell.

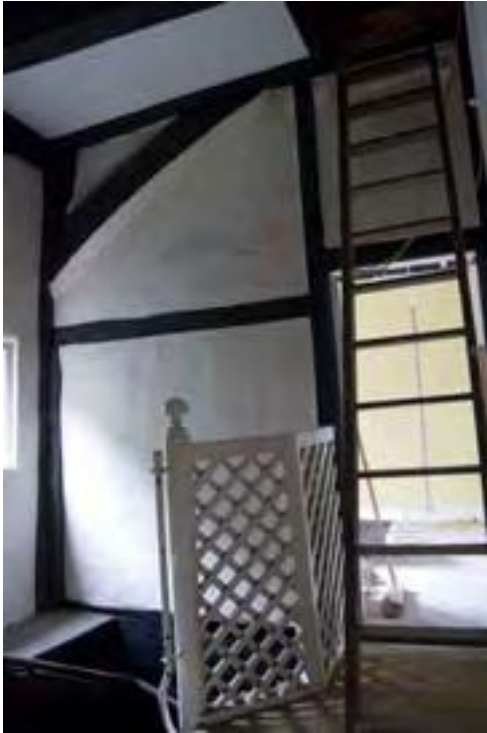
Fig. 18: Landing of principal stair.
Photograph by Derek Kendall (DP042404).

The principal stair, to the northeast of the hall, is a winder of probable early 17th century date, which turns 360° from the ground to the first floor. It has an octagonal newel terminating in an octagonal finial. More unusual is the lattice balustrade of the stair head,

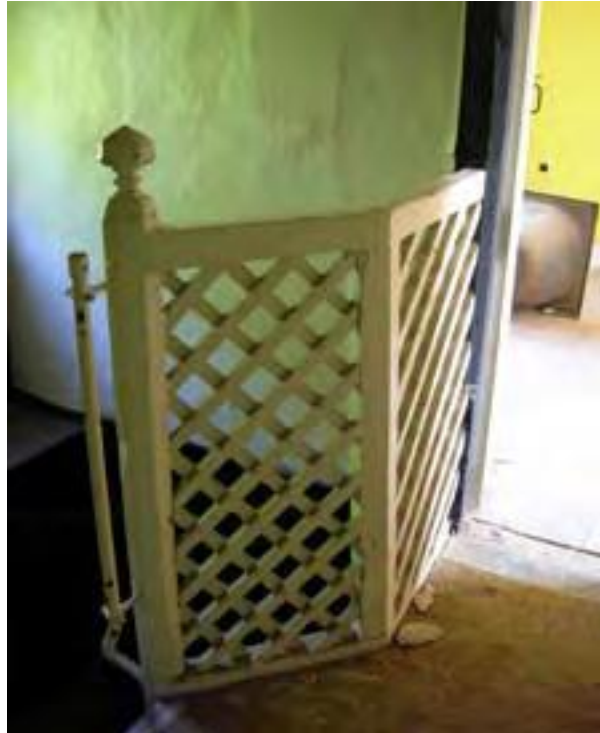
Fig. 19: Lattice balustrade, octagonal newel and finial of principal stair. (DP040086).

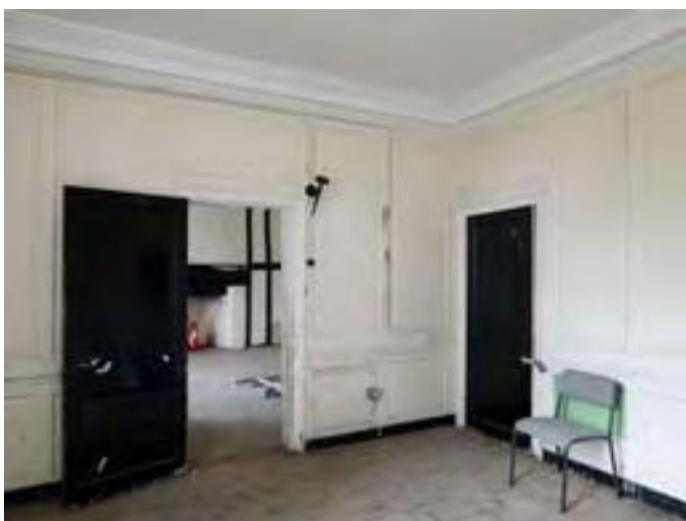
Fig. 20: Fielded panelling of entrance hall.
Photograph by Derek Kendall (DP042329).

The entrance hall is of Georgian appearance, and is panelled throughout. The panelling, which dates stylistically to the 1720s or 1730s¹⁵, has tall fielded panels above a moulded chair rail and

square fielded panels below, with a deep moulded cornice and a narrow skirting board. The sash window in the west wall is accommodated by the panelling and has a solid seat with a moulded edge and a shallow panel below. The shutters have fielded panels and a single plain leaf in the centre, decorative H-hinges and a security bar.

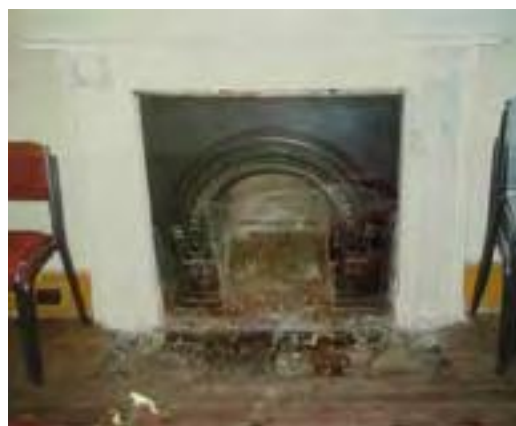
Fig. 22 Detail of Room 10 fireplace in the late 20th century. (Local history room at Manor Farm Library, Ruislip).

a later addition. There is a 19th century skirting board and moulded picture rail. Also of the early 19th century is the fireplace, with its moulded, light grey marble surround with corner blocks containing roundels, and a plain marble mantelshelf; the semi-circular cast-iron grate is a later 19th century insertion. A segmental-headed blocked door in the south wall, uncovered during the present works, is of possible 19th century date and gave access to the kitchen extension.

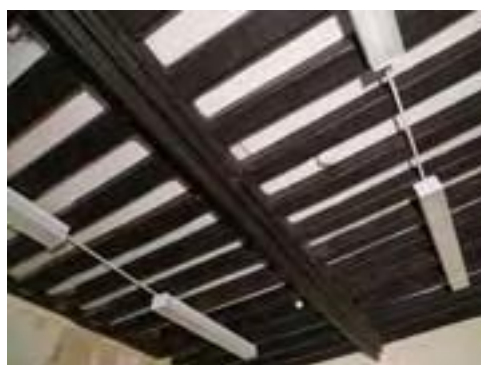
*Fig. 23: Parlour ceiling, looking west.
Photograph by Derek Kendall (DP042341).*

The Parlour is the only room where the open ceiling is still exposed. There is a heavily-moulded spine beam and hollow-chamfered joists, all of good quality.¹⁷ The joists have runout stops at the spine beam, joined with soffit tenons with diminished haunches. The easternmost five joists are also stopped at the north wall. In front of the stack is a trimmer tenoned and pegged into two of the joists.¹⁸

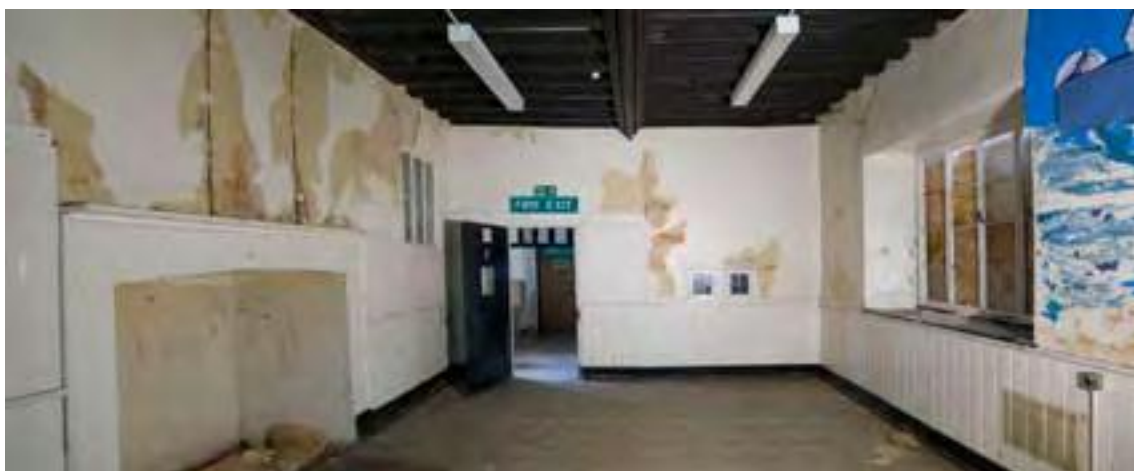
Fig. 24: Parlour (room 15), looking west. Photograph by Derek Kendall (DP042340).

Otherwise the character of the room is firmly 19th century. The north and east casements are enlargements of original windows; the east wall window has a seat. The lower half of the walls are lined with vertical planking, a chair rail and moulded skirting board. The large fireplace has a shallow segmental arch and a plain mantelshelf. In the east wall is a cupboard with double doors, each with three recessed panels, and with two shelves inside. There is a four-panelled door to the stairwell. However, the door into room 13 may date from the 18th century. This has two panels with an additional narrow panel over, and a plain beaded architrave; the panels are feathered on the parlour face, and there is a later glazed light in the middle panel.

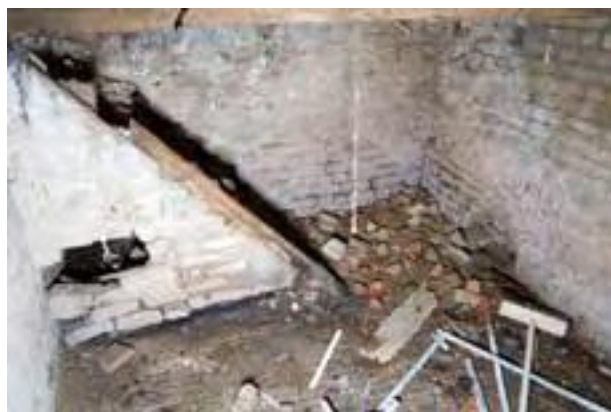
Fig. 25: Cellar underneath Room 14. Photograph by Derek Kendall (DP042412).

This room, in the north-western angle of the cross wing, is lit from the west by a sash window. There is an inserted, and subsequently blocked, opening in the north wall. The original timber framing of the east wall is exposed, with fairly widely-spaced studding with a middle rail. The sill beam is some 6in (15cm) below the current floor level. The south wall has a four-panelled door and chair rail. Underneath room 14 is an inserted brick cellar of 18th or 19th century date, accessed by a trap door in the floor.

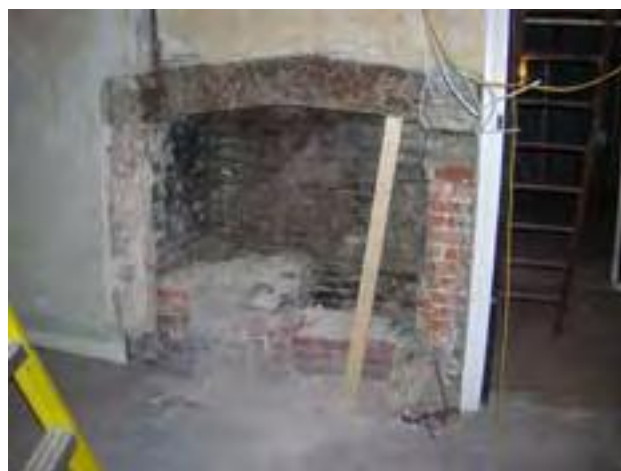
Fig. 26: Hall chamber fireplace, exposed during works in 2007-08 (DP040087).

The original hall chamber fireplace was unblocked during a refurbishment in 2007-08 to reveal a wooden lintel with an unchamfered depressed four-centred arch. Because the face of the timber has been hacked back to receive plaster, any chamfers or mouldings have been lost. The fireplace opening is square with some plaster surviving on the west wall. Two rows of square tiles are employed in place of a hearthstone. Above the fireplace the original wall surface is recessed behind the current wall face: it may have a recessed panel, as in room 28. The present wall surface is stud, lath and plaster.

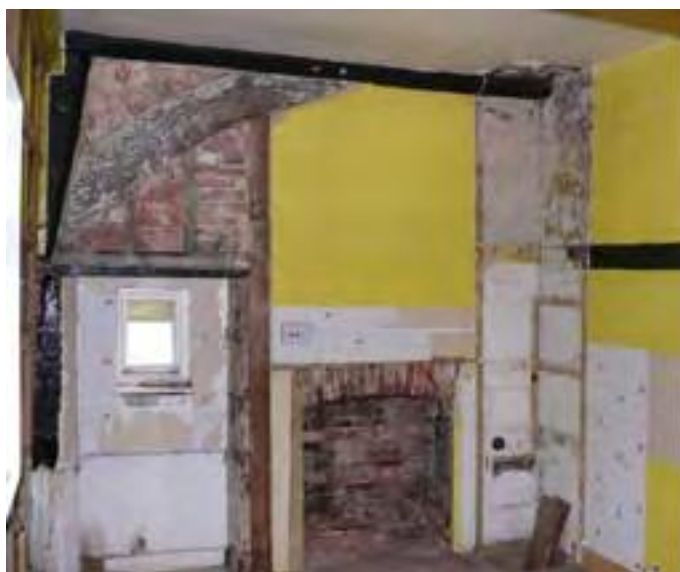
Fig. 27: Room 20, looking south (DP040088).

This plain room occupies the eastern half of the southern bay. The jowled eastern post and brace of the southernmost truss is visible, below which is a cupboard recess with a window in the south wall. The room is lit from the east by a 20th century cross window and has a segmental-headed fireplace in the south gable end. It has replacement floorboards running east-west on top of earlier boards. The door has an early 19th century architrave.

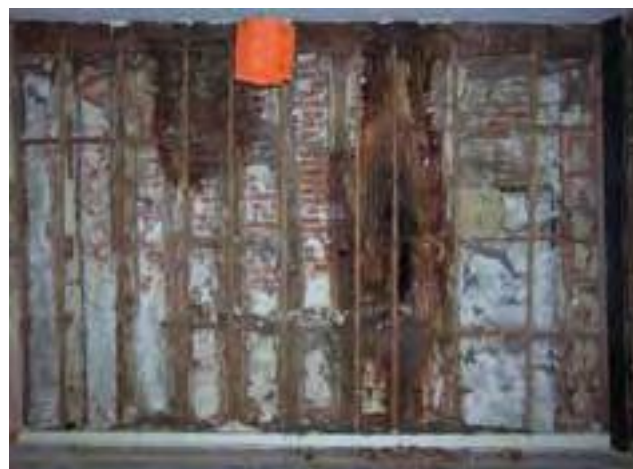
Fig. 31: North wall of Parlour chamber (Room 28), exposed during works in 2007-08. Note blocked garderobe door to right. (DP040090).

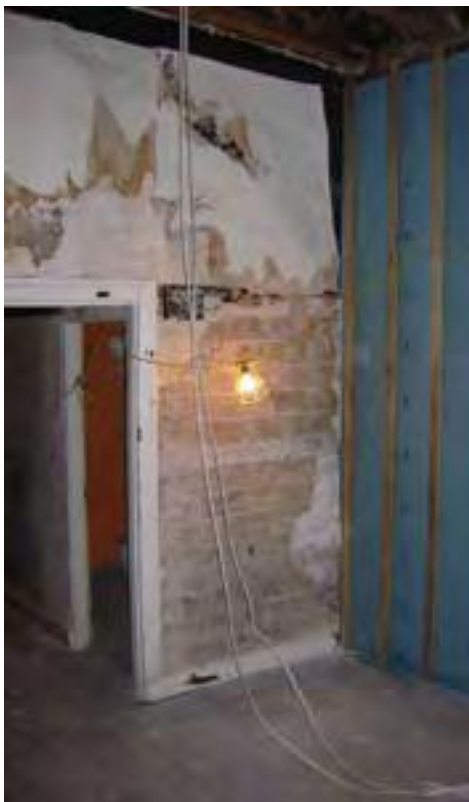
Fig. 32: Blocked doorway in the east wall of room 25 (DP040092).

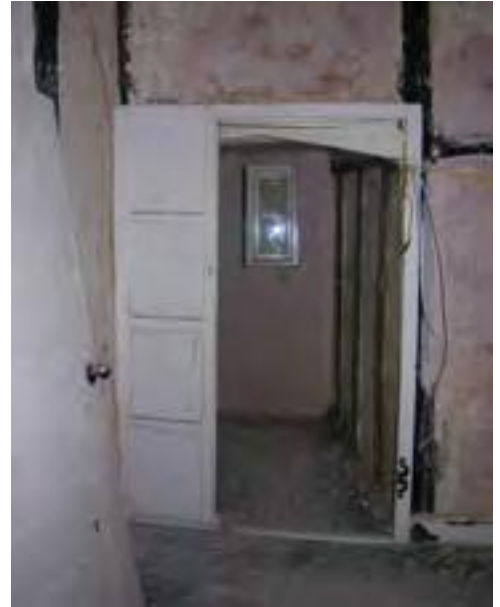
Fig. 33: Original, four-centred doorway to closet (room 26), reduced in size with reused 17th century door (temporarily removed) and panelling (DP040093).

At the south end of the east wall the rail accommodates an original doorhead, subsequently brick-blocked. Adjoining this is an inserted doorway from room 28 with a plank and battern door; the original access between rooms 28 and 25 was via the stair head (room 24). The doorway to the closet (room 26) has a depressed four-centred arch and is set directly under the rail of the north wall. The doorhead has a small chamfer on both faces and there is a hollow chamfer on the south side of the rail. The opening has later been reduced in width by the insertion of a reused section of late 16th or early 17th century small-square panelling and an eight-panelled door with cockshead hinges.²⁰

The original, four-centred doorway from room 25 into its closet (room 26) is unusually wide, occupying the full width of the closet. One explanation is that room 26 originally functioned as a lobby for an external entrance at first-floor level. The north elevation contains evidence for a first-floor doorway that would have served an external stair or adjoining structure since lost (see page 34).

- 19 No wallpaper fragments were found in this room, however.
- 20 Mortises in the eastern jamb for panelling rails show that it was not originally a doorway, and is therefore reused in its present position.

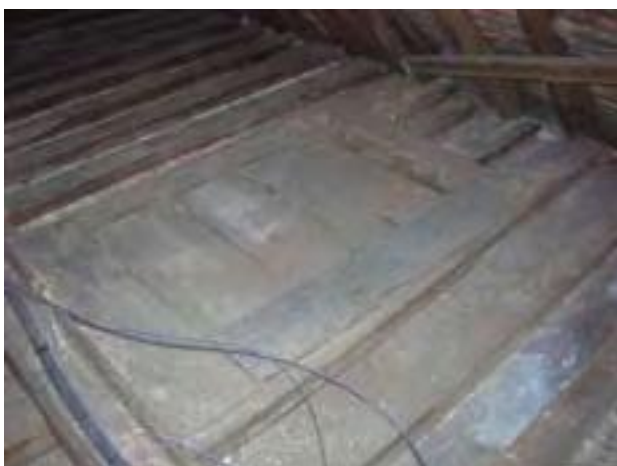
Fig. 34: Framed opening in attic floor (DP040094).

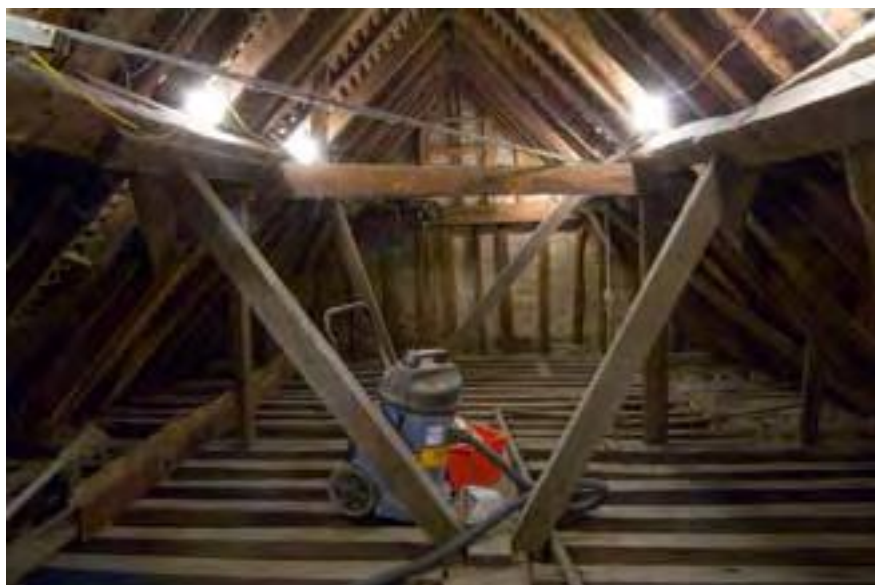
Fig. 35: Roof space of hall range, looking north. The struts in the foreground are later insertions. Photograph by Derek Kendall (DP042418).

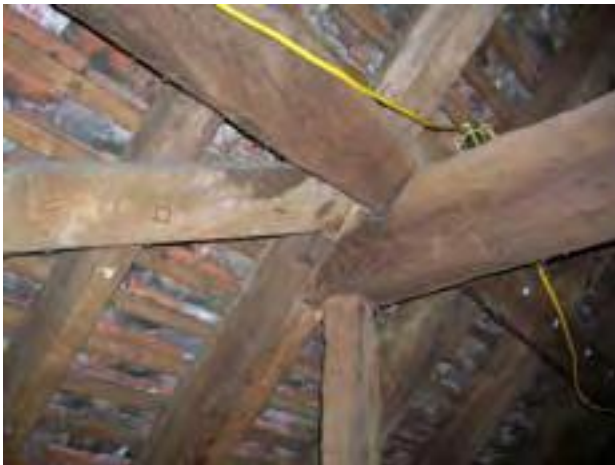
Fig. 36: Detail of principal truss, showing clasped purlin construction and windbrace (DP040095).

The hall range roof, like that of the cross wing, is of clasped-purlin type with diminished principal rafters and tenoned collars. There is a large, flat ridge piece, set parallel to the western pitch and joined by an edge-halved scarf at Truss III. Pairs of unpegged and curved windbraces provide lateral stiffness to the outer bays.

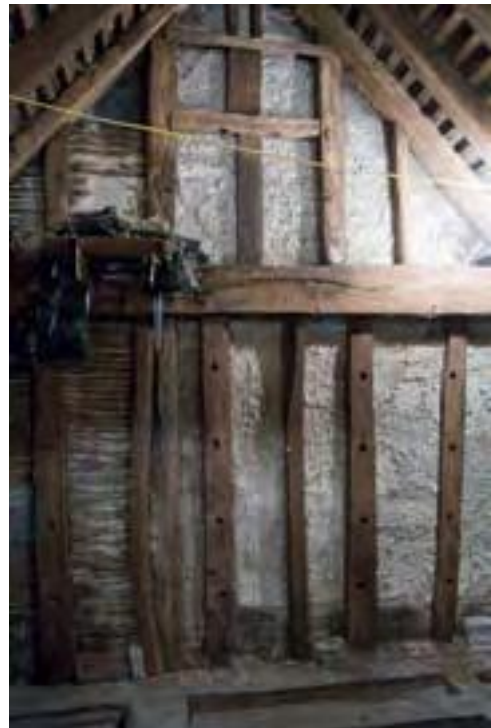
Fig. 37 (above): Western truss of cross wing. Note pegholes for fitting below collar, and former three-light window above. Photograph by Derek Kendall (DP042424).

The truss in the west gable end retains all its original studs, with two extra ones inserted in the middle. Its infill panels are 20th century replacements. The six central studs have rows of large pegholes suggesting that four shelves were built against the lower part of the truss. Above the collar are four studs, the middle two having a horizontal timber with mortises for diamond-set mullions, showing that there was a three-light unglazed window in the centre of the gable. Subsequently, the window was blocked and a central stud inserted. Generally, the studs of the west gable end are unpegged and spindly, that is of lesser quality than the exterior framing on display elsewhere in the house. The implication is that a brick gable end was intended, or that the west side of the house was built against an existing building; the existence of the unglazed window implies that it had a lower roof.

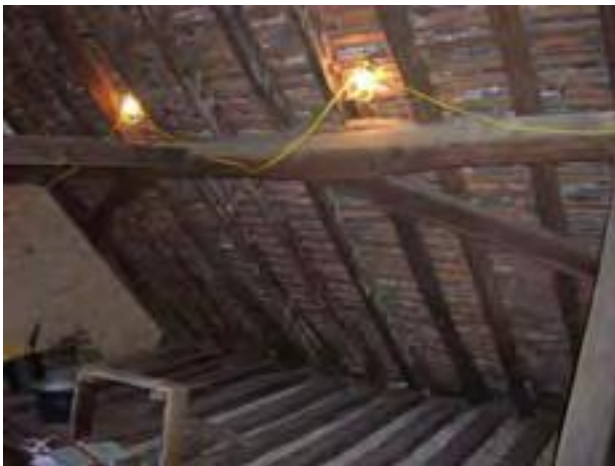
Fig. 38 (left): Northmost bay of hall range, looking east. Note windbraces (DP040097).

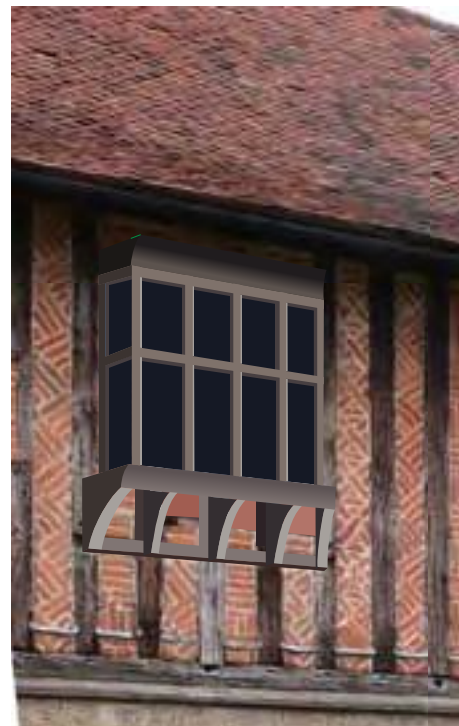
Fig. 41: Conjectural reconstruction of appearance of oriels.

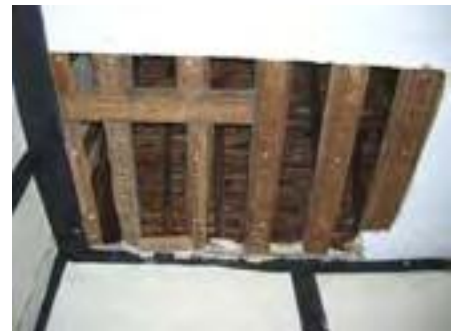
Fig. 43: Framed opening adjacent to north wall of room 25 (DP040098).

The joists above the closet are later insertions, suggesting that the space was originally open to the roof. The restricted headroom would have made ingress and egress difficult; a loading trap is an alternative explanation.

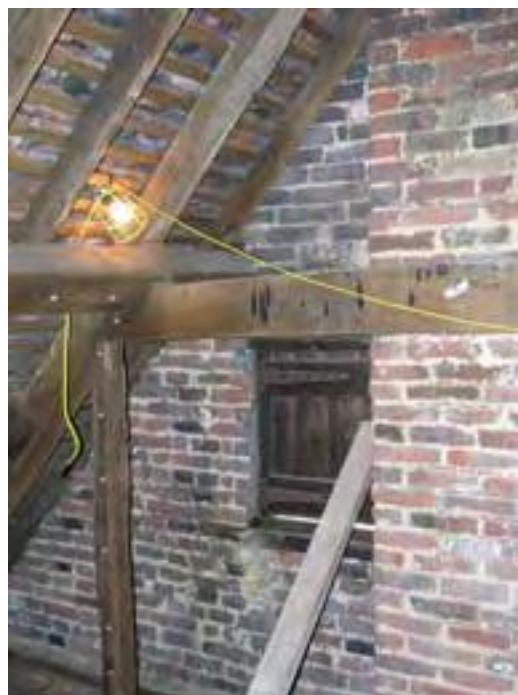
Fig. 45: Detail of south truss of hall range. Fair face outwards, indicating a terminal truss. The purlin extends beyond the principal rafter and there are no signs that the truss was ever closed. The stack is visible to the right (DP040099).

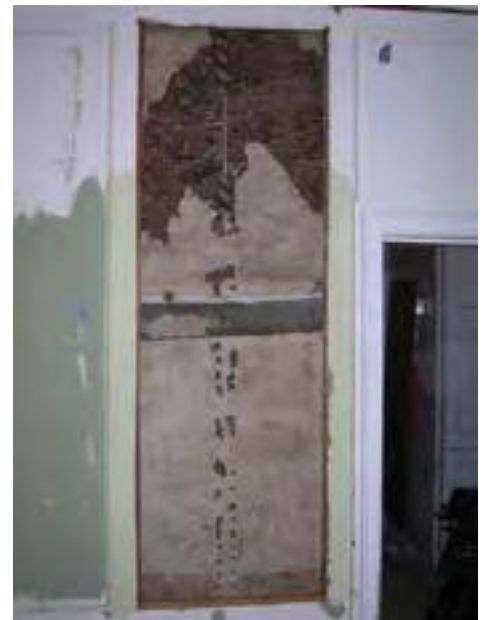
Fig. 47: South wall of entrance hall (room 9). Fragments of wallpaper of c.1700 survives under later panelling (DP040100).

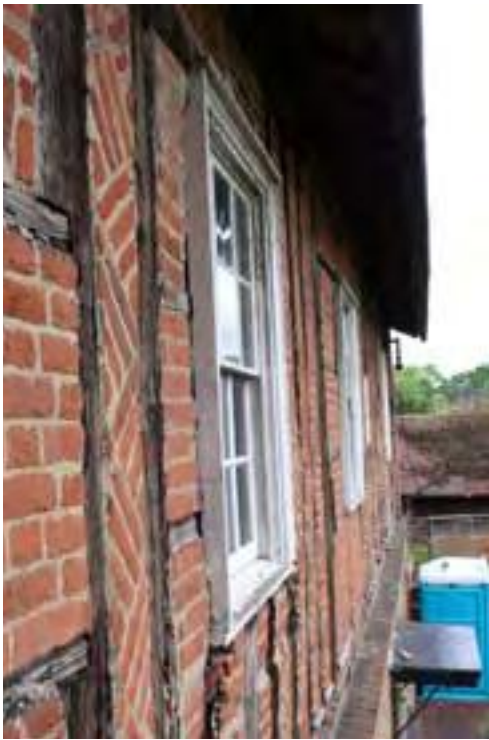
Fig. 49: Detail of south elevation, showing projecting 18th century architraves (DP070335).

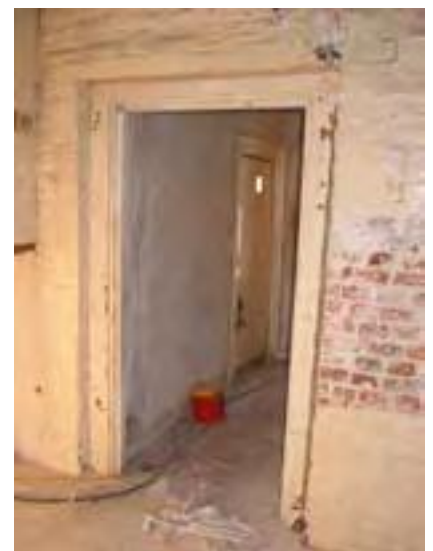
Fig. 50: Back door (DP070337).

The space to the east of the entrance hall presumably served as a lobby to the extension, and was not drylined. It is possible that the rebuilding of the adjacent part of the east wall, and the creation of a wide external doorway, dates to this period. The back door has a tenoned and pegged frame, with a large bead moulding on the inner face, which could date from the end of the 17th- or the first half of the 18th century. It is rebated on the outer face, with the back door opening outwards into the extension. The opening is set within an area of brick rebuilding in header-rich bond, which includes bricks of probable 18th century date (figure 50). It is presumed that this rebuilding represents the removal of the opposed entrance of the original house.

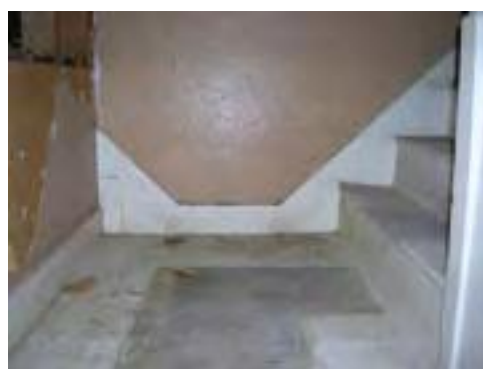
Fig. 52: The back stair originally divided into two short flights of three steps, leading into lobbies to the north and south (DP070338).

The 19th-century layout of the first floor is now difficult to reconstruct. The space that became room 33 may have been an open landing at the head of the new back stair. Similarly room 22 may have been an open space. Large landing areas of this type are not unknown in early 19th century houses and possibly served as first-floor sitting areas. The south branch of the stair would have given access to room 20, with the short corridor room 19 created to give separate access to room 21. Room 21 retains its plain two-panelled door from this period.

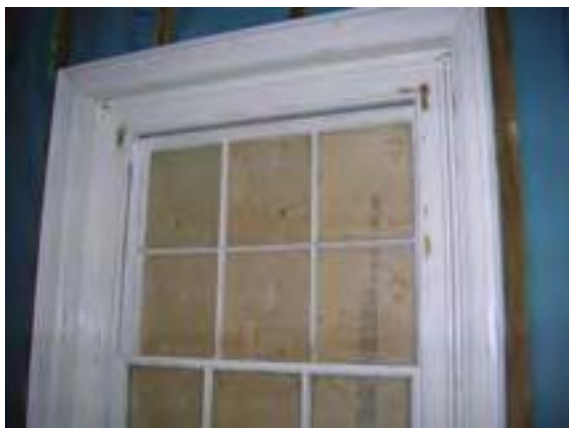
Fig. 53: West window of room 23, showing early 19th century glazing bars within an 18th century architrave (DP070336).

Many first floor window architraves were renewed in the early 19th century. Around the same time, wooden casement windows were inserted in the closets on either side of the stack (room 24 and the stairhead) and in the east wall above the back stair. The rooms over the hall were redecorated with green wallpaper which has a pin-prick floral design in black; until 2008, substantial fragments survived in room 23/31/32 and a smaller amount on the north wall of room 22/33.⁷⁴ It may also have been in this period that floorboards in room 23/31, and room 25 were renewed. In room 25 these run east-west and have been laid over earlier floorboards. Room 25 also retains the skirting board from the early 19th century on the east, west and north walls.

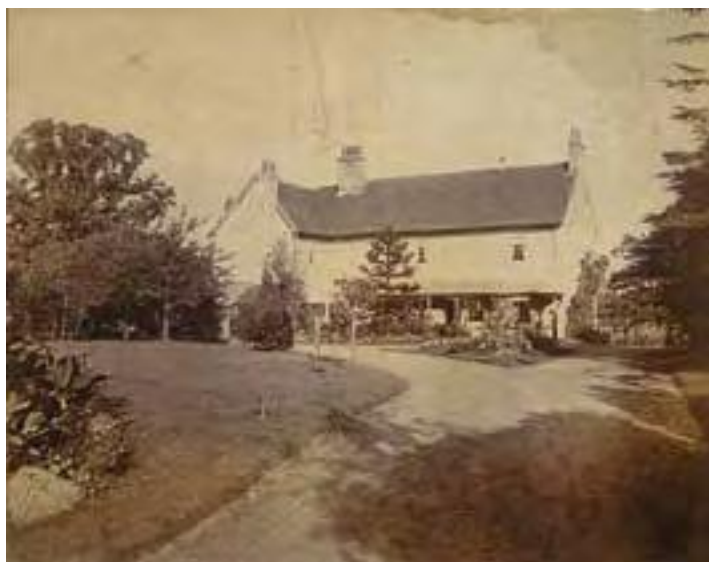
Fig. 54: Early 20th century view of Manor Farm, showing verandah (Hillingdon Local Studies, Archives and Museums Service; © Records of the Ewer family).

The work described here largely represents piecemeal alterations by resident tenant farmers. In the early 20th century a veranda was added on the west side of the building with its floor level raised above ground level and tiled. The line of the lean-to roof is indicated by lead flashings inserted into the base of the timber-framed wall. A conservatory was installed in the internal angle of the L plan of the house. Both additions survived to be depicted on a plan of 1933 (figure 89).

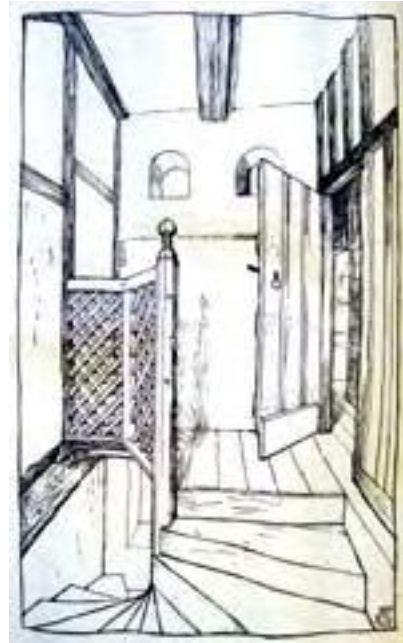
Fig. 55: Sketch of principal stair, dated 1930. On the left, the doorway to room 31 is depicted as blocked (Hillingdon Local Studies, Archives and Museums Service; © Records of the Ewer family).

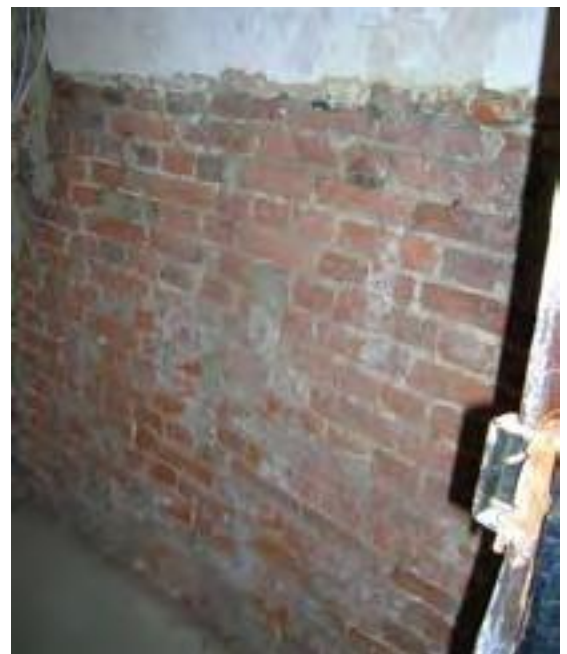
Fig. 57: East wall of room 12 (west wall of principal stack) exposed during works in 2007-08. Note inserted, and subsequently blocked, sockets for stair risers. (DP0070339).

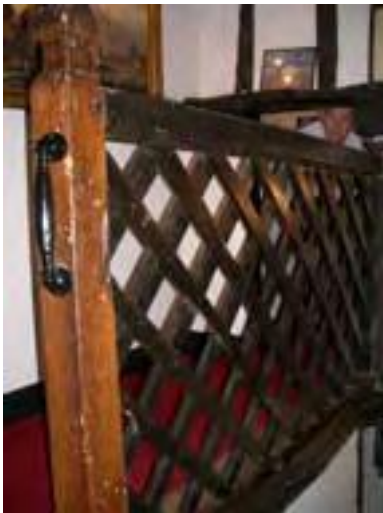
Fig. 58: Lattice balustrade to stair in East End Farm, Cottage, Pinner (© Patricia A. Clarke).

- 70 Two early modern examples of lattice balustrades are known. East End Farm Cottage, Pinner has a straight length of lattice balustrade of similar construction but with slightly larger timbers and with the same handrail; it has a square newel post with a simple finial, and is of probable 17th century date. The Hospital of St Cross, Winchester has a straight flight stair from the great hall to the gatehouse solar with a pair of lattice balustrades. Unfortunately the Winchester stair resists confident dating. It has a grip handrail of a type common in the early 17th century, although it is not known when the type was introduced. The newel post has the remains of a bird finial, which is shown complete in an early drawing (reproduced in Warren 1889, 77). It is clearly a pelican, the badge of Bishop Fox, Bishop of Winchester, and Master of the hospital 1500-17. Fox funded work

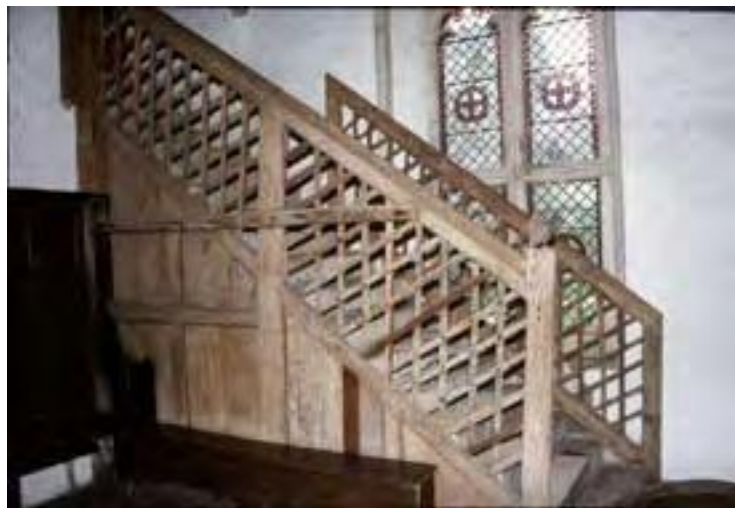
Fig. 59: Lattice balustrades to stair at the Hospital of St Cross, Winchester (© Linda Hall).

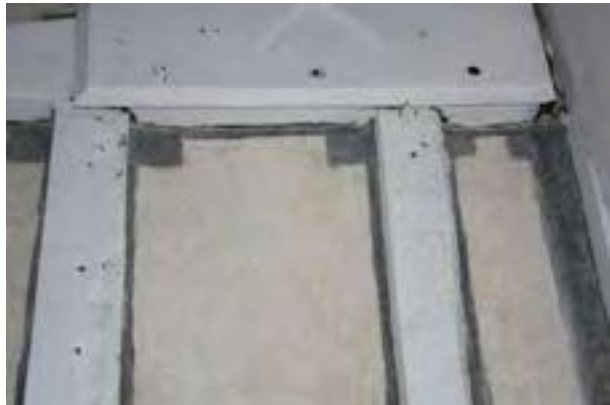
Fig. 60: Painted decorative scheme in the infill panels of the framing of the principal stair (DP070340).

The grey has been analysed and is a pigment mixture of chalk and charcoal black. The use of charcoal black results in a grey that is 'bluish' – possibly an intended effect. The same pigment mixture was identified on the newel and lattice stair and the 17th century door into the parlour chamber (room 28). The principal stair and door to room 28 are of probable early-17th-century date, which would be an acceptable date for this type of scheme.¹ The staircase seems to be the only area with embellishment. That is, the timbers were grey as elsewhere, but the infill panels had roughly square indents painted in each corner. Much of the evidence in other rooms was fragmentary, so the precise format is uncertain. It is, however, possible that the staircase was the only area elaborated in this way. Later in the century, the grey was repainted with brownish-red scheme with a slightly different format. This scheme was extremely fragmentary, although traces could be found in a number of rooms, including the staircase and parlour chamber.

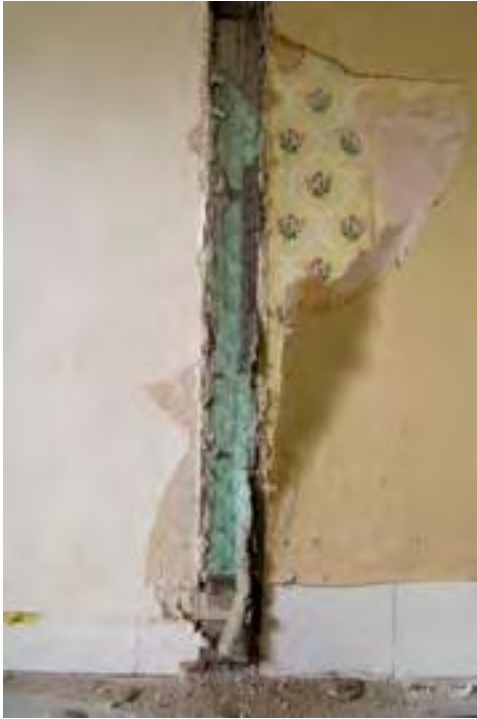
Fig. 64: Wallpaper fragments discovered in 2007 on the north wall of the hall chamber when partitions formerly dividing rooms 23, 31 and 32 were removed.
 Photograph by Derek Kendall (DP042394).

The Manor Farm paper was pasted directly onto the plaster wall and then nailed down at the edges for safety; this was common for the period and has its origins in the putting up of fabric wallcoverings.

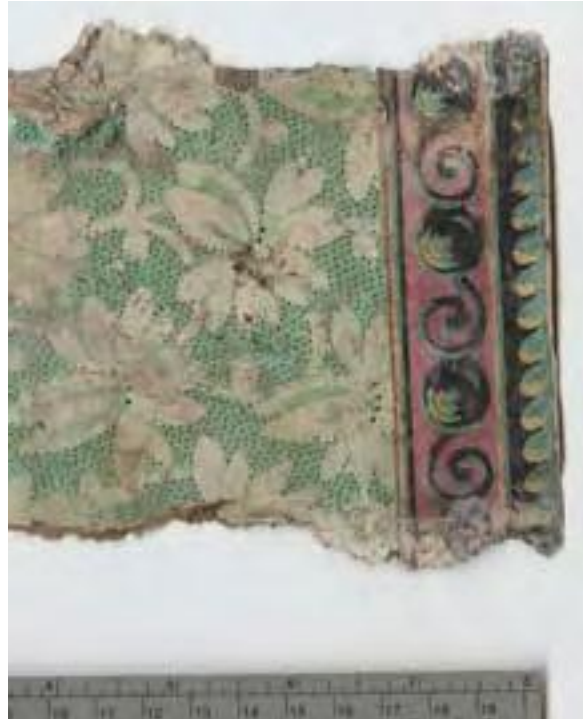
Fig. 65 Detail of wallpaper fragment.
 Photograph by Derek Kendall (DP042432).

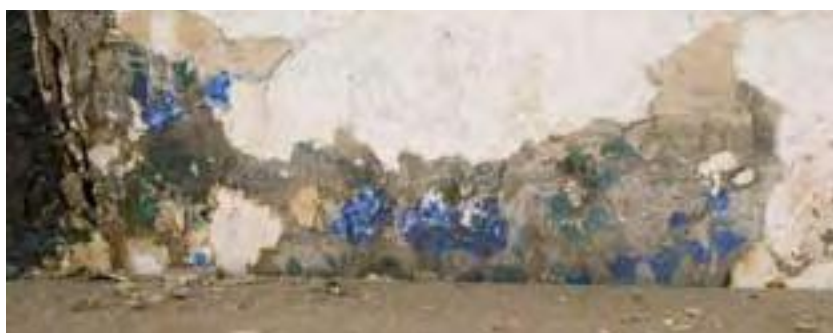
Fig. 66: Wallpaper fragments discovered in 2007 over the mantelpiece of the inserted fireplace on the west wall of room 25. Photograph by Derek Kendall (DP042410).

The pin-print comes complete with its lining paper and also the rough, coarse hessian scrim that was stretched over the wall before applying the lining paper. It is interesting that the three layers seem to have been glued onto the plaster rather than stretched over it as was the normal practice.
