MANOR FARM, RUISLIP, LONDON BOROUGH OF HILLINGDON

HISTORIC BUILDINGS REPORT

Research Department Report Series 63–2008

**MANOR FARM, RUISLIP,
LONDON BOROUGH
OF HILLINGDON
HISTORIC BUILDING REPORT**

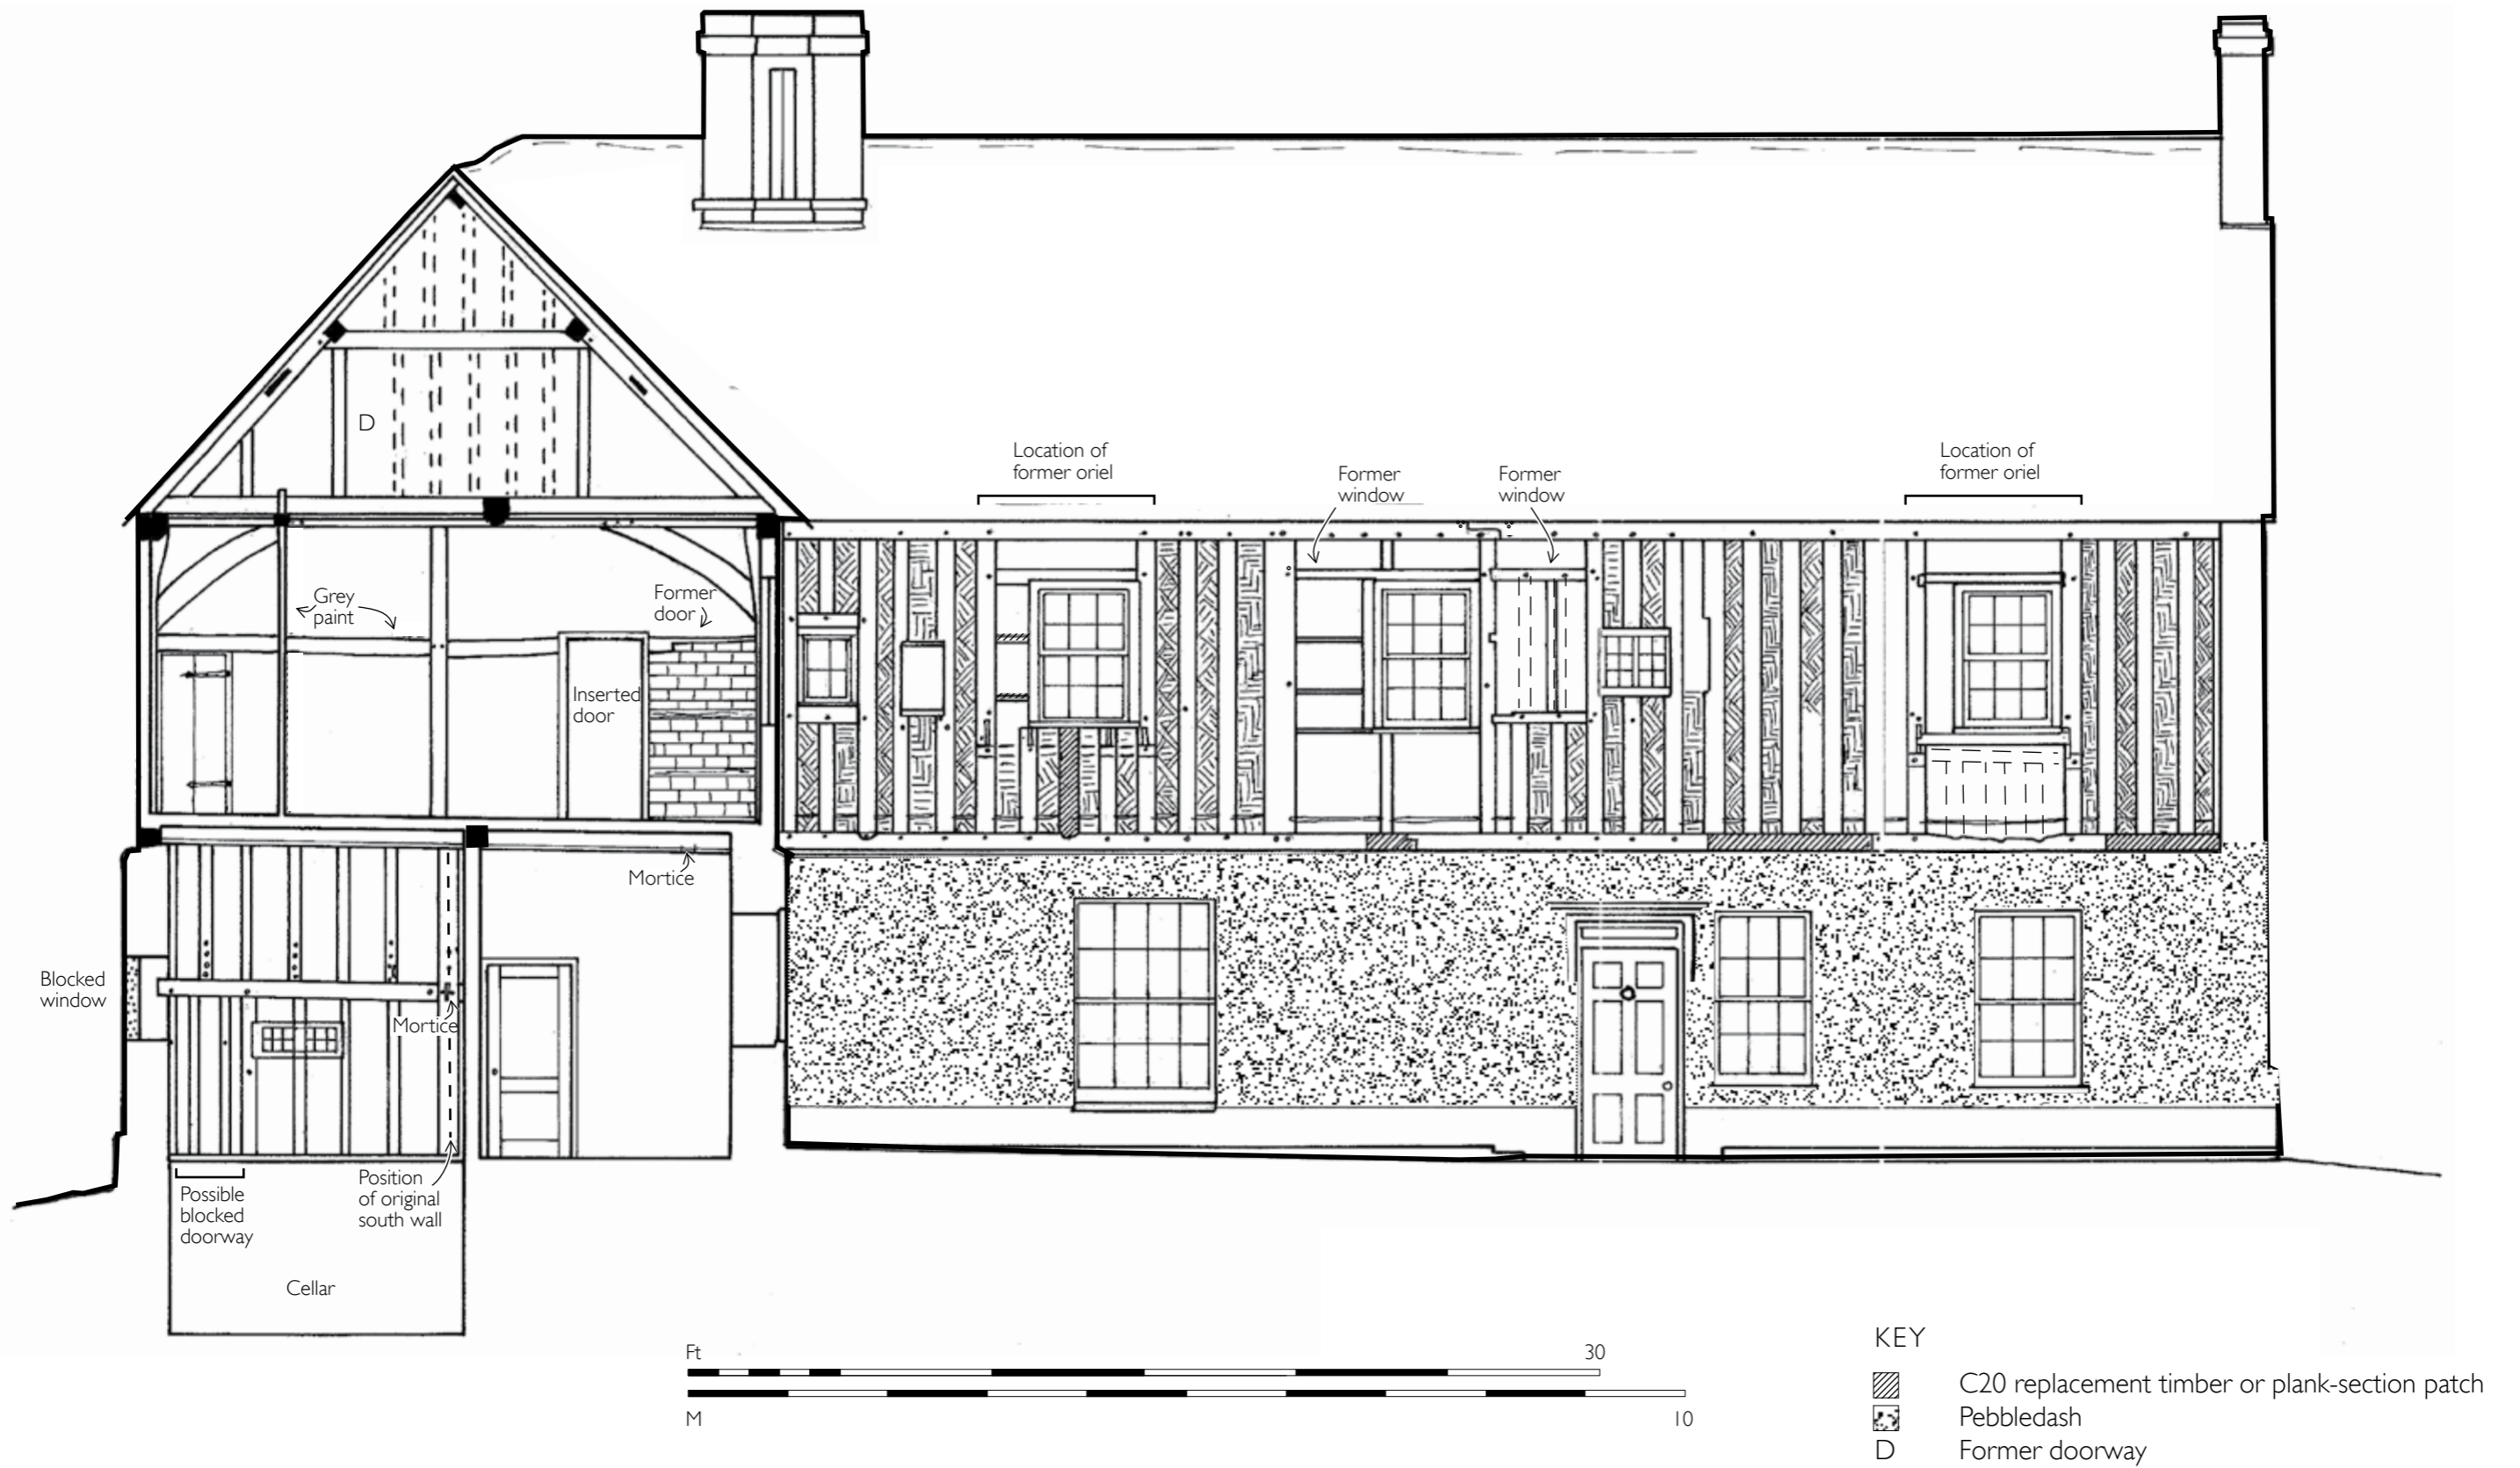
Fig. 71: West elevation of hall range, with cross section of cross wing. (Drawing by Linda Hall; © English Heritage).

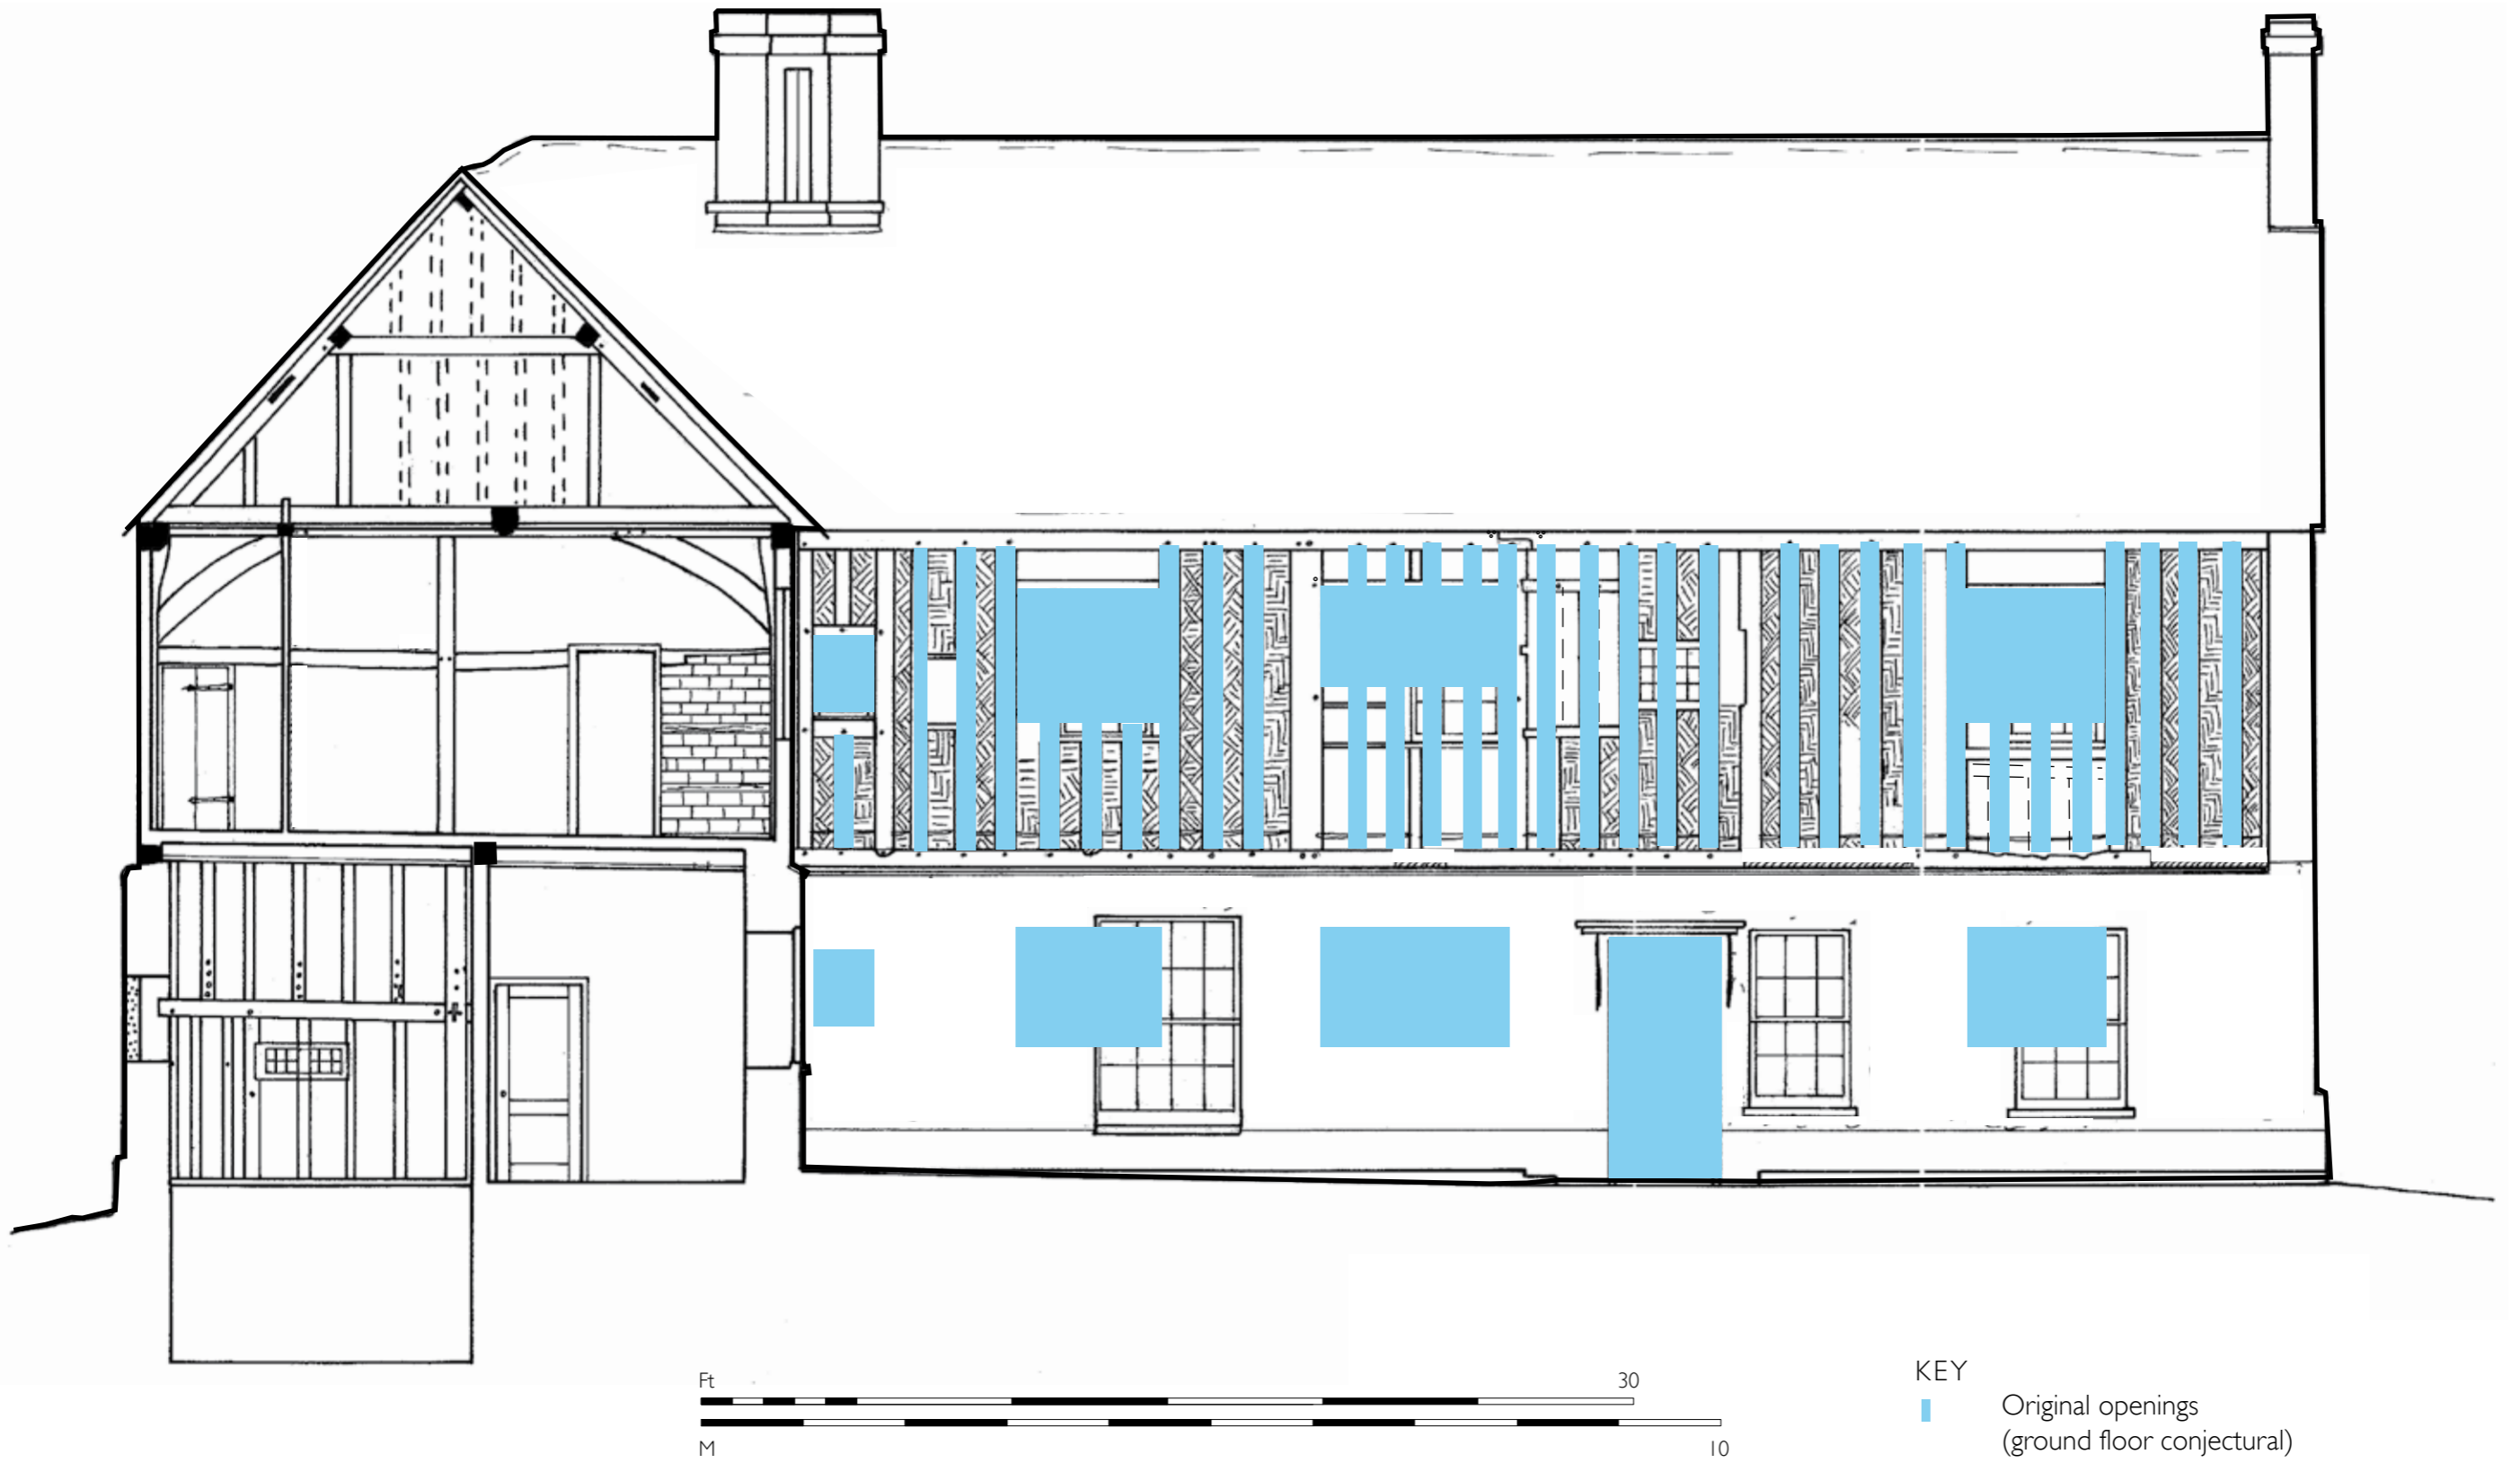
Fig. 72: West elevation of hall range, with cross section of cross wing. Conjectural reconstruction of original window openings shown in blue. (Drawing by Linda Hall; © English Heritage).

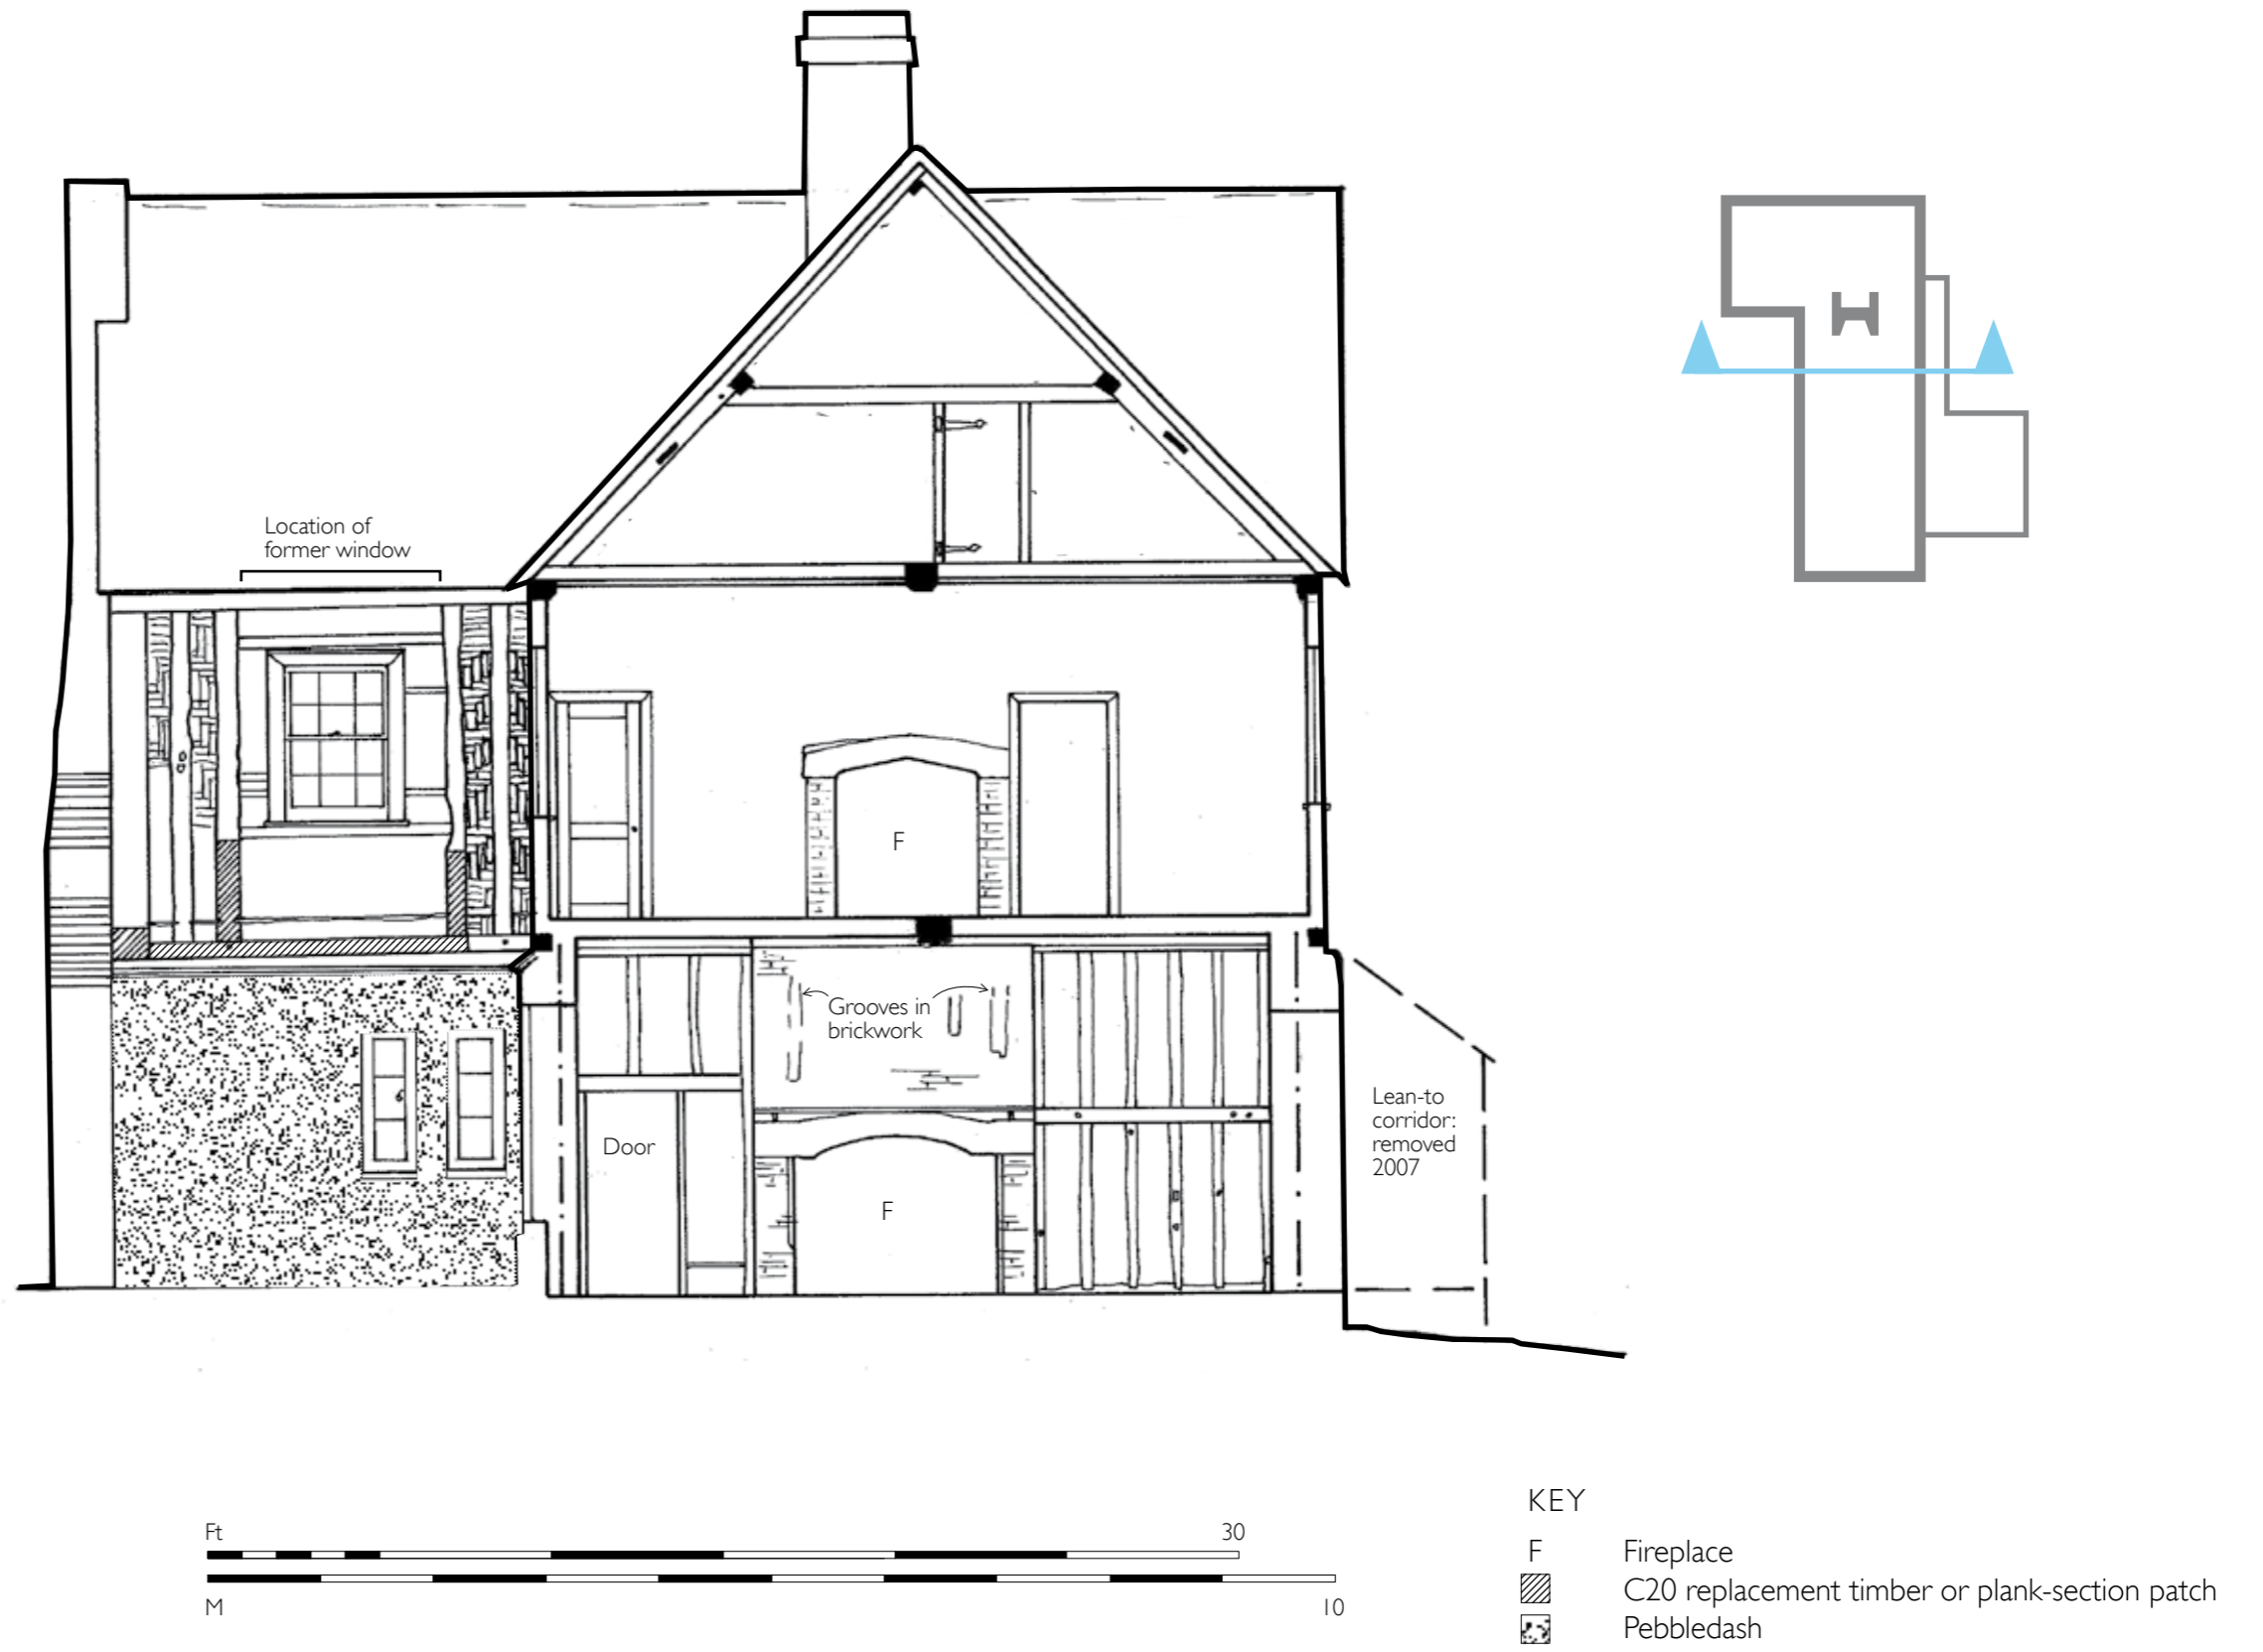
Fig. 80: Cross section, through hall range, looking north, with south elevation of cross wing.
 (Drawing by Linda Hall; © English Heritage).

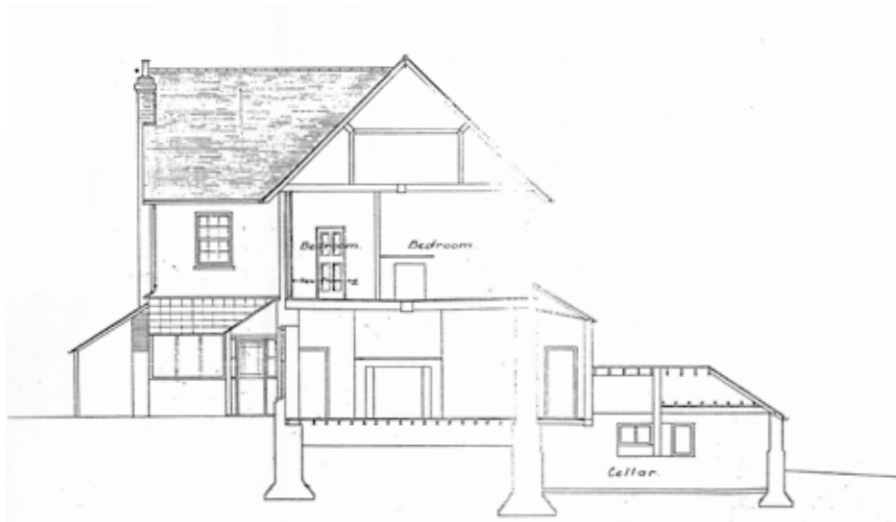
SECTION B-B

Fig. 91: 1933 Cross sections A-A and B-B, by H.R. Metcalfe for the Ruislip Northwood Urban District Council (rescaled to 1:75 from 1:96). (© London Borough of Hillingdon).
