SCORDALE LEAD MINES, CUMBRIA A PRELIMINARY ASSESSMENT OF THE THREAT FROM RIVER EROSION

INTERIM SURVEY REPORT

Research Department Report 15/2007

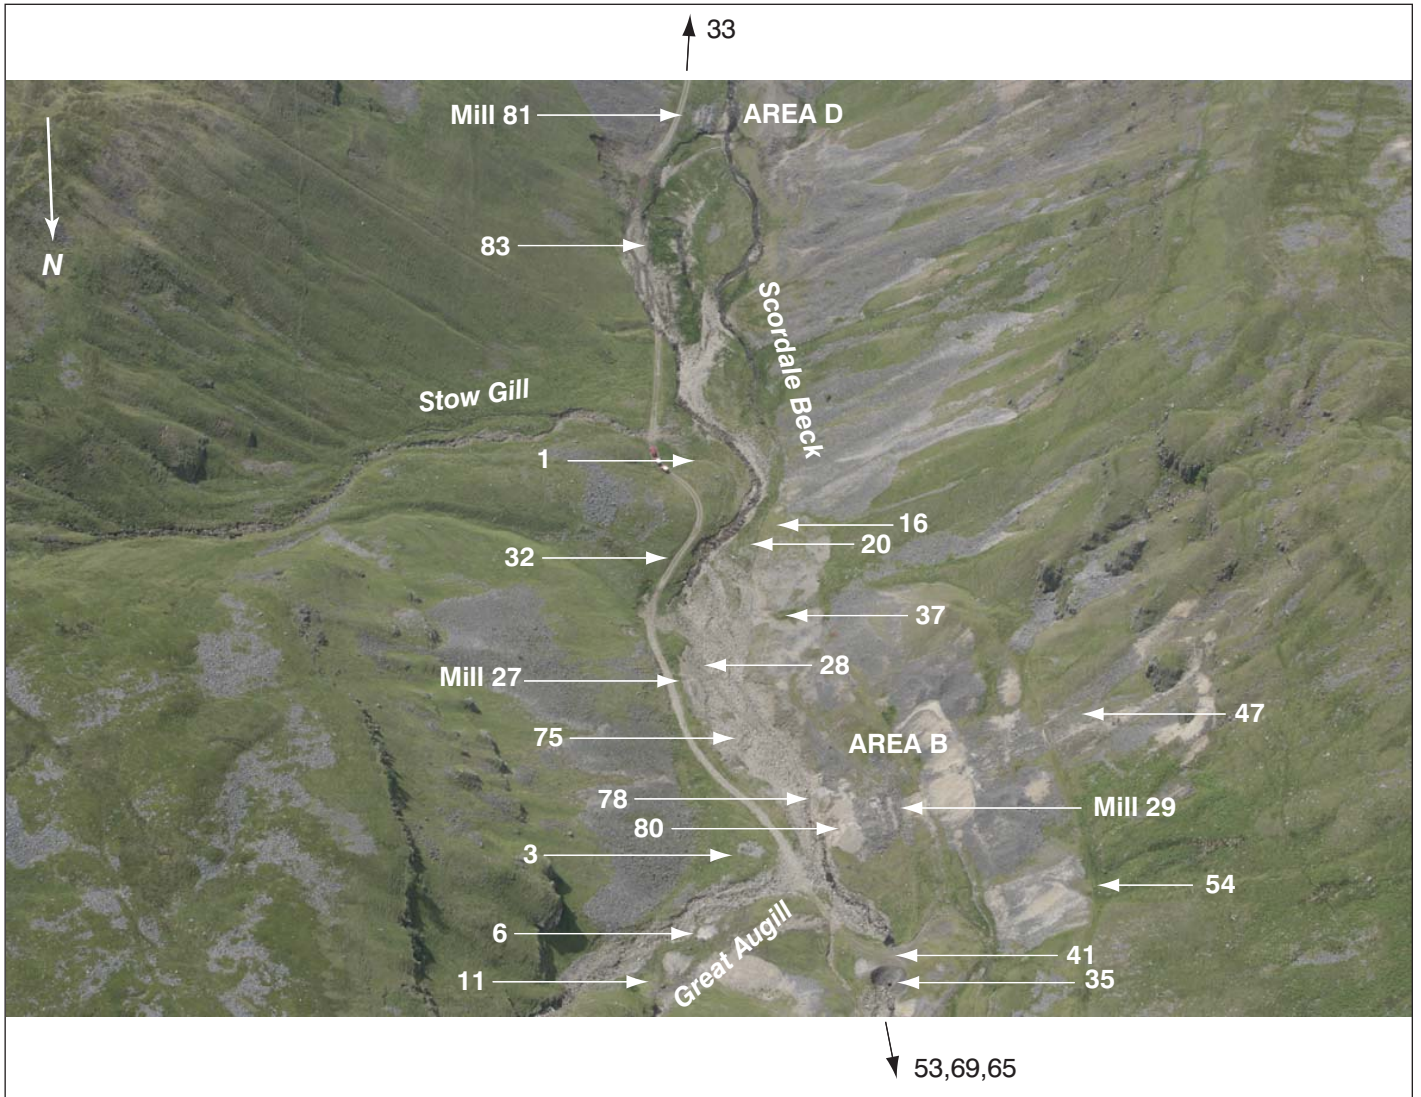
Figure 3. Aerial photograph of the northern part of Scordale indicating the location of features discussed in the text. (Aerial photograph © English Heritage. NMR 20555 Frame 20 13-Jul-2006)

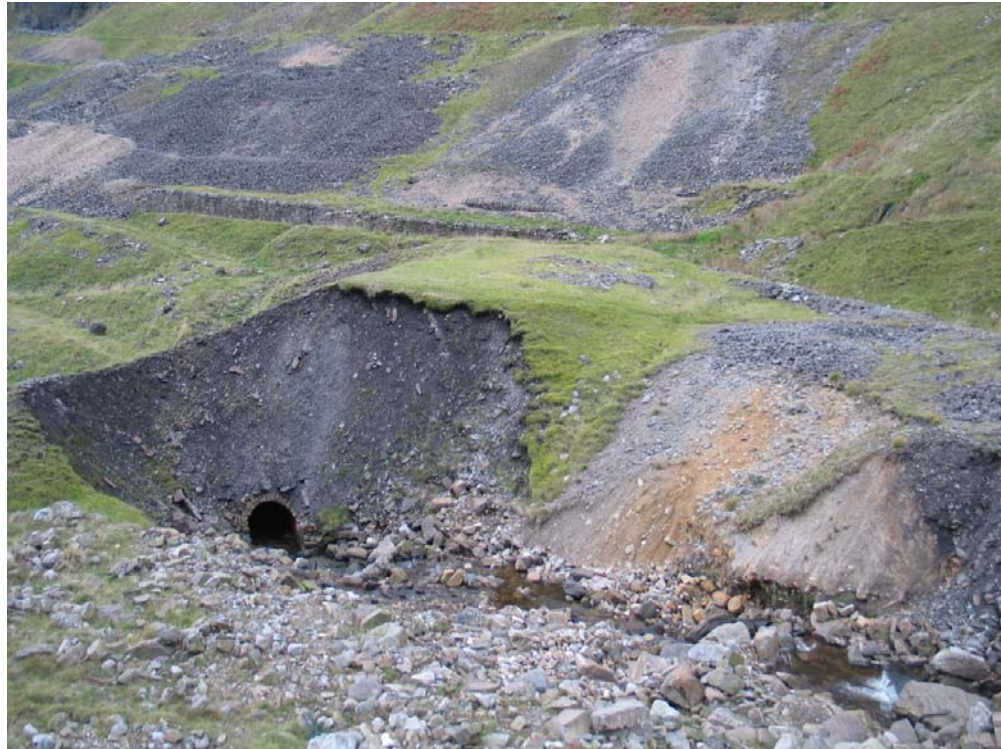
At the point at which the mine road (32) crosses the Scordale Beck, water gushes through a narrow stone-lined culvert (35) below a waste heap (41), the construction of which on map evidence can be dated to between 1861 and 1899 (Ordnance Survey 1861; 1899), and then descends in a number of braided channels through what was the main processing area. On the north side of the crossing, erosion has caused the partial collapse of the waste heap and the culvert (Figure 4), truncation of two leats (53, 69) which originally fed water to the

Downstream of the culvert (35) under the mine road the erosion is at its worst on the west side of the Scordale Beck. Here, on top of waste material, *in situ* timbers, flooring and internal processing structures associated with the stone-built elements of a crushing-mill (29) to the west are exposed and falling into the Scordale Beck, whilst the slippage is also revealing stone structures at lower levels (80) (Figure 5). Although collapsed, the stone-built elements of the mill seem relatively stable. However, the east side is only a matter of 3m from the edge of the waste slopes which are being eroded by the Scordale Beck, and at the north, stone from the mill has already fallen down the slope. A crushing-mill has been depicted on mapping here since 1861 but seems to have expanded significantly, or have been replaced by a new, larger mill during the period 1861 to 1899 (Ordnance Survey 1861; 1863; 1899). The depiction of a mill race leading to the mill suggests that in 1861 it had a

Figure 4
*Erosion of waste heap
 41 over culvert 35 and
 the surrounding area
 (taken in November
 2006)*

The conservation of the standing fabric of the two mills (27 and 29) in Area B would benefit from the opinion of a specialist structural engineer as to their long-term stability, particularly (29) with its proximity to the collapsing waste heaps. A programme of regular monitoring and photography is also recommended for these and also the nearby waste heaps above the culvert (35).

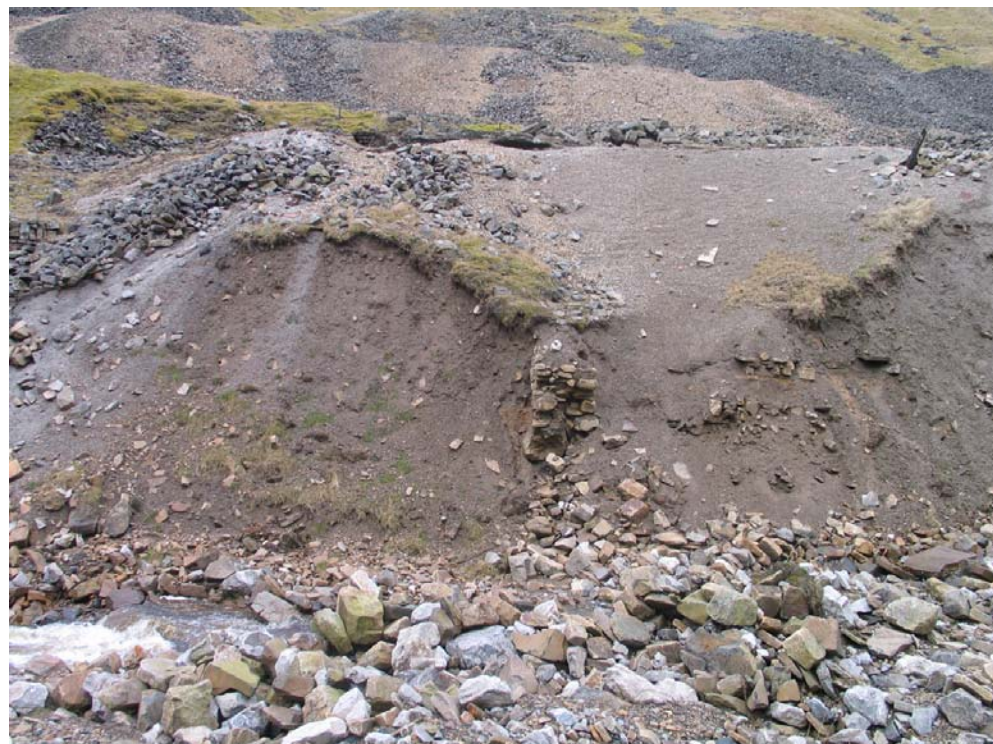
Figure 5
*Erosion below the
 crushing-mill (29)
 exposing further
 structural remains
 (80) (taken in April
 2006)*

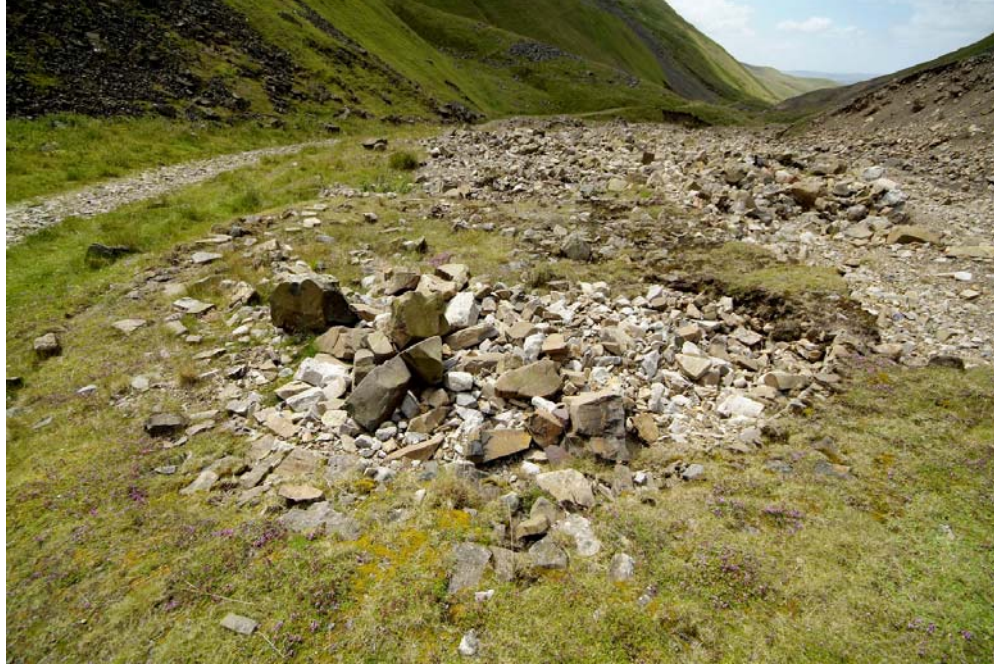
To the north of the dressing-mill (27) noted above, between the mine road (32) and Scordale Beck, are a number of low earthworks and structures. The most clearly identifiable are a series of three round buddles and a possible rectangular structure (75) which are stepped down the slope (Figure 6). The west side of this group is suffering river erosion. Between here and the dressing mill, other low earthworks probably relate to further washing areas. Some of these have been subject to river erosion, but others have been covered by river-deposited stones and sediment. A washing area here may be what is depicted on the First Edition 25-inch map Ordnance Survey (1861) map, but the features shown are rectilinear

Figure 6
Remains of a buddle (75), the western edge of which is being eroded by Scordale Beck (right-hand side of the photograph). (Taken in July 2006)

not round; the round buddles which survive today may have replaced the features shown on the map. The remains of another buddle has been identified on the opposite side of the Beck, some 100m to the south (20).

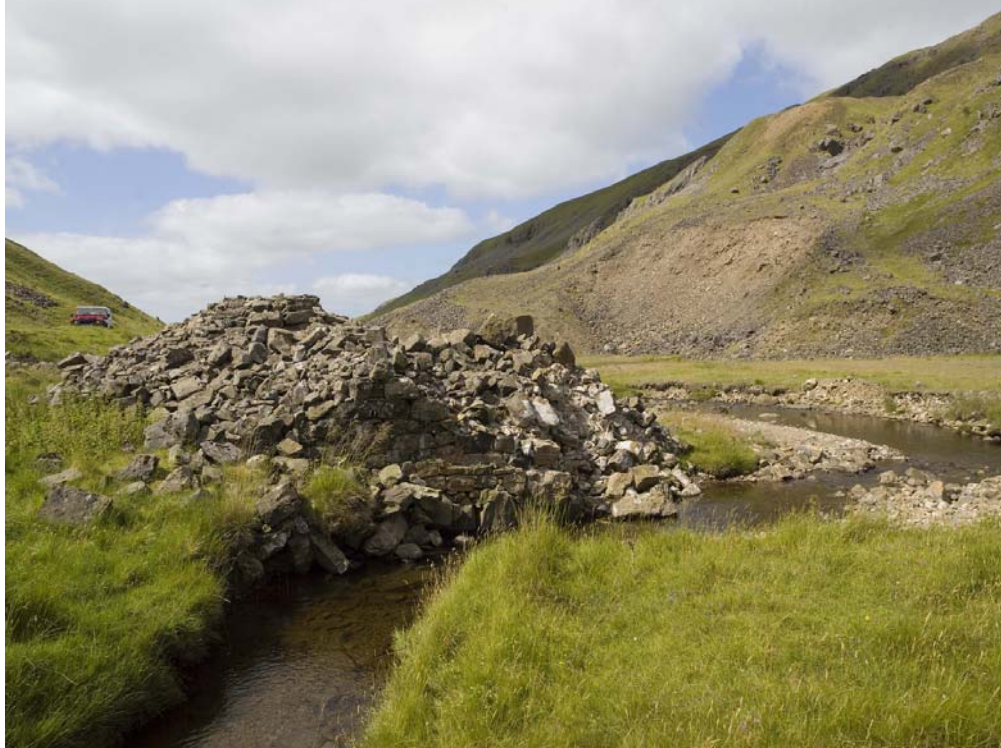
The mill (81) is situated slightly above the valley floor and the principal course of the Scordale Beck, but is also approached by a braid in the channel from the north-east; the latter seems to flow continuously even during dry periods (Figure 7). This braid is probably the feature

shown linking the washing floors or settling ponds to the mill on the Second Edition 6-inch Ordnance Survey map (1899). This channel is deflected around the north-east corner of the wheel-pit and has slightly undermined the masonry on that corner.

Figure 7
The remains of a dressing-mill (81) with a braid of Scordale Beck running up to and around it. (Taken in July 2006)

There is some slight undermining of masonry occurring at the mill (81) in Area D. Although there still appears to be a high level of structural integrity, this site would repay regular ground inspection and photographic monitoring. Consideration ought to be given to providing an appropriate level of protection to the northern edge of the wheel-pit before erosion causes further collapse. The conservation of the standing fabric would also benefit from the opinion of a specialist structural engineer as to its long term stability.
