HOARSTONE FARM,  
BEWDLEY, WORCESTERSHIRE  
DENDROCHRONOLOGICAL ANALYSIS  
OF OAK TIMBERS

SCIENTIFIC DATING REPORT

**HOARSTONE FARM  
BEWDLEY  
WORCESTERSHIRE**

**DENDROCHRONOLOGICAL ANALYSIS OF OAK TIMBERS**

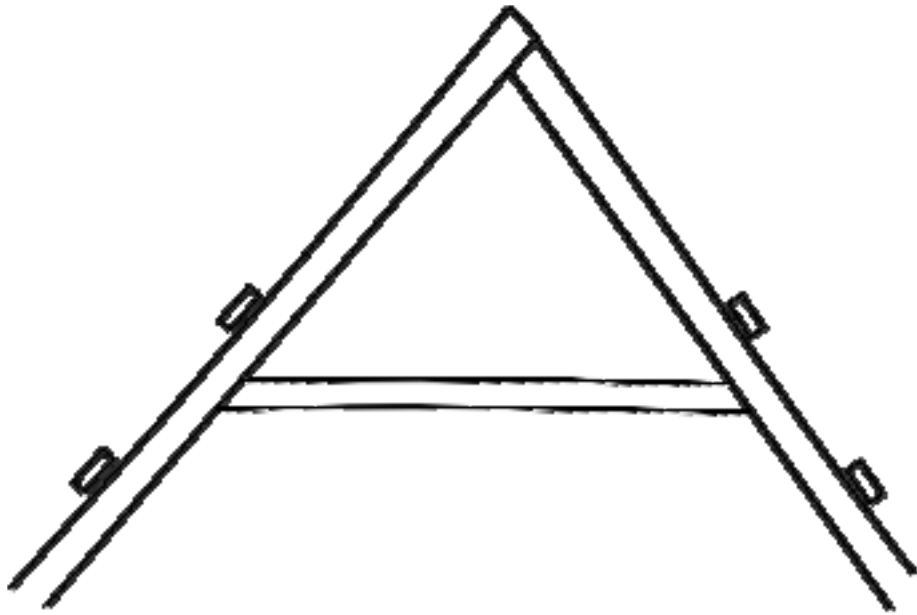
*Figure 3. Schematic section of main roof truss (figure supplied by English Heritage)*

The central range roof comprises two trusses (T4 and T5, Figures 2–4). The eastern truss, T5, has a doorway through it. These simple A-trusses have diminished principal rafters, and interrupted collars to allow for access. T4 has clasped purlins, and there are straight wind-braces. Both T4 and T5 have their upper face to the east. There is no evidence the central range originally had end-trusses.

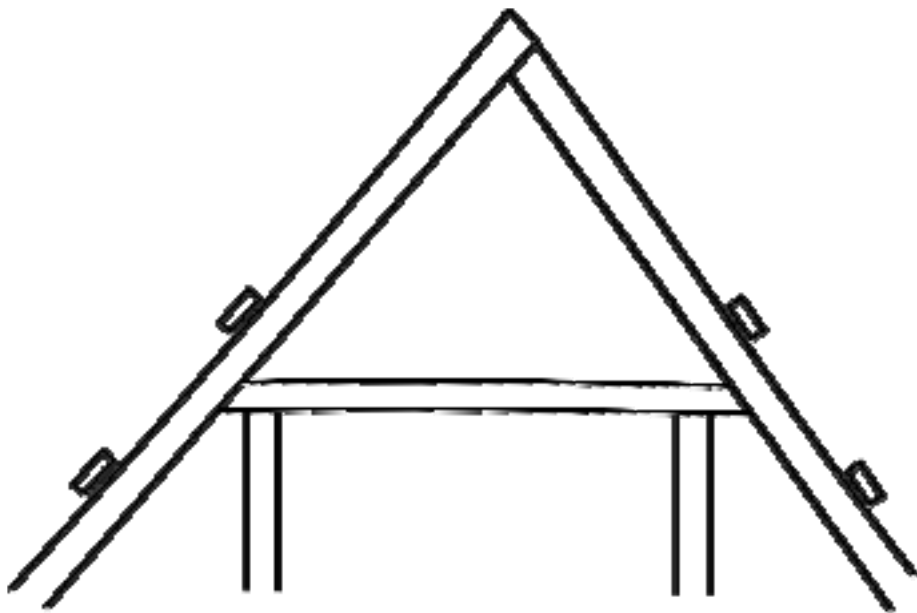
*Figure 4. Schematic section of main roof truss with door (figure supplied by English Heritage)*

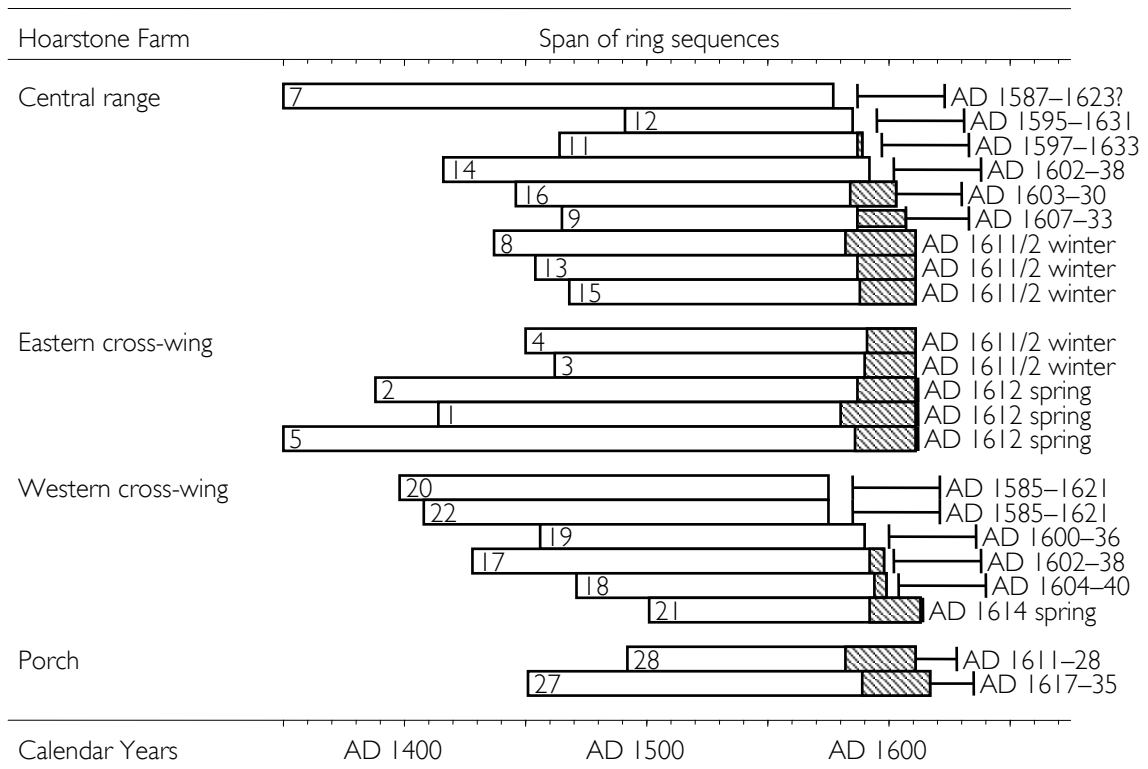
**Figure 5. Bar diagram showing the absolute dating positions of the 22 dated tree-ring sequences for samples from Hoarstone Farm. The interpreted felling dates are also shown for each sample.**

KEY White bars are oak heartwood, hatched bars are sapwood, the narrow bar represents unmeasured sapwood.

The samples were prepared for analysis, measured and the resultant ring series were compared with each other. The nine suitable samples from the central range roof were found to cross-match each other well (Table 2), all five of the eastern cross-wing roof samples cross-matched (Table 3), the six samples from the western cross-wing cross-matched (Table 4), and the two suitable samples from the porch cross-matched (Table 5). Each cross-matched group was then combined into a single composite data set. These were then compared with each other, the composite series from all four areas were found to form an internally consistent group (Table 6). These four groups were then combined into a final site composite which was then compared with medieval and later tree-ring data from throughout England and Wales. The composite sequence was found to cross-match very strongly against data from sites in the West Midlands and South-West regions (Table 7). This cross-matching provided consistent calendar dates for the sequence. A summary of the results for the component samples of this chronology are provided in Table 1 and Figure 5.

The tree-ring analysis dates the rings present in the cores. The correct interpretation of those dates relies upon the characteristics of the final rings in them. Bark-edge survived on three of these timbers, significant amounts of sapwood on another two, and a small amount on a third, and the heartwood/sapwood boundaries were present on the remaining three. Making allowances for minimum and maximum likely amounts of missing sapwood provides individual felling dates, or felling date ranges, for each of the datable timbers. Figure 5 and Table 1 include the felling date or interpreted felling date ranges for each of the datable samples.

Bark-edge survived on all five of these timbers. No allowance needs to be made for missing sapwood; instead, individual felling dates can be assigned to each of the datable timbers. Figure 5 and Table 1 include the felling date for each of these datable samples.

Bark-edge survived on one of these timbers, sapwood on another two, and the heartwood/sapwood boundaries were present on the remaining three. Making allowances for minimum and maximum likely amounts of missing sapwood provides individual felling dates, or felling date ranges, for each of the datable timbers. Figure 5 and Table 1 include the felling date or interpreted felling date ranges for each of the datable samples.

No bark-edge survived on these timbers, but significant amounts of sapwood survived on both. Making allowances for minimum and maximum likely amounts of missing sapwood provides felling date ranges for both of the datable timbers. Figure 5 and Table 1 include the interpreted felling date ranges for both samples.
