# MITCHELL'S BREWERY, BREWERY LANE, LANCASTER TREE-RING ANALYSIS OF TIMBERS

SCIENTIFIC DATING REPORT

NGR: SD 4479 617

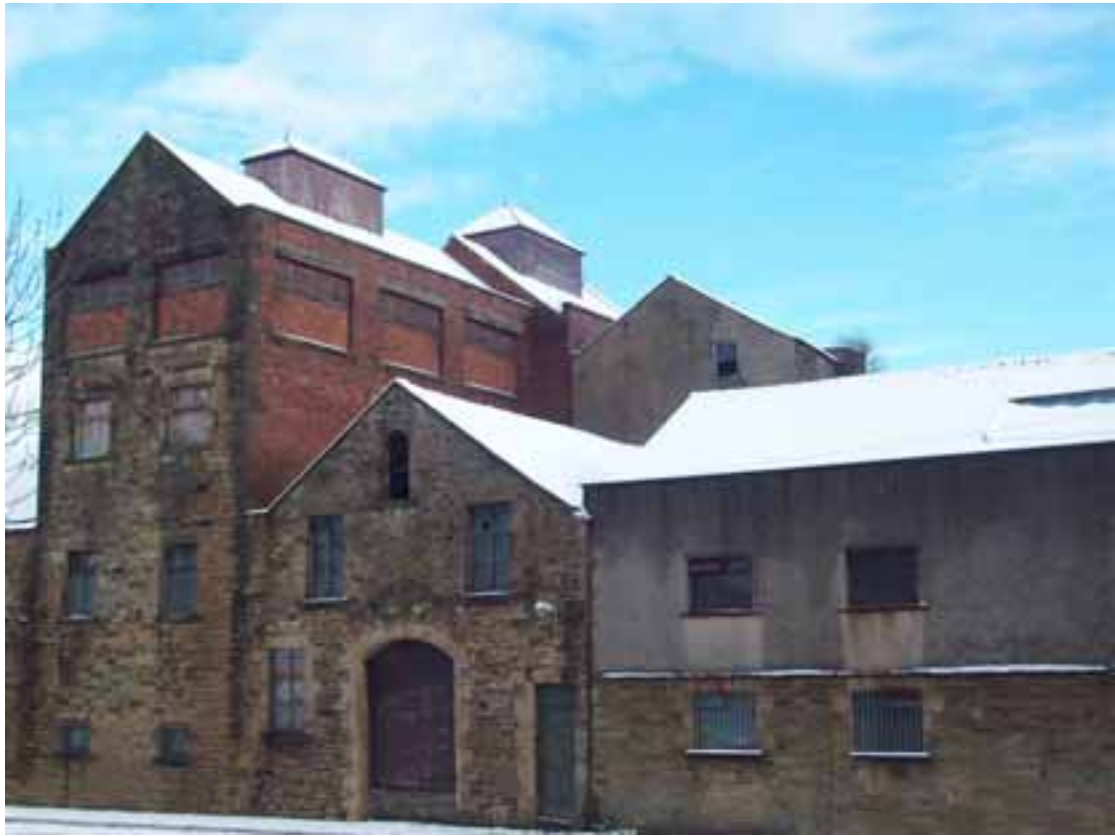
*Figure 4: View of Mitchell's Brewery from Brewery Lane. To the left (north) rises the brick-built, partially stone-fronted, nineteenth-century building. In the middle, with its arched double door, is the stone-built north wing. To the rear of this rises the 'tower', the west window of which is just visible. To the right is the position of the eighteenth-century stables and the former courtyard, demolished and then enclosed in 1969 by the stone-block and rendered building*

The brewery complex comprises what appear to be a number of different elements (see basic schematic plan, Fig 3, and Fig 4).

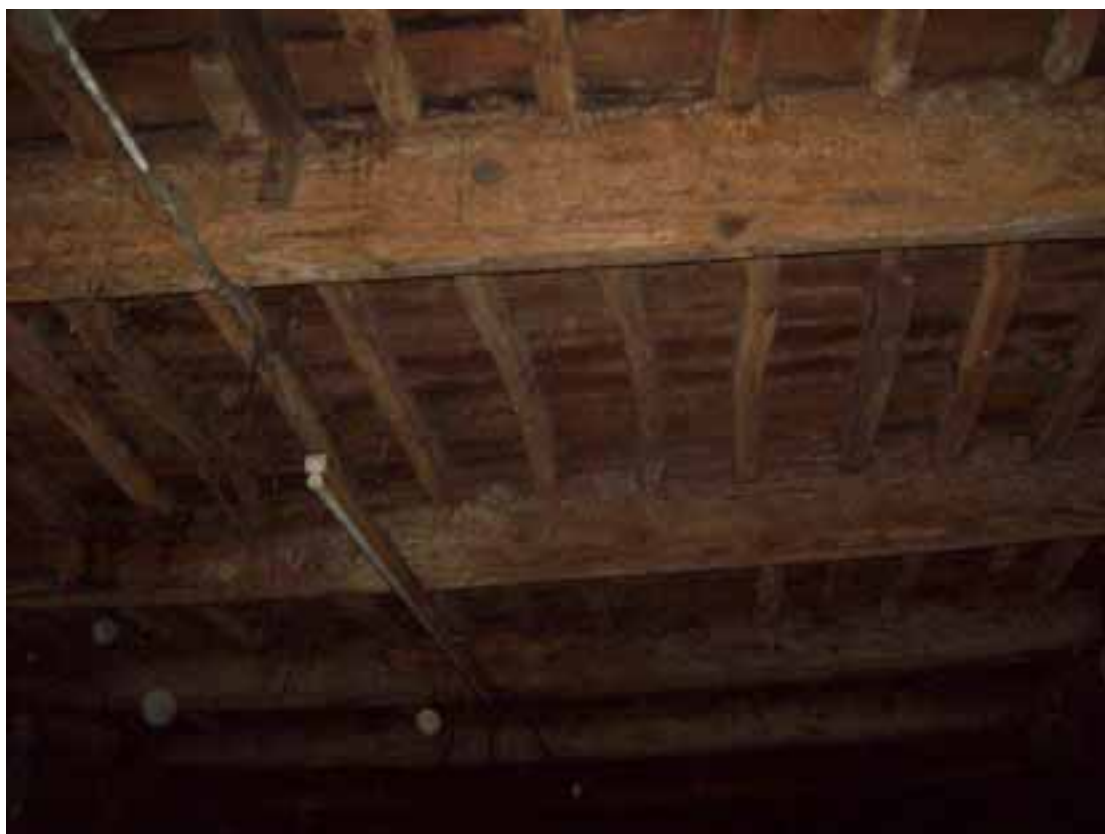
*Figure 5: View of the main beams of the frame to the first floor*

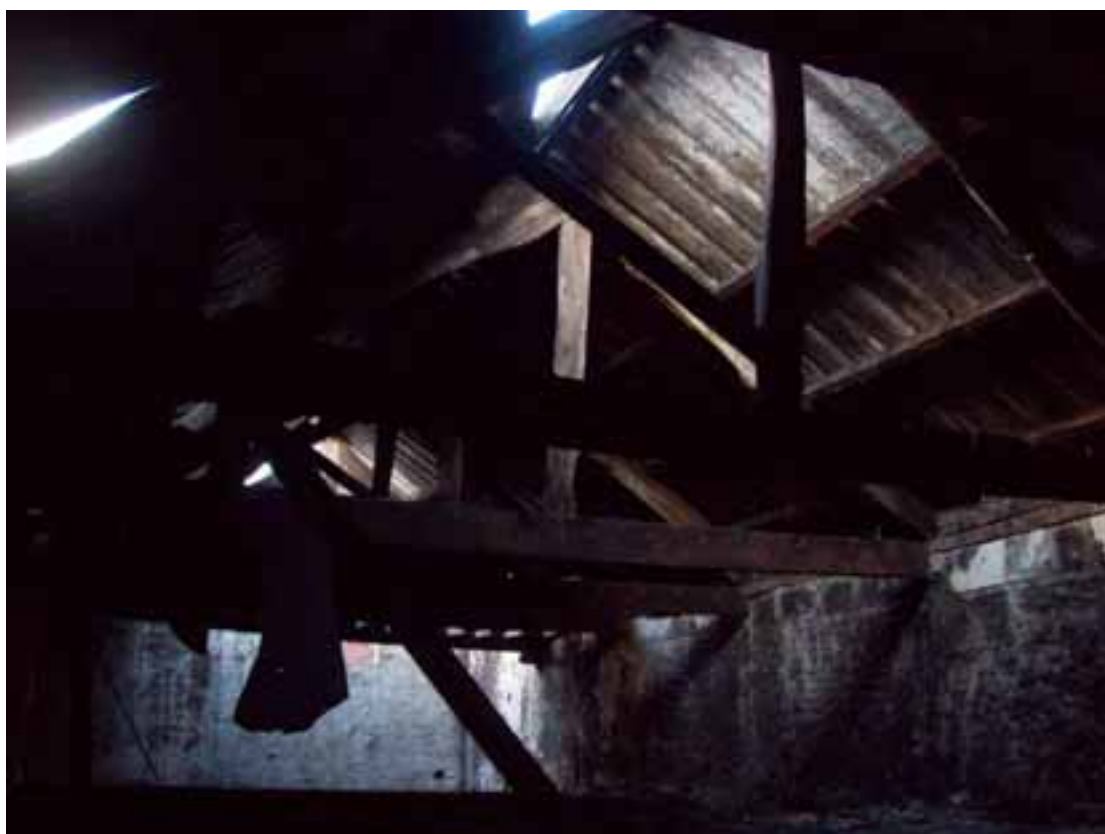
*Figure 6: View of the roof trusses to the malthouse*

The roof of the malthouse comprises eight king-post trusses with principal rafters and tiebeams (Fig 6). It would appear that originally there were also struts rising from near the bases of the king posts to the principal rafters. The majority of these struts are now missing. Within these king-post trusses we find a combination of timber species, with the tiebeams, resting directly on the side walls of the malthouse without wall plates, being of conifer, while the king posts, principal rafters, and few remaining struts, are all of oak. The double purlins to each pitch of the roof appear to be modern, probably twentieth-century, softwood insertions, perhaps connected with the conversion of the roof covering to corrugated iron. There are now no common rafters to this roof and are no further timbers, either oak or conifer, to the walls of the malthouse.

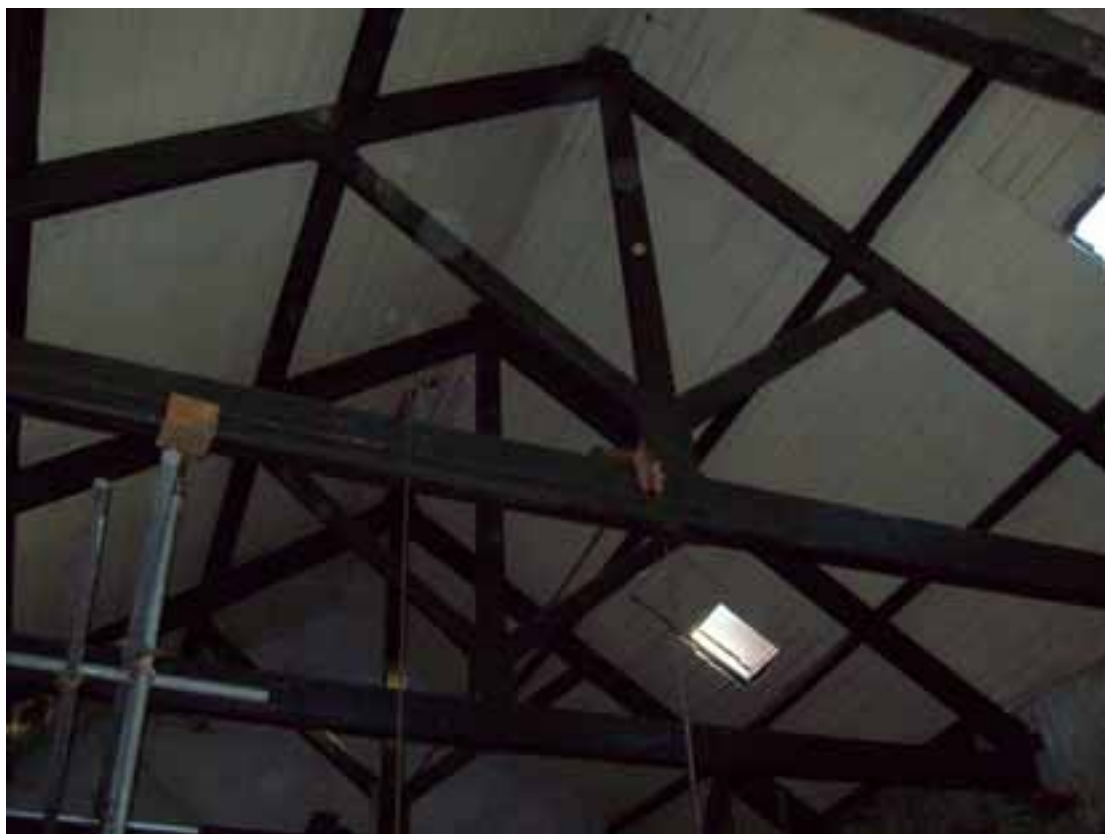
*Figure 7: View of the roof trusses to the north wing*

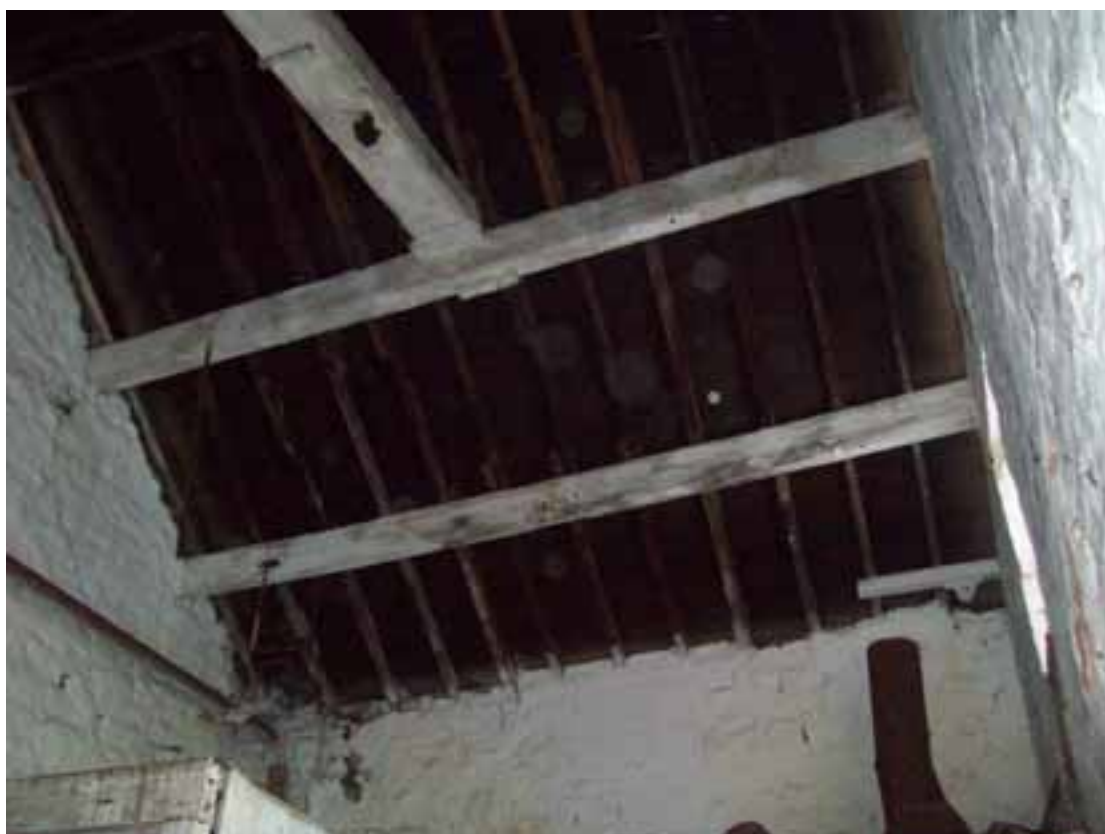
*Figure 8: View of the south slope to the roof of the 'tower'*

Within the 'tower' we find a relatively modern, probably late-twentieth century, conifer, coupled common rafter, roof, which retains two conifer purlins to its southern pitch (Fig 8) and a single conifer purlin to its north pitch (Fig 9). Two window openings, also at third-floor level, one to the west or front, and another (now bricked up) to the east or rear, each retain single conifer lintels. It is believed that at least one of these windows, the now-blocked east window, which is in a stone wall, may be part of the primary build of the 'tower', there being no evidence for it having been knocked through later. There is slightly less certainty about the still-open, west, window, which is in a brick wall. It is thought possible that this wall may represent a later modification of the 'tower', in which case the window would not be primary.

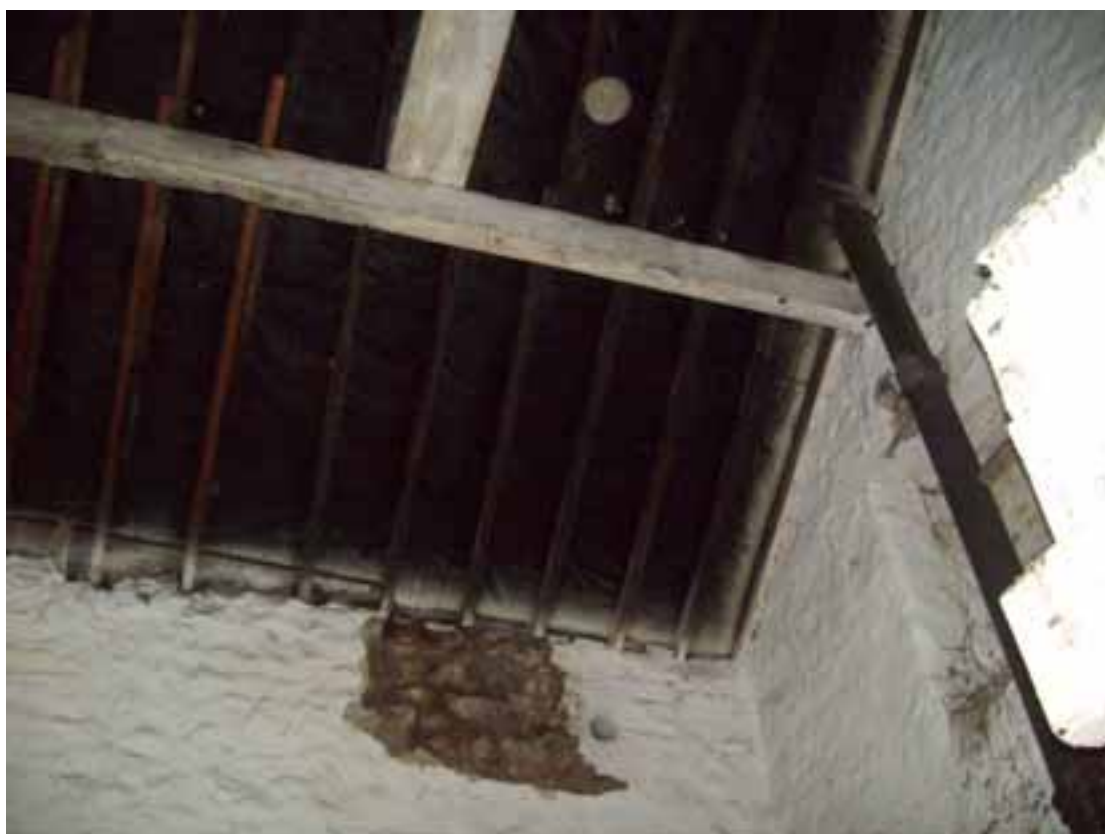
*Figure 9: View of the north slope to the roof of the 'tower' (the blocked east window behind the black downpipe)*

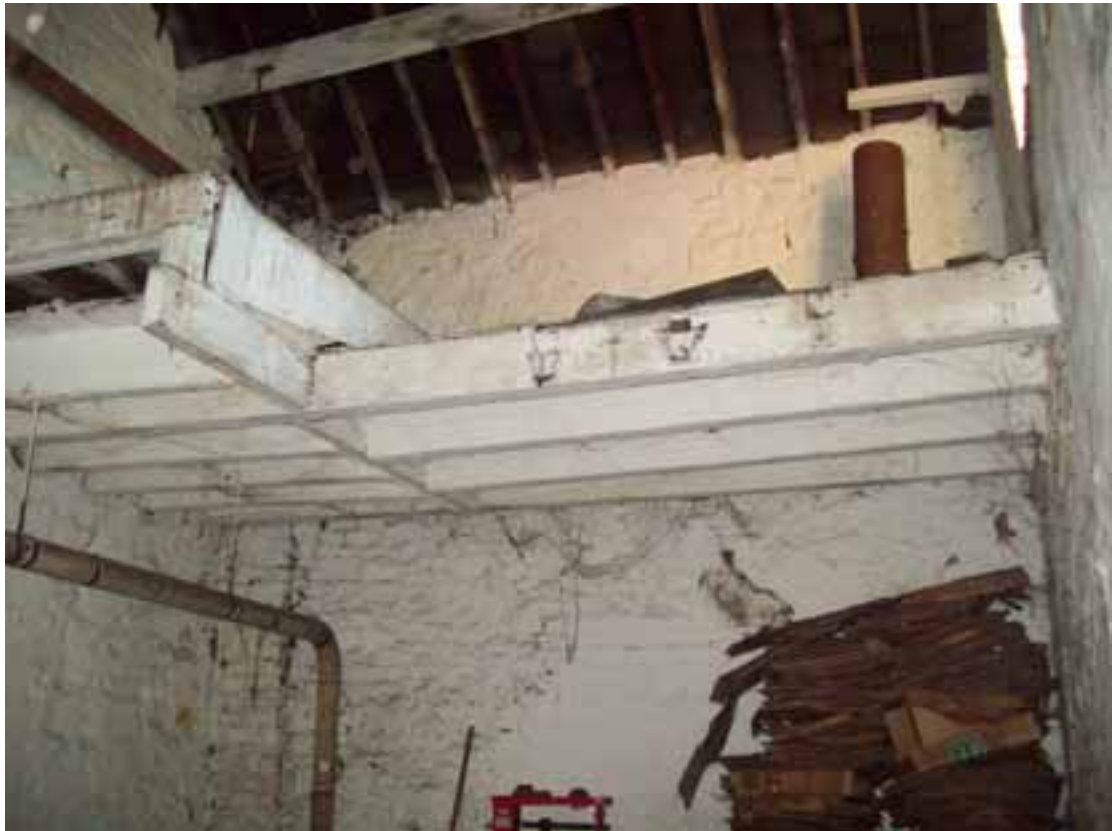
*Figure 10: View of the remains of the third-floor frame of the 'tower'*

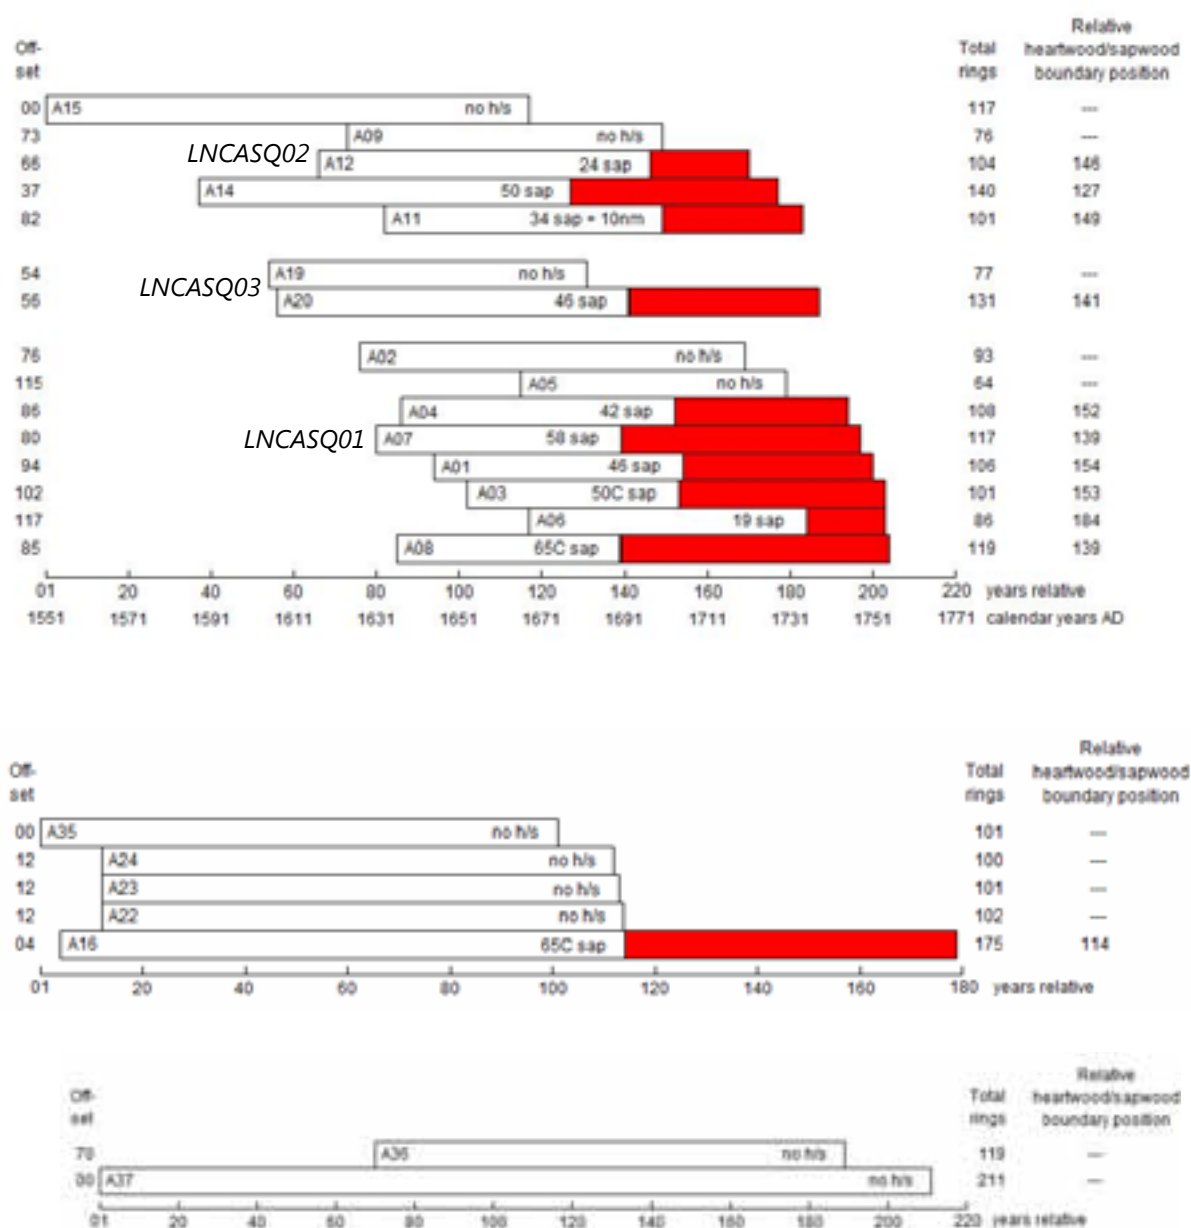
White bars

= heartwood rings, shaded bars

= sapwood rings  
h/s = the last ring on the sample is at the heartwood/sapwood boundary (only the sapwood rings are missing)  
C = complete sapwood is retained on the sample. Where dated this is the felling date of the tree represented

Site chronology LNCASQ01, comprising eight samples with an overall length of 128 rings, was found to match repeatedly and consistently with a series of reference chronologies when the date of its first ring is AD 1627 and the date of its last measured ring is AD 1754. Site chronology LNCASQ02, comprising five samples with an overall length of 183 rings, was found to match when the date of its first ring is AD 1551 and the date of its last measured ring is AD 1733. Site chronology LNCASQ03, comprising two samples with an overall length of 133 rings, was found to match when the date of its first ring is AD 1605 and the date of its last measured ring is AD 1737. The evidence for this dating is given in Tables 2, 3, and 4. The samples of these three site sequences are shown in bar diagram Figure 12a.

The two final site chronologies, LNCASQ04 and SQ05, shown in Figure 12b/c, remain undated. The 11 remaining measured but ungrouped single samples were also compared to a full series of reference chronologies for various conifer species, but again there was no satisfactory cross-matching and these timbers, therefore, must also remain undated.

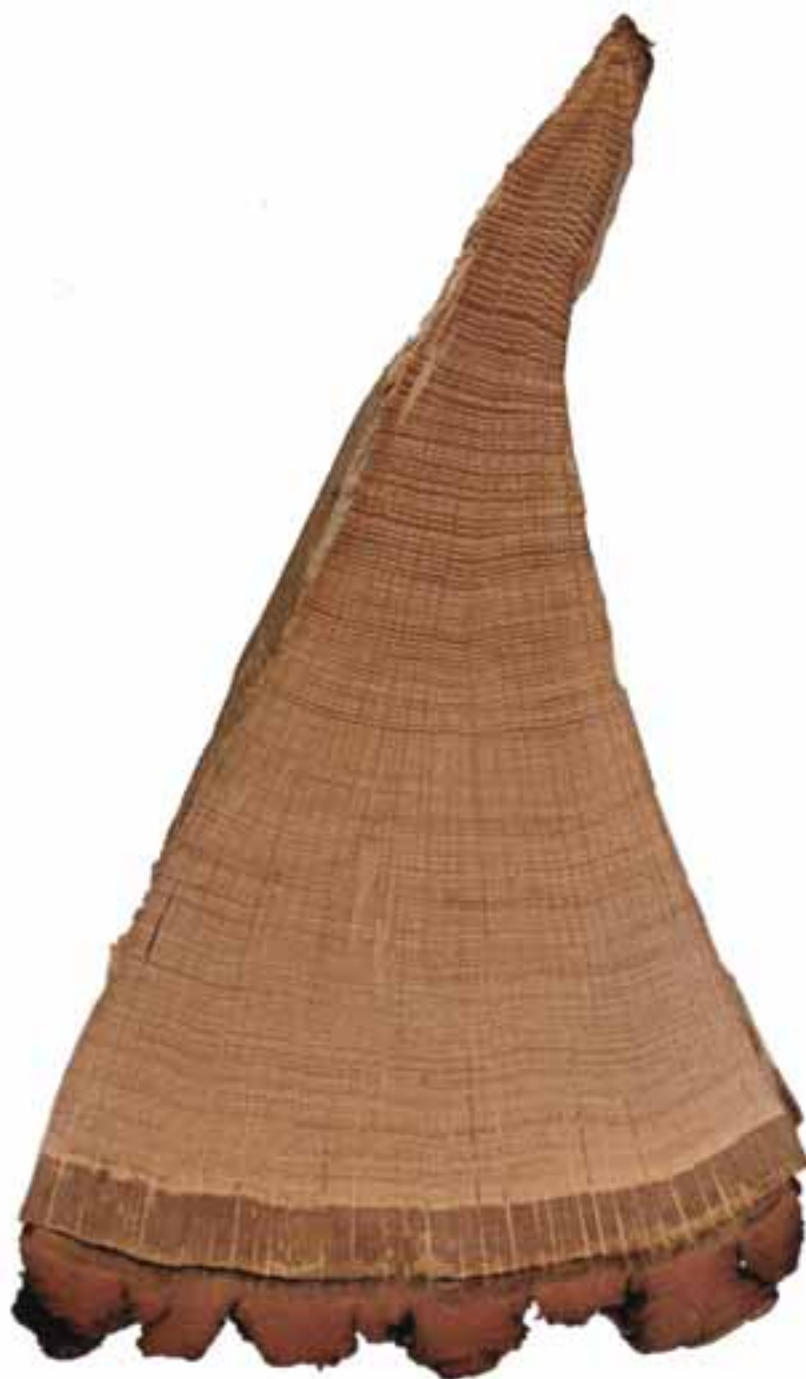
*Figure A1: A wedge of oak from a tree felled in 1976. It shows the annual growth rings, one for each year from the innermost ring to the last ring on the outside just inside the bark. The year of each ring can be determined by counting back from the outside ring, which grew in 1976*

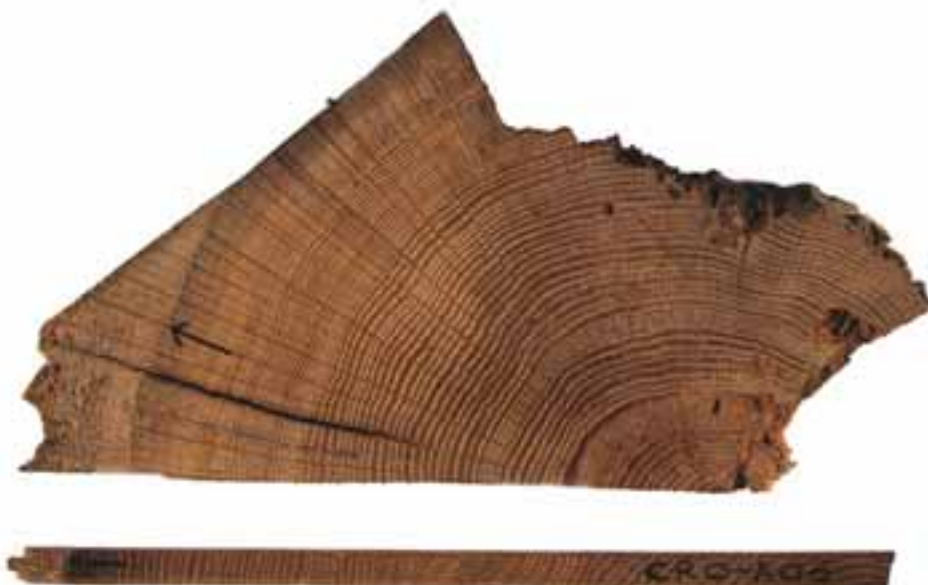
*Figure A2: Cross-section of a rafter, showing sapwood rings in the left-hand corner, the arrow points to the heartwood/sapwood boundary (H/S); and a core with sapwood; again the arrow is pointing to the H/S. The core is about the size of a pencil*

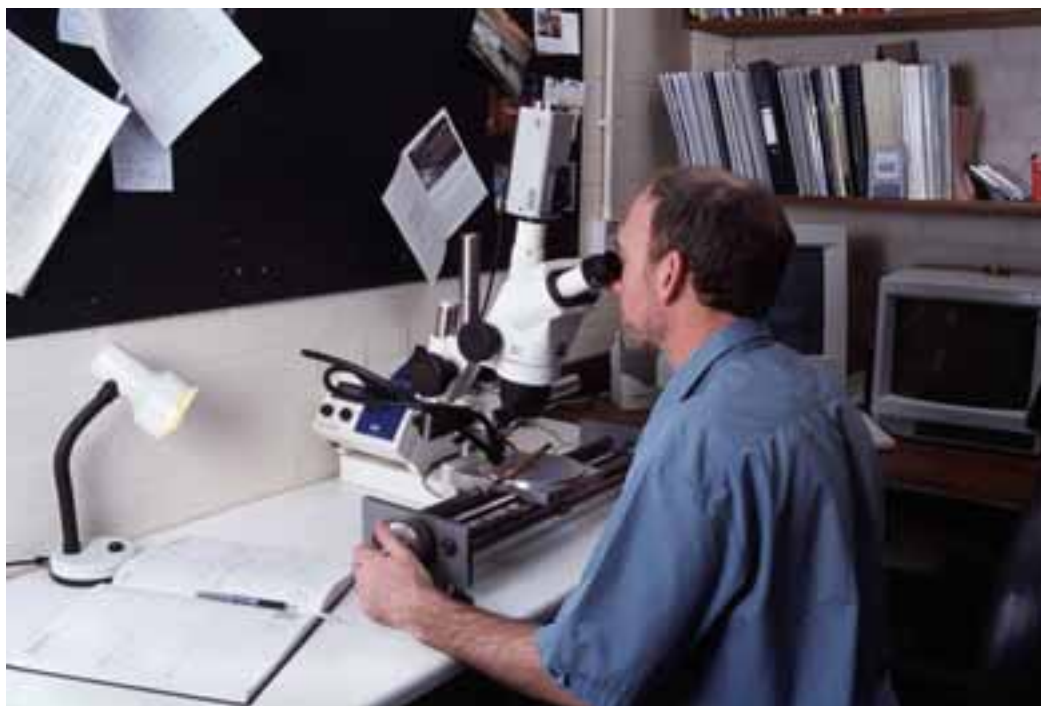
*Figure A3: Measuring ring widths under a microscope. The microscope is fixed while the sample is on a moving platform. The total sequence of widths is measured twice to ensure that an error has not been made. This type of apparatus is needed to process a large number of samples on a regular basis*

**2. Measuring Ring Widths.** Each core is sanded down with a belt sander using medium-grit paper and then finished by hand with flourgrade-grit paper. The rings are then clearly visible and differentiated from each other with a result very much like that shown in Figure A2. The core is then mounted on a movable table below a microscope and the ring-widths measured individually from the innermost ring to the outermost. The widths are automatically recorded in a computer file as they are measured (see Fig A3).

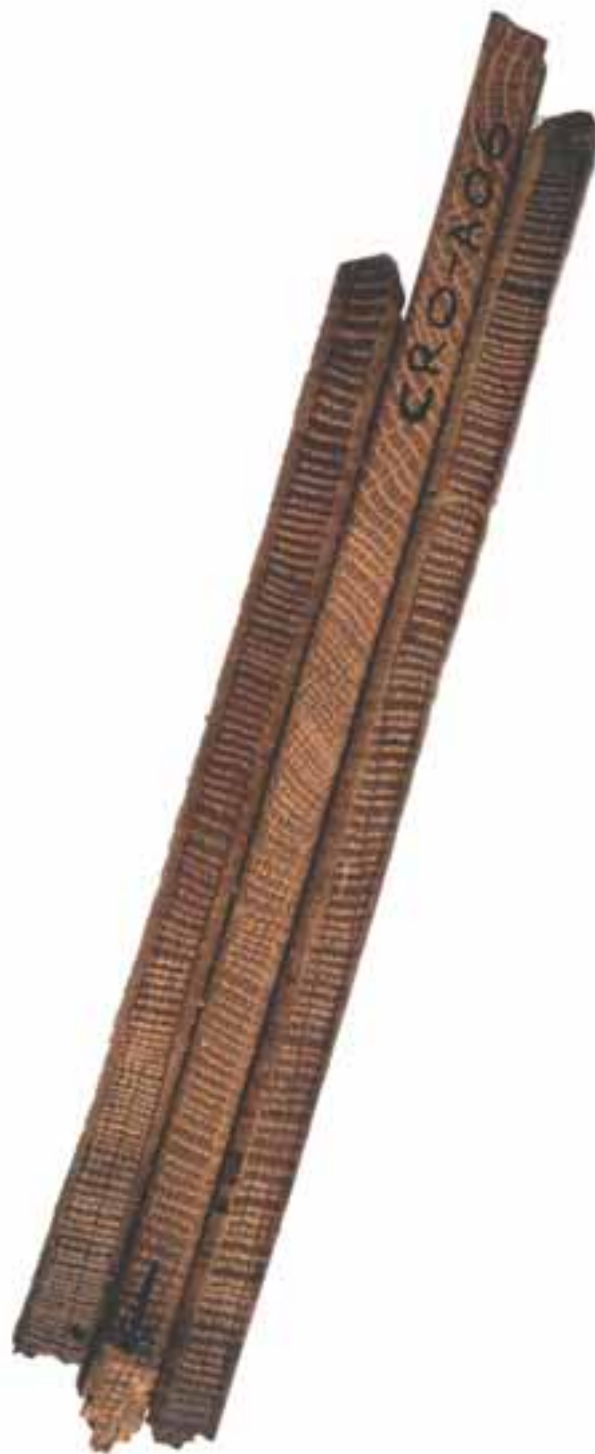
*Figure A4: Three cores from timbers in a building. They come from trees growing at the same time. Notice that, although the sequences of widths look similar, they are not identical. This is typical*
