YARDE FARMHOUSE, MALBOROUGH, SOUTH HAMS, DEVON TREE-RING ANALYSIS OF TIMBERS

SCIENTIFIC DATING REPORT

Research Department Report Series 103-2009

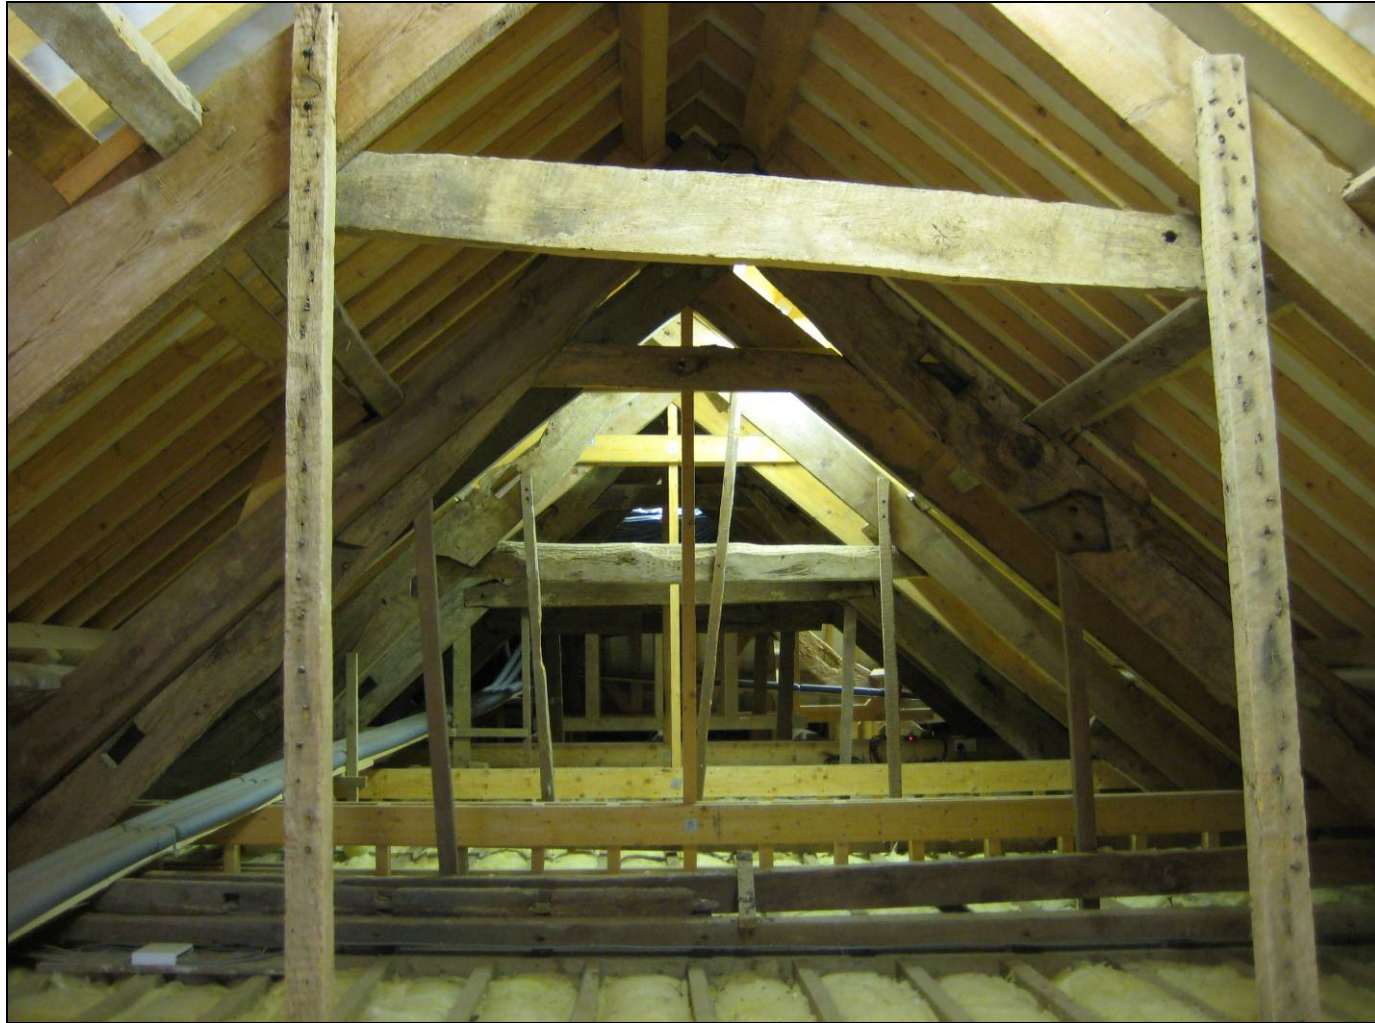
Figure 5: North-south range, showing the empty mortices for collars and through purlins in the principal rafters, looking north

This two-storey range is thought to predate the AD 1718 South range and to have originally been the medieval hall. It has a small room at the higher end with a larger heated room beyond it, at the end of which is a through-passage running from the front to the back of the wing (www.lbonline@english-heritage.org.uk). The roof is constructed of a mixture of modern softwood and historic oak timbers. The majority of the oak trusses contain principal rafters which have empty mortices for two sets of through purlins, and would have had halved lap collars, but these are missing (Fig 5). One of the oak trusses (truss 1) can be seen to retain its cranked collar with notched halving joint (Fig 6).

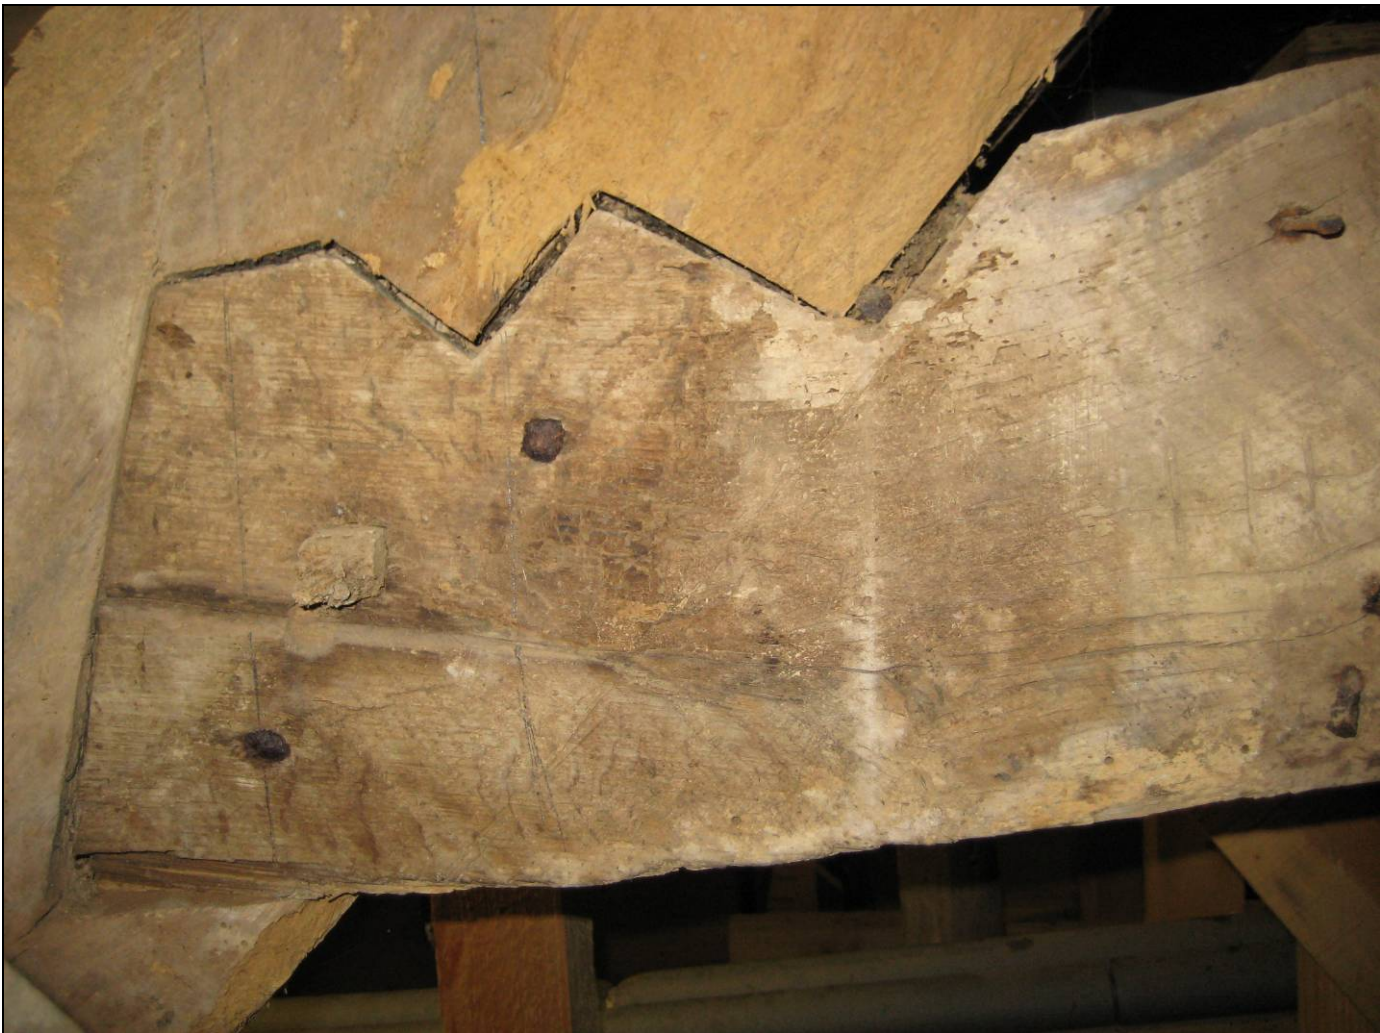
Figure 6: North-south range; truss 1, taken from the north-east

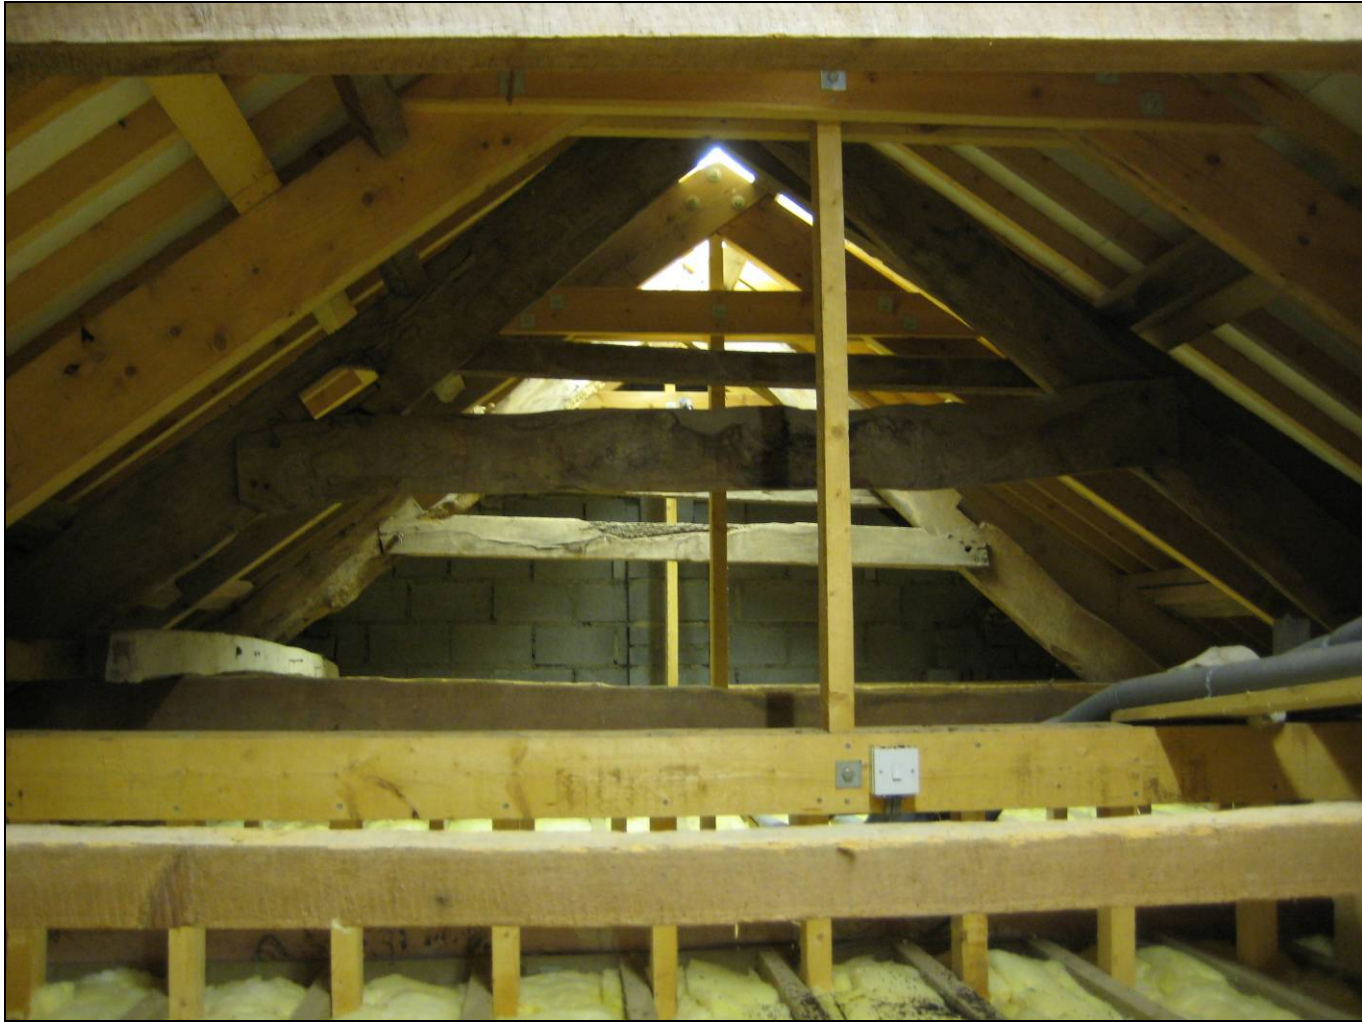
Figure 7: North range; looking east

This two-storey range was thought to have been added in the seventeenth century to run parallel to the original parlour range (www.lbonline@english-heritage.org.uk). Although most of the roof is modern, two trusses contain historic timbers. The north principals of these two trusses again have empty mortices, demonstrating they once had through purlins, whilst the southern principals had trenched purlins (Fig 7).

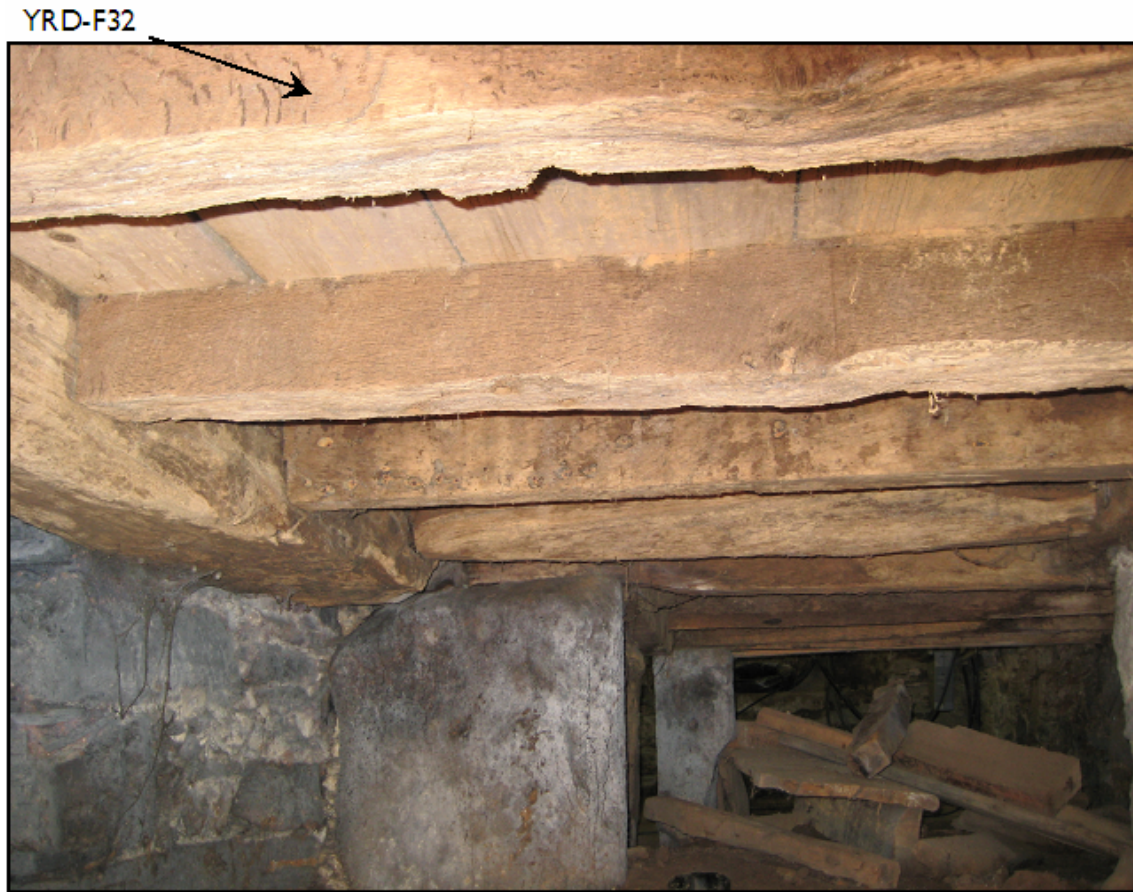
Position and orientation of Fig 15

Figure 15: South range: Cellar, showing the location of sample YRD-F32

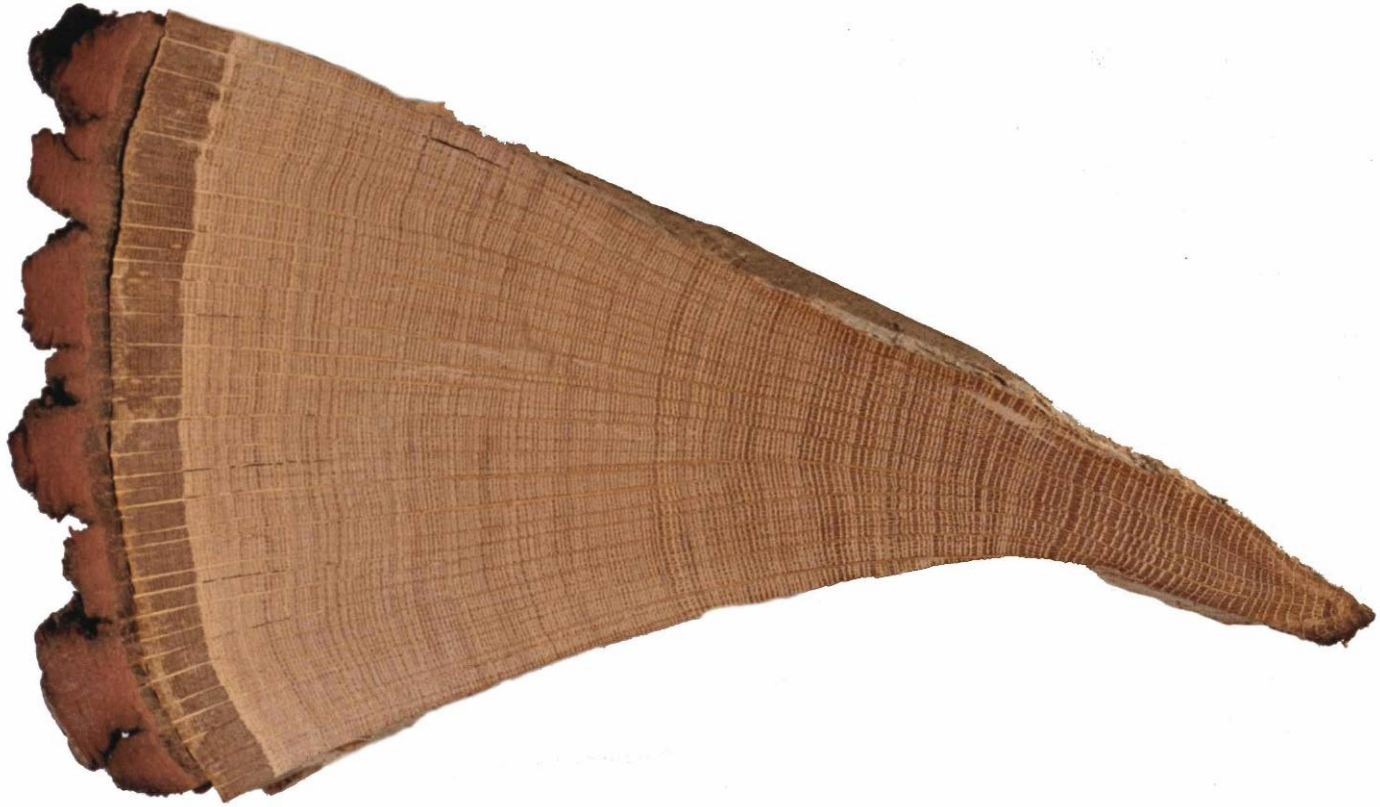
Figure A1: A wedge of oak from a tree felled in 1976. It shows the annual growth rings, one for each year from the innermost ring to the last ring on the outside just inside the bark. The year of each ring can be determined by counting back from the outside ring, which grew in 1976

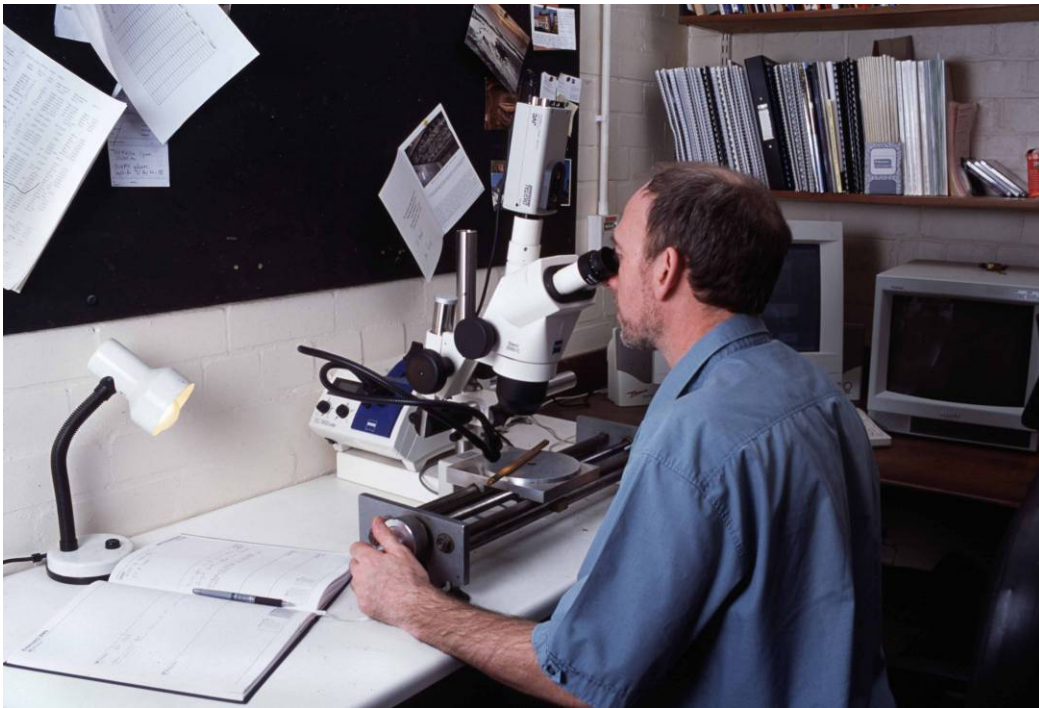
Figure A3: Measuring ring widths under a microscope. The microscope is fixed while the sample is on a moving platform. The total sequence of widths is measured twice to ensure that an error has not been made. This type of apparatus is needed to process a large number of samples on a regular basis

2. Measuring Ring Widths. Each core is sanded down with a belt sander using medium-grit paper and then finished by hand with flourgrade-grit paper. The rings are then clearly visible and differentiated from each other with a result very much like that shown in Figure A2. The core is then mounted on a movable table below a microscope and the ring-widths measured individually from the innermost ring to the outermost. The widths are automatically recorded in a computer file as they are measured (see Fig A3).

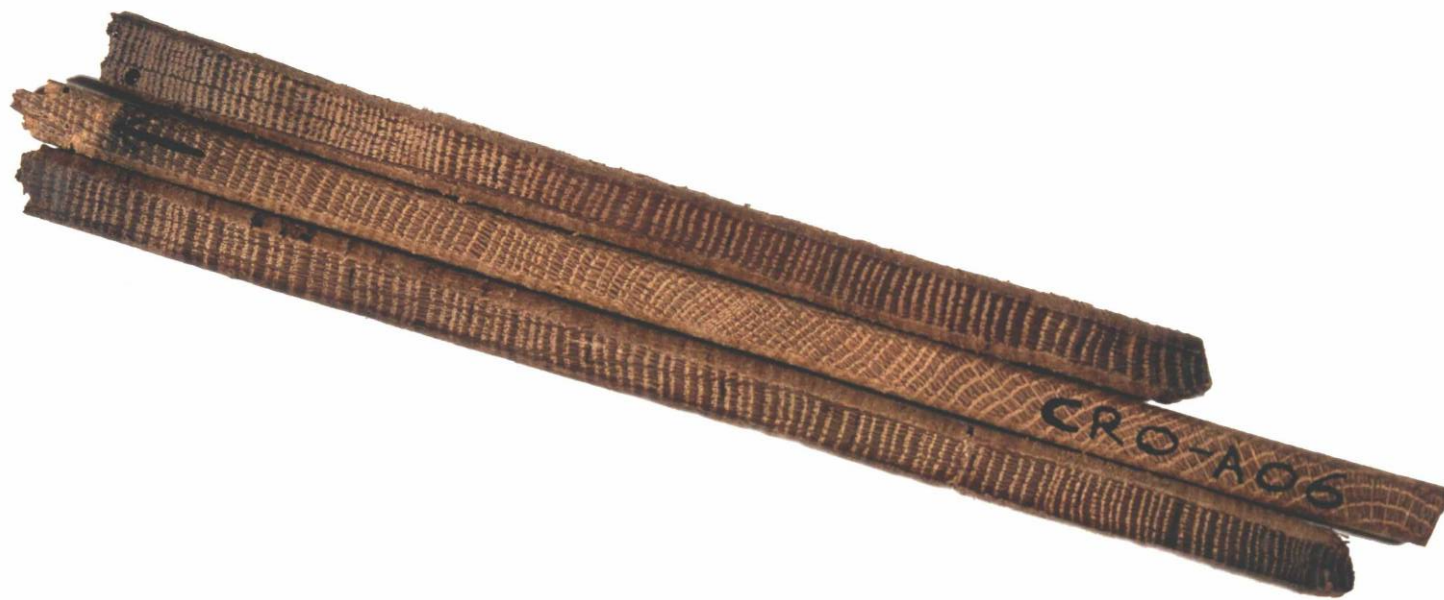
Figure A4: Three cores from timbers in a building. They come from trees growing at the same time. Notice that, although the sequences of widths look similar, they are not identical. This is typical
