CHISWICK HOUSE, LONDON BOROUGH OF HOUNSLOW REPORT ON THE ARCHAEOLOGICAL EVALUATION TRENCH IN THE CAMELLIA GARDEN

CHISWICK HOUSE FACILITIES DEVELOPMENT PROJECT,
PROJECT 4584

Research Department Report Series 52/2007

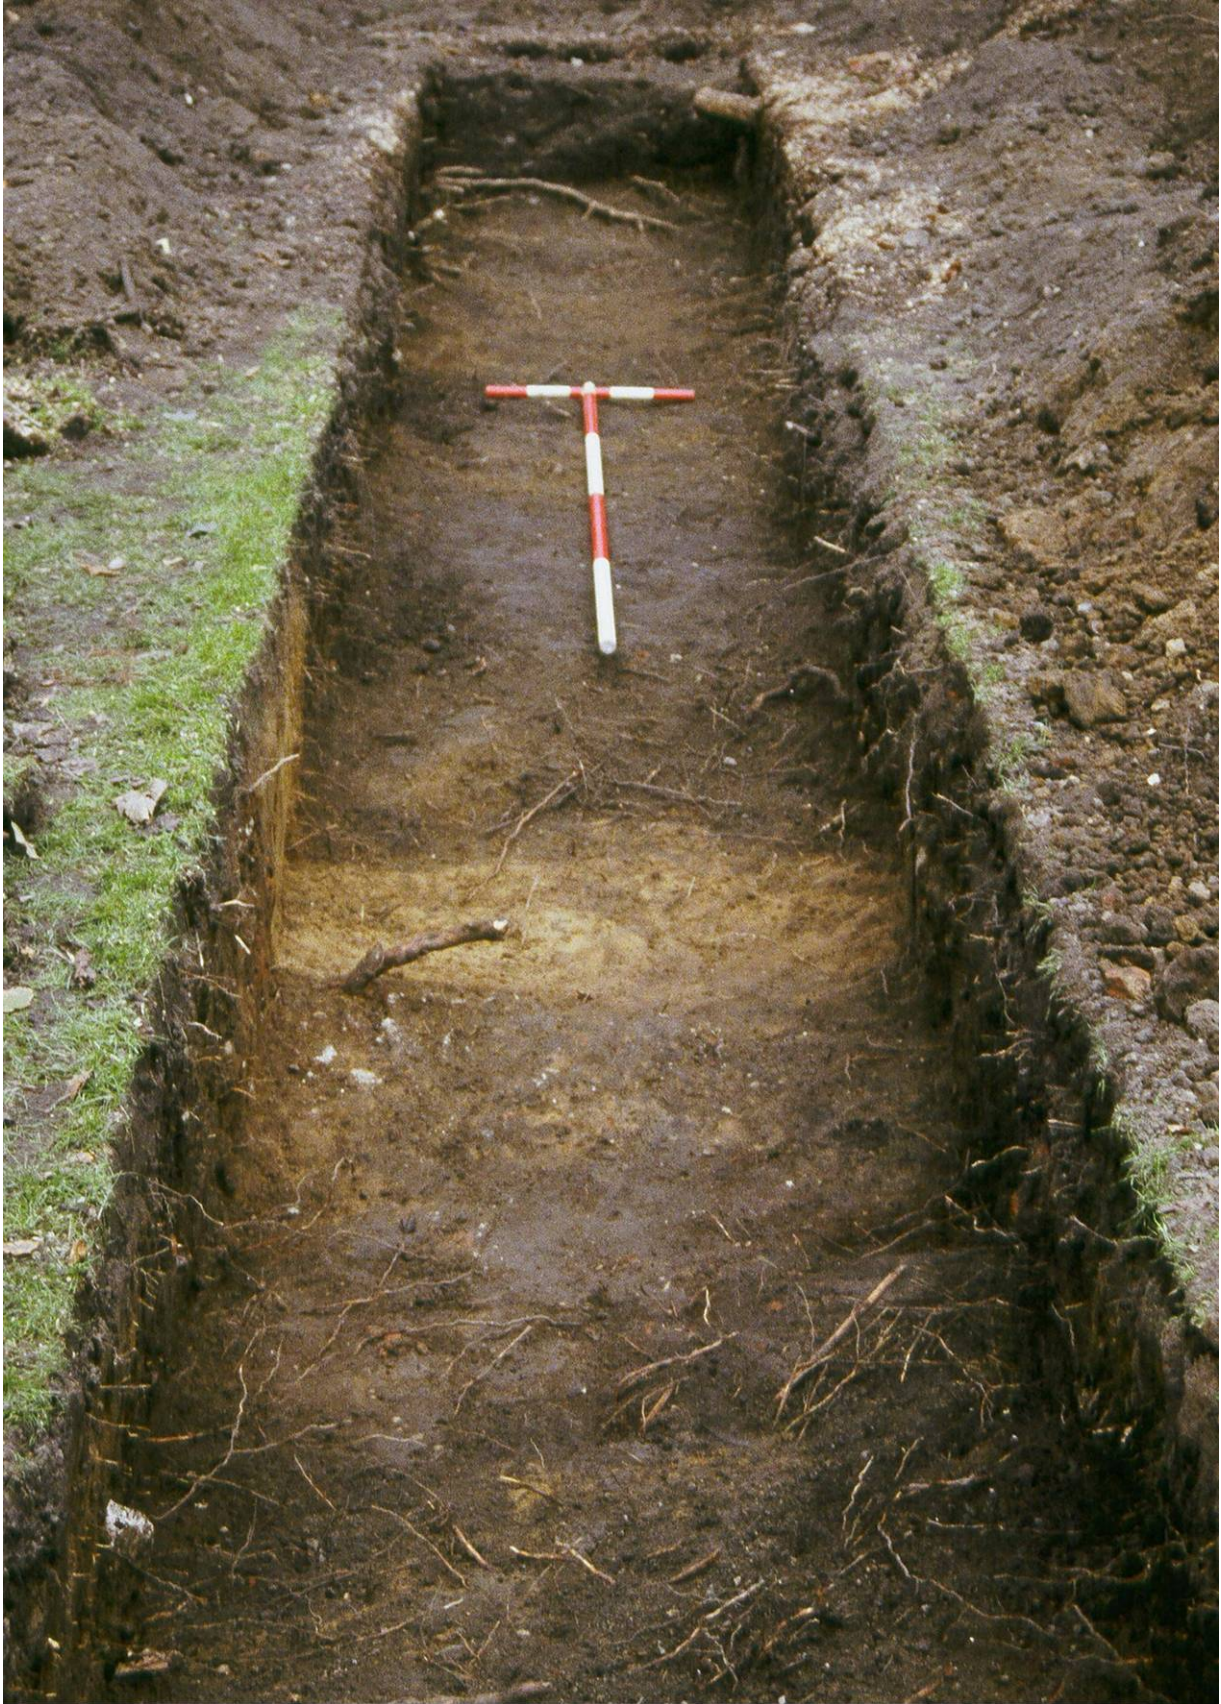
Plate I General view of evaluation trench, looking north-east
(2m and 0.5m scale)

A NE-SW-aligned trench measuring 9.7m x 1m was excavated by hand across the lawn of the Camellia Garden (for location plan, *see Figure 2*; for general overview, *see Plate 1*).

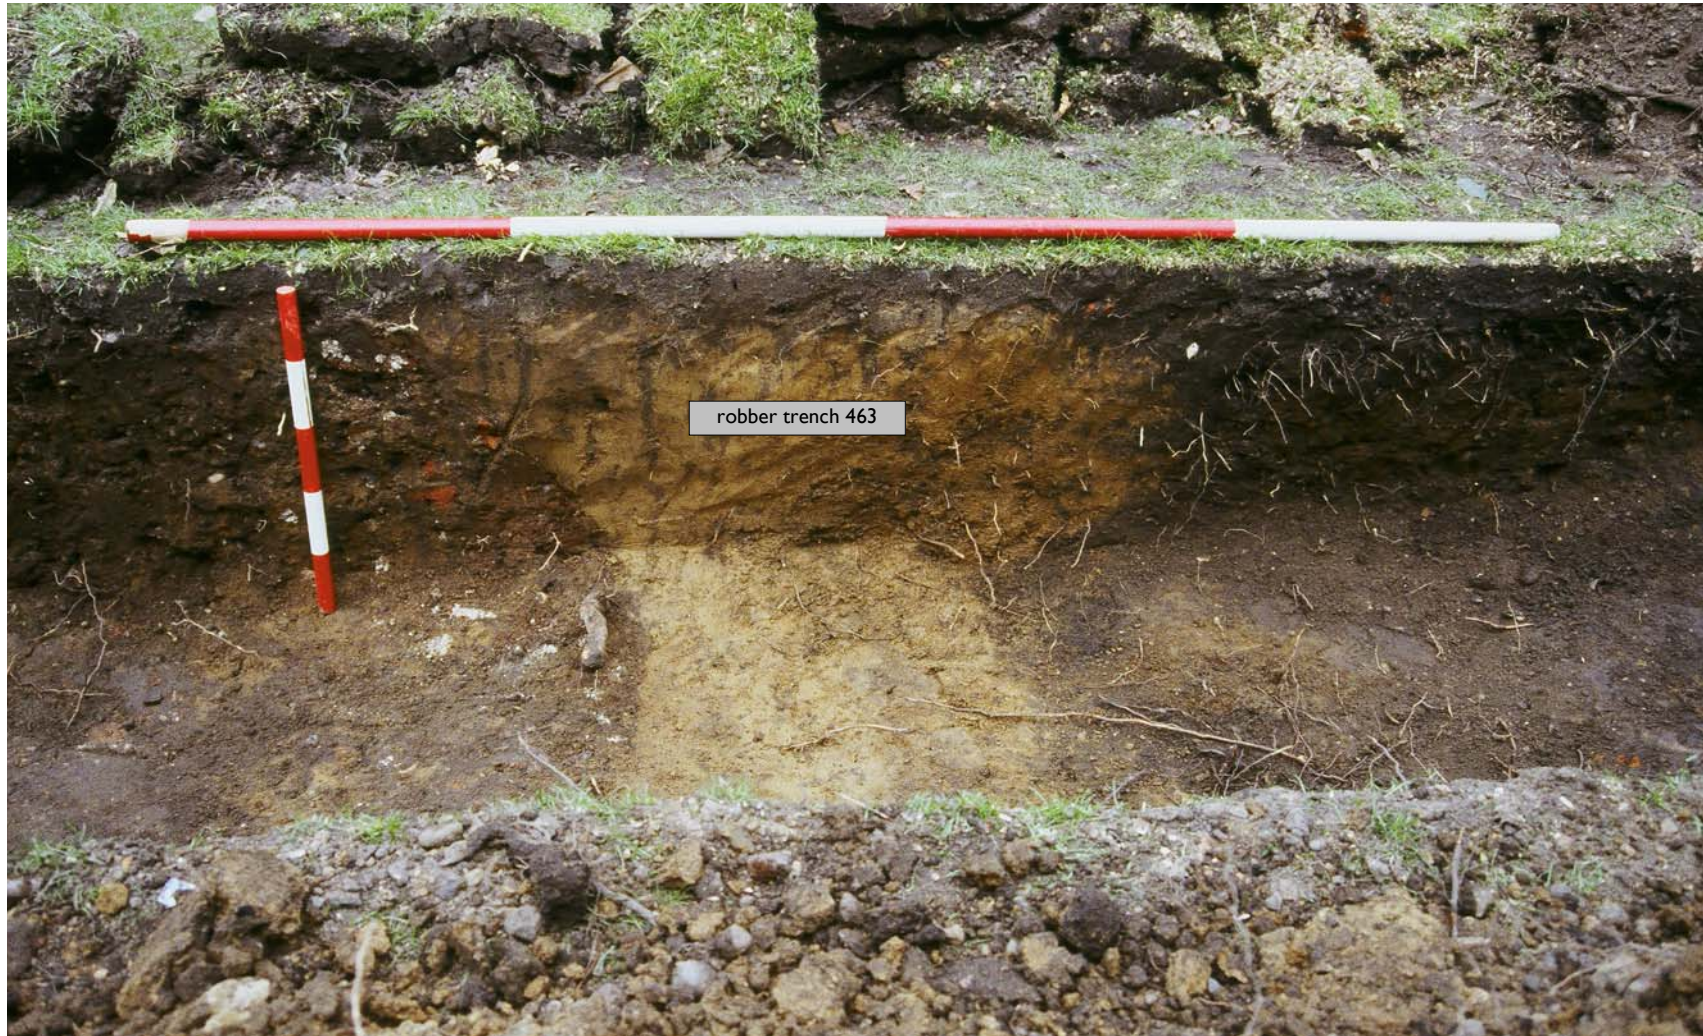
Plate 2 View of north-western section of the evaluation trench, showing the robber trench cut (context 463)
(2m and 0.5m scale)

The south-western half of the excavation trench revealed a more complex sequence of archaeological remains. Cutting across the centre of the trench was a linear steep-sided cut running NW-SE – context 463 (*see Plate 2*). Only the north-eastern edge of this cut was seen, the south-western edge having been obscured or removed by later works. The cut was filled by a very clean, dark-yellowish-brown sandy material, context 464, and was excavated down to a depth of 0.93m, although at this depth its base had not been reached. Excavation was halted as the trench was deeper than the proposed cultivation depth, and the final extents of this cut remain unknown.

The nature and position of this cut suggest that this was the robber trench for the removal of the garden or yard wall shown on the early surveys of the Moreton Hall estate. The location of this wall could not be accurately plotted from the early surveys (although a 'best-

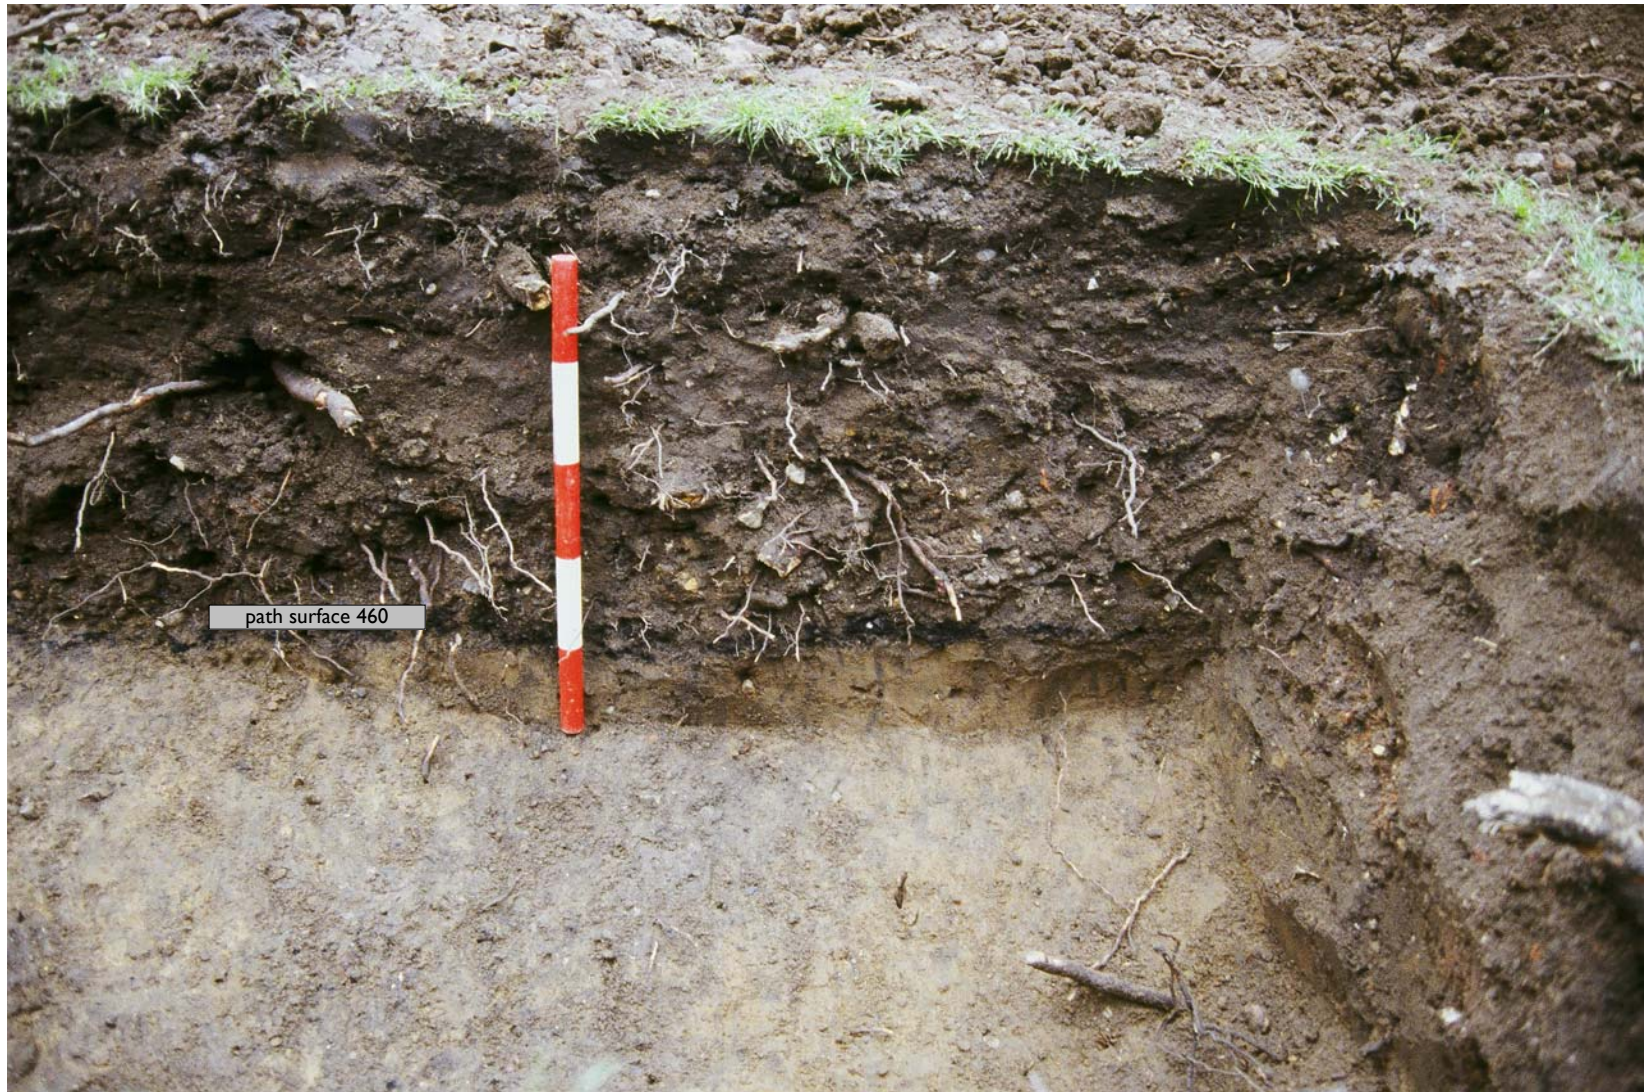
Plate 3 View of south-eastern section of the evaluation trench, showing the buried path surface (context 460)
(0.5m scale)

At the south-western corner of the trench the levelling layer 457 overlaid a 0.04m thick layer of clinker path material, context 460 (*see Plate 3*). The path was aligned NE-SW, and a 1.44x0.23m section of the path was excavated. The path was laid on top of a dark-grey-brown silt deposit (context 459), an early landscaping or levelling layer that extended across the whole of the evaluation trench (recorded as context 465 to the east of the robber trench - cut 463).

The upper surface of the path was at a depth of 0.47m below the present ground level, and dates from the early garden works of the Moreton Hall Estate (17th-18th century in date).
