THE FORMER DRILL HALL,
YORK ROAD,
GREAT YARMOUTH
SURVEY AND ANALYSIS

HISTORIC BUILDING REPORT

**The Former Drill Hall
York Road
Great Yarmouth, Norfolk
Historic Building Report**

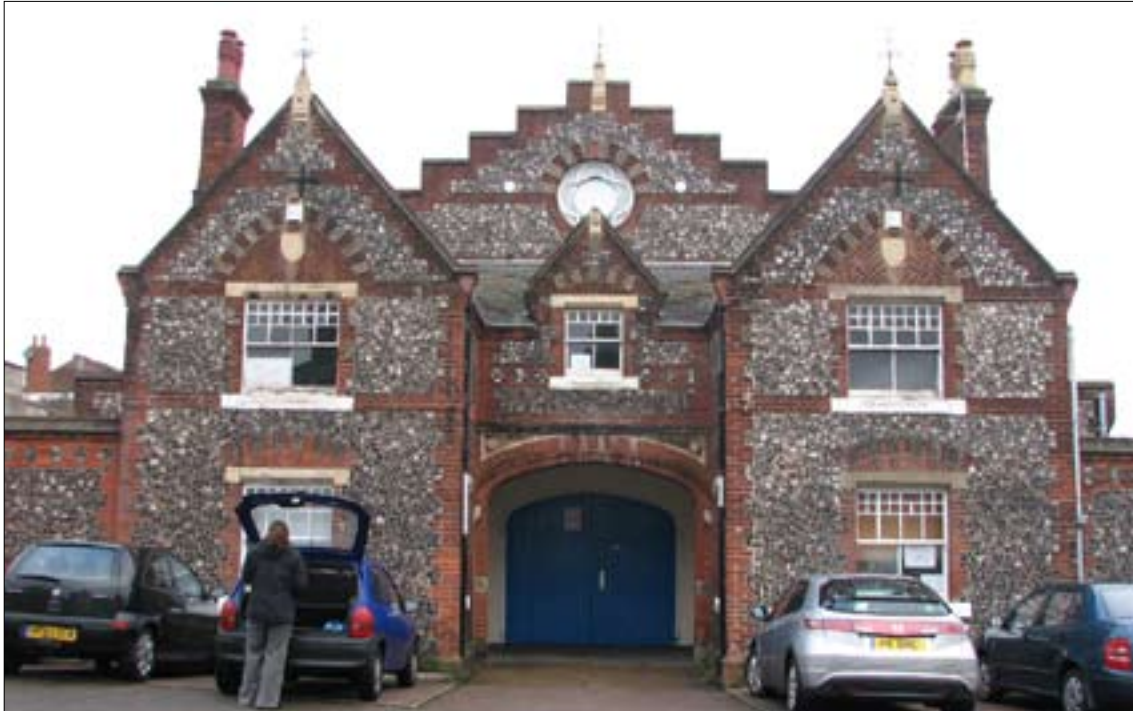
Figure 2. Southern facade of the drill hall.

The residential front block is symmetrical in appearance and formed from two two-storeyed gabled bays connected by a central linking bay at the first-floor level, flanked by single storeyed bays (Fig. 2). The capping stones of the end bays conceal flat roofs which creates the appearance of walled yards rather than solid structures. The central bay forms a porch below, accessed by a four centred open arch (once containing gates) and providing access to the hall behind. The crow-stepped gable wall of the hall rises behind this central bay with an oculus clearly visible above the gabled dormer – forming the central focus of this façade.

The building is highly decorated with a polychromatic Gothic Revival style formed by the facing of uncoursed knapped flint with dressings of red brick, yellow brick and some ashlar. The red brick is used for quoins, window and door surrounds, chimney stacks, horizontal bands at first-floor and eaves level, and to edge the steps of the gable. The

porch arch is formed from moulded red brick with the addition of moulded stone spandrels. Stone is also used for the ashlar window sills and lintels although some have been replaced in concrete due to weathering. The windows themselves largely contain attractive Edwardian glazing with two lights to the lower sash and a more detailed upper sash containing a number of smaller lights. Several single light windows (Fig. 3) retain the original Gothic glazing with cusped heads and pierced spandrels. This original glazing is shown in the 1868 engraving of the property (Fig. 4) and had been replaced by the time that the time a photograph (Fig. 5) was taken in c.1911. The principal windows have very decorative heads with polychrome segmental and pointed brick relieving arches. The pointed arches contain herringbone brick infilled tympana with plain stone shields whilst the segmental arches are filled with radiating brickwork. The gables are surmounted by ornamental stone finials with decorative wrought iron terminals. The pitched roofs are covered in slate.

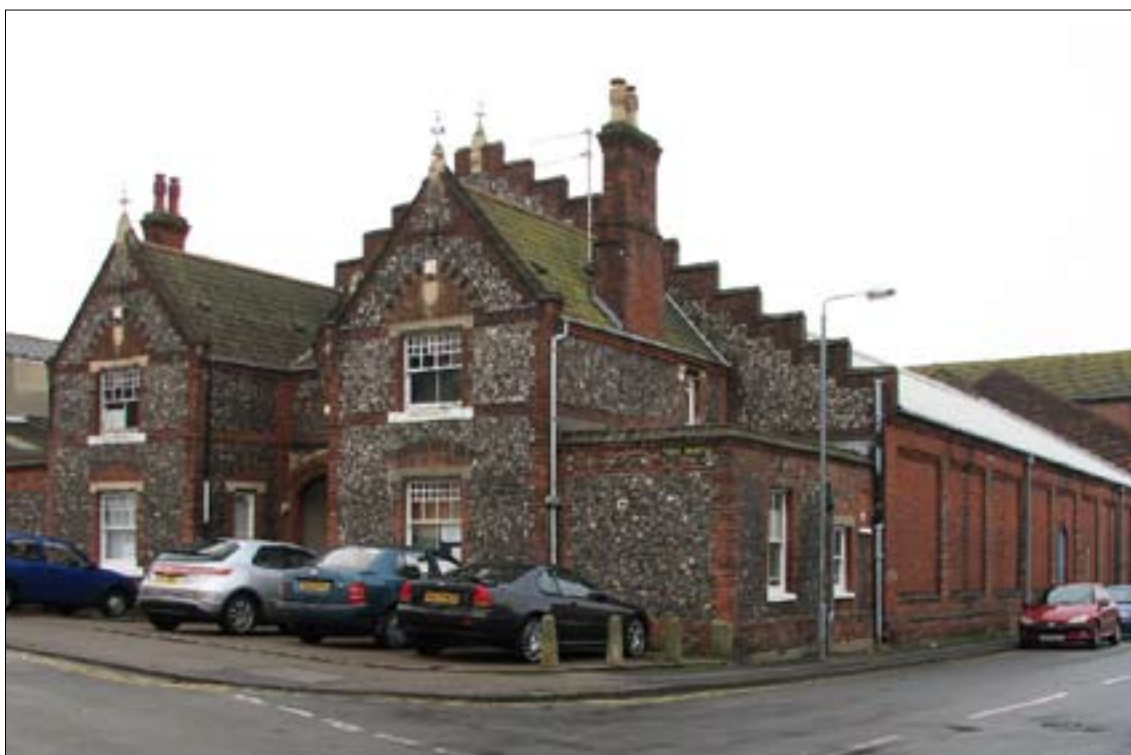
Figure 6. Front block with the drill hall behind.

The stepped southern gable wall of the hall forms the rear of the front block and accordingly is constructed from matching red brick and flint. The apex of the gable is topped with a finial to match those on the front gables, whilst the circular window containing quatrefoil glazing has a polychrome brick surround to its upper half and a plain red brick surround to its lower half, continuing to either side as a band. The main structure (Fig. 6) is 10 bays long, constructed from red brick in Flemish bond on a brick plinth with no windows or doors along the west wall and a single doorway in the fifth bay from the south along the east wall. The hall is lit from above by a skylight running the length of the hall along the apex of the roof. Whilst this is not an original feature it replaced an earlier version which, as may be seen in Fig. 4, was originally in the form of a ridge lantern.

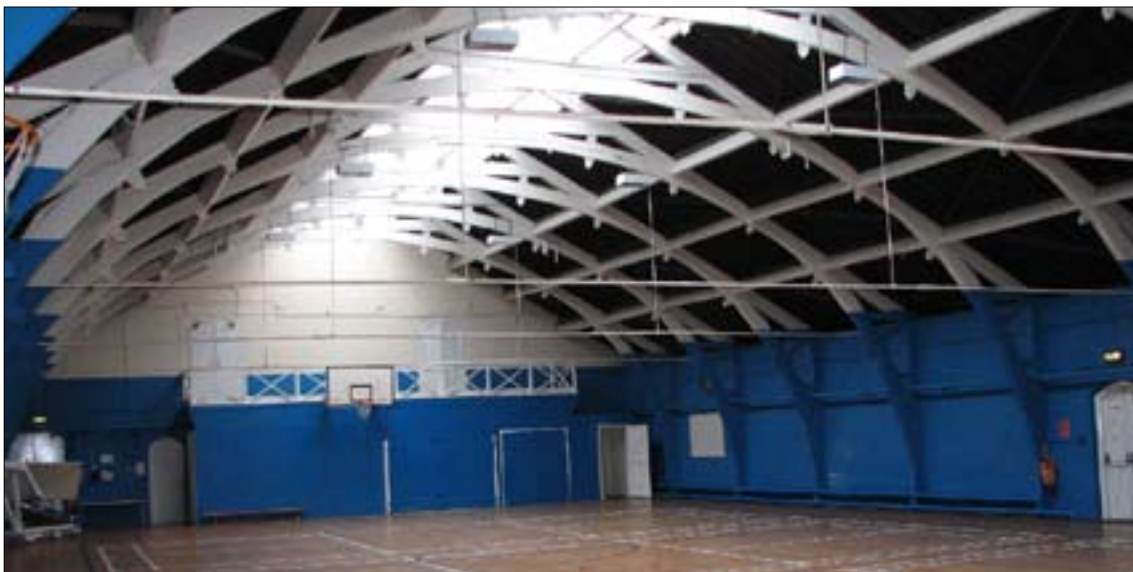
Figure 7. Interior of the drill hall looking north.

The roof is supported on composite or laminated timber curved braces set within a simple frame with small king posts with diagonal braces rising from the collar to support the modern ridge beam (Fig. 7). The lightweight metal tie beams and the timber arrow-shaped finials projecting from the trusses increase the visual impact of the roof itself which arches in a single span across the entire width of the hall – a distance of some 65 ft. *The Illustrated London News* reported that 'the ribs, principals and purlins are stained of a brown colour relieved with borders of ivory white and with gilding, so as to bring out the constructive features'.⁸

The wooden floor appears to be original and is laid on top of concrete so as to minimise the noise from drill marches. At first-floor level along the south wall are the remains of six timber supports for a viewing gallery (no longer extant) with a blocked two-centred arch headed doorway on the first floor to the west side. As galleries were generally used by the public it would appear that the eastern part of the front block allowed access to this gallery and was not, therefore, part of the private accommodation. A matching gallery existed at the north end of the hall (although this has been replaced) and was accessed via a pair of doors at first-floor level. A two-centred arch headed doorway is found to either side of this end wall, matching those seen elsewhere, whilst two further doorways are found nearer the centre of the wall. Central heating in the form of substantial hot water pipes, heated by a boiler in the rear block, runs around the room at floor and head height and, if not an original feature, is certainly not much later than 1867.

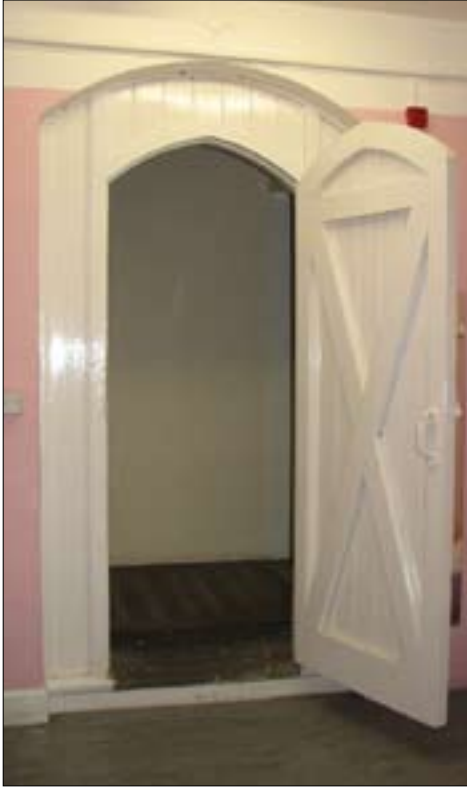
Figure 9. External door reset in an internal doorway.

Internally, the doorway to the far west of the hall provides access to the staircase to the first floor – a doorway on the west side of the rear block allows direct access to this staircase from outside. The next doorway from the hall opens into an office with early reeded glass in the windows; these are barred – suggesting that this office or store was intended to be secure. This room was never plastered, although the salient framing around the windows suggests that it was originally intended to be. The far west room, the boiler room, is accessed through this office. The boiler is not original but the function of the room seems original and there is only one, small, window in the west wall. The second room from the east, now lavatories, appears to have been offices although few features remain – the door here (Fig. 9) is an external one which has been

removed from its original location and re-set. The doorway to the far east of the hall provides access to a room with a number of decorative details such as an alcove, skirting and a blocked fireplace. The width of the threshold into this room, and the drop in the floor level, clearly demonstrates that this part of the rear block is a later addition.
