HARTLAW COTTAGES, NEWTON-ON-THE-MOOR, HARTLAW, SHILBOTTLE, NORTHUMBERLAND TREE-RING ANALYSIS OF TIMBERS

SCIENTIFIC DATING REPORT

Alison Arnold and Robert Howard

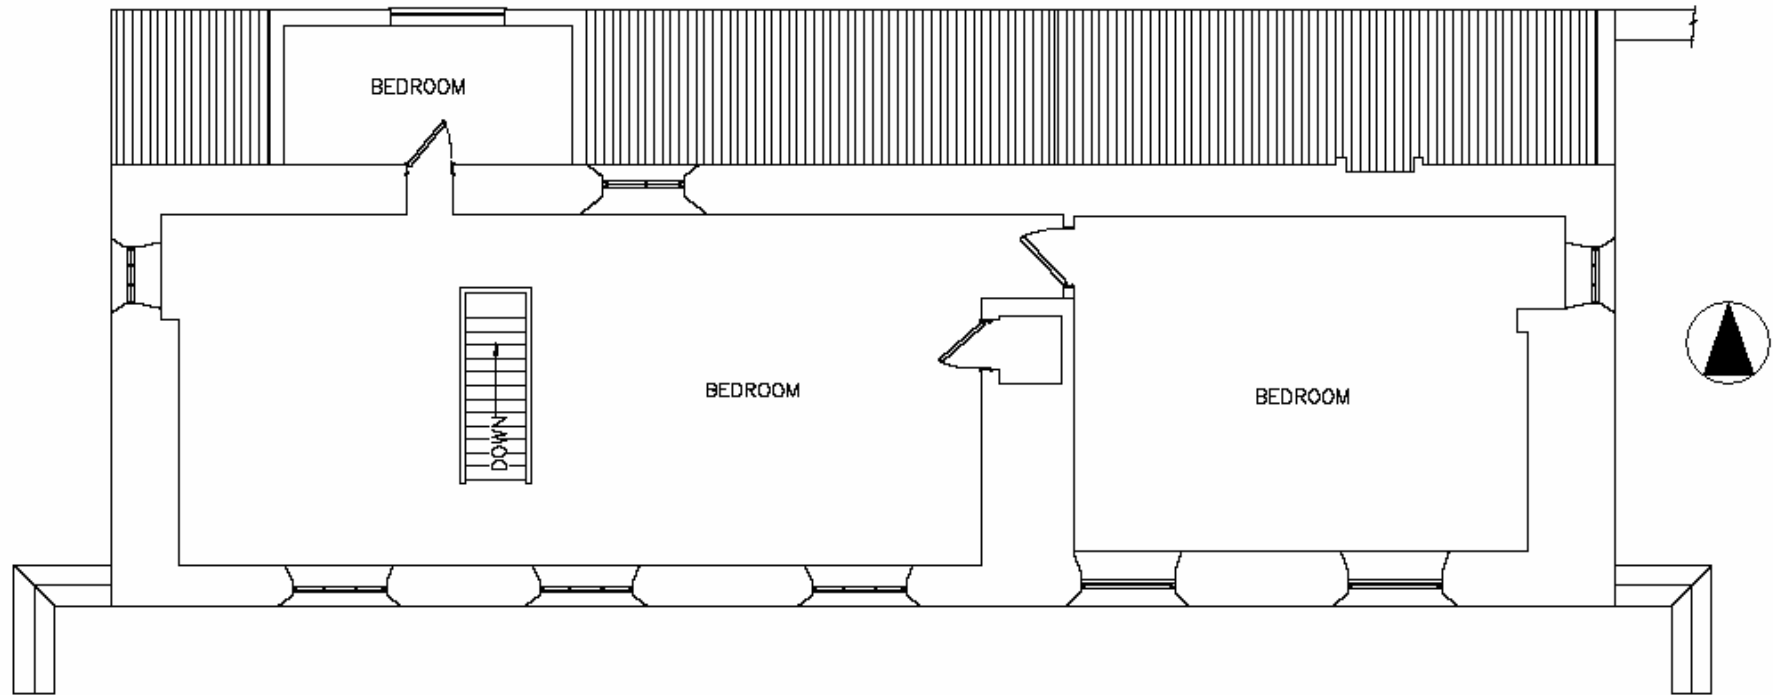
Figure 5: First-floor plan (Morton & Hall Consulting Ltd)

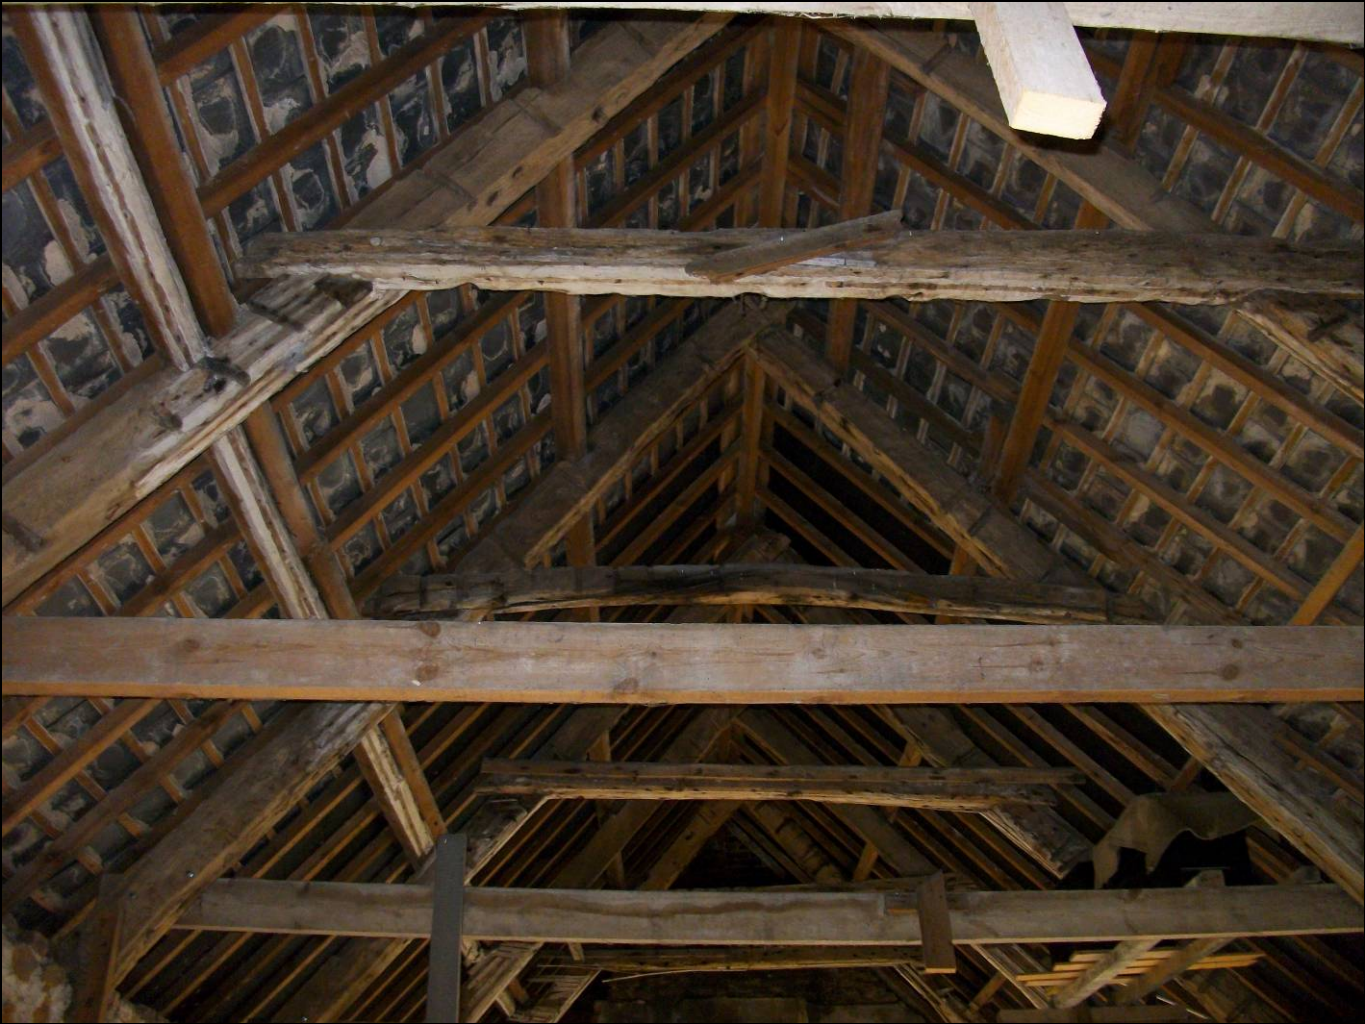
Figure 6: Roof, with truss 6 in the foreground (photograph taken from the east)

With the exception of the existing tiebeams, the timbers of the present roof appear to be primary to construction. There are ten evenly spaced trusses, each truss consisting of principal rafters, halved, lapped and pegged at the apex, collars (again half-lapped and pegged), and tiebeams (Fig 6). These last components are softwood, but the remains of the sawn-off original oak tiebeams can be seen in the walls. There are a few original lower purlins still *in-situ*, which rest upon intervening blocks affixed to the upper surface of the rafters.

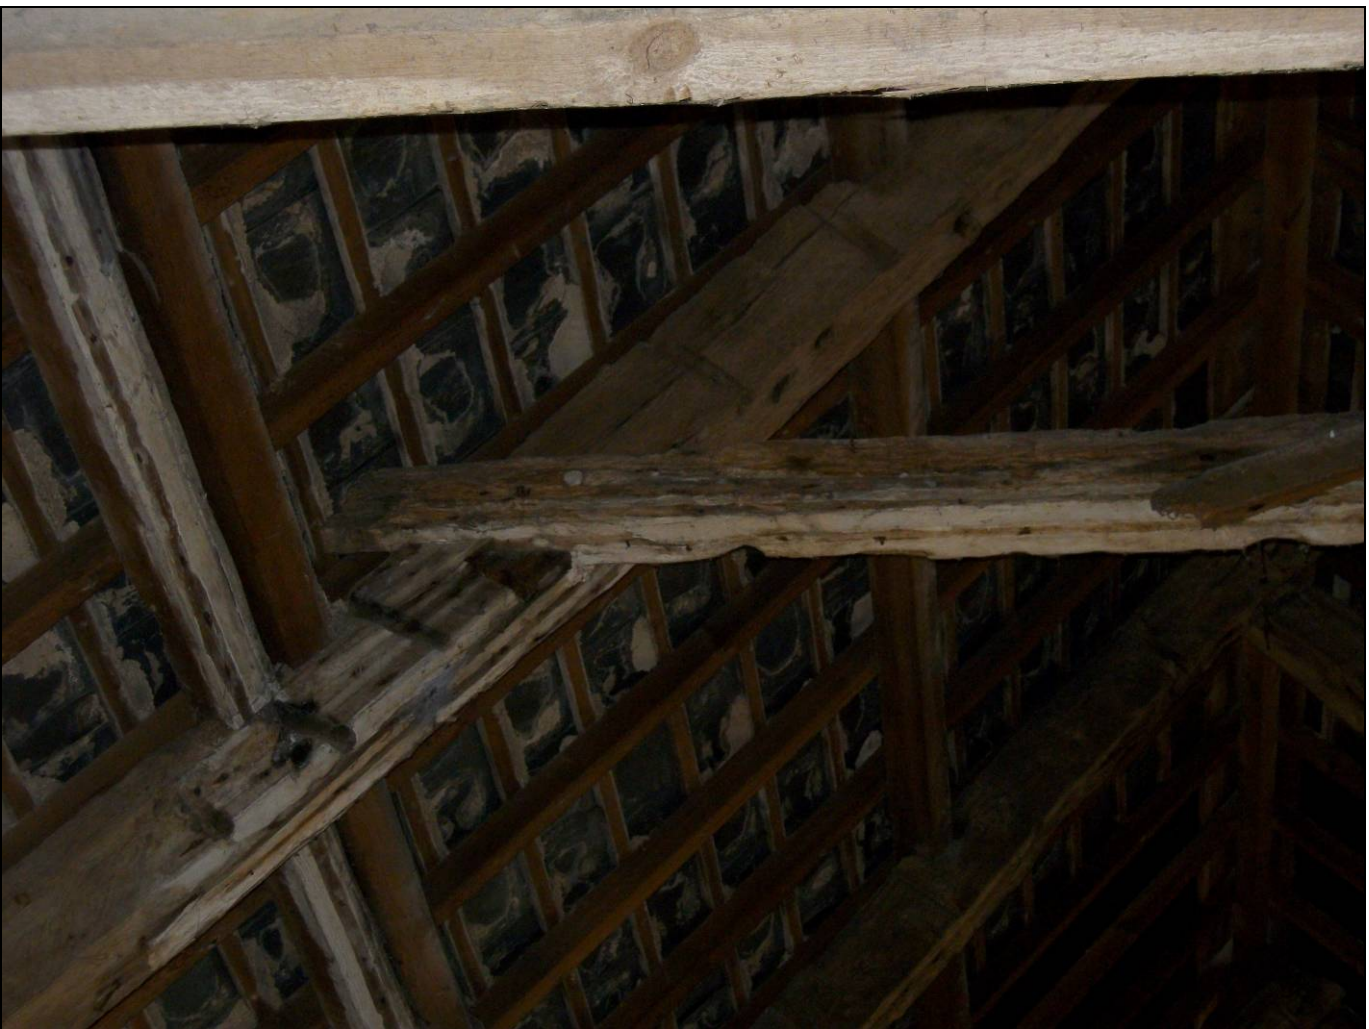
Figure 7: Close up of truss 6 showing the drilled holes for trenails (photograph taken from the east)

The majority of the apparently primary timbers of the roof are thought to be reused, with many of them having multiple large peg holes (Fig 7). These are thought to be trenails (large circular pegs within circular drilled holes), a characteristic of maritime construction whereby the outer planking of the hull is fixed to the main framing by large pegs. On some of the timbers these trenails inter-cut each other, suggesting the vessel itself had seen repeated repair. A number of the window lintels also have these trenails (Figs 8 and 9). The information above is based on the survey undertaken by Addyman Archaeology (2009).

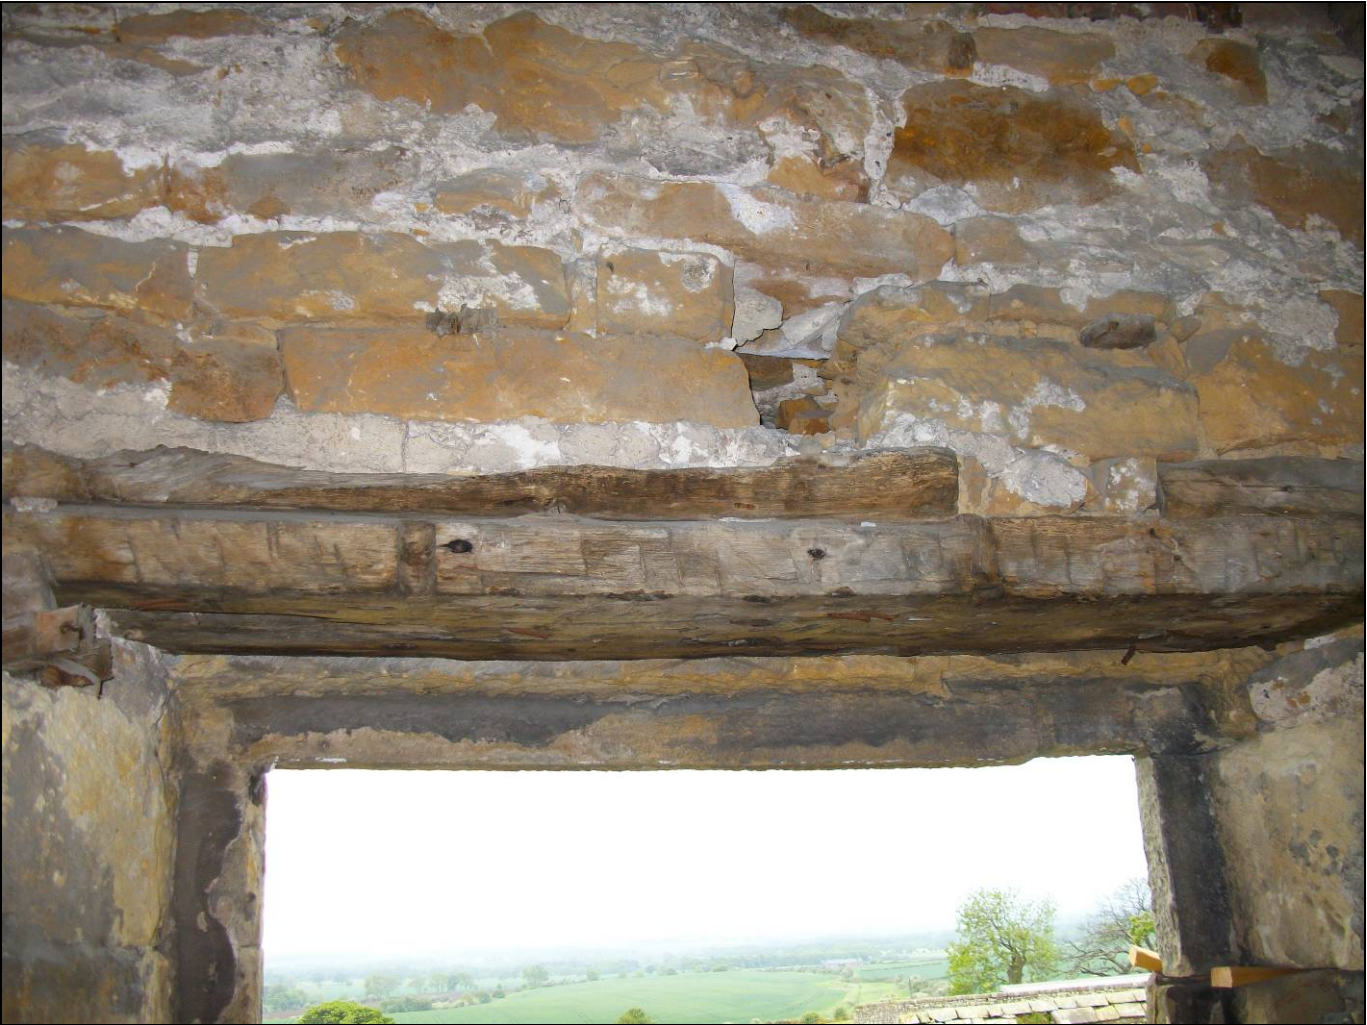
Figure 8: Lintel over the south window between trusses 5-6

lintels displayed the same large peg holes as those seen in the roof timbers, suggesting a similar previous use.

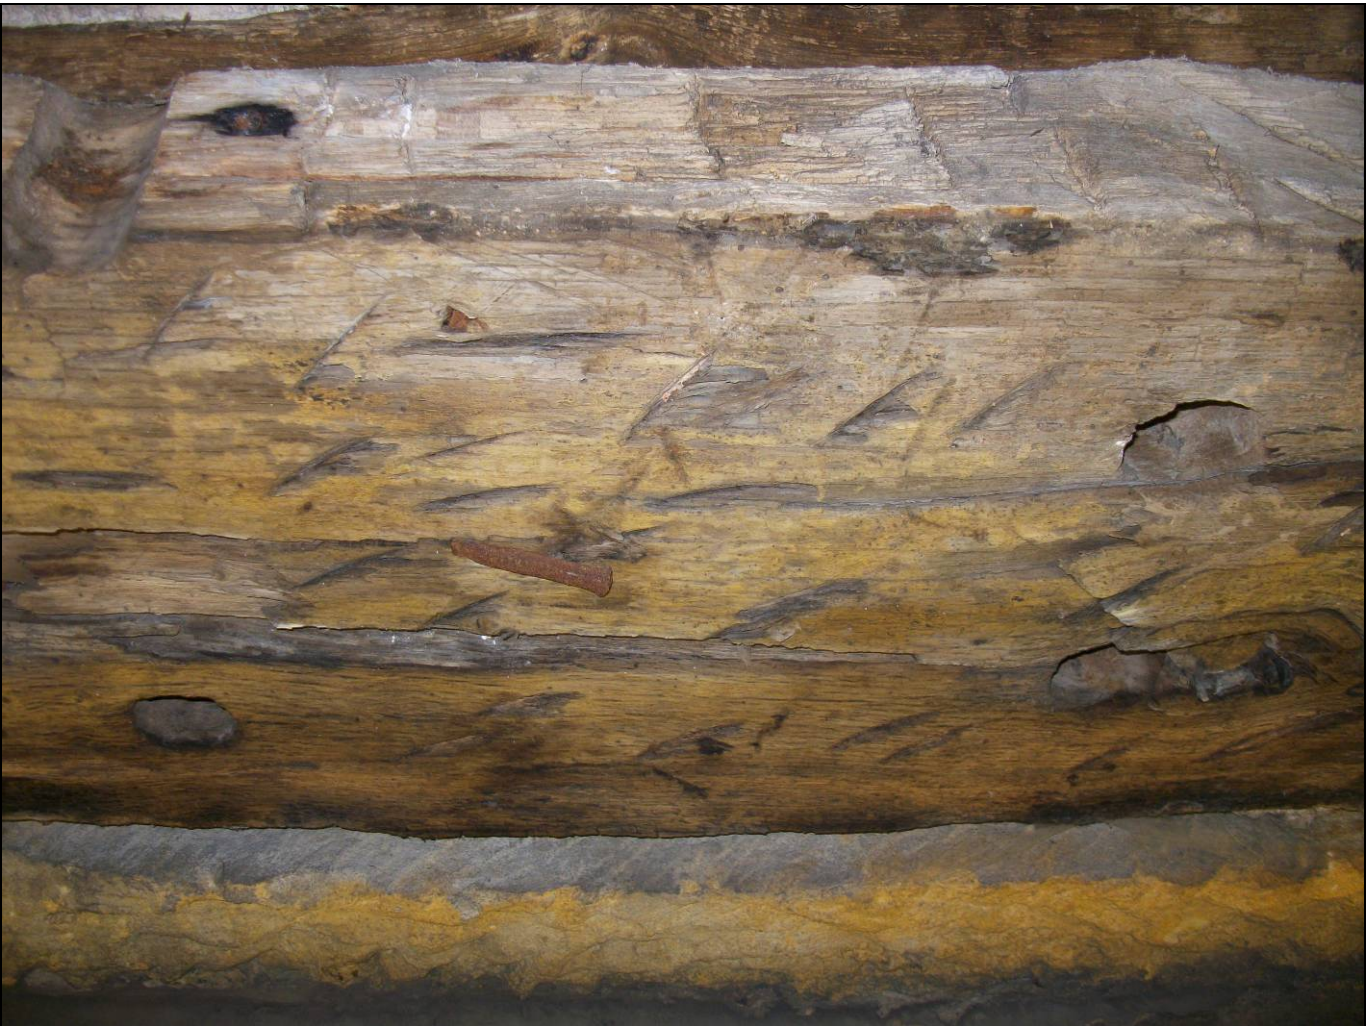
Figure 9: Lintel over south window between trusses 5-6, close up showing the same large peg holes

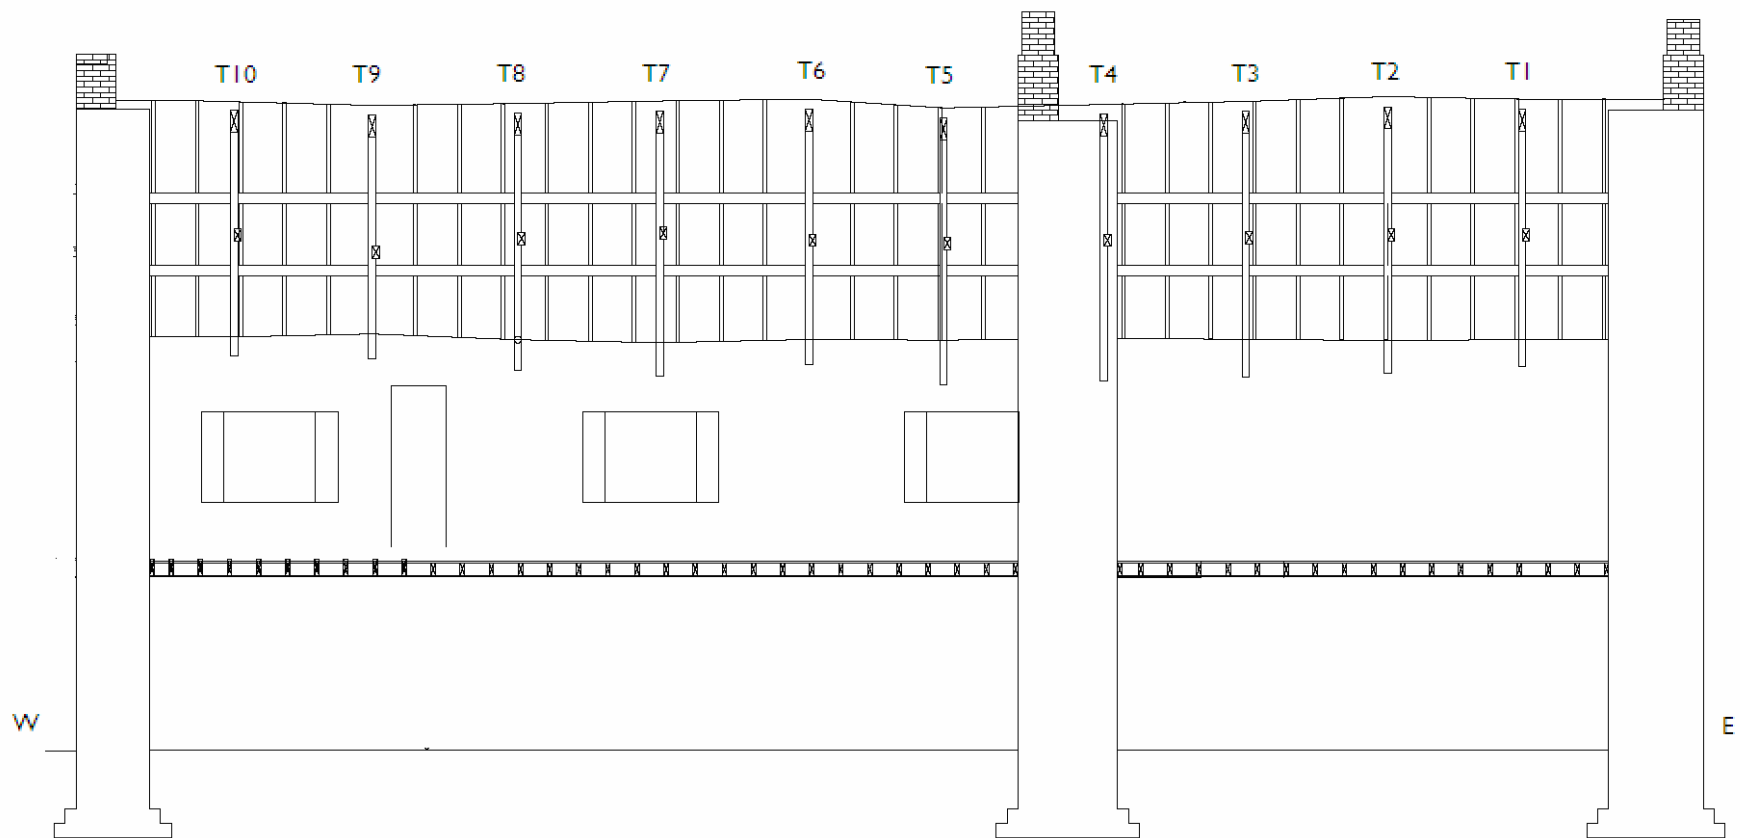
Figure 10: Section through building, showing truss numbering (Morton & Hall Consulting Ltd)

A total of 17 timbers was sampled. Each sample was given the code HRT-L (for Hartlaw) and numbered 01–17. Thirteen of these samples are taken from timbers of the roof (HRT-L01–13) and four from lintels (HRT-L14–17). Trusses have been numbered from east to west (Fig 10). The location of samples was noted at the time of sampling and has been marked on Figures 11–19. Further details relating to these samples can be found in Table 1. It is unfortunate that only the principal rafters were suitable for sampling but a surface inspection of the ring pattern of the collars and purlins showed them to be fast-grown, with less than the minimum number of rings required.

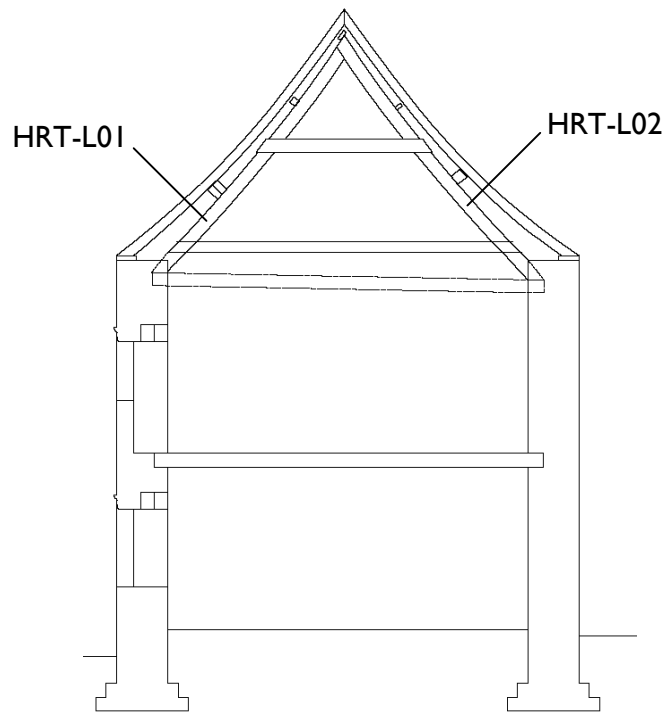
Figure 11: Truss 1 (west face), showing the location of samples HRT-L01 and HRT-L02 (Morton & Hall Consulting Ltd)

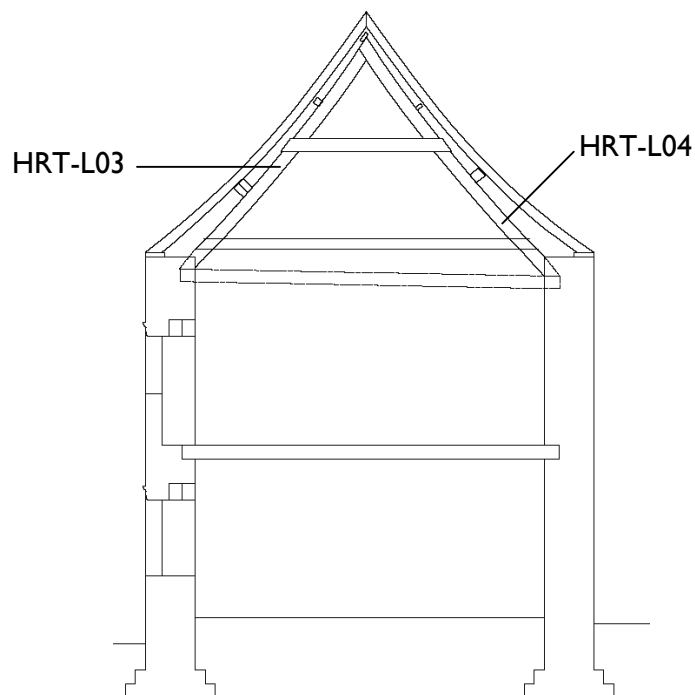
Figure 12: Truss 2 (west face), showing the location of samples HRT-L03 and HRT-L04 (Morton & Hall Consulting Ltd)

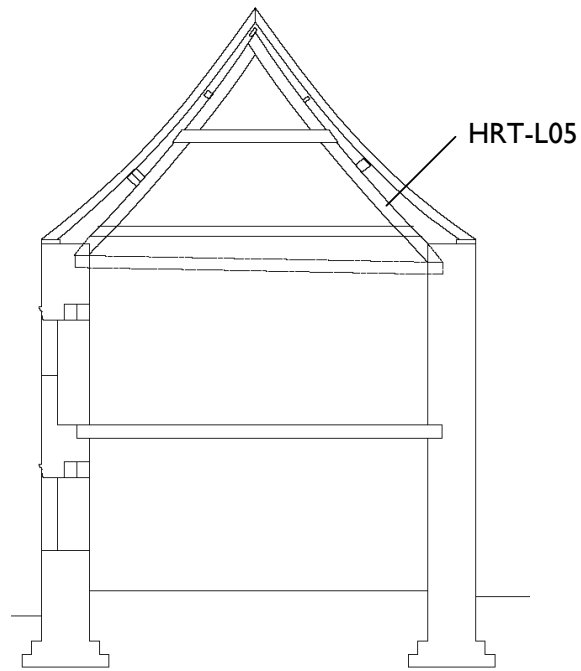
Figure 13: Truss 3 (west face), showing the location of sample HRT-L05 (Morton & Hall Consulting Ltd)

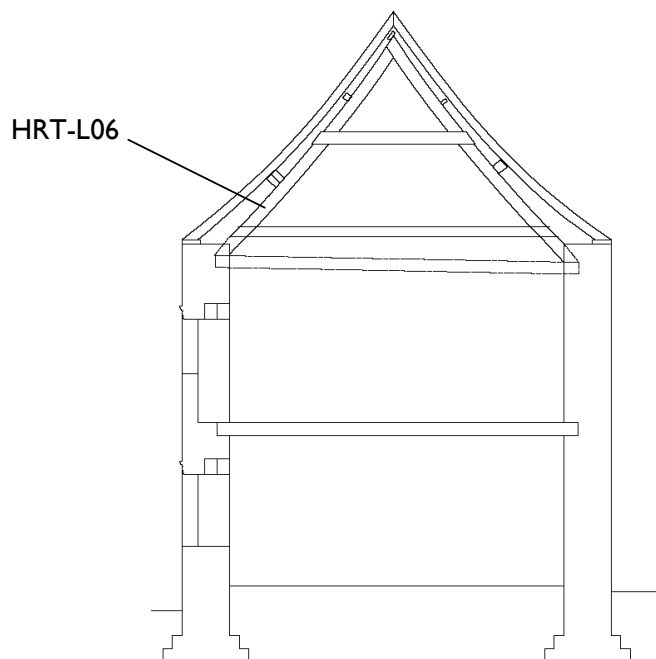
Figure 14: Truss 4 (west face), showing the location of sample HRT-L06 (Morton & Hall Consulting Ltd)

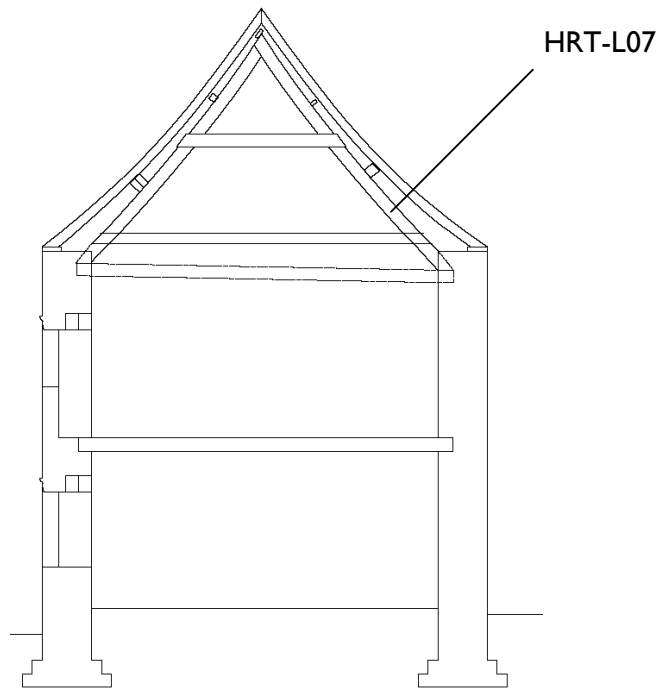
Figure 15: Truss 5 (west face), showing the location of sample HRT-L07 (Morton & Hall Consulting Ltd)

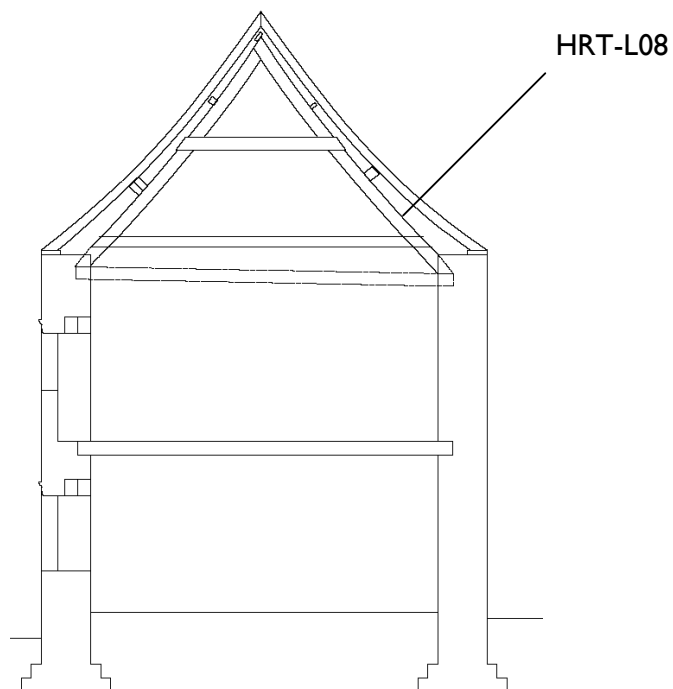
Figure 16: Truss 6 (west face), showing the location of sample HRT-L08 (Morton & Hall Consulting Ltd)

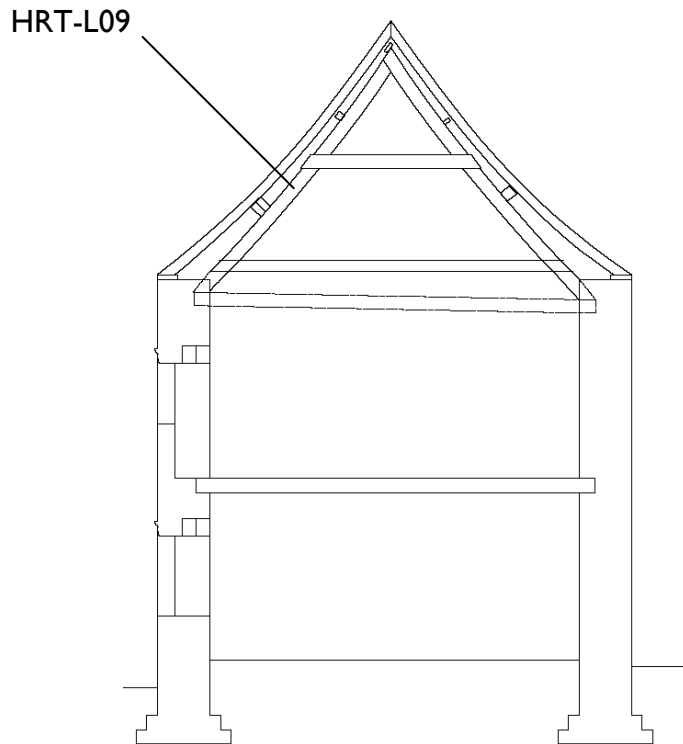
Figure 17: Truss 7 (west face), showing the location of sample HRT-L09 (Morton & Hall Consulting Ltd)

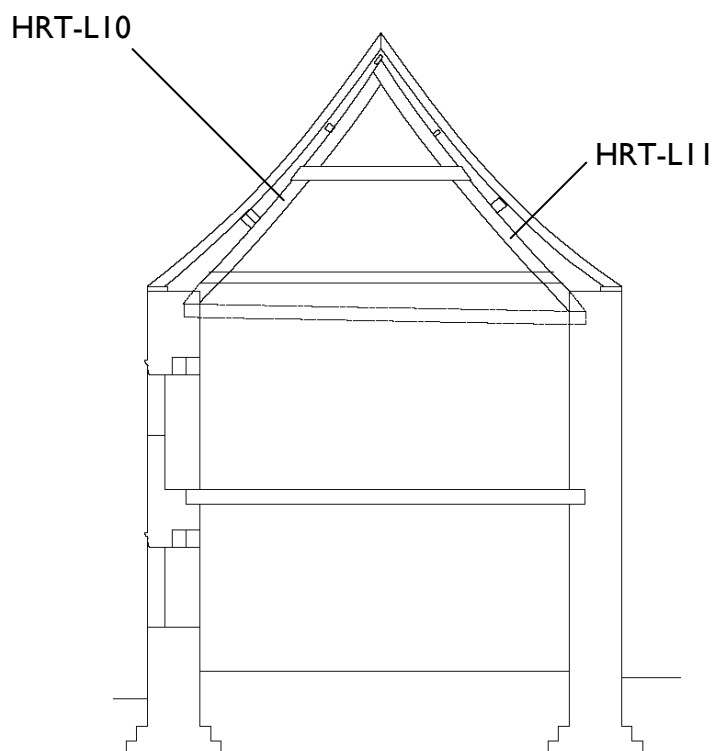
Figure 18: Truss 9 (west face), showing the location of samples HRT-L10 and HRT-L11 (Morton & Hall Consulting Ltd)

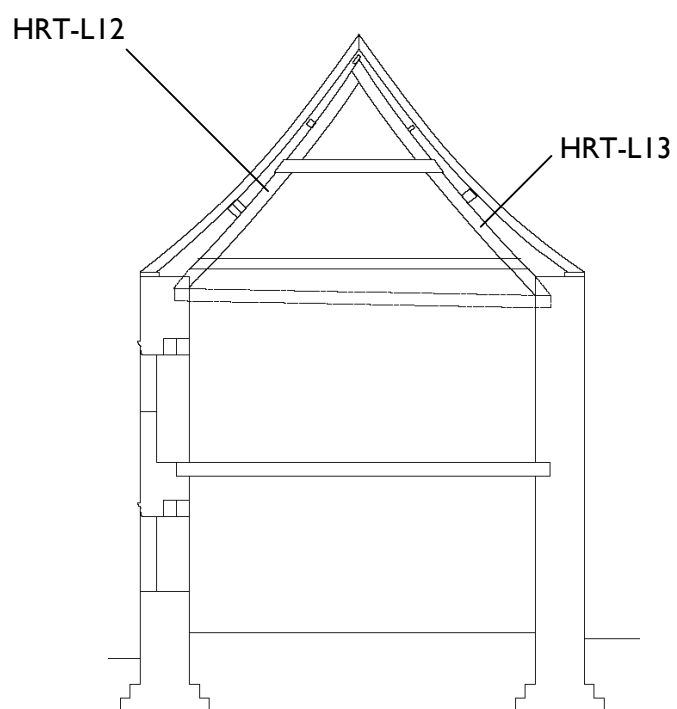
Figure 19: Truss 10 (west face), showing the location of samples HRT-L12 and HRT-L13 (Morton & Hall Consulting Ltd)

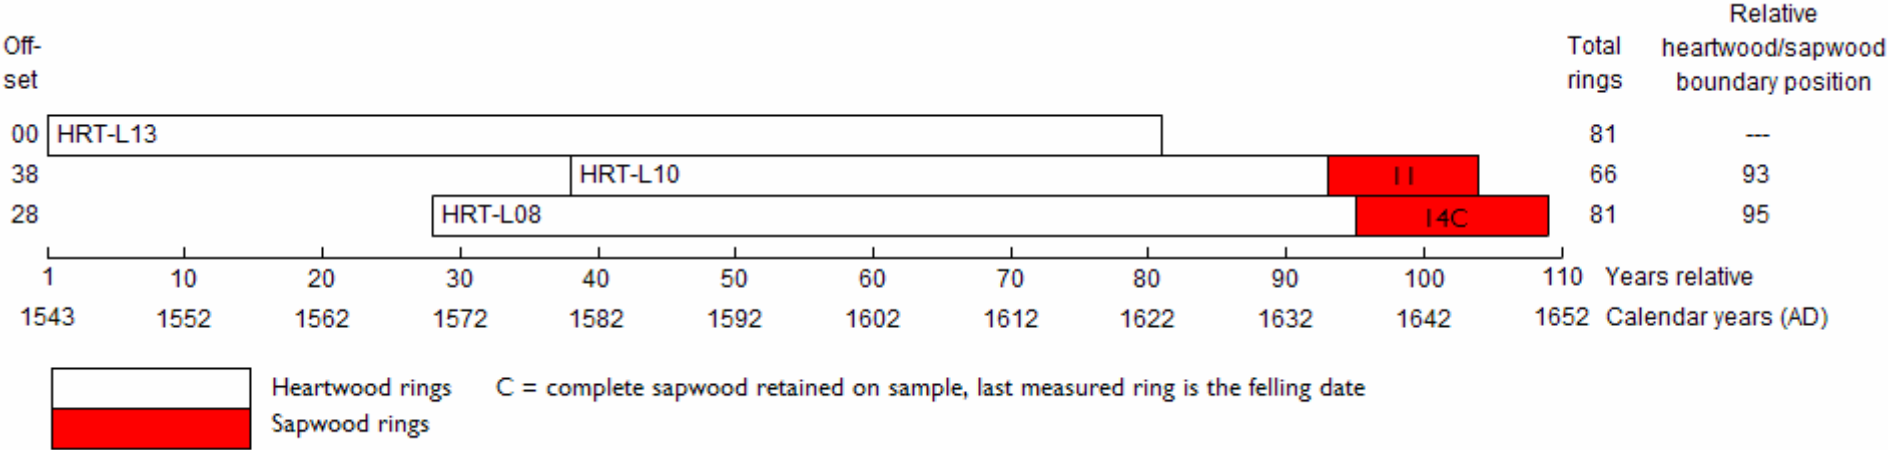
Figure 20: Bar diagram of samples in site sequence HRTLSQ01

Three samples, all from the principal rafters, matched each other and were combined at the relevant offset position to form HRTLSQ01, a site sequence of 109 rings (Fig 20). This site sequence was compared against a series of relevant reference chronologies for oak, where it was found to match consistently and securely at a first-ring date of AD 1543 and a last-measured ring date of AD 1651. The evidence for this dating is given by the *t*-values in Table 2. One of these samples (HRT-L08) has complete sapwood and the last-measured ring date of AD 1651, the felling date of the timber represented. A second sample (HRT-L10) has the heartwood/sapwood boundary ring date of AD 1635, which allows an estimated felling date to be calculated for the timber represented to within the range AD 1650–75. The third sample (HRT-L23) does not have the heartwood/sapwood boundary ring and so an estimated felling date cannot be calculated, except to say that it would be AD 1639 at the earliest.

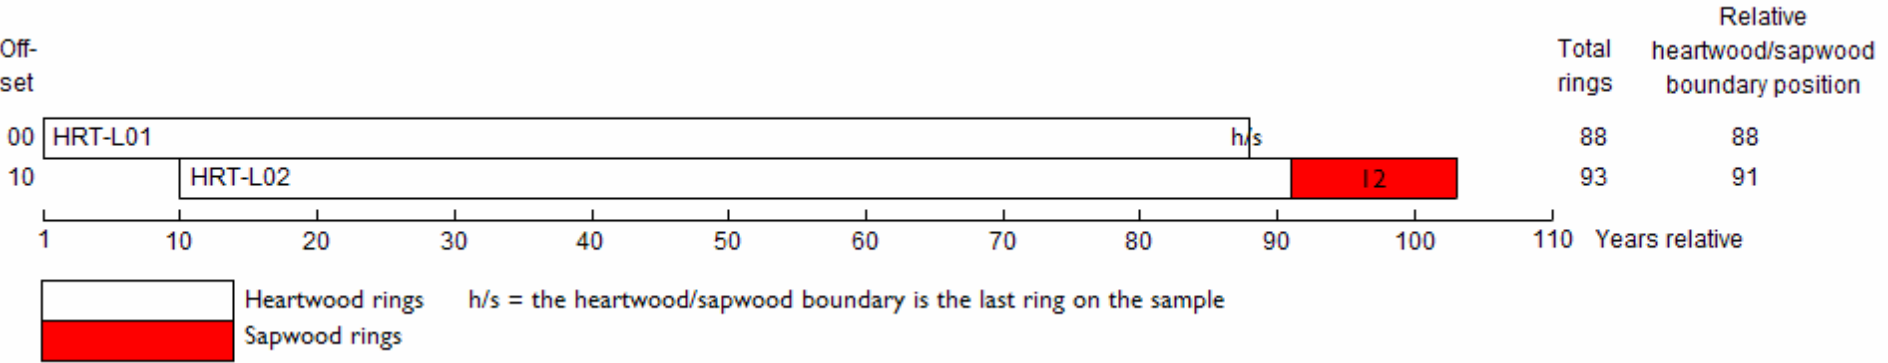
Figure 21: Bar diagram of samples in undated site sequence HRTLSQ02

Attempts were then made to date the other three site sequences (Figs 21–3) and the five ungrouped samples by comparing them against the reference chronologies. Although some tentative matching was noted for one of the individual samples, this was not considered of a satisfactory level for reliable and secure dating. None of the other site sequences or single samples could be matched and these are also undated.

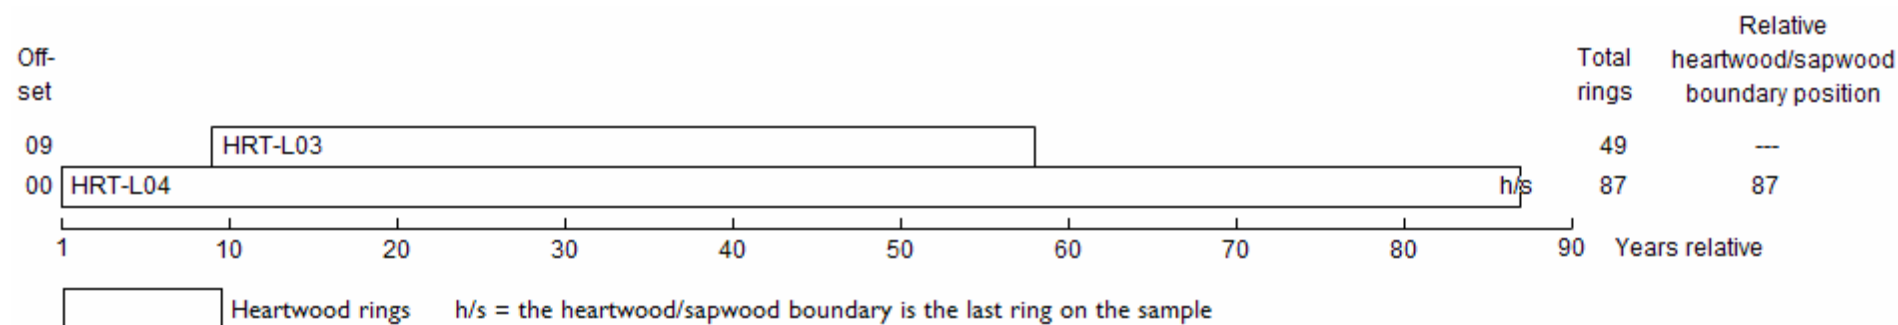
Figure 22: Bar diagram of samples in undated site sequence HRTLSQ03

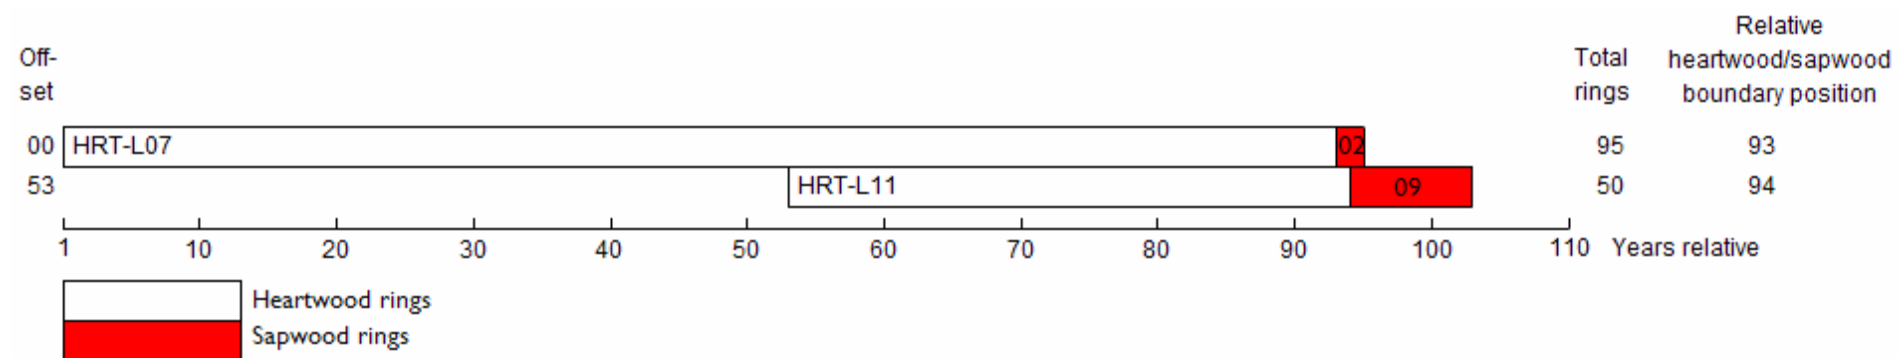
Figure 23: Bar diagram of samples in undated site sequence HRTLSQ04

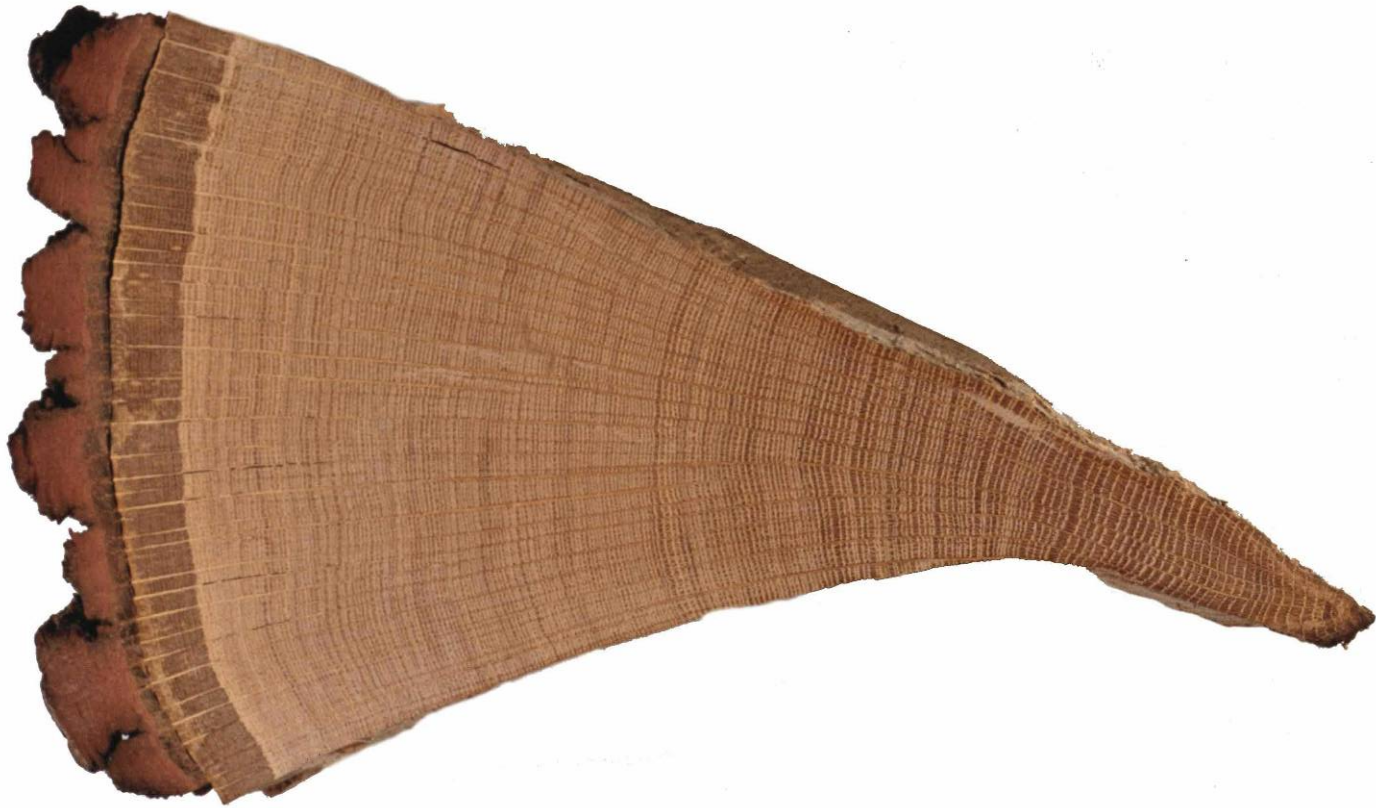
Figure A1: A wedge of oak from a tree felled in 1976. It shows the annual growth rings, one for each year from the innermost ring to the last ring on the outside just inside the bark. The year of each ring can be determined by counting back from the outside ring, which grew in 1976

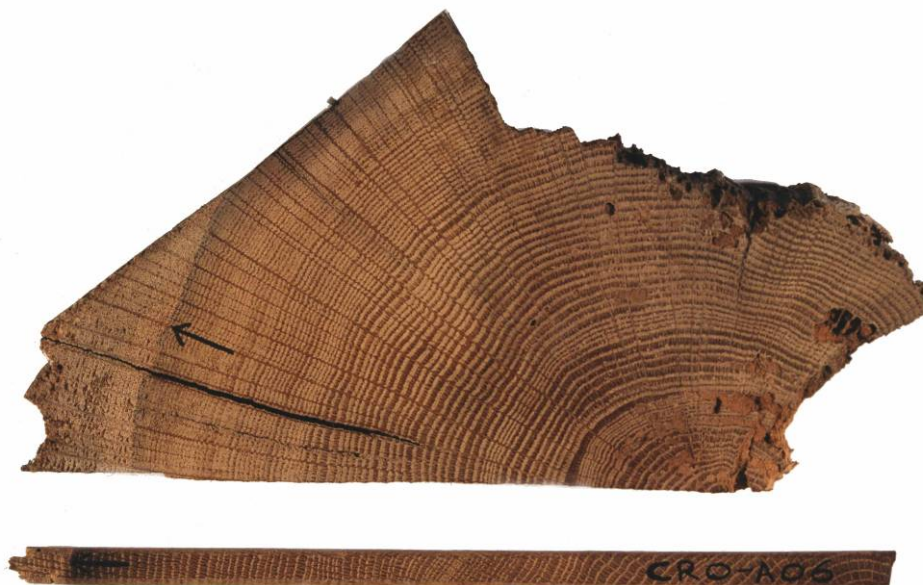
Figure A2: Cross-section of a rafter, showing sapwood rings in the left-hand corner, the arrow points to the heartwood/sapwood boundary (H/S); and a core with sapwood; again the arrow is pointing to the H/S. The core is about the size of a pencil

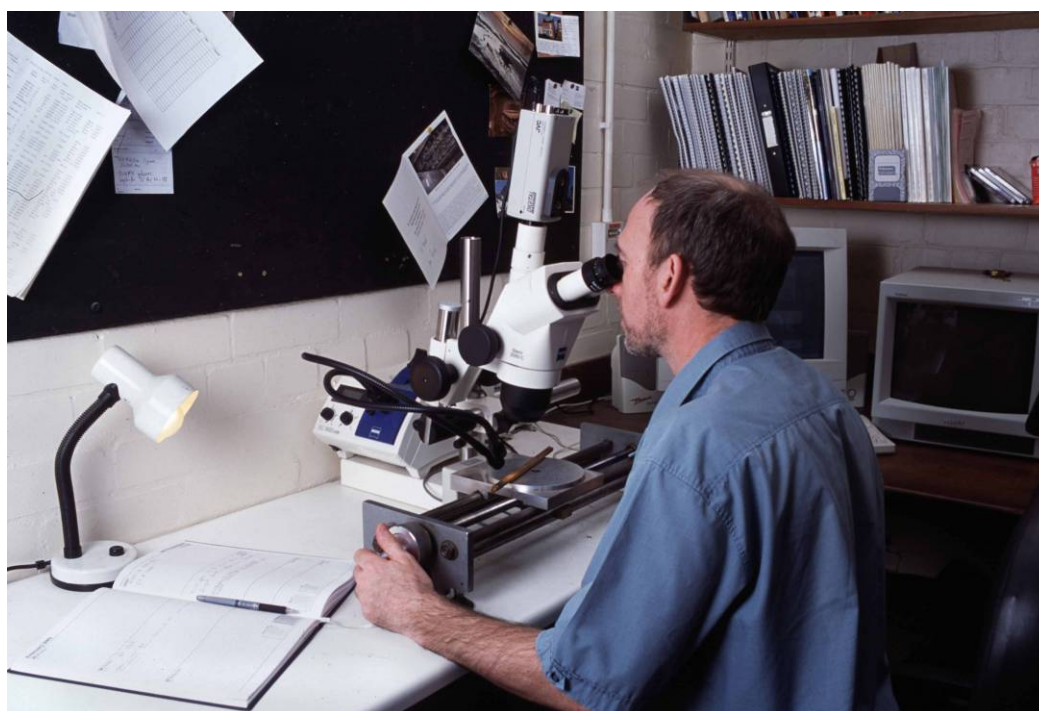
Figure A3: Measuring ring widths under a microscope. The microscope is fixed while the sample is on a moving platform. The total sequence of widths is measured twice to ensure that an error has not been made. This type of apparatus is needed to process a large number of samples on a regular basis

2. Measuring Ring Widths. Each core is sanded down with a belt sander using medium-grit paper and then finished by hand with flourgrade-grit paper. The rings are then clearly visible and differentiated from each other with a result very much like that shown in Figure A2. The core is then mounted on a movable table below a microscope and the ring-widths measured individually from the innermost ring to the outermost. The widths are automatically recorded in a computer file as they are measured (see Fig A3).

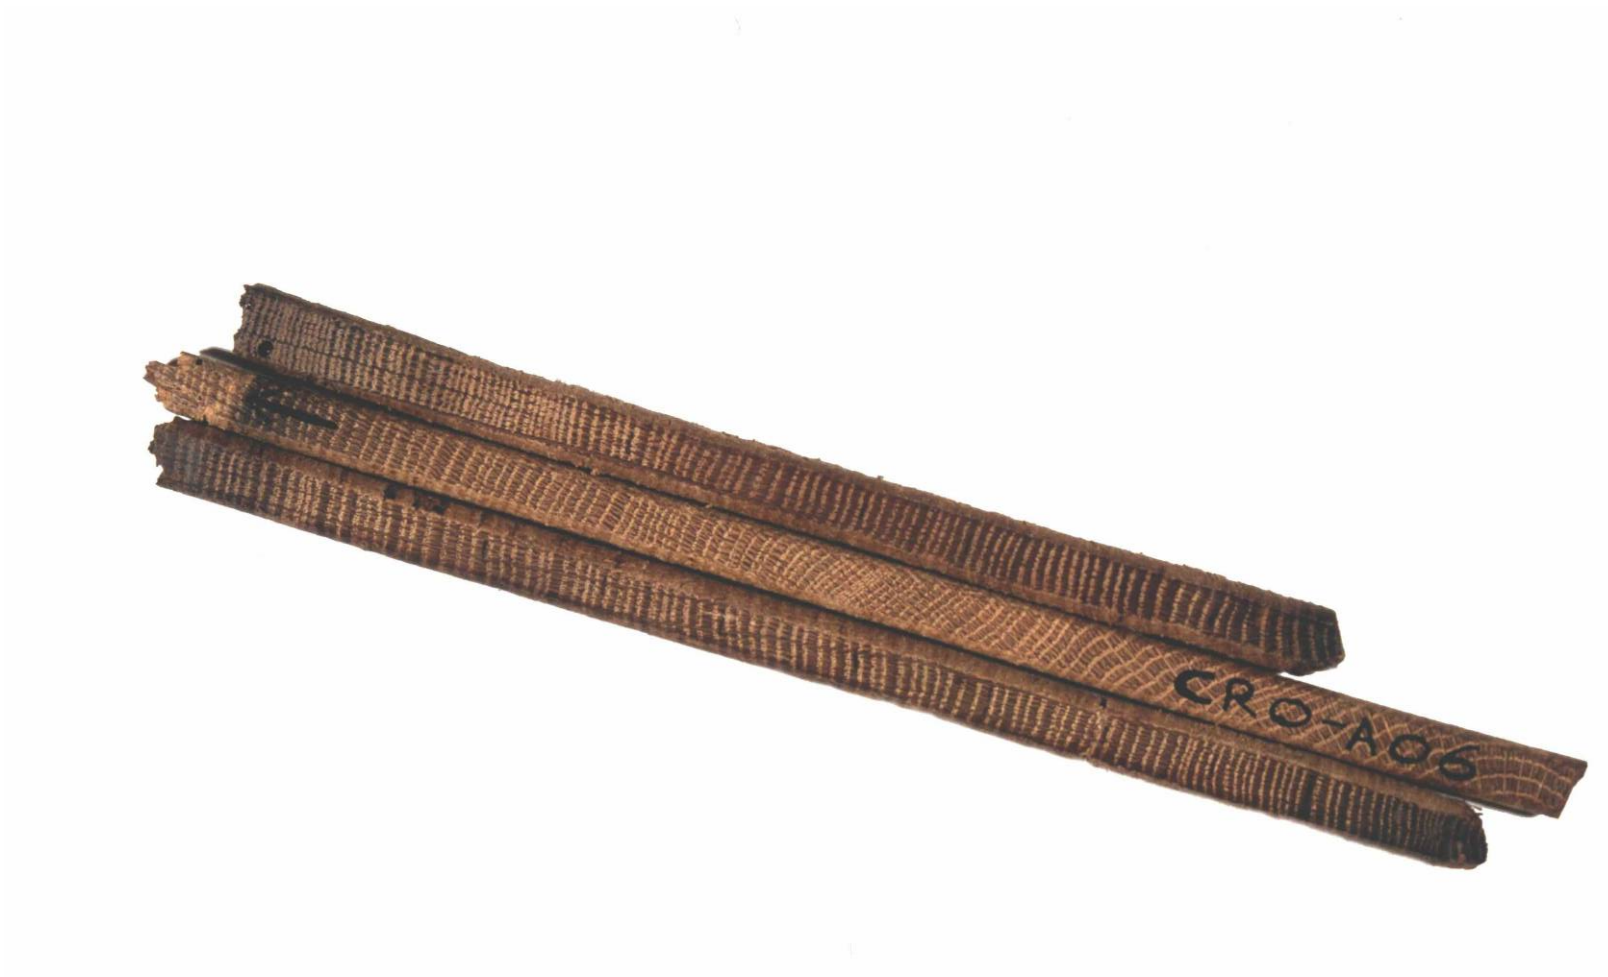
Figure A4: Three cores from timbers in a building. They come from trees growing at the same time. Notice that, although the sequences of widths look similar, they are not identical. This is typical

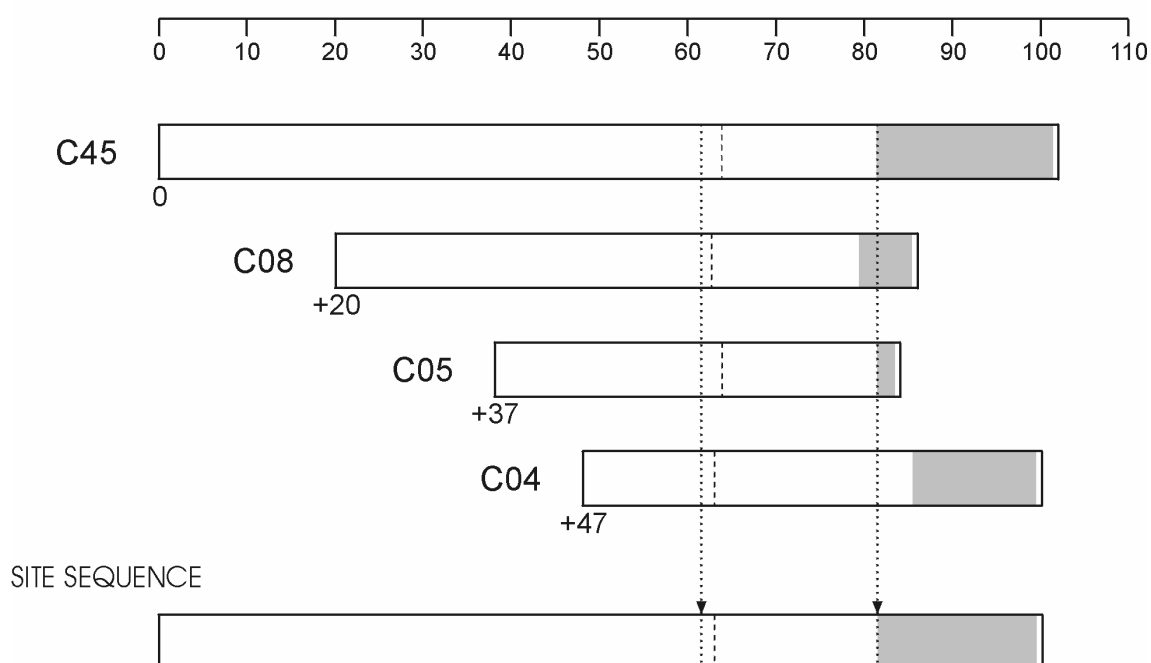
Figure A5: Cross-matching of four sequences from a Lincoln Cathedral roof and the formation of a site sequence from them

The bar diagram represents these sequences without the rings themselves. The length of the bar is proportional to the number of rings in the sequence. Here the four sequences are set at relative positions (offsets) to each other at which they have maximum correlation as measured by the *t*-values. The *t*-value/offset matrix contains the maximum *t*-values below the diagonal and the offsets above it. Thus, the maximum *t*-value between C08 and C45 occurs at the offset of +20 rings and the *t*-value is then 5.6. The site sequence is composed of the average of the corresponding widths, as illustrated with one width
