HARTLAW COTTAGES, NEWTON-ON-THE-MOOR, HARTLAW, SHILBOTTLE, NORTHUMBERLAND TREE-RING ANALYSIS OF TIMBERS

SCIENTIFIC DATING REPORT

Alison Arnold and Robert Howard

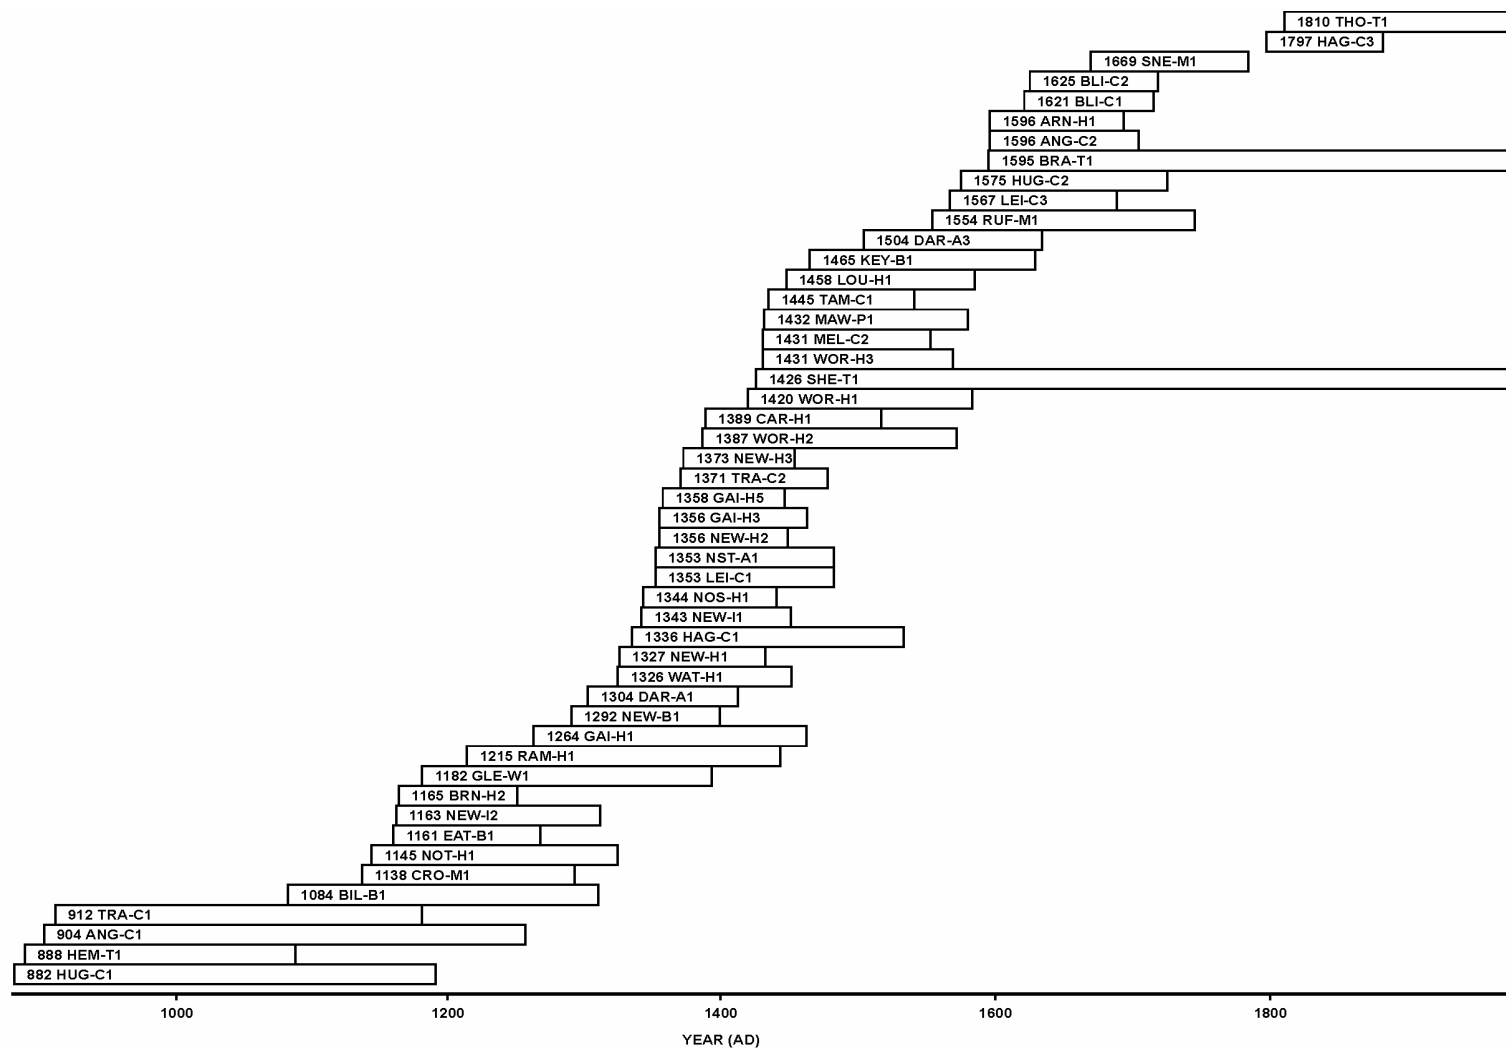
Figure A6: Bar diagram showing the relative positions and dates of the first rings of the component site sequences in the East Midlands Master Dendrochronological Sequence, EM08/87

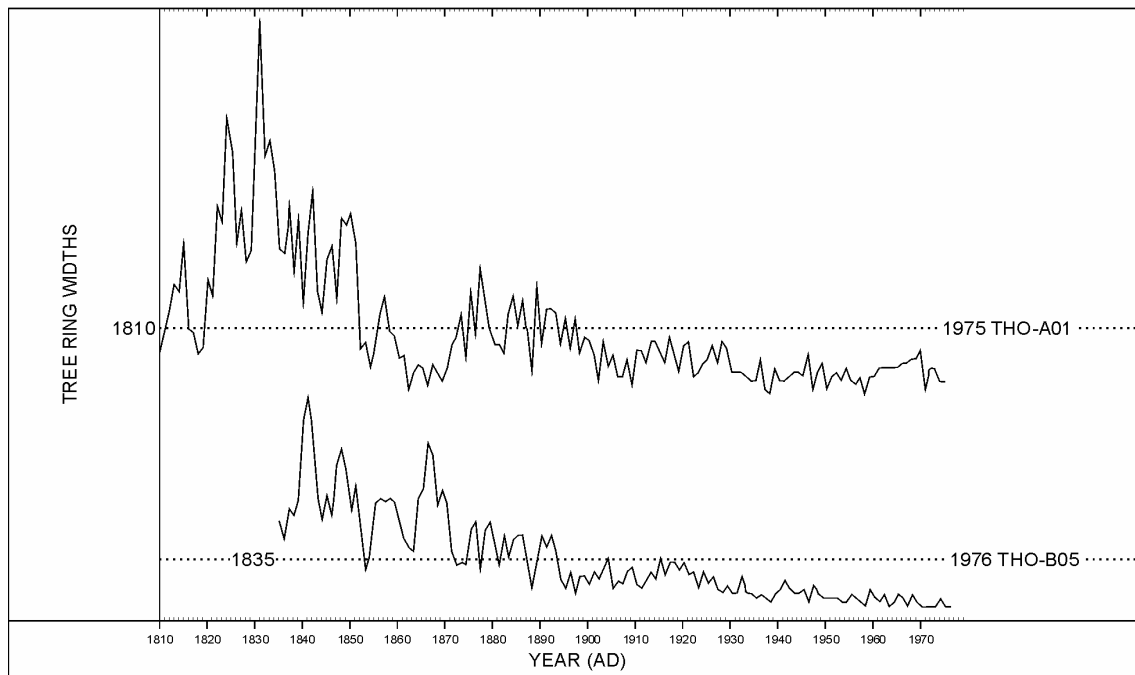
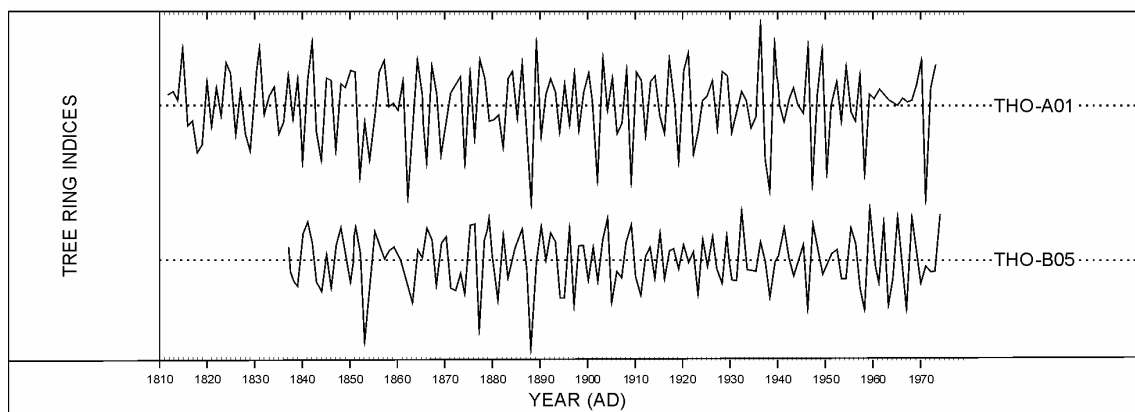
Figure A7 (a): The raw ring-widths of two samples, THO-A01 and THO-B05, whose felling dates are known

Here the ring widths are plotted vertically, one for each year, so that peaks represent wide rings and troughs narrow ones. Notice the growth-trends in each; on average the earlier rings of the young tree are wider than the later ones of the older tree in both sequences
