HOLY TRINITY CHURCH, NORTH TIDWORTH, WILTSHIRE TREE-RING ANALYSIS OF TIMBERS FROM THE BELFRY FLOOR AND BELLFRAME

SCIENTIFIC DATING REPORT

Research Department Report Series 83-2009

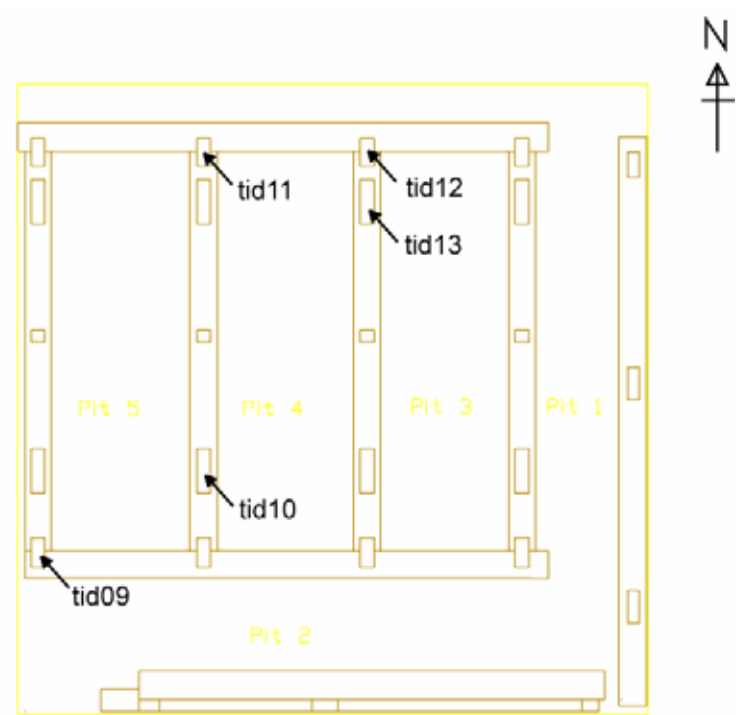
Figure 3: Drawings of the belfry floor and bellframe, North Tidworth, showing the timbers sampled

Belfry floor beams

Bellframe at sill level.

Table 1. Details of oak (*Quercus spp.*) timbers sampled from the belfry floor and bellframe, Holy Trinity Church, North Tidworth. Joists are numbered from east to west
