THE WEST WINDOW, BEVERLEY MINSTER, BEVERLEY, EAST YORKSHIRE CHEMICAL ANALYSIS OF THE WINDOW GLASS AND PAINT

TECHNOLOGY REPORT

David Dungworth, Helen Bower, Alison Gilchrist and Roger Wilkes

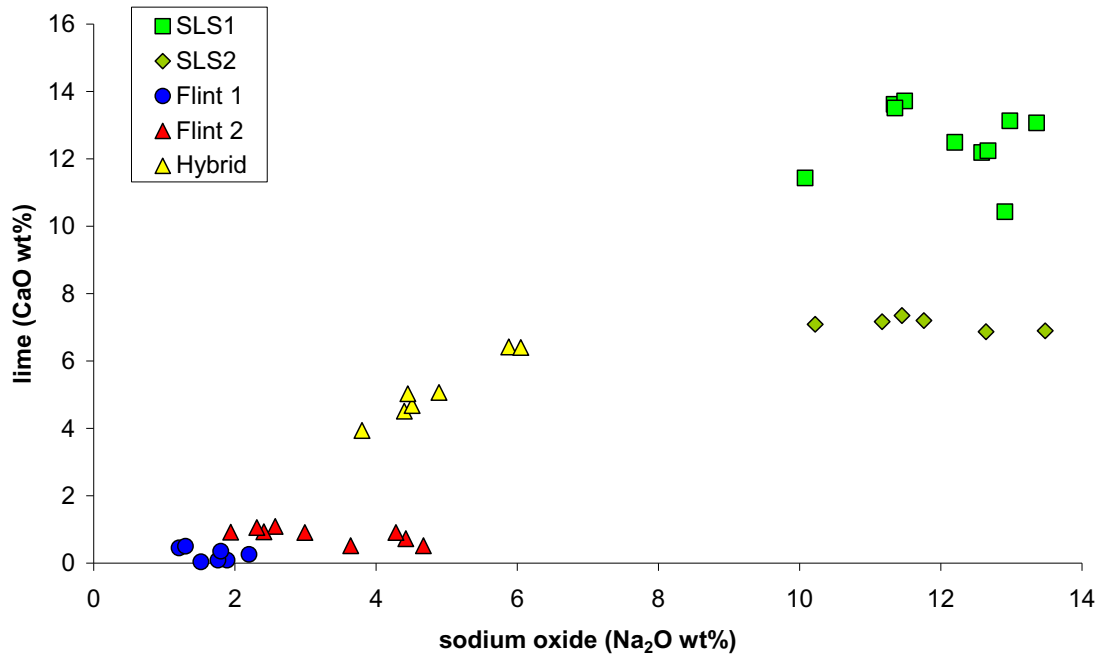
Figure 3. Sodium oxide and lime content of the Beverley Minster window glass (omitting 6d1)

The analysed samples from the west window of Beverley Minster can be grouped into a number of different glass types depending on the proportion of major elements (Figures 3 and 4). There are two major categories of glass present: soda-lime-silica, and flint glass. In addition there is a hybrid group with a composition which lies between flint glass and soda-lime-silica glass. One sample (6d1) has a composition which does not match any of the other glass and it is considered below.

The soda-lime-silica glasses were clearly made using pure materials (including a synthetic soda such as that made using the Leblanc process) and can be further divided into two groups: SLS1 with high calcium and SLS2 with low calcium. The flint glasses, besides silica, contain mainly potassium oxide and lead oxide and belong to the same broad type of glass used for the manufacture of some tablewares (Dungworth and Brain 2005; forthcoming). The flint glasses have been divided into Flint1 and Flint2 on the basis of their lead content as well as the concentrations of a range of other oxides. The flint glasses often contain small amounts of phosphorus and this generally correlates with the calcium content of these samples (Figure 5). It is possible that the calcium and phosphorus content of the flint glass is due to use of a small proportion of bone ash in the glass batch.

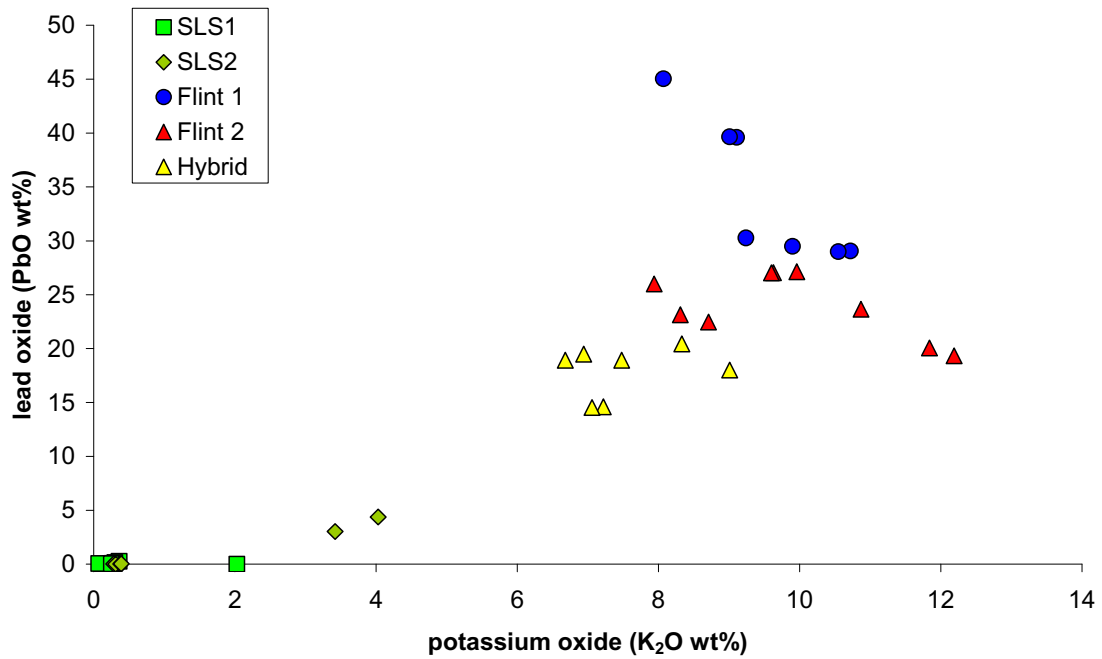
Figure 4. Potassium oxide and lead oxide contents of the Beverley Minster window glass (omitting 6d1)

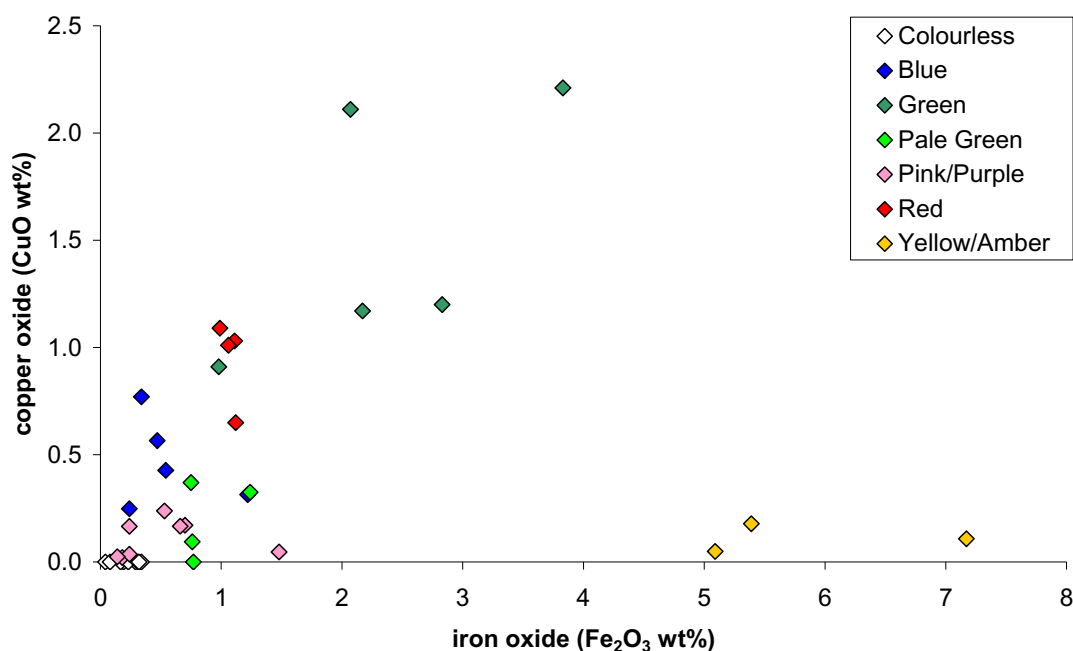
Figure 7. Iron oxide and copper oxide contents of the Beverley Minster window glass

The Beverley Minster window glass samples include a wide range of colours which were achieved through the deliberate addition of varying amounts of metal oxides (Figure 7). The colourless glasses are generally characterised by low levels of any metal oxides that could give colour. On average the iron oxide content of the colourless glass is 0.22wt% Fe_2O_3 , which is consistent with ordinary window glass of the 19th century (Dungworth 2009; Dungworth and Wilkes 2010). Almost all of the coloured glass contains elevated levels of iron oxide and it is likely that this was deliberately added. Iron can give blue, green or even yellow colour to a glass depending on its concentration and oxidation state, and the presence of other metal oxides. The blue glass was usually coloured using small amounts of cobalt, although this was often accompanied by a range of other metals (manganese, iron, copper and nickel). Copper was used to produce blue-green colours in pot metals and was also used to make the thin layers of flashed red glass. In the former case the colour was present as oxides throughout the glass while in the latter case the copper was present as metallic nano-particles in the thin flashed layer. The darker green

glass contained higher concentrations of copper than the pale green. In addition, the darker green glass was usually a flint glass while the pale green was usually a soda-lime-silica glass.

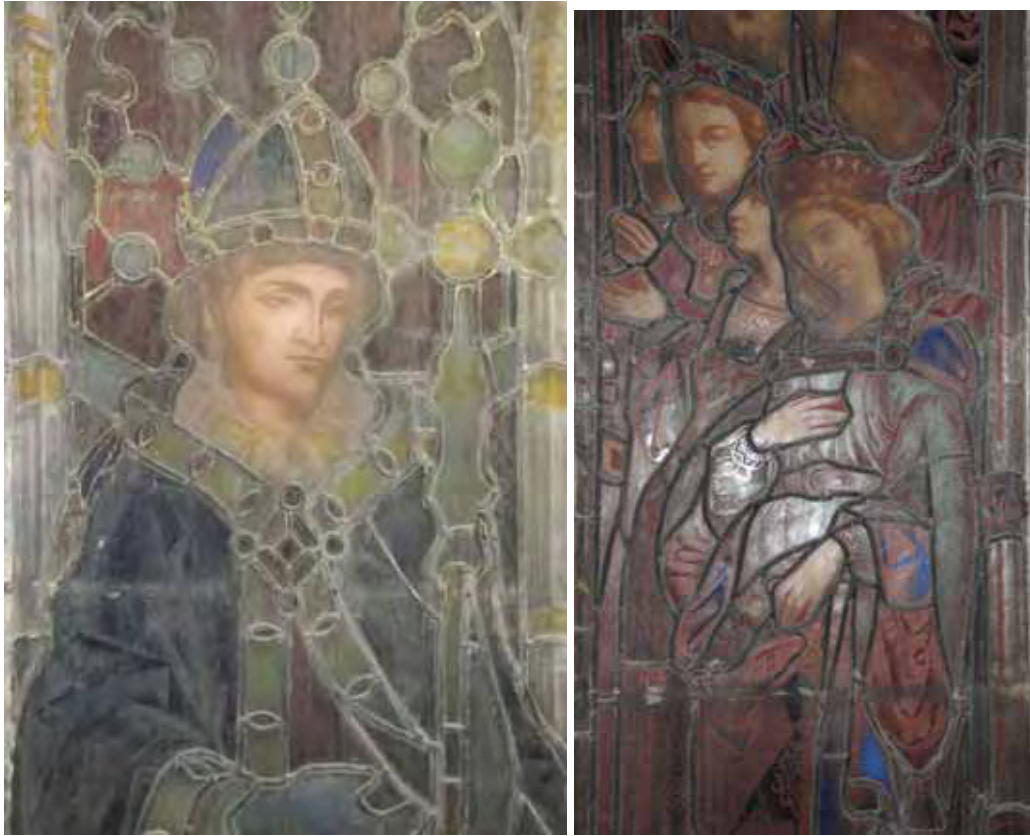
Figure 13. Panels 2a and 6d seen in reflected light

The Beverley Minster paint samples from panel 2a contain a very wide variety of metal oxides which at high concentrations would render it black. Contemporary recipes suggest the use of several different metal oxides in varying proportions to achieve grey, black or other colours (Cable 2008, 540–541). For grey, Bontemps recommends burnt umber which would contain manganese and iron (as well as clay minerals). The elevated levels of aluminium in the paint compared to the underlying glass, could derive from clay minerals in a burnt umber, however, the manganese concentrations in the paint samples are somewhat lower than might be expected. For black, Bontemps recommends burnt umber and azure (a hydrated copper carbonate), but none of the paint samples contains copper concentrations as high as those predicted by his recipe. Perhaps the most striking aspect of the paint is the inclusion of such a wide variety of metal oxides: chromium, manganese, iron, cobalt, nickel, copper, zinc and antimony. This suggests that on occasion the glass painters (or their suppliers) added every metal oxide available to them to achieve a desired shade of grey or black. In contrast, the samples from panel 6d show only iron oxide at a much higher level, giving a black appearance in transmitted light but a reddish-brown in reflected light.

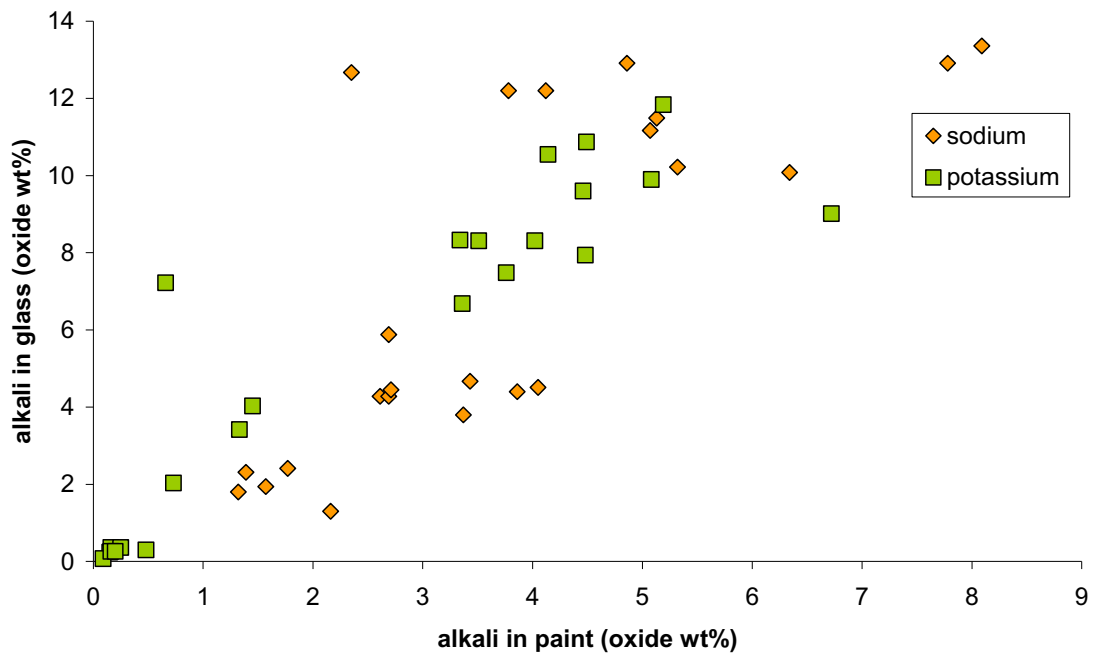
Figure 13. Alkali contents of the painted surfaces compared with the alkali contents of the associated glass

The painted surfaces all contain appreciable concentrations of sodium and potassium but it is far from certain whether either of these two oxides was deliberately added to the raw materials used to make the paint. The concentrations of the two alkalis in the painted surfaces generally correlate with the concentrations of the alkalis in the underlying glass (Figure 13). The detailed study of the painted surfaces on the Margam Castle glass showed that (presumably during the firing process) alkalis diffused from the glass into the paint (and vice versa). The strong correlation between the alkalis in the Beverley Minster glass and associated paint suggests that alkalis were not part of the paint batch.
