THE CHURCH OF ALL SAINTS, RAVENSTONE, NEAR OLNEY, BUCKINGHAMSHIRE TREE-RING ANALYSIS OF TIMBERS

SCIENTIFIC DATING REPORT

Research Department Report Series 56-2010

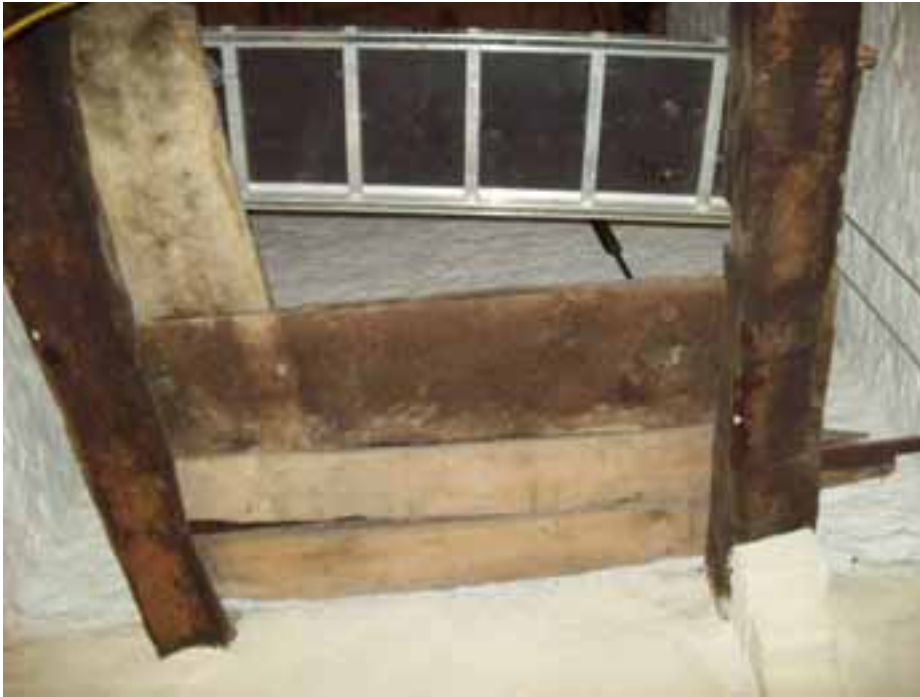
Figure 4 (top): View, looking up, of the partial lower floor

Within, to its lower levels, the tower contains a first-floor frame comprising two substantial, parallel, north–south beams, upon which are laid a few broad but thin, and otherwise unsupported, planks to form a partial floor (Fig 4). The western of these two north–south beams is supported at either end by a stone corbel projecting from the wall, but both ends of the eastern beam are set fully within the tower walls. These timbers are believed to be potentially of some antiquity but possibly not original, as they cut across the middle of the single-lancet west window of the tower. This partial floor is reached by a dog-leg staircase.

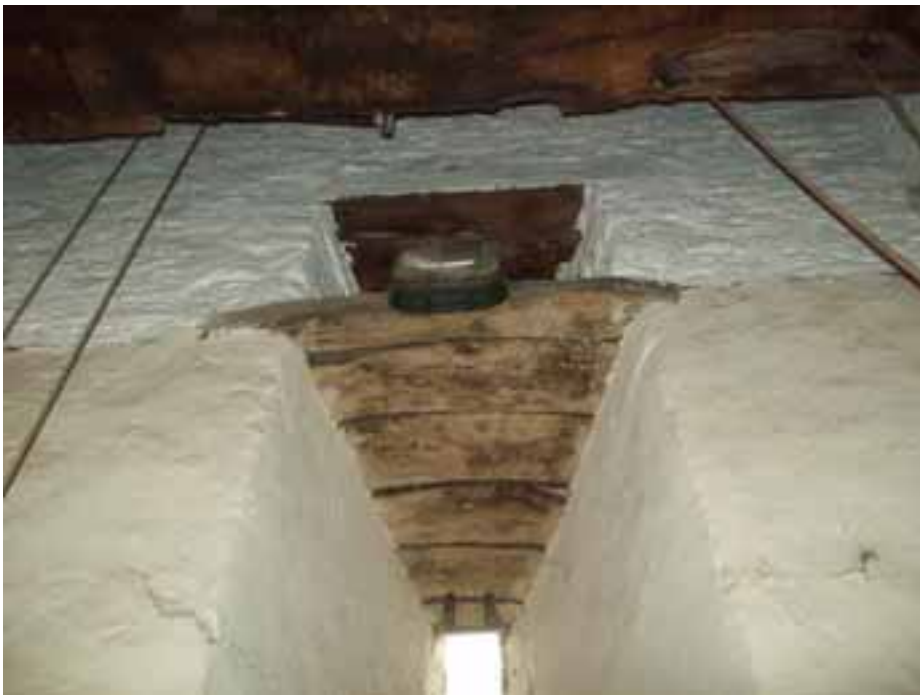
Figure 5 (bottom): View of the double set of beams to the tower's west window

The internal opening of the window to the west wall of the tower is splayed and retains two sets of timbers. Each set comprise six beams placed one behind the other in the thickness of the wall, the top set forming the lintels to the window opening, with a further six timbers set in a similar fashion, to the middle of the opening (Fig 5). Two of the upper lintels appear to have redundant mortices in them and the timbers may thus be reused in their present positions.

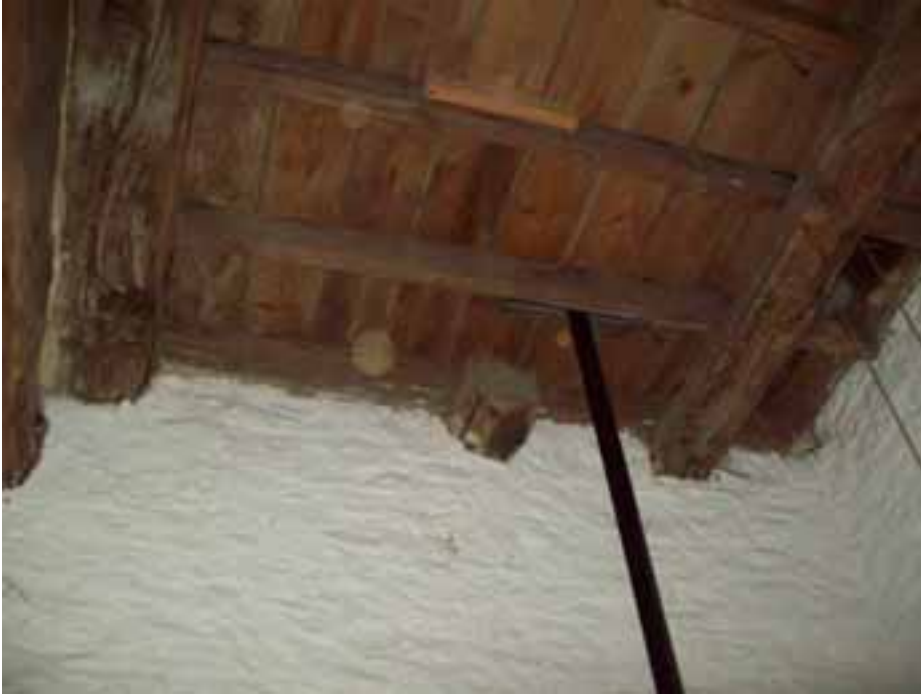
Figure 6 (top): View of the beams to the floor of the winding chamber

A wooden ladder rises steeply from the partial floor frame to the clock or winding chamber above. The floor of this chamber, formed of modern, probably late-twentieth century softwood joists and tongue-and-groove boards, is again supported by two full-length north–south beams (an east beam and a west beam), their ends set in the walls, and by the stub remains of a third, 'middle', beam, extant in the south wall only (Fig 6). A fourth, larger, north–south beam is also found here, set close to the east wall but at a slightly lower level. It appears to act in isolation and offers no support to the floor frame of the winding chamber.

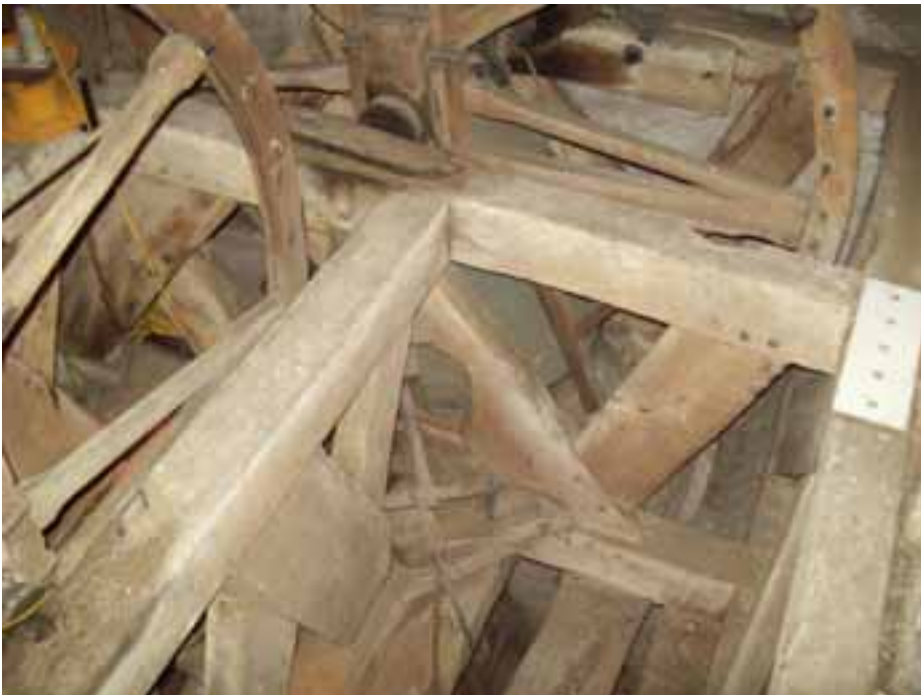
Figure 7 (bottom): The bellframe viewed from the south-east

The ceiling of the winding chamber comprises four north–south beams, the ends of which are set in the tower walls. These beams also form the sub-structure of the bellframe above. The bellframe (Fig 7) has three parallel pits, aligned north–south, with a fourth east–west pit at its north end (Fig 8). The trusses of the frame may be described as inverted double jack-braced type, having sills, long heads, outward braces from sill to head, and jack braces from sill to braces and from braces to head, a form categorised as type 6E (long-headed frames without centre posts) in Pickford’s classification (Pickford 1993). All the timbers of the bellframe appear integral to each other, being jointed and pegged, and show no evidence for the reuse of older timbers or the insertion of later repairs.

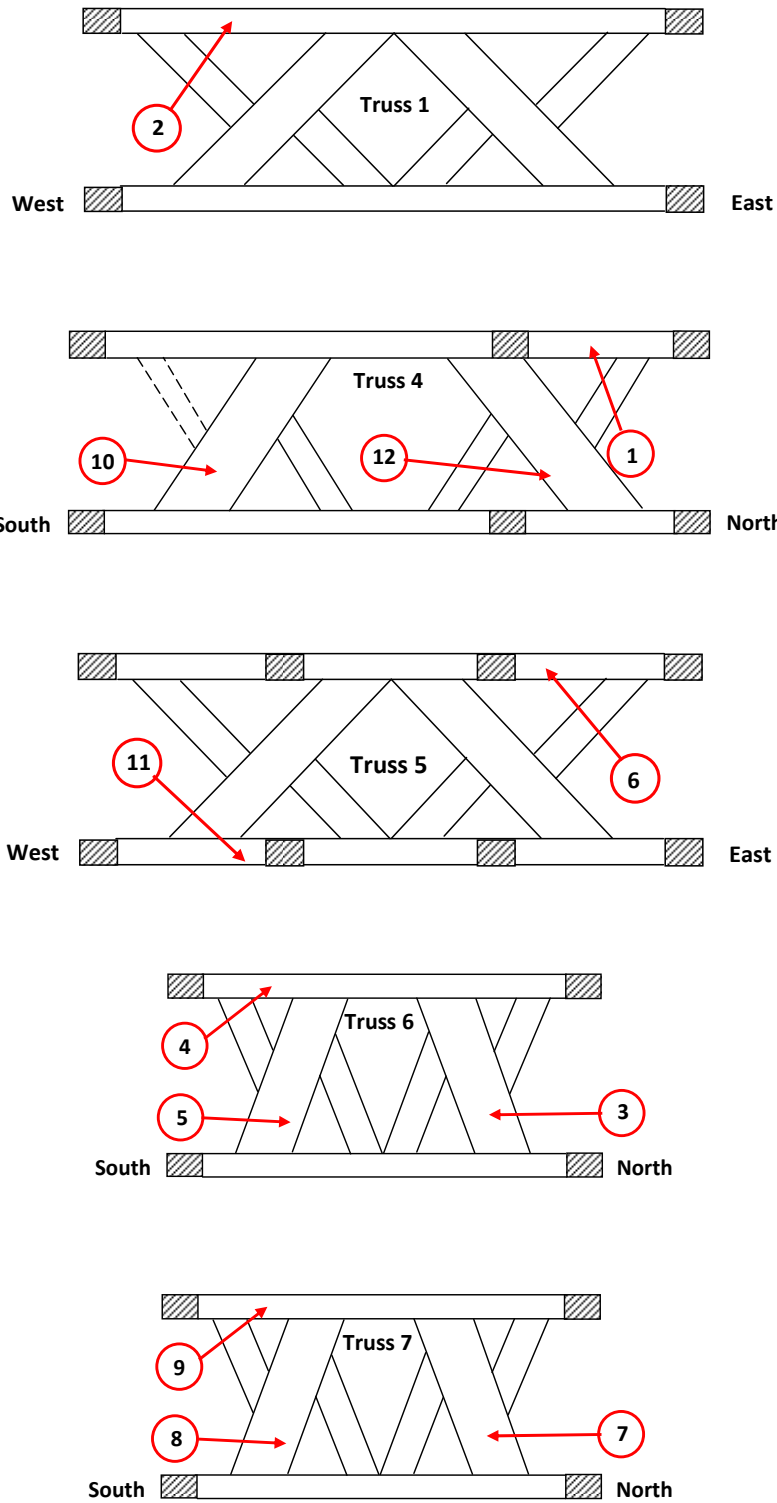
Figure 9: The bellframe trusses to show sampled timbers

Where possible, the positions of these samples are marked on drawings made or photographs taken at the time of sampling. These are reproduced here as Figure 3 and Figures 9 and 10. Details of the samples are given in Table 1. In this table all the trusses and the individual timbers have been identified and numbered from either north to south or east to west as appropriate (see Fig 8).

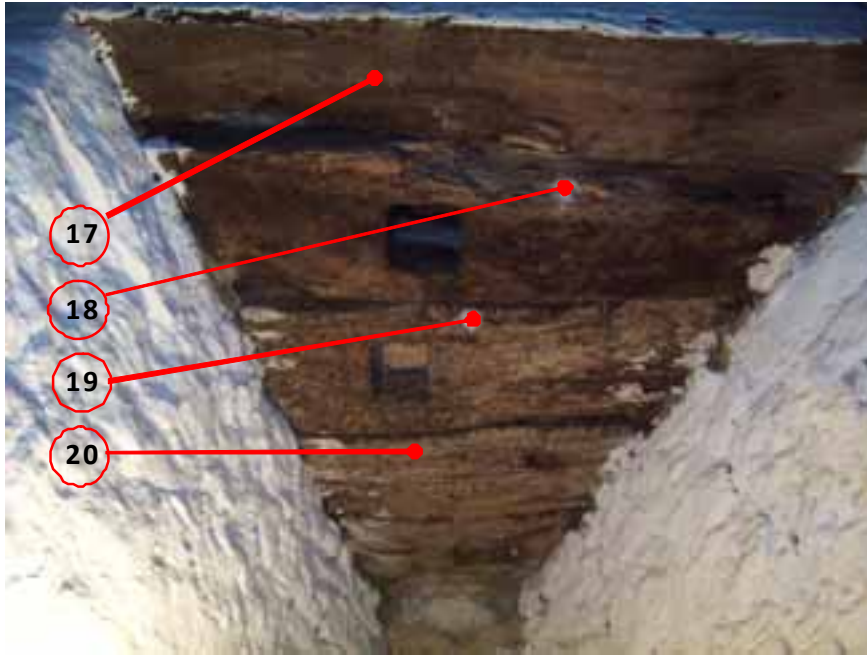
Figure 10: Photograph of the west window lintels to show sampled timbers

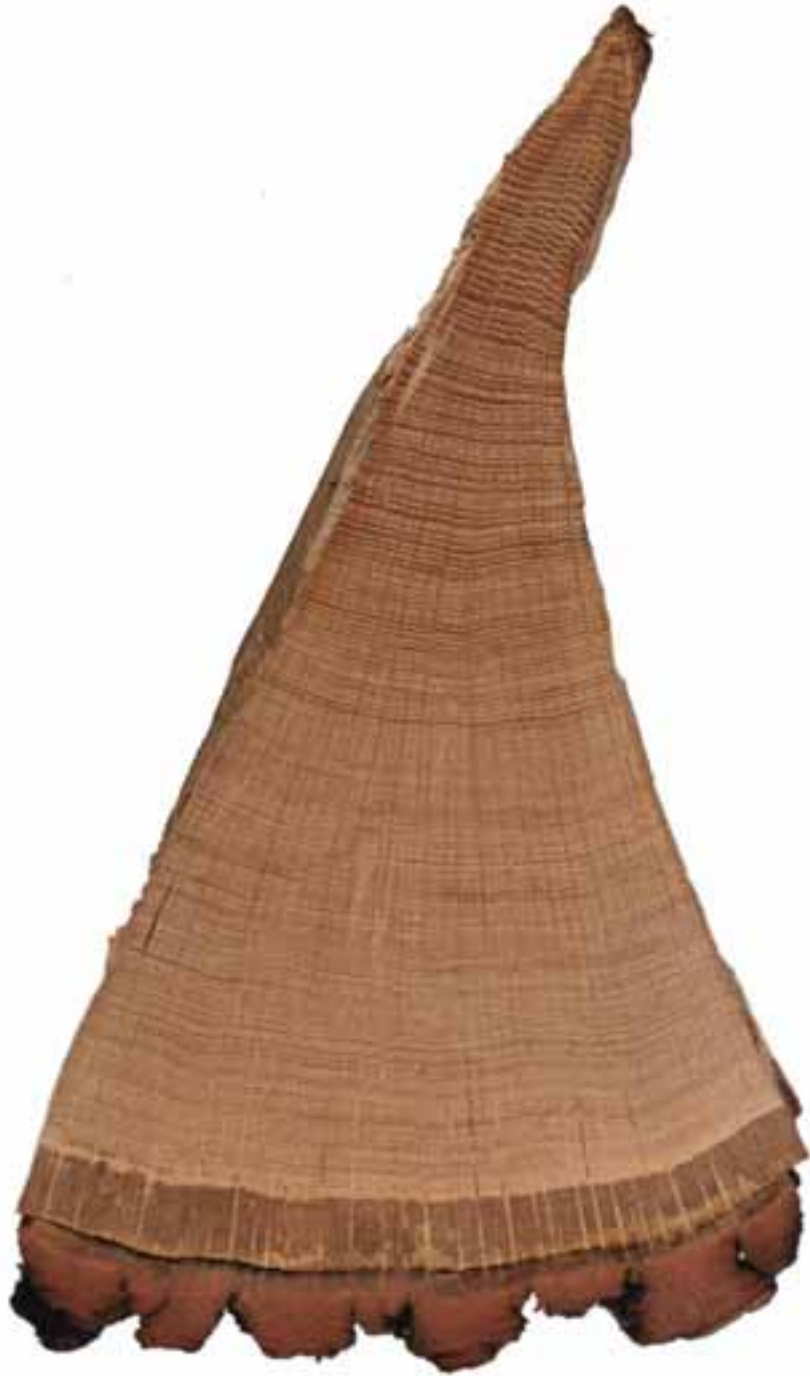
Figure A1: A wedge of oak from a tree felled in 1976. It shows the annual growth rings, one for each year from the innermost ring to the last ring on the outside just inside the bark. The year of each ring can be determined by counting back from the outside ring, which grew in 1976

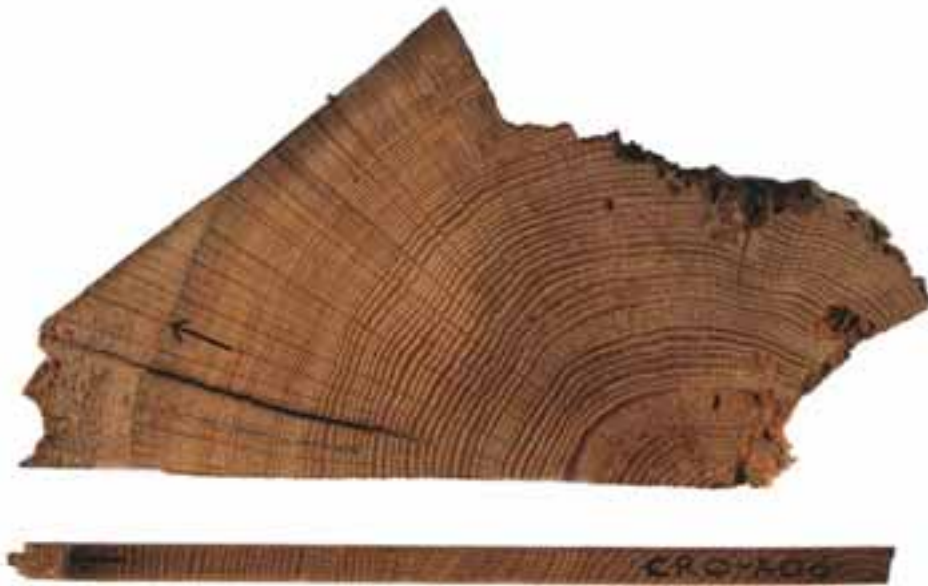
Figure A2: Cross-section of a rafter, showing sapwood rings in the left-hand corner, the arrow points to the heartwood/sapwood boundary (H/S); and a core with sapwood; again the arrow is pointing to the H/S. The core is about the size of a pencil

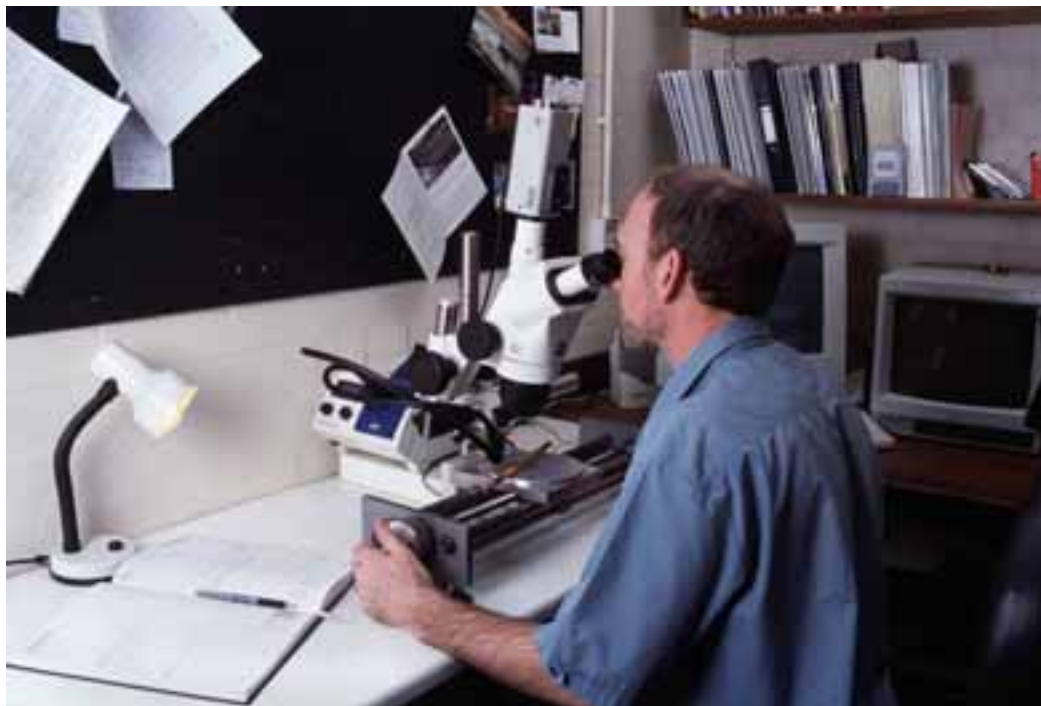
Figure A3: Measuring ring widths under a microscope. The microscope is fixed while the sample is on a moving platform. The total sequence of widths is measured twice to ensure that an error has not been made. This type of apparatus is needed to process a large number of samples on a regular basis

2. Measuring Ring Widths. Each core is sanded down with a belt sander using medium-grit paper and then finished by hand with flourgrade-grit paper. The rings are then clearly visible and differentiated from each other with a result very much like that shown in Figure A2. The core is then mounted on a movable table below a microscope and the ring-widths measured individually from the innermost ring to the outermost. The widths are automatically recorded in a computer file as they are measured (see Fig A3).

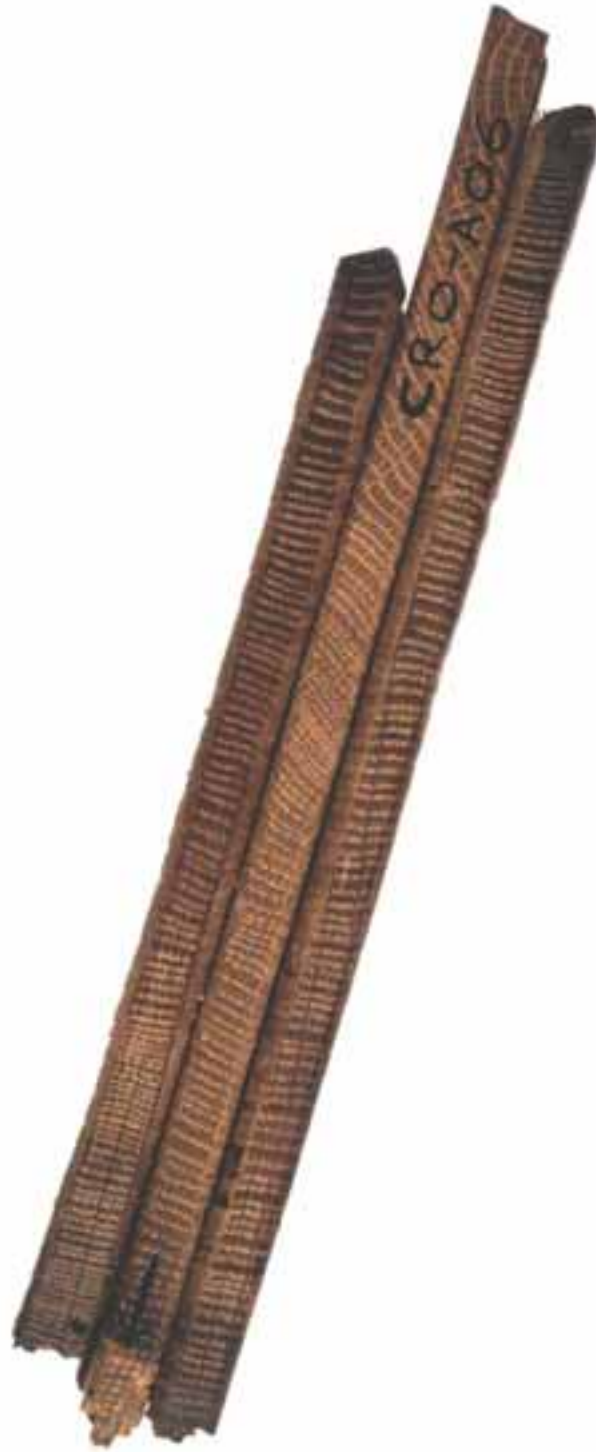
Figure A4: Three cores from timbers in a building. They come from trees growing at the same time. Notice that, although the sequences of widths look similar, they are not identical. This is typical
