# THE BARFORD BROTHERS' DYE AND BLEACH WORKS, NORTH STREET, LUTON

## HISTORIC BUILDING REPORT

Katie Graham

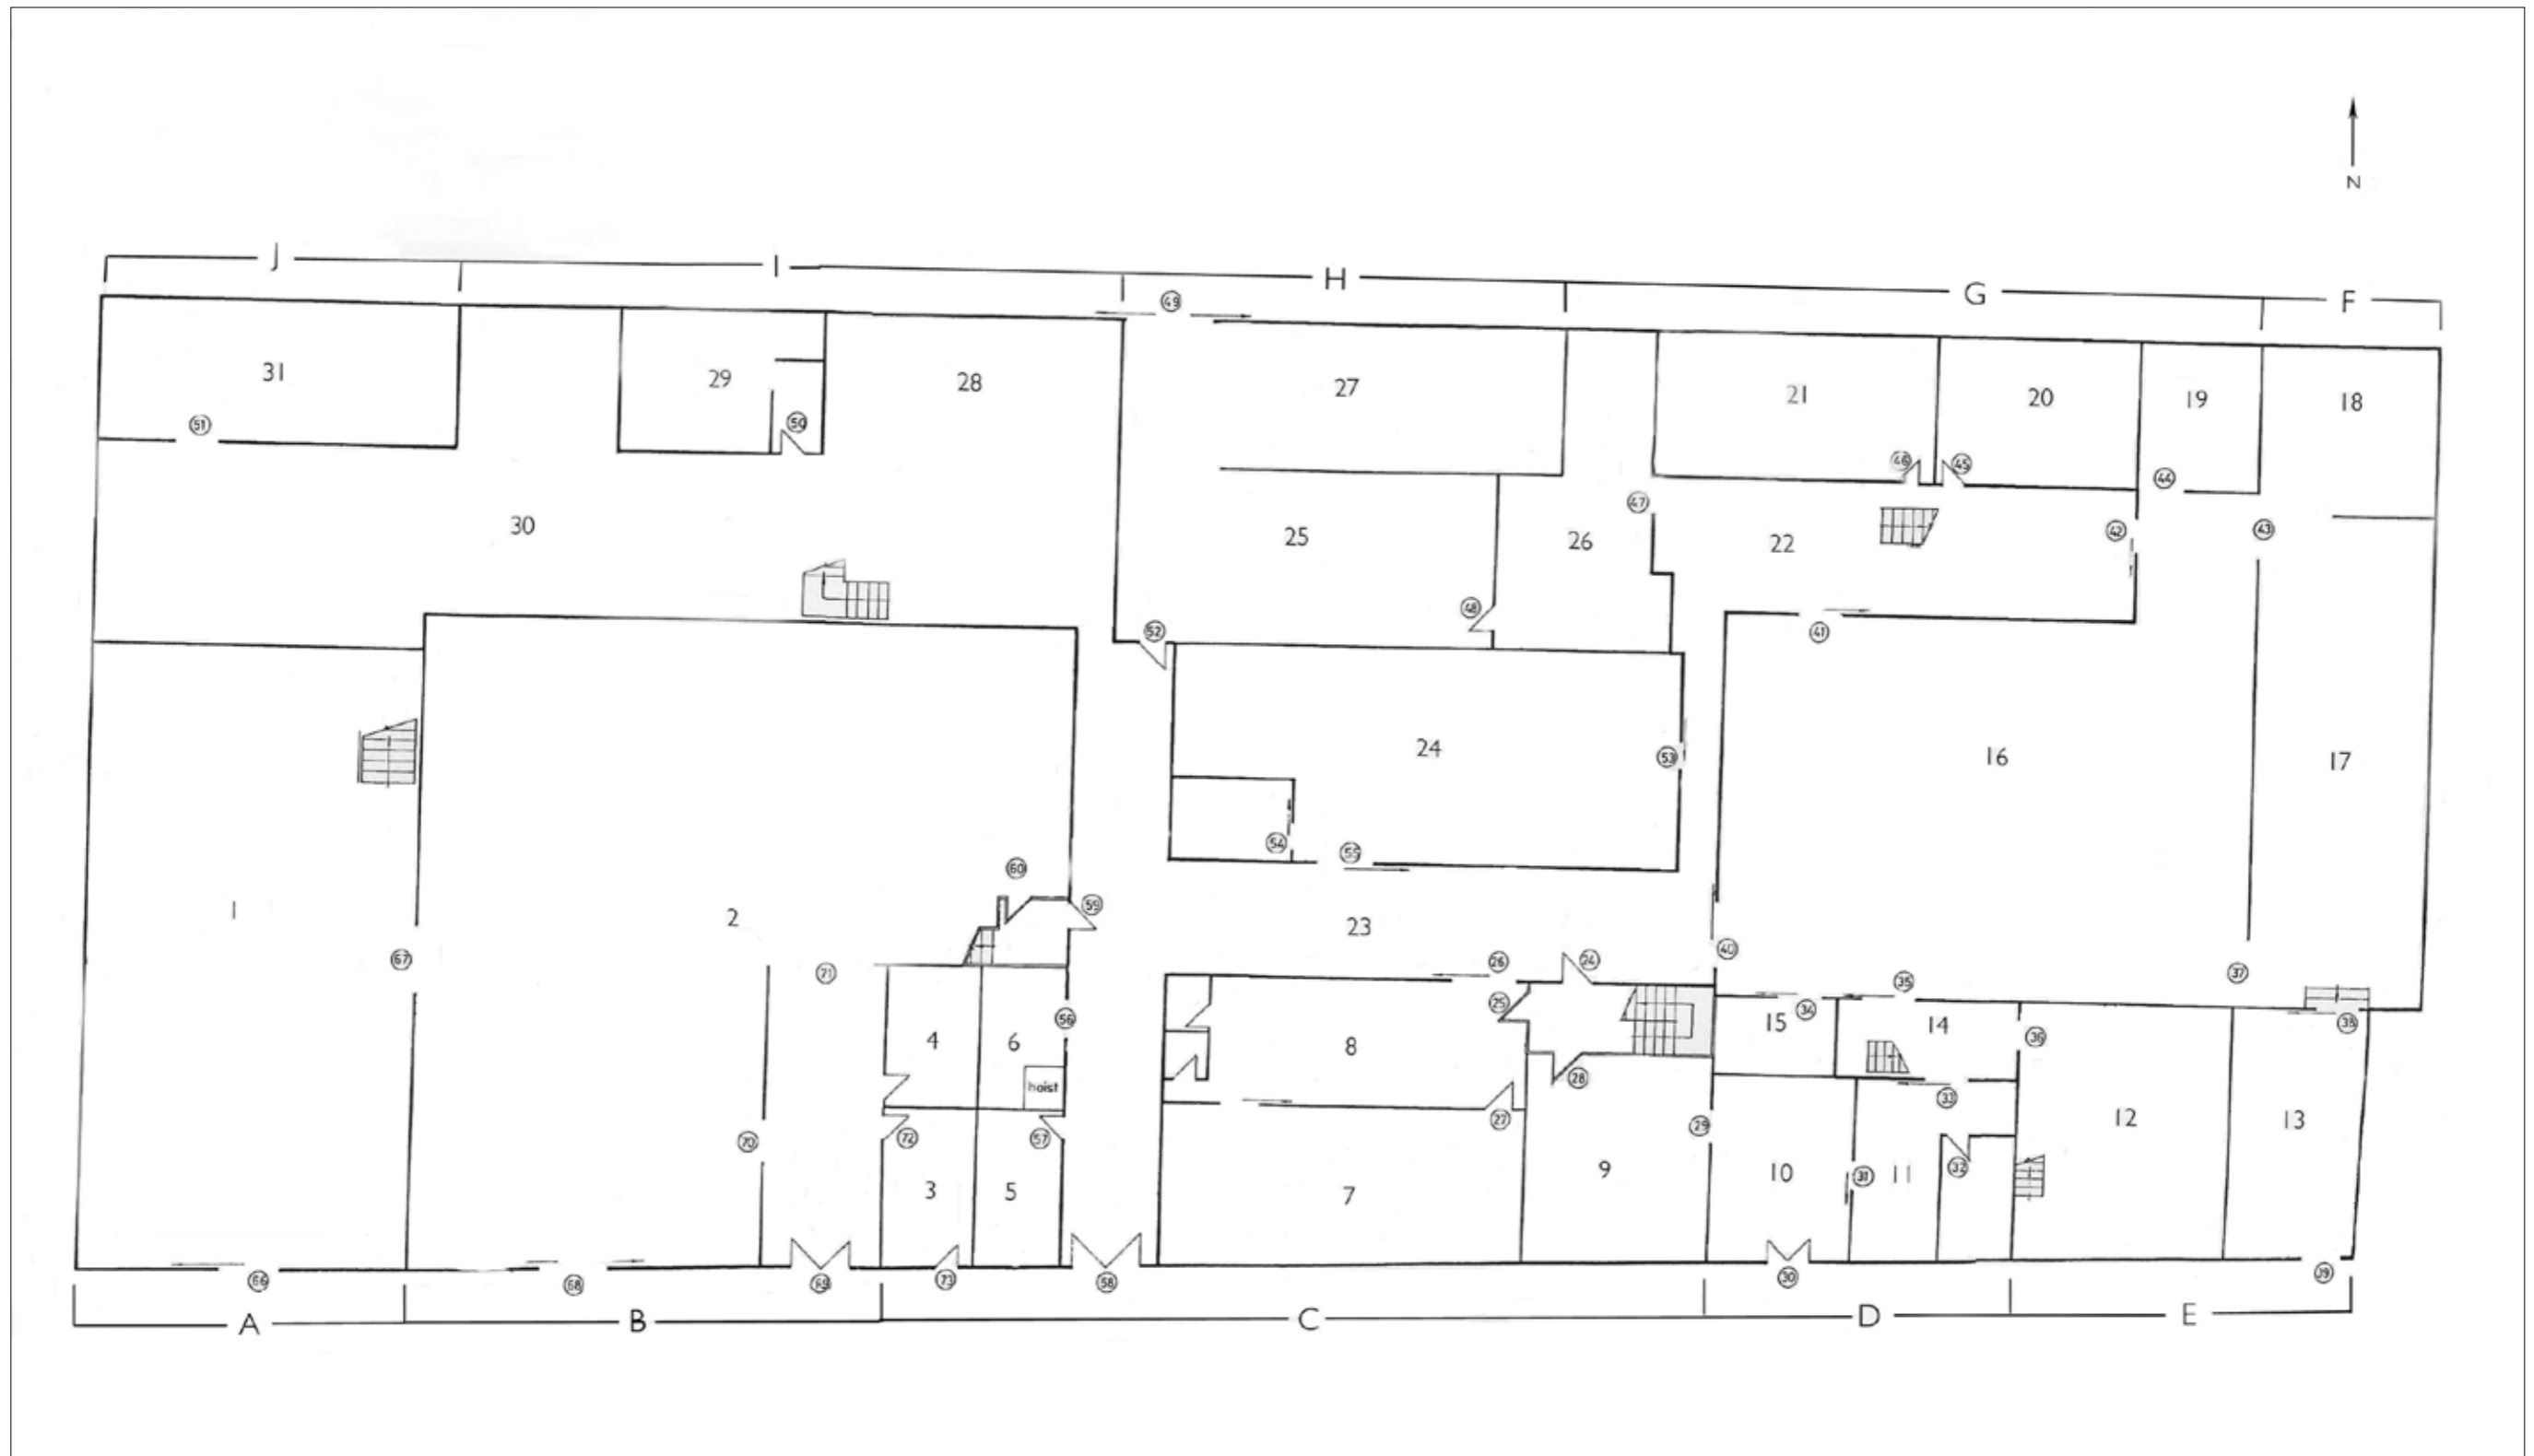
Figure 3 Ground floor layout of the Barford Brothers' dye and bleach works, Luton.

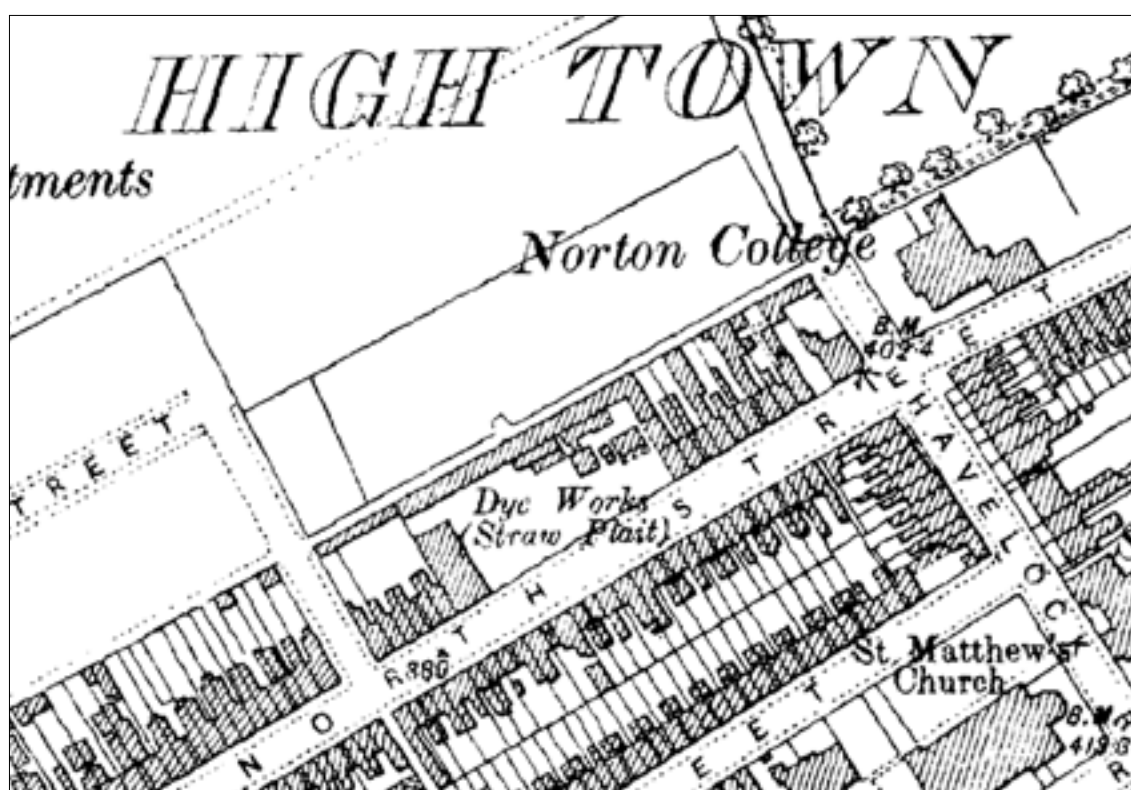
The firm was founded in 1894 and by 1901 the dye works are not only present but are marked on the map as 'Dye Works (Straw Plait)' and surrounded by further terraced housing. The basic layout for the works had been established, with a complete rear range along Mussons Path and buildings at either side of the site creating a U-shaped complex open to North Street. A number of small structures are shown within the yard but do not appear to form an integral part of any of the main buildings.

Figure 5 The extent of the site in 1901.

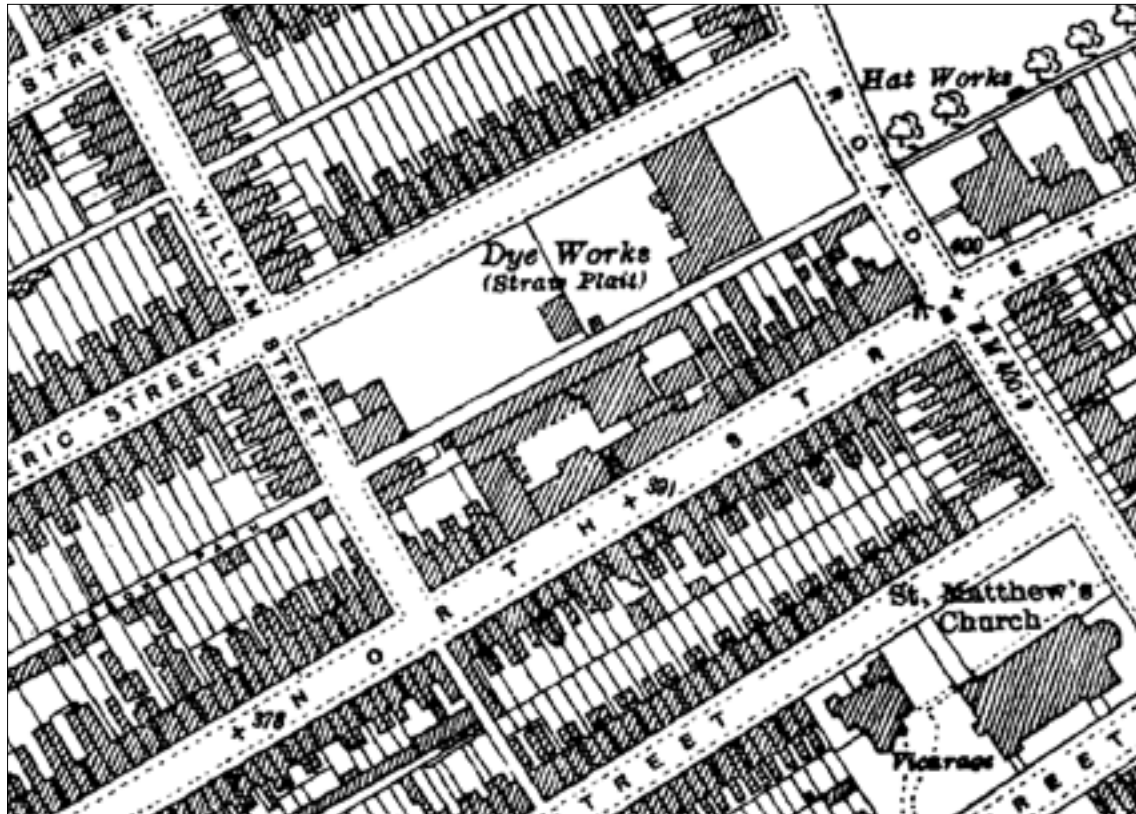
A less detailed 1902 OS map of Bedfordshire suggests that no substantial alterations had been carried out with the year. By the time of the 1924 OS map the High Town area had greatly expanded and the dye works had taken on the form we largely see today, with the enclosure of the courtyard behind a front range and the construction of substantial buildings abutting the rear range within the yard, as well as the construction of stables on William Street. The 1926 and 1938 OS maps of Bedfordshire suggest little substantial change to the site during this time.

Figure 6 The extent of the site in 1924.

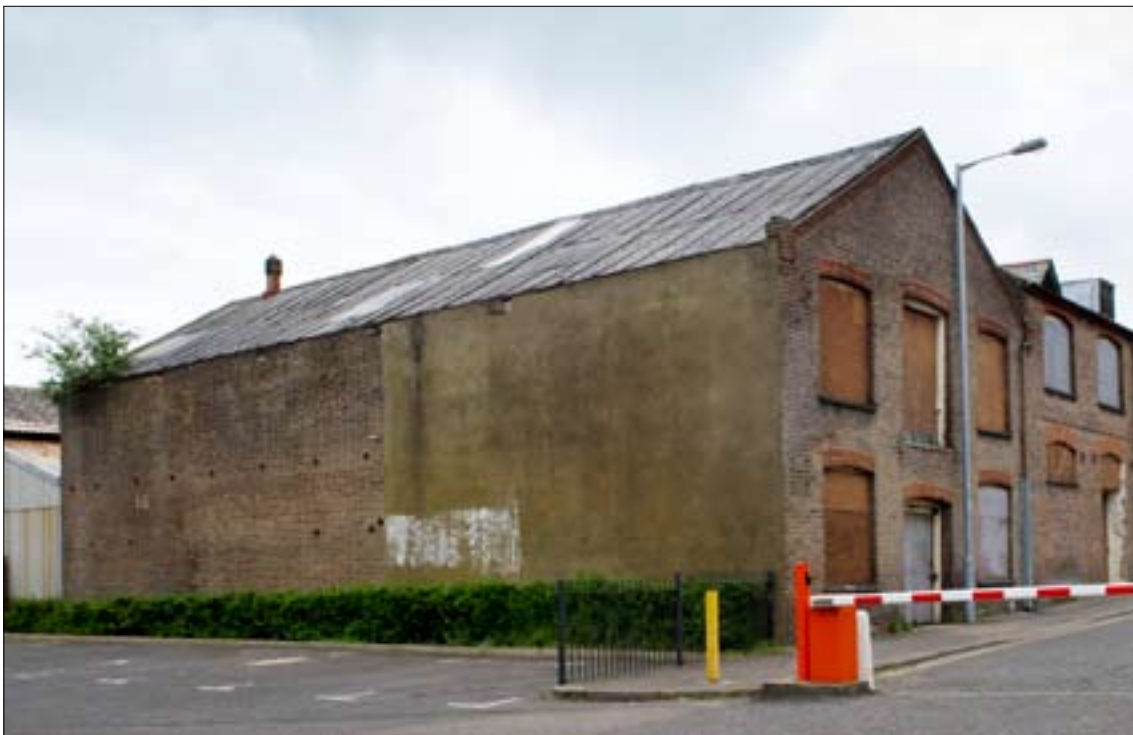
Figure 7 Block A.

Block A is a two-storeyed building with brick detailing, gabled to the street. The roof covering has been replaced with asbestos cement sheeting and the windows have been boarded over. The southern elevation is symmetrical with a wide central doorway (66) flanked by single windows on the ground floor and a taking-in door on the first-floor (although there is no evidence of fixings for any form of crane), again with a window to either side. The windows and doorways have segmental heads formed from a double row of red brick headers terminating in single stretchers, with engineering brick sills to the windows. The lower position of the main doorway compared to the window heads to either side appears, from the presence of quarter-bats, to be the original height. The brickwork beneath the clearly secondary concrete sill of the taking-in doorway has been patched and repaired – probably during the replacement of the sill. Situated on a slight hill, there are two air-vents below the left-hand window on the ground floor, allowing ventilation beneath the floor. The western elevation is partly rendered, showing the position of the terraced houses which once abutted the building. This elevation is blind and whilst the lower half of the exposed section of wall is in English bond, the upper half is constructed from Flemish bond although in the same size and type of brick and with obvious no change in mortar. The rear elevation faces area 30, a covered dye yard, and has two windows - the western window is bricked up but has a segmental head of the same style as the windows to the front elevation, the eastern window has been altered with the insertion of a metal lintel and has metal glazing bars dividing the window into twelve rectangular panes with an engineering brick sill below. A support for a drive shaft has been inserted between the windows. The eastern elevation is not visible externally.

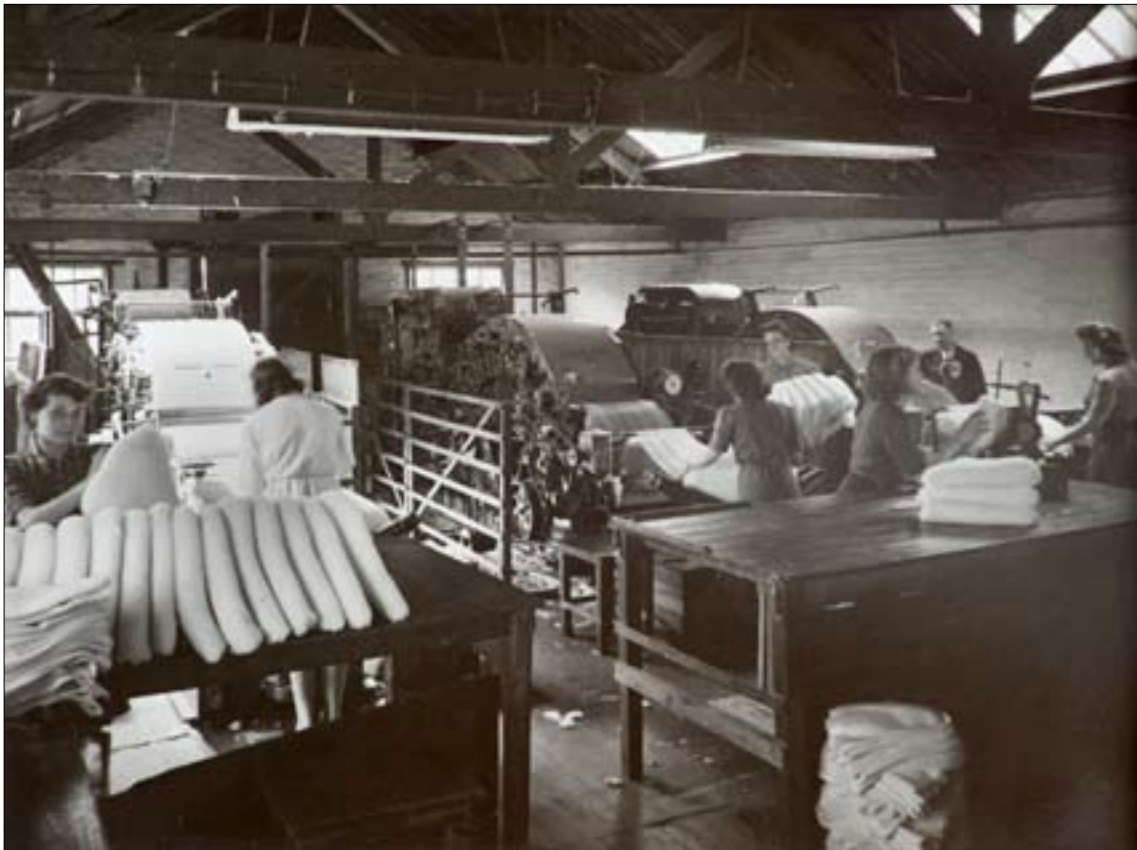
Figure 8 Block A, room 32 showing the carding process circa 1940.

This building was used for the production of felt. A variety of felt was produced, including piece felt approximately 1 metre wide and 9 metres long which would be dyed and sold for use in clothing, toys and craftwork. Mechanical felt was also produced and was either undyed or a grey blend and used for washers, spacers, filters etc. The main work of the felt department was making the caps and cones from which felt hoods would be shaped and then dyed on site. The wool first went through several carding processes to form a web which was then wound on to a cone to form rolls of cotton wool (as seen in fig 8) – this process was almost always done by women as the fine web would catch on any hairs on the arms or hands and rip. During the forming process the wool would be cut and steamed before being pulled over blocks to create the basic hood shape (fig 10). This was very painful to do and large calluses quickly developed on the workers' hands from the heat and roughness of the felt. The actual felting process took place either in a multi-roller (fig 11) or a more aggressive bumping machine (fig 12) where the hoods would be hammered with hot water and sulphuric acid until the fibres had curled and knitted together evenly – this part of production was generally overseen by men and the bumping machines ran continuously, even when a hood would be pulled out by hand to check whether more water or acid was needed.

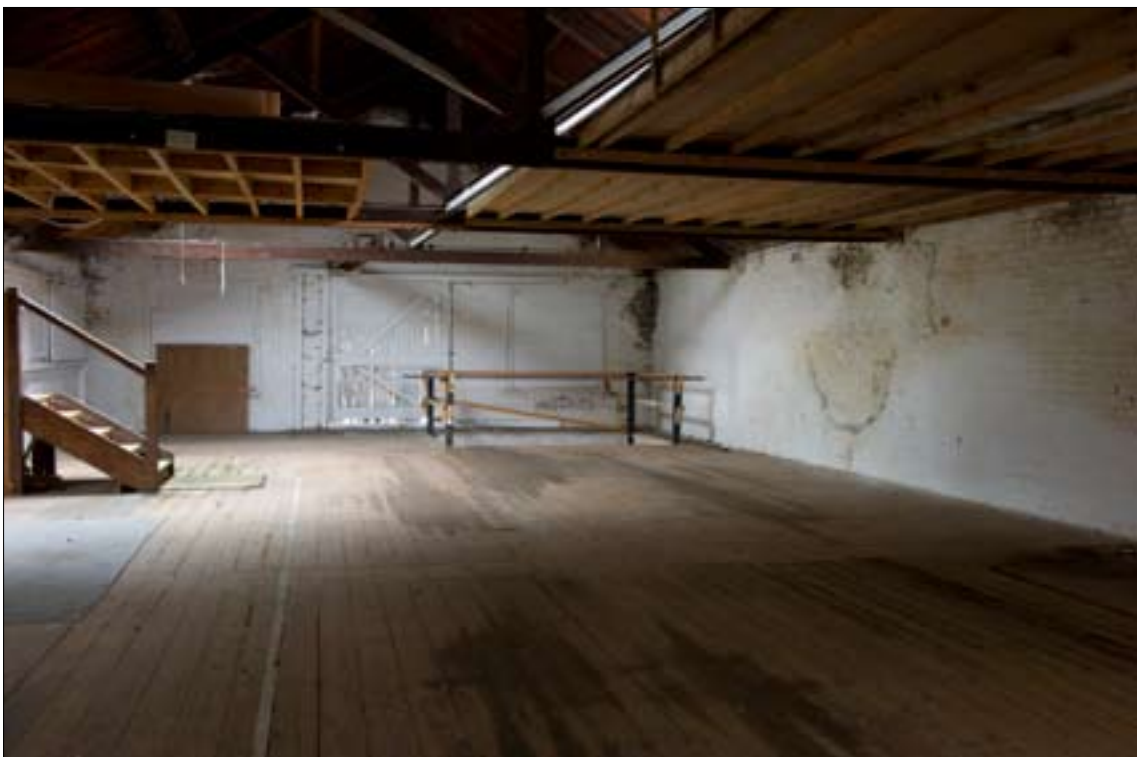
Figure 9 Block A, room 32 in 2010.

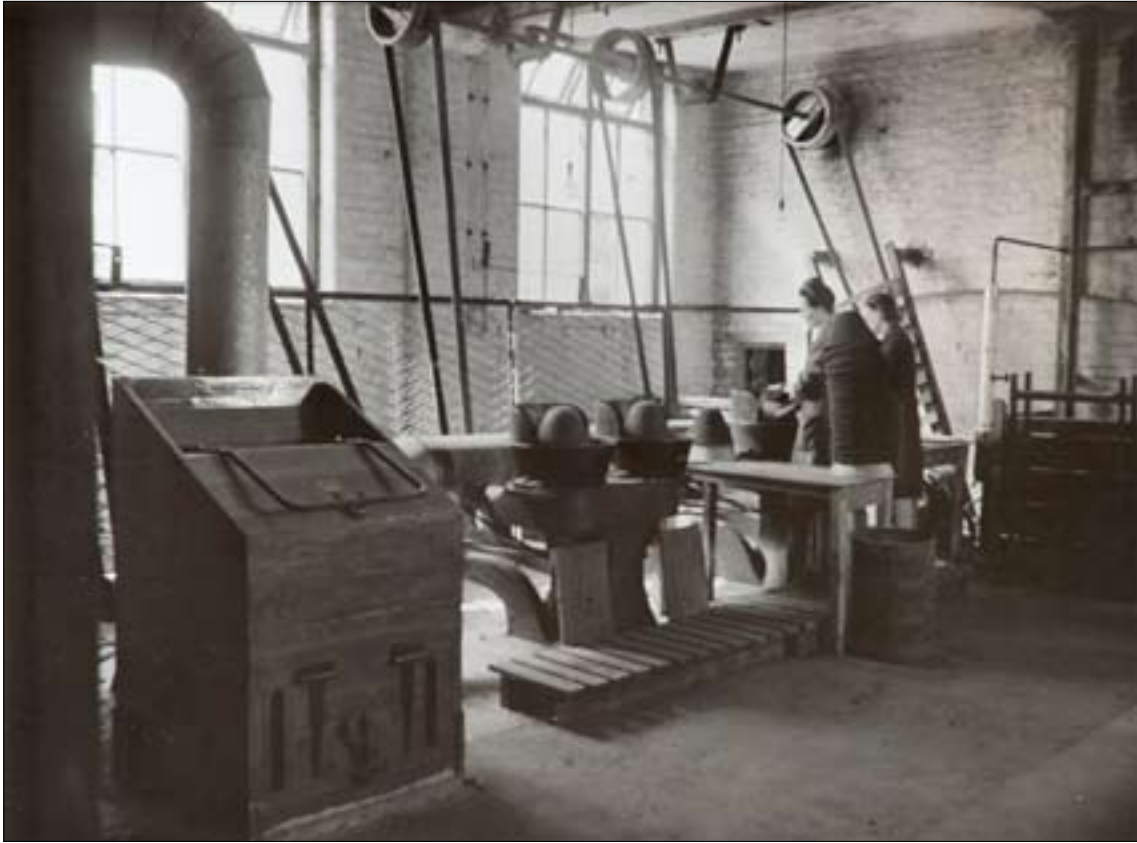
Figure 10 The forming process, circa 1940 (interior of room 44, block E).

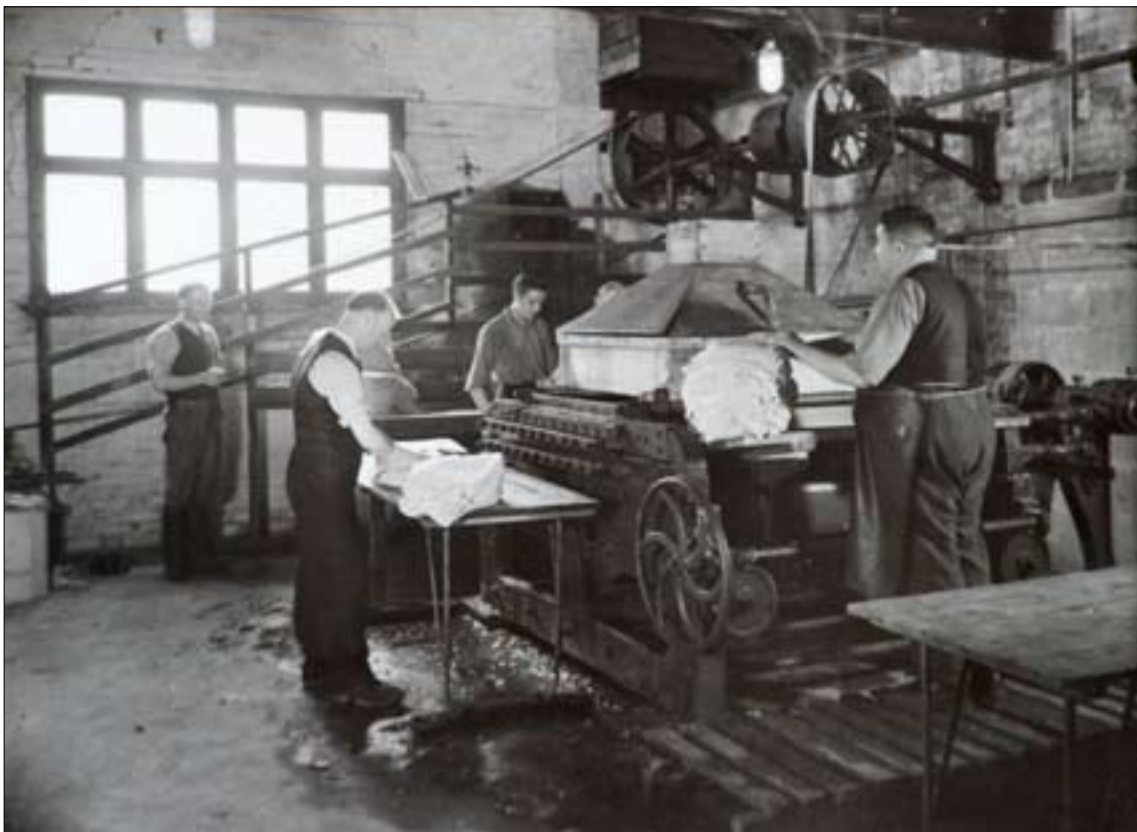
Figure 11 A Mazzera multi roller, circa 1940. Unidentified location.

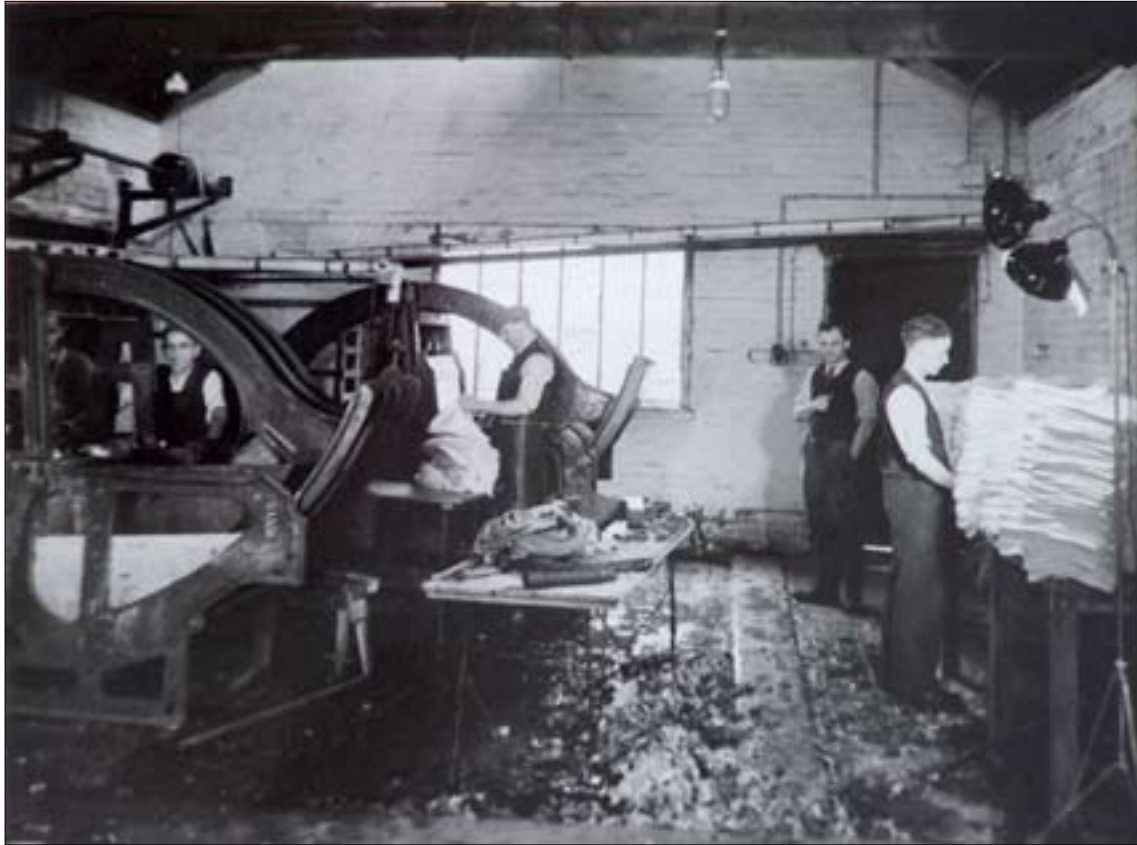
Figure 12 Bumper machines, circa 1940. Unidentified location.

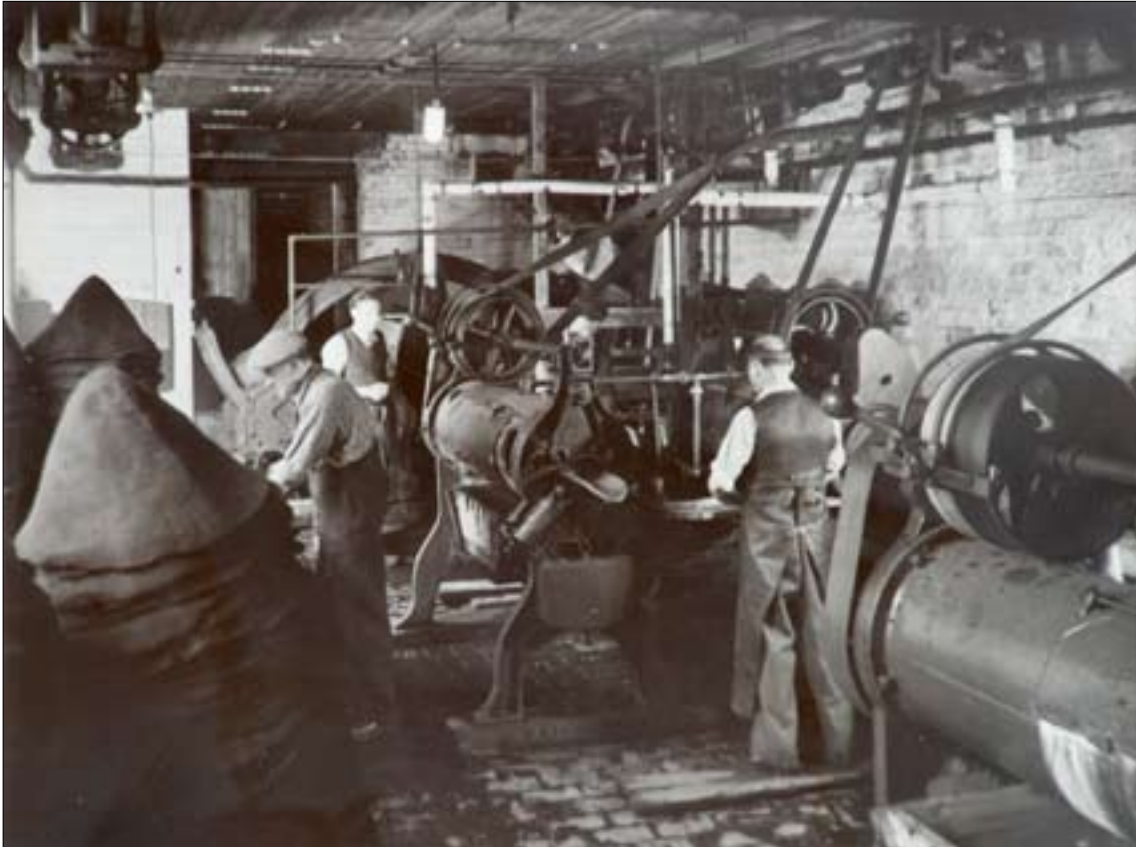
Figure 13 Rotary proofing machines for stiffening felt hoods, circa 1940. Unidentified location. Collection of Mr John Horn.

Internally, the northern wall was demolished during the addition of a modern warehouse and replaced with a stud wall. The floor has been covered but appears to be of solid construction. The western wall is blind save for the doorway leading to building A. Similarly, the eastern wall is blind with the exception of a square headed blocked opening leading to the easternmost section of B. Beneath the easternmost window in the south wall is a hatch which once brought shellac in to be processed for the stiffening of certain shapes of felt hats. This process (fig 13) involved the hoods being submersed in a solution of shellac before the excess was removed and the hoods left to dry. The ceiling is made

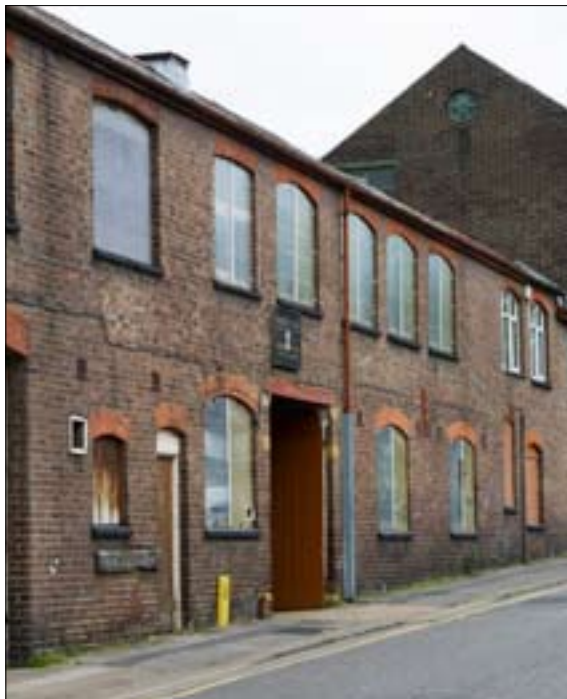
Figure 17 Block C.

Block C (fig 17) is slate roofed, built against block B, and incorporates the through passage leading from North Street to the central yard. All of the windows and the

doorway to room three (73) on the front elevation have brick segmental heads formed by a double row of headers terminating in a single stretcher. The windows have engineering brick sills and (with the exception of those to room 42 which have been replaced with uPVC frames) have metal glazing bars dividing the window into square panes – six across and four high with a further row cut at an angle to allow for the segmental head. Beneath this row is a square pivot opening light of four panes. To the west of doorway 73 is a small window to room 3 whilst to the east is a large window to room 5. The passageway itself is formed by a wooden lintel resting on stone corbels incorporated into the surrounding brickwork, with a set of stone blocks approximately one foot further down, and a further set just above ground level. Above the passage is a wooden sign (fig 18) with a black background and gold lettering announcing the building as 'Barford Brothers Ltd. Hubbard of Luton', with the previous lettering 'Members of

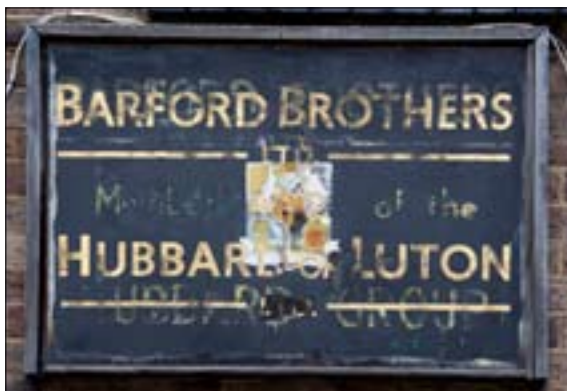
Figure 18 Hubbards sign.

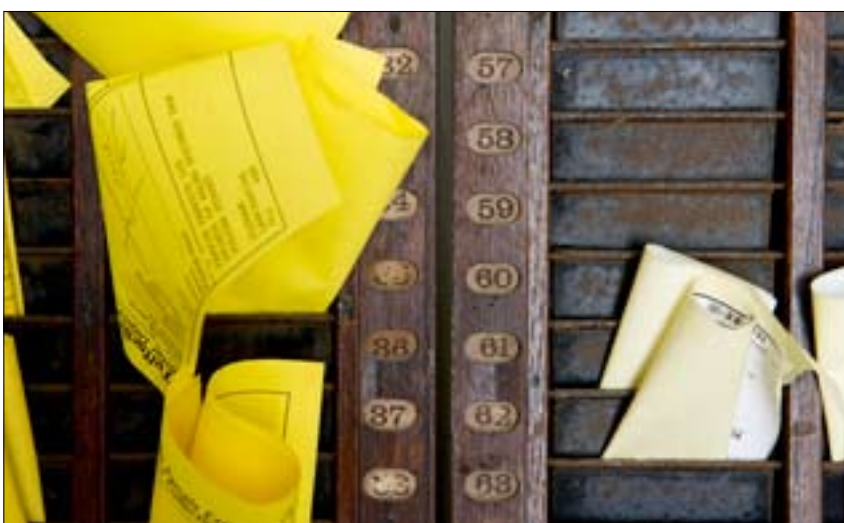
*Figure 19 Detail of clocking-in apparatus.  
© English Heritage  
NMR DPI10754*

The interior of rooms 3, 4, and 5 were not accessible. Room 6 contains the hoist which rises to room 41 and the clocking-in equipment. Room 7 contains a number of blocking machines by Boon & Lane of Tailor Street, Luton, and Weatherhead & Sons, also of Luton. The blocking of hats to a specific shape can be done by hand or by machine. The straw or felt is wetted or steamed and then quickly pulled over the crown of a block and pulled evenly on all sides before it dries. In a complicated shaped hat the brim may be made separately and attached during the finishing process. Blocking machines are essentially large presses with an upper and lower pan, each heated by gas burners. The form of the hat to be produced is inserted within these pans and then the hood (having been wetted or steamed first and treated with a stiffening agent, such as shellac) is inserted and the pans brought tightly together. If a hydraulic machine is being used then at this stage water is pumped into a rubber bag in the pan, compressing the hat tightly against the form.

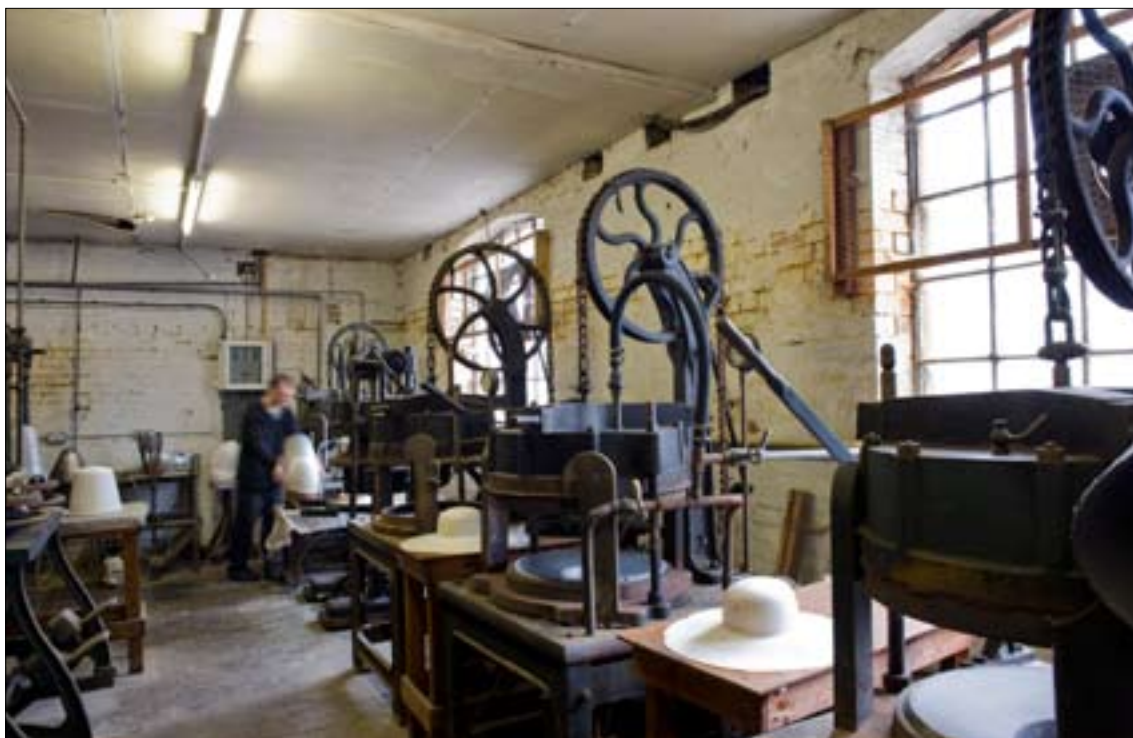
Figure 20 Blocking machines in room 7, block C.

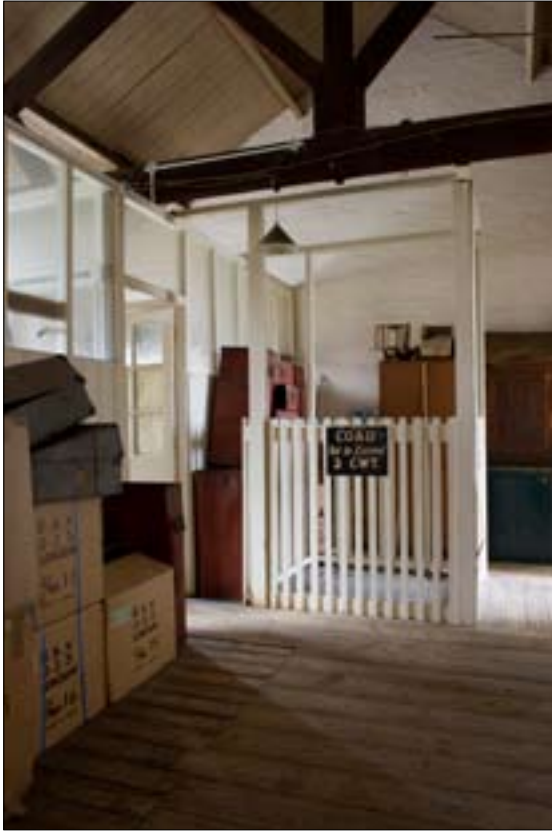
Figure 21 Hoist in room 40, block C.  
© English Heritage NMR DPI10742

Room 40 is a continuation of room 41 as, although the wall partly separates the two spaces, the floorboards run through without interruption. The room is open to the roof and there is a single exposed king-post truss. Partitioned sections create rooms 38 and 39 as well as the WC and sink area in the north-west corner. The hoist made by Tanove of Birmingham runs along the north side of the room from east to west and has a sign 'No 1 Hoist, load not to exceed 5CWT'. The hoist shaft is enclosed and has an attached sign stipulating 'Load not to exceed 2CWT' (fig 21). Room 38 has no ceiling, being a partitioned area, but has tongue and groove panelled walls with glazing and a hinged door (23) with bakelite handle and a linoleum floor covering. Room 39 (fig 22) again has no ceiling but has tongue and groove panelled walls with glazing and a sliding door (22) as well as built in shelving and cupboards.

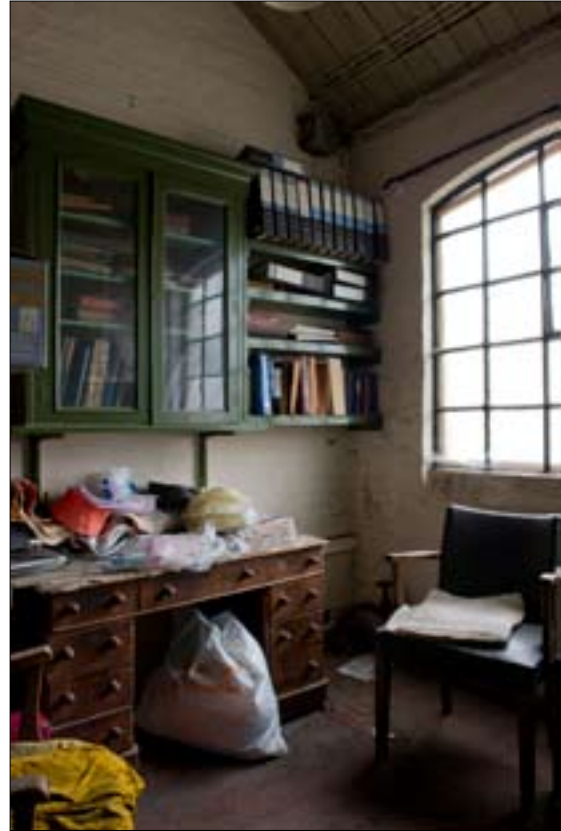
Figure 22 Room 39, block C.  
© English Heritage NMR DPI10744

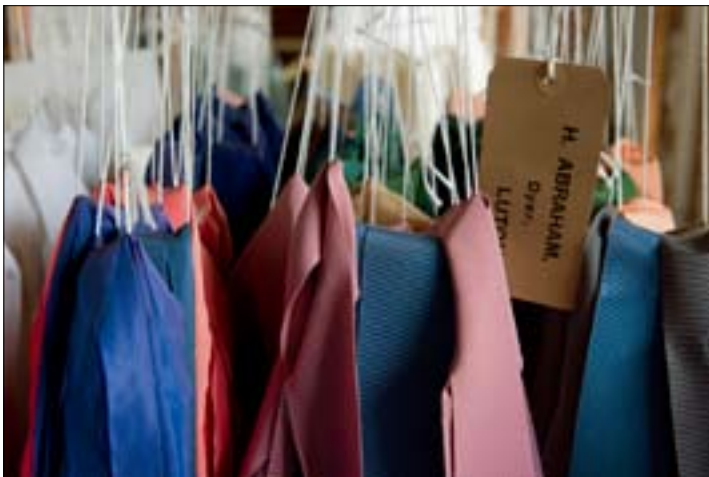
Figure 23 Hanks of ribbon.  
© English Heritage NMR DPI10750

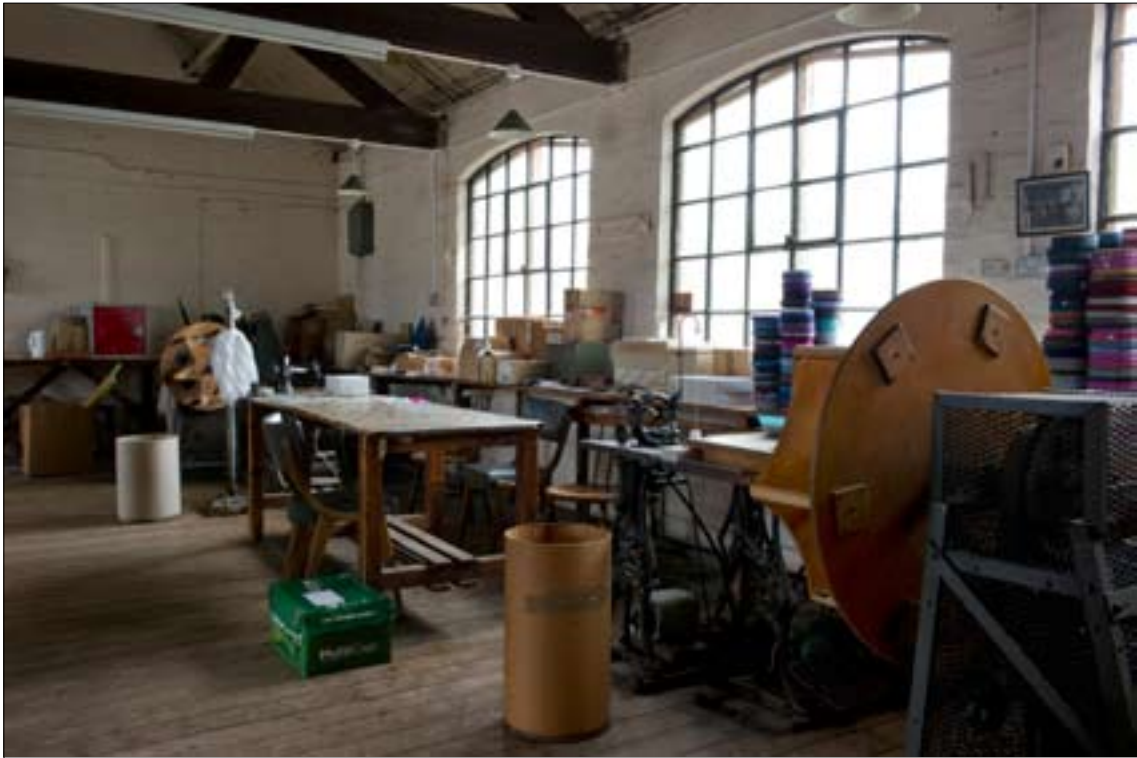
Room 41 (the ribbon room) is also open to the roof, which comprises three visible king-post trusses with an engaged ridge beam and two principal purlins on either side. There are two openings in the roof – one to the extreme east of the room and one in the centre – indicating the position of the louvres. The centre of the room is occupied by wooden frames for drying ribbons – complete with adjustable spindles for sorting hanks of ribbon (fig 23). The eastern wall has a doorway (20) which appears to be original; the northern wall shows evidence for the blocked doorway as well as evidence for further ribbon frames. The room (fig 24) has changed very little since a black and white photograph of the room was taken in circa 1940 (fig 25).

Figure 24 Room 40, block C, in 2010.

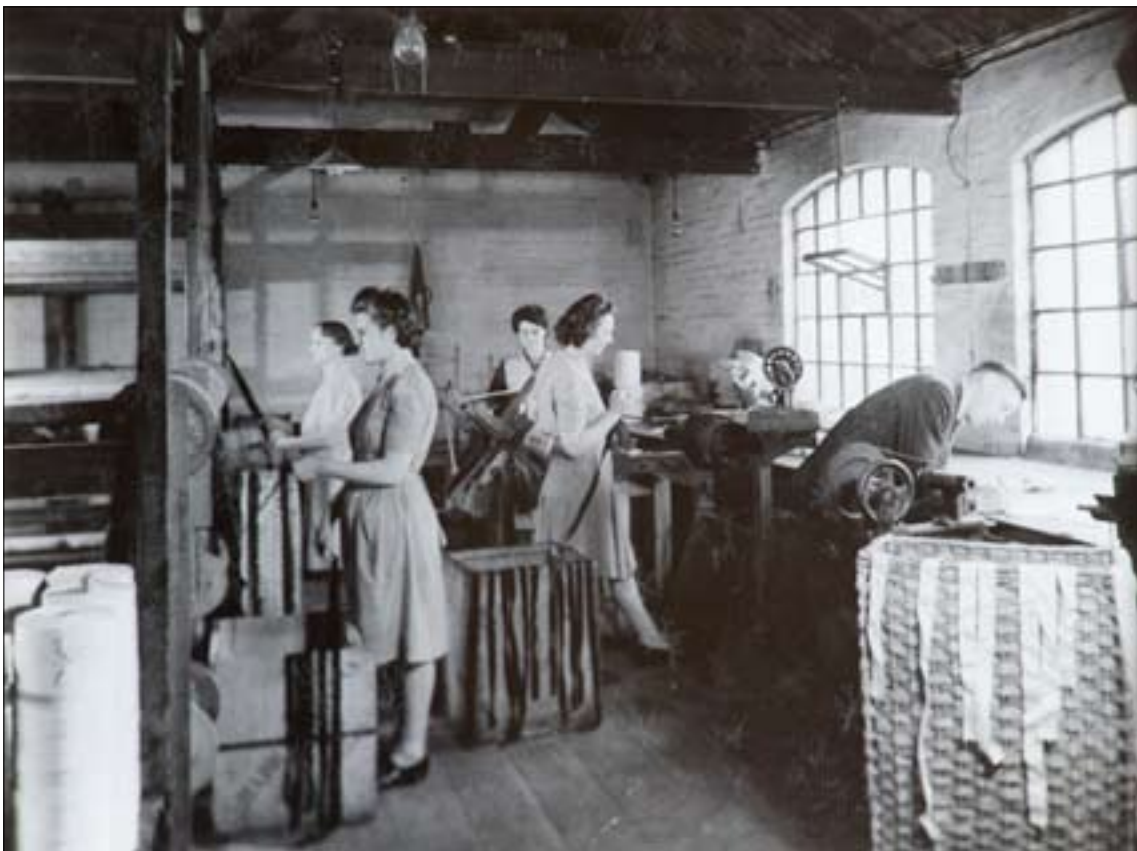
Figure 24 Room 40, block C, in circa 1940.

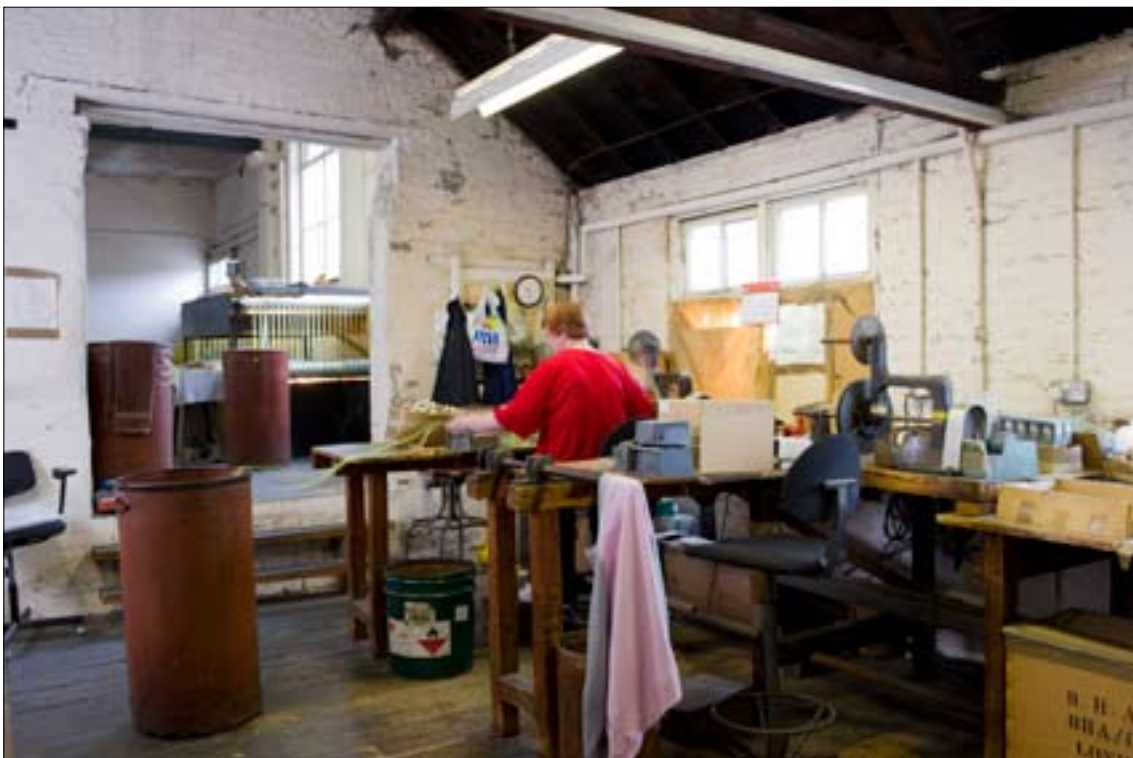
Figure 25 Room 43, Block D.

Room 43 has two visible kingposts. The west wall contains a wide, filled in archway beside which, in the north-west corner, is an inserted doorway (36). The northern wall shows possible evidence for drying racks beside the doorway in the north-east corner and the east wall has been altered to create the large opening through to room 44. The room is currently used for the winding of ribbons into rolls (fig 25).

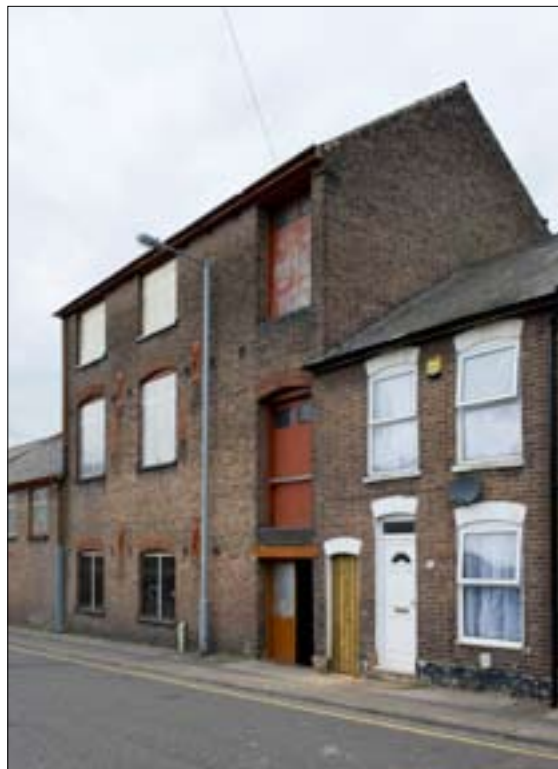
Figure 26 Block E and 113 North Street.  
© English Heritage NMR DPI10764

Block E (fig 26) is a three-storey building with two windows and a loading door to each floor. The ground floor and first-floor windows have segmental heads formed from three rows of headers terminating in a stretcher with a header above, as does the first-floor loading doorway. The second-floor windows have square heads beneath the eaves, whilst the second-floor and ground-floor doorways have wooden lintels. All the windows have engineering brick sills, those on the ground floor being sloped and those on the first and second floors being set at a right angle. The fenestration is very similar in style to that seen in block C but with plain square heads even where the window heads themselves are segmental. Between the doorway and the easternmost window and again between the windows on the ground and first floors are large metal ties with additional straps below those on the first floor. Each of the windows on the ground and first floor has a set of air vents to either side, with an additional one to the east of the last window on the ground floor and an additional two on the first floor.

No. 113 North Street, to the east of block E, appears to have been built as part of the same building – there is no building break in the brickwork and the treatment of the window heads appears to be the same. A plan detailing proposed additions and alterations by Anscombe & Franklin Architects, dated 5 December 1907,<sup>17</sup> shows two separate buildings occupying the footprint of block E (fig 27). The westernmost building was part of the dye works, with a store and dye house on the ground floor and a converted drying house above. No. 111 North Street appears to have been a house (described on the plans as a converted carpenters' shop) shown with proposals to remove the chimney breasts and staircase and to insert a sliding door and a window to the front elevation on both the ground and first floor. A new dye house (the westernmost half of room 17) was constructed behind no. 111, infringing on the garden of no. 113 North Street. Consequently, the scullery of no. 113 was rebuilt as part of the proposed works – suggesting that the factory also owned this house. Clearly, the works proposed in this plan were not carried out as shown – the building is of three storeys and there are two windows beside the taking-in doors rather than just the one. Given that there is no evidence of a building break between the factory building and no. 113 North Street, it seems likely that the conversion was carried out much as planned but with the addition of an extra storey and the change in fenestration. This theory is reinforced by the faint change in the brickwork between the first and second floor of block E.

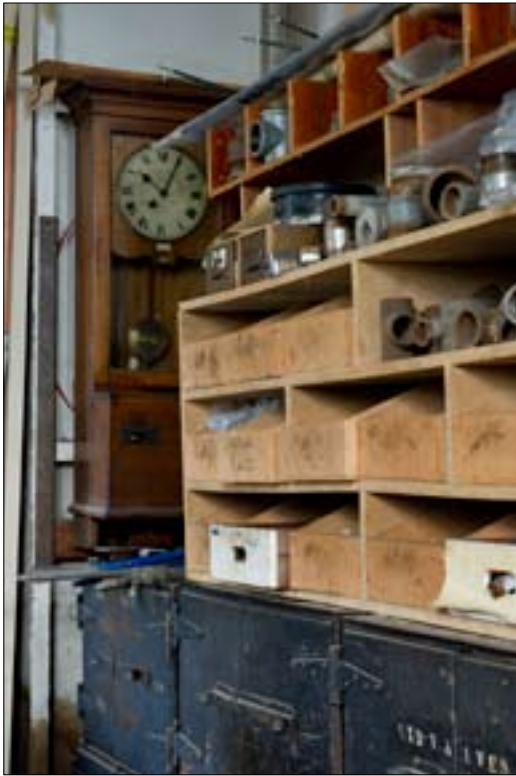
Figure 28 Room 12, block E.  
© English Heritage NMR DPI10724

Room 12 is a largely disused workshop with a riveted beam running north-south and terminating on brick pilasters with curved edges. A staircase against the western wall provides access to room 44. The floor is a combination of concrete and brick. Room 13 has two floor levels – the western half being 24cm lower than the eastern half. At the point of change in floor level on both the north and south walls is a brick pier with curved corners which support a riveted iron beam. The window on the south wall also has curved bricks to the surround whereas the two brick piers on the east wall have
