# THE BARFORD BROTHERS' DYE AND BLEACH WORKS, NORTH STREET, LUTON

## HISTORIC BUILDING REPORT

Katie Graham

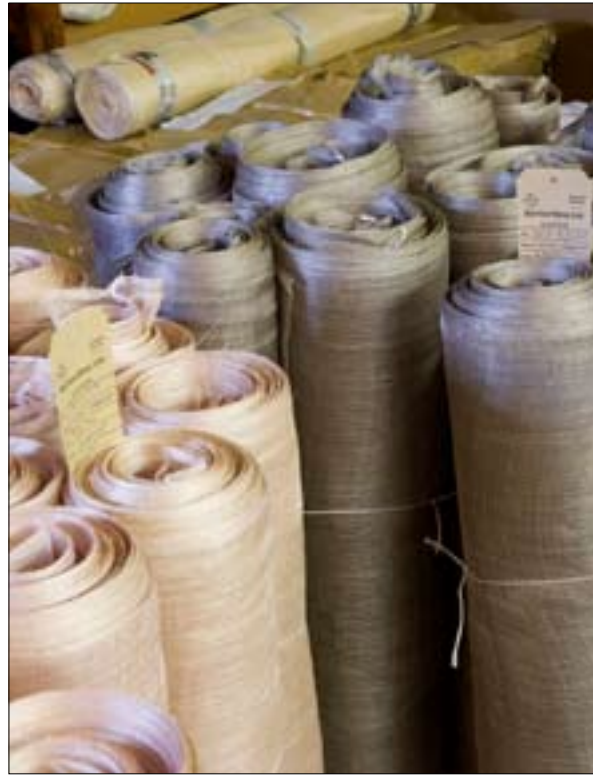
Figure 29 A delivery in room 13, block E.  
© English Heritage NMR DPI10726

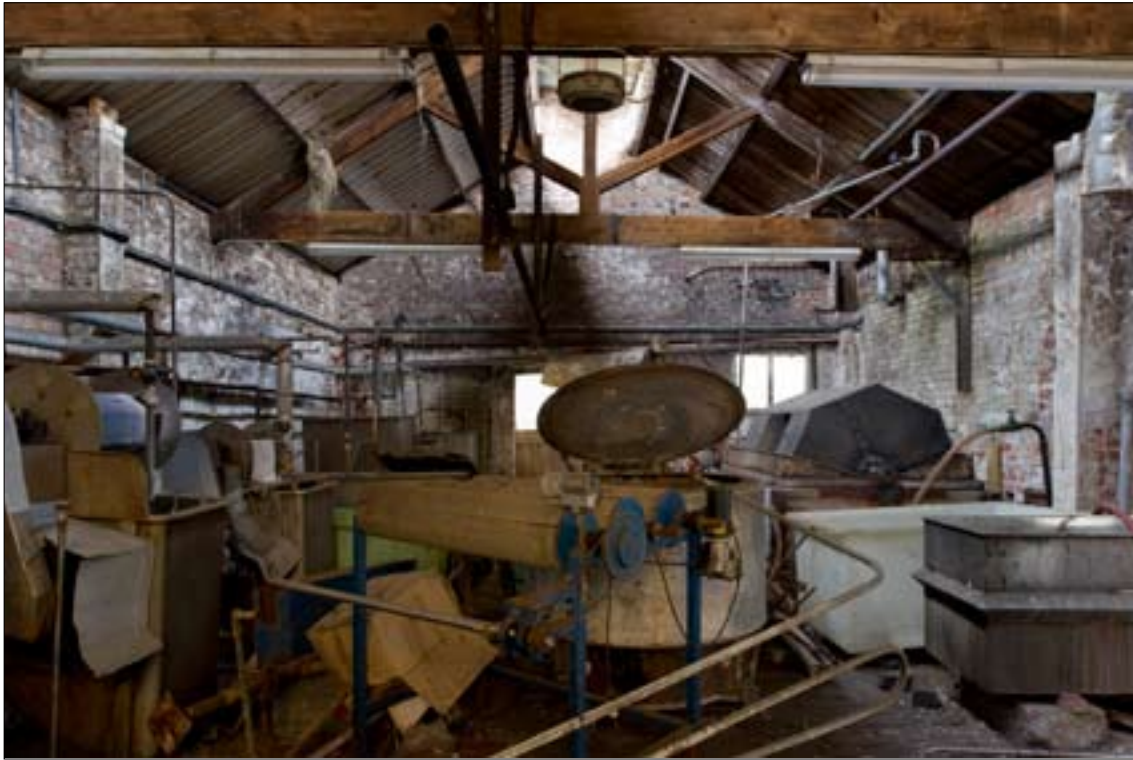
Figure 31 Interior of room 24.

Room 24 has a king post roof with a raised ridge section which is open at the sides – although the height of the king posts indicates that this is not the original roof

configuration. The floor is formed from engineering blocks. The south wall has a brick pier between trusses two and three (as numbered from west to east), whilst the north wall has three piers – one to the west of truss one, one between trusses one and two and one between trusses two and three – these appear to correlate with the brick sections between the windows which would once have looked in to room 25 (the boiler house on the 1910 plan). In the south-west corner is a brick built, roofed room with a sliding door, concrete floor and glazing to the north (looking into room 24).

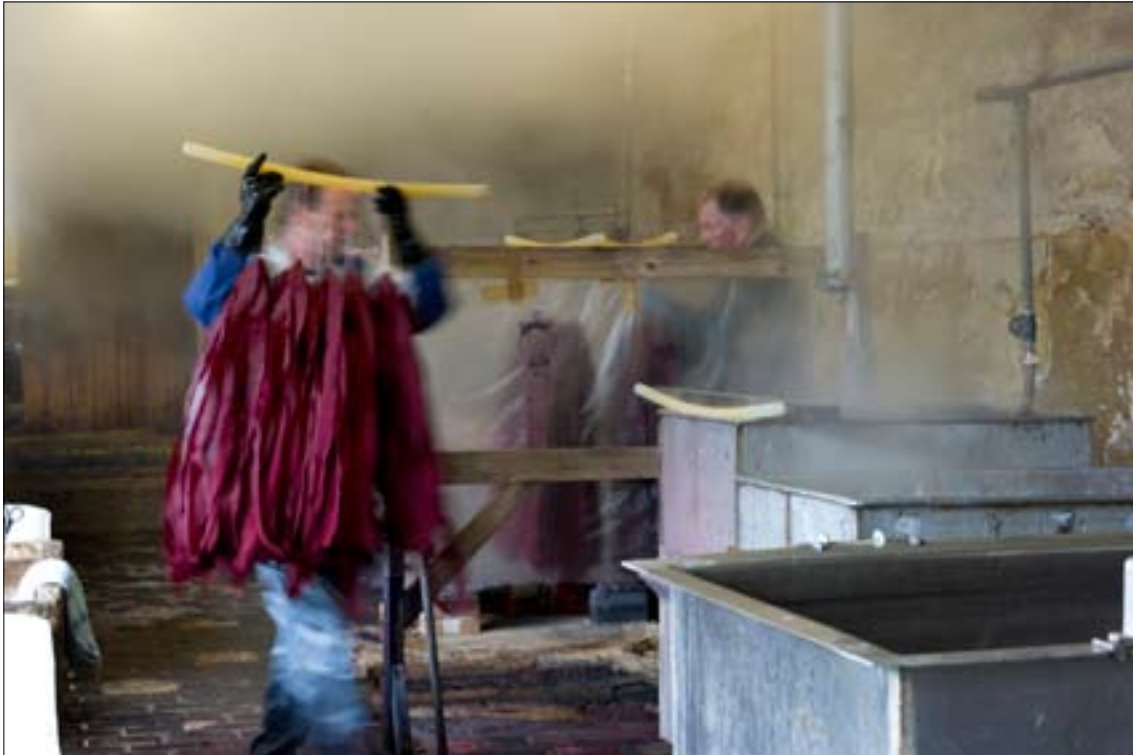
Figure 32 Room 17 - the dye yard.

Room 17 consists of two spaces either side of a central spine wall. The western wall (seen from shed 17) has been cut away on the ground floor whilst there are three blocked windows on the first floor, each with a single row of headers forming the segmental head. The eastern wall has three windows on the ground floor, each with brick segmental heads formed from a double row of headers terminating in a single stretcher, above these on the first floor are three blocked up windows with square heads to room 46. The northern wall has a blocked first-floor window and doorway with segmental heads as seen on the ground floor. The spine wall is heavily painted in places and the northern end has been rebuilt on the western face whilst the lower half of the eastern face has been rendered. The floor is made from engineering bricks and has run-off channels for water. The interior sills of the windows along the eastern wall have been removed leaving only rubble. This space is still in use as a dye yard (fig 32) – stainless steel tanks line the side of the rooms and are fed by hot water pipes, dye pigments are

mixed up by hand and added to the water into which hoods or ribbons are added and stirred regularly. The colour of the product is judged by eye and the colour adjusted as necessary – the quantities of dye used are very precise and lighter colours will be completely absorbed by the ribbon or hoods leaving the water clear.

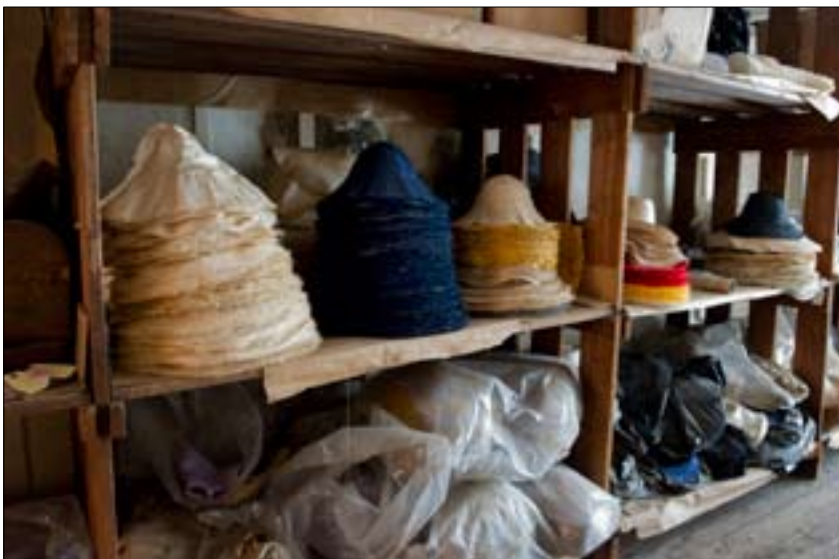
Room 45 has a simple A frame roof and wooden floorboards. The upper section of the northern gable has wooden cladding, the west wall has a window in the north-west corner which has been partially infilled and opposite, on the eastern wall, is an inserted doorway (11) to room 46.

Figure 33 Stored hoods in room 45.

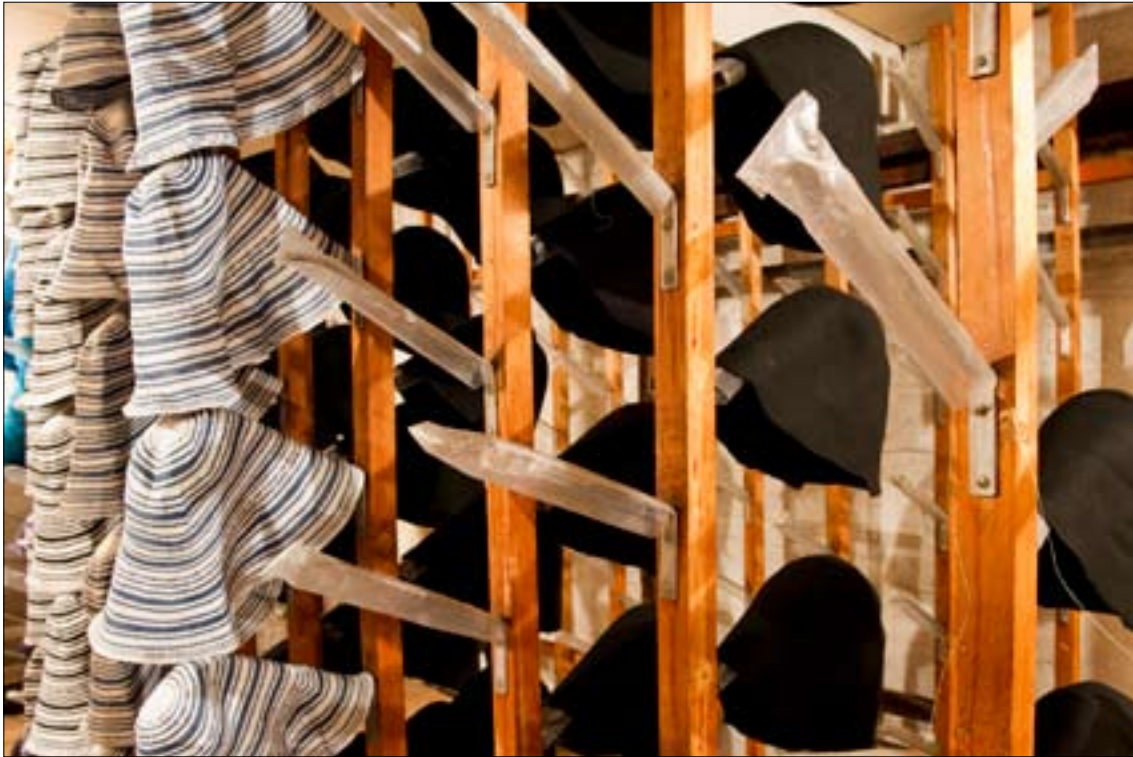
Figure 33 Drying racks in room 46.

Room 46 is a drying room with long rows of drying racks and a system of steam heated pipes around the room at floor level. The doorway in the south-west corner (12) is a later insertion – the 1910 plan for this phase of construction indicates that the doorway was inserted at this date, whilst the doorway in the southern wall to room 44 appears to have been a window which was converted for use as a doorway when room 46 was built.

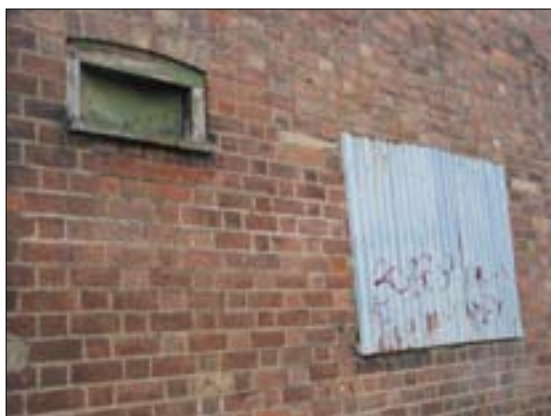
At the eastern end of the north wall, on the ground floor, is a single window to room 19; this window has a segmental head formed from a single row of headers and wooden glazing bars with a wooden sill. The elevation has a matching arrangement of rectangular stones set into the wall on the ground and first floor as seen on the southern elevation (fig 34). Towards the western end of the wall are two small openings with segmental heads formed from a single row of headers set just below ceiling level on the ground floor; the western one has been filled in and the eastern one has a wooden sill. Between these is an inserted window (boarded over) with a wooden sill. To the west of these openings, very close to the building break at floor level is a small, bricked up, rectangular opening with a segmental head formed by a double row of headers (fig 35).

Figure 34 Two stones set into the northern wall of block G.  
Hannah Waugh.

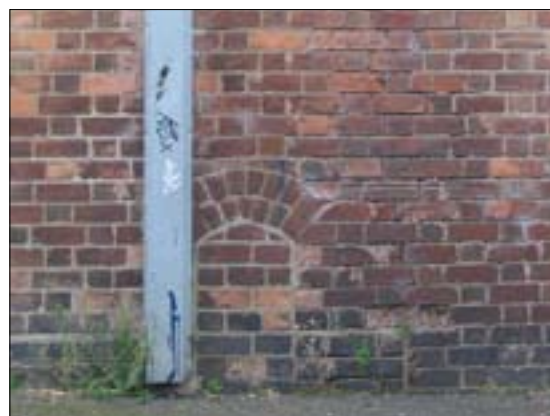
Figure 35 A blocked opening in the northern wall of block G.  
Hannah Waugh.

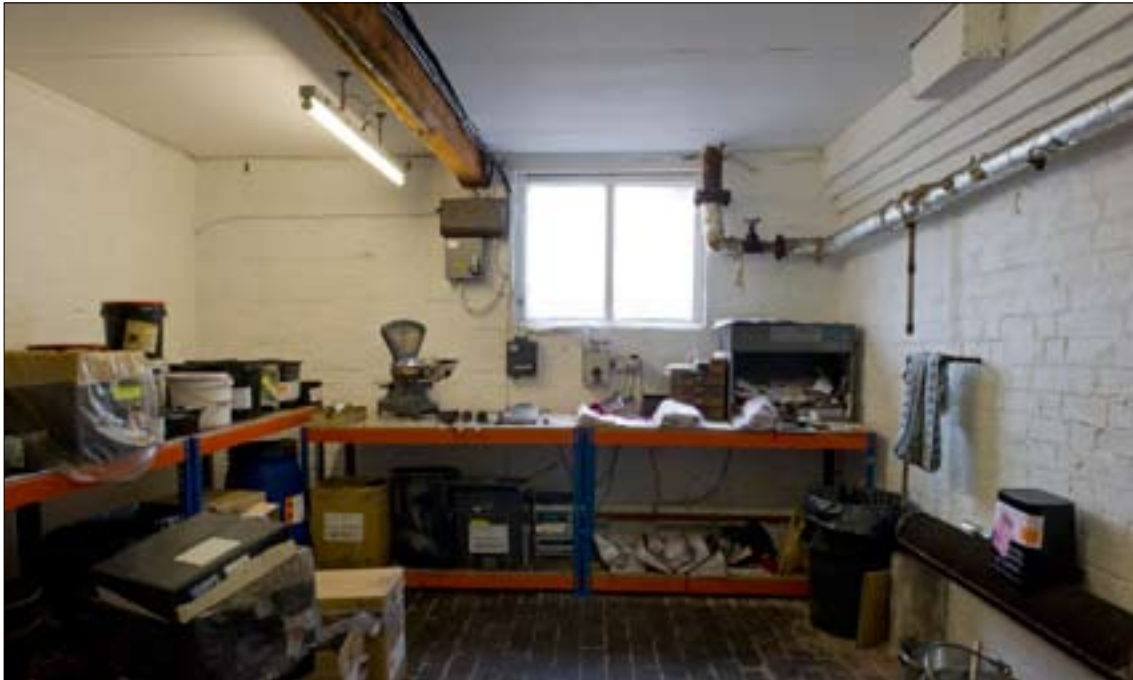
Figure 36 Room 19, showing the stepped eastern wall.

The entrance to room 19 appears to be an enlarged window or doorway and the eastern wall is stepped at the top, projecting into the room. Room 20 has a blocked doorway in the east wall to room 19, whilst the west wall is stepped out at the top.

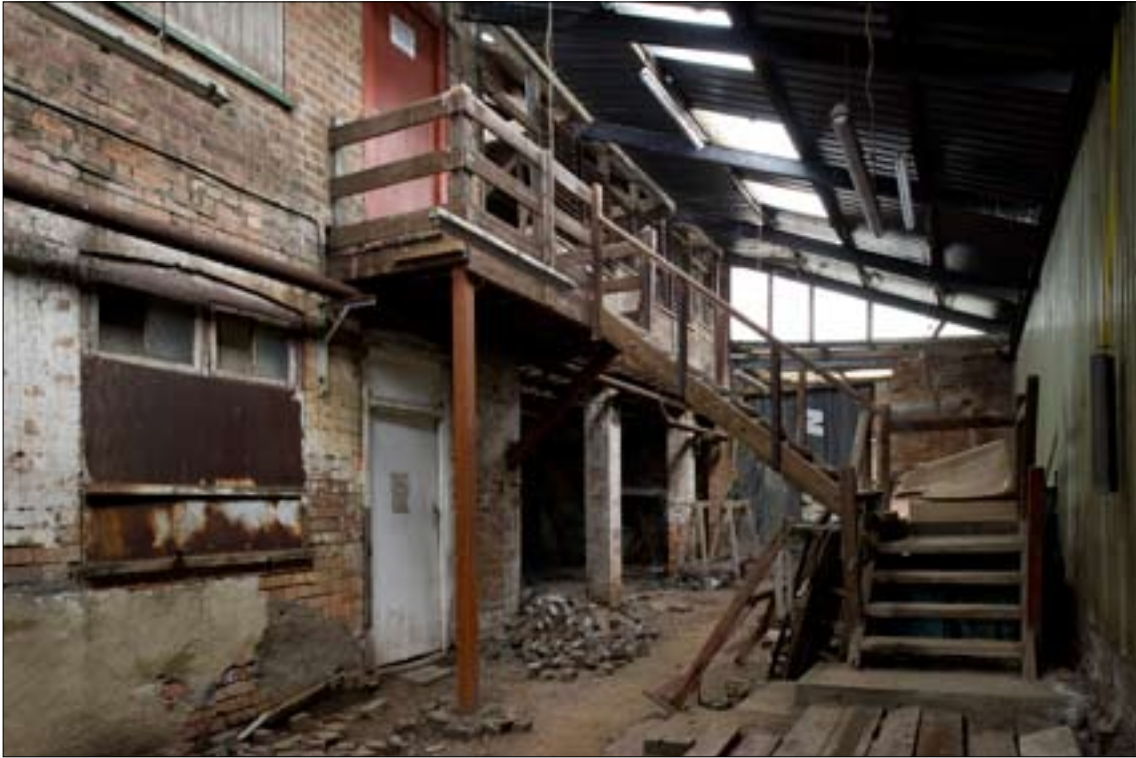
Figure 37 Yard 30.

Area 30 has an engineering block floor with drainage channels and recent areas of concrete infill. Pipes for steam injection of the dye tanks are supported at first-floor level on struts which run below the level of the wooden walkway. There are two large pits – the smaller of the two to the east formed the base for a large tank to be dropped into and the larger one to the west in front of the northern wall of block A was a collection pool for waste water. Rooms 31 and 53 are unsafe to enter.

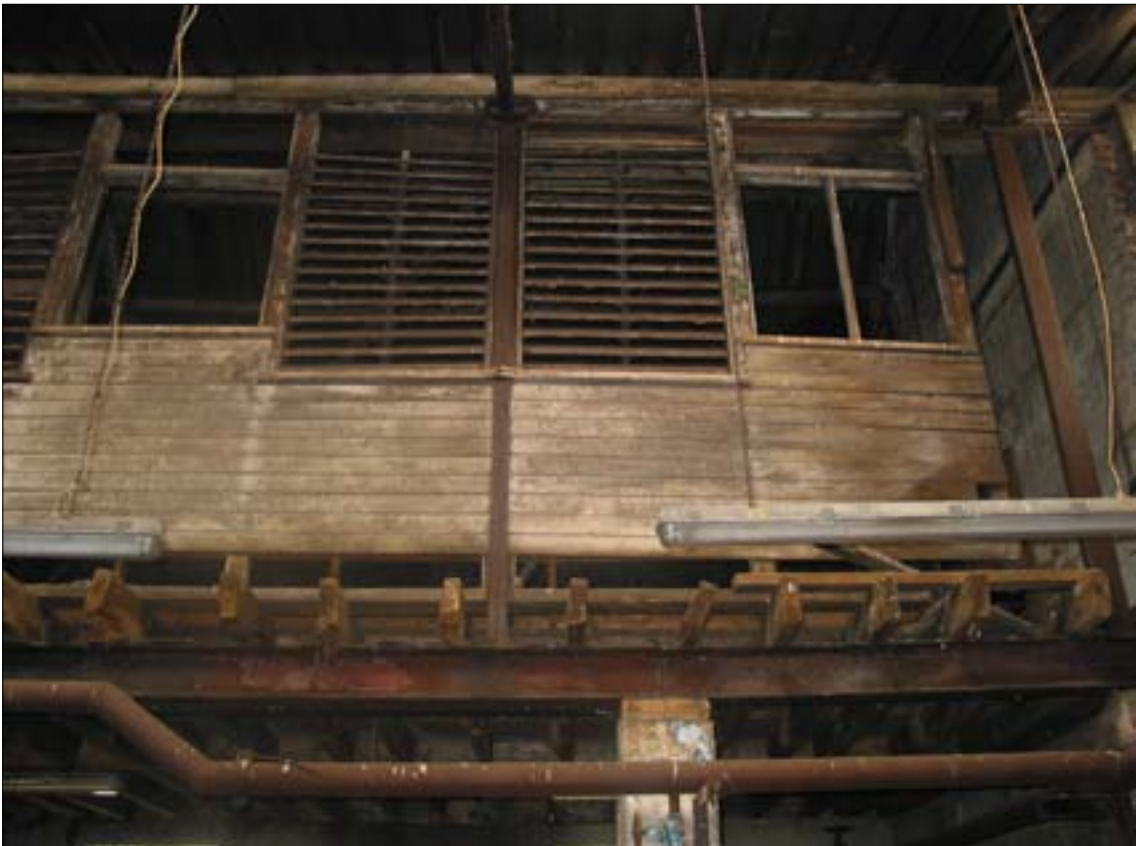
Block I opens onto yard 30 to the south (fig 37), with area 28 being separated from the main yard by two supporting piers to room 50 above. The southern wall of room 29 has two segmental windows and one doorway (50) with double row headers terminating in stretchers and with wooden sills; the same arrangement is seen on the first floor. Whilst the upper windows are boarded over and the eastern window on the ground floor has been shortened, it appears that they had the same style of glazing as seen on the southern elevation of block E. The upper doorway (4) is accessed by an external wooden staircase to yard 30 which also provides access to room 50 which has a king post roof and wooden louvres along its southern elevation (fig 38).

Figure 38 Wooden louvres on the southern elevation of room 50.

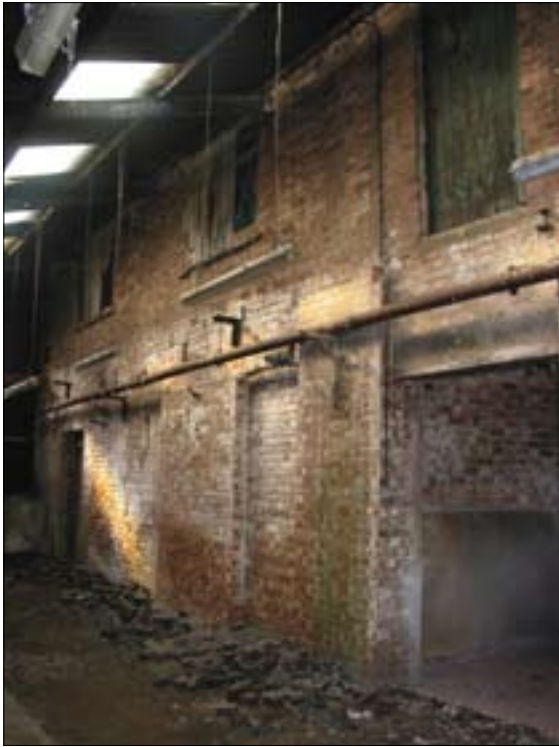
*Figure 39 Southern elevation of block J.  
Hannah Waugh.*

Block J was constructed in two phases, originally being only a single-storey building. The southern elevation has three segmental headed windows on the ground floor to room 31 with brick segmental heads formed from a double row of headers terminating in stretchers. Two of these windows are filled in and partially obscured by the addition of later pilasters constructed to support the external walkway above; the westernmost window has been converted into a doorway (51). The first floor is a later addition with two square headed windows and one doorway to room 53 (door 1, accessed via the walkway). The area to the east of room 31 is open to the yard on the ground floor. The first floor is unsafe to enter but has a concrete floor with iron supports and two wooden trusses. There is a doorway opening in to the room from yard 30 and, to the east of this is a blocked window.
