STONEHENGE WORLD HERITAGE SITE
LANDSCAPE PROJECT
LAKE DOWN, WILSFORD-CUM-LAKE
ARCHAEOLOGICAL SURVEY REPORT

Research Department Report Series 95-2010

ARCHAEOLOGICAL SURVEY REPORT

NGR: SU 118 392

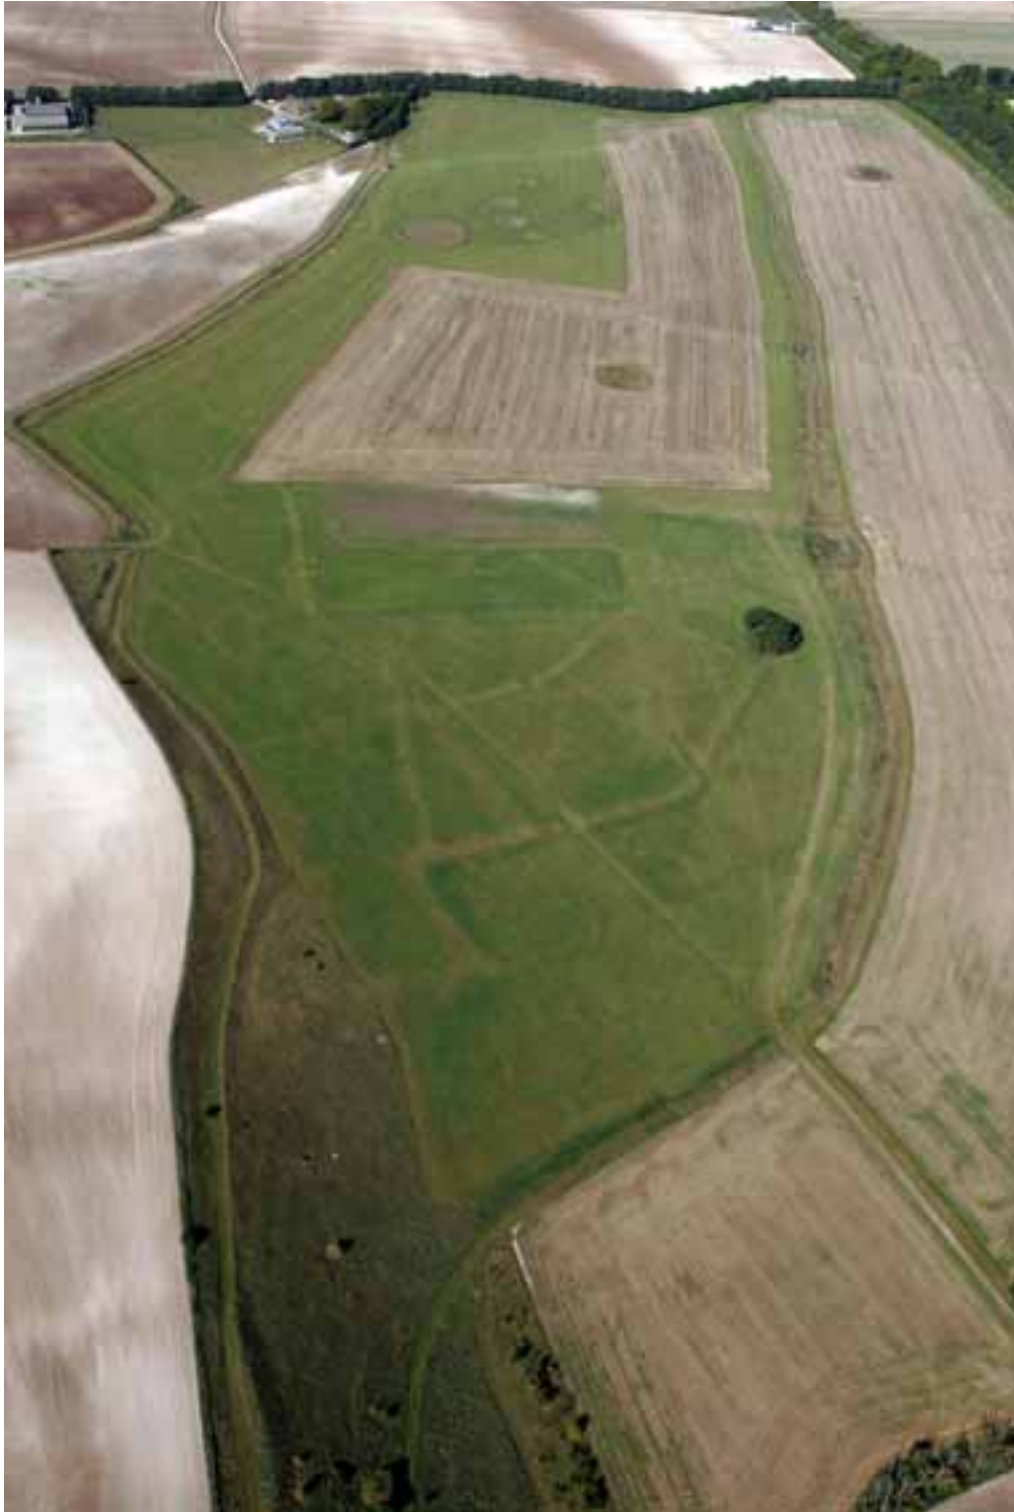
Frontispiece: Lake Down from the south-east, photographed 24th September 2005. In the foreground 'Celtic' field system (NMR SU 13 NW 5) extends into cultivated ground to the left. Two Bronze Age linear ditches (NMR SU 13 NW 18; labelled S and T on plans) extend north-westwards, to 'enclose' the Lake Down barrow group (NMR SU 13 NW 48) and its outlier (SU 13 NW 150; G82), which is seen here within an area of cultivation. To the north of the north-eastern linear earthwork, seen in upper right of the photograph, lies another barrow (SU 13 NW 133; G74); this is an outlier to the Wilsford barrow group situated within the wooded area to the north, which is just visible top right. (NMR 24078/004 © English Heritage. NMR)
