BESSIE SURTEES HOUSE, SANDHILL, NEWCASTLE UPON TYNE DENDROCHRONOLOGICAL ANALYSIS OF OAK TIMBERS

SCIENTIFIC DATING REPORT

Research Department Report Series 26-2010

NGR: NZ 2516 6385

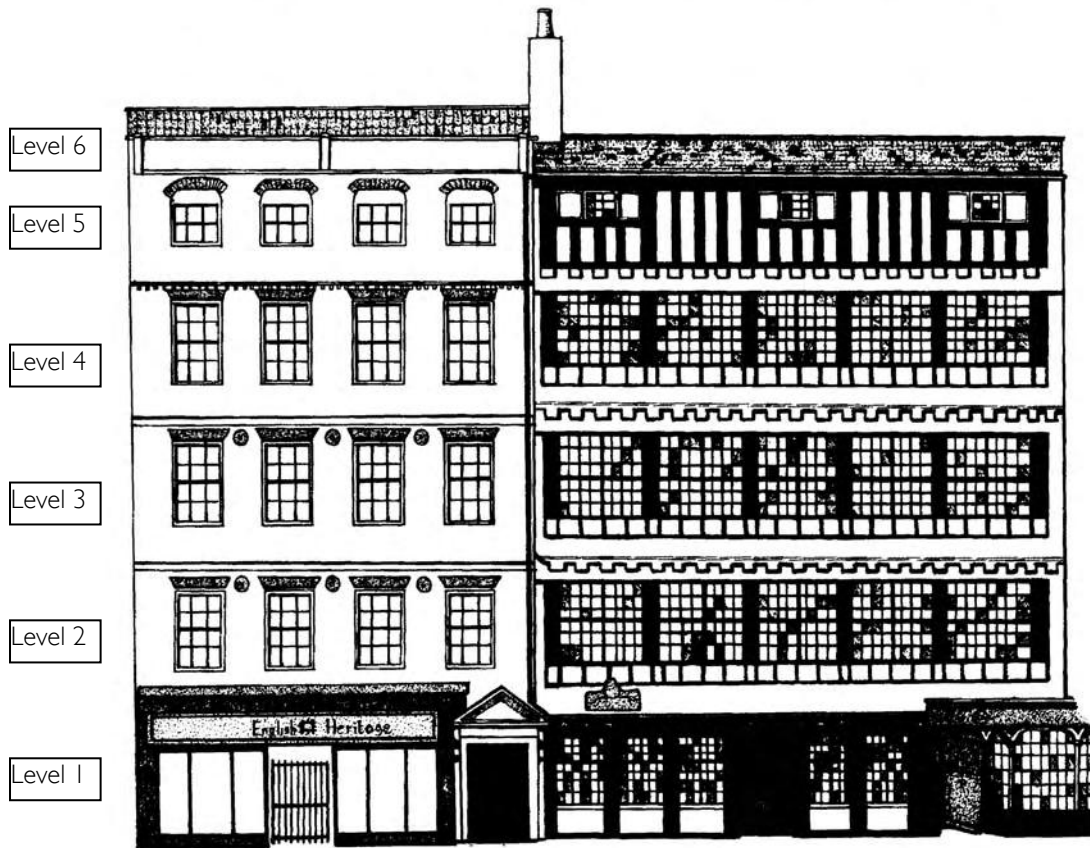
Figure 3. Street frontage of Bessie Surtees House showing the contrasting frontages of Milbank House and Surtees House and also showing Levels 1–6 following the convention of Heslop et al (1994). Based on a figure from English Heritage leaflet 'Bessie Surtees House, Information for Teachers', English Heritage 2000

This five-storey building is a bay wider than Milbank House (Fig 3). The timber-framed structure is jettied at every level (Fig 11), and is one floor lower than Milbank House. The attic had a secondary remodelling to form the garret on the front elevation. The building only came into the same ownership as Milbank House from 1931, so it might be expected to have different construction events, though these are likely to be within a general chronological framework of the same economic and social pressures to extend and aggrandise.

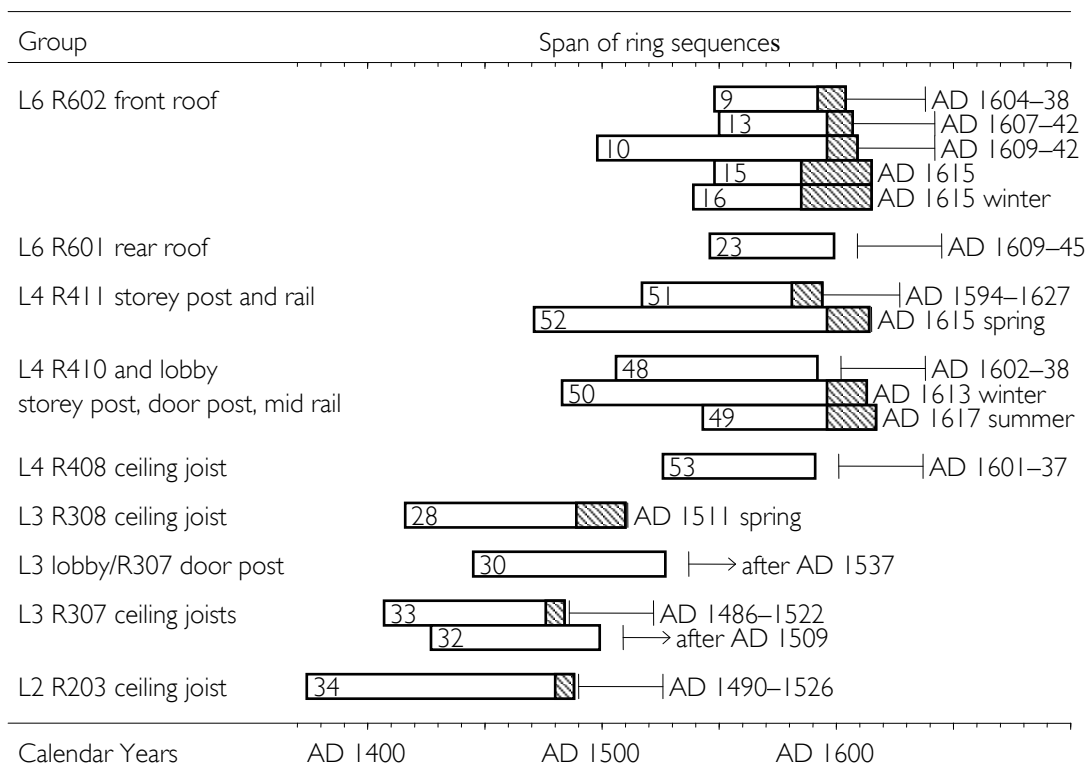
Figure 12. Bar diagram showing the absolute dating positions of the 17 dated tree-ring sequences for samples from Milbank House, Bessie Surtees House. The interpreted felling dates are also shown for each sample

KEY L1-L6 building levels, eg R203, R602 room numbers, following Heslop *et al* (1994), see also Figures 4-9. Horizontal scale the same as for Figures 13 and 14. White bars are oak heartwood, hatched bars are sapwood

from these, named Bessie 2, which matches with reference data (Table 14) at AD 1471 to AD 1650 inclusive. A summary of the results for the component samples of these chronologies are provided in Tables 1–3 and Figures 12–14.

The 32 samples obtained from timbers within Milbank House yielded 17 datable tree-ring sequences. These fall into two clusters of dates: five samples are broadly early sixteenth-century, and were derived from levels 2 and 3, and 12 samples are broadly early seventeenth-century, and were derived from levels 4 and 6 (Fig 12).

The tree-ring analysis dates the rings present in the cores. The correct interpretation of those dates relies upon the characteristics of the final rings in them. Bark-edge survived on one of these timbers, some sapwood on another two, and no sapwood was present on the remaining two. Making allowances for minimum and maximum likely amounts of missing sapwood provides individual felling dates, or felling date ranges, or *terminus post quem* dates for each of the datable timbers. Figure 12 and Table 1 includes the felling date or interpreted felling date ranges for each of the datable samples.

The correct interpretation of these results relies upon the characteristics of the final rings in the samples. Bark-edge survived on five of these timbers, some sapwood on another four, and the onset of sapwood was present on the remaining three. Making allowances for minimum and maximum likely amounts of missing sapwood provides individual felling dates, or felling date ranges, for each of the datable timbers. Figure 12 and Table 1 includes the felling date or interpreted felling date ranges for each of the datable samples.
