WALMER CASTLE, DEAL, KENT ANALYSIS OF THE GLASS

TECHNOLOGY REPORT

Research Department Report Series 2-2011

ANALYSIS OF WINDOW GLASS

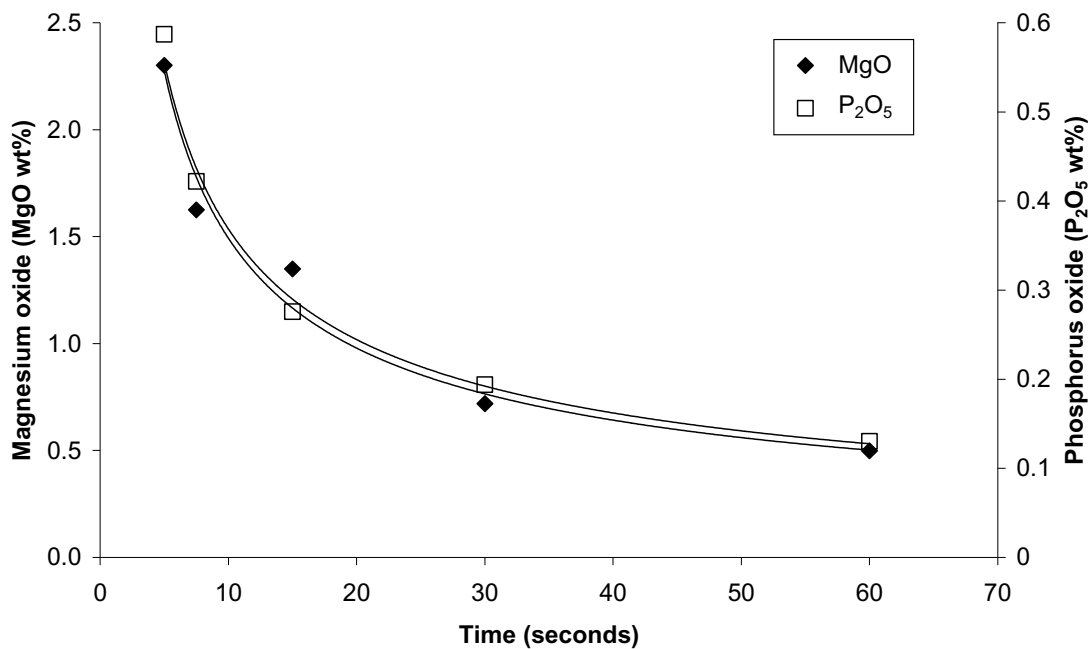
Figure 2. Limits of detection for magnesium and phosphorus oxides for different count times

Initially the instrument was tested (against reference materials) using a count time of 60 seconds for each condition. Such a long count time; however, would mean that it would have taken two to three weeks to complete the number of analyses required to characterise the window glass of a historic building. Several steps were taken to reduce the total count time so that analysis could proceed as quickly as possible. The first step was to reduce the count time for the High condition to 0 seconds; this can be justified on the grounds that this condition is used to detect elements (Table 2) which have not been shown to help assign historic window glass to chronologically significant compositional groups. The second stage comprised a gradual reduction in the count time for the Main, Low and Light conditions. As the count times were reduced the effect on accuracy and limit of detection were determined (Figure 2). The identification of acceptable accuracy and limits of detection were framed by the data obtained from the laboratory-based analysis of historic window glass (Figure 1; Table 1). It was found that count times of 5 seconds each for Main and Low conditions and 15 seconds for Light condition provided sufficient accuracy and limits of detection (Table 3).

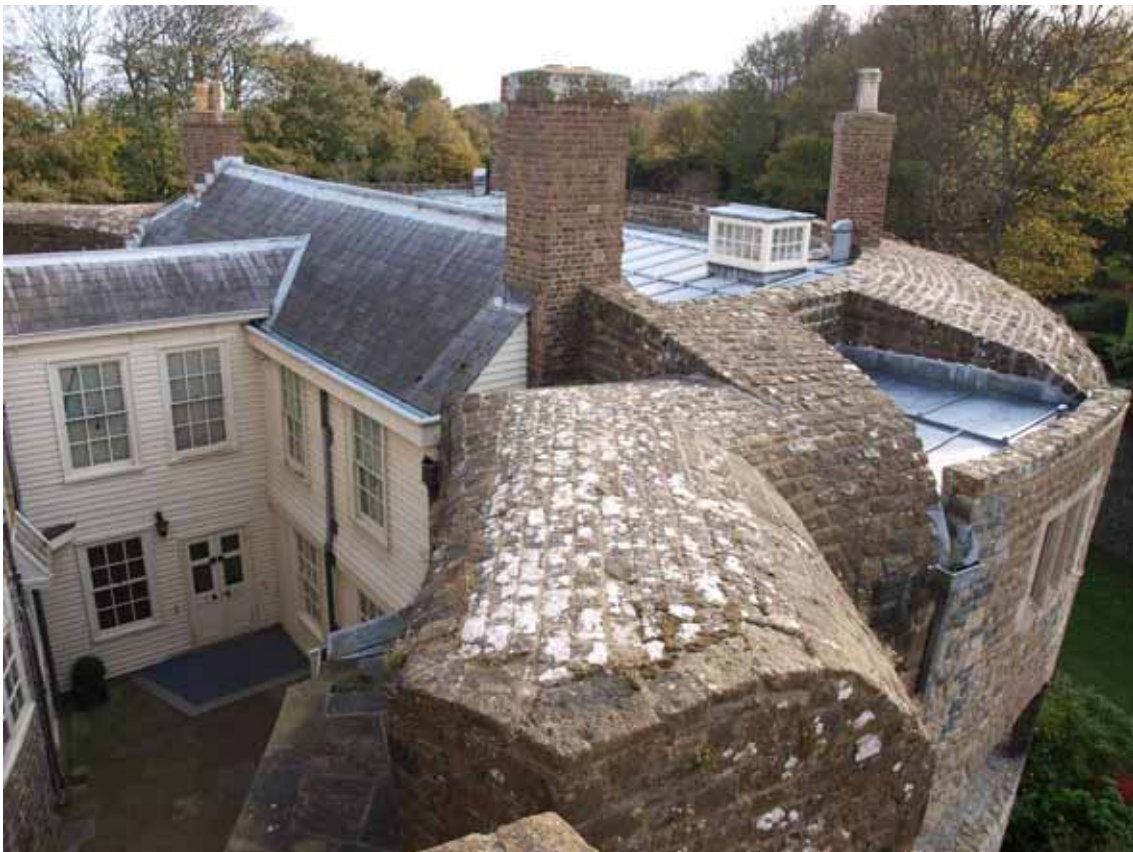
Figure 7. The Gunners' Quarters added to the south-west bastion in the early 18th century

William Pitt (1792–1806) seems to have been responsible for the conversion of the Gunners' Quarters into accommodation for the Lord Warden and his guests. He is also probably responsible for the extension of these rooms to cover the entire south-west bastion (Figure 7). The Earl of Granville (1865–1891) commissioned considerable alterations to the north-west bastion. It was heightened to provide the Earl with extra accommodation (Figure 10) and 'the outline is now one of picturesque variety' (Newman 1983, 489). The mullioned windows in the south-west bastion are also thought to have been installed at this date.

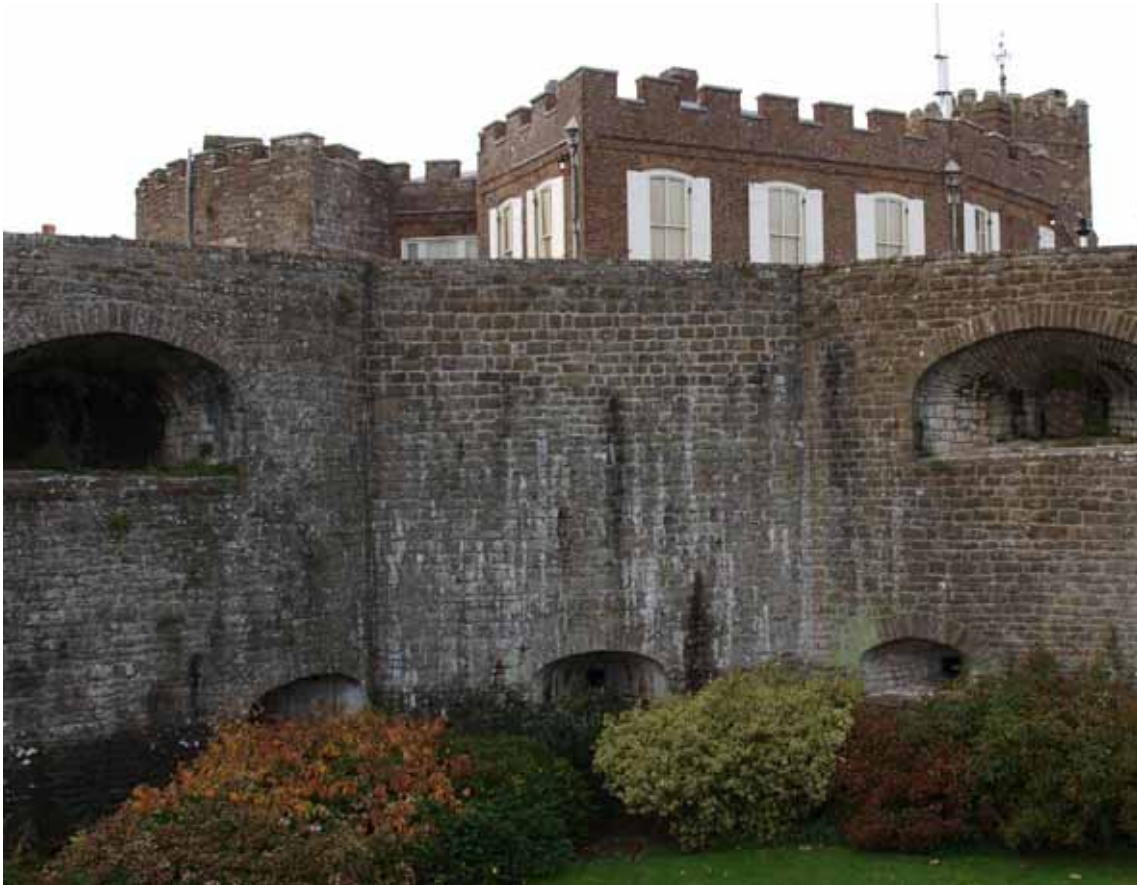
Figure 8. Brick-built rooms (F14 and F15) added to the north-east bastion in the early 18th century

Much of Walmer Castle comprises the Henrician fort built in the 16th century although the additions and alterations of various Lords Warden can be identified (Newman 1983, 489). The earliest alterations belong to the early 18th century when the Duke of Dorset was Lord Warden (Figure 6). It is likely that the first floor of the central tower was at this time converted to provide accommodation. Rooms were added to the south-west bastion which are labelled on contemporary documents as Gunners' Quarters (Figure 7). Above the north-east bastion, the Duke of Dorset added a series of brick-built rooms with castellated wall summits (Curzon 1927, 14; Newman 1983, 489; Figure 8). Some of

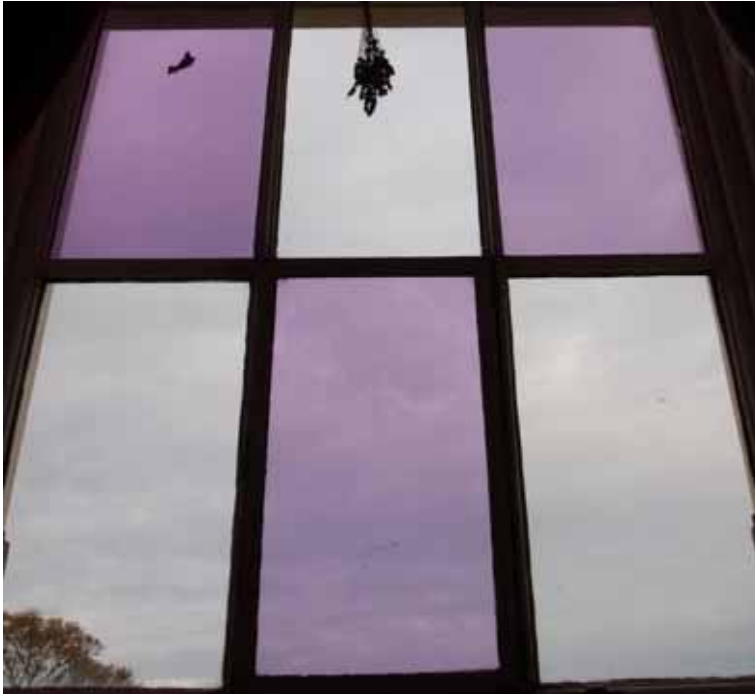
Figure 9. Window 41 showing pink/purple glass attributed to Earl Liverpool (1806–1828)

the windows in these rooms contain pink/purple glass (Figure 9) which has traditionally been ascribed to the Earl of Liverpool (1806–1828), 'I was further told that the tinted glass in several of the sash windows of the Castle was introduced because one of his two Countesses had weak eyes, but I should not like to vouch for this legend.' (Curzon 1927, 160).

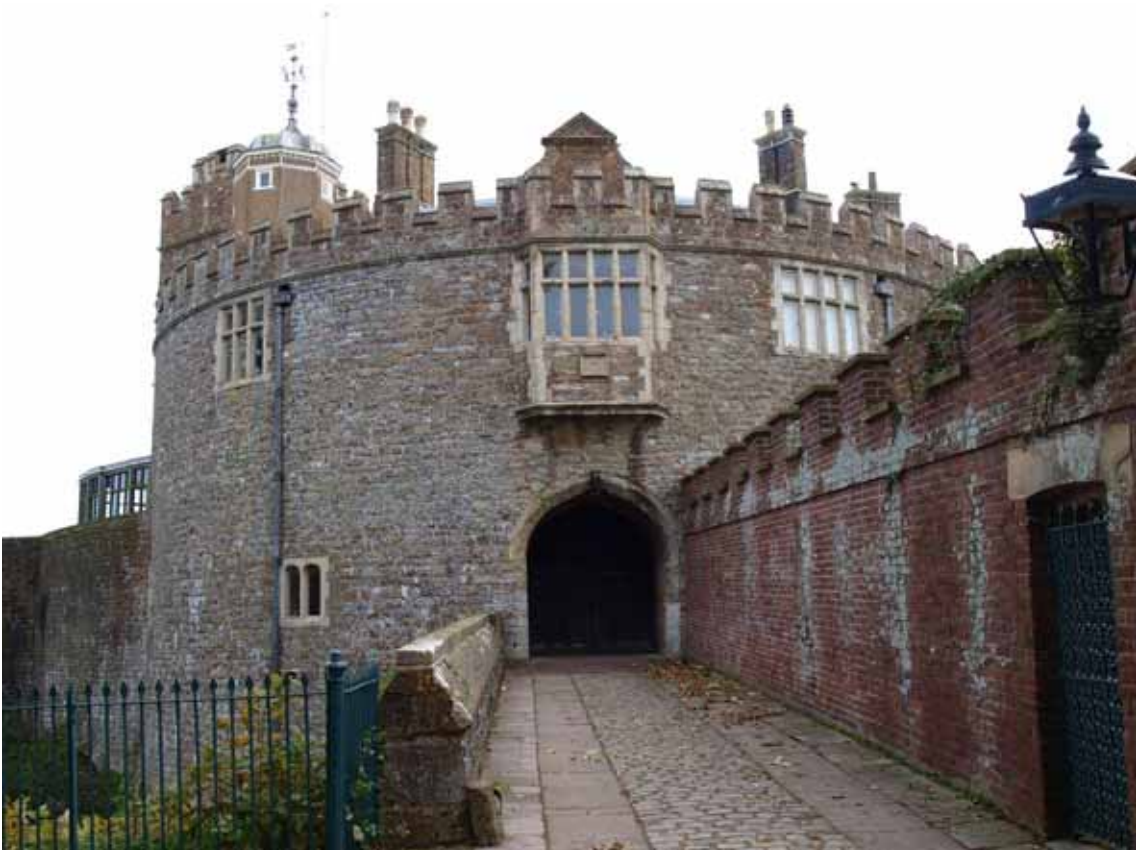
Figure 10. The north-east bastion which was heightened in the 1870s

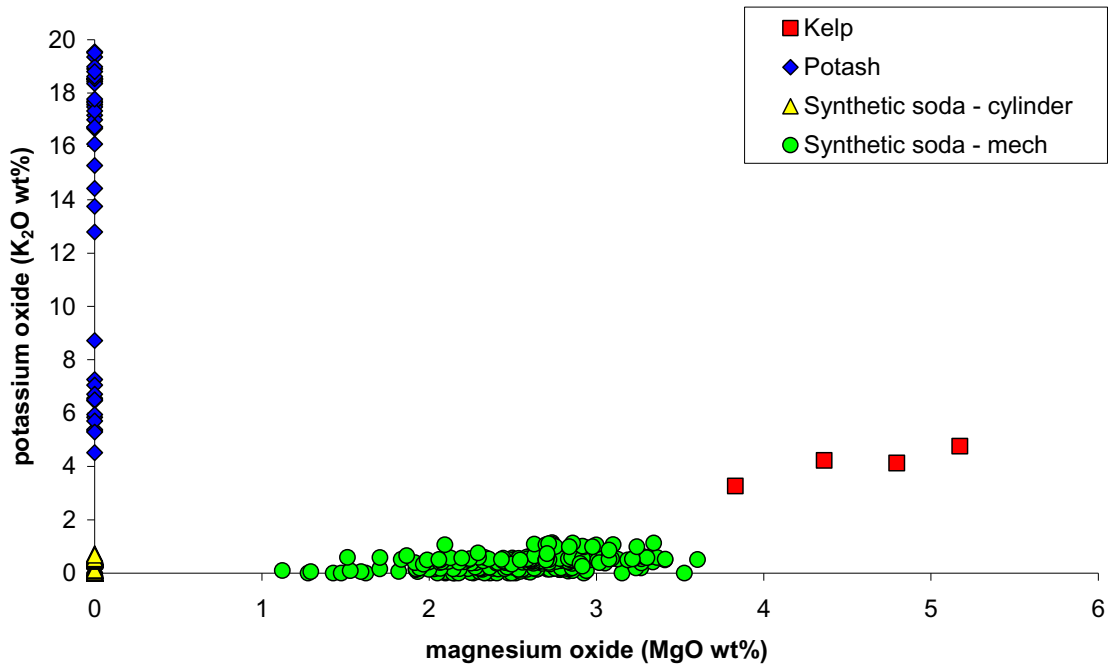
Figure 11. Magnesium and potassium concentrations of window glass from Walmer Castle (includes only samples that were analysed without UV-absorbing films)

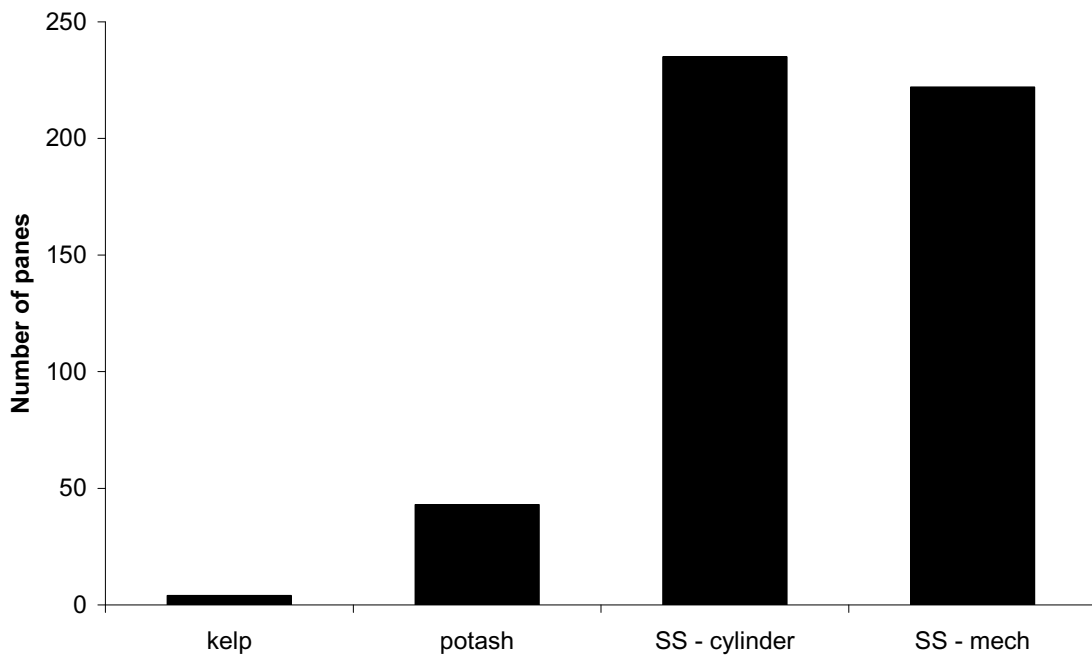
Figure 12. Histogram showing the proportion of different major window glass types from Walmer Castle (includes only samples that were analysed without UV-absorbing film)

The window glass from Walmer Castle is dominated by synthetic soda glass: 90% of the analysed panes were made after the introduction of Leblanc soda in 1835 (Figure 12). About half of these synthetic soda glasses would have been made prior to 1930 and half afterwards. Less than 1% of the analysed panes are made of kelp glass (c1700 to c1835). The remaining 9% are the potash glasses.

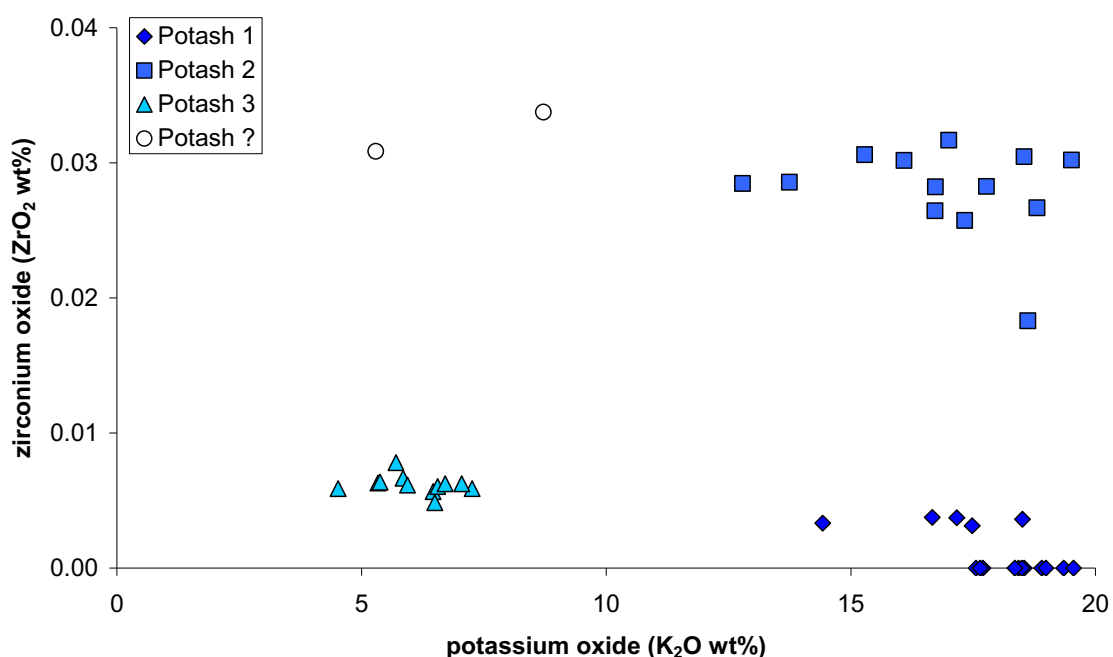
Figure 13. Potassium and zirconium content of the potash glass from Walmer Castle

The potash glass can be divided into three compositional groups (Figure 13; Table 8) which suggests that not all of this glass was made at the same time or place. While some of the potash glass is colourless (Potash 3) most is pink or purple in colour due to the presence of manganese (Table 8).

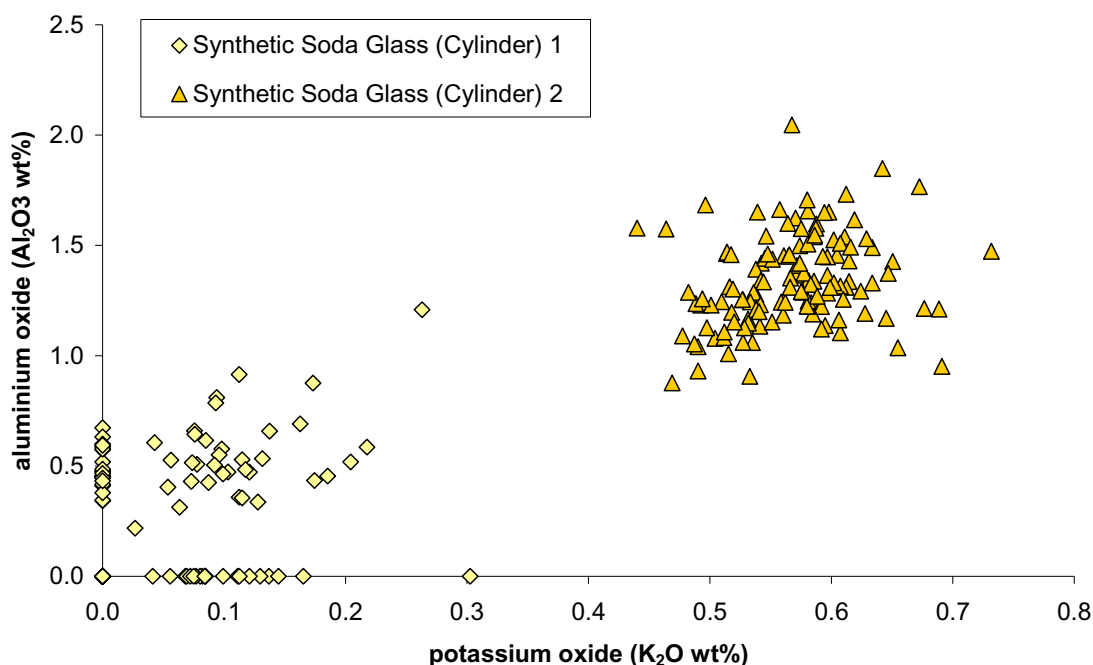
Figure 14. Potassium and aluminium content of Synthetic Soda Glass (Cylinder)

The synthetic soda glass (cylinder) can be divided into two compositional groups: the first with low aluminium and potassium and the second with higher concentrations of both elements (Figure 14; Table 9). There are few other differences between these groups, although the first tends to contain more arsenic. Arsenic appears to have been used as a refining agent for several decades after the introduction of Leblanc soda and then (c1870) largely replaced by potassium nitrate (saltpetre). It is likely that synthetic soda glass (cylinder) 1 was manufactured and installed before synthetic soda glass (cylinder) 2.

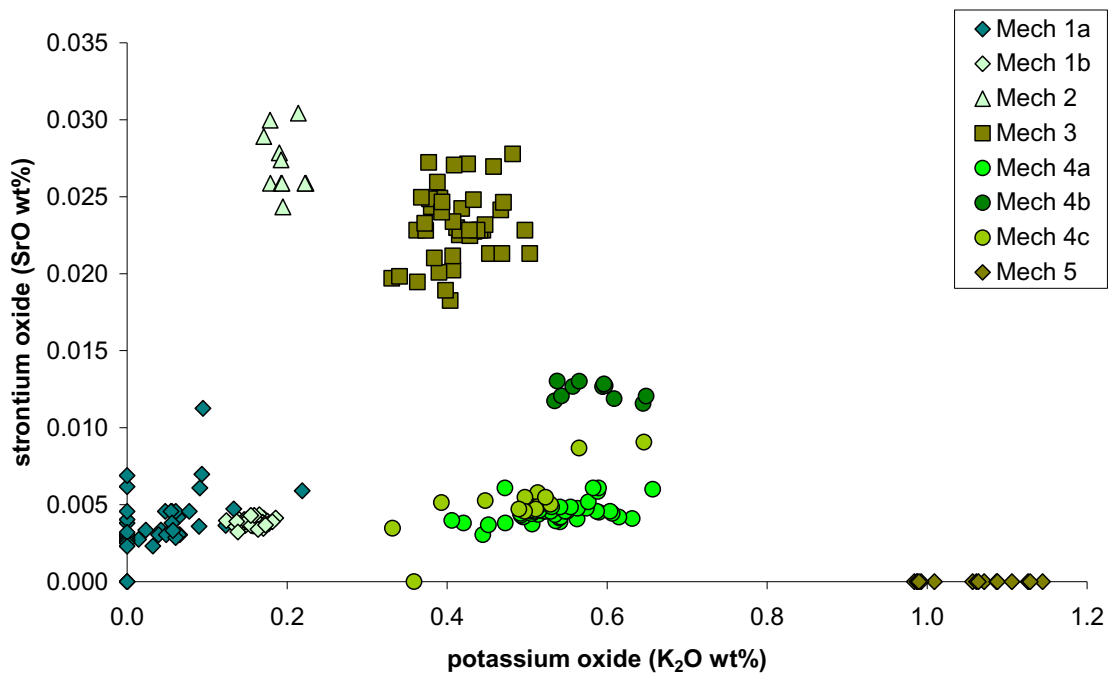
Figure 15. Potassium and strontium content of the mechanised glass

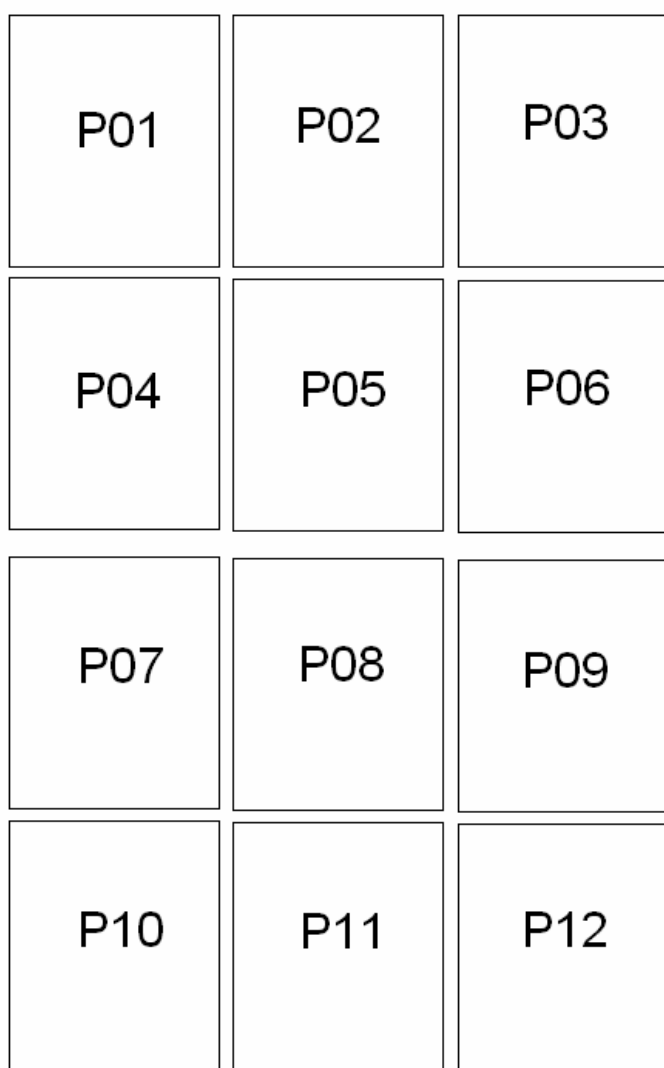
Figure 16. Hypothetical window showing the convention for numbering the panes

This section considers the analytical results window by window. The window numbers are those given in the plans and list in the appendices. In each window the panes were identified individually. The first pane was in the top left hand corner and subsequent pane numbers assigned by 'reading' from left to right and then beginning on a new row (Figure 16). The numbers were assigned when the window was analysed and this was either from the interior or exterior depending on circumstances. Care was taken to ensure the same pane numbers were used for those windows where analysis was carried out on interior and exterior surfaces.

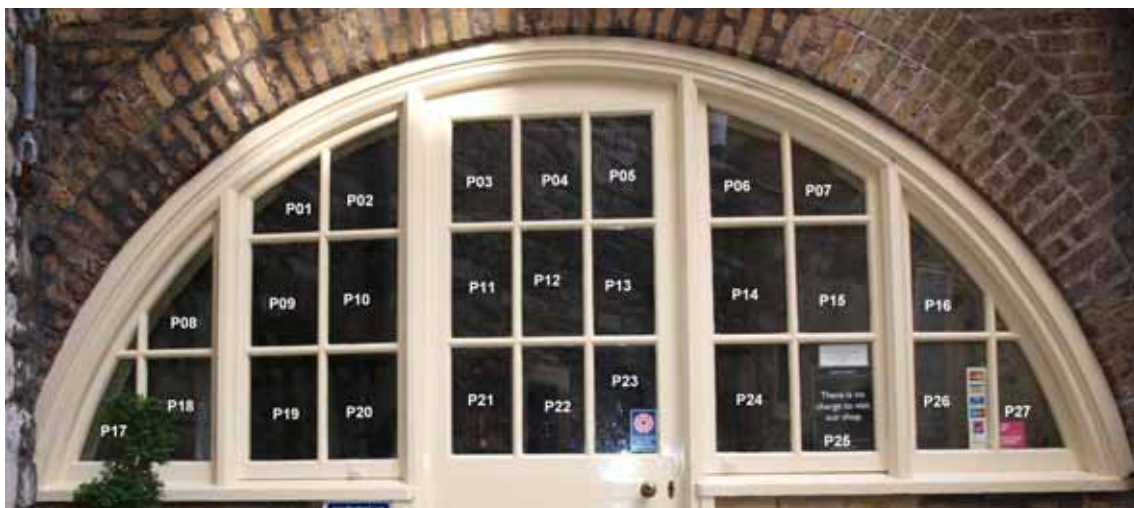
Figure 17. D12

Twenty-seven panes of glass (two very small panes are not included) within a door and two flanking windows forming the main entrance to the shop (numbered from the outside, G19, see Figure 17). Twenty-three of the panes are synthetic soda (cylinder) 2 glass and share a virtually identical composition. This is the same composition of glass as used for D13 (see below). It is likely that all of these panes were installed at the same time and they may even represent the original glazing. This type of glass was most likely to have been manufactured between c1870 and c1930. The four replacement panes are 13, 16, 19 and 21 and each of these is a member of a separate sub-group of mechanised glass, suggesting the replacement of individual panes as this became necessary. Two out of the four replaced panes are in the door rather than the flanking windows probably because these panes would be subject to greater danger of breaking (eg slamming door).

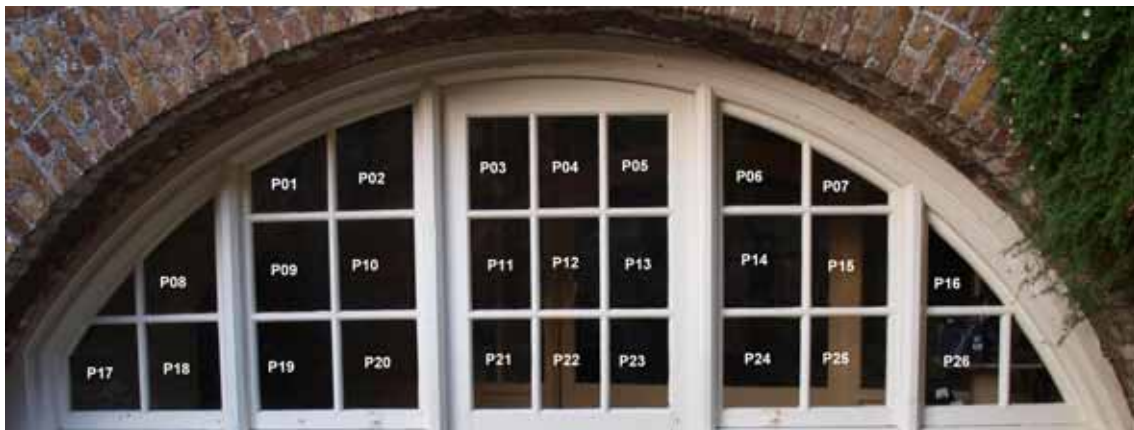
Figure 18. D13

A door very similar to D12 with twenty-seven panes of glass (two very small panes are not included). This door and two flanking windows form the rear entrance to the shop (numbered from the outside, G24, see Figure 18). Twenty-three of the panes are synthetic soda (cylinder) 2 glass and share a virtually identical composition. This is the same composition of glass as used for D12 (see above). It is likely that all of these panes were installed at the same time and they may even represent the original glazing. This type of glass was most likely to have been manufactured between c1870 and c1930. The four replacement panes are 3, 4, 18 and 22 and each of these is a member of a separate sub-group of mechanised glass, suggesting the replacement of individual panes as this became necessary. Three out of the four replaced panes are in the door rather than the

flanking windows probably because these panes would be subject to a greater danger of breaking (eg slamming door).

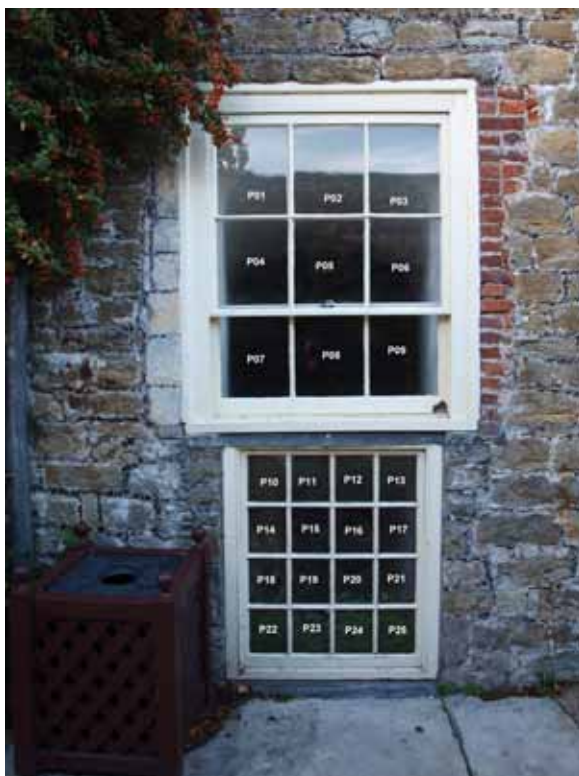
Figure 19. W14

Twenty-five panes of glass making two separate windows, one above the other (Figure 19). The top window has nine panes arranged in three rows of three. The bottom window has sixteen panes arranged in four rows of four. All sixteen panes in the lower window are mechanised glass and all share the same composition. The glass in this window has been installed at some time after c1930. The upper window contains a single pane of synthetic soda (cylinder) 1 glass, four synthetic soda (cylinder) 2 glass panes and four mechanised glass panes. The earliest extant glass in this window was probably manufactured between c1835 and c1870.

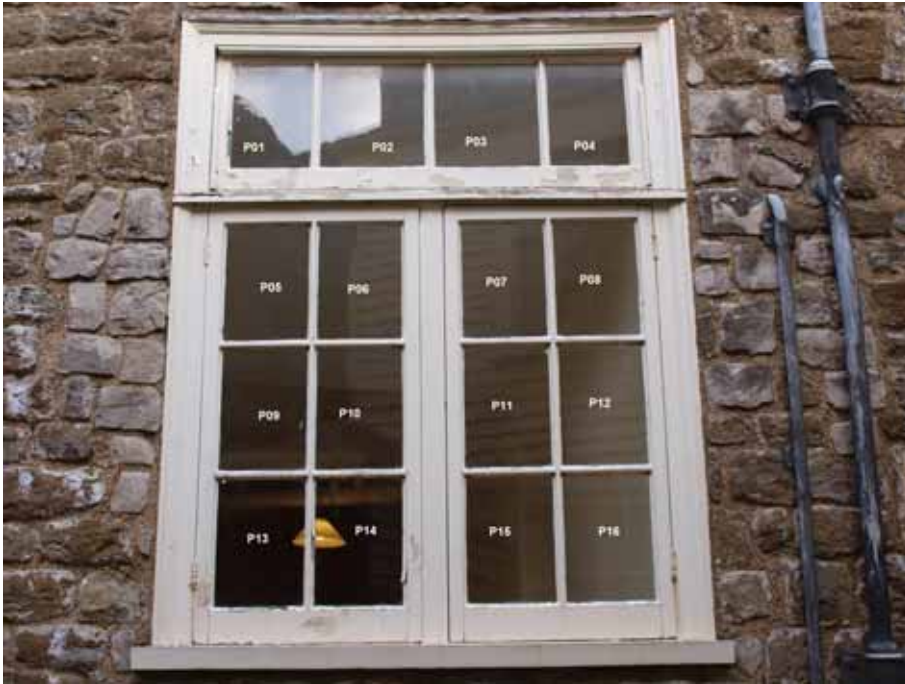
Figure 19. W20

Sixteen panes in four rows of four (Figure 19). A single pane is a synthetic soda (cylinder) 1 glass but all of the others are synthetic soda (cylinder) 2. If the single pane of synthetic soda (cylinder) 1 glass represents the original glazing then this can be placed in the period c1835 to c1870.

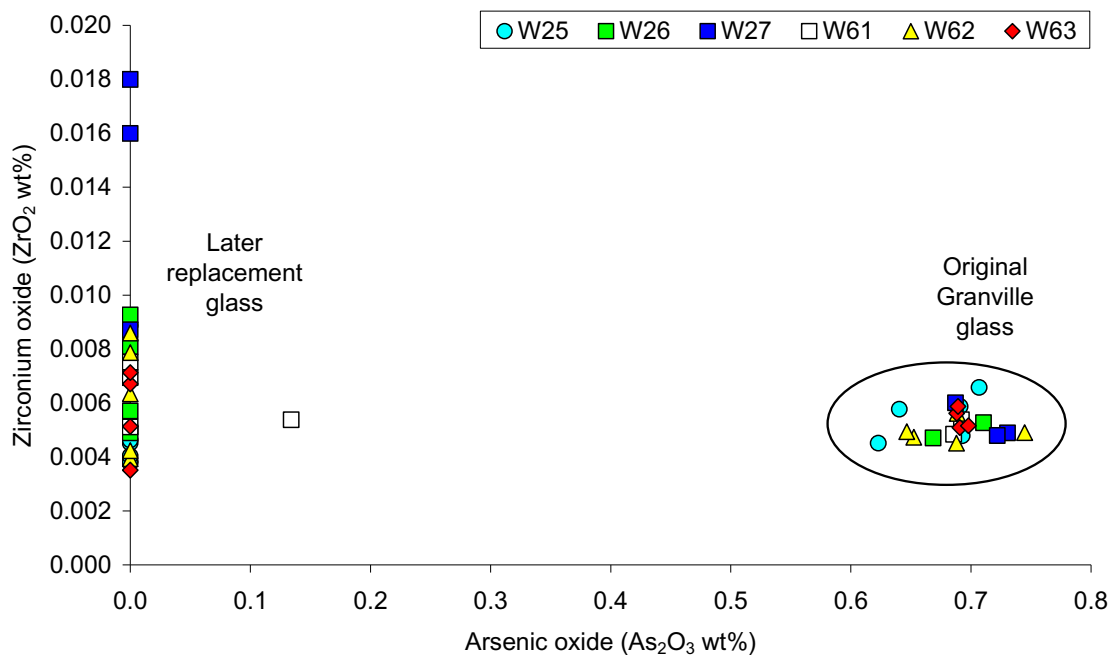
Figure 20. Arsenic oxide and zirconium oxide content of glass from six windows in the rooms added by the Earl of Granville in the 1870s

A single type of synthetic soda (cylinder) glass with a distinctive arsenic content has been identified in W25–27 and W61–63 (Figure 20). These rooms were created in the 1870s by the Earl of Granville and this glass probably represents the glass originally installed in the 1870s. All of the remaining panes of glass in these rooms have compositions which are consistent with their being later replacements. The remaining synthetic soda glass (cylinder) displays considerable compositional variation suggesting the extensive but perhaps piecemeal replacement of much of the Walmer Castle window glass.
