# 8-9, 9A, AND THE LAW LIBRARY, THE CLOSE, EXETER, DEVON TREE-RING ANALYSIS OF TIMBERS

## SCIENTIFIC DATING REPORT

Research Department Report Series 21-2011

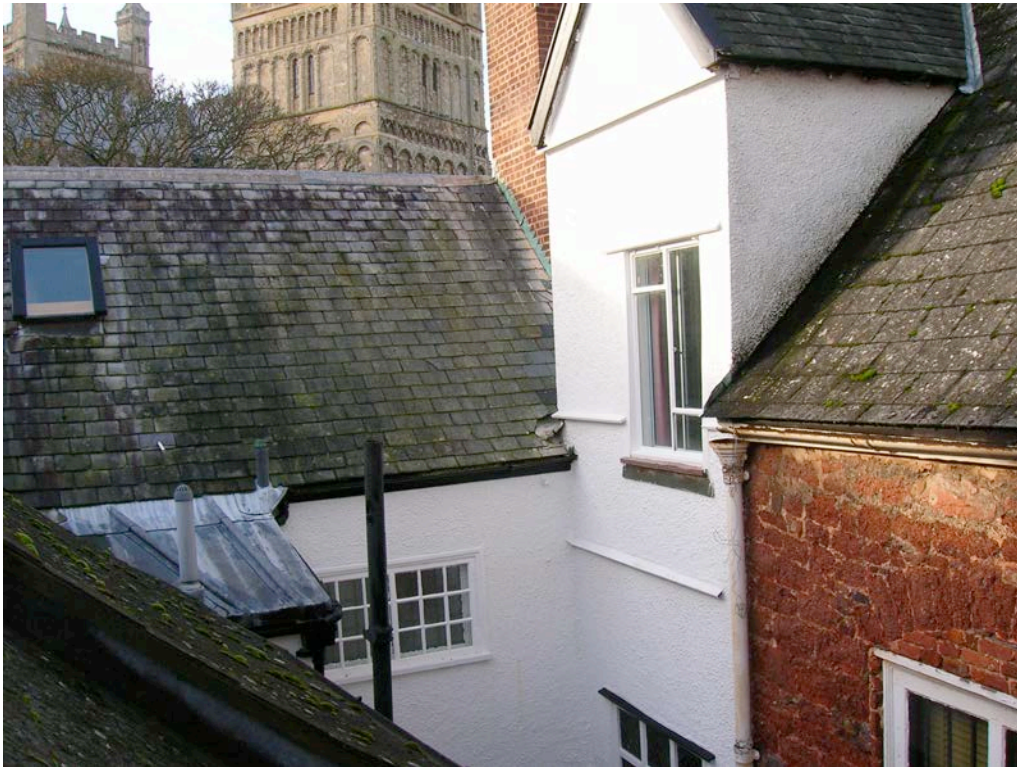
*Figure 4: View of the small enclosed rear courtyard area from the attic of 9a The Close. To the right may be seen the southern end of the Law Library attached to the rear of numbers 8-9 The Close. Exeter Cathedral may be glimpsed beyond*

This complex of buildings under investigation is located on The Close in Exeter (SX 921 926; Figs 1 and 2). Number 8-9 forms a broad front range facing south onto Cathedral Green, whilst two additional ranges run from the rear of this front range at obtuse angles (Fig 3). The rear range at the east end forms 9a The Close, whilst the rear range at the west end is known as the Law Library. Together the three ranges thus almost enclose a small, elongated, courtyard (Figs 3 and 4).

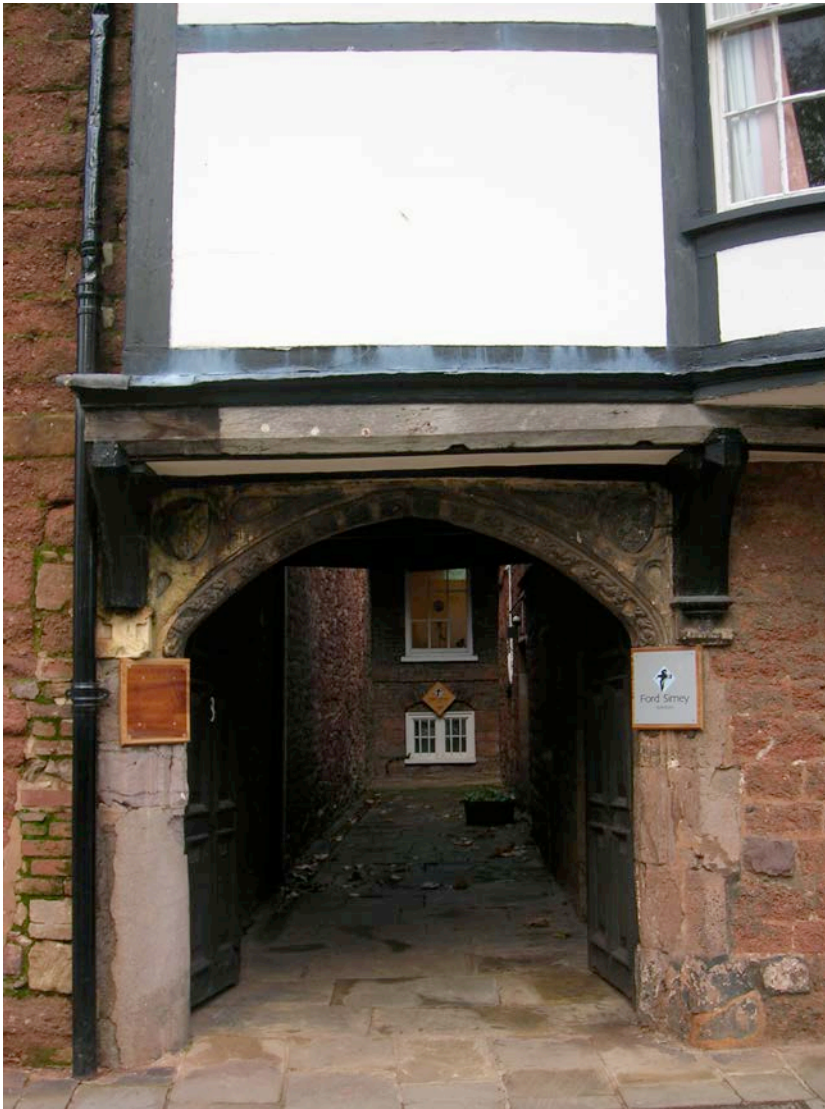
*Figure 5: 8-9 The Close; view of the passageway with its decorated arch at the west end of the front range*

The front range, 8-9 The Close, is of two storeys, coursed in Heavitree stone to the ground floor, with a wide, decorated, arched passageway at its west end (Fig 5). The half-timbered upper floor over-sails the lower, being supported on curved oak brackets resting on stone corbels. The roof of the front range is of comparatively plain principal rafter trusses with collars and arch-braces, the principals carrying double through-purlins. All such timbers are lightly carved with shallow roll-mouldings. Although no date has been ascribed to this range, it is thought to be late-medieval.

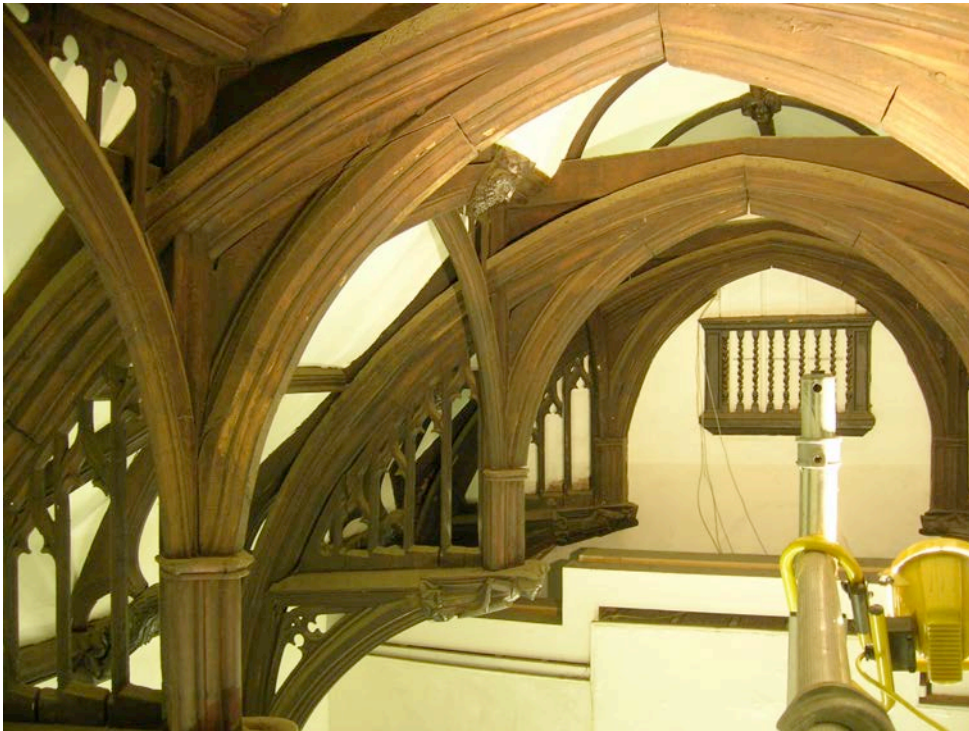
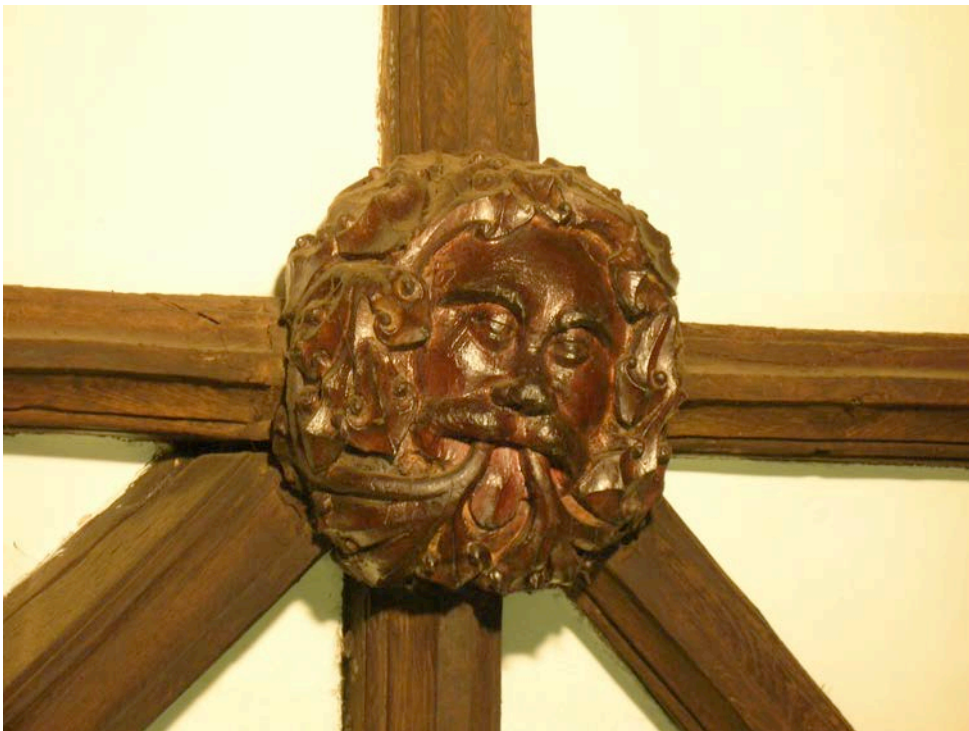
*Figure 6a (top): View of Law Library roof*

*Figure 6b (bottom): View of a boss hiding the junction of timbers*

The rear west range, the Law Library, contains a three-bay open hall formed by four single hammer beam roof trusses of a design similar to that of Westminster Hall. Between the main trusses there are intermediate frames. The hammer-beams, arch-braces, coved rafters, and purlins, along with many other elements, are all highly moulded and carved, as is the open-work tracery in-fill. The ends of the hammer beams are decorated with angels, whilst ornately carved bosses hide the joints between timbers (Fig 6a/b). The roof is thus exceptionally decorative, even by the standards of the Exeter group, of which other examples include The Archdeacon's House, The Guildhall, and The Deanery (Howard *et al* 1999a, 1999b, 2000). The Law Library is believed to date to c AD 1450-AD 1550, but a date as early as c AD 1390 has also been suggested.

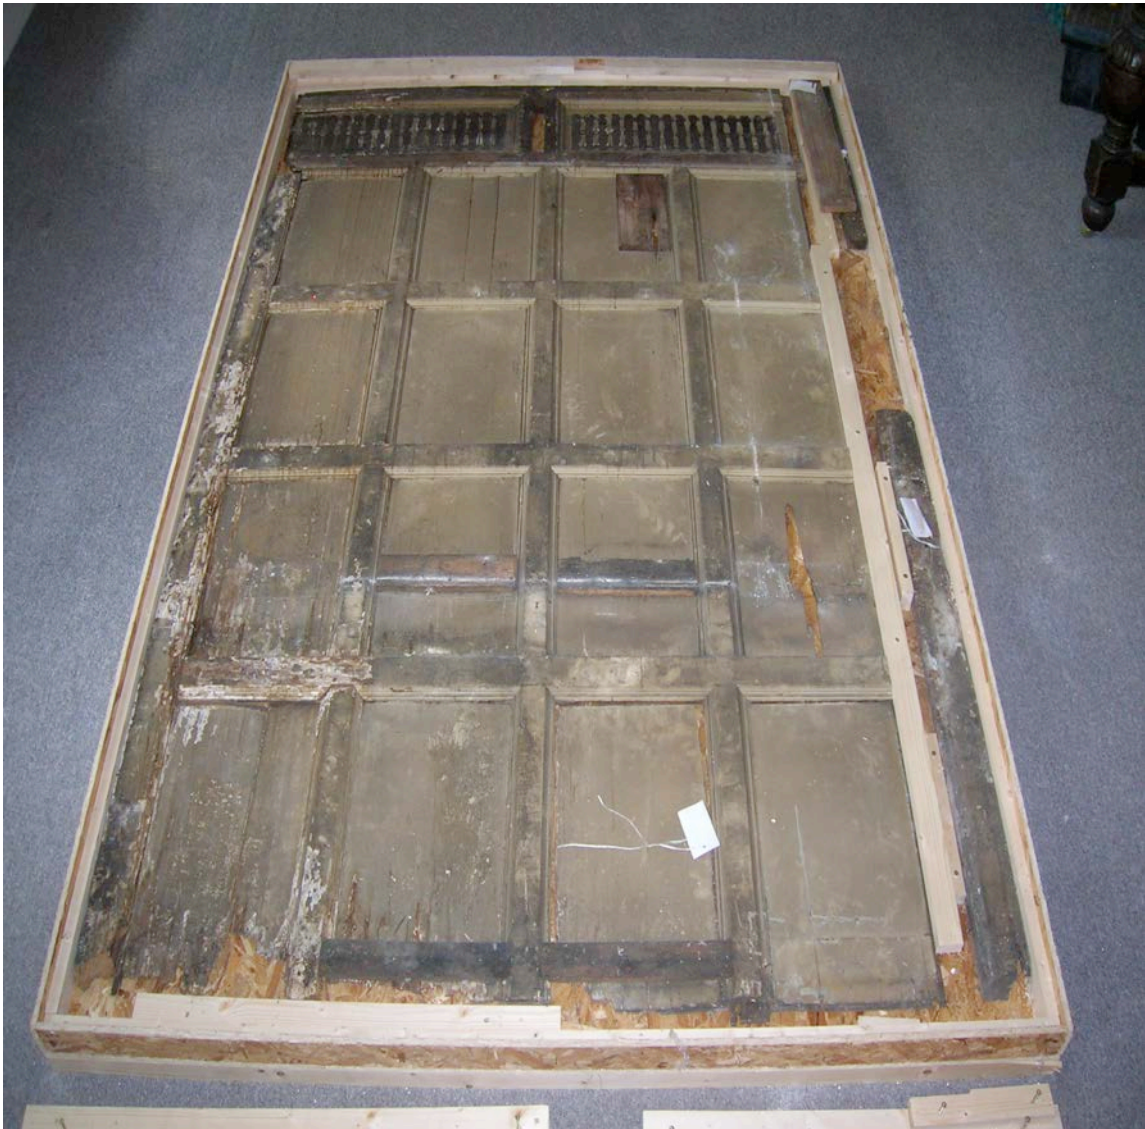
*Figure 8: View of the panels from 8-9 The Close*

Sampling and analysis by tree-ring dating of timbers from the three constituent parts of this building complex, 8-9 The Close, 9a The Close, and the Law Library, were commissioned by English Heritage. Apart from the roof timbers of each part, this programme of analysis was to include a series of joists to the ground-floor ceiling of the front range, both those always exposed in the external west passageway and those exposed by the lifting of a small number of first-floor floorboards during internal renovation works. The sampling and analysis of a small section of wall panelling temporarily removed from the front range during repairs was also requested (Fig 8).

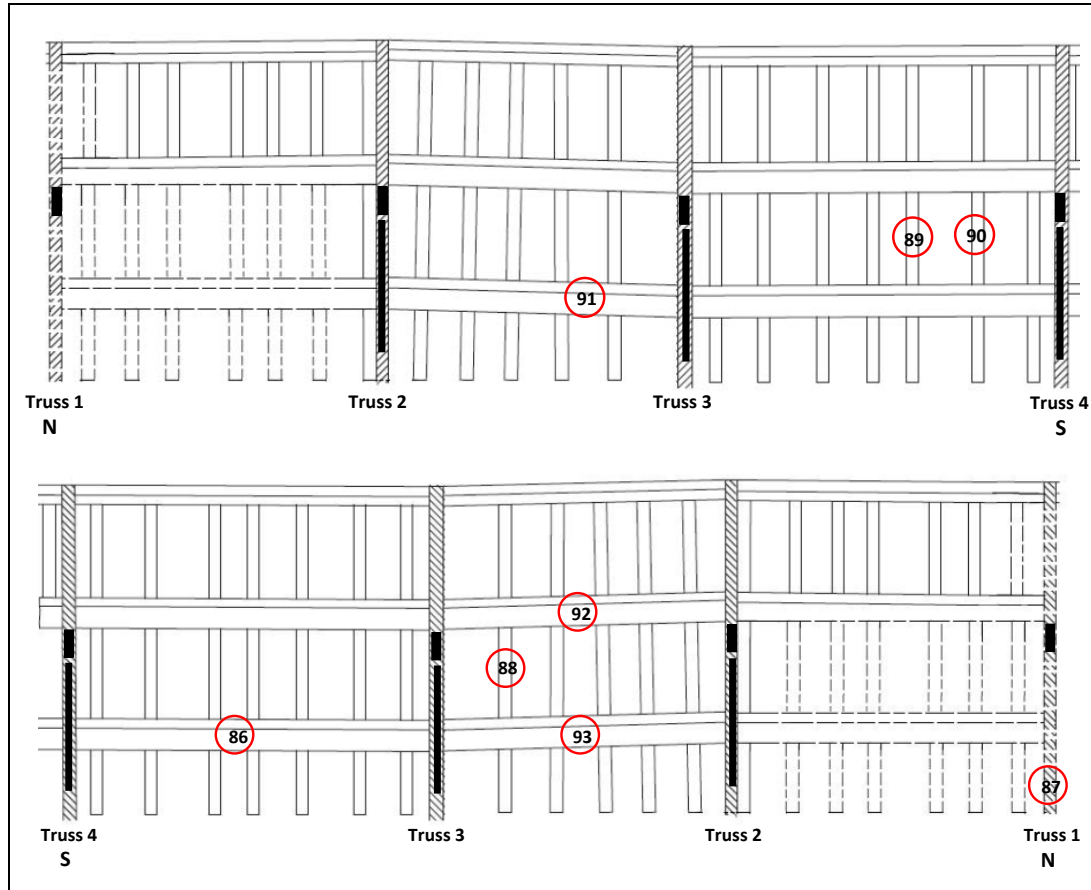
Figure 11d: 9a The Close (roof 1); long-sections through upper parts of trusses 1-4 showing sample locations (after John Allan, Exeter Archaeology)

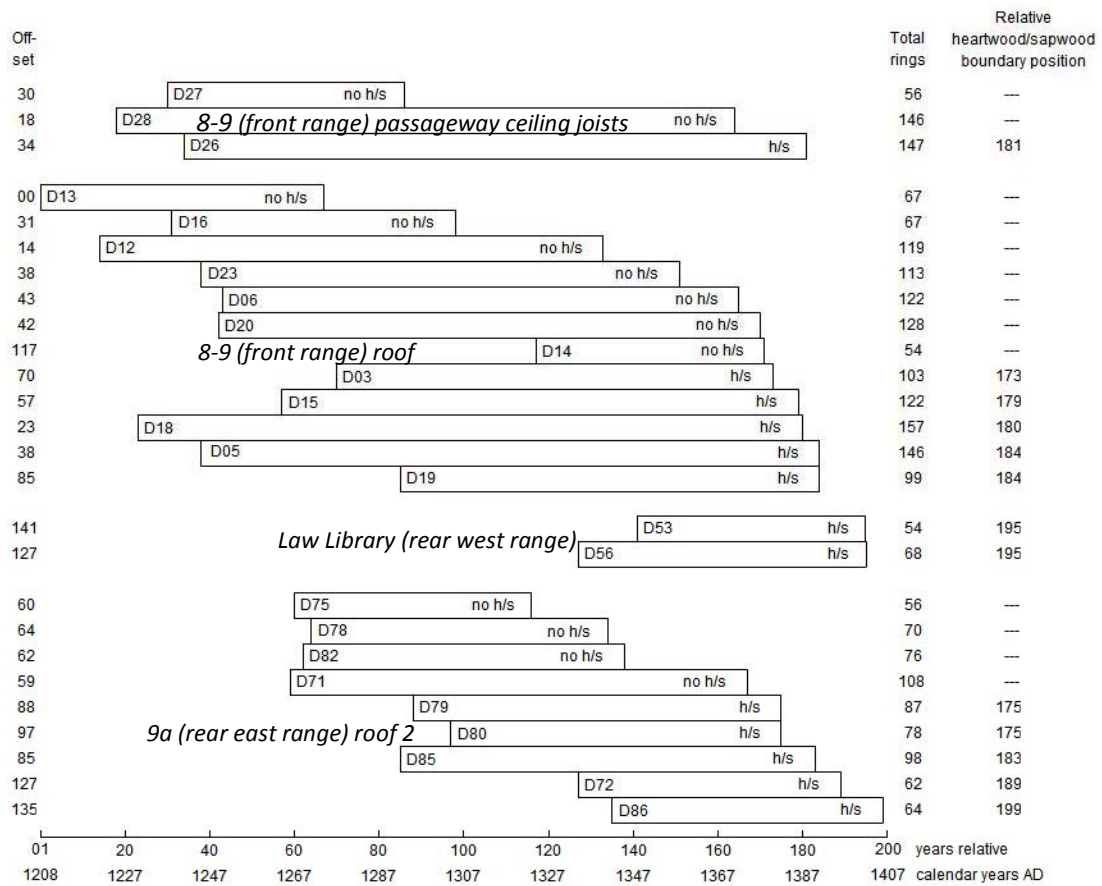
Empty bars  = heartwood rings

h/s = the last ring on the sample is at the heartwood/sapwood boundary, only the sapwood rings are missing. NB: Samples D75 & D79 are from the same timber)

Figure 12: Bar diagram of the samples in site chronology EXTDSQ01 sorted by sample location in last measured ring date order

As may be seen from Table 1 and the bar diagram, Figure 12, where the cross-matching samples of dated site chronology EXTDSQ01 are shown sorted by sample location and in last measured ring date order, the overall position of the heartwood/sapwood boundary varies by some 26 years. The earliest sapwood boundary is a relative position 173 (AD 1380), on sample EXT-D03, with the latest boundary being at relative position 199 (AD 1406) on sample EXT-D86. This variation is possibly slightly wider than might be expected in a group of timbers were they all cut at the same time as each other in a single episode of felling, but might be explicable in timbers felled over a period of time. In respect of this possibility, it may be of interest to note that if the samples are examined by area group, a slight difference in felling date range may be detected. Although this dating would support the relative sequence of building construction as intimated by the structural evidence, because the date ranges have a significant overlap, this does not necessarily indicate that the two parts of the building are definitely of different construction dates.

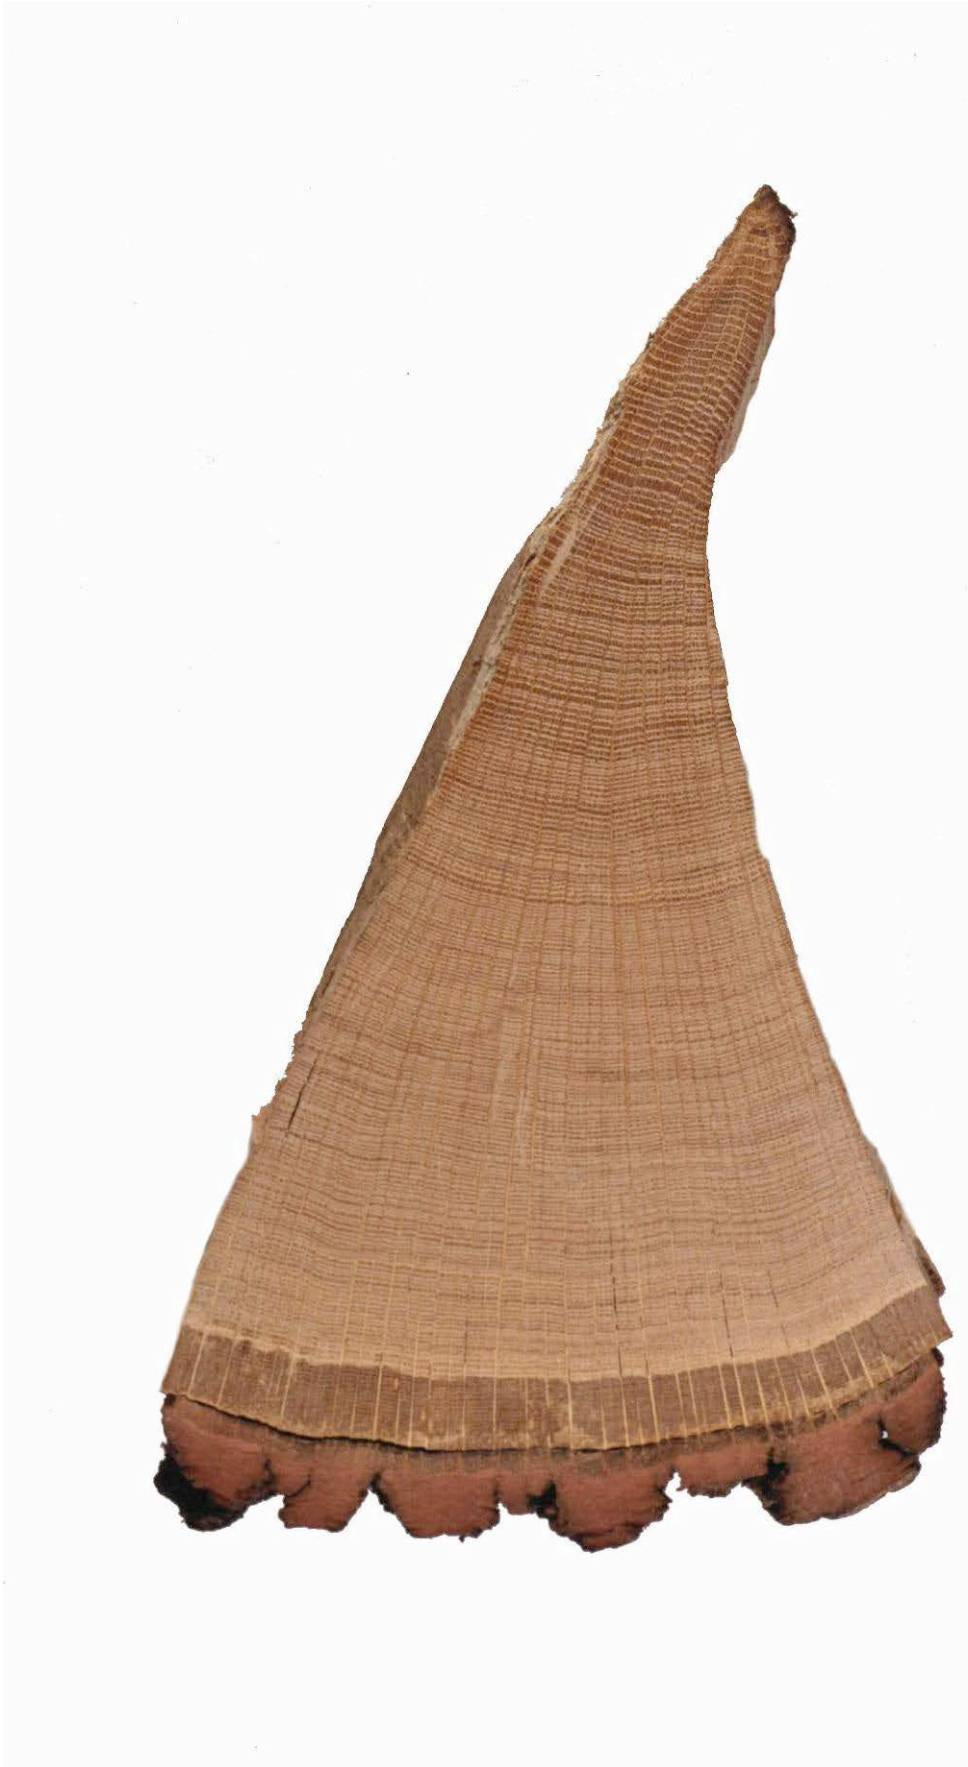
Figure A1: A wedge of oak from a tree felled in 1976. It shows the annual growth rings, one for each year from the innermost ring to the last ring on the outside just inside the bark. The year of each ring can be determined by counting back from the outside ring, which grew in 1976

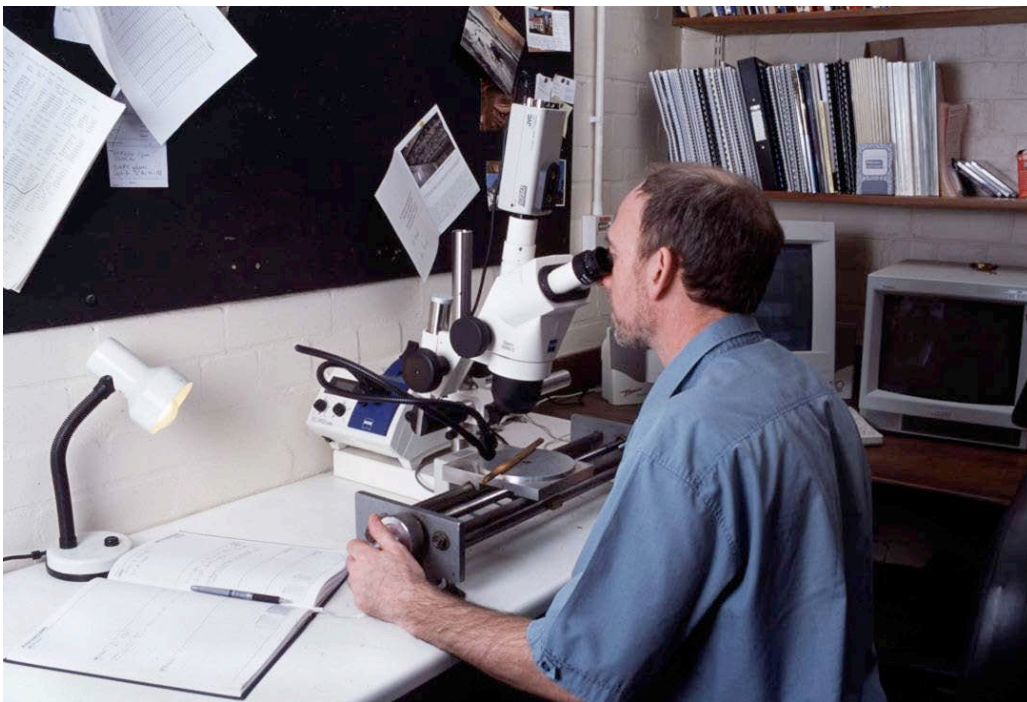
Figure A3: Measuring ring widths under a microscope. The microscope is fixed while the sample is on a moving platform. The total sequence of widths is measured twice to ensure that an error has not been made. This type of apparatus is needed to process a large number of samples on a regular basis

**2. Measuring Ring Widths.** Each core is sanded down with a belt sander using medium-grit paper and then finished by hand with flourgrade-grit paper. The rings are then clearly visible and differentiated from each other with a result very much like that shown in Figure A2. The core is then mounted on a movable table below a microscope and the ring-widths measured individually from the innermost ring to the outermost. The widths are automatically recorded in a computer file as they are measured (see Fig A3).

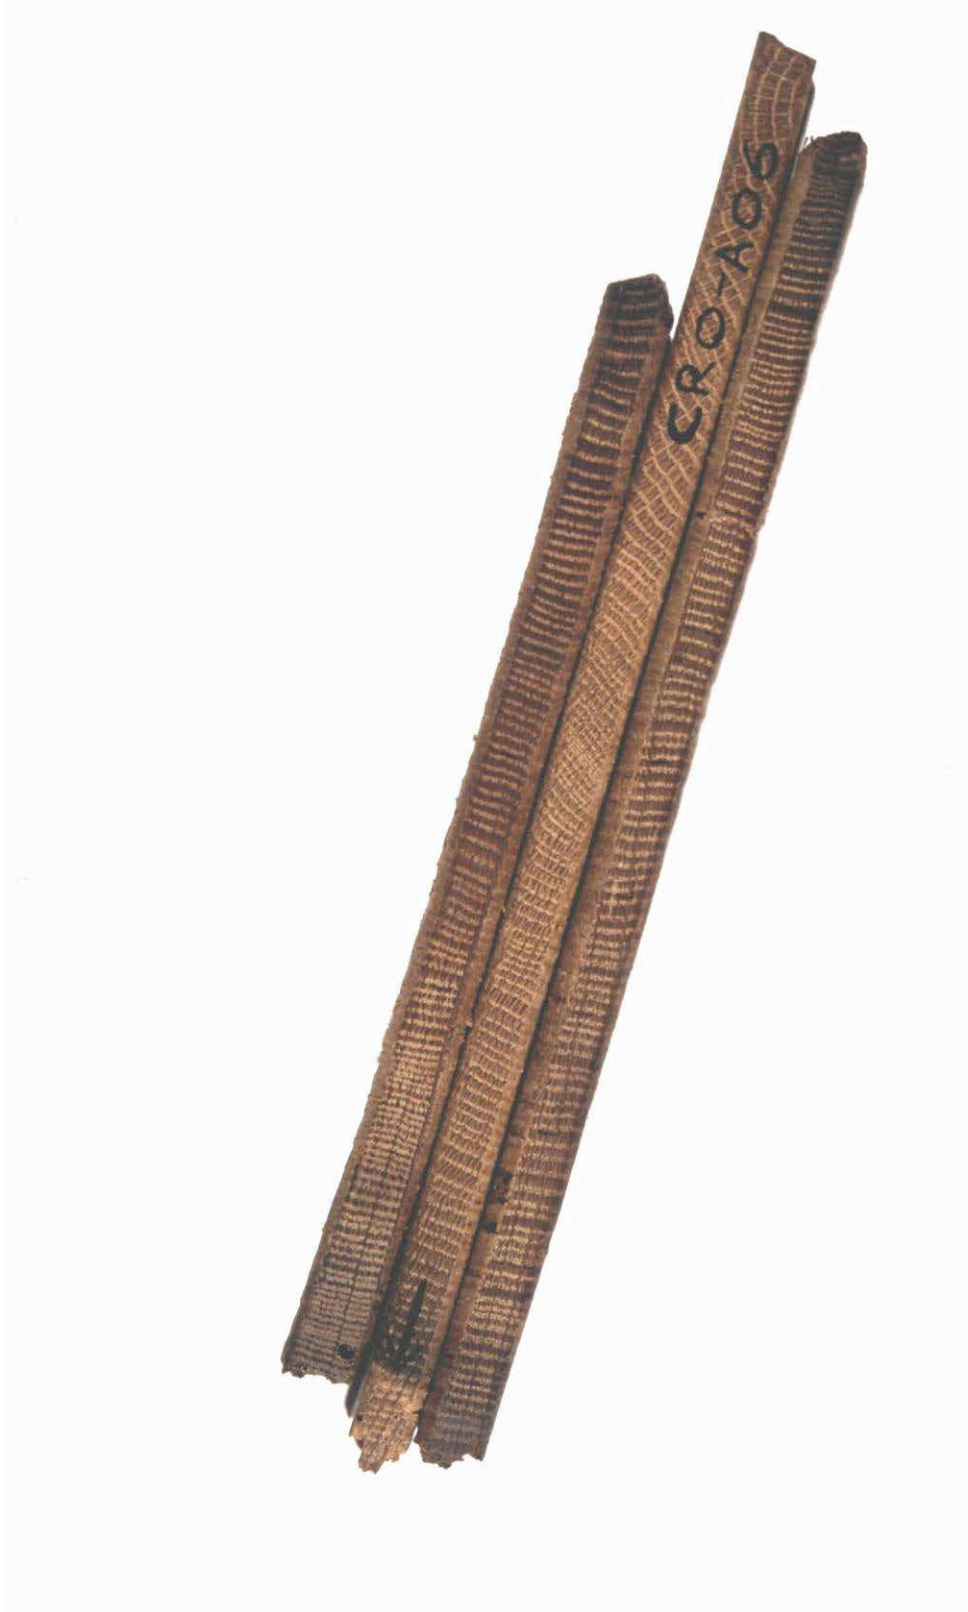
Figure A4: Three cores from timbers in a building. They come from trees growing at the same time. Notice that, although the sequences of widths look similar, they are not identical. This is typical
