Proceedings of the Cambridge Antiquarian Society

**Volume LXXXVI
for 1997**

Figure 5. East range, Cloister Court – Analysis of the conversion c. 1500 to college rooms

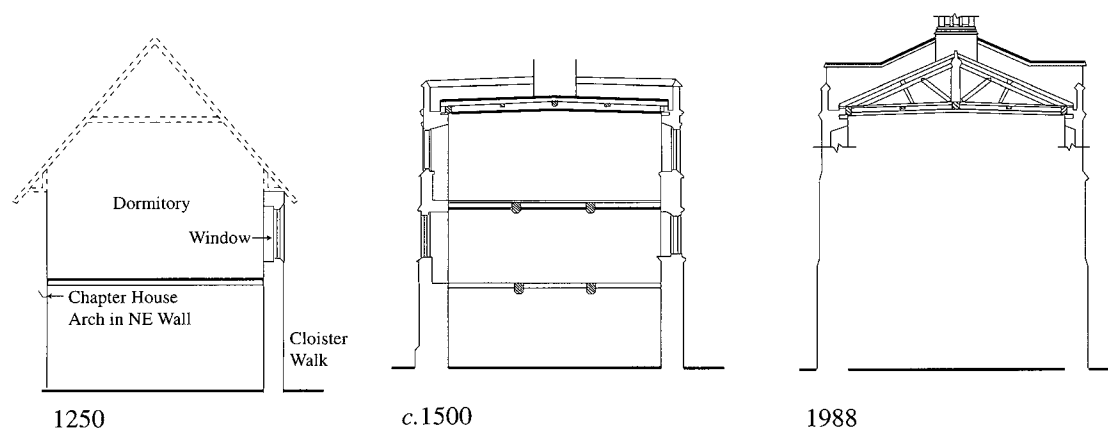
Figure 6. East range, Cloister Court – Development of the section

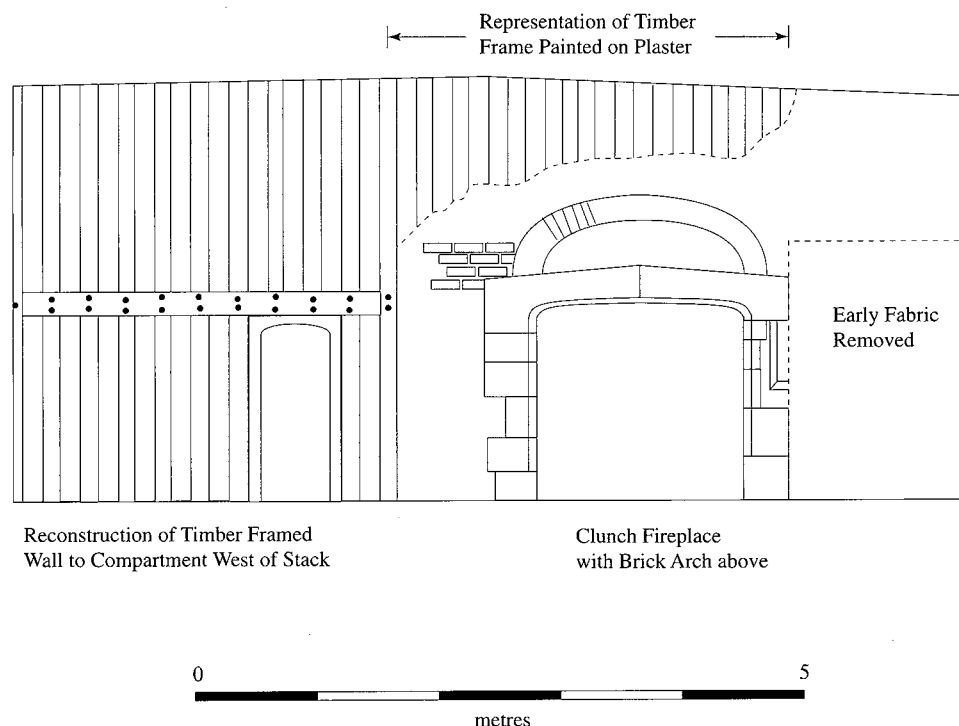
Figure 9. East range, Cloister Court – Decoration c. 1500

Evidence of what was almost certainly the original scheme of decoration was found in the north room of the second floor of F Staircase. The external masonry walls were plastered as was the stack; internal partitions were constructed of timber-framing with broad studs and rails. The spaces between were filled with flush plasterwork. This pattern was carried across one of the masonry walls, the plaster of which was painted with a representation of timber-framing. Only preserved over the fireplace, there is no evidence to show how other walls were treated (fig. 9).

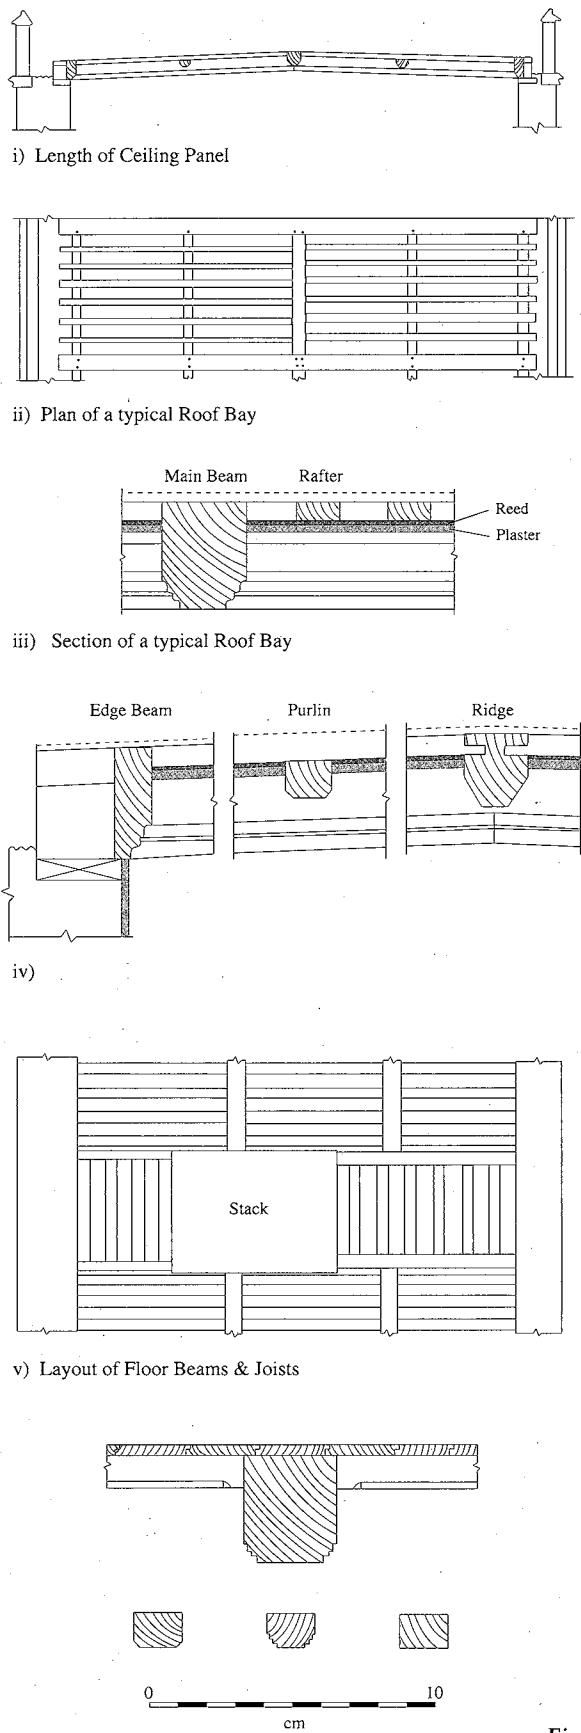
Figure 10. East range, Cloister Court – Roof (i–iv) and floor details (v & vi)

that the structure of the ground and first floors was built before the range was raised in height (fig. 10). This would have given stability to the surviving structure and could also have served as a platform from which to construct the new walls of the second floor. The form of the staircases leaves no doubt that

The ceilings of the ground and first floor rooms also had a pattern of major and minor timbers (fig. 10). The major beams were arranged in pairs along the length of the building defining three parallel bays. These beams have double-ogee mouldings smaller, but similar to those of the principal roof timbers. The only exception are the beams in the northern bay which were plain chamfered. The remainder of the structure was made up of common rafters which ran

The structure of the 16th century roof survives as the ceiling to the second floor and has already been described (fig. 10). A later roof of steeper pitch, probably of the 19th century, was constructed above it (see below). The only elements of the earlier roof which are missing are the deck which consisted of wide boards and the covering which must have been of lead. This is confirmed by Loggan's print which shows a flat-pitched roof with details consistent with a lead covering (i.e. panels defined by rolls; fig. 1). The existence of the deck was confirmed by the discovery of widely spaced nail holes in the upper surfaces of the main beams and rafters on which it is laid. It was presumably removed before the construction of the later roof.

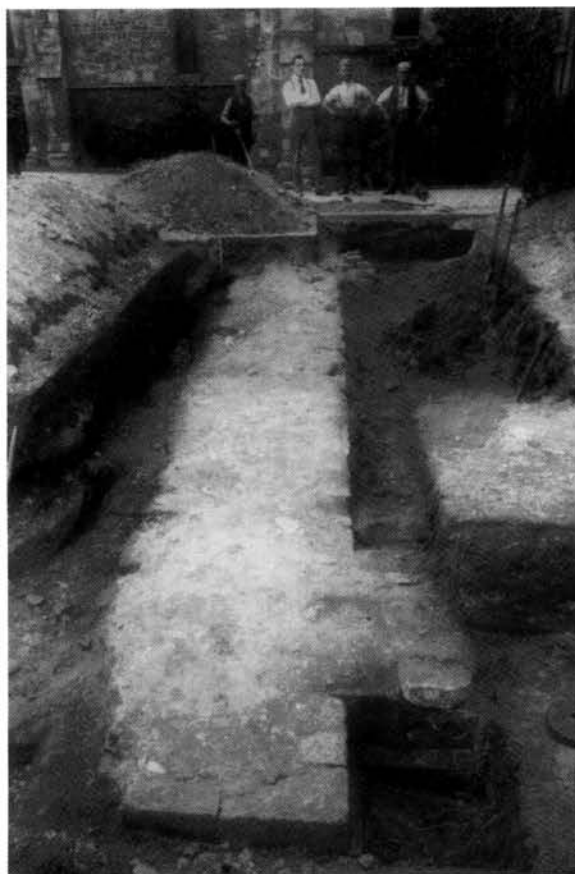
Plate i) Gray and Atkinson's 1894 Investigations of the east end of the Chapter House (looking south towards the chapel)

there is no discussion of strata or floor levels. Built of Barnack stone, the corner was found to be substantially buttressed with the outer face showing two courses of 'wrought stone'. Below this, a chamfered plinth was uncovered; otherwise the fabric was rough clunch. Along the foot of the eastern wall was found what was thought to be the remains of a clunch-built 'bench'. Noted as standing 10" higher than what should be the floor (based upon the level of the column bases in the west front), their means of calculation implies that they did not actually find, or at least recognise, the floor within their trench.

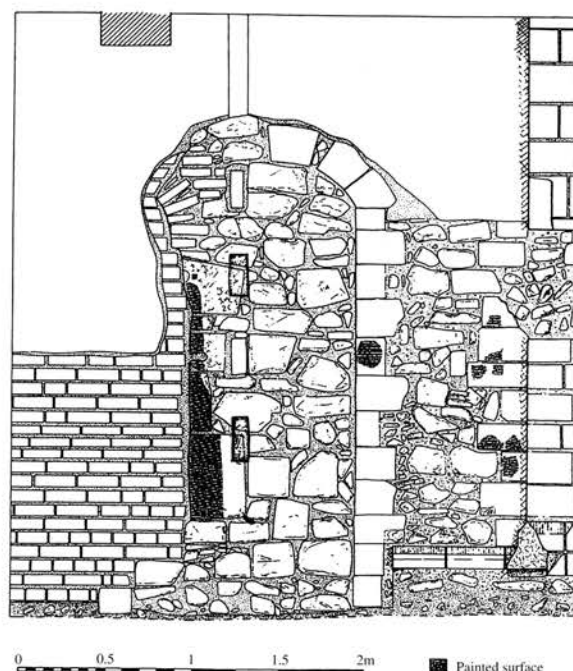
Figure 16. The Chapter House Investigations – Area C, south elevation (see fig. 15)

The fabric of the 12th century chapel transept was exposed within the southern wall of Room/Area C ([190]; fig. 15 & 16). A chamfered Barnack plinth, offset by c. 80mm from the upper face, divided the wall. Consisting of irregularly coursed large clunch fragments (50–80 x 160–200mm) in hard mid-brown mortar, the exposed face below ([194]) appeared vertically trimmed flush with the plinth. There is little stone in the build and it is footing-like (i.e. no facing whatsoever). The western corner of the wall was supported by a stepped buttress carried upon an additional plinth. This is built of large finely dressed ashlar blocks; none occurs beneath the plinth level – it is rubble below. East of its quoins was an exposed 'core' of

In Area C the arched doorway within the north transept wall was infilled with irregularly coursed medium-large clunch fragments (fig. 16). Bonded in an off-white sandy chalk/clunch-based mortar, many displayed traces of moulding implying their re-use. Set into the lower eastern edge of this build was a dressed clunch frame with a moulded edge, c. 1.30m high. Evidently the side of another fireplace, it is capped by a (later truncated) mantel 0.30m thick. Above the fireplace proper and integral with its build, is a brick relief arch. Much graffiti was found cut into the frame of the fireplace, which also carries traces of red and blue paint. The arched doorway in the western wall of that room was similarly infilled with a 'jumble' of irregular (non-)coursed large clunch blocks and smaller rubble, bonded in soft off-white mortar (fig. 17). The insertion of this material clearly involved the robbing of a large moulded stone at the foot of the arch proper.

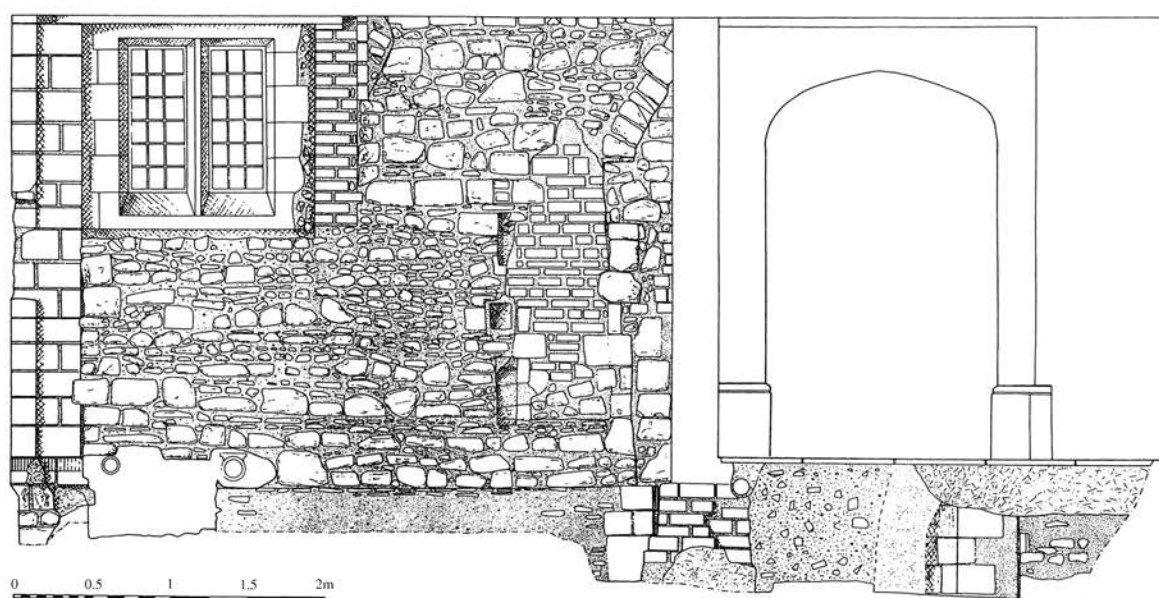
Figure 17. The Chapter House Investigations – Area C & B, west elevation (see fig. 15)

The lower western wall within that room was distinct ([195]; fig. 15 & 17). Unlike the upper portion, it was rendered over with a smoothed brown sandy mortar. Where visible, its fabric consists of regularly coursed small-medium tabular Barnack in very loose sandy grey-brown mortar. At its northern end the wall is finished with large ashlar blocks dressed to a chamfered corner which carry traces of plaster rendering and red 'paint' (see below). The base of the wall *per se* was observed in a sondage, where it was found to be without foundation. Standing 0.60m high, its top was horizontal (i.e. not ragged). Modern intrusions had cut away the junction between this wall and the chapel buttress. However, by the 'logic' of the construction sequence (and its inferred relationship to the inserted southern doorway), [195] must post-date it.

Within Area C the upper western wall, built directly upon the (horizontal) top of [195] and extending south to clad the chapel buttress (fig. 15 & 17), consisted in the main of medium-large pieces of clunch rubble ([191]). Roughly coursed by 'zones', some 10% of its fabric consisted of dressed Barnack (up to 160 x 320mm) and smaller tabular pieces; 5–10% seemed reused (dressed, none moulded). The wall was bonded in loose grey-brown sandy mortar; no brick was incorporated within its fabric. In the north, the wall ended with a rough frame of large clunch quoins (one piece of dressed Barnack). Although partially disturbed through robbing and inset by c. 80mm from the chamfered end of the lower wall, this was clearly the frame of a door/passageway. An arch springs from the projected top of this edge to the north. Built of roughly worked and keyed clunch pieces, the steepness of its angle suggests a 'late' pointed form (?13th century). A 'complex' elevation, interpretation is not abetted by the fact that the stone from which the arch springs (?moulded capital) had evidently been extracted.

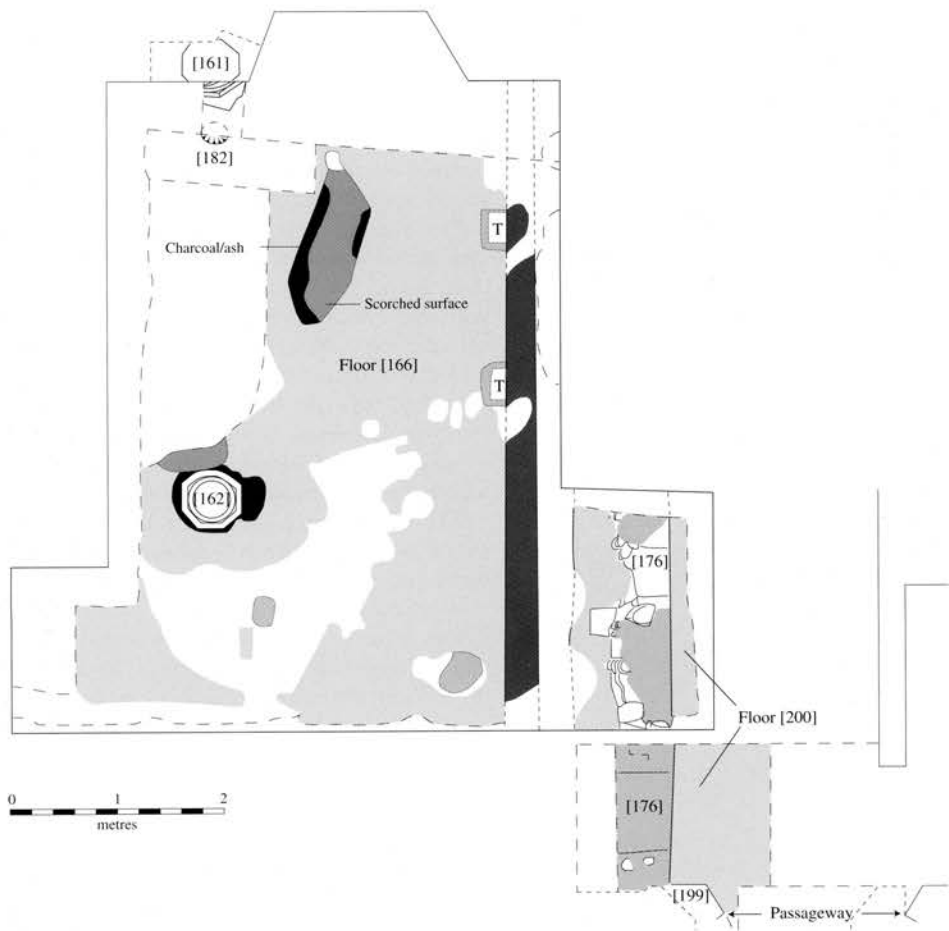
Figure 18. Chapter house plan

A substantial posthole was exposed in section within the northeastern sondage within Area A (F. 51; fig. 18–20). Although truncated, its profile could be observed to a depth of 0.50m; in total, it must have been c. 0.70m deep. Similarly, while it was seen to be some 0.60m across, its top is estimated to have been 0.90–1.00m wide. Flat-based, its lower profile narrowed to 0.20–.25m diameter, suggesting the dimension of the post. The lower fill consisted of dirty reddish brown sandy loam, above which it had frequent small-medium clunch fragment inclusions. The ‘primary’ status of this feature is indisputable, however considerable ambiguity relates to its structural associations. Similarly, in the western half of the sondage (well beyond the diameter of this cut), a surprisingly high density of medium-sized sandy yellow mortar fragments were observed within the lower sub-soil horizon whose derivation is unclear.

Confirming the results of Gray and Atkinson's investigations, a substantial east-west wall was found to run east from [199] and under the stairs in Area A ([176]; fig. 18; pl. iv). Its southern side stood some 0.30m high and was faced in a 15mm thick, smoothed whitewashed rendering which continued over the [199] stonework. The northern side was ragged having been extensively disturbed. Generally surviving 0.50–0.60m wide, one flush-set stone protruding to a width of c. 0.85m must suggest its true dimension. The fabric consisted of roughly coursed Barnack slabs. These were roughly dressed to lie flush along the surviving face; medium-large fragments of clunch were more roughly set into the core (one piece of

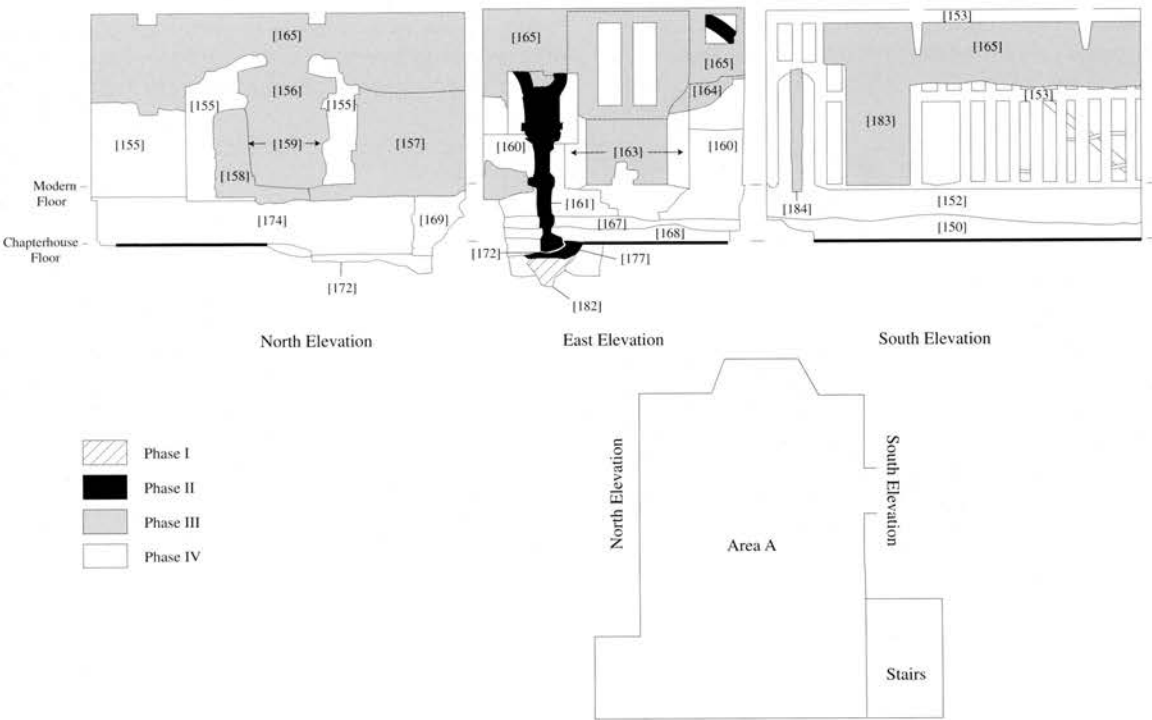
Figure 19. The Chapter House Investigations – Area A, location and section guide: north elevation, fig. 21; east elevation, fig. 20 & pl. ii; south evaluation, pl. iv

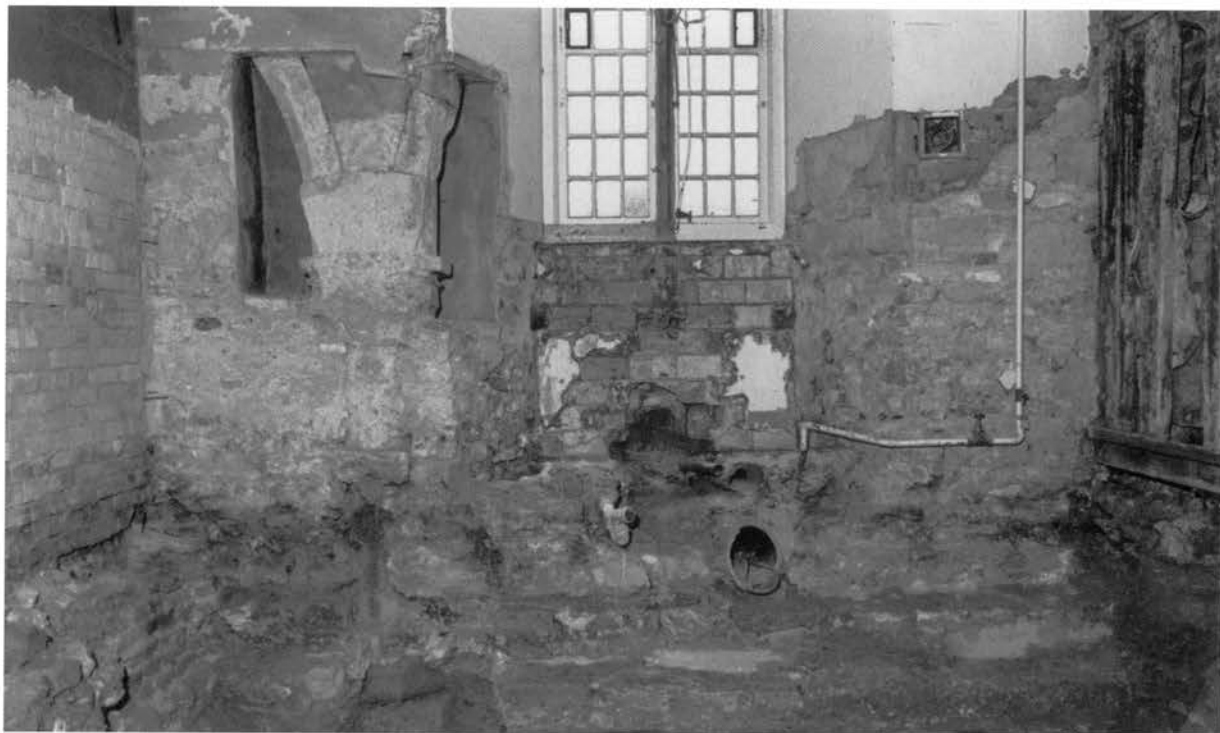
Plate ii) The Chapter House Investigations – Area A, east wall; note encased pier with moulded mid-rib and cushion capital (left side; see fig. 20)

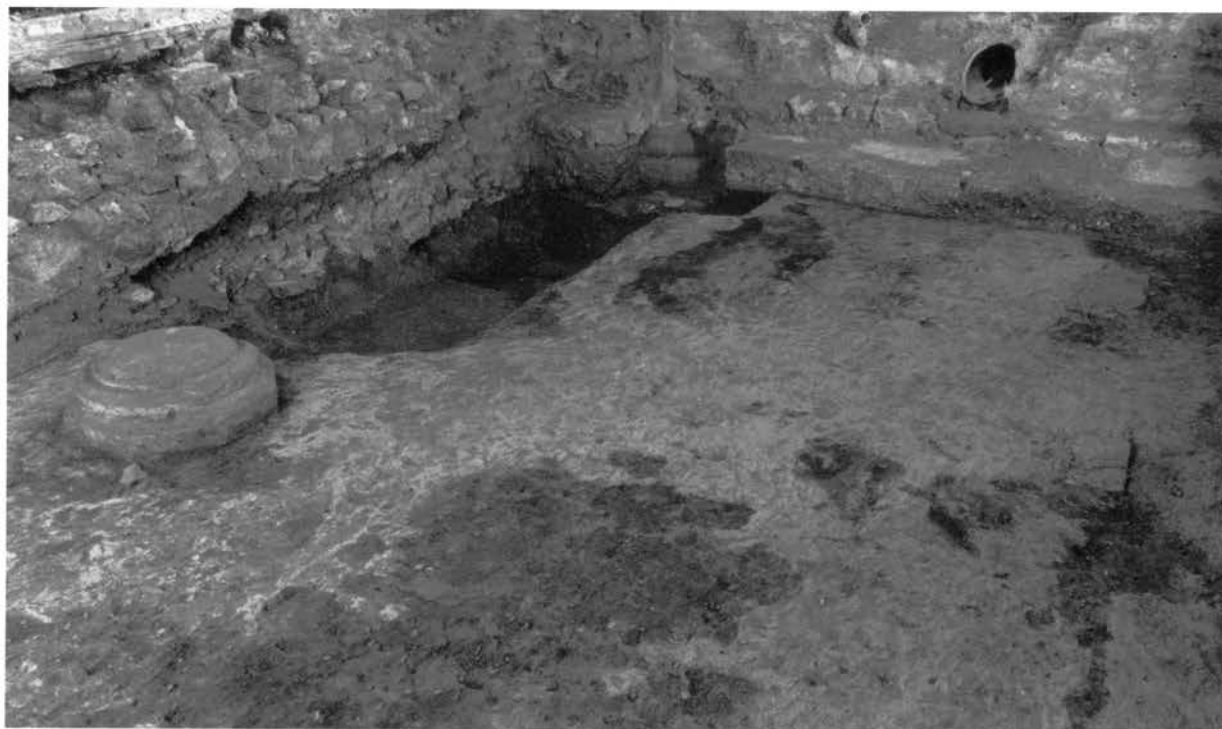
Plate iii) The Chapter House floor with central pier base (left side; see fig. 18)

Although patchy, extending throughout the area (and sealing the foundation pits for the two piers) the chapter house floor consisted of a 10–15mm thick surface of crushed clunch and mortar ([166]; fig. 18; pl. iii). Lying directly upon the prepared surface of the natural soil, locally a very fine, almost polish-smoothed surface survived and there were some indication of re-surfacing. A 20mm high ridge in the floor was apparent along the southern side of the room,

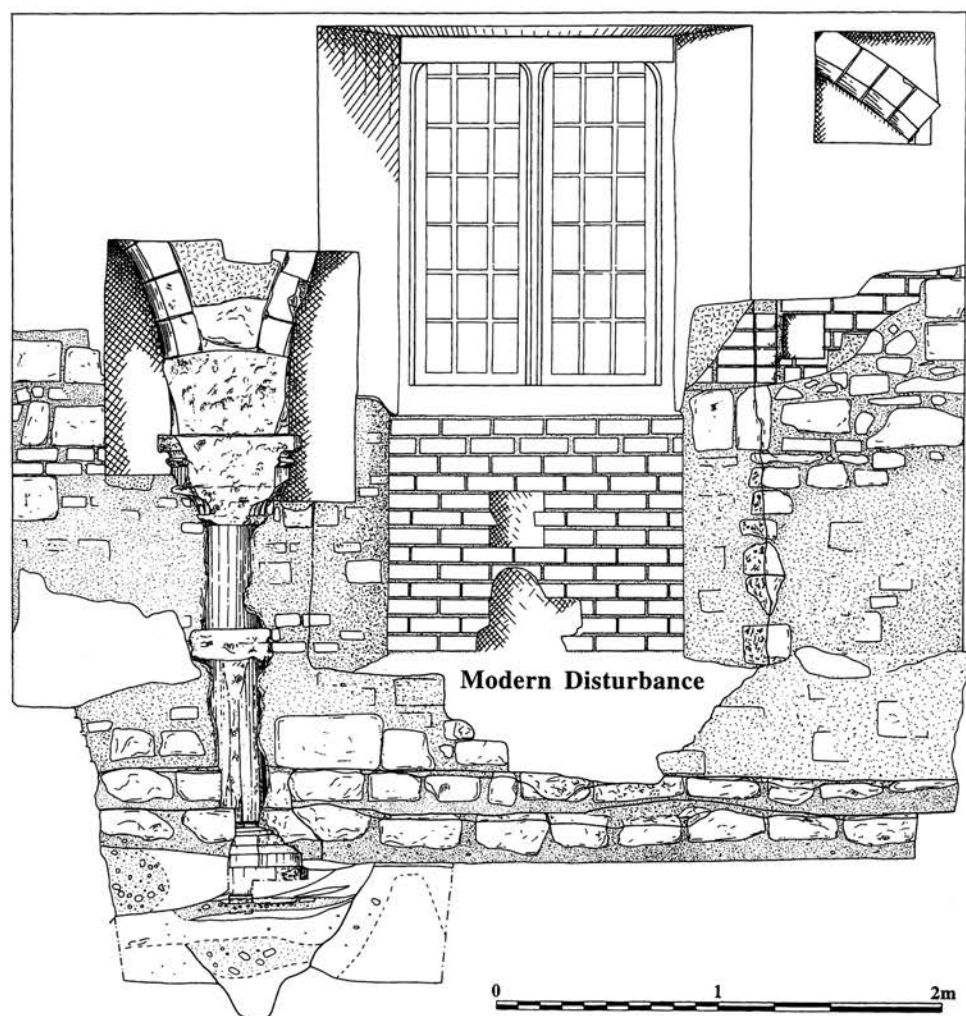
Figure 20. The Chapter House Investigations – Area A, east elevation (see fig. 19 & pl. iv)

0.11–17m high stepped foundation ([167]) which projects 0.22–.28m beyond the base of the extant eastern wall with which it is structurally integral ([160]; fig. 22 & 20). Both were built encasing the eastern pier and entailed truncation of its decorative elements and any westward springing features (e.g. carving away of vertical rib and western side of mid-ring/capital). In other words, these elements were cut flush so as to not project beyond the wall face. The wall was observed to stand to 2.00m above its foundation step and must infill all the area beneath the chapter house’s arches. Where exposed in the stripped window recess, the faced rubble-built wall was 0.75m(+) wide. The core generally consisted of medium sized fragments of clunch/chalk bonded in off-white sandy chalk mortar; its face of roughly dressed and coursed clunch/chalk blocks extending 0.15–.20m into the fabric. Red bricks had been sporadically incorporated (55 x 110 x 220mm); their employment was more extensive and regular in the upper northern side. There were also coursed ‘zones’ of large moulded clunch, presumably deriving from the demolition of the chapter house/nunnery. Given the assortment of building materials in its fabric and irregular coursing, this masonry was clearly not intended to be visible and traces of a rough mortar rendering could be distinguished.

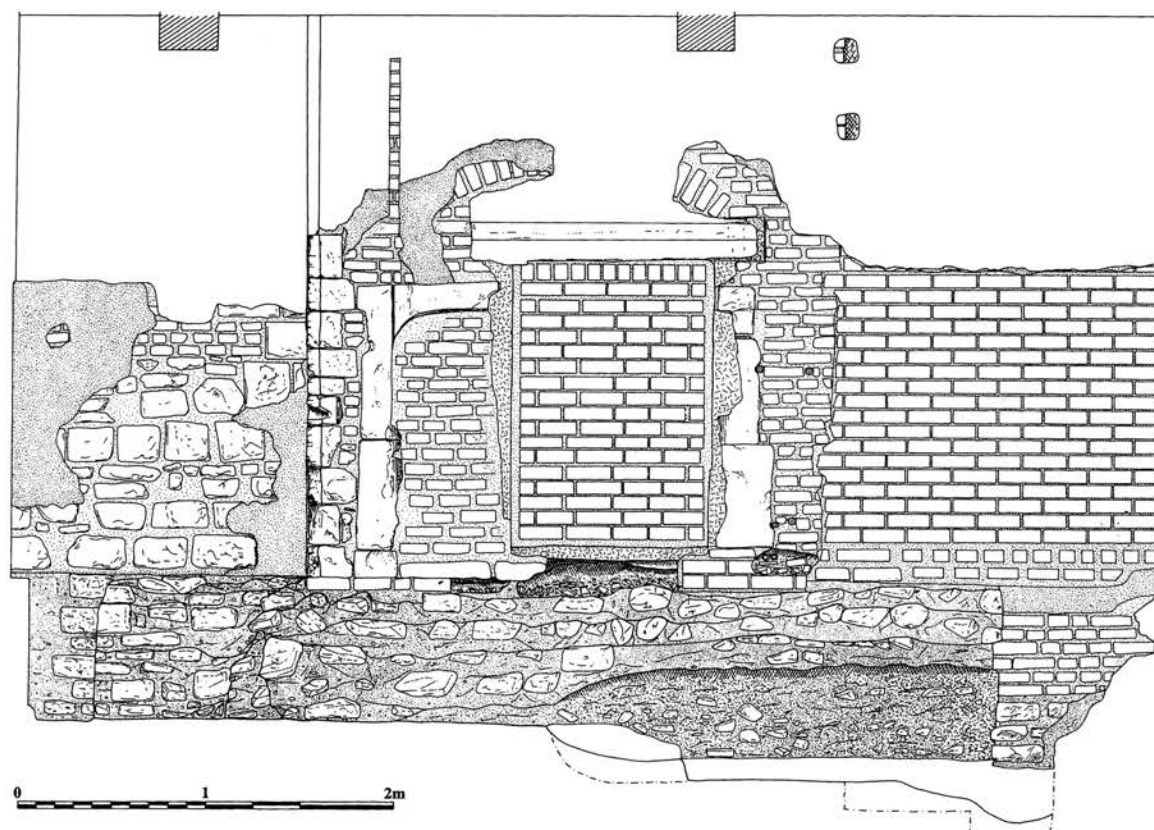
Figure 21. The Chapter House Investigations – Area A, north elevation (see fig. 19)

While the fabric of the northern wall in Area A essentially matches that of the eastern (faced rubble-core bonded in off-white mortar, locally including large re-used building stone and red bricks: [155]), its construction differed inasmuch as it was carried on a trench-built rubble foundation ([174/175]) which cut down through the [150] make-up horizon (fig. 19 & 21). While generally c. 0.80m deep (bottoming on the chapter house floor), where it crossed the F. 52 pit the

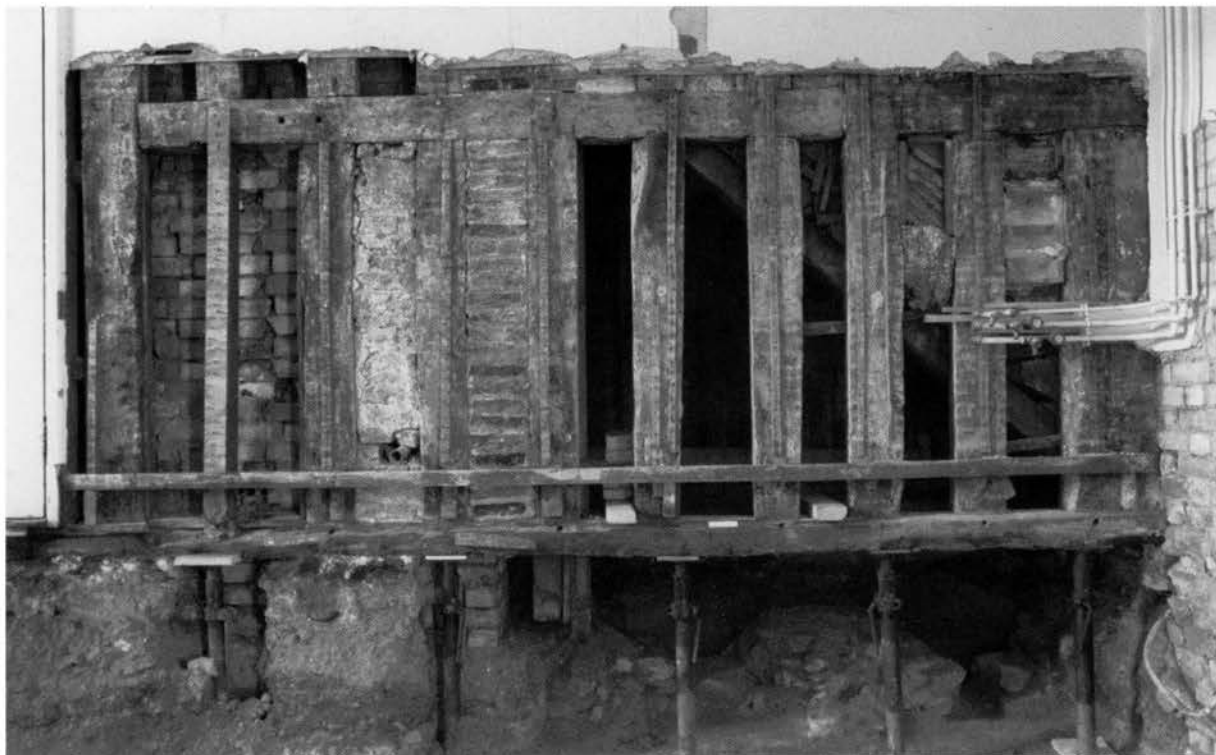
Plate iv) The Chapter House Investigations – Timber-frame wall (western two-thirds only); note south wall of Chapter House beneath (see fig. 19)

was blackened, suggesting mould staining below a suspended timber floor. It carries a timber-frame wall which runs along the southern side of the room and abuts the eastern wall ([153]; fig. 22; pl. iv; see Evans 1995b: fig. 10). Built of 'rock hard' oak, only one element had required replacement. Two posts set symmetrically within the frame run from the sill up to the ceiling plate (150 x 110mm). These support range-longitudinal ceiling beams (carried on moulded knees) that are tied into the northern wall. Stud-timbers (170 x 120–130mm) are set at intervals of 0.16–.25m in peg-doweled mortise-and-tenon joints into the sill, top-plate and mid-rail. The structure is simple inasmuch as there is no cross-bracing, nor was re-used timber apparently utilised; carpenter's marks were observed.

The stripping of plaster revealed an original door-frame in the eastern end of the frame wall. Very narrow (0.60m wide and 1.80m high), it is set between the end post and another forming the western side (one intervening stud ran down to join its top). The internal sides of the posts are moulded as a frame and the carving continues around the slightly arched piece set to form its top which also has carved triangular recesses. A worn recess mid-way up the west side of the frame obviously held a latch-plate.

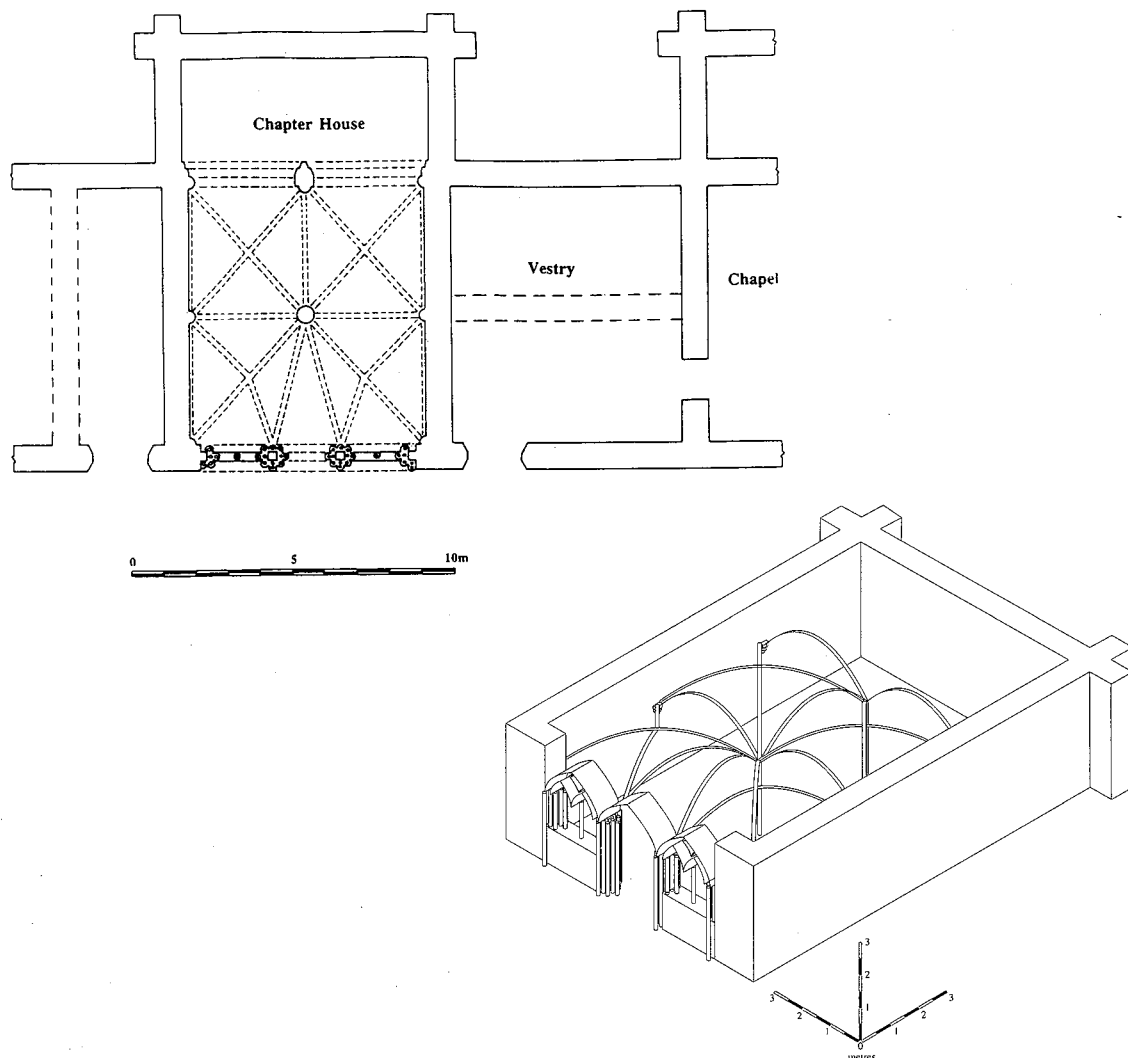
Figure 23. Chapter house plan and reconstruction

The accepted plan of the chapter house is that published in the Royal Commission's 1959 survey. Gray's photograph evidently was not consulted, for it shows that the east wall of the chapter house directly aligned with the buttressed northeastern corner of the Organ Chamber. Whereas Gray's sketch, and the Commission's plan after it, displaces the wall c. 1.00m to the west. During the course of recent fieldwork the wall was cored and found aligned on the Organ Chamber; c. 1.50m wide, it lies approximately 0.40m below the lawn. (To negative result the lawn south of the path was also cored to test whether the chapter house wall-line continued south beyond the buttressed corner.) Restoring the wall further to the east has ramifications for the reconstruction of the chapter house: the 'bay'- distance between the wall and the easternmost pier becomes roughly equivalent to that between that and the central one (c. 3.50m; fig. 23).

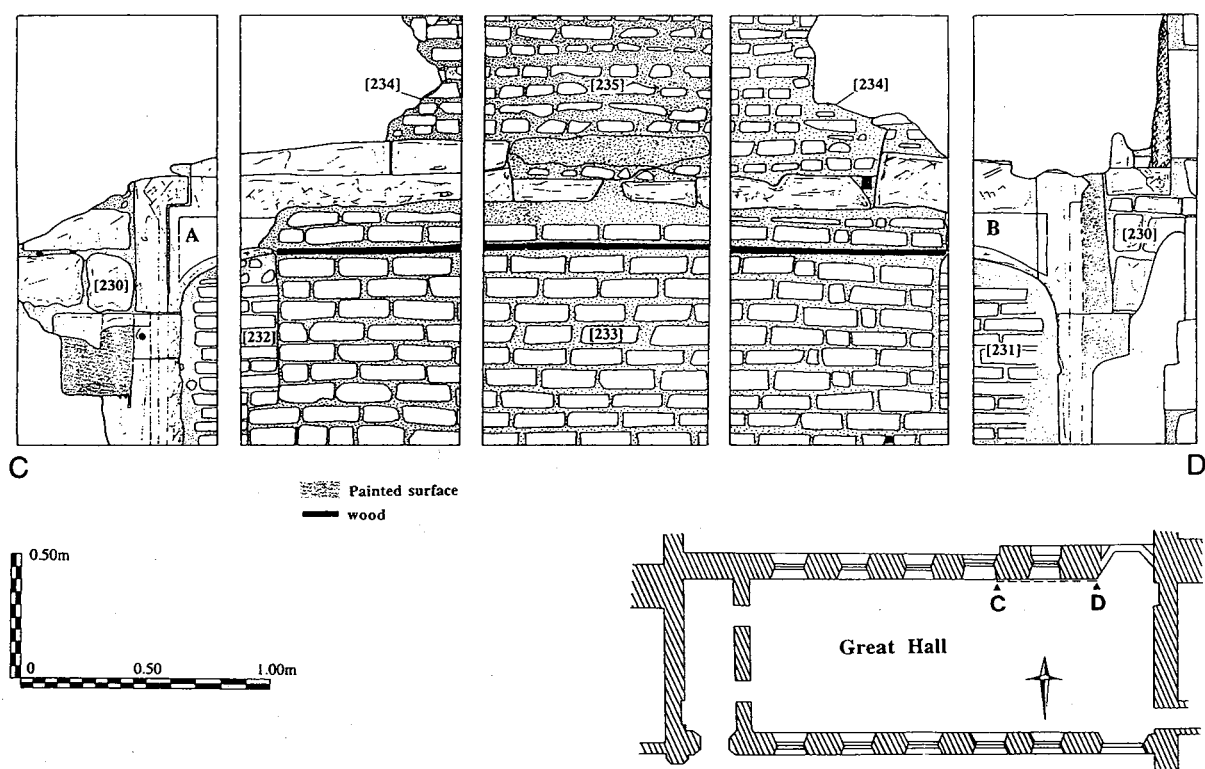
Figure 24. Hall fireplace

During the renovation the wooden panels which surround the lower walls of the hall were removed exposing the 'great' fireplace situated within the eastern

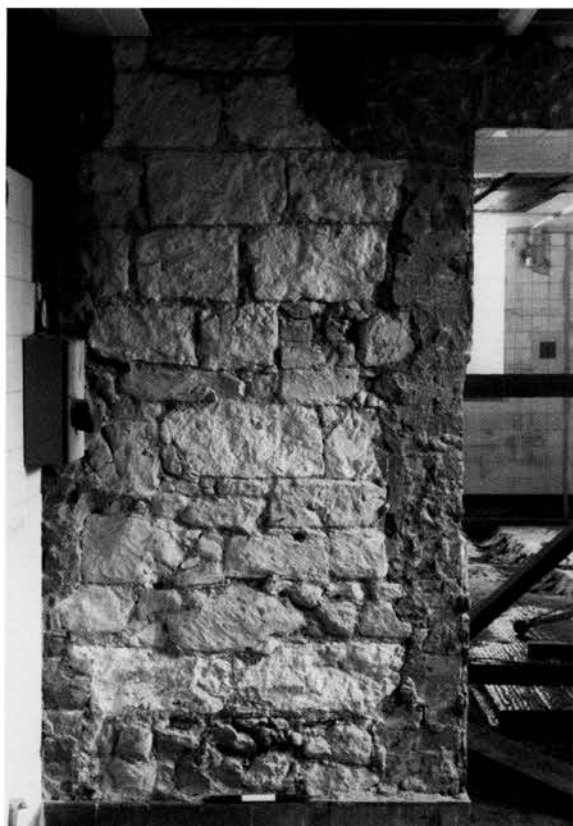
*Plate v) The Kitchen Range – Interior elevation
(see south end/left side fig. 25)*

kitchen range was recorded (fig. 25). Projecting south on this line, the eastern face of an internal wall (dividing the kitchens from the hall range) was also drawn upon the removal of its applied tile cladding. Between the two, the fabric was found to be continuous. The footing consists of roughly coursed clunch, limestone, brick and tile set in a loose pale buff mortar (0.40m depth; [201], [202] & [224]). Upon this, and in places the distinction between the two mortars was very clear, is a slightly more formally, though still quite roughly coursed wall ([209] & [225]). The lower 1.20m of this build consisted of clunch blocks (100–200 x 150–400mm) with brick and tile set in a fine pale buff mortar, above it is more formally coursed and constructed from larger rough dressed clunch blocks in which no brick or tile was evident. Within the southern interior elevation this was capped by the Ketton slab flooring of the first storey hall. In their study the Royal Commission ascribe this wall a 13th century date. However, the presence of brick/tile within the footing and wall (apparently integral and not later inserted) indicates an early/primary college date. Apart from the possible stairway footing, there is no direct evidence as such of the nunnery at this point.

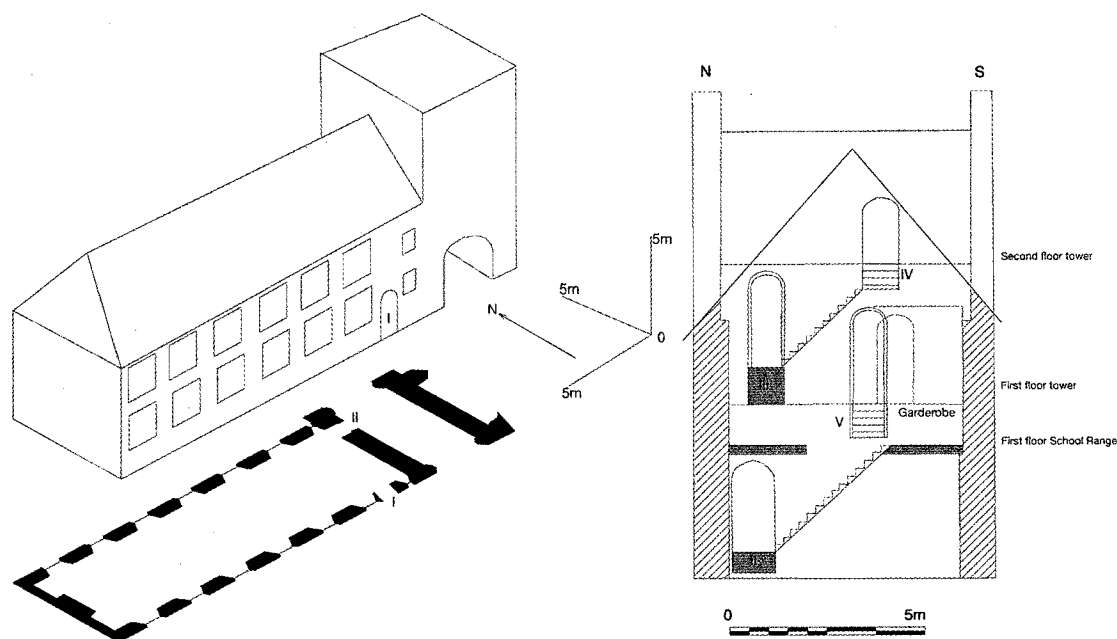
Figure 26. Reconstruction of School Range and Gatehouse (16th century; note Gatehouse windows not indicated); right, eastern elevation of west wall of Gatehouse

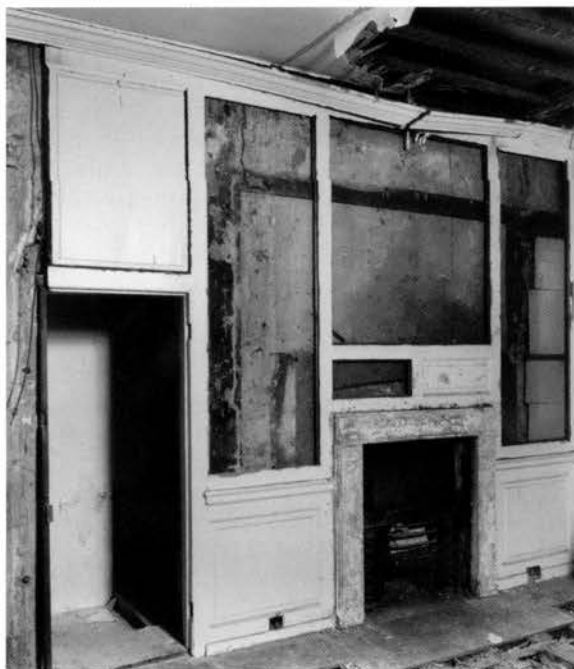
Plate vi) The Gatehouse – Green-bar painted first floor gatehouse room; note marble painted frame of original fireplace visible through panelling (RCHM © Crown copyright)

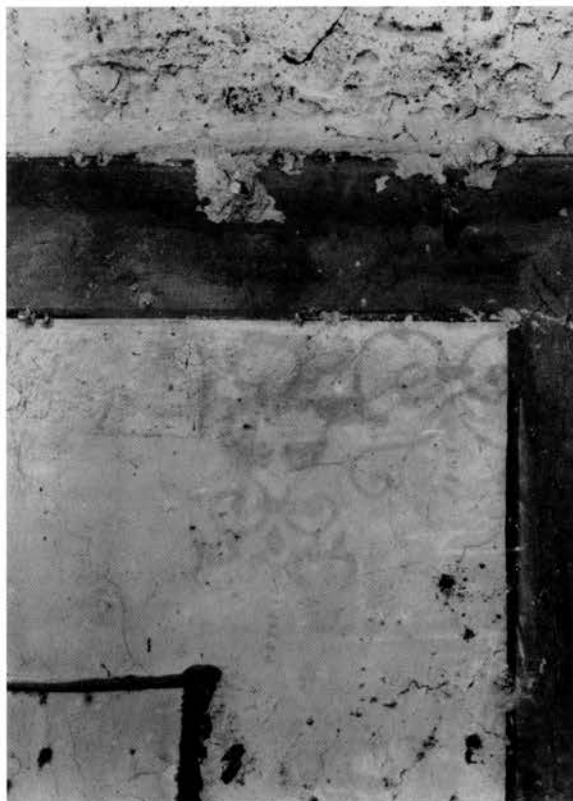
Plate vii) The Gatehouse – Detail of green-bar scheme with faint impression of wallpaper pattern; note wall-hanging tatters lower left (RCHM © Crown copyright)

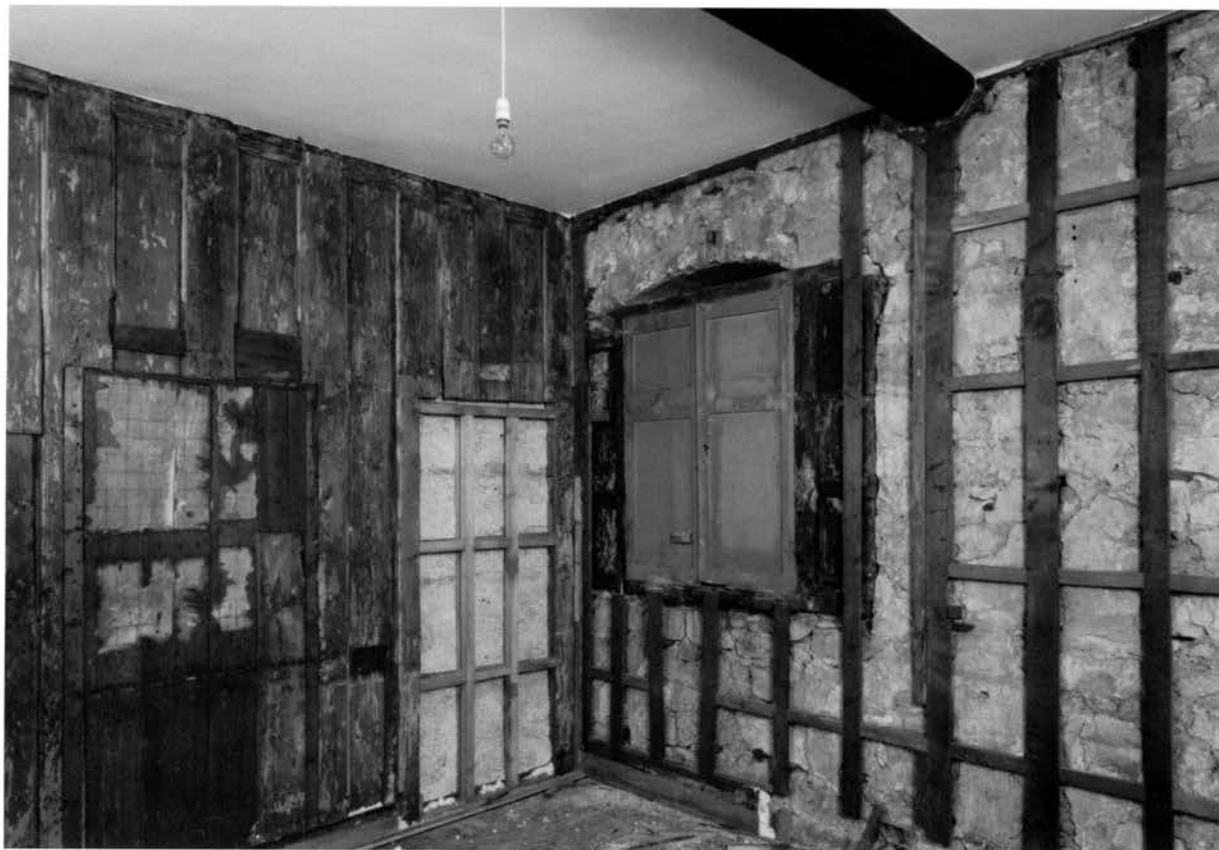
Plate viii) Master's Lodge with panel wall left; clunch-built west wall of chapel right, with arch of viewing niche visible above inset cupboard at north end (RCHM © Crown copyright)

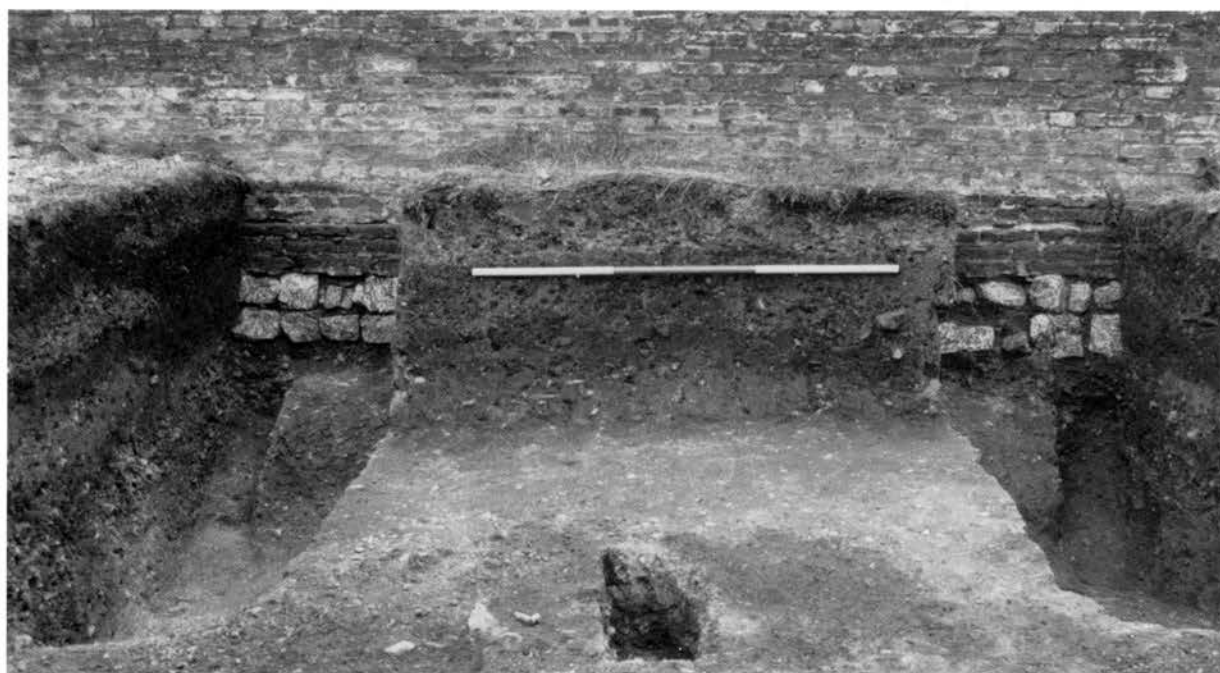
Plate x) The Library Site (Trench IV) – the exposed footings of the southern boundary wall with Lane-side ditches in mid-ground (see fig. 28)

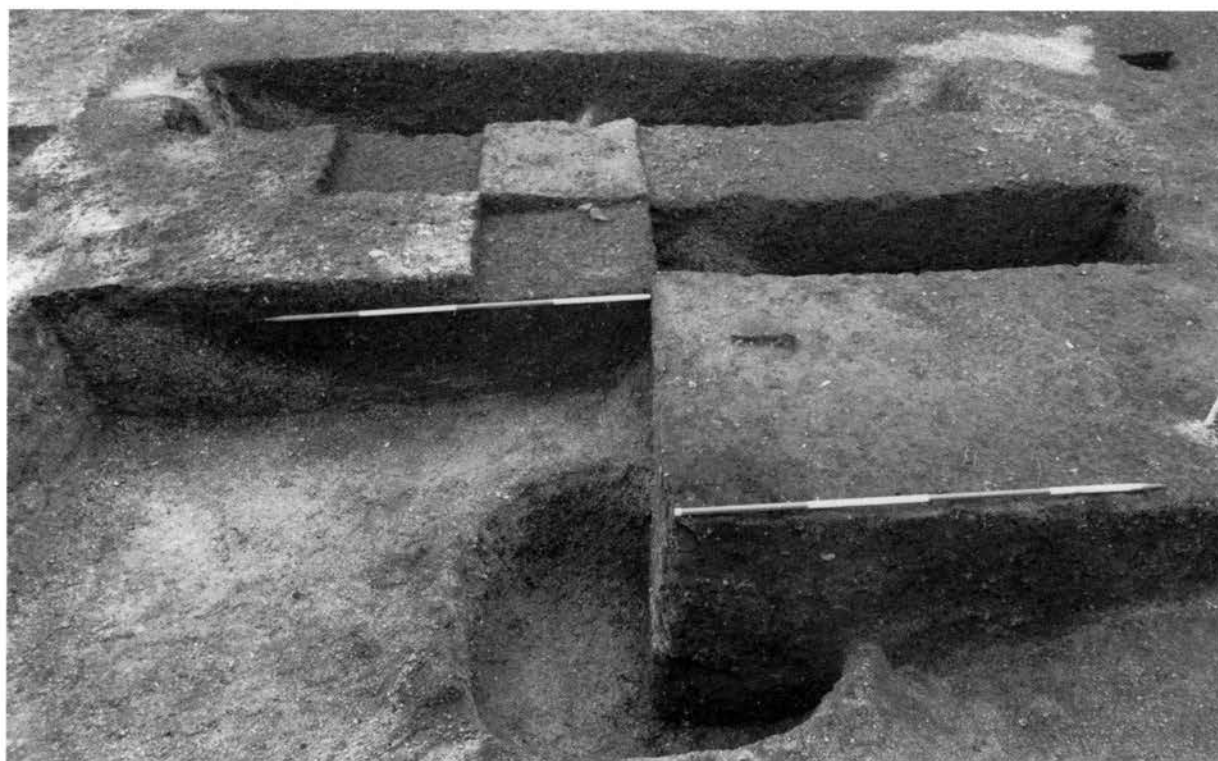
Plate xi) The Library Site – Looking west with well F. 6 cutting through quarry pit F. 7; note partial excavation of metallised surface atop mid-ground cross-baulks (see fig. 29)

Deposited across the main quarry zone (F. 7 northwards) was a relatively uniform spread of dark brown very sandy silt, 0.20–.30m thick (pl. xi). Whilst not robust, this carried an 'informal' or patchy metallurgy (F. 31). Only intensively excavated where it dipped into the top of the quarry hollows, artefacts were found to bed horizontally on its surface. Associated with this was a large well (F. 6); partially excavated during the evaluation, another quadrant was dug in 0.20m spits (pl. xi). Truncating the quarry backfill, its fill sequence

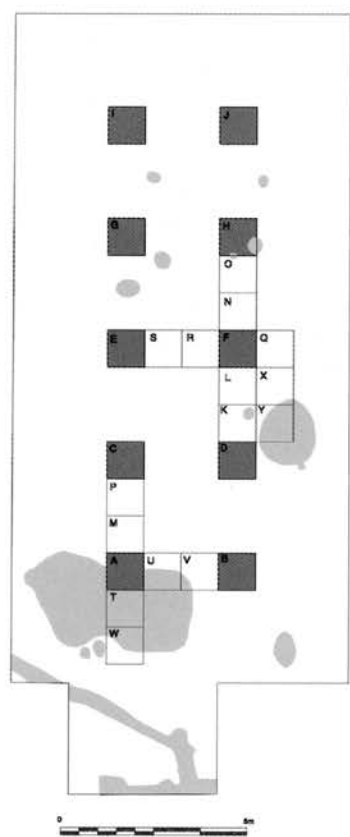
Figure 30. The Library Site – Sample square location

Previous to machine-stripping this horizon was sample excavated. Twenty-five 1m squares were hand-dug with ten laid-out on a 2.00m grid to provide basic sample cover ('A'–'J'); the remainder judgmentally sited on axes bisecting two areas of high artefact density ('K'–'Y'; fig. 30). Three of these were 100% sieved (5mm mesh; 'C', 'F' & 'G') and six bulk sampled for environmental and small finds data ('D', 'E', 'F', 'N', 'H' & 'X'). Quantities of diverse materials were recovered ranging from worked flint to Roman, medieval and later pottery, glass, metal and clay pipes, and also a broad spectrum of building materials (5142 artefacts in total). A methodology more commonly used on prehistoric scatter sites, this sampling was undertaken to investigate the character of the
