Proceedings of the Cambridge Antiquarian Society

**Volume LXXXVI
for 1997**

Figure 5. East range, Cloister Court – Analysis of the conversion c. 1500 to college rooms

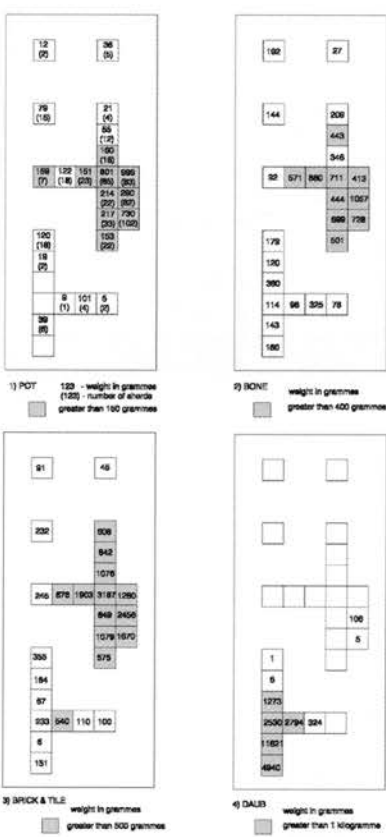
Figure 31. The Library Site – Sample square plots (see fig. 30)

Due to recovery bias (i.e. small fragmentation), the distribution of shell – predominantly oyster, but also mussel and scallop – is less ‘measurable’. Nevertheless, varying in density from 0–75 pieces within the grid-sample squares (8.6 ave.), higher-than-average densities also occurred in the same mid-east zone. (Not including a spurious nil value for Sq ‘Q’, the average density across a 6 x 4m area was 82.7 per m².) Similarly, the low recovery of glass and clay pipe fragments does not lend itself to valid statistical analysis. Occurring in only three of the ten grid-sample squares and 11 of 25 units in total, the latter only ranged from 0–6. The distribution of glass was similarly uneven. Occurring within 12 squares in total,
