EXETER CITY DEFENCES

EXETER CITY DEFENCES
EXCAVATION AND SURVEY ON THE CITY WALLS
FROM THE NORTH GATE TO THE CASTLE 1978-88
PART I : ROMAN

Exeter Museums Archaeological Field Unit

Report No. 88.13

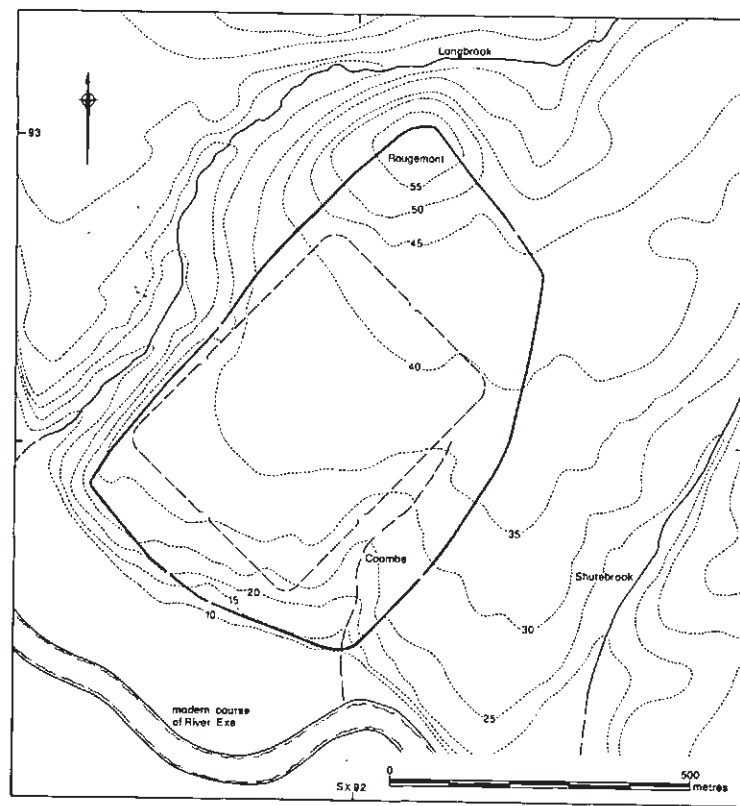
Fig. 1 Contour plan of the site of Exeter, showing the outline of the Roman Wall and the site of the fortress.

The area spanned by the wall between North Gate and Rougemont lies on the upper eastern slope of the valley of the Longbrook (Fig. 1). To the north-east the gradient steepens towards the hill of Rougemont, westward the ground falls away in a gentle uniform slope, towards the Longbrook. At the south-west end, near the site of the North Gate, the sides of the valley begin to steepen (by the time the slopes appear in the modern townscape in the St Bartholomew's Cemetery further south-west the wall is running along the crest of a very steep slope which drops some 60 feet to Exe Street) and a small (?) re-entrant valley causes the ground surface to drop further to 24m O.D. at North Gate, Site A. The level of natural subsoil beneath the wall at Site B was c. 26.90m. The fall is therefore c. 3.00m in c. 15.00m north-east to south-west. At the next observation of the subsoil 25m to the south-west, beyond the site of the gate, the natural subsoil lies at c. 28.50m. These levels give a skeletal profile across the course of this side valley.

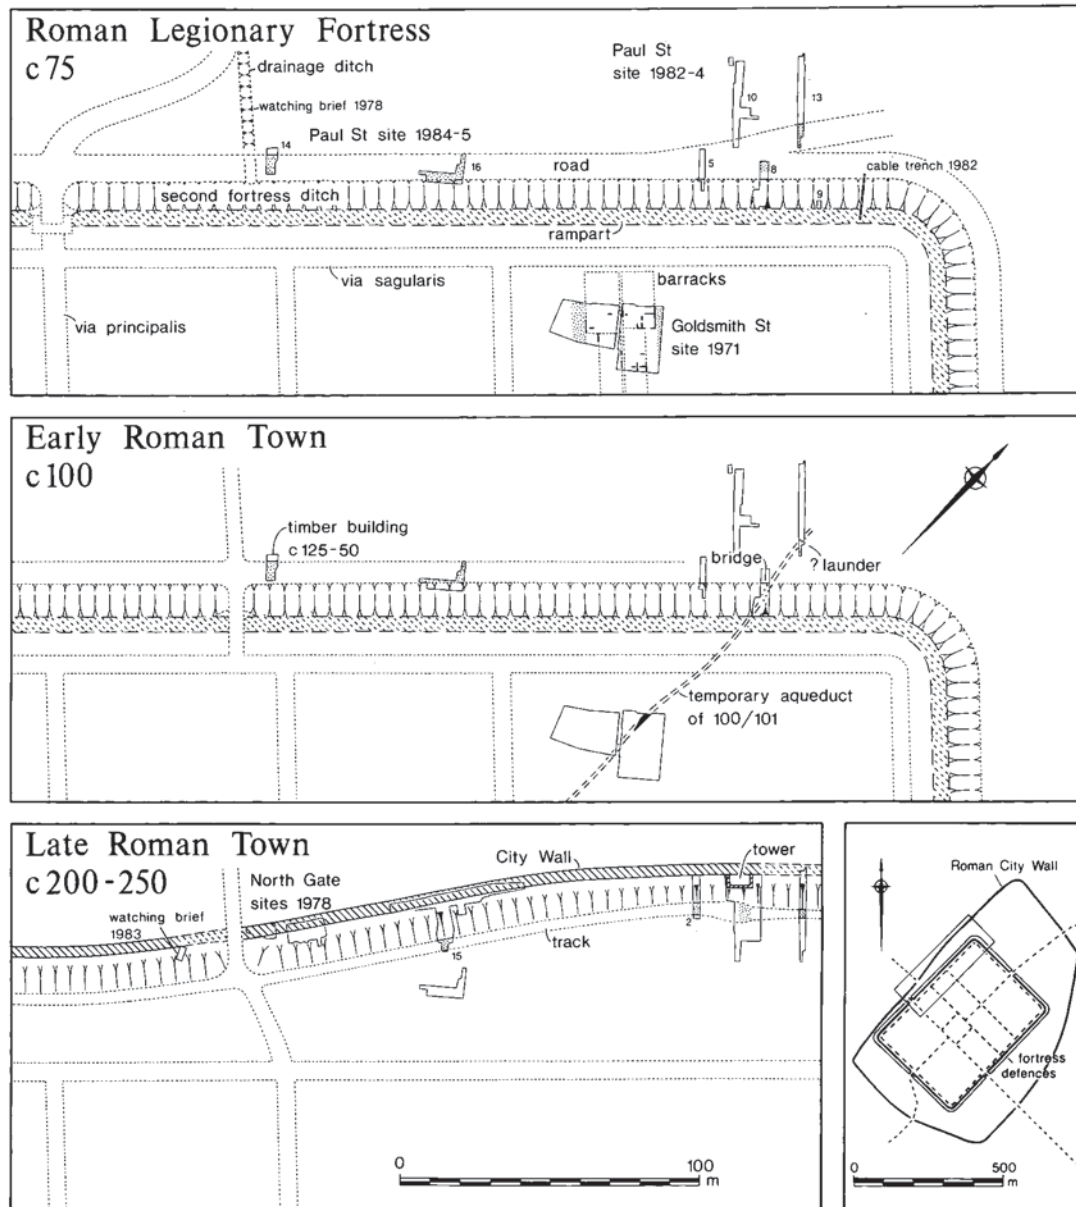
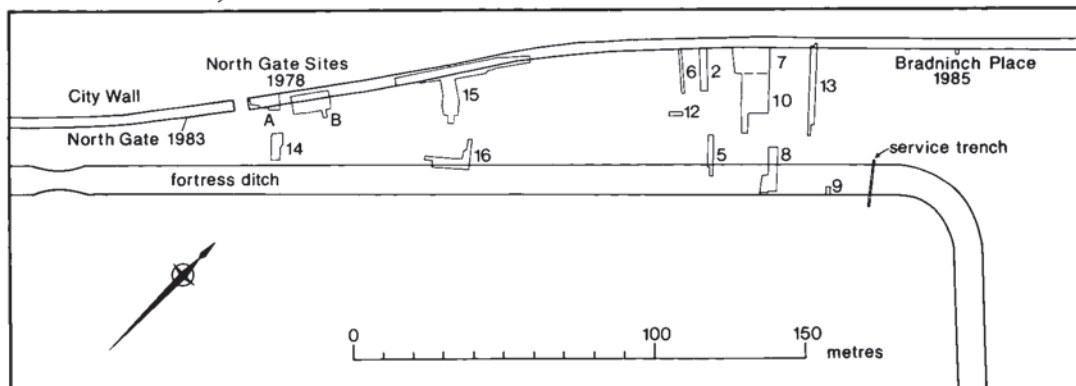
Fig. 2 Development of the north-western section of Exeter in the Roman period, with position of sites mentioned in text (bottom).

Although not directly relevant to the subject of the development of the defences of Exeter, some account of the early Roman deposits in this area is given here by way of a background to the events of the late second century. The positions of the trenches excavated between 1978 and 1986 are shown, in the context of the known Roman development of the area, on Fig. 2. The ditches of the north-western side of the legionary fortress defences lay within the area available for examination on the Paul Street site. A number of the trenches excavated contributed information towards the greater understanding of the fortress defences. A full section through both ditches was obtained in trench 8; a portion of the smaller inner ditch, with its centre line, was revealed in trench 9; further to the south-west, the outer edge of the larger, second fortress ditch was located in trench 5. These observations enabled the precise orientation of the ditches to be plotted. Three trenches excavated in the later stages of the Paul Street excavations, Nos. 13, 14 and 16, contained sections of the metalled track surface which ran along the outer edge of the second fortress ditch. To the north-east the traces of this surface became excessively wide; where seen in trench 13 the north-western limit of the track was c. 16m from the outer edge of the second fortress ditch. This divergence has been interpreted as a broadening of the track outside the ditch and has been reconstructed as such on the plan, Fig. 2.

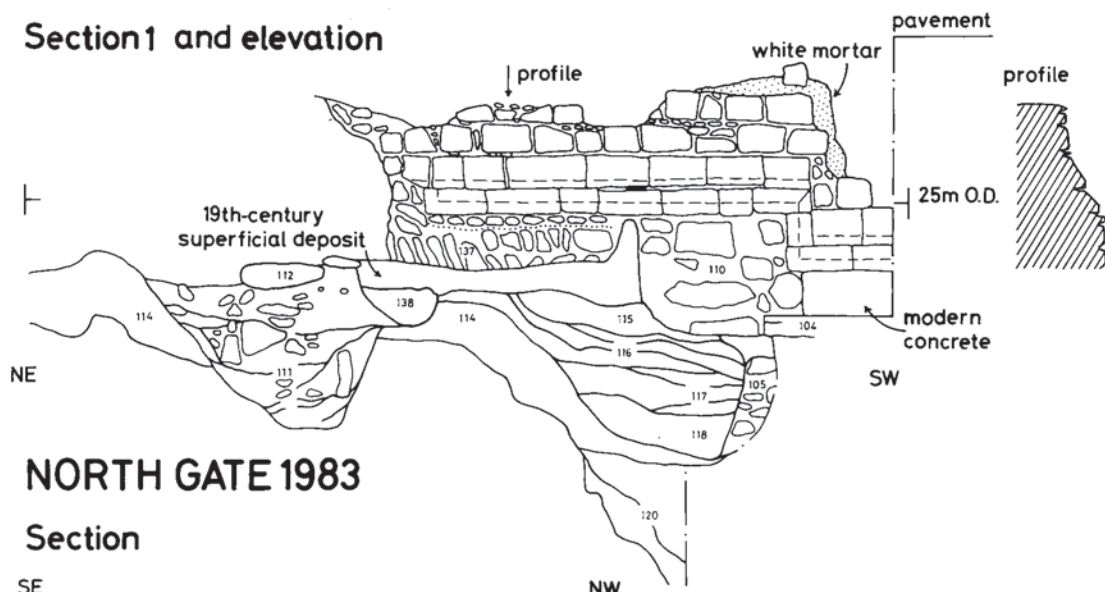
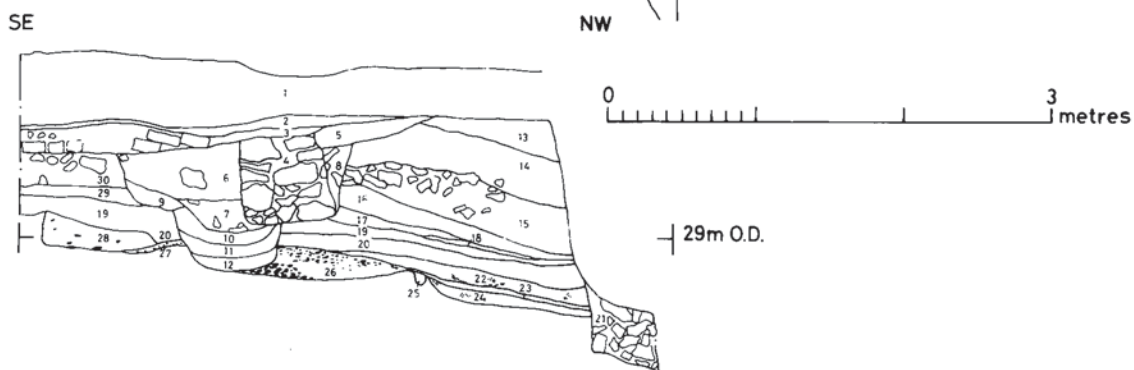
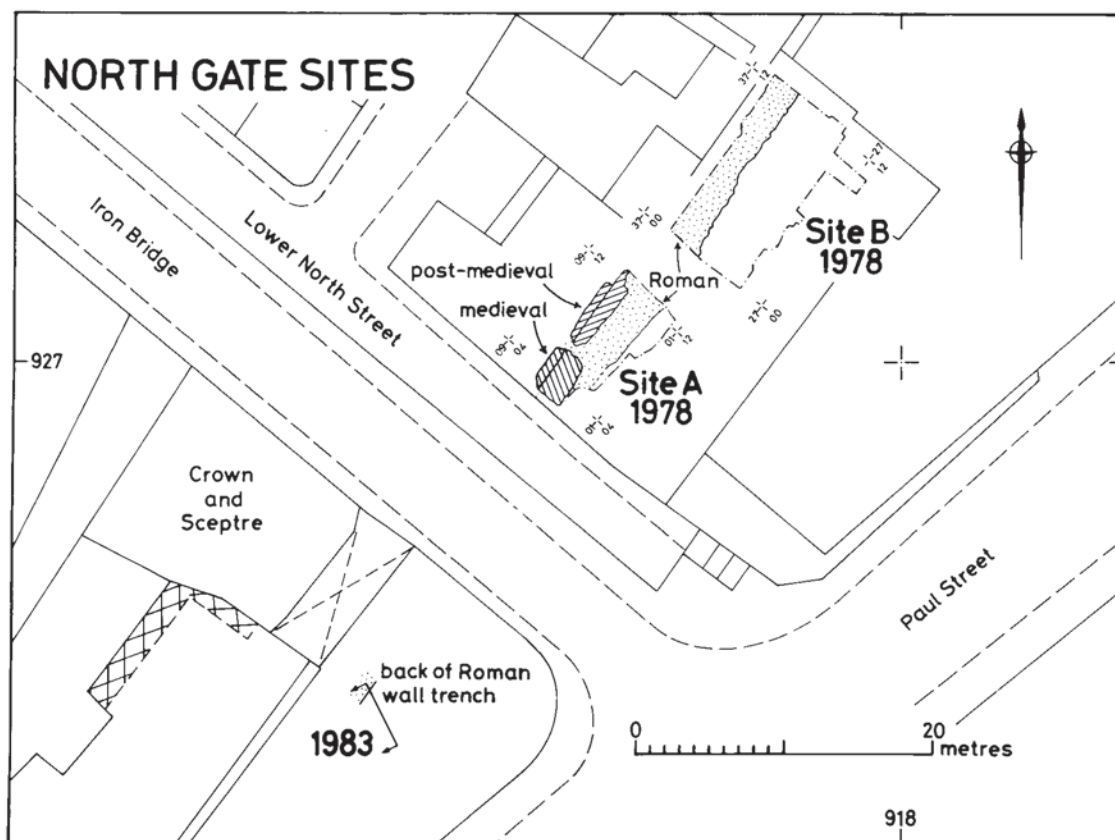
Fig. 3 North Gate sites, 1978 and 1983: Location.

North Gate 1983. A section through the rampart deposits was recorded during a watching brief on the opposite side of the site of the North Gate in 1983. The record of this is drawn up with the 1978 excavation (Fig. 3).

the bank tend to follow that gradient (see North Gate site B, section 5, and North Gate 1983: Figs. 3 & 4).

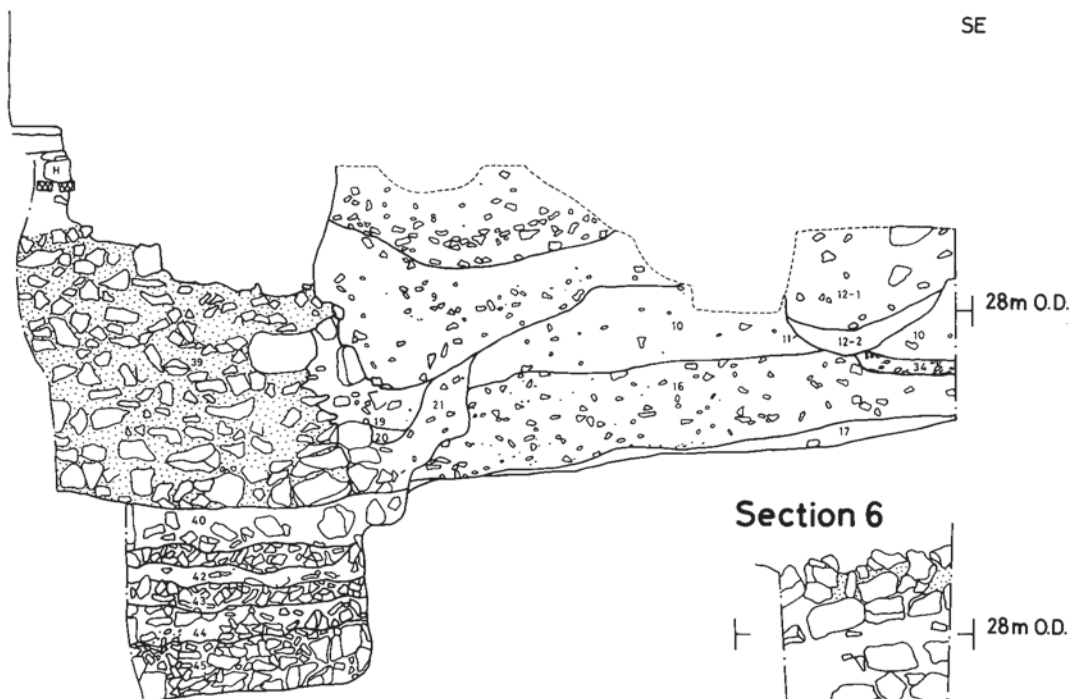
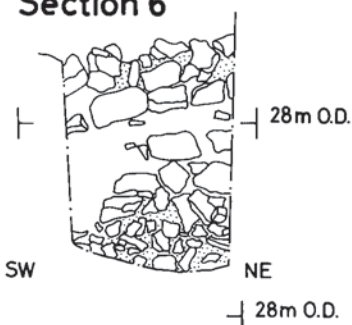
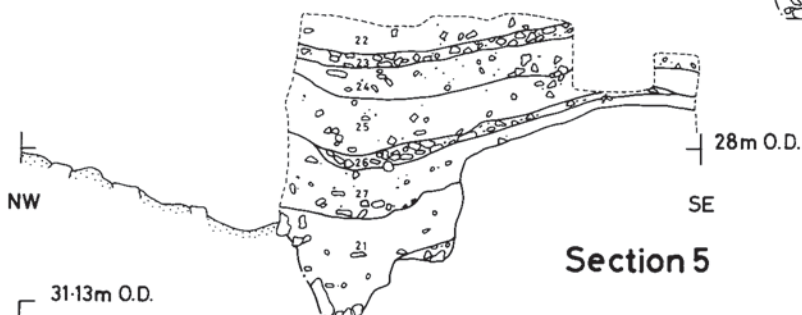
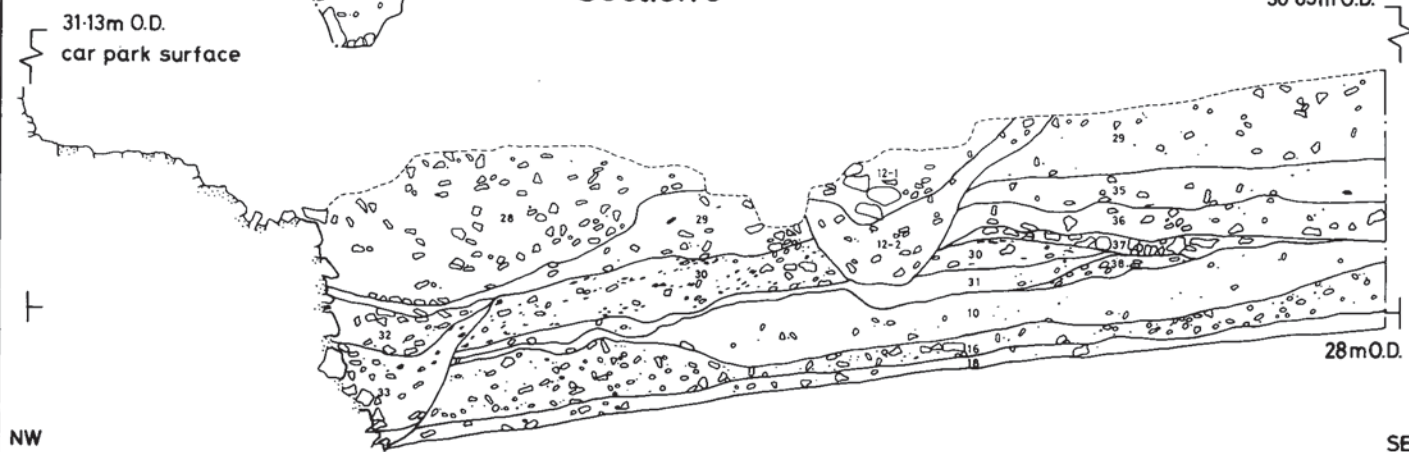
Fig. 4 North Gate, site B, 1978: sections through the wall and ramparts.

The excavations, watching briefs and recording of the standing structure in various places along the wall are here summarised with a brief description: North Gate 1978. Project number 69. Two trenches were excavated over the line of the City Wall, revealing the footings (Fig. 3). The first, Site A, spanned the full width and extended beyond the front face but no levels contemporary with the construction of the wall survived (being cut away by a cellar). Site B examined the development of the ramparts. One section was cut through the wall footings and the clay bonded foundations (Fig. 4, Section 1).

and 41.80m O.D. on the north-east side of Queen Street in the Bradninch Place trench. Accompanying the south-westerly slope is a more gradual falling off of the ground surface to the west and north-west towards the Longbrook valley. At times this is almost imperceptible especially towards the higher north-eastern part of the area, e.g. trench 13 (Fig. 9), but is noticeable in trench 10 (Fig. 10, section 55/108) where recorded levels of natural subsoil decline from 38.02m O.D. at the south-east end of the trench to 37.60m at the north-west end. This north-westerly slope is still more pronounced at the North Gate site (Fig. 4, Section 5; 69).

Evidence recorded on the upper surface of the first bank at North Gate (Fig. 4, section 5) and to a lesser extent in Paul Street trenches 7 and 13, suggests that the top of the bank may have seen some exposure and use as a surface before being covered by the heightening of the bank. At North Gate the bank layers were covered by a layer (Fig. 4, section 5, 30) of dark grey organic clay with daub, charcoal, cess and pottery sherds, obviously material derived from occupation here or elsewhere. This may, like other layers observed as occasional elements within the first bank, have been merely occupation material redeposited within the bank, or may have accumulated on top of it. In its turn, layer 30 was partially covered by a rough surface of cobbles and volcanic stone (layer 37) which was traced over a distance of 7.5m (plan, Fig. 5). If this surface represented a temporary street, as is possible, it was not detected farther to the north-east, in fact in most other sections in which the tail of the first bank was exposed the surface was clean, with no trace of superincumbent deposits. Only at Paul Street trench 13, where a layer of gravel and small stones (Fig. 9, section 127, 1979) was seen (in

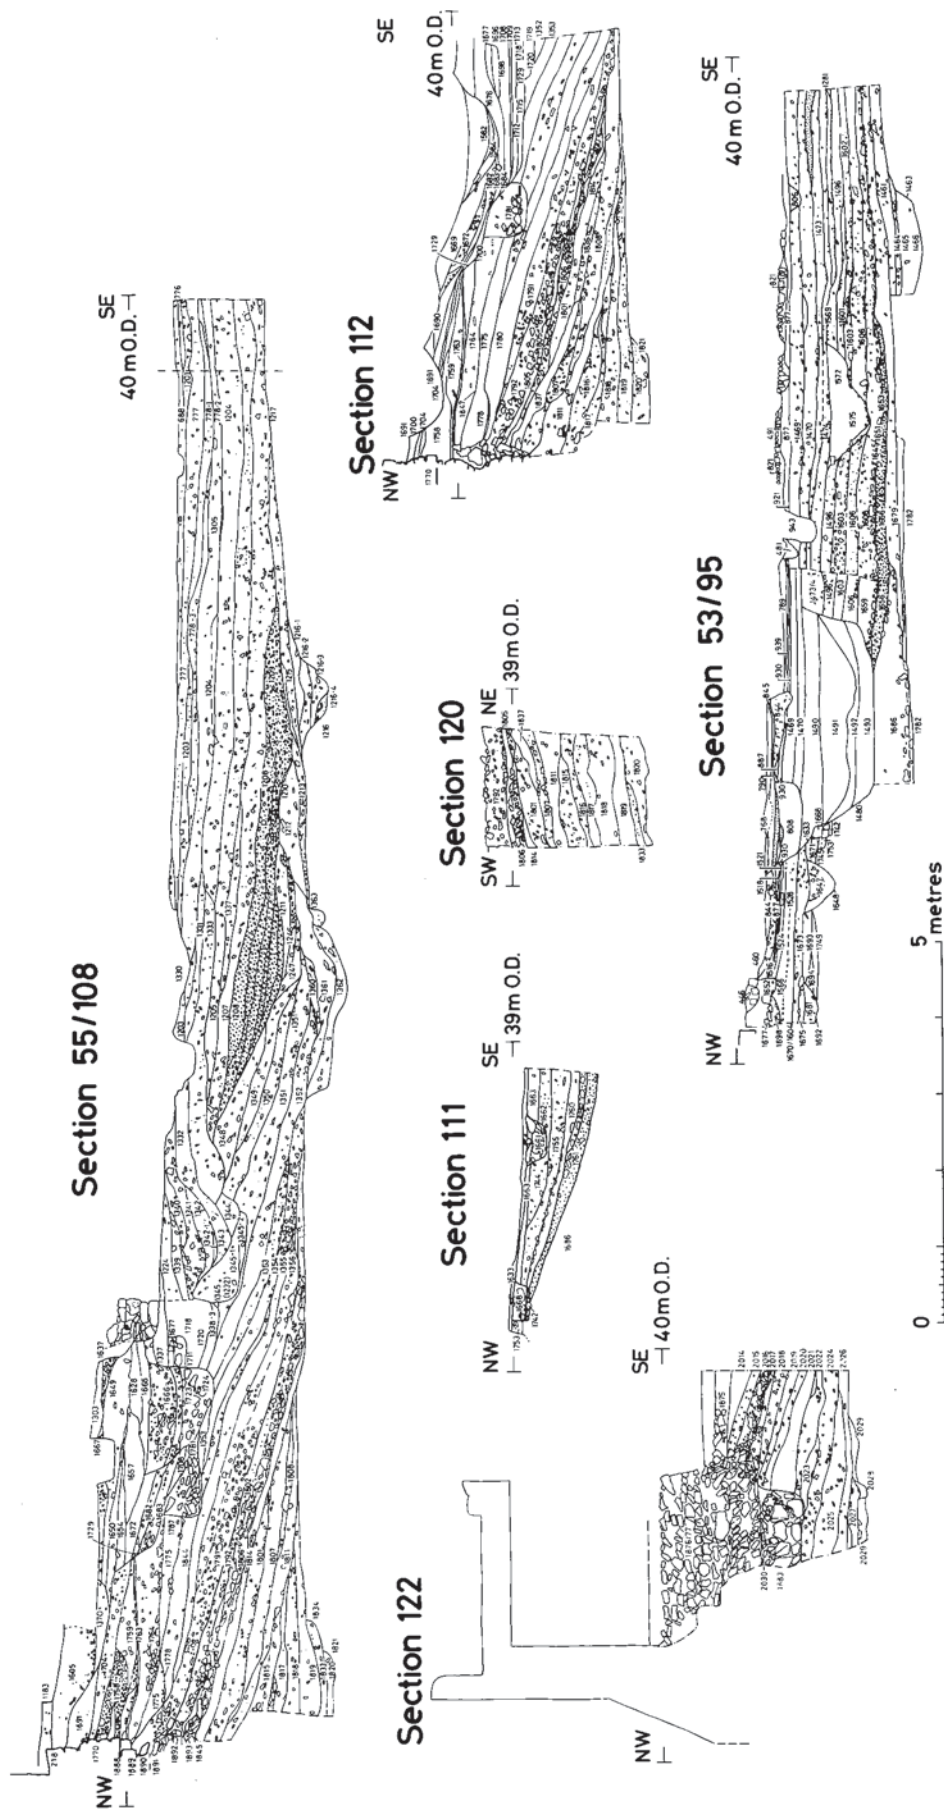
Fig. 6 Paul Street, Trenches 7 and 10, sections through the Roman defences.

section only) was a comparable layer traced. Nevertheless at these two points at least some activity was present, which must represent the passage of time between the two stages of rampart. Additionally at Paul Street trench 7 (Fig. 6, section 55/108) the natural ground surface behind the tail of the first bank was marginally lower than that preserved beneath the bank, suggestive of a period of wear or erosion before it too was sealed off by construction deposits relating to the City Wall.

The cut for the City Wall, where it was seen at Paul Street trenches 7 extension (Fig. 6, section 122) and 13 (Fig. 9, section 127), was not cut fully through the clay layers of the early bank on the line of the rear of the wall, but was cut in a series of steps, with the bank layers running beneath the footings. The first step was revealed in trench 7 extension, and the base of a cut, some 1.50m within the line of the rear face of the wall, in trench 13. No further stepping down was noted. This was prevented by lack of access to the footings further forward. Elsewhere, at Paul Street trenches 2, 7 and 15 and at Bradninch Place only the upper limit of the cut was traced since in these positions the presence of the standing wall above denied access to the footing trench. The first step of the trench did not always cut into the underlying bank to the same depth. In trench 7 extension the full depth of 0.60m of clay-bonded footings was accommodated within a cut (Fig. 6, section 122, 1883) but in trench 7, between 3 and 5 to the north-east, the clay-bonded footings,

the rampart at this point, both composed of fine chippings of volcanic trap. The lower of these (1778, Fig. 6) was confined to a narrow linear depression, c. 1.00m wide. Waste deposits of the same yellow mortar as was used to bond the wall core were mixed with the chippings. The second surface, 1763, was more extensive, spreading over the whole of the surviving upper surface of the rampart, but composed of the same fine stone chippings. It is probable that the material on the surfaces was derived from the dressing of stone for the wall. The mortar present in the first surface indicates that it was in use as the upper footings were under construction. The level of the second surface coincides with the base of the facework of the rear face and thus it may be suggested that this deposit represents the construction surface for the faced wall, the fine chippings being the residue of final working of the blocks before they were set in position. The facework of the wall in the position of trench 7 was built on an alignment at variance with that of the unfaced core beneath, the bottom course of facing stones oversailing the footings by a maximum of 0.15m. This was not a common feature at this point of transition, but it provides evidence that the wall beneath was largely obscured by rampart deposits when the facework commenced. The upper layers of the rampart continued according to the same pattern. Little more has been available for inspection in the various sections excavated. Invariably the uppermost parts of the rampart, and sometimes the facework of the wall, were removed by later intrusions.

Traces of footings for a later structure added to the rear face of the Roman wall were first detected in trench 7 (Fig. 6, sections 55/108 and 112, 1781), represented by a trench cut into the upper layers of the rampart containing stone rubble. Where first observed the trench was badly disturbed by later activity but subsequent extensions of the area of excavation revealed less disturbed footings to the south-west and a robbing trench in the bottom of the cut for a 17th-century bell-casting pit to the north-east (Fig. 7, 1875, 1874, 1841). Thus the full plan of a rectangular structure was recovered. The footings were of mixed volcanic rubble and river cobbles bonded with red clay, set in a shallow footing trench, from 0.20-0.60m deep (this, of course, was originally much deeper, having been truncated with the upper levels of the rampart). Internal dimensions of the building were 6.50m NE-SW and 3.30m NW-SE with walls up to 1.20m thick. Estimates of the original depth of the footing trenches are entirely dependent on those of the original height of the rampart. If the rampart stood c. 4.50m high, a minimum height which seems probable in the information obtained on the rear face of the wall at Bradninch Place (above p. 14), footings up to 3.00m deep may be suggested, at least for the part of the structure immediately behind the wall. If the remnants of this building were at all similar in construction to the wall itself then the south-west wall (the only portion not subsequently disturbed by robbing of stone) may represent clay bonded footings originally surmounted by mortared masonry.

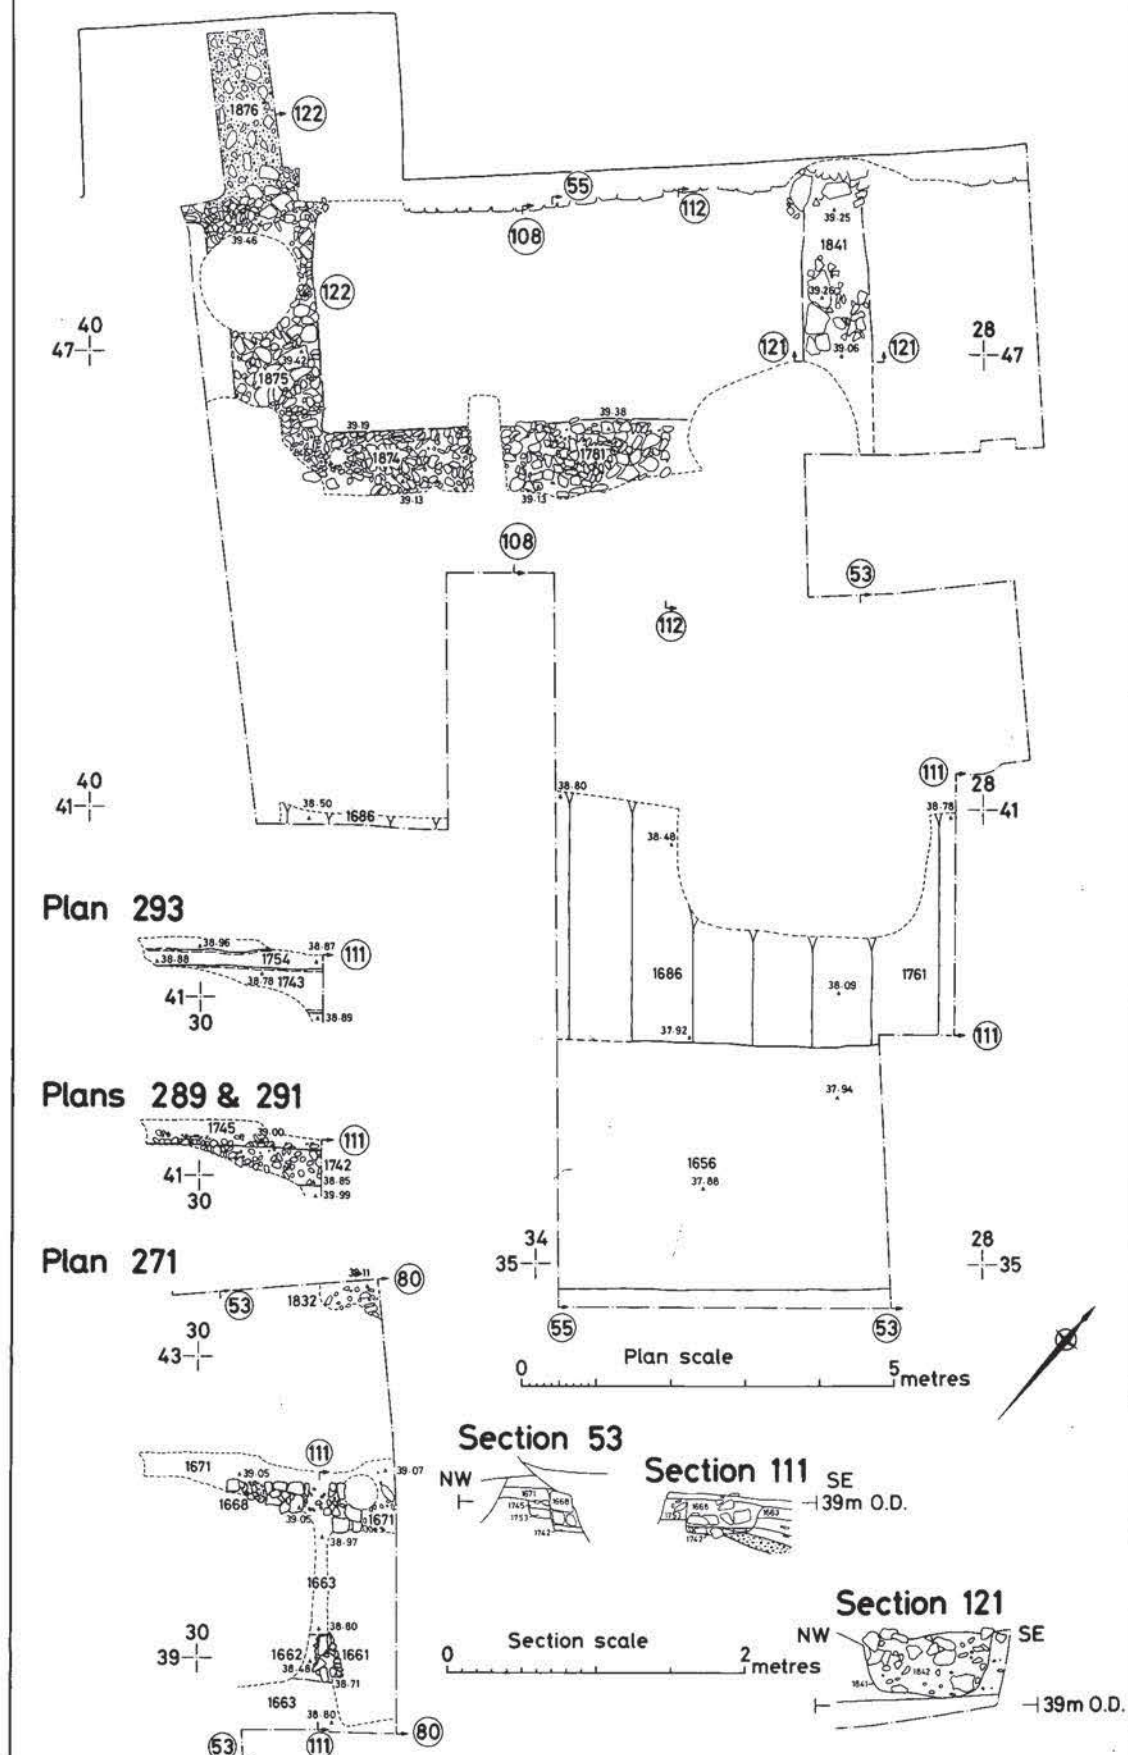
Fig. 7 Paul Street, Trenches 7 and 10, Plan of Tower, base of Wall and limits of Rampart.

Trenches 7 and 10. Roman levels in this trench were largely excavated in the course of 1983 with an extension to the south-west being made in early 1984. The sequence of banks and the construction of the city wall were examined in detail in a number of trenches, with later Roman development excavated over a wider area (Figs. 6 & 7). Recording of the standing structure of the wall also took place whilst the excavation was in progress (Fig. 12).

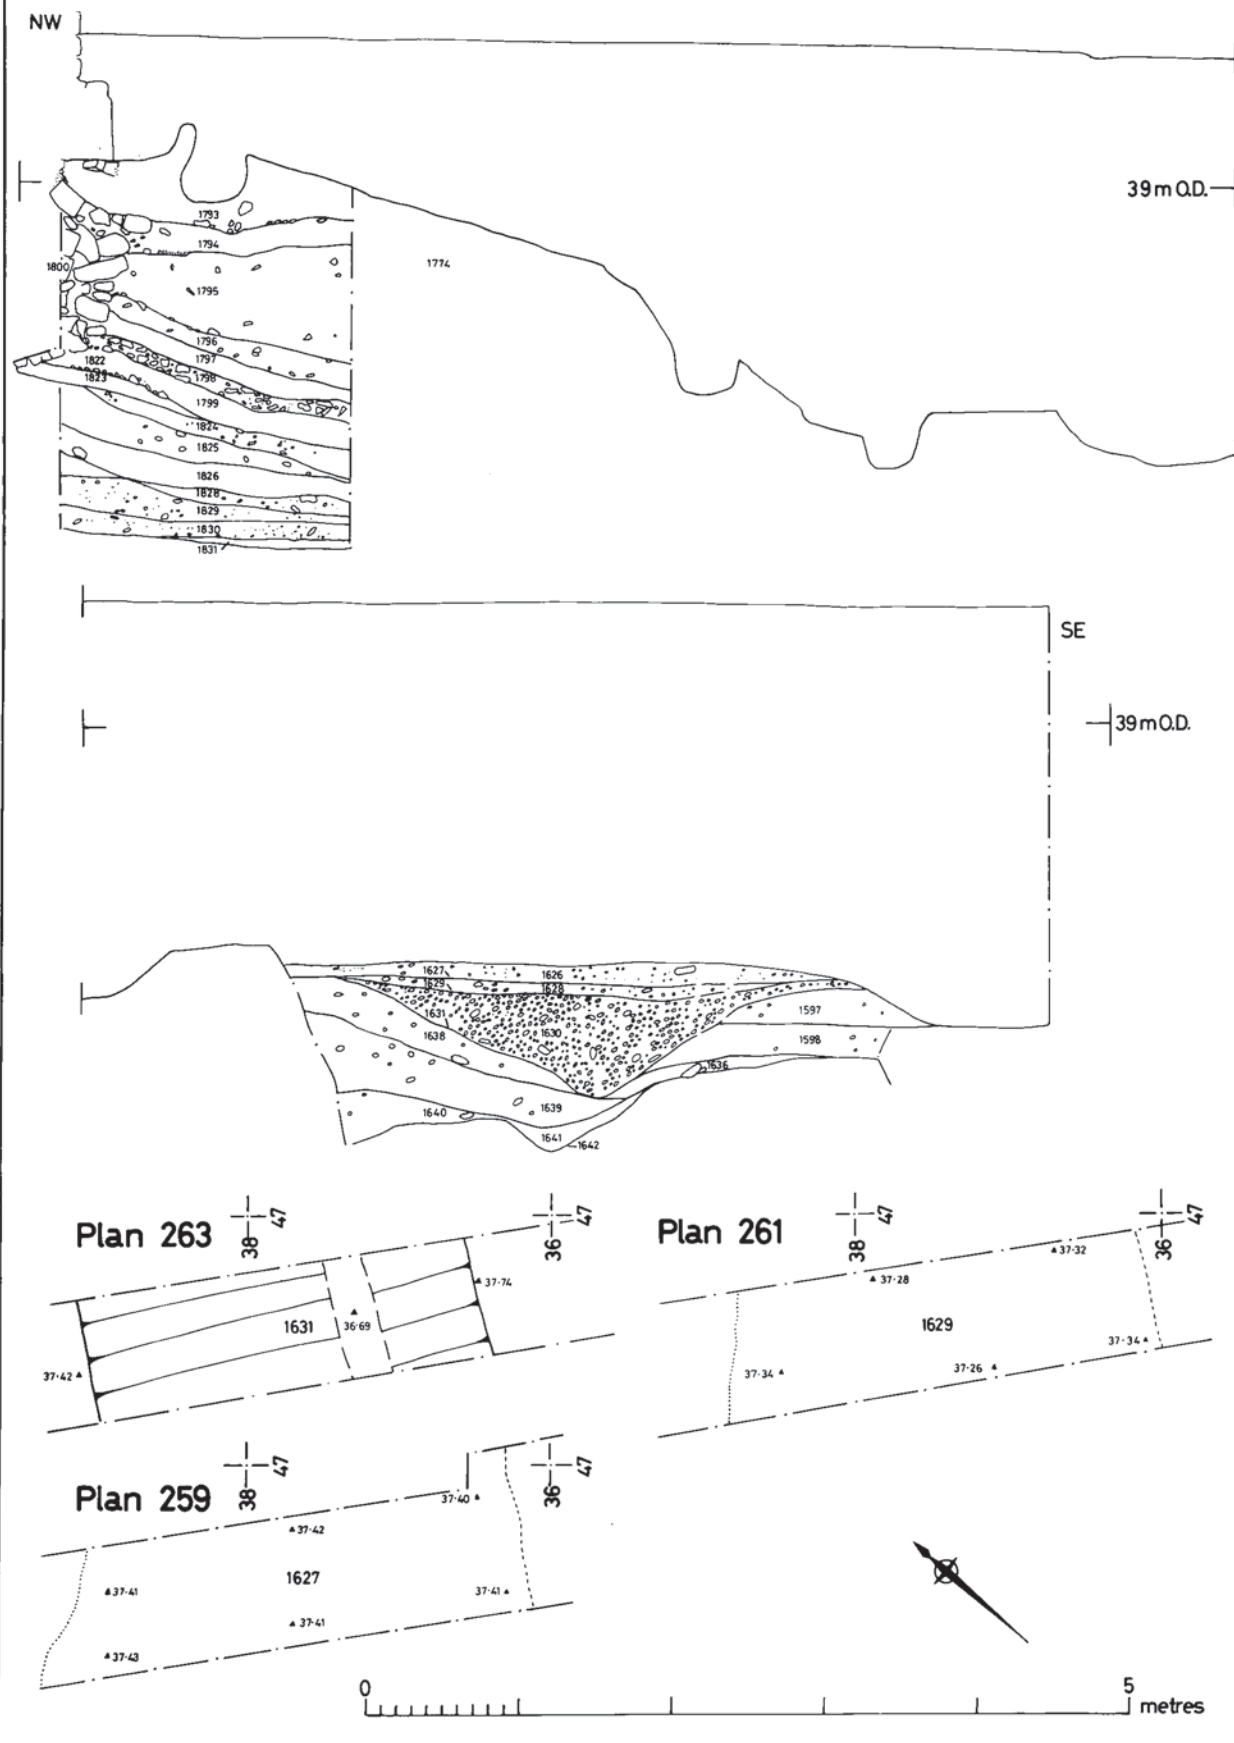
Fig. 8 Paul Street, Trench 2, Rampart section.

Trench 2. At the same time as Trench 7 a further section above the ramparts was excavated, partly by machine. A full section through the Roman levels was not obtained, but the rear of the rampart was excavated and a section through the two banks immediately behind the wall was obtained by the removal of the lining of a deep intrusion (Fig. 8).

Where the clay-bonded footings stood above the bank only the roughest of faces was fashioned. This was often obscured by a transitional deposit of loose volcanic rubble and clay lying against the rough face and merging with the clay of the rampart layers, e.g. section 55/108 (trench 7). A clear transition from the rough face to the sequence of rampart layers, observed in trench 2 (Fig. 8, section 107) indicates the variable nature of the structure.

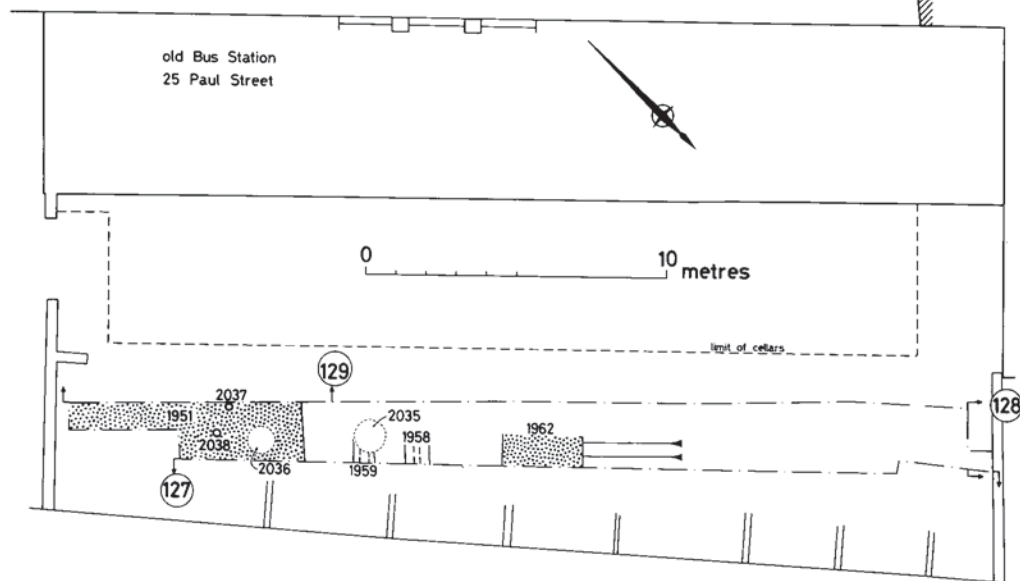
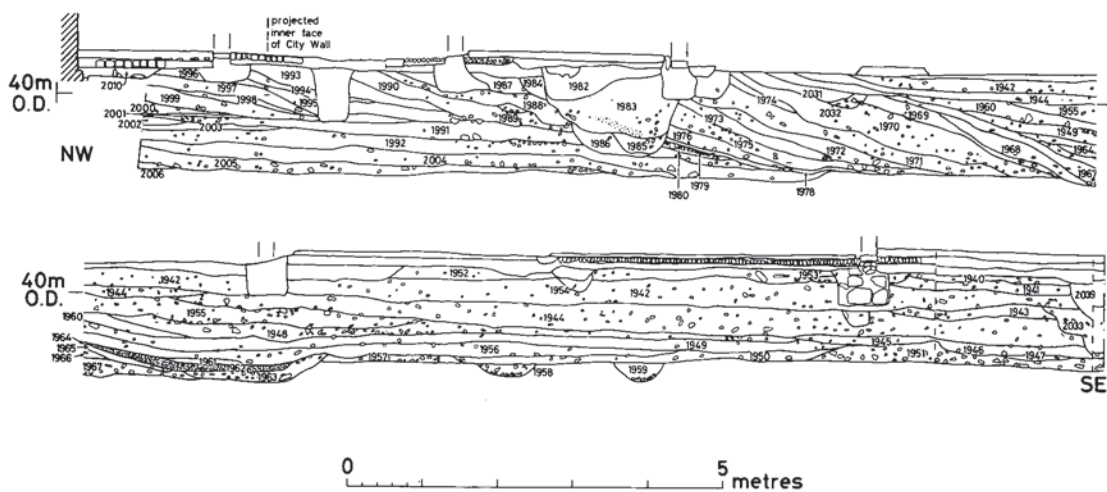
EXETER : PAUL STREET 1984 TRENCH 13

the Roman wall and through the two ramparts, complementing sequences observed in trenches 2 and 7 (Fig. 9).

Maximum surviving dimensions for the bank were recovered from Paul Street trench 13 (Fig. 9, section 127) where the trench extended beyond the projected line of the city wall by some 2.4m. Here the bank was obviously truncated by modern levelling yet stood to a height of 1.40m, approximately the same height as seen in Paul Street trench 15, and at Bradninch Place. In Paul Street trench 7, where the bank was preserved beneath the later rampart, but was not traced so far towards the outer limit, the maximum height surviving was 1.50m. In this section there was no sign of the tip lines within the bank levelling out that might have indicated proximity to the top of the bank. The width of the bank was variable. In Paul Street trench 13 the full width recovered was 10.10m, including 2.40m within the projected line of the wall. It may be suggested that the original outer limit of the bank, if in the same position as that of the later wall, was within 1.00m of the outermost point seen in section 127, for nowhere has the wall been observed to exceed a thickness of 3.50m. Confirmation of this and information as to the form of the front of the bank must await further exploration for this part of the sequence has not yet been seen in excavation. It must be allowed that if the supposition mentioned above is correct: that the front of the wall coincided with that of this bank, then there is little chance of these questions being answered since the construction of the wall footings must necessarily have removed the front of the bank.

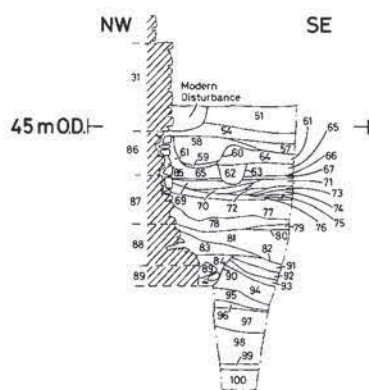
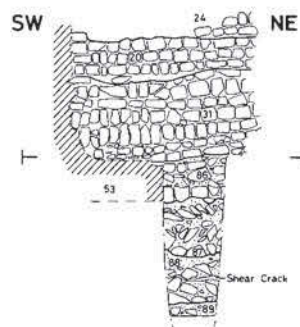
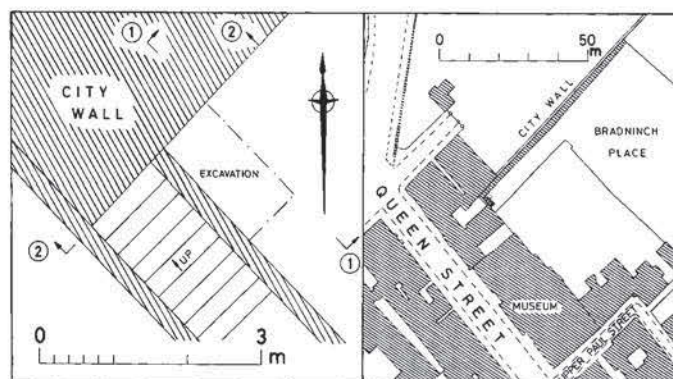
Fig. 11 Bradninch Place, location and details of trench.

Bradninch Place 1985: project number 82. A small section was excavated in 1985 against the inner face of the wall behind the R.A.M. Museum. A sequence of bank deposits and wall footings was recorded (Fig. 11). This ties in with the standing wall recording at Northernhay Gardens (below).

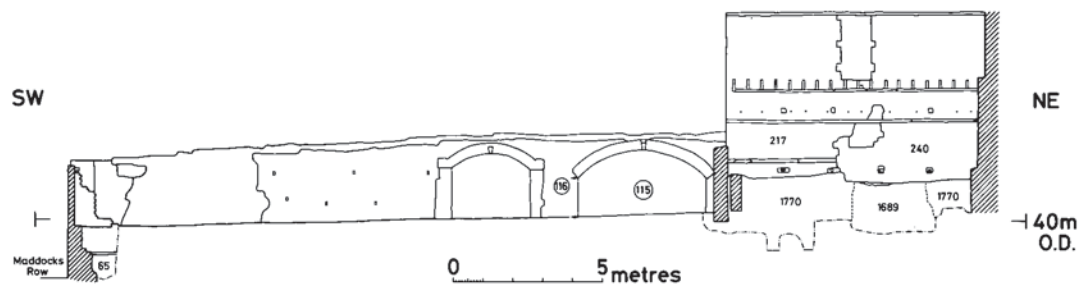
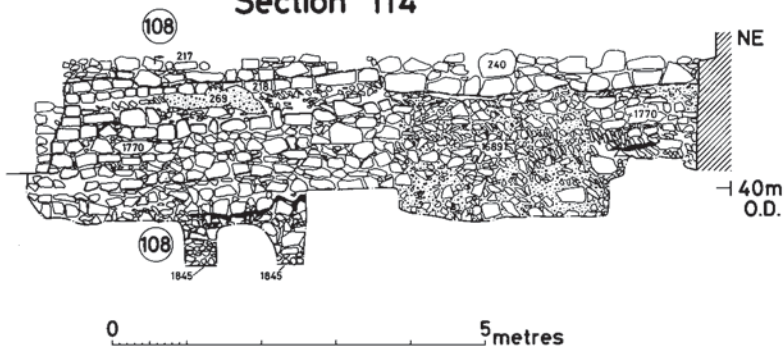
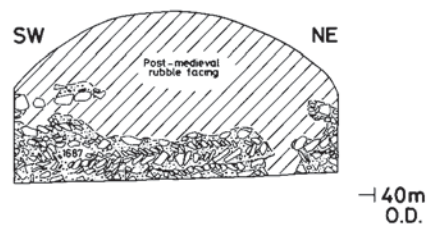
Fig. 12 Paul Street, 1983, City Wall elevations.

At Paul Street a similar sequence was observed although less well preserved. The detailed extract from Section 114 (Fig. 12) shows all the surviving Roman facework in the vicinity of trench 7. Above the unfaced core (for which see above and Fig. 6, section 55/108), a face of up to six courses, 1.10m high, formed the lowest level of facework (1770), over a maximum length of 8.20m (interrupted by an area of exposed core produced by post-medieval activity in the area). The courses were inclined slightly south-westward again. At the north-eastern limit the face was much shallower, up to four courses, 0.55m. Above 1770 the north-eastern half of the wall was rebuilt (240) but to the south-west up to two courses of an upper stage of Roman facework survived (218). No further facework was recovered but a minimum height was obtained from the observation of Roman corework standing to a height of c. 4.50m above original ground level some 15m to the south-west (Fig. 13, 2035). Unlike the wall at Bradninch Place, no change in mortar type was observed here to coincide with the beginning of faced construction. Although the facework of 1770 was bonded in a good quality mortar, that of the core (Fig. 13, 2035; Fig. 12, section 115, 1687; section 114, 1689) was of the same coarse type as seen in the footings below.

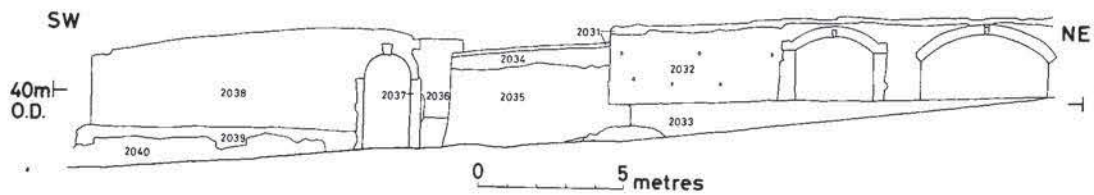
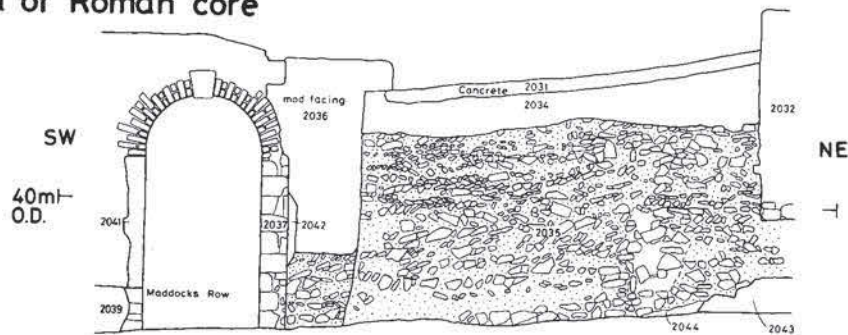
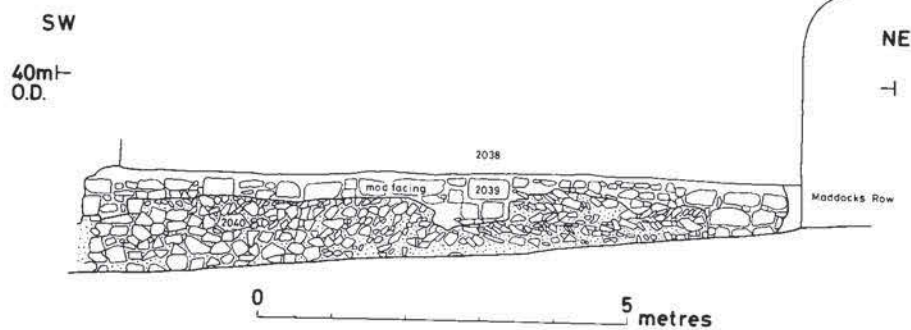
Fig. 13 Paul Street, 1988, City Wall elevations.

Further wall recording in 1988. A length of recent facework to the north-east of Maddocks Row collapsed in 1988 revealing Roman core. The the area NE and SW of the Maddocks Row archway was recorded again in its new form with Roman work exposed and the ground level lowered in 1988 (Fig. 13, cf. Fig. 12).

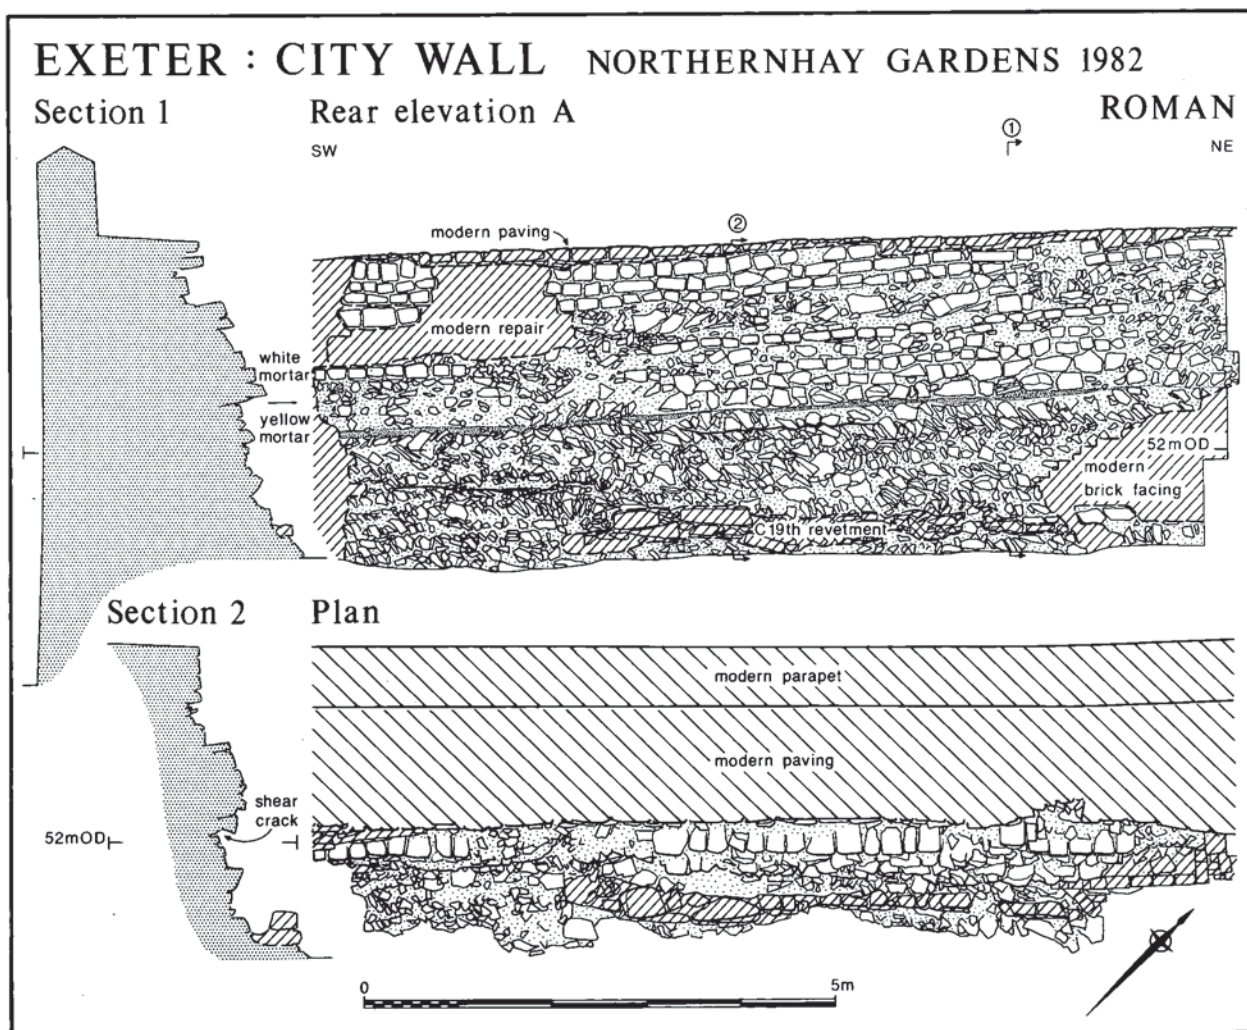
Fig. 15 Northernhay Gardens, rear elevation I.

and in the upper builds of the wall (e.g. Bradninch Place/Northernhay Gardens, Fig. 15) although the use of this was not universal (cf. the section of core recorded in 1988 at Paul Street (Fig. 13, 2035) where the yellow mortar type was employed to the full height of the surviving core.

Two sections which preserve Roman facework in quantity were particularly informative: for the lower part of the wall that seen in rear elevation A (Fig.

15) displays the lower, unfaced mortared wall, bonded with yellow, pebbly mortar (Fig. 17, 46) standing to a maximum height of 1.60m. The herringbone pitching of the unfaced core is clearly visible. Two horizontal shear cracks appear in this section (above p. 11; Fig. 17). At the point where facework began the mortar changed to the finer white variety. The facework courses (Fig. 17, 39) were constructed on a slight gradient to the south-west, presumably following the slope of the ground at least in part, and were laid in two faces separated by an offset. Each stage was of approximately five courses (the coursing is irregular and inconsistent). The offsets are clearly seen in the profiles of the wall (Fig. 15, sections 1 and 2).

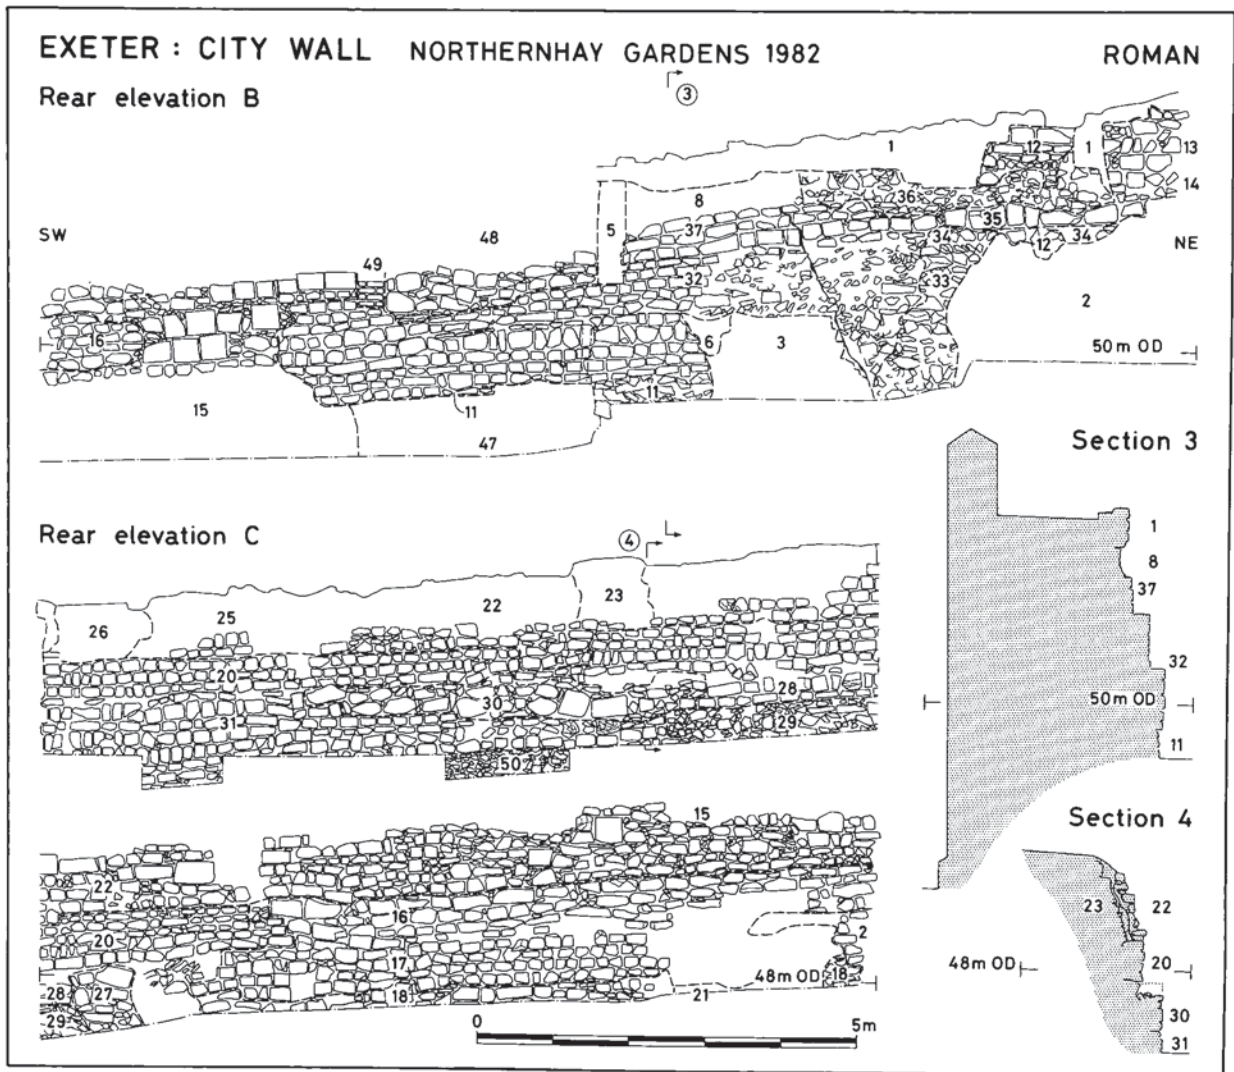
Fig. 16 Northernhay Gardens, rear elevation II.

In the second section, some 23m to the south-west, the wall is preserved to a greater relative height and here three offsets were seen (Fig. 16, section 3). The two lower faces were again of five courses apiece (0.70 x 0.20m) (11, 32), the top face (37) of three only, the facework having been lost from the top of the wall. The exposed core at the top of the wall (8) spanned the height of another two courses, suggesting that the third face too was of similar height. The total height of rear facework in this position, across the three faces, was 2.40m. The top of the third face was 4.50m above the external ground level. If this level is taken as an approximate equivalent to the original ground level, and given that from the top of the third offset (37/8) the rear face stepped in once again and rose for some way to the top of the wall, a minimum height for the wall top in this position would seem to have been in the region of 5.00m+.
