EXETER CITY DEFENCES

EXETER CITY DEFENCES
EXCAVATION AND SURVEY ON THE CITY WALLS
FROM THE NORTH GATE TO THE CASTLE 1978-88
PART I : ROMAN

Exeter Museums Archaeological Field Unit

Report No. 88.13

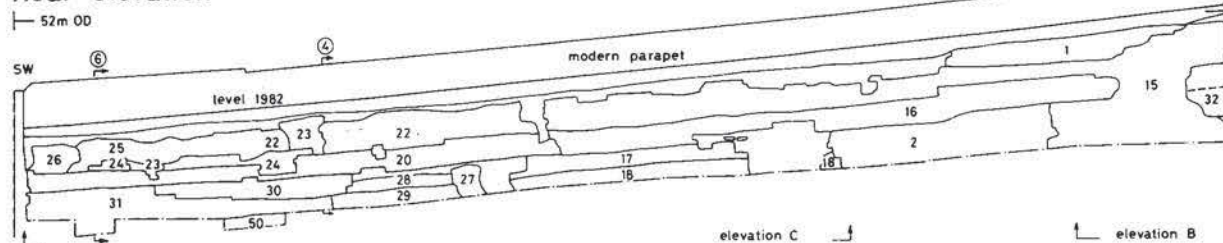
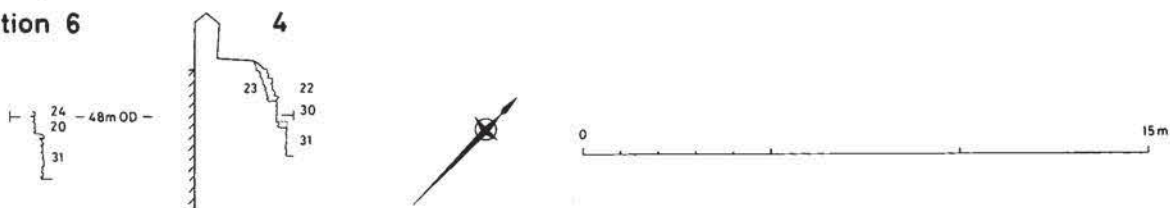
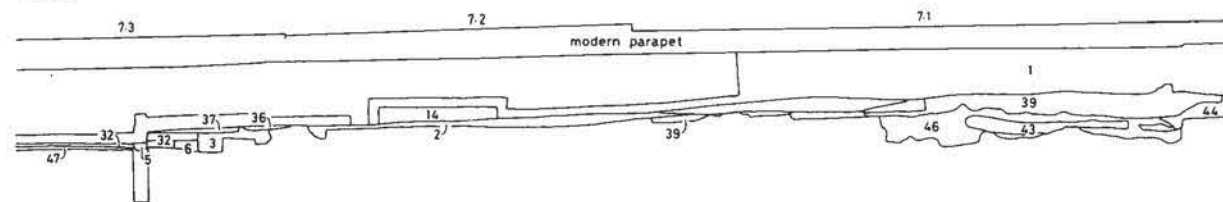
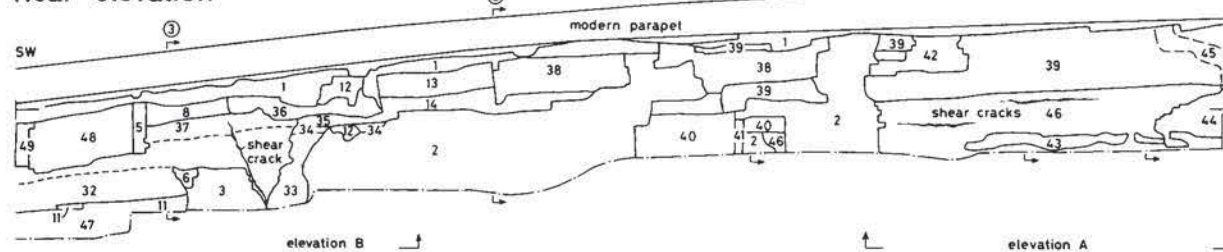
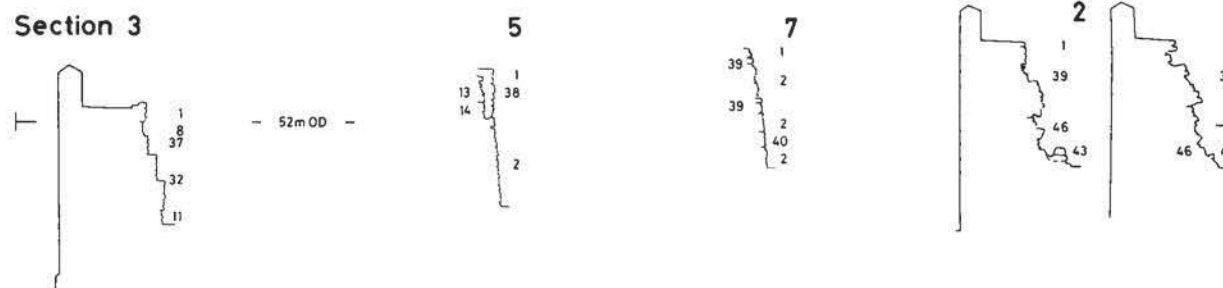
Fig. 17 Northernhay Gardens, outline rear elevation of City Wall.

The rear elevation is best preserved at Bradninch Place, to the rear of Northernhay Gardens (by which name the survey of that part of the wall is presently identified, Figs. 14-16). An outline elevation of the whole length of wall is given in Fig. 17, details of well-preserved areas of Roman facework in Figs. 15 and 16 (rear elevations A-C) and supplementary information from excavation in Fig. 11. Large areas of rear facework in several steps or offsets are visible, complemented by information from the wall adjacent to the South Gate (Fox 1968, 11-12 and Fig. 5) give the clearest picture of the form of the rear elevation. It is assumed that all of the facework that survives was originally obscured by the rampart to the rear of the wall. The original height of the wall is unknown, although sections at Bradninch Place where the wall top is c. 5.00m above external ground level, and the parapet c. 6.00m, may not be too far below that level (Fig. 17, sections 2 and 3).
