Exeter City Defences (Friernhay and Snaggle Tower) 1980 - 1990

**EXETER CITY DEFENCES
RECORDING OF THE EXTERIOR ELEVATION
OF THE CITY WALL BETWEEN FRIERNHAY
AND SNAYLE TOWER, 1980 AND 1990**

Exeter Museums Archaeological Field Unit

Report 94.38

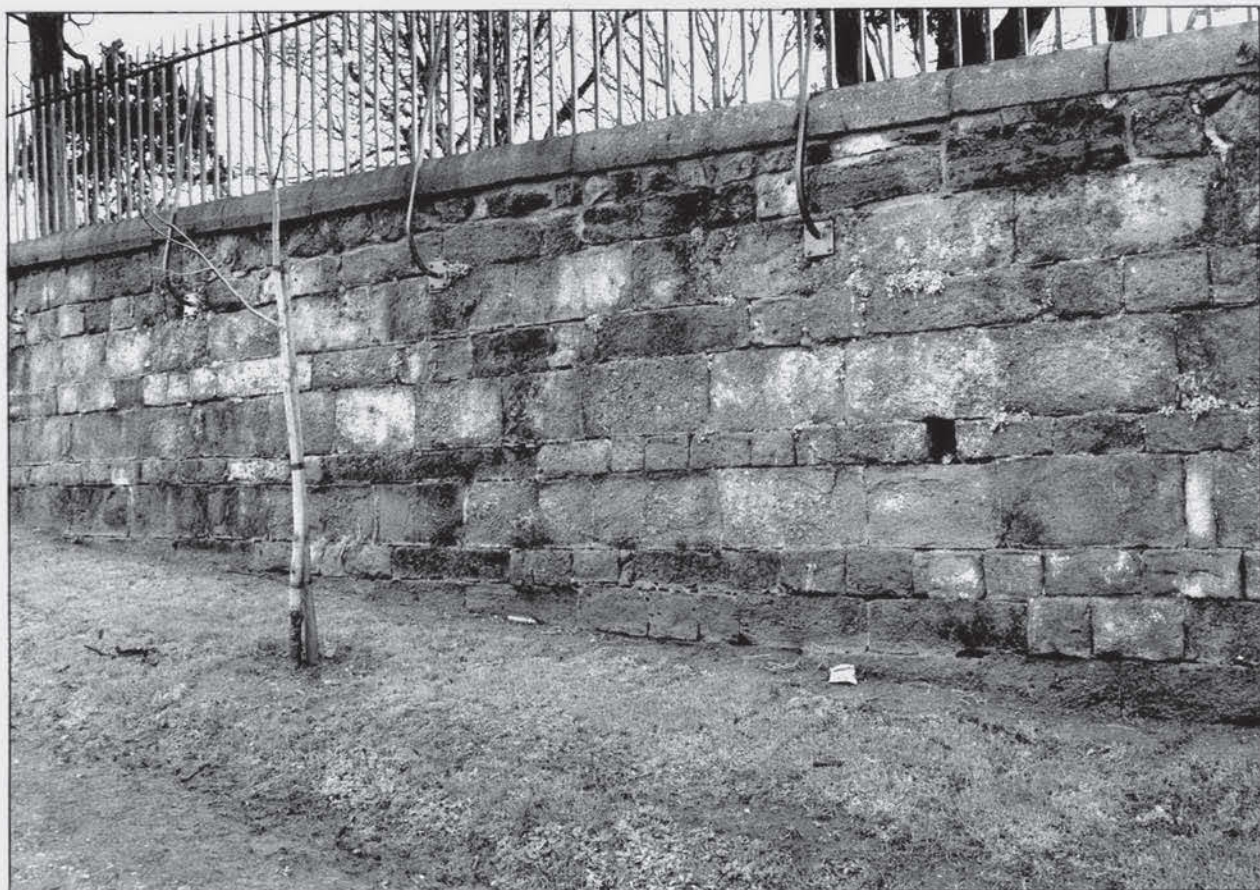
Section 14.2: (22m.) Large, well-squared, rectangular blocks of breccia in regular courses of varied height. Occasional intermixture of volcanic blocks, and some intervening thinner courses of pale grey volcanic stone; the scheme not fully consistent (Pls 1&2). Possible putlog holes are seen in one of the thinner courses, although the lack of putlogs on other levels reduces the likelihood of this identification. The stone is bonded in hard white, gravelly mortar; slates and small volcanic stones are used throughout for the levelling of blocks. Several blocks of a breccia plinth are exposed at the south-west end of the build, where the present ground level is at its lowest; the plinth was a plain projecting offset course, without a chamfer, although there is one volcanic block in the middle of the run which may bear the remains of a chamfer (reused from an earlier plinth?). The plinth of this build is one course higher in level than that of the next section to the south-west (14.3), but both plinths indicate the approximate level of the ancient ground level in this area.

Plate 1 Section 14.2, central part looking east in 1994, showing characteristic masonry style.

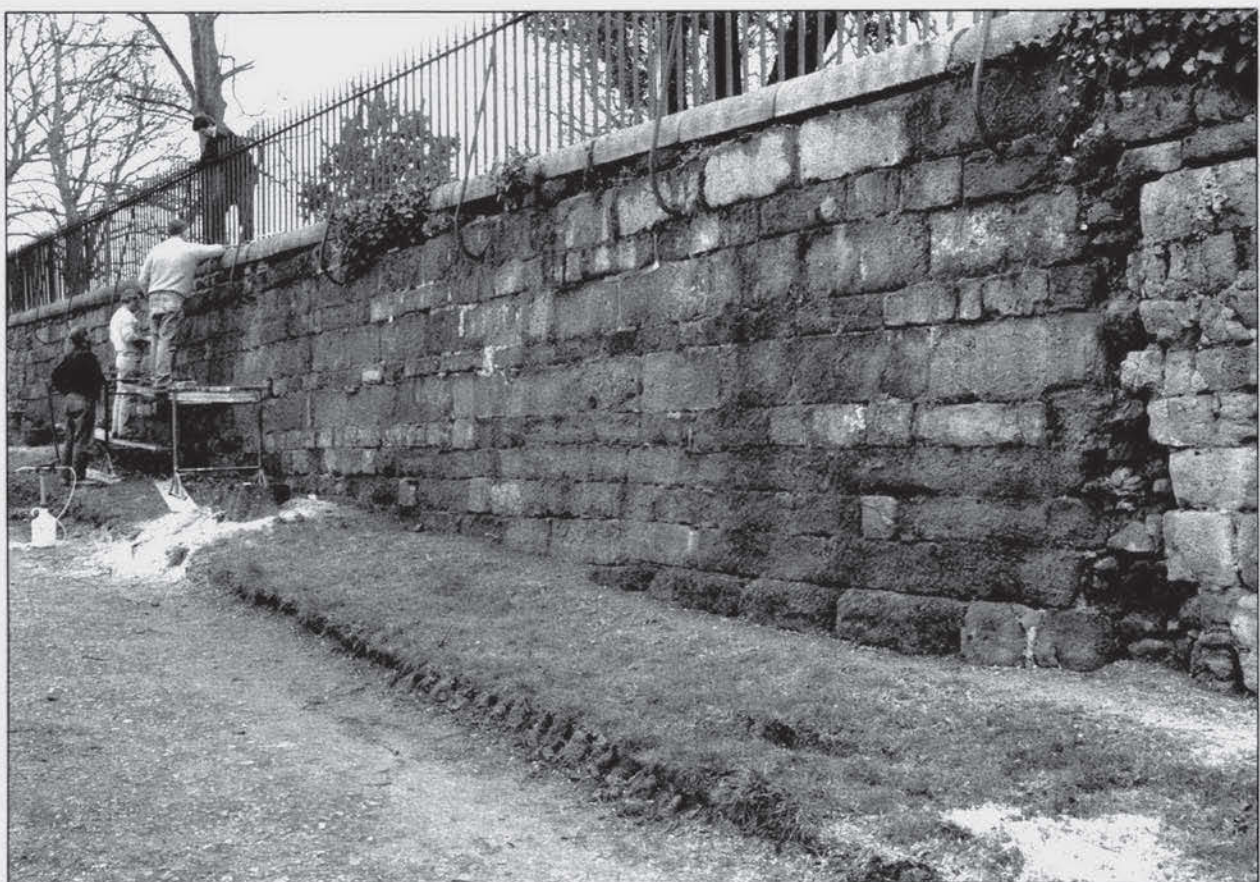
Plate 2 Section 14.2, from south-west end, looking east (repairs in progress, April 1990).

Friernhay/Bartholomew Yard 1990. In 1990 repairs were carried out to the exterior facework of the city wall in this area under the auspices of Exeter City Council. Large trees which had been growing close against the face of the wall were felled, the facework cleaned and repointed and the iron railings above were painted and their coping stones consolidated. During the course of this work, which took place over several months in the spring of 1990, Exeter Museums Archaeological Field Unit made a systematic photographic record of the exterior elevation (Pls 1-9), and kept notes on observations which aided the interpretation of the structural history of the wall.

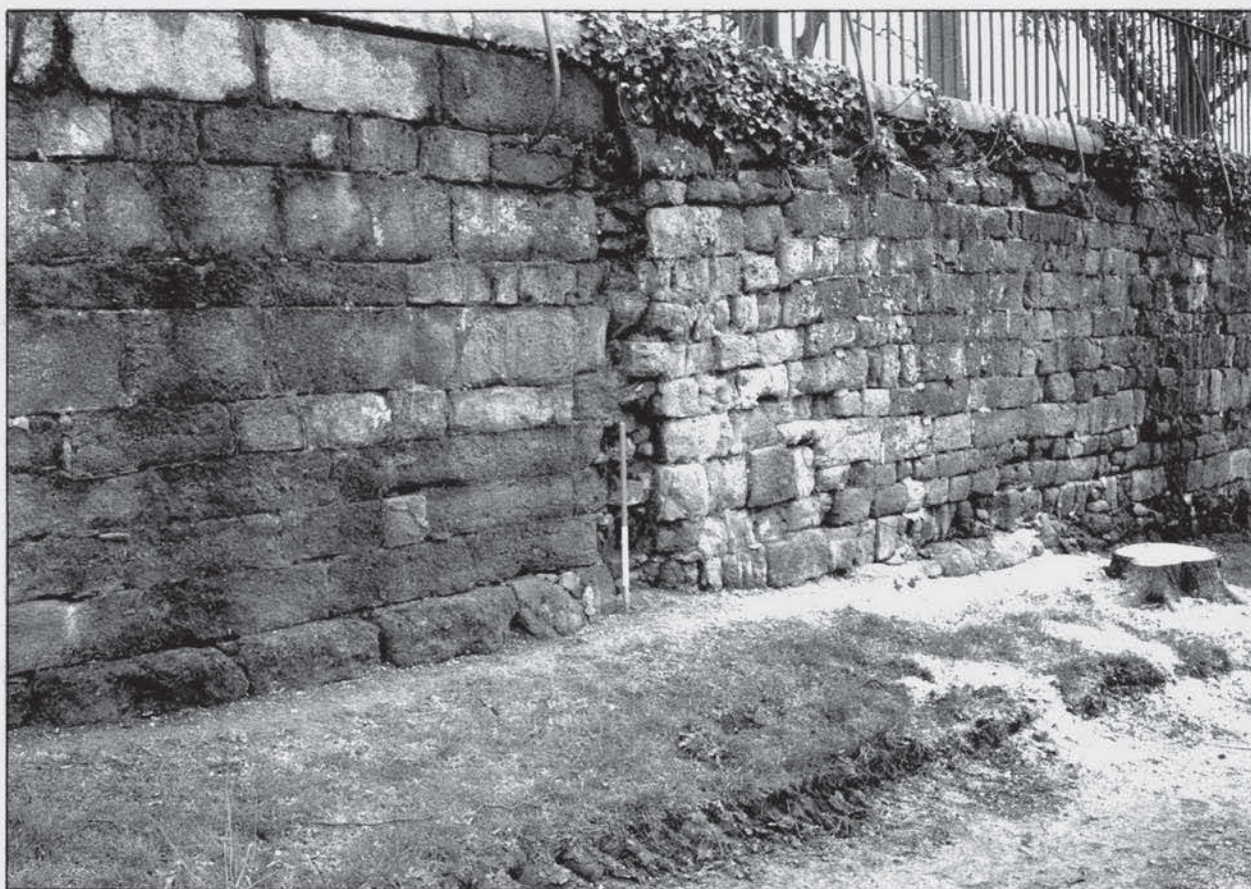
The junction between sections 14.2 and 14.3 (the earlier build) is untidy (Pl. 3); there is a difference of some 0.10m. in the planes of the two sections (14.3 stepping out from the earlier build), with a narrow area of exposed core at the junction of the two builds. This is interpreted as the position of a buttress, integral to build 14.3, which was incorporated into build 14.2 (or rebuilt at the time of its construction), and then removed at some later time. Both builds show work which is bonded to the buttress scar, and the breccia blocks of the later build to the north-east also show some differential weathering which may have been caused by the protection given by the quoin of the buttress.

Plate 3 Junction of sections 14.2 and 14.3, looking south.

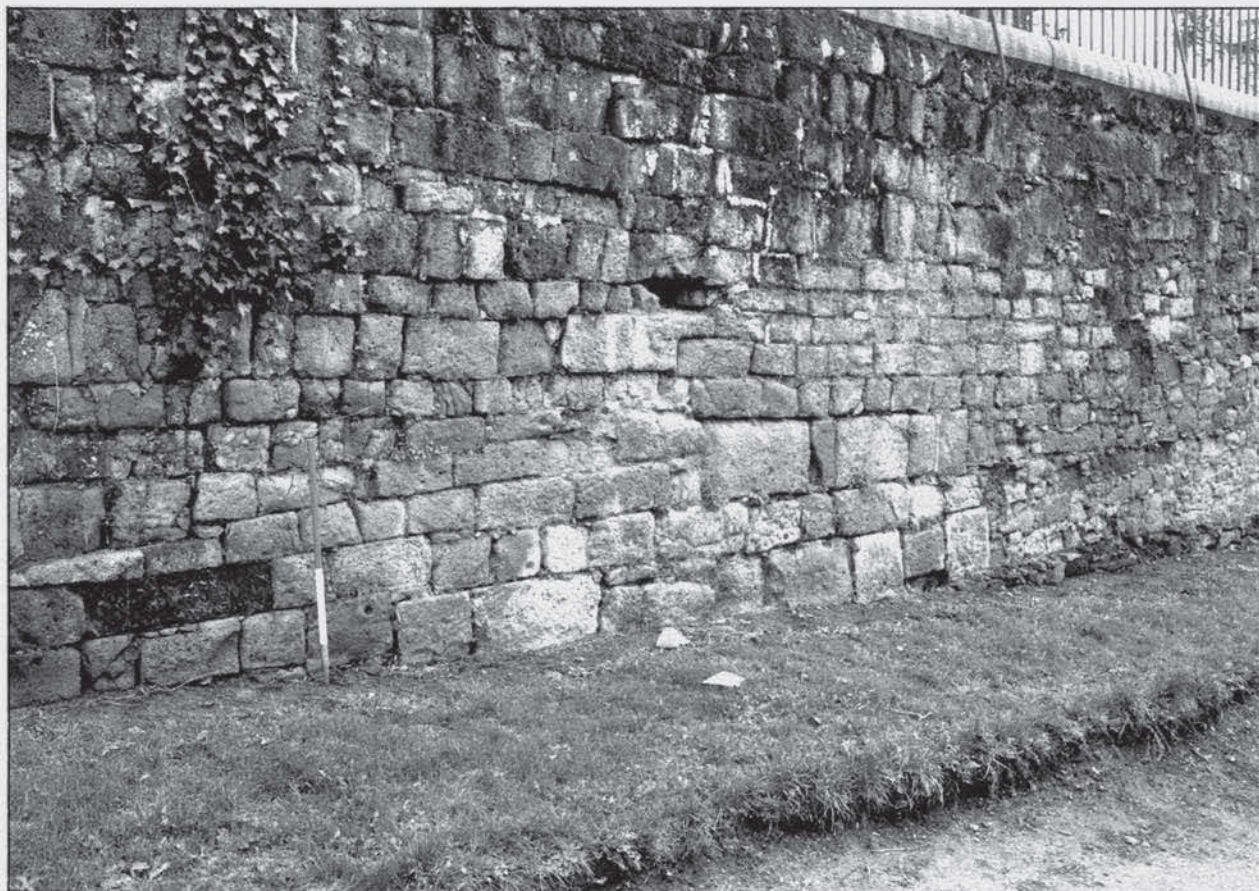
Section 14.3: (14.5m.) Well coursed volcanic blocks, courses of variable width, some courses and occasional individual blocks very deep (Pls 4&5). The stone is predominantly pale grey in colour, some of it is brownish; individual blocks are weathered, especially towards the base; hard white mortar; slates used as levelling in joints. A chamfered plinth in poor condition survives at the north-east end of the section (Pl. 4), but from c.4.5m. into the build the plinth is removed and replaced with underpinning of breccia and brick. Towards the south-west end of the build the plinth probably stepped down (with the natural slope of the ground) as good facework survives here to a lower level than that of the surviving plinth; there are also some very large blocks in the facework at this point. The plinth and some of the facework are probably Roman, fulfilling some of the criteria for the identification of Roman work described elsewhere (Blaylock 1993(a), 2-3): large squared but weathered blocks; uniform colour and texture; a rough plinth with a weathered chamfer of a variable angle. Some of the upper courses may be a later rebuilding, incorporating reused stone; but if this is so it is not easy to see a break, or set limits on the original and later builds. One course of masonry at the top is rebuilt to support the granite base for the railings of Friernhay yard.

Plate 5 Section 14.3, south-west part, looking south.

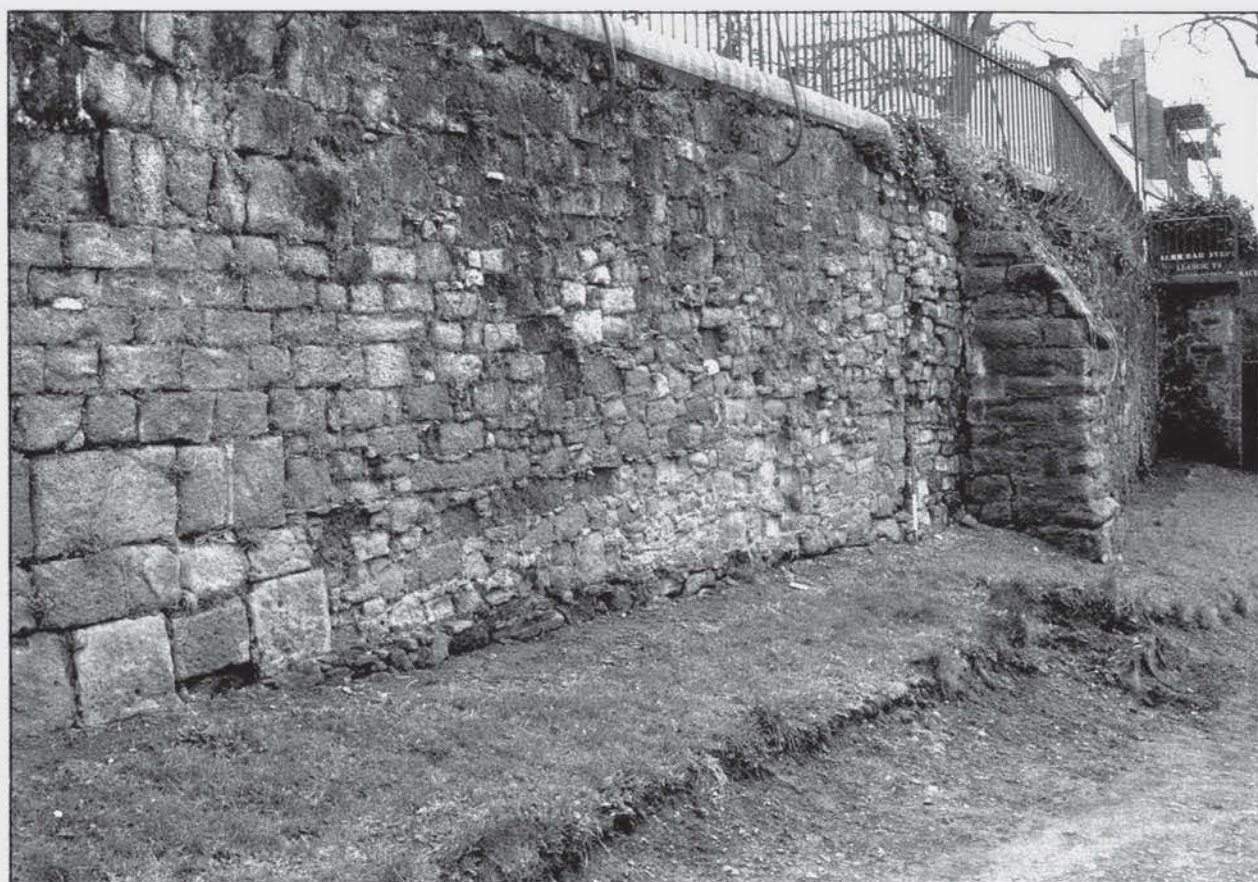
Section 14.4: (6.8m.) This section is essentially a continuation of the previous build, but with extensive repairs to the facework giving it a different appearance (Pl. 6). The additional masonry comprises irregularly coursed work of small volcanic stone, some of it veined in texture; breccia (15%); plus some chert and brick. The coursed and uniform volcanic blockwork of the previous build rides over 14.4, and some continuous courses can be traced running through. The composition and characteristics of the two builds are very different, although in any given area it is difficult to trace a clear division between them. In other words, 14.4 is a patching and underbuilding of build 14.3. A projecting course of rubble work at the base of the wall may have been constructed in imitation of the plinth. The presence of breccia and brick together here suggest a late post-medieval date for these repairs.

Plate 6 Section 14.4, looking south.

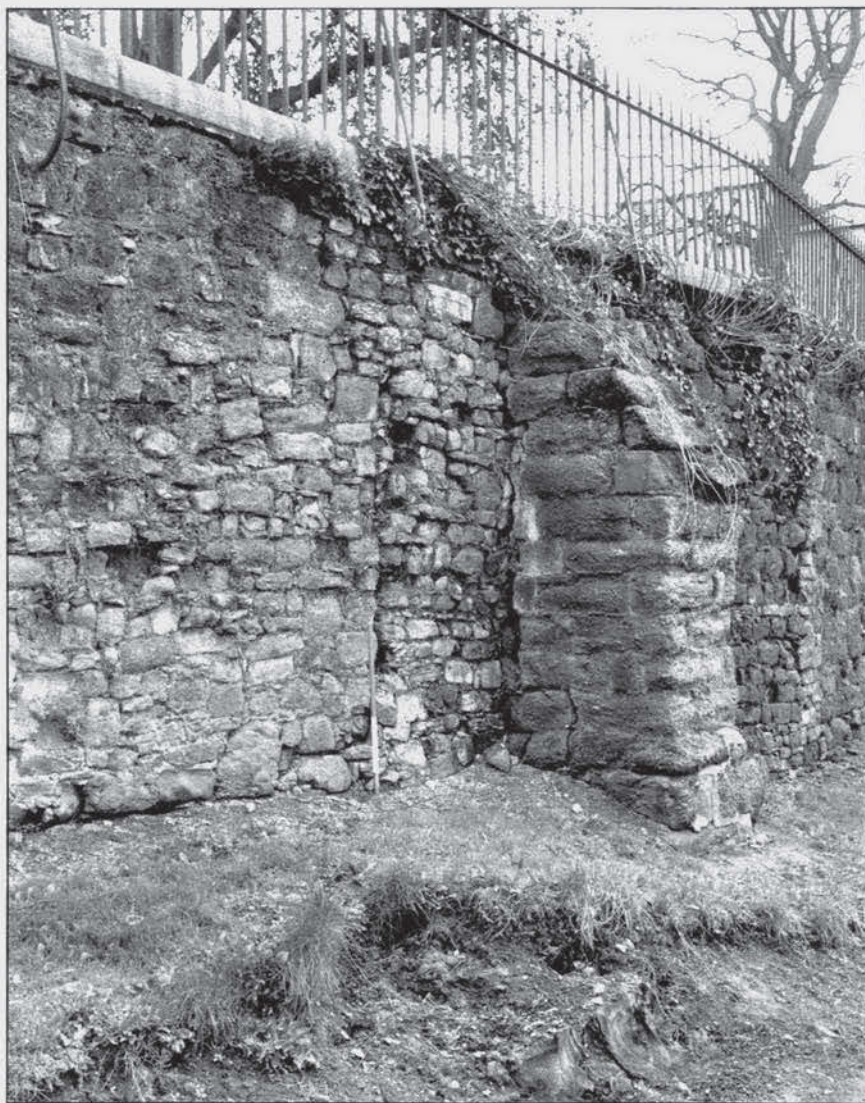
Section 14.5: (5.4m.) Irregularly coursed volcanic stone with some veined textured stone, all quite uniform in texture and colour (dark purple), some Triassic sandstone as an occasional extra. Putlog holes, as well as the composition suggest a late-medieval date. No plinth or other lower limit visible, perhaps buried by raised ground level (as the plinth, where last seen in section 14.3) was stepping down. Abutted by 14.4 (Pl. 7); and by 14.6 (Pl. 8). The junction of 14.5 with 14.6 coincides with a change in the angle of the wall (Fig. 2, and Pl. 8), the junction is awkward as if something has fallen away at this point, and there is some patching of the facework with unsquared veined volcanic masonry to repair the raggedness of the join. The facework is abutted by a buttress of breccia ashlar at 1.10-2.00m. from the north-east end of the build. It is constructed with a sloping top and a chamfered string course or plinth on three faces at present ground level (the uncertainty over ancient ground level in this area, cf. above on the plinth of the wall itself, makes it likely that the buttress continues down for another stage). This is a late medieval or early post-medieval addition. A profile was published by Burrow (1977, Fig. 12 [All Hallows]). The top of the buttress was rebuilt in 1990 (after the photographs of Pls 7-8 were taken).

Plate 7 Section 14.5, looking south, with buttress.

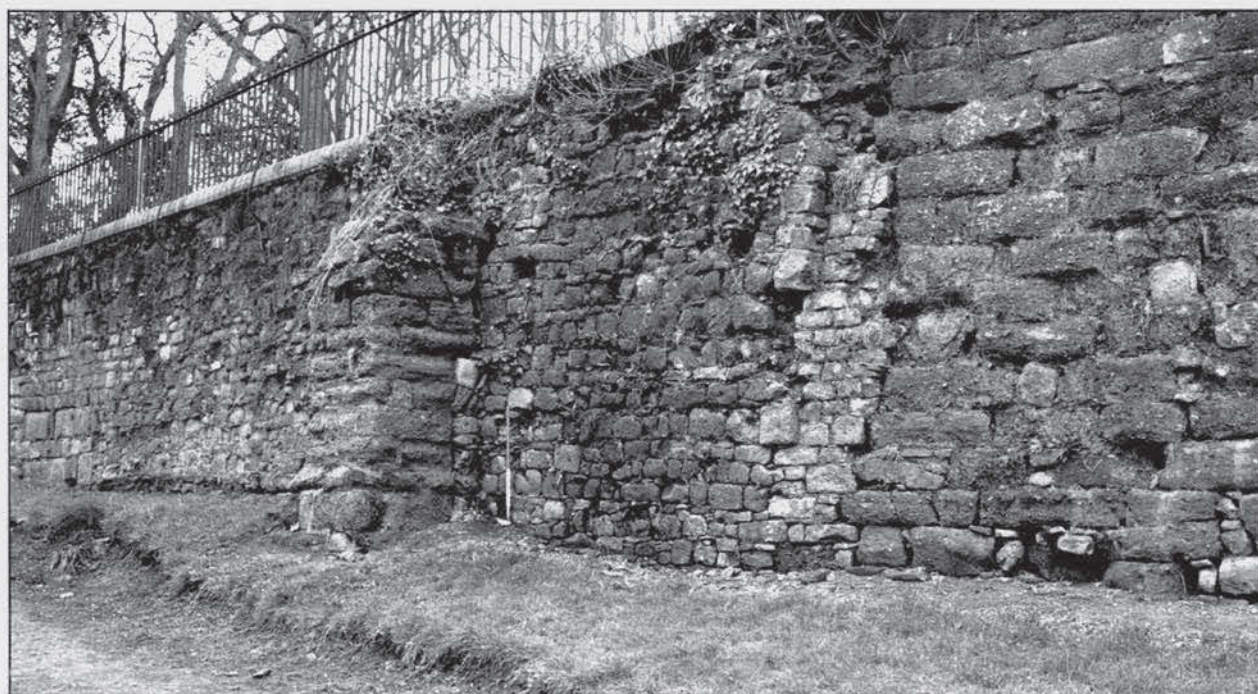
Plate 8 Section 14.5, looking east, note junction with 14.6 to right of picture.

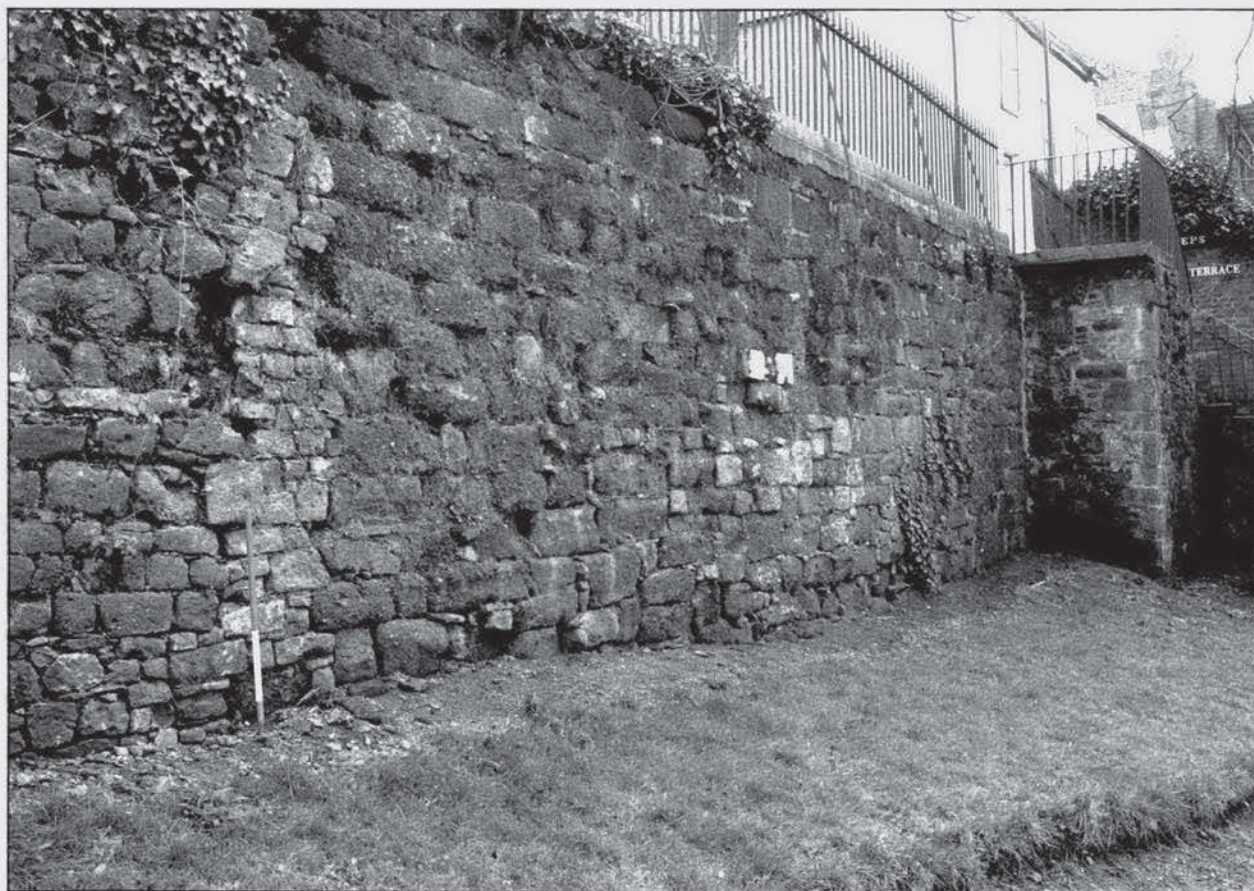
Section 14.6: Coursed facework predominantly of breccia blocks, but with some volcanic trap, Triassic sandstone, plus two blocks of hard white limestone (Bath or Portland) and one of Ham Hill stone (Pl. 9). These accidentals suggest a later date than the overall appearance of the build, so perhaps 18th century in date. There is a change in the coursing and style of the facework, 2.5m. short of 14.7, from the mixed composition described above to wholly breccia facework, which is noticeably less weathered and whose courses do not fully align with those of the rest of the section. This may be a separate build, or may represent protection by a structure against the face of the wall (a predecessor to Barbican Steps?).

Section 14.7: (5.5m.) The wall is obscured by Barbican Steps (Pl. 9); the structure of which is later than the railings of Friernhay yard, therefore mid-late 19th century.

Plate 9 Section 14.6, looking south.

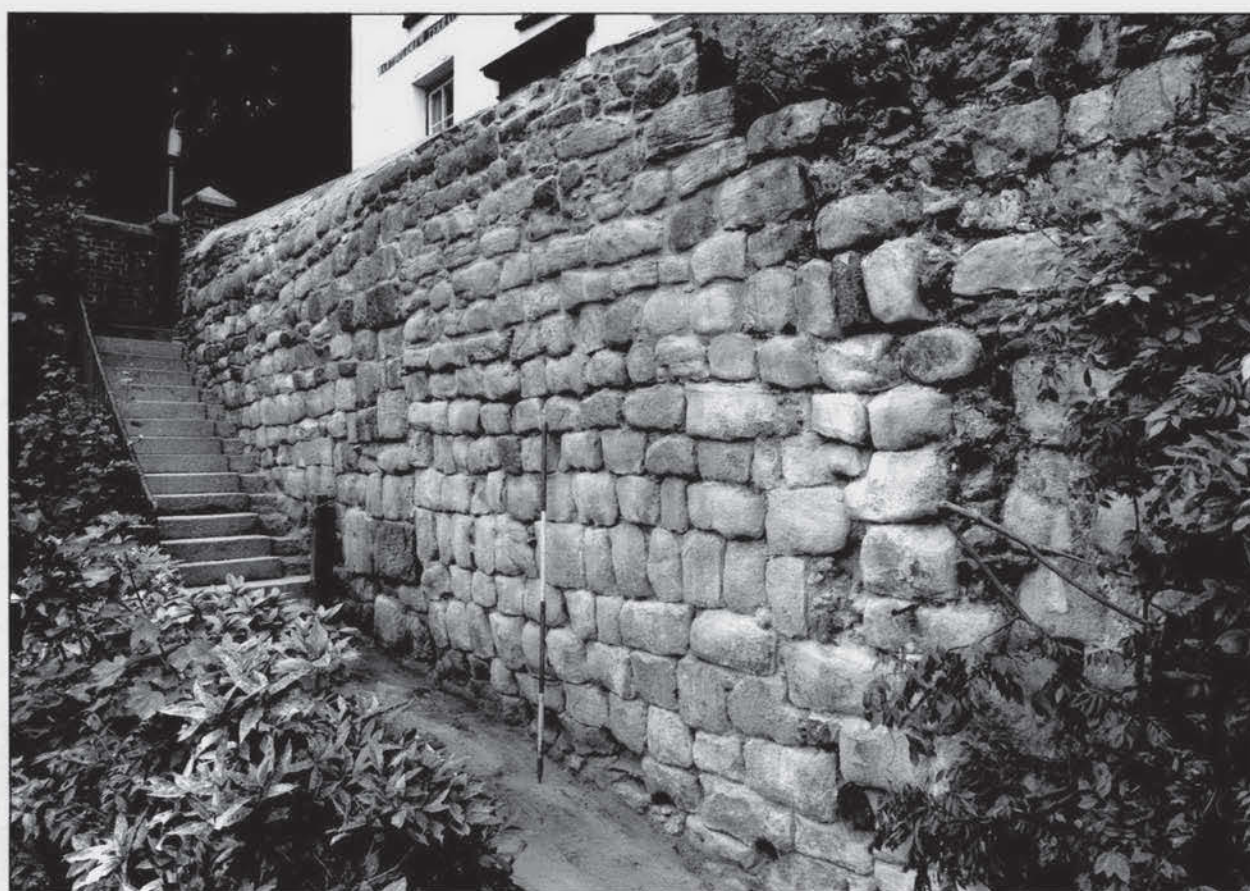
This section is 41m. in length and contains interesting and ancient masonry. The main build of the section (15.3) has two ancient buttresses, towards the south west end of the section, and one modern buttress at the north-east end, whose construction in 1979-80 provided the occasion for the photographic recording of this area (Pl. 10).

Section 15.1: (2m.) Modern entrance to Hillyfield House garden, and obscured by steps (Pl. 10).

Section 15.2: (5.5m.) A section of rebuilt wall containing mainly re-used material (Triassic sandstone and volcanic trap), but with some exotics: a greenish-grey ?York stone, and several early-looking bricks. The work abuts section 15.3 to the south west (Pl. 10); probably 18th or 19th century, coeval with new building at Bartholomew Terrace? The parapet is a separate, later, build containing breccia (as is all of the parapet of section 15).

Plate 10 Sections 15.2 and 15.3 in 1980, prior to the building of a new buttress, looking east.

Hillyfield House/Snayle Tower 1980. J.R.L.Thorp undertook monitoring work on the wall at the western corner of the city whilst repairs were being carried out, and additional buttressing was being constructed in this year. The repair work comprised the removal of some ancient facework and its replacement with new (partly in stone, partly in brick) and the construction of two massive brick buttresses on the site of the Snayle Tower itself, and the erection of a further large brick buttress to support the wall where it acts as a revetment to Bartholomew Terrace (in the gardens of Hillyfield House). The record of this work is confined to a photographic record of the appearance of the wall before the additions were made (Pls 10,13 and 21-22, below).

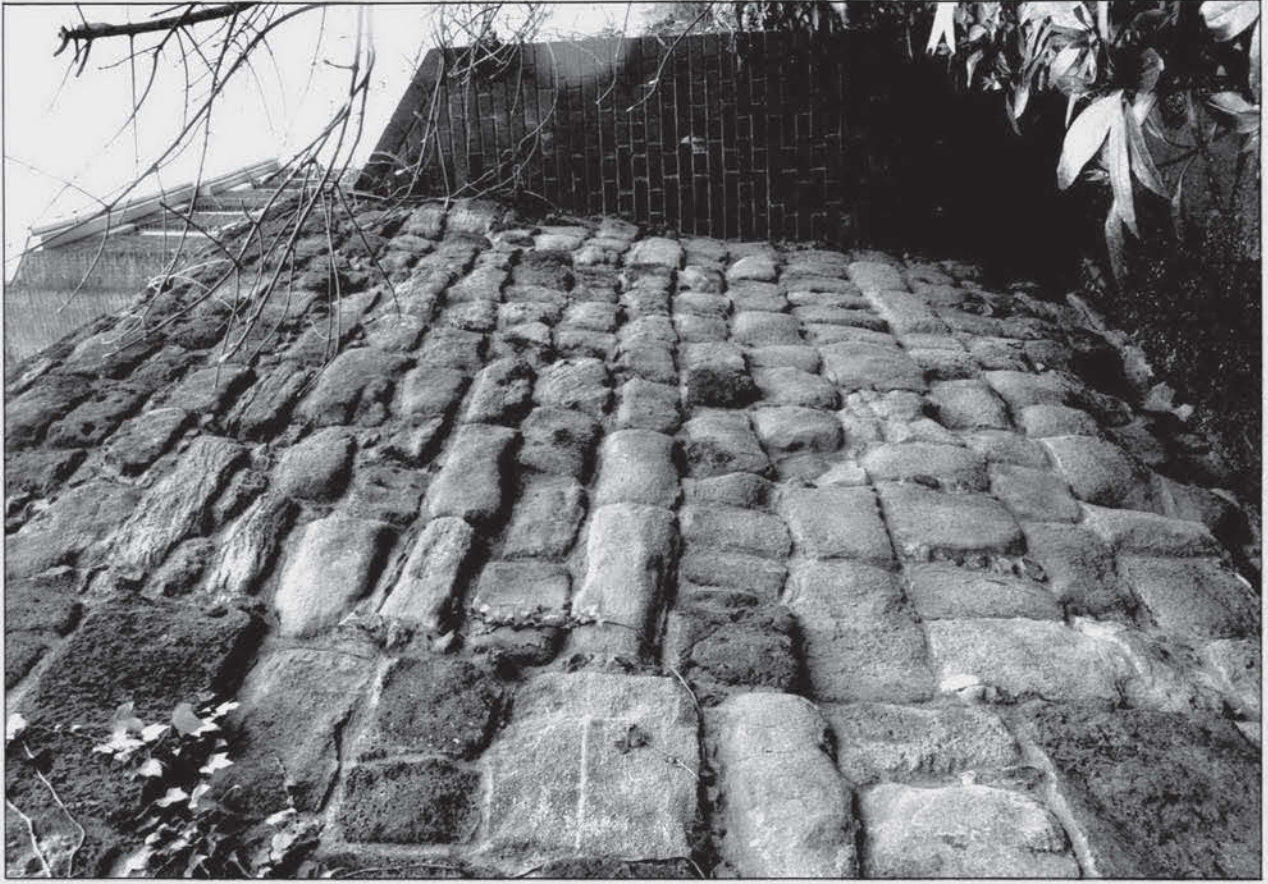
Section 15.3: (33.5m.) To an extent this is a composite of several builds; the wall here is generally obscured by climbing plants (wisteria, so a little more accessible in winter than summer). The general character of the wall, however, is uniform enough to warrant its description as one, although patched. The build is punctuated by buttresses at xx (the modern one), xx and xxm. from its north-east end, which sub-divide the section into convenient parts: (a) c. 4.5m. of well-coursed large Triassic sandstone blocks of varying depth; poorly jointed in that the style of masonry pays little attention to vertical bonding of the blocks (Pls 10-11); parapet rebuilt, as above. The build ends in the modern buttress (Pls 11 & 12), but the photograph of 1980 shows a break in the masonry in the wall now obscured (Pl. 10). (b) 10-11m. to the south west of the buttress is completely obscured by wisteria, when the fabric is visible again it is of broadly similar composition, although with rather more volcanic trap than in sub-division (a) (Pls 13 & 14). The second buttress (Pl. 15) is composed of 60% Triassic sandstone plus volcanic trap and breccia, the topmost courses are rebuilt in a variety of exotic stones. (c) Beyond the second buttress the facework is still predominantly of Triassic sandstone, but is heavily rebuilt or patched and contains an appreciable quantity of breccia (Pls 15 & 18). The distinction between the facework and the rebuilt parapet is also less clear-cut here than elsewhere. (d) The third buttress is mainly of breccia, with a weathered plinth of volcanic trap (Pl. 16). The top has been rebuilt recently; one block of Bath stone on a quoin (pl. 18) suggests that the whole buttress was rebuilt, perhaps in the 19th century. (e) For the final stretch of this section (Pls 17 & 19) two builds are distinguished, again representing rebuilds of a common original build: the first 3.5m. is mainly of Triassic sandstone but has some breccia mixed in; the second stretch, also 3.5m., is of roughly coursed work of volcanic trap, breccia and Triassic sandstone running as far as the modern brick buttress on the site of the Snayle Tower (16.1, below). Immediately short of the brick buttress is a chase in the wall face representing the rear wall of the 19th-century buildings of Paradise Place (cf. the O.S. Town Plan at 1:500 of 1876).

Plate 11 Section 15.3 in 1994 with brick buttress.

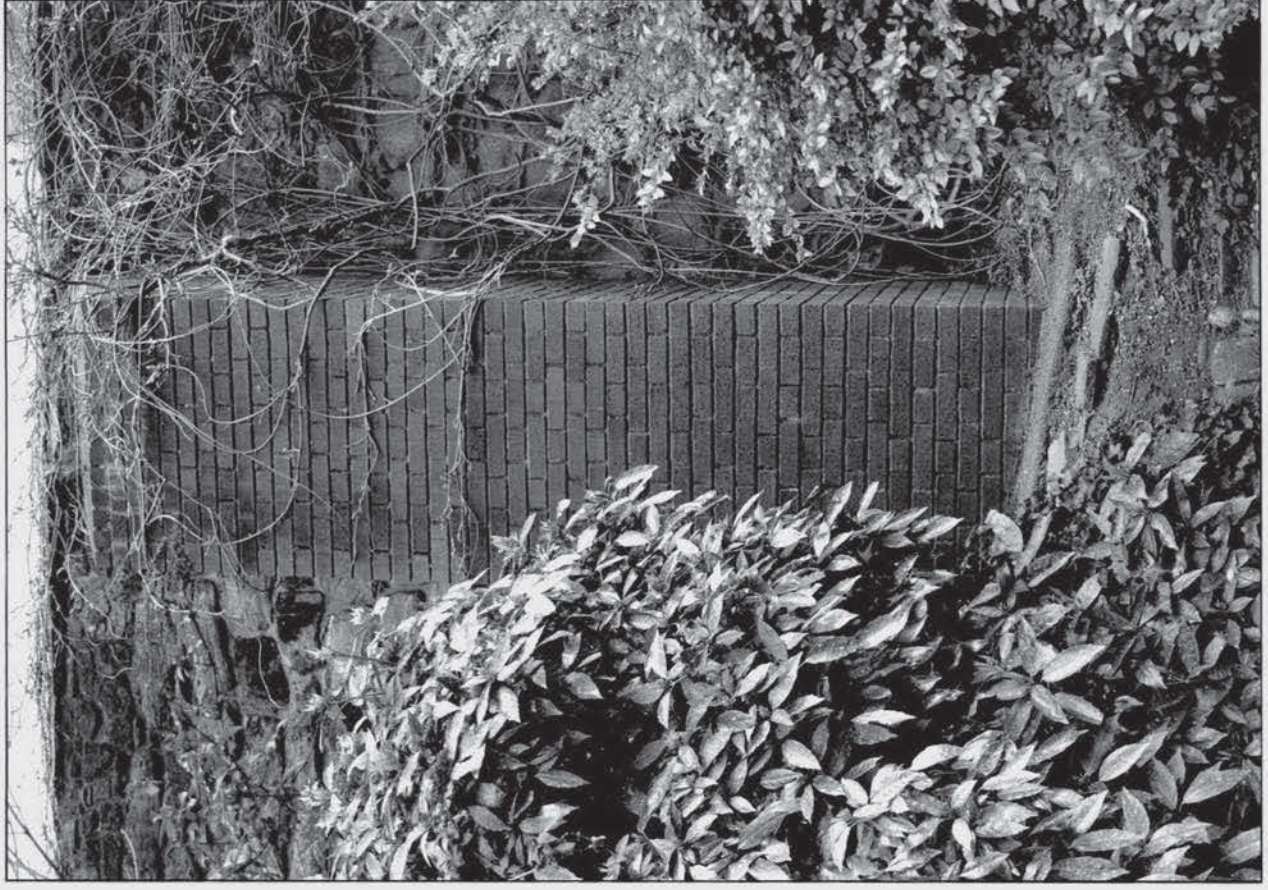
Plate 12 General view of brick buttress in 1994.

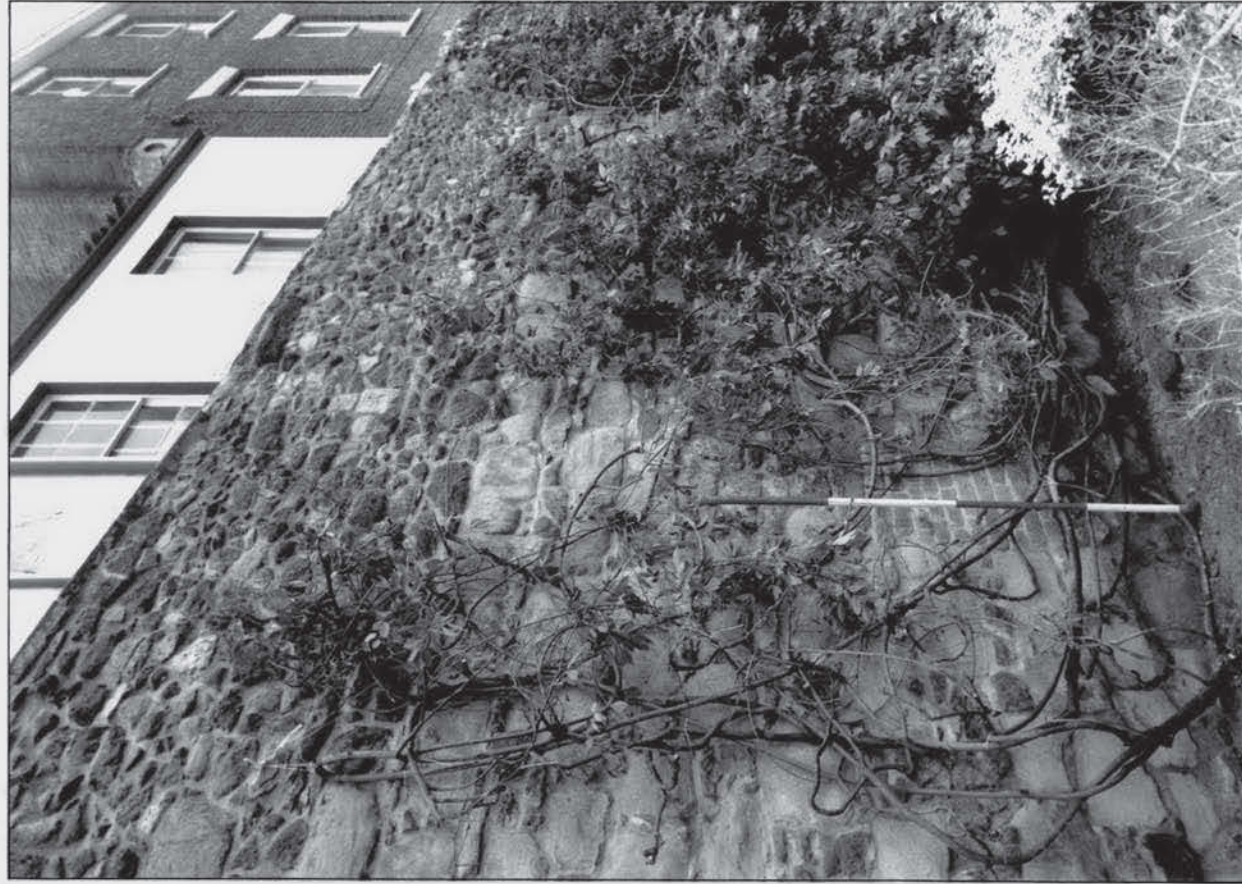
Plate 13 Facework between the first and second buttresses, below 2-3 Bartholomew Terrace.

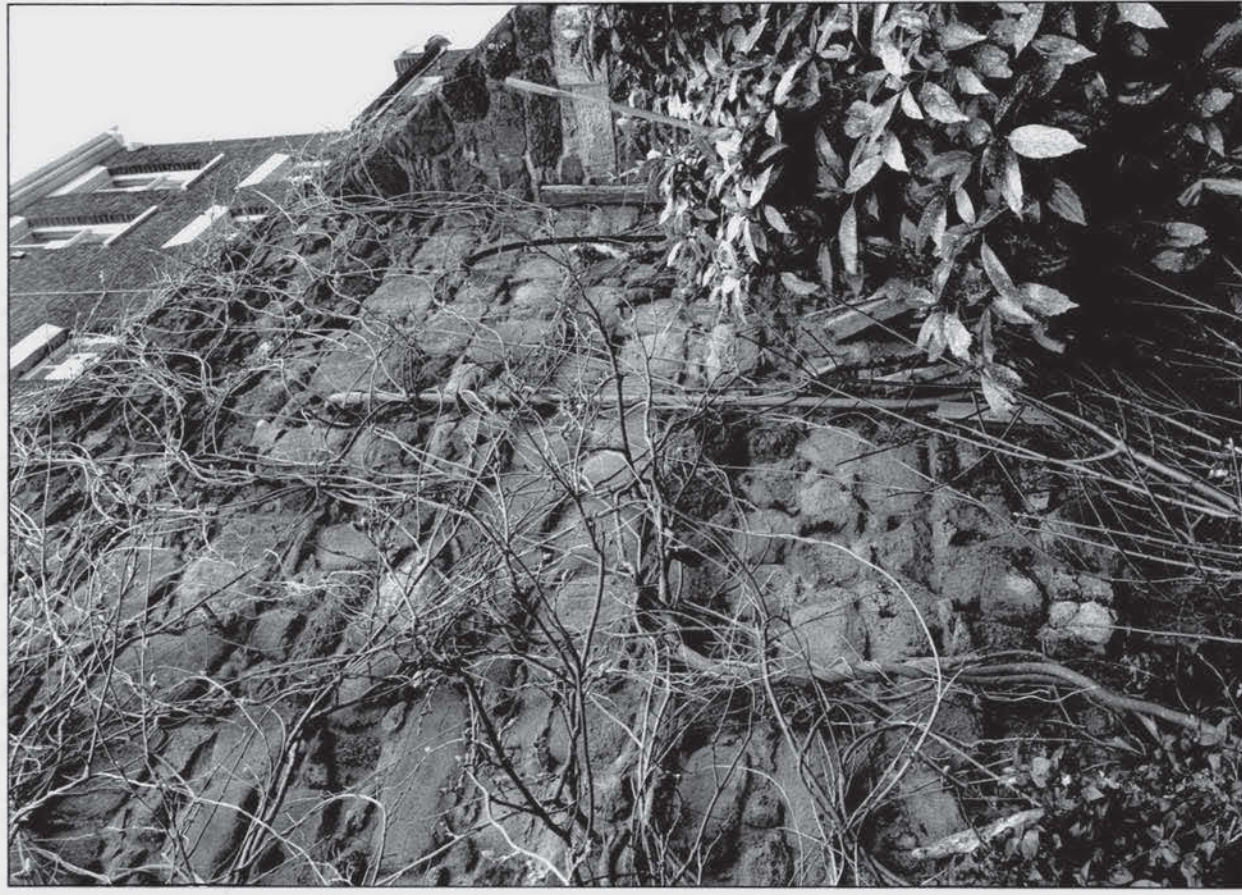
Plate 14 Facework between the first and second buttresses, below 3 Bartholomew Terrace, with the second buttress in the background.

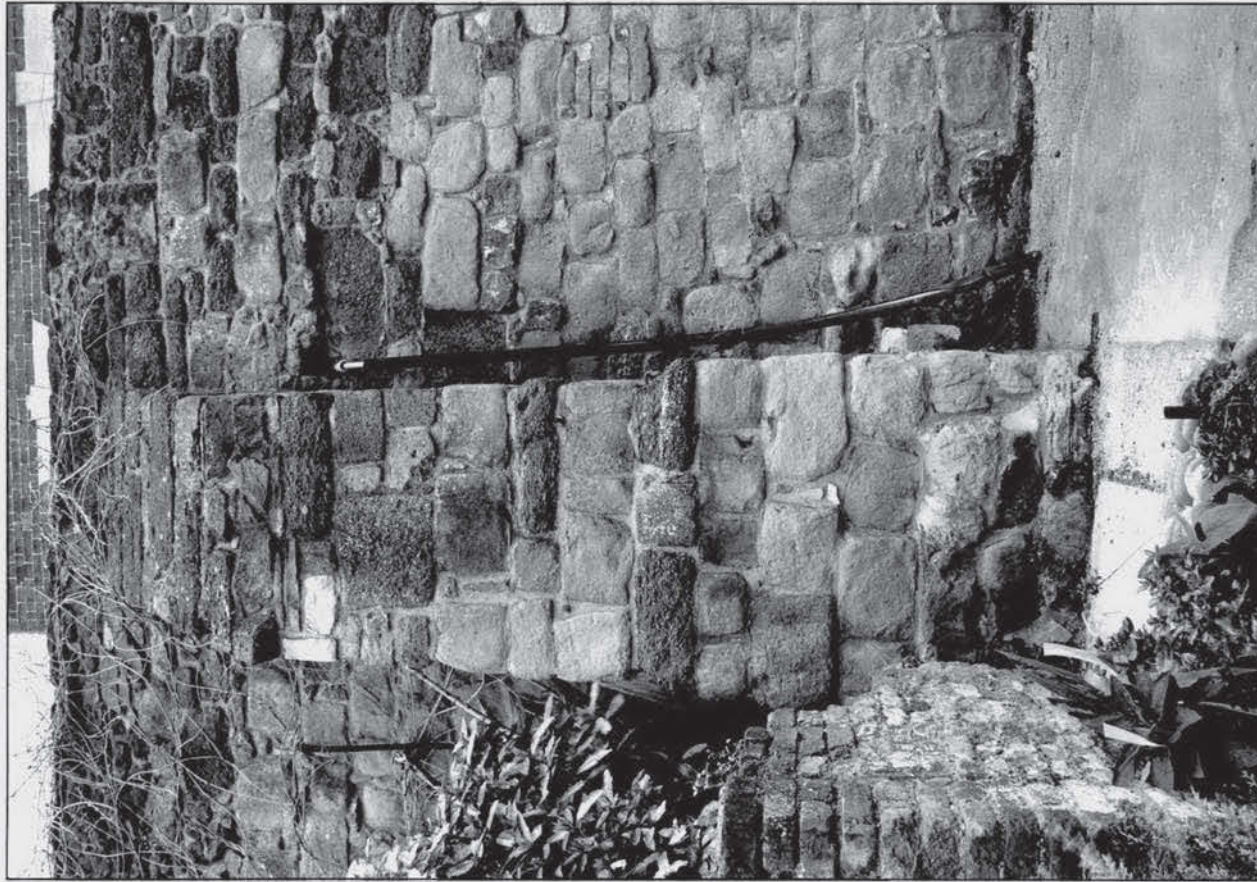
Plate 15 Elevation view of the second buttress.

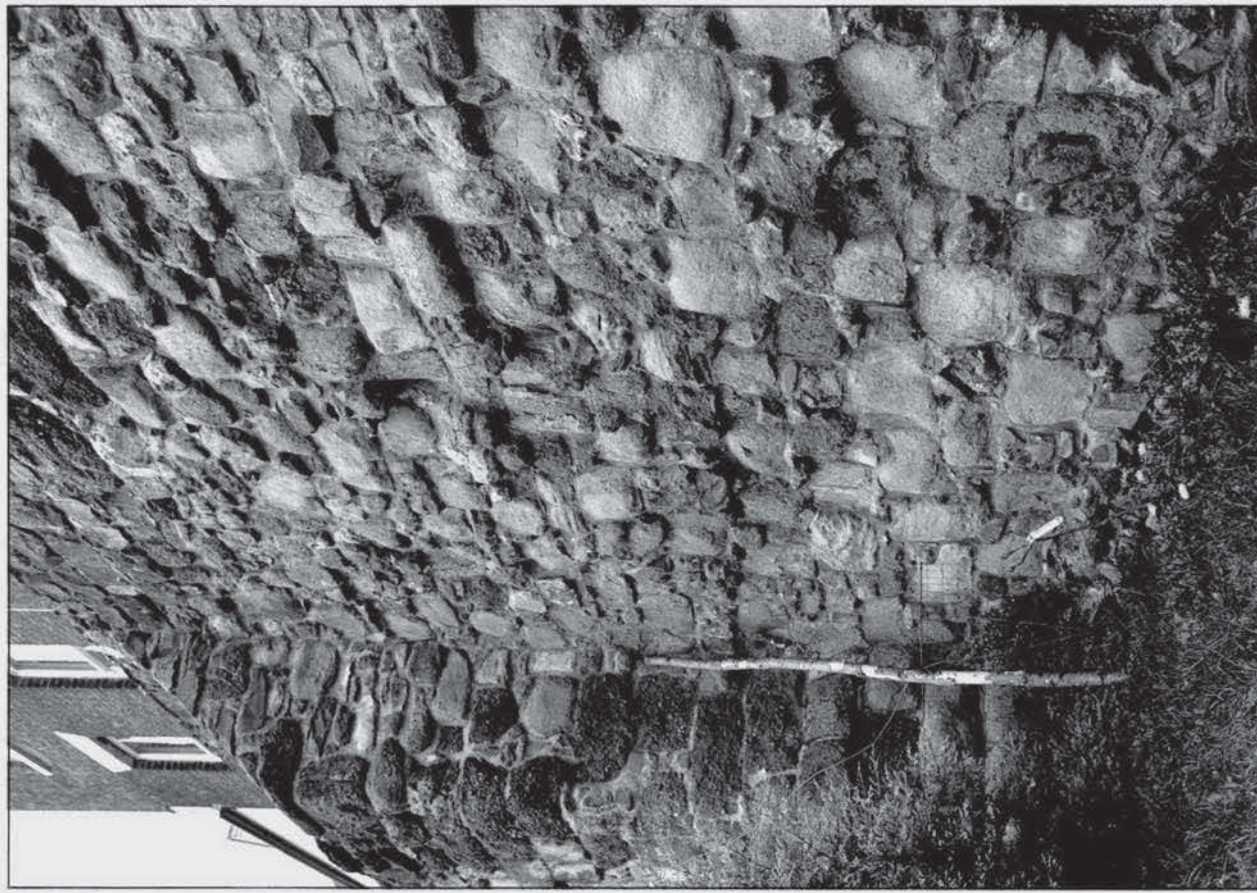
Plate 16 The third buttress and facework to the south west, oblique view looking east.

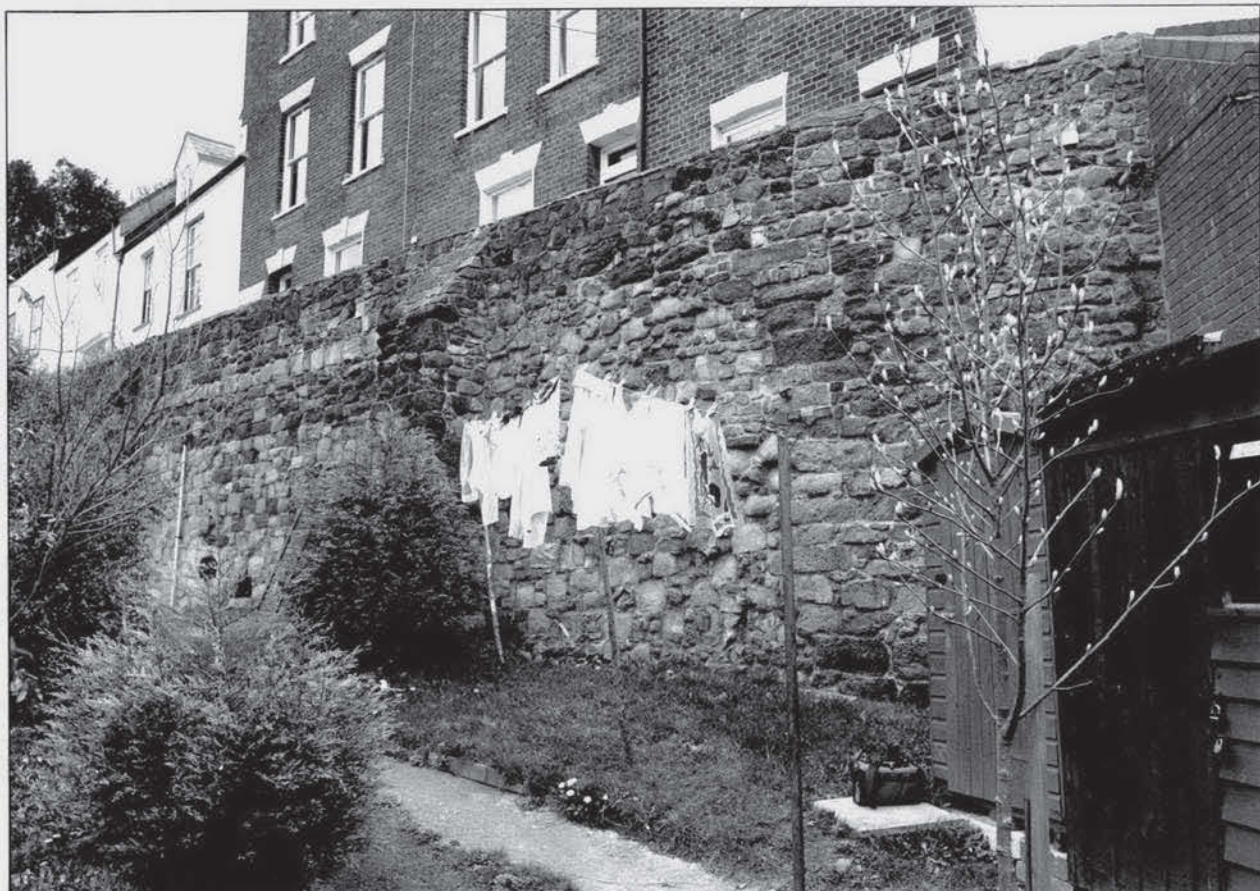
Plate 17 General view of the third buttress and facework of section 15.3 to either side, looking east.

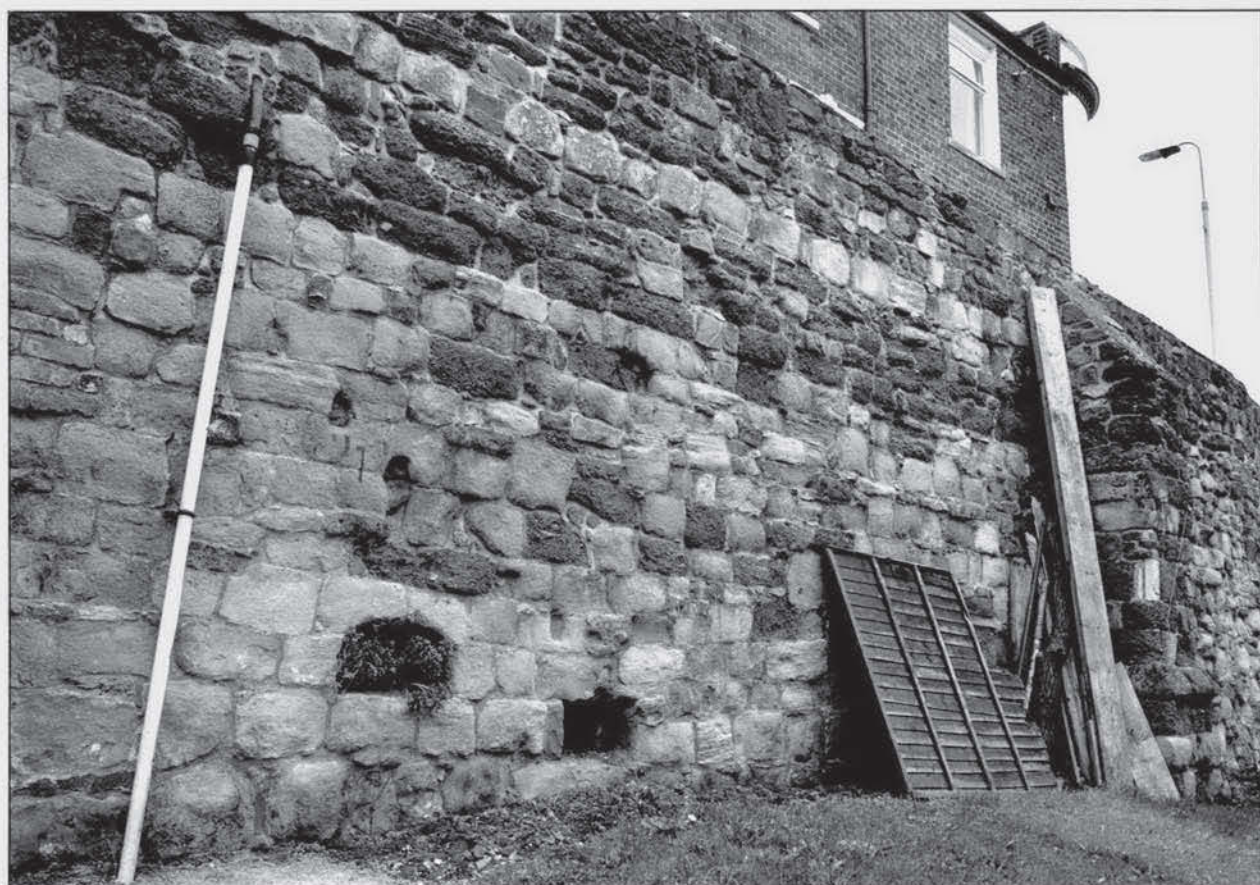
Plate 18 General view of the facework to the north-east of the third buttress, looking south.
