Exeter City Defences (Friernhay and Snaggle Tower) 1980 - 1990

**EXETER CITY DEFENCES
RECORDING OF THE EXTERIOR ELEVATION
OF THE CITY WALL BETWEEN FRIERNHAY
AND SNAYLE TOWER, 1980 AND 1990**

Exeter Museums Archaeological Field Unit

Report 94.38

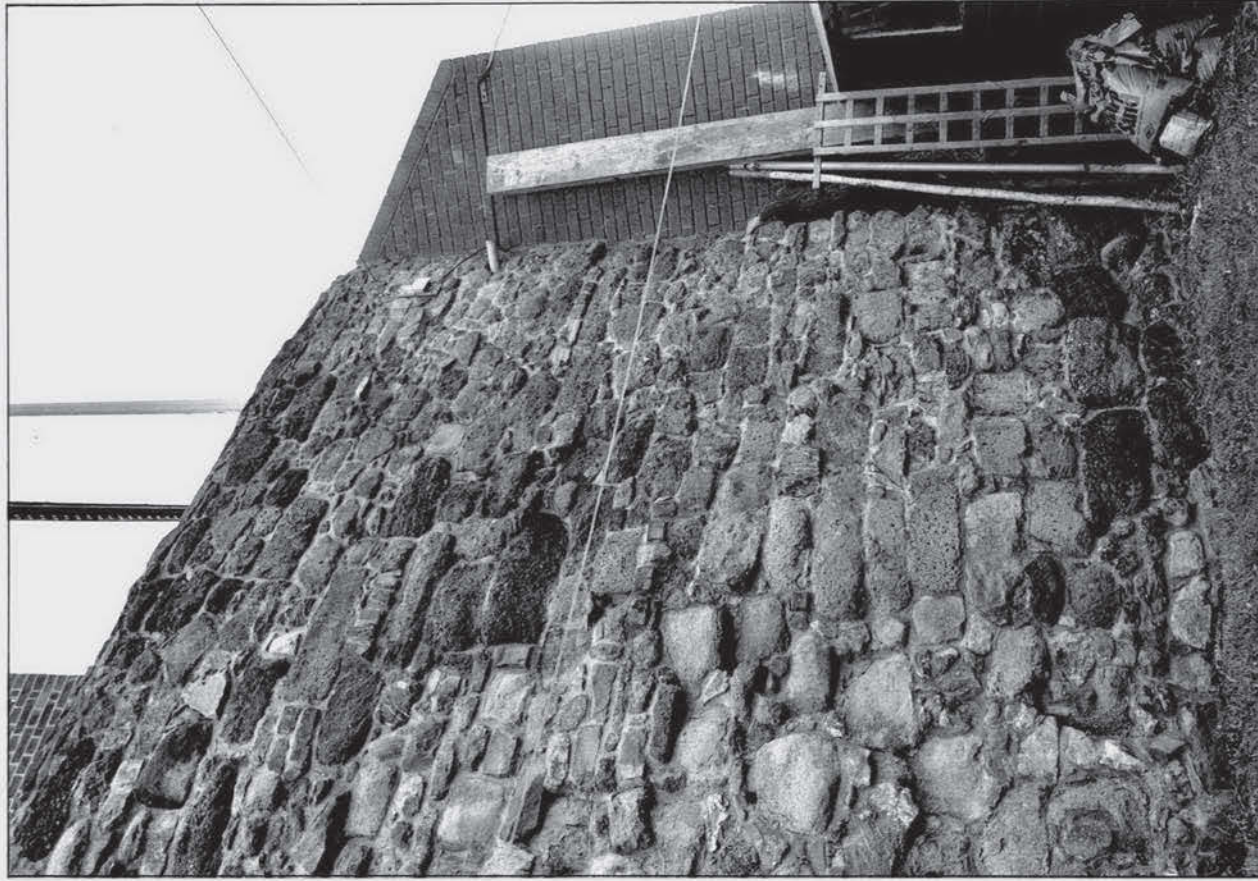
Plate 19 Section 15.3, southwestern extremity and brick buttress on the site of Snayle Tower.

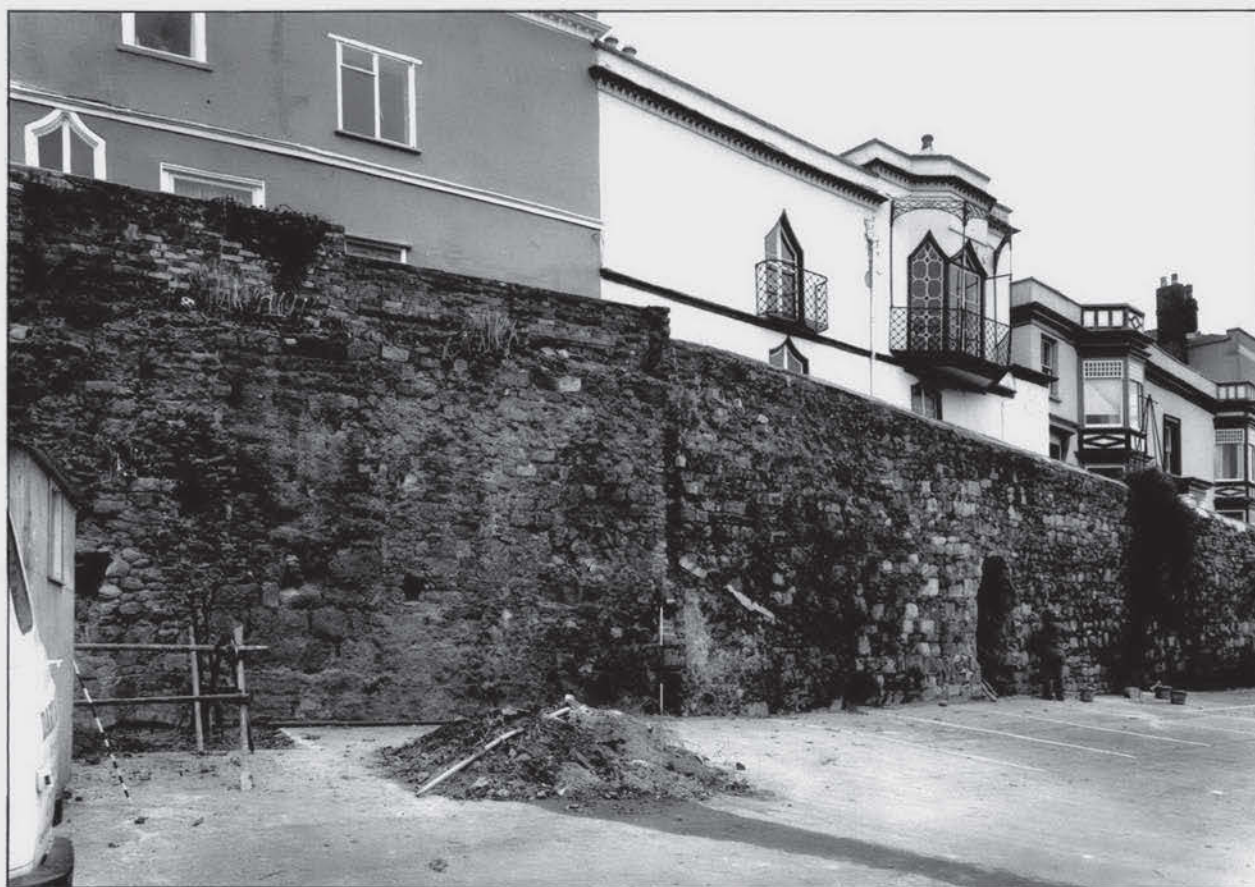
Given the history of the structure just outlined, the fabric which survived on the site of the Snayle Tower, and which was recorded in the photographs of 1980 (Pls 21 & 22), must have dated to the early 19th century, or later, i.e. after the removal of the bastion. Some time later a small terrace of houses was built at right angles to the wall, butting against it, known as Paradise Place or Ash Grove. This was demolished in the 1950s or '60s. When the present facework was under construction in 1980 a trench was dug at the base of the wall on the site of the tower; although this gave useful archaeological observations at a level beneath (and regarding a period earlier than) the city wall (Bedford and Salvatore 1992, 88-90), it showed that, below ground, the only fabric to survive was the brick foundations and partially-upstanding walls of the Paradise Place Houses (cf. a brick arch visible at the extreme left hand side of the photograph in Pl.22).

Section 16.2: (1.5m.) A short length of facework of large squared breccia blocks, rather weathered, plus some volcanic trap and Triassic sandstone fragments at the west end (Pls 22 & 23). This might be a remnant of fabric associated with the Snayle Tower (in which case it might date to the early post-medieval period or later), or more probably it represents a part of the infill of the site of the tower after its removal in the early 19th century. If the latter is so then the eastern limit of the build may coincide with the limit of the tower.

Section 16.3: (8m.) Remnants of good-quality medieval type facework of squared volcanic blocks in regular courses; heavily patched with small volcanic rubble facework of a late date (?re-using core stone plus occasional exotics such as South Devon Limestone and beach pebbles) (Pls 21-23). Survives as runs of blocks in single courses, occasionally more. Presumably 14th or 15th century in date.

Plate 22 Sections 16.1-16.4 before repairs in 1980, looking north-east.

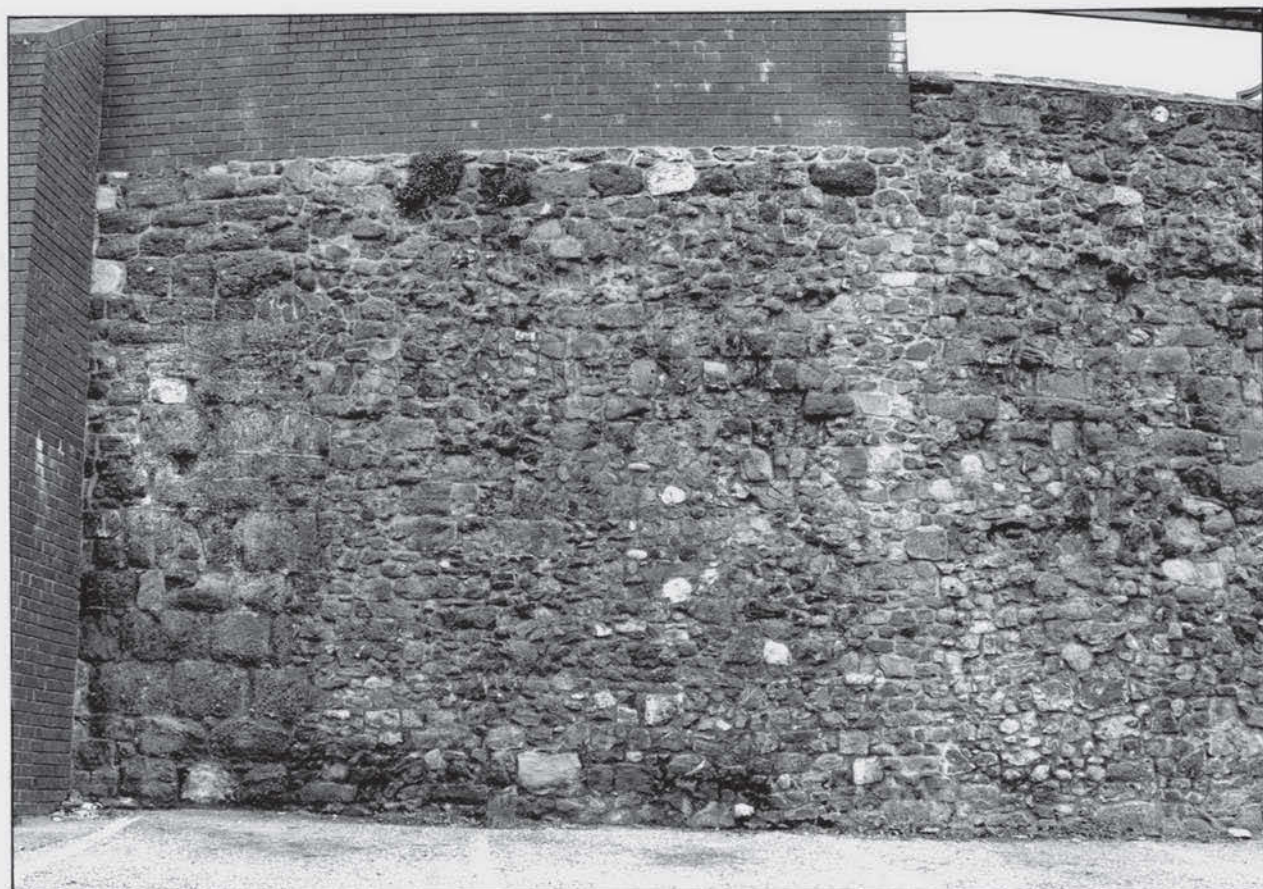
Plate 23 Sections 16.1-16.3 in 1994.

The work of 1980 involved the removal of the greater part of the facework and its replacement with two massive sloping buttresses of brick (Pl. 20), and new brick facework between (and a little new stone facework at the base of the wall). Extensive rebuilding was done top the parapet at the same time, both in this section, and to that to the south west (Pl. 23).
